Kugluktuk Water Treatment Plant

Raw Water Pipeline Assessment

Government of Nunavut, CGS

March 3, 2020

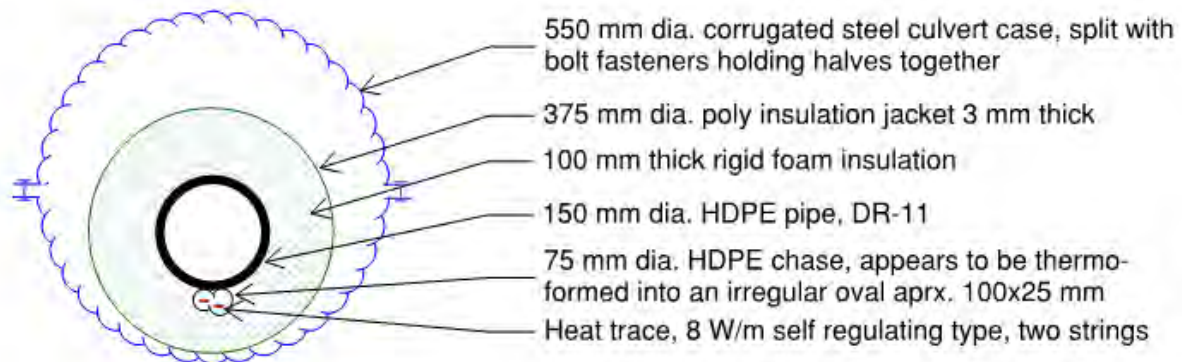
The original branch raw water pipeline consists of a 150 mm (6") HDPE pipe encased in 100 mm (4") rigid foam insulation. The insulation is jacketed in 3 mm (1/8") poly shell. The assembly is contained in a 550 mm (22") corrugated steel culvert which is split and has bolt fasteners at 100 mm (4") intervals. A chase containing the heat trace element is cast in the foam insulation just below the HDPE pipe. The chase appears to be 50 mm (2") PVC pipe, thermo-formed into a rough oval which gives better thermal contact with the HDPE pipe than if it was left round. See Figure 1.

*Figure 1: Raw Water Pipeline Cross Section (2000 branch)*

Heat trace in the original branch runs in an irregular chase (see section 6.1.1 and Figure 1) which will likely cause trouble for an electrician installing new heat trace. The old heat trace may prove difficult or impossible to remove by pulling on one end. It may also be difficult to thread a new strand just using fish tape. Replacement may involve unearthing, opening the steel casing, cutting through the insulation and cutting opening the plastic chase to clear obstructions. A considerable contingency amount should be allowed for when budgeting this item. A note should be made on construction documents to alert contractors.

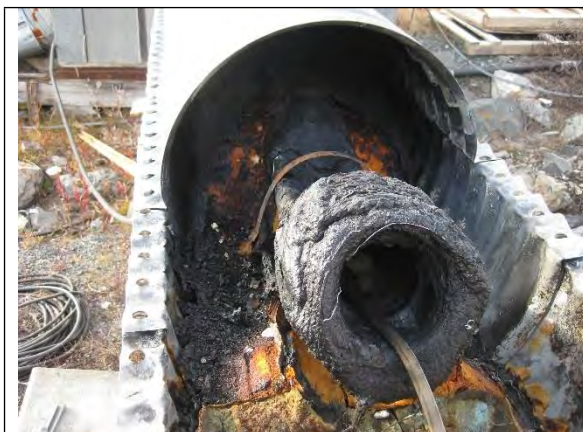
Photo 1: Burned tee to old pumphouse.

A short section of pipeline was destroyed by fire; the fire was caused by failure of the heat trace. Fire is a risk whenever heat trace is water damaged or kept in service longer than the manufacturer recommends. A tee and short branch of pipeline to the old pumphouse is not currently connected to the pipeline as a result (Photo 1.) The tee has been replaced with a straight piece of pipeline and now terminates only at the Old Access Vault 1 near the Coppermine River (Photo 2.) This branch is currently used with the 'ice shack' to pump fresh water when the new intakes are suffused with sea water. The Old Pumphouse is not usable with this configuration so a new tee should be installed.

The damaged Tee at the Old Pumphouse should be replaced with a new tee fitting and new pipe to the extent of the damaged area.

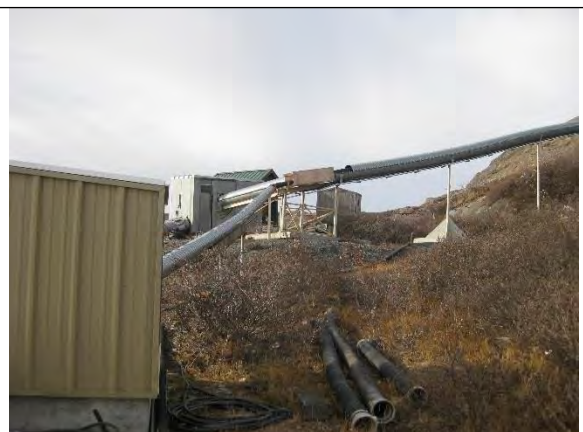
Photo 2: Tee removed, original pipeline now terminates only at the Old Access Vault 1.

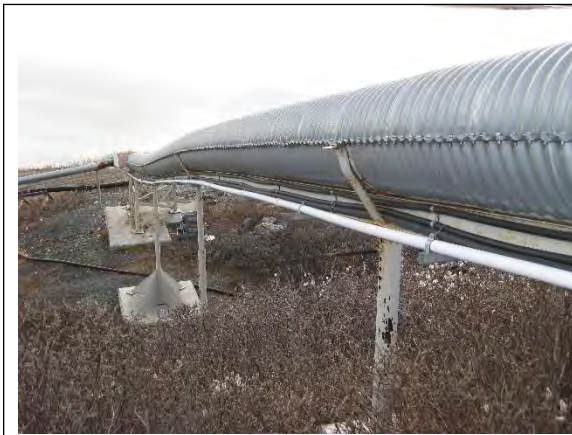
Photo 3: Elevated pipeline is supported on columns and concrete pads.

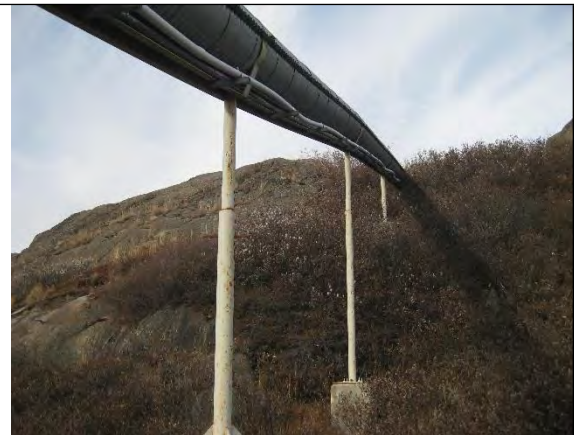
Photo 4: Frost action has caused supports to become uneven.

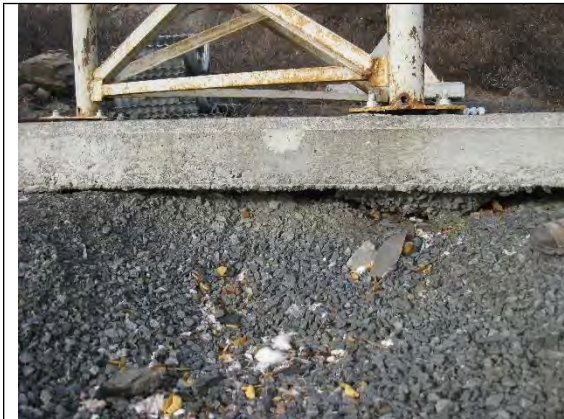
The culvert emerges from the granular cover about 30 meters up from the old pumphouse; there is a steep rock outcrop which necessitates a change from buried to overhead support. There are steel columns supporting the pipeline for this portion, two are resting on concrete columns and two on concrete pads (Photo 3.) The concrete pads have moved through frost action and support of the pipeline is not straight and even (Photo 4.) The pipeline appears not to have suffered ill effects from this but some of the supports are overloaded and straightening is required. The supports have height adjustment holes and pins so straightening should not be time-consuming or difficult. The concrete pads are losing granular support on the downhill side so granular should be added (Photo 5.) The pads still appear to be level.

Photo 5: Concrete pads are losing granular support.

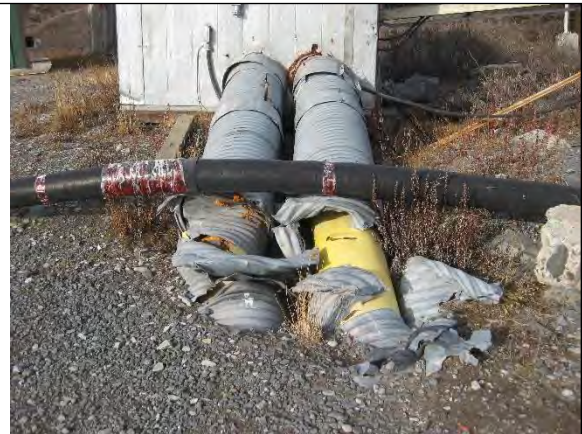
Photo 6: Steel casing and jackets damaged at the road crossing.

The intake lines from the Old Pump house to the Coppermine River are not currently serviceable as they are fouled with silt. They could be returned to service by clearing the intakes which may be as simple as reverse-flowing them. The steel casing and poly jackets have been damaged by heavy equipment where the road crosses just downhill from the Old Pump house (Photo 6.)

One of the pumps from the old pumphouse has been removed for use in the Ice Shack. Since the Ice Shack has proven to be an operational necessity a new pump should be provide for the old pumphouse. The River Pipeline cases should be repaired to prevent damage to the pipeline.

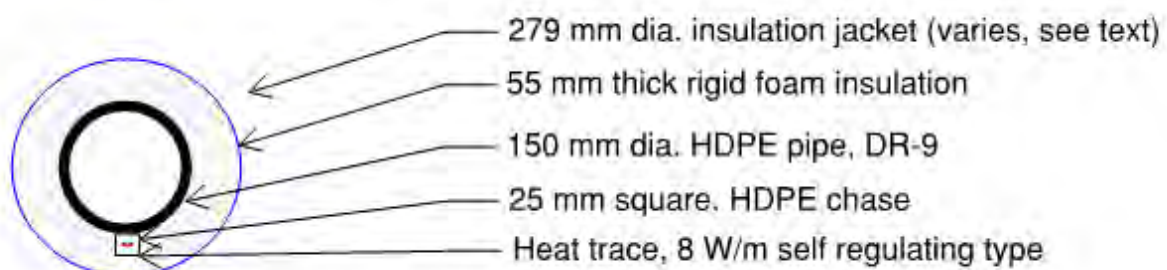
The new raw water branch (2014) has three variants of pipeline. The run from the branch to the New Pump house is a manufactured product called 'Spiwrap' by Urecon (Photo 7.) There is a 150 mm (6") DR-9 HDPE pipe encased in polyurethane foam insulation and jacketed in 22-gauge galvanized steel. The jacket has an outward dimension of 279 mm (11") and provides 55 mm (2.188") insulation thickness. There is a heat trace chase with a roughly square section about 25 mm on a side which is cast with one side touching the outer pipe surface. See Appendix C for product submittal information.

Figure 2: Raw Water Pipeline Cross Section (2014 branch)

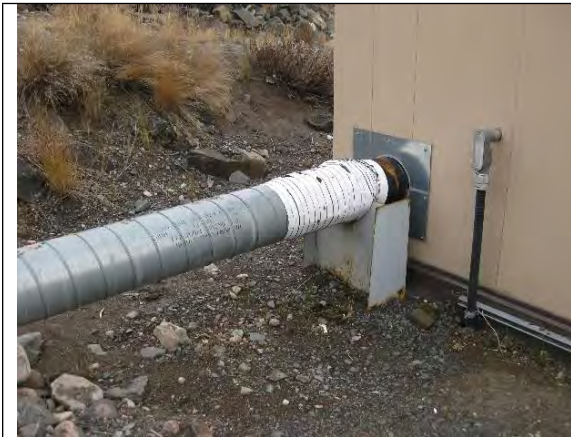
Photo 7: Pipeline uphill of the New Pumphouse.

There is a wide-flange steel beam segment used as a support for the pipeline just outside the New Pumphouse in the uphill direction (Photo 7.) The beam appears to be frostjacking and is exerting upward force on the pipeline. The support should be removed, and a surface support should be installed in its place which would stop the frostjacking. Damage to the jacket and insulation should be repaired.

The pipe support noted in section 6.1.2 is frost jacking and damaging the pipeline. This should be removed and replaced with a new grade-supported arrangement. The jacket and insulation should be repaired where it has been damaged.

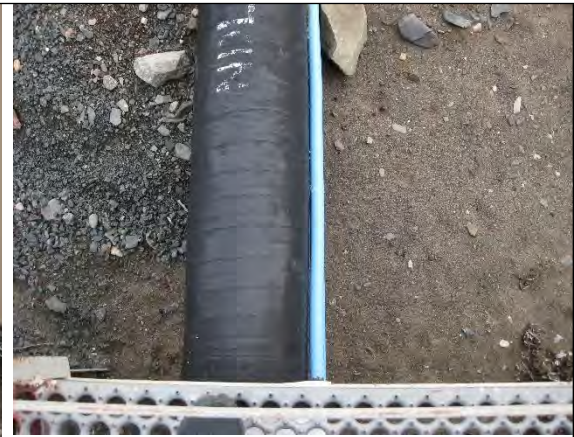
The run from the New Pumphouse to Access Vault 2 is a similar product but with a spiral poly tape wrap over the insulation instead of steel (Photo 8.) From the New Pumphouse to the river intakes the pipelines are accompanied by compressed air lines (blue jacket) for intake screen blowout.

Photo 8: Pipeline downhill of the New Pumphouse. Compressed air line with light blue jacket.

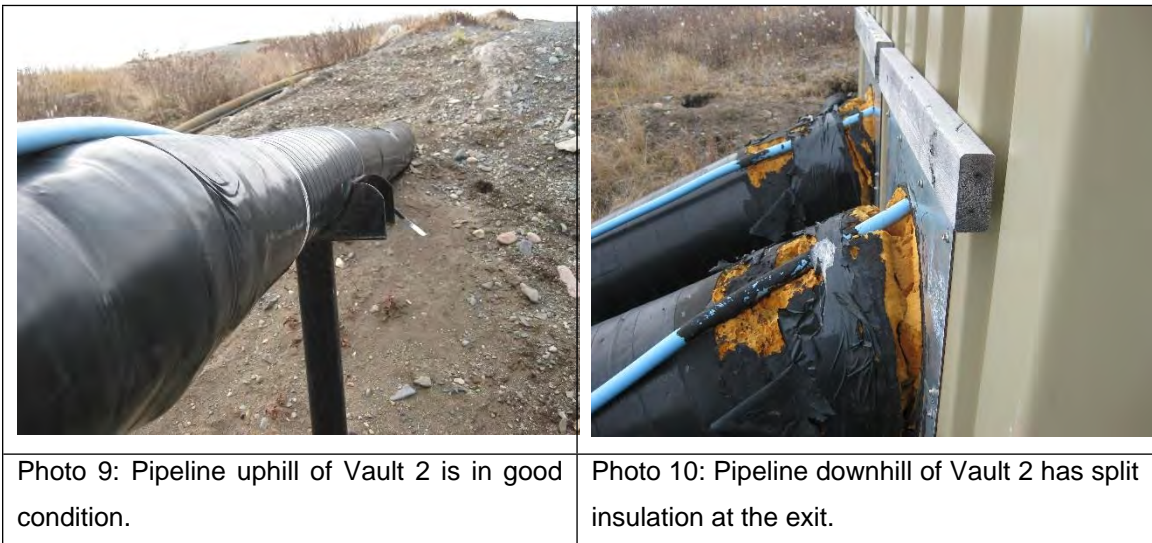
The segment downhill from Access Vault 2 is in good condition except for immediately at the exit from the vault. Both lines have a split in the insulation on the top half of the pipe. This may be caused by differential movement of the vault relative to the pipeline so the vault should be monitored for level and potential frostjacking. The split insulation and jacket should be repaired.

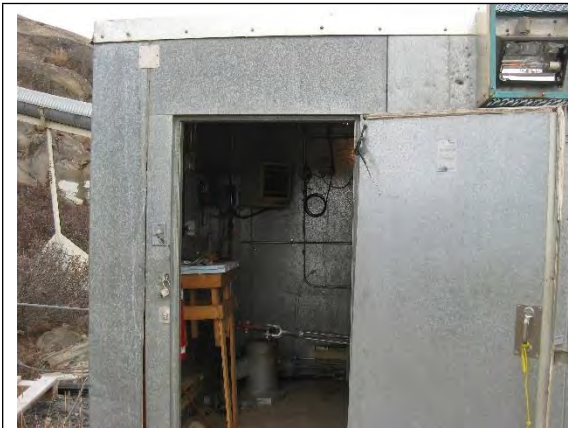
Photo 11: Old Pumphouse is in fair condition.

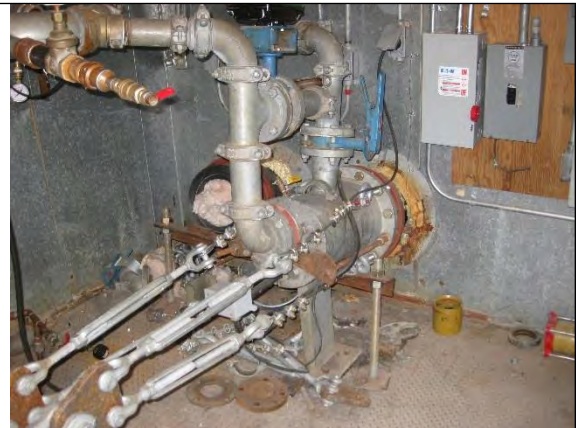
Mechanical components consist of pipeline connections, valves and pumps and are generally in fair condition. One of the pumps has been removed to be used with the 'ice shack' and should be replaced if the Old Pumphouse is to be retained for redundancy.

Photo 12: Mechanical equipment in the Old Pumphouse is in fair condition. One of the pumps has been removed.

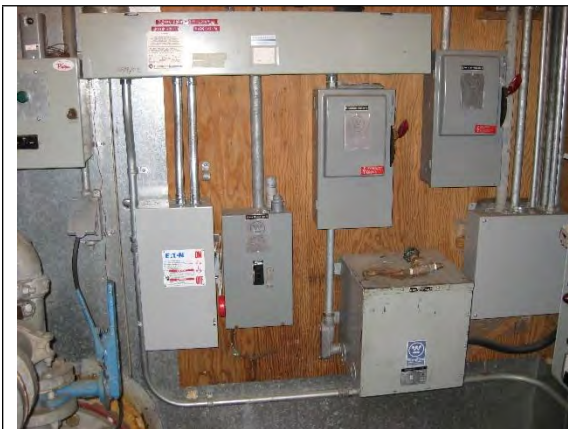
The Old Pumphouse has 600V service from the Old Water Treatment Plant. The raw water pumps are fed from the building as well as a 240V panel which serves lighting, outlets and heat tracing. The electrical equipment is in fair to poor condition with several items not meeting current code.

Photo 13: 600V equipment for raw water pumps.

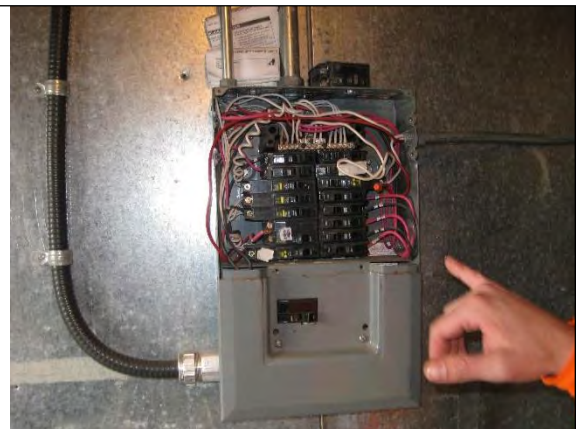
Photo 14: 240V panel needs front cabinet.

The 208V electrical panel in the Old Pumphouse should be replaced. An outlet with switching should be provided to Access Vault 1 for operation of the Ice Shack pump.

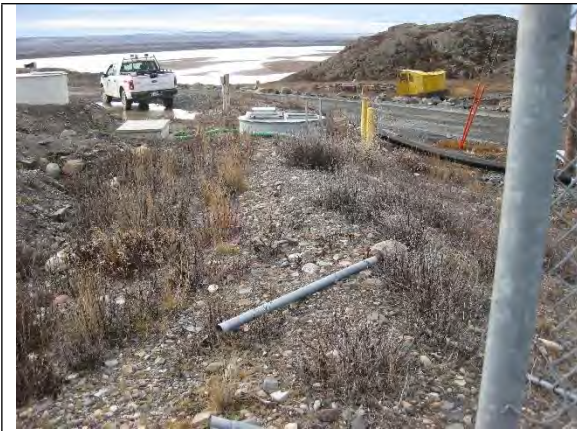
Photo 15: Vault 4 (center) and Vault 5 (top left).

Vault #4 is in fair condition; no action is required.

Vault #5 is in good condition; no action is required.

The interconnect of vaults #4 and #5 would allow decommissioning of the old Water Treatment Plant. Connecting the vaults with a new length (about 8 m) of HDPE pipe would allow water to pump directly to the New Plant. Relocating the 600 Volt electrical service to the New Plant or establishing a new outdoor 600 Volt service would also be necessary. Redirecting the pump controls would be the costliest aspect but this would make complete operation of the plant including raw water pumps possible from the New Plant. This is recommended, with low priority, since it simplifies the system and eliminates the need to heat the Old Plant.

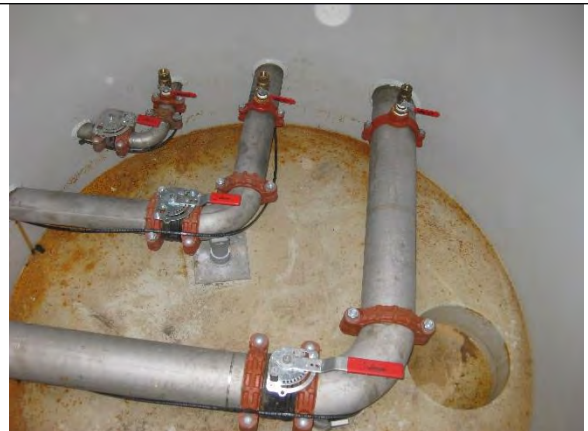
Photo 16: Vault 5 contains elbows and shut-off valves. Note heat trace.
