# Government of Nunavut

## Design Brief

**Project Name:**  
New Pump House Upgrades

**Project Number:**  
OTT-00208308-A0

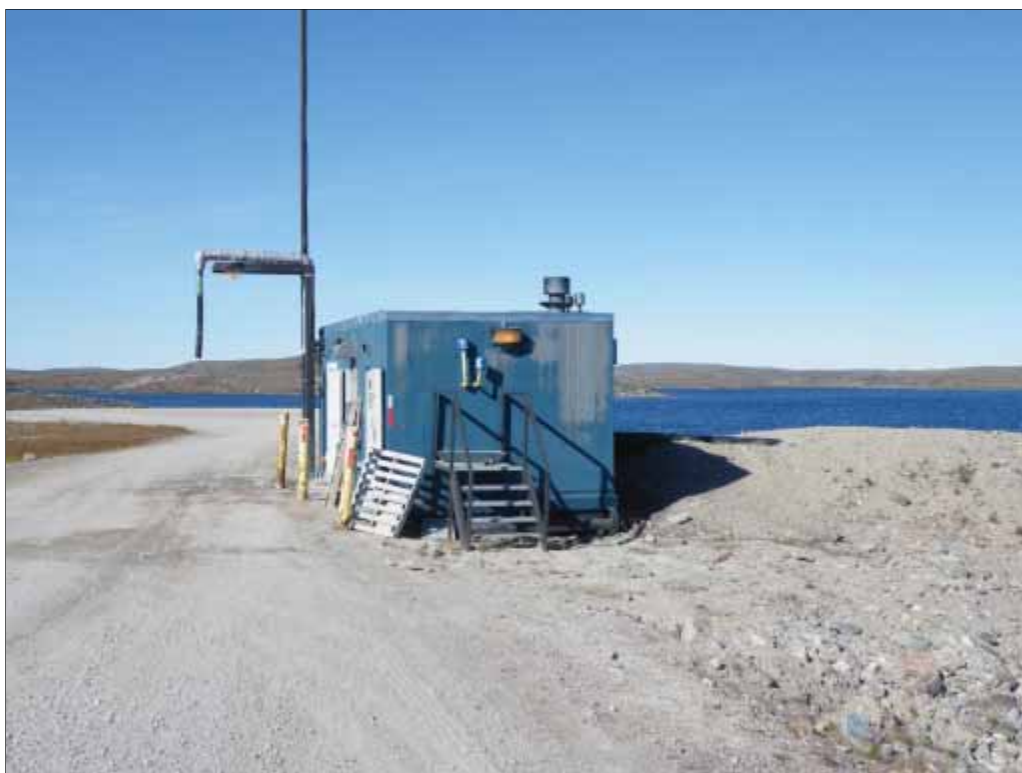
Photo 1: Site

The truck-fill station is accessed via a 4 km long road from the Hamlet. A truck turn-around loop has been provided approximately 100 m beyond the truck-fill. Water service vehicles were observed to easily manage this turn-around loop. Following the turn-around, water trucks drive directly under the truck-fill arm. No challenges were observed with the placing the truck-fill hose into the fill port on the top of the truck tank. It is not anticipated that winter conditions will cause unusual operational challenges, in terms of truck access to the fill point.

No actions that require short term action were noted in connection with the site or building siting. There is sufficient space, with minor relocation of the access road, to accommodate a larger facility.

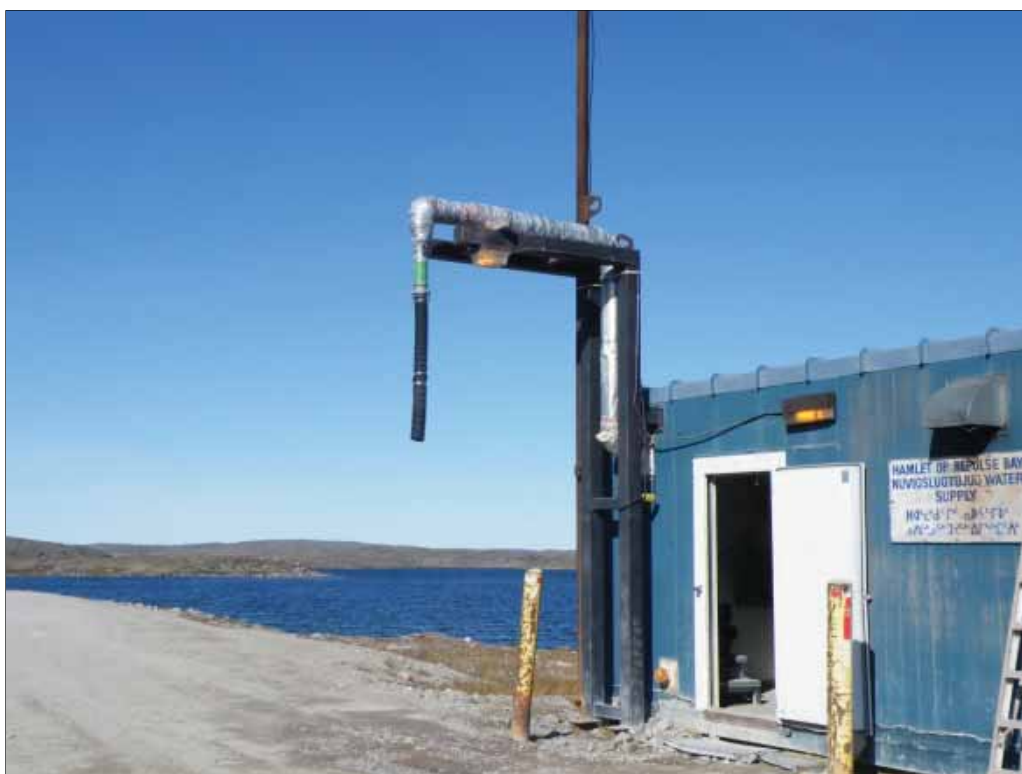
Photo 2: Fill Arm

The truck-fill arm, which is illustrated in photograph no. 2 in Appendix B, was noted to be in good condition. It did not display obvious damage from vehicle traffic. The electrical heat trace appeared to have an open circuit, which suggests that it is currently not functional. This may be the cause for the occasional freeze of this piping reported by local staff.

Recommended short term actions are limited to reinstatement of the heat trace cable.

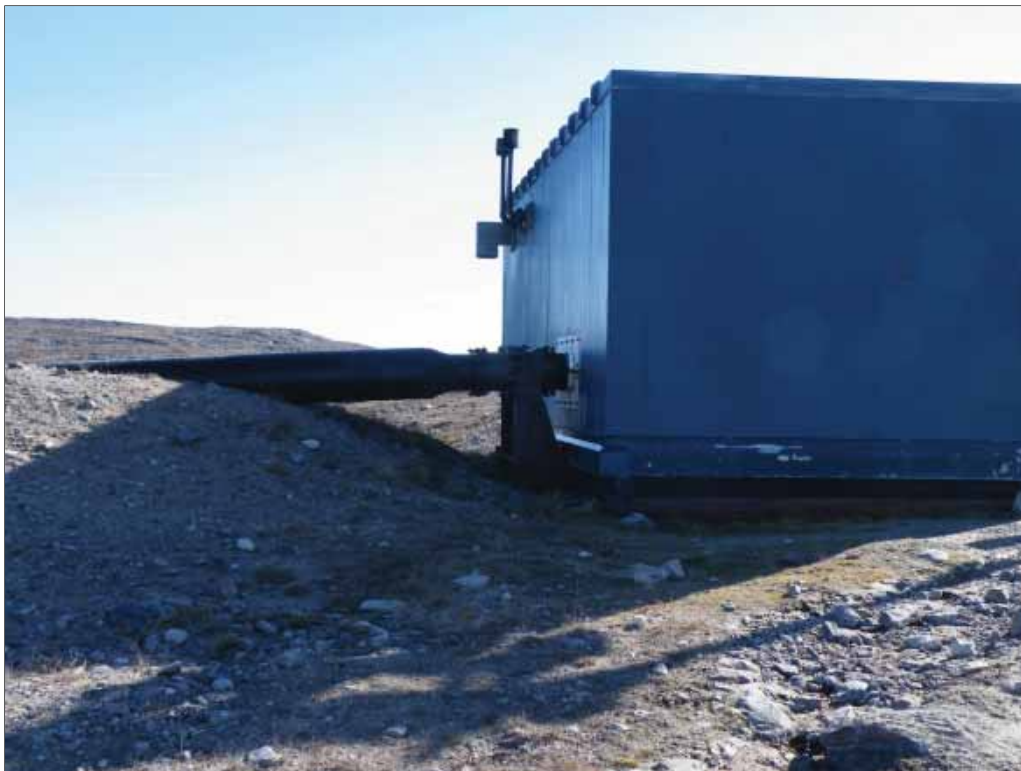
Photo 3: Intake 1

The intakes do not display indications of movement and the ballast blocks appear to be intact. The piping and insulation jacket did not display signs of distress or vandalism. Comments cannot be provided regarding the condition of any intake screens.

No short term recommendations are presented as regards to the intakes. A future reconstruction of the truck-fill station may require extension of these intakes. The existing intakes are suitable for incorporation into the design of a new truck-fill station.

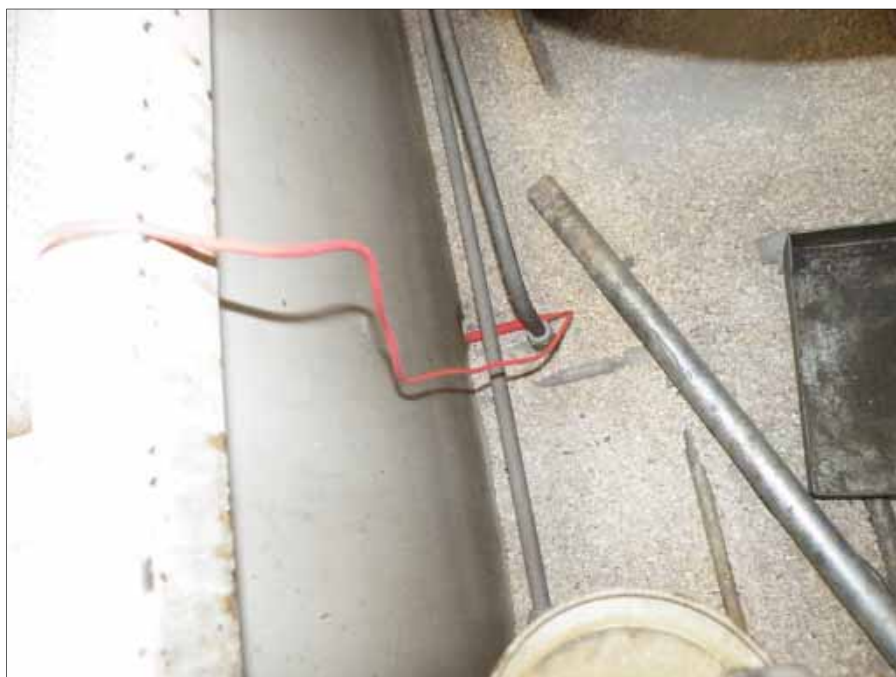
Photo 6: Fuel Hole

The fuel system is limited to that equipment required to provide a supply to the pair of generators. The fuel system includes an internal tank in the generator room, fuel containment and some internal piping. It was noted that there are penetrations of the fuel containment at two locations, with a total of three penetrations at each location, to permit fuel lines to be extended to the generators. It was noted that one of these penetrations was open, which creates the potential for a fuel spill in the event of a failure of any portion of the fuel system within the containment. The risk of a fuel spill is an especially sensitive issue as the truck-fill is adjacent to the community water source. A photograph of this penetration is provided in Appendix C.

It is also noted that the current fuel system does not comply with current code requirements. This system must be brought into compliance with current codes if any changes to the system are undertaken. Compliance with current codes would require the replacement of the entire system.

It is recommended that the opening in the fuel containment be plugged at the first opportunity. No other short term actions are recommended. In the longer term, any reconstruction of the truck-fill station would require the replacement of the fuel system with one that complies with current code requirements.
