- **Government of Nunavut**

Design Brief

Project Name
New Pump House Upgrades

Project Number
OTT-00208308-A0

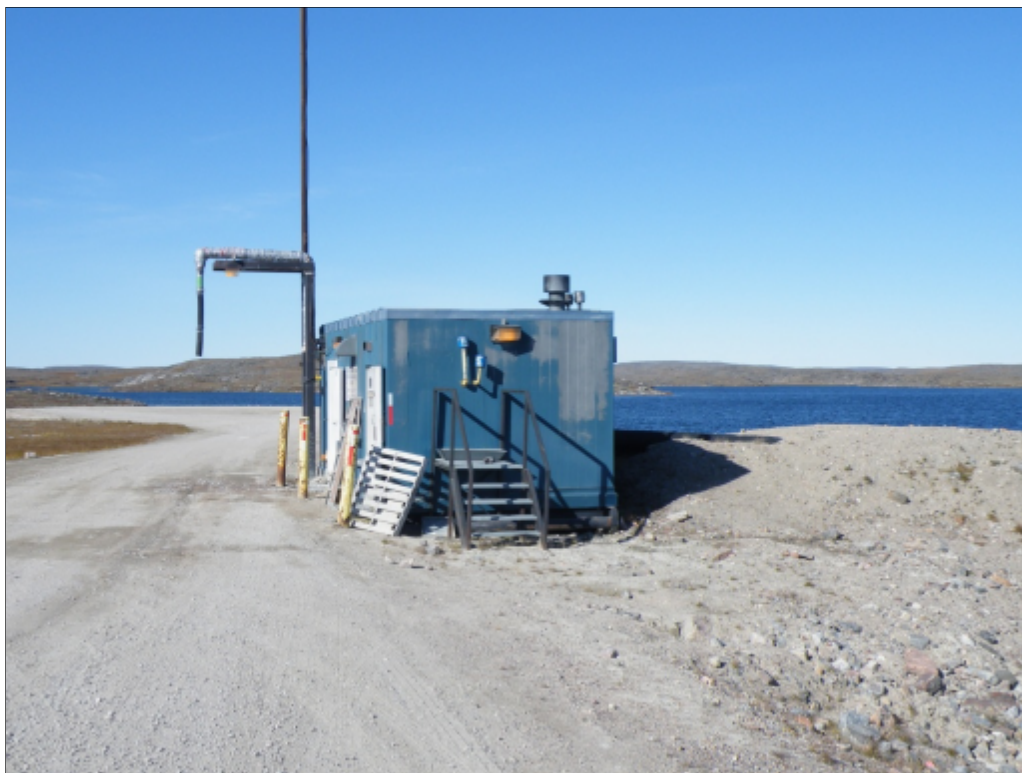
Photo 1: Site

The truck-fill station is accessed via a 4 km long road from the Hamlet. A truck turn-around loop has been provided approximately 100 m beyond the truck-fill. Water service vehicles were observed to easily manage this turn-around loop. Following the turn-around, water trucks drive directly under the truck-fill arm. No challenges were observed with the placing the truck-fill hose into the fill port on the top of the truck tank. It is not anticipated that winter conditions will cause unusual operational challenges, in terms of truck access to the fill point.

No actions that require short term action were noted in connection with the site or building siting. There is sufficient space, with minor relocation of the access road, to accommodate a larger facility.

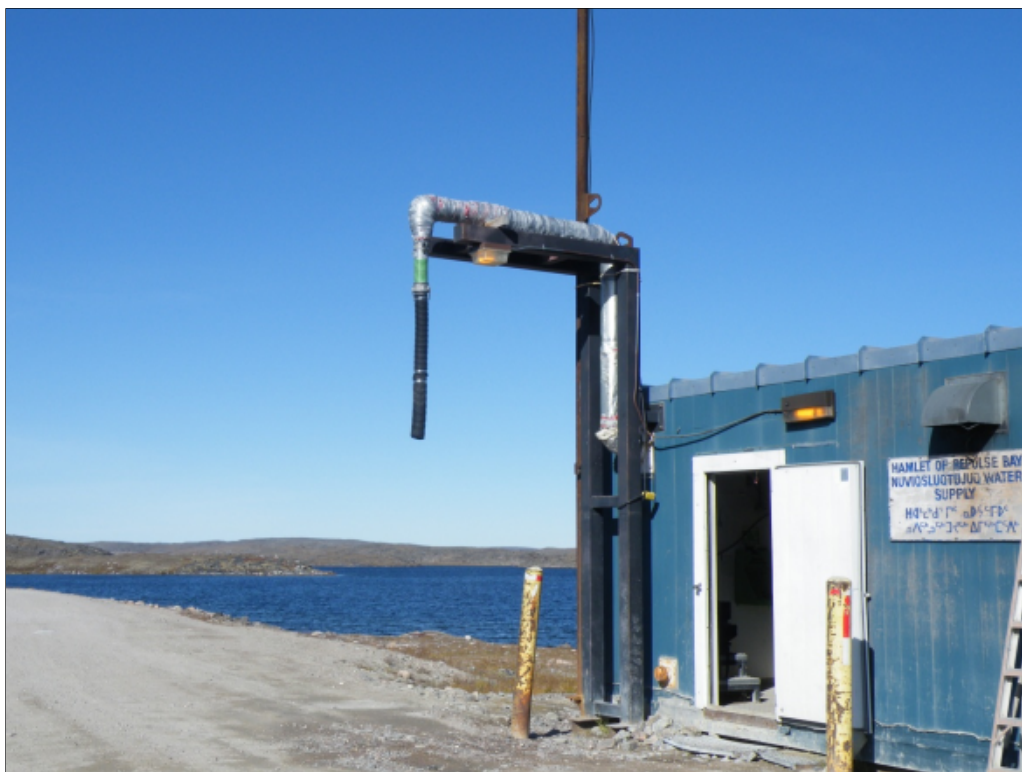
Photo 2: Fill Arm

The truck-fill arm, which is illustrated in photograph no. 2 in Appendix B, was noted to be in good condition. It did not display obvious damage from vehicle traffic. The electrical heat trace appeared to have an open circuit, which suggests that it is currently not functional. This may be the cause for the occasional freeze of this piping reported by local staff.

Recommended short term actions are limited to reinstatement of the heat trace cable.

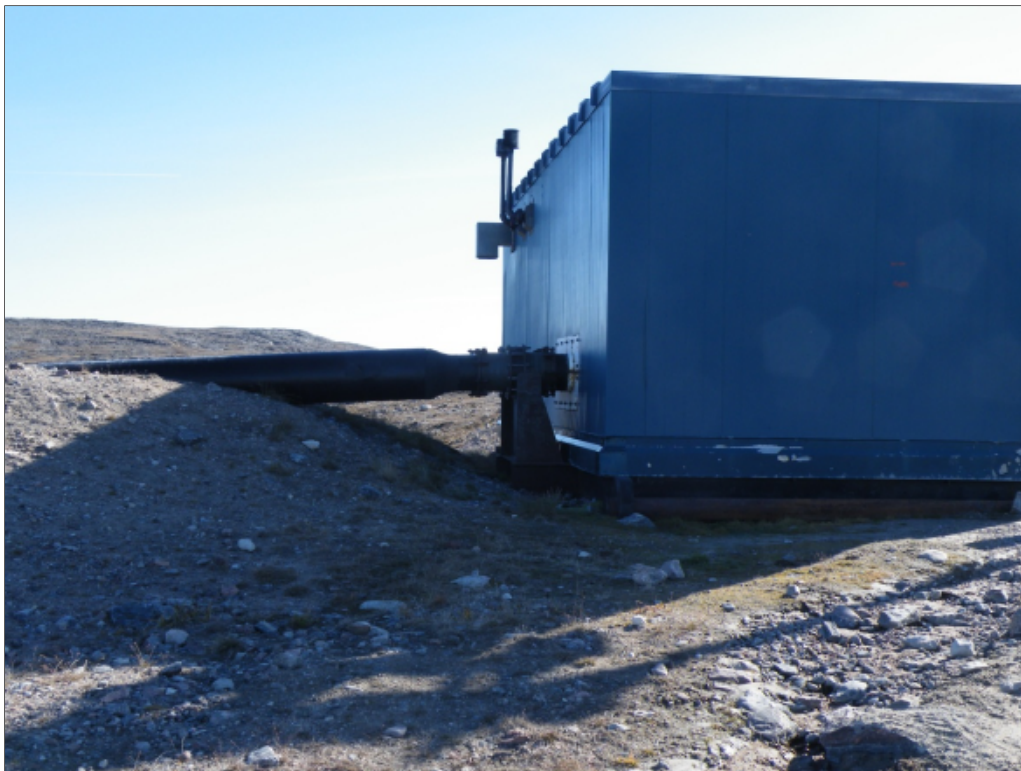
Photo 3: Intake 1

The intakes do not display indications of movement and the ballast blocks appear to be intact. The piping and insulation jacket did not display signs of distress or vandalism. Comments cannot be provided regarding the condition of any intake screens.

No short term recommendations are presented as regards to the intakes. A future reconstruction of the truck-fill station may require extension of these intakes. The existing intakes are suitable for incorporation into the design of a new truck-fill station.

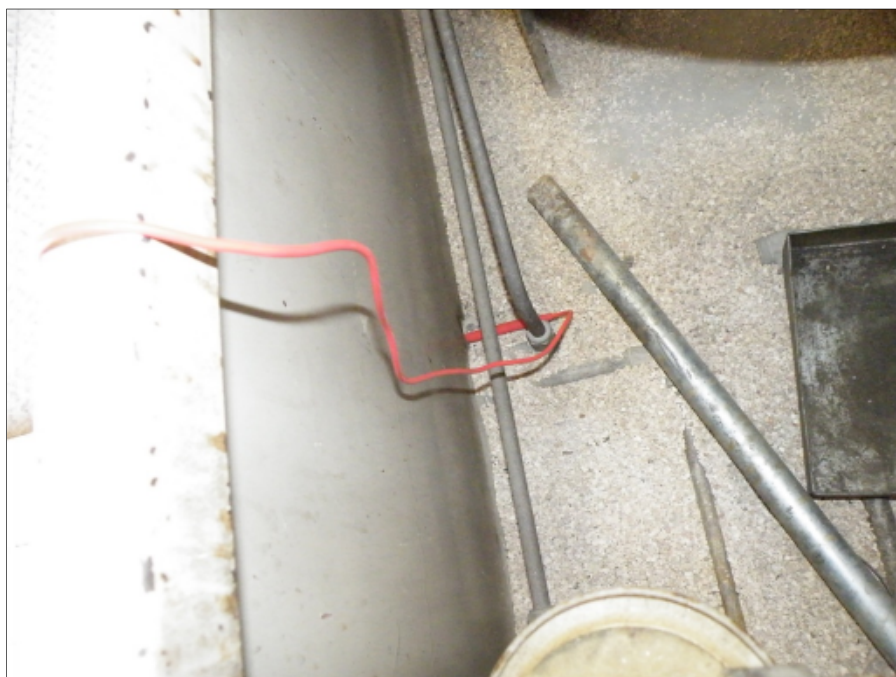
Photo 6: Fuel Hole

The fuel system is limited to that equipment required to provide a supply to the pair of generators. The fuel system includes an internal tank in the generator room, fuel containment and some internal piping. It was noted that there are penetrations of the fuel containment at two locations, with a total of three penetrations at each location, to permit fuel lines to be extended to the generators. It was noted that one of these penetrations was open, which creates the potential for a fuel spill in the event of a failure of any portion of the fuel system within the containment. The risk of a fuel spill is an especially sensitive issue as the truck-fill is adjacent to the community water source. A photograph of this penetration is provided in Appendix C.

It is recommended that the opening in the fuel containment be plugged at the first opportunity. No other short term actions are recommended. In the longer term, any reconstruction of the truck-fill station would require the replacement of the fuel system with one that complies with current code requirements.
