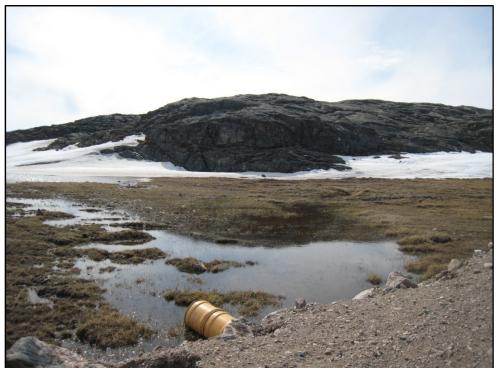
Photo 7 CRS-2 crossing west aspect with installed culvert and upstream pond flow pattern; upstream water body is confirmed fish-bearing pond.

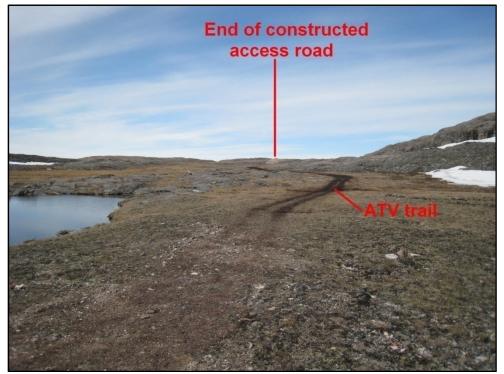
Photo 8 End of constructed access road with existing ATV trail near Km 2.9 of the proposed route; north aspect.

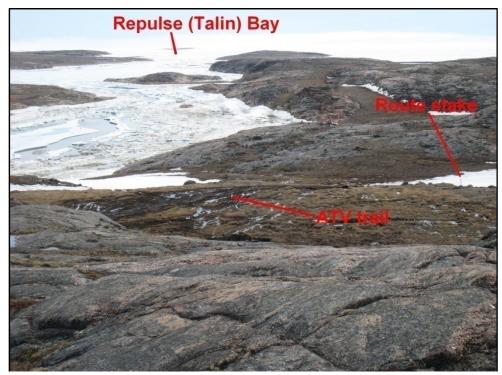
Photo 9 Muddy and rutted ATV trail along proposed access road route, near Km 3.0; southwest aspect.

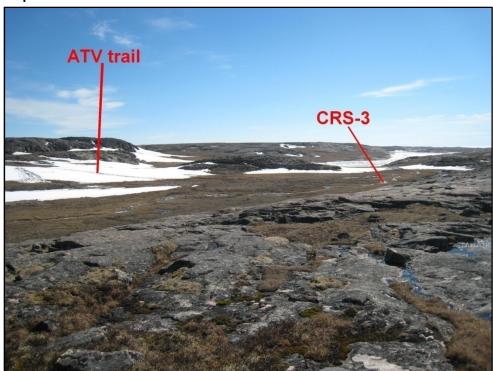
Photo 10 Stream flow pattern upstream of CRS-3 with existing ATV trail and proposed access road route on the left side of the photo, note bedrock ridges on east and west; southeast aspect.

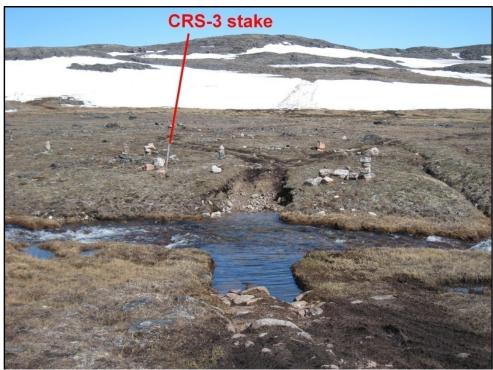
Photo 11 East aspect of impacted stream banks at existing ATV trail stream crossing; site is also CRS-3 crossing of the proposed access road at Km 3.5; note numerous inuksuit present.

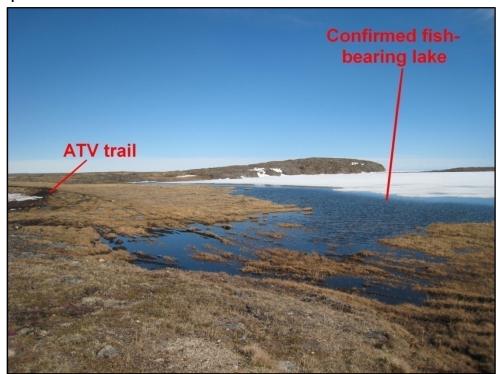
Photo 12 Confirmed fish-bearing lake and existing ATV trail near Km 4.0 of the proposed access road route; southeast aspect.

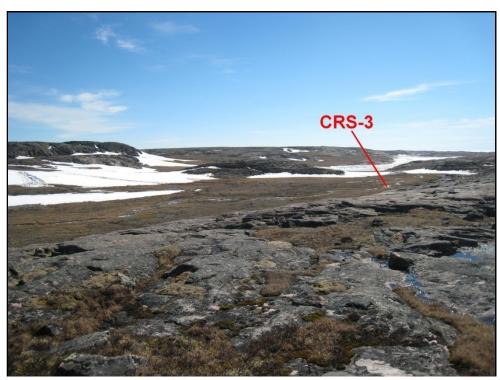
Photo 13 Stream flow pattern upstream of CRS-3 with existing ATV trail and proposed access road route on the left side of the photo; southeast aspect.

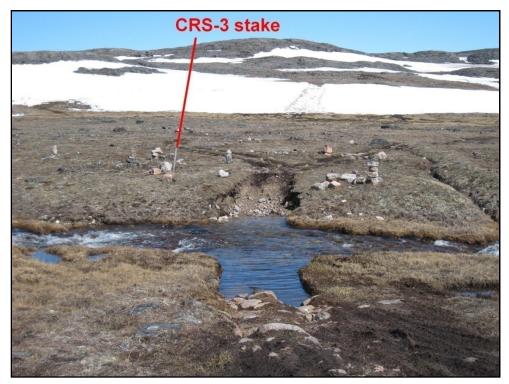
Photo 14 East aspect of impacted stream banks at existing ATV trail stream crossing; site is also CRS-3 crossing of the proposed access road at Km 3.5.
