Government of Nunavut

Design Brief

Project Name:
New Pump House Upgrades

Date Submitted:
January 2013

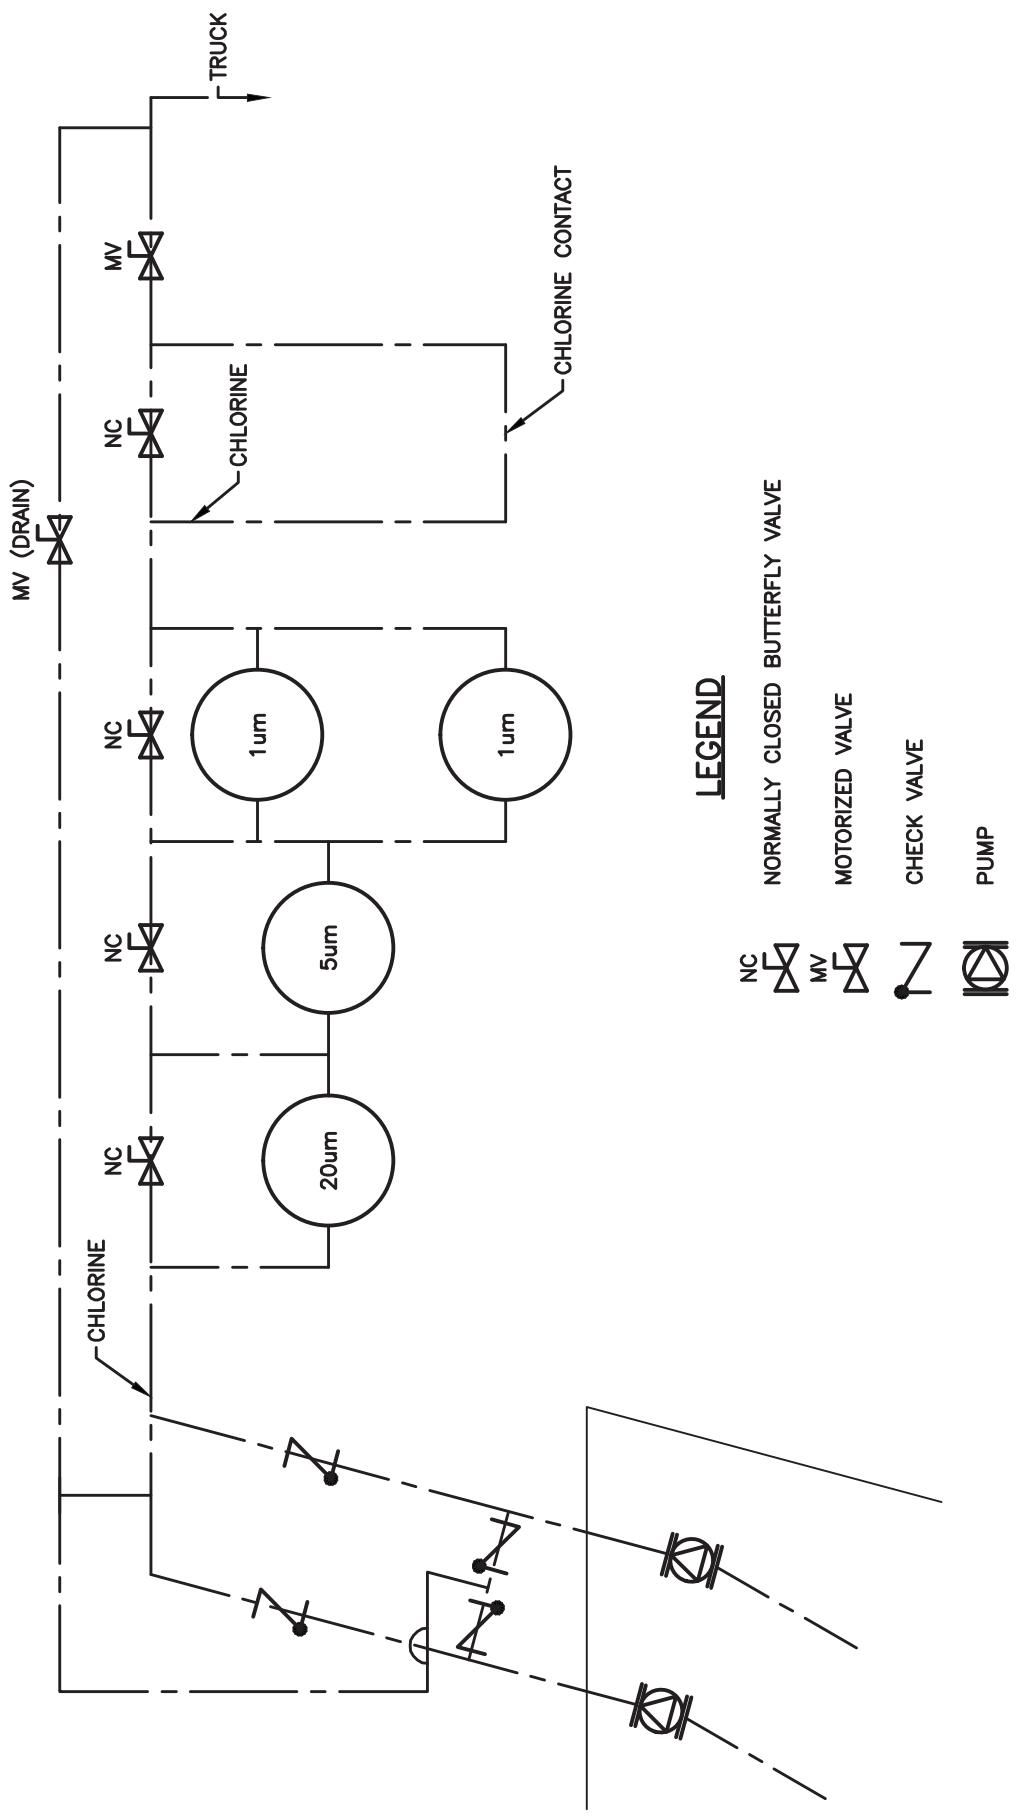
The recommended water treatment system includes the use of cartridge filters and a chlorine contact pipe. The proposed sequence of filters would include 20 microns, followed by 5 microns, followed by 1 micron filters, all followed by a chlorine contact pipe as shown on Figure 1.

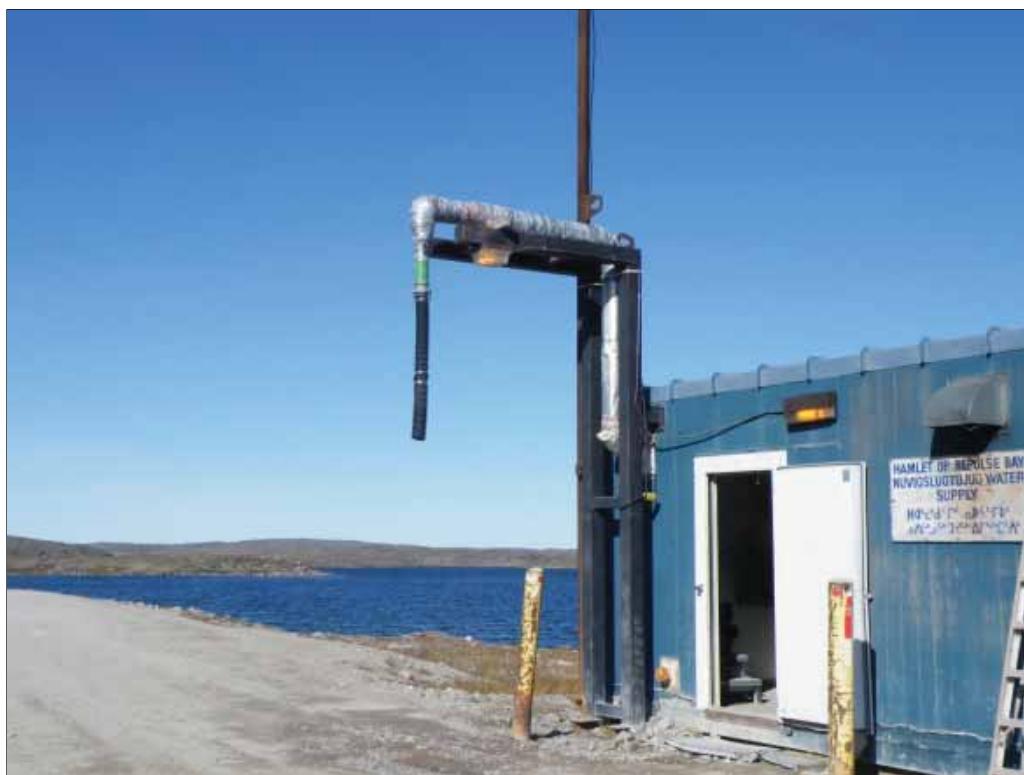
Photo 2: Fill Arm

The truck-fill arm, which is illustrated in photograph no. 2 in Appendix B, was noted to be in good condition. It did not display obvious damage from vehicle traffic. The electrical heat trace appeared to have an open circuit, which suggests that it is currently not functional. This may be the cause for the occasional freeze of this piping reported by local staff.

Recommended short term actions are limited to reinstatement of the heat trace cable.

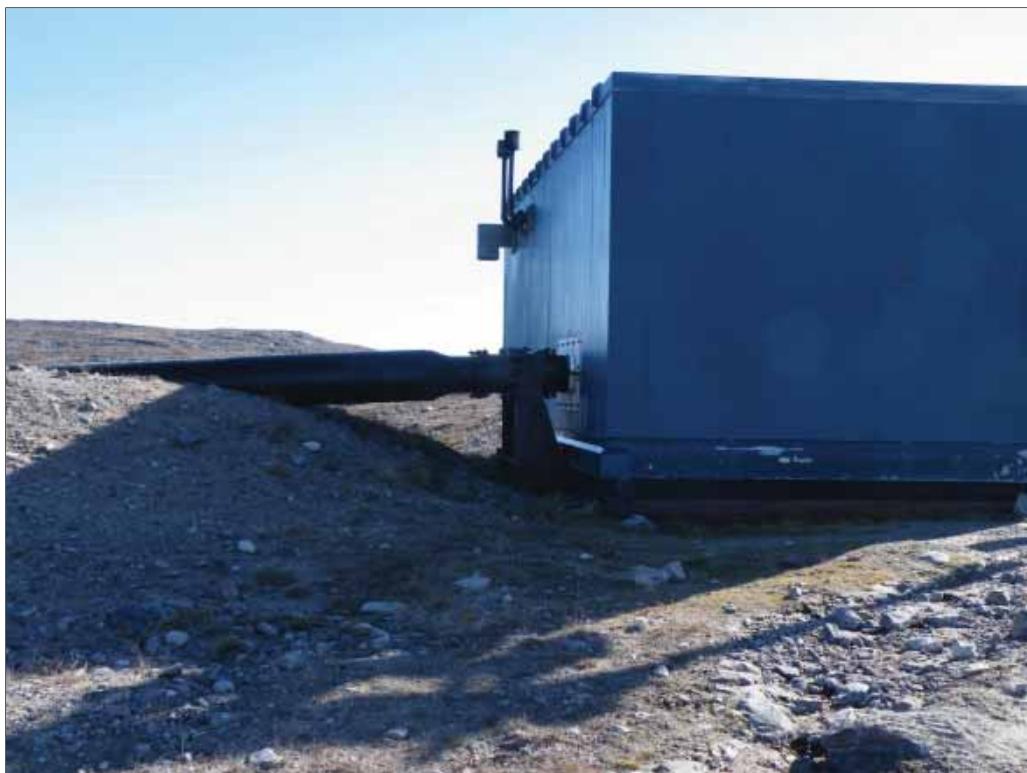
Photo 3: Intake 1

The intakes do not display indications of movement and the ballast blocks appear to be intact. The piping and insulation jacket did not display signs of distress or vandalism. Comments cannot be provided regarding the condition of any intake screens.

No short term recommendations are presented as regards to the intakes. A future reconstruction of the truck-fill station may require extension of these intakes. The existing intakes are suitable for incorporation into the design of a new truck-fill station.

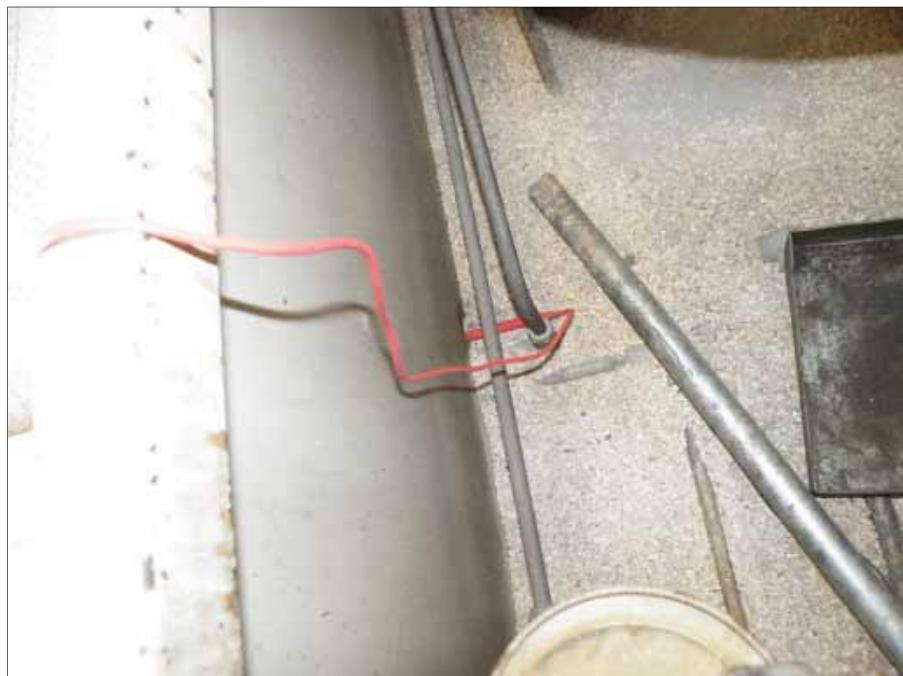
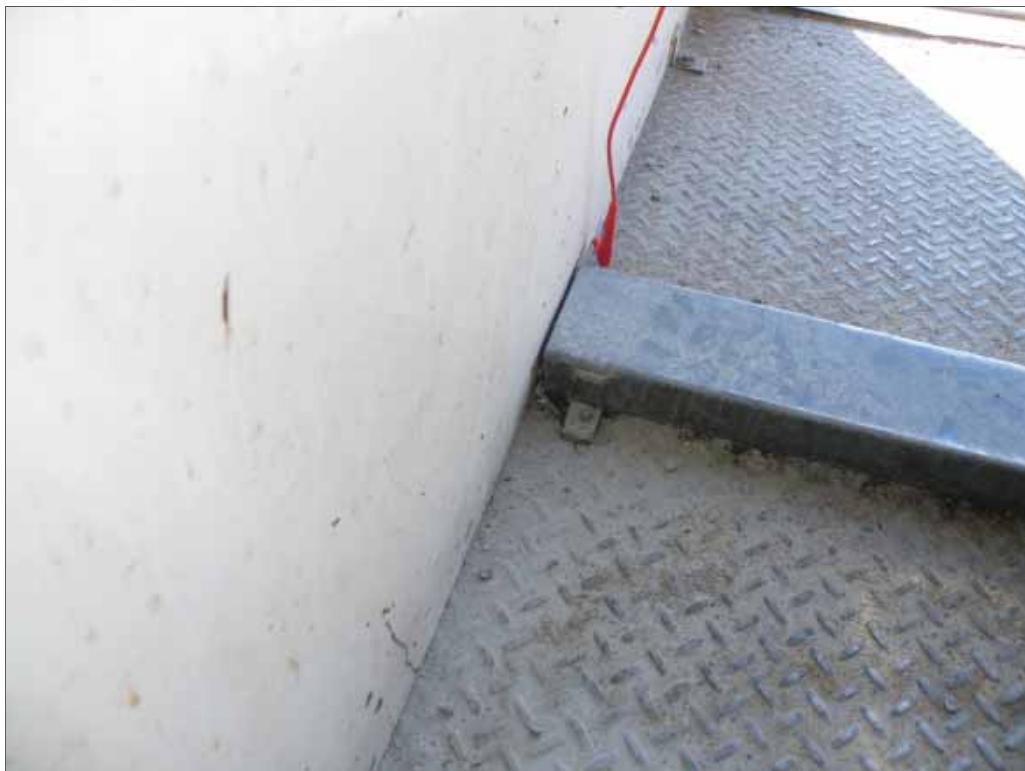
Photo 6: Fuel Hole

The fuel system is limited to that equipment required to provide a supply to the pair of generators. The fuel system includes an internal tank in the generator room, fuel containment and some internal piping. It was noted that there are penetrations of the fuel containment at two locations, with a total of three penetrations at each location, to permit fuel lines to be extended to the generators. It was noted that one of these penetrations was open, which creates the potential for a fuel spill in the event of a failure of any portion of the fuel system within the containment. The risk of a fuel spill is an especially sensitive issue as the truck-fill is adjacent to the community water source. A photograph of this penetration is provided in Appendix C.

- a. Most of the internal system remained serviceable.
 - b. The existing fuel containment system was not leak-tight, and there was a potential for a fuel spill to spread beyond this containment.

It is recommended that the opening in the fuel containment be plugged at the first opportunity. No other short term actions are recommended. In the longer term, any reconstruction of the truck-fill station would require the replacement of the fuel system with one that complies with current code requirements.
