Appendix B Photographs of the Project area

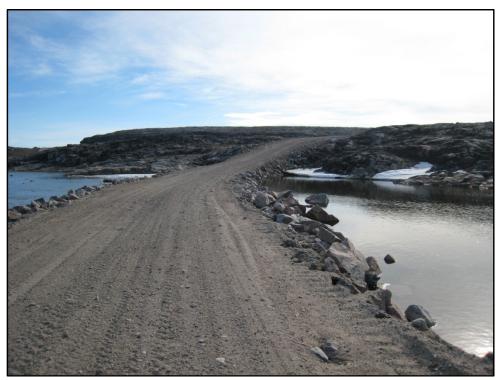
Photo 1 West aspect of constructed CRS-1 crossing at Km 0 of the North Pole River access road, marine Tariuraq Inlet on the left side of photo and the freshwater lake on the right side; no culverts installed.

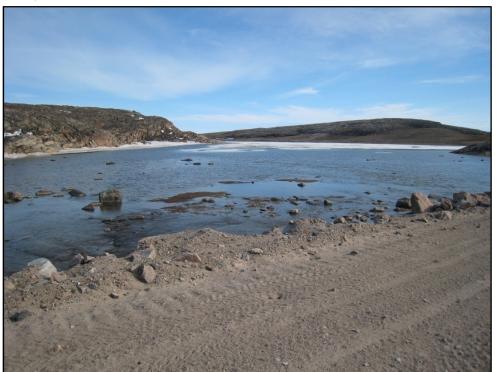
Photo 2 South aspect from the constructed CRS-1 crossing; marine Tariuraq Inlet in background.

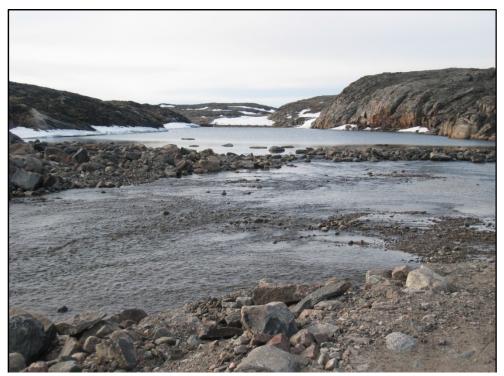
Photo 3 North aspect from constructed CRS-1 crossing; the freshwater lake in background.

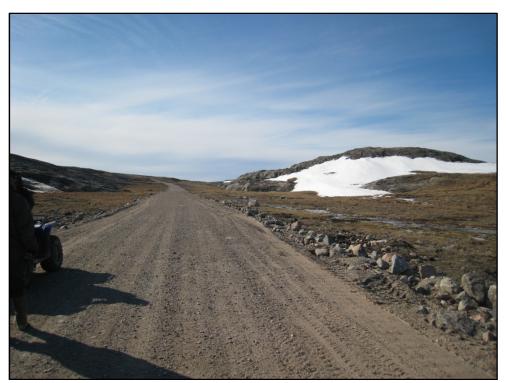
Photo 4 Km 0.5 of constructed access road, note bedrock ridges and vegetated slopes; north aspect.

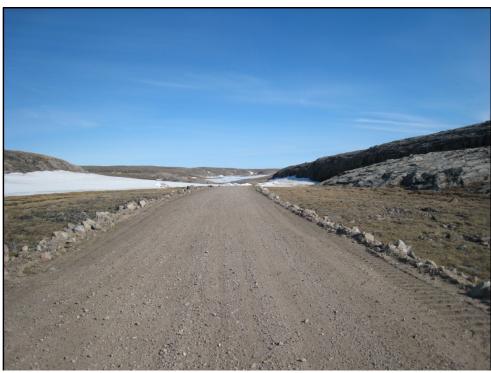
Photo 5 Km 0.5 of constructed access road, note bedrock ridges on east and west; south aspect with Tariuraq Inlet in far background of photo.

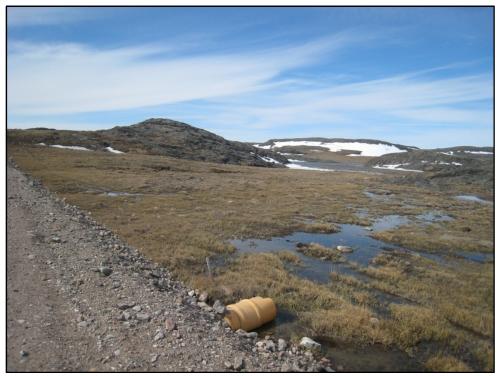
Photo 6 CRS-2 crossing at Km 1.8 of the constructed access road, north aspect with installed culvert and downstream flow pattern.

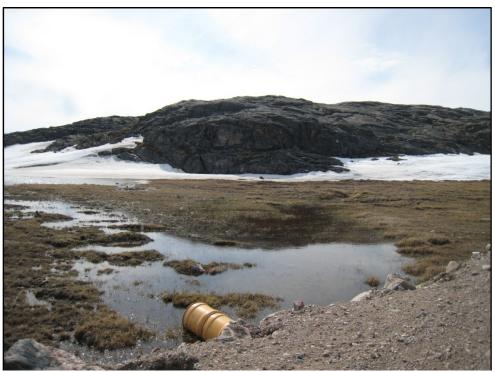
Photo 7 CRS-2 crossing west aspect with installed culvert and upstream pond flow pattern; upstream water body is confirmed fish-bearing pond.
