**INAC-Water Resources
Field Operations
Box 100
Iqaluit, Nunavut
X0A 0H0**

Re: Hamlet of Repulse Bay Water Licence Inspection

MUNICIPAL WATER USE INSPECTION REPORT

Licensee: Hamlet of Repulse Bay

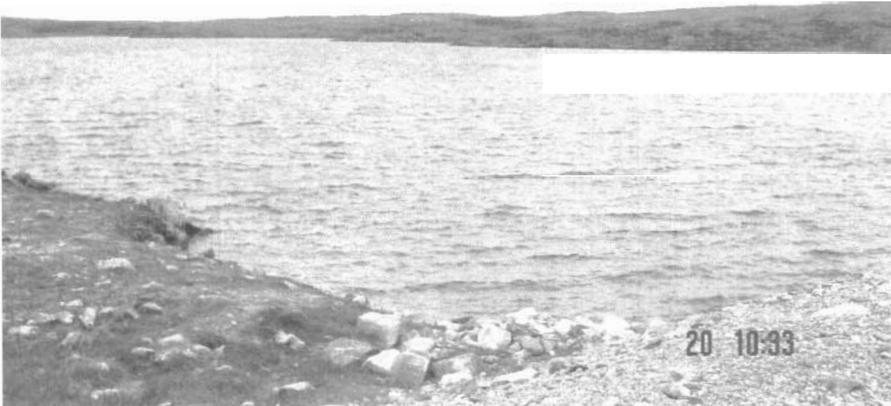
The Hamlet of Repulse Bay uses chlorination to treat drinking water, however record keeping for chlorine concentrations and water volumes pumped are inadequate. At the time of the inspection chlorine concentrations had not been recorded since May 26, 2003. The almost complete lack of record keeping is unacceptable, the lack of monitoring poses a significant health risk to the community and the situation needs to improve. The pumphouse is identified as the Hamlets water supply (figure 2). Water samples taken from the shore of the lake exceeded the *Summary of Guidelines for Canadian Drinking Water Quality 2003* for turbidity (1.1 NTU > 1.0 NTU). All of the remaining sample results were within Canadian Guidelines.

Figure 1. Freshwater source for the Hamlet of Repulse Bay.

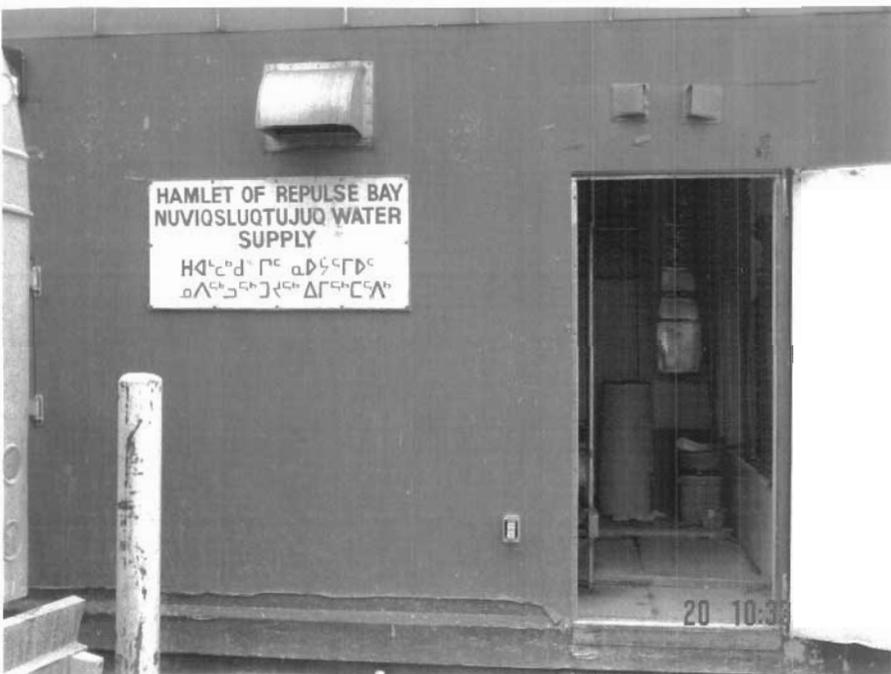
Figure 2. Pumphouse at freshwater source for Repulse Bay.

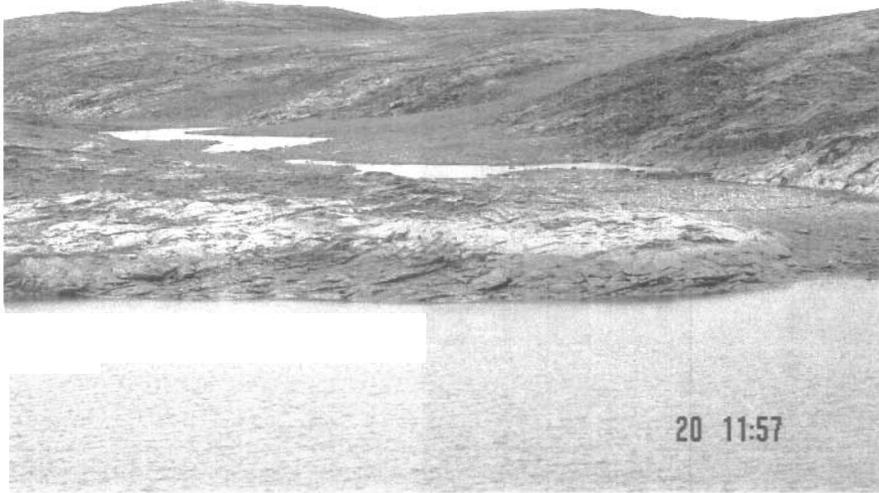
The sewage treatment wetland in the Hamlet of Repulse Bay is quite extensive. The combination of the wetland and the system of ponds between the sewage dump off point and the marine environment likely provide very good treatment and high effluent quality (figure 3). As the system lacks a lagoon, solids migration may be a concern. Unfortunately the inspector was unable to take samples of the lagoon effluent because of a mix up with sample bottles.

Figure 3. The final path of sewage effluent before entering the ocean in Repulse Bay.

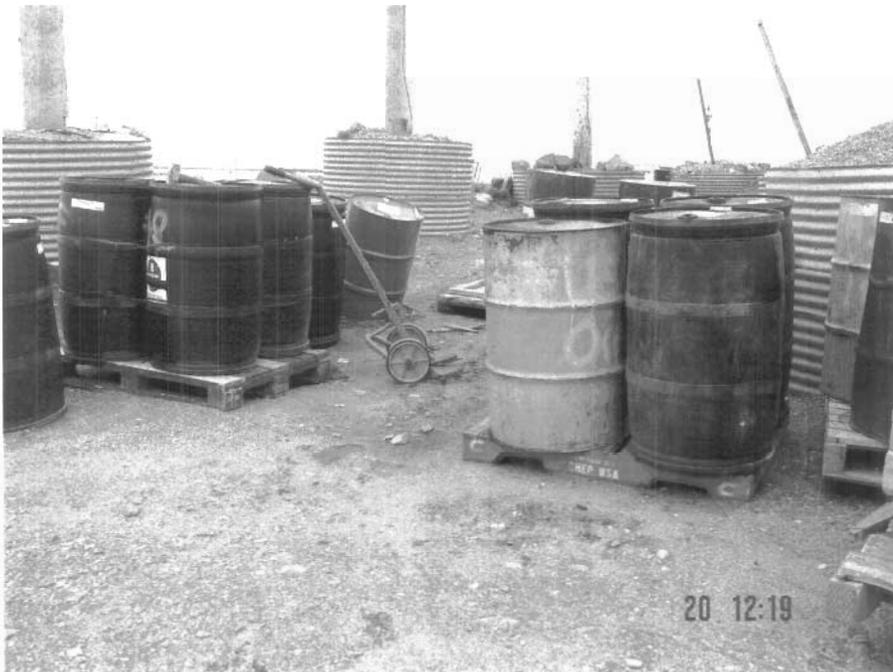
Waste oil is currently stored adjacent to the land farm for contaminated soil remediation. Waste drums are generally in good condition, stored on pallets until they can be shipped out (figure 4). The community should look into obtaining a waste oil burner, this would eliminate the expense of shipping out the waste and could also provide a source of energy to the community.

Figure 4. Waste oil drums in the Hamlet of Repulse Bay.

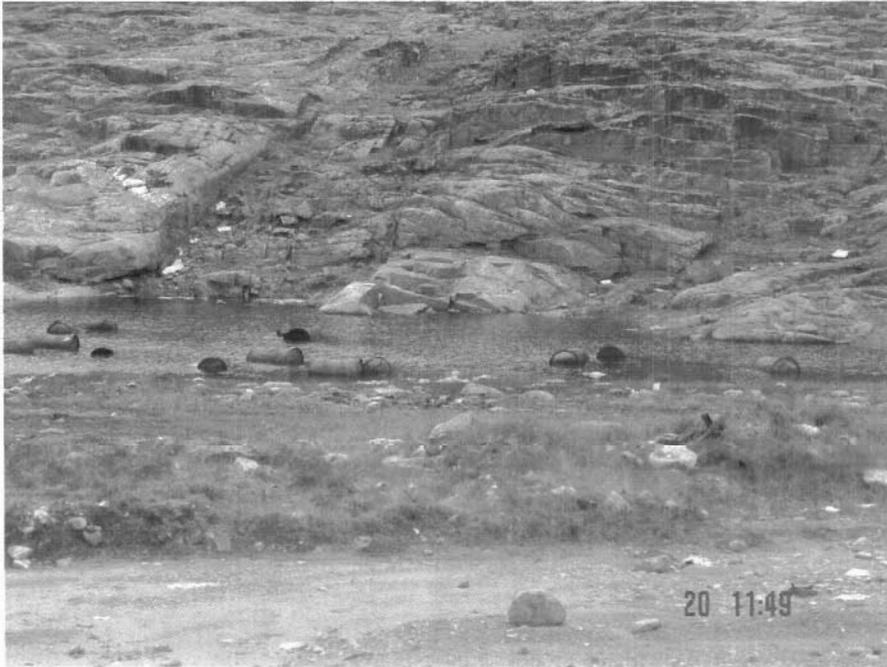
A large number of drums were observed in a pond near the Ocean edge (figure 5). These drums need to be removed from the pond, crushed and landfilled. Mr MacQuarrie assured me that they would be cleaned up come springtime.

Figure 5. Old barrels floating in a pond near the sewage effluent discharge to the ocean.

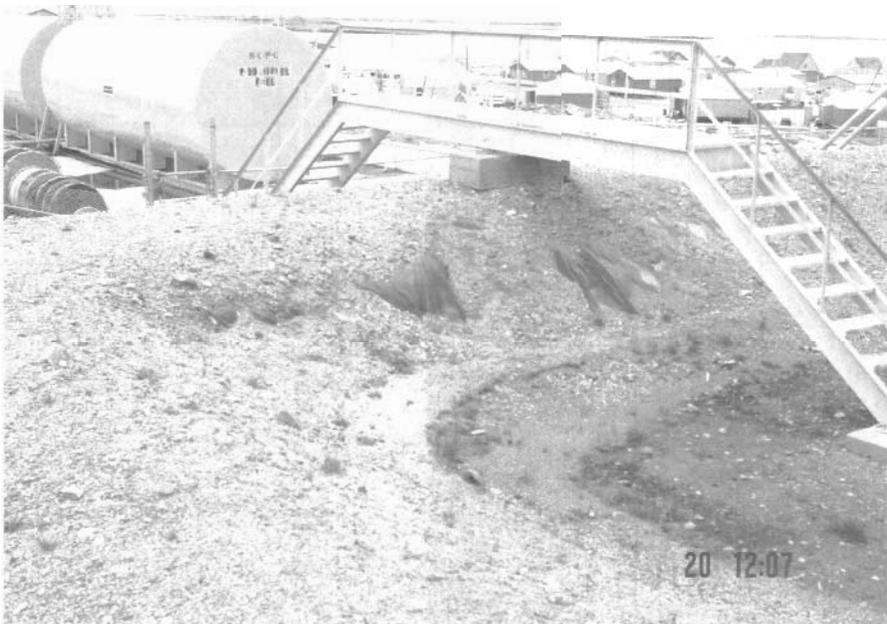
There are a number of sections of exposed liner (figure 6) at the fuel storage facility and the liner is punctured in one section (figure 7). Exposure of the liner and punctures obviously compromise the integrity of the liner. The liner needs to be repaired and covered in order to function effectively.

Figure 6. Exposed liner at the Hamlet of Repulse Bay bulk fuel storage facility.

Unacceptable: The liner in the bulk fuel storage facility is exposed in a number of places and the liner was observed to be punctured in one place.

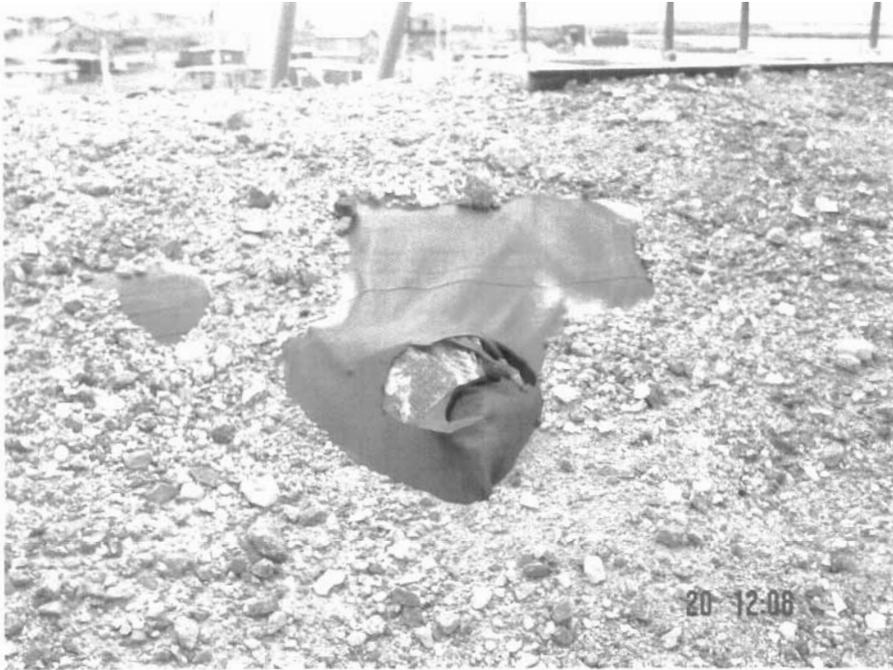
Figure 7. Punctured liner at the Hamlet of Repulse Bay bulk fuel storage facility.
