WATER LICENCE INSPECTION FORM

Licensee Hamlet of Naujaat	Licensee Representative Kevin Tegumiar
Licence No. / Expiry 3BM-NAU2126/January 26 th , 2026	Representative's Title Senior Administrative Officer
Land / Other Authorizations --	Land / Other Authorizations --
Date of Inspection August 18 th 2021	Inspector Atuat Shouldice
Activities Inspected	
<input type="checkbox"/> Camp <input type="checkbox"/> Drilling <input type="checkbox"/> Mining <input type="checkbox"/> Construction <input type="checkbox"/> Reclamation <input type="checkbox"/> Fuel Storage <input type="checkbox"/> Roads/Hauling <input checked="" type="checkbox"/> Other: Waste Disposal Facility <input checked="" type="checkbox"/> Other: Water Treatment Facility

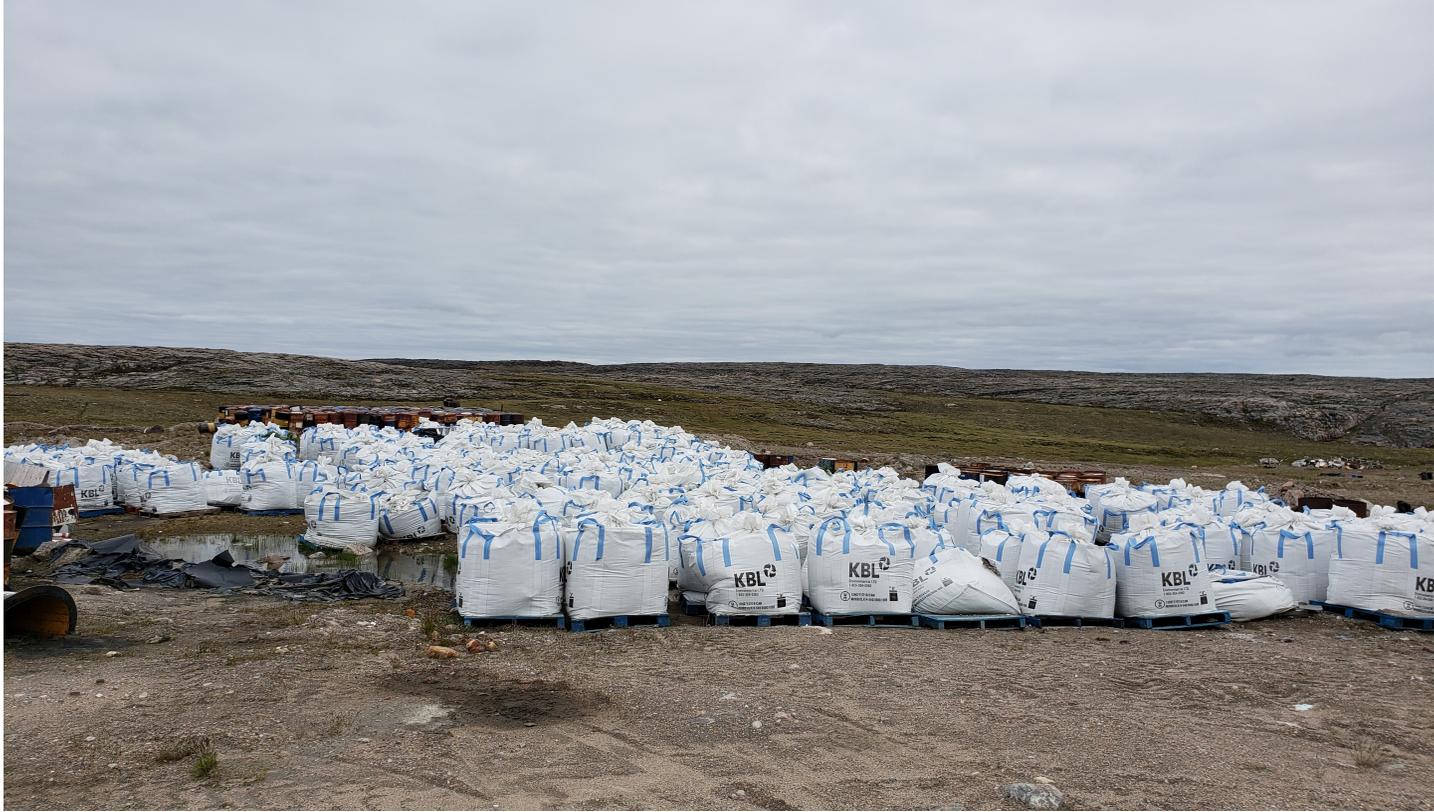
Date:	Authorization Number:	Camera/Model:	Inspector
August 18th, 2021	3BM-NAU2126	Samsung S9	RMO Shouldice
Photo #		Location:	
1		Waste Oil Storage Area

8. The Hamlet is currently looking for a location for a new Landfill.
9. Mega bags of contaminated soil are located near the Waste Oil Storage Area. These bags had been observed during previous inspection in 2020. The number of bags have increased since last year. A number of organizations have committed to shipping these bags out in 2022.

Contaminated soil being stored by various companies at Waste Oil Storage Area

- The Hamlet shall submit a plan to the Inspector by December 15th 2021, as to how they will repair the breached south berm at the Landfill and maintain the battery storage area. This plan shall include a brief summary of work and completion date.
- With the large amount of contaminated soil stored in the community the Inspector recommends that the Hamlet and local organization explore options for soil remediation options within the community.
- The Hamlet is recommended to work with the Government of Nunavut, Department of Environment, Environmental Protection Officers to ensure contaminated soil is disposed of appropriately moving forward.

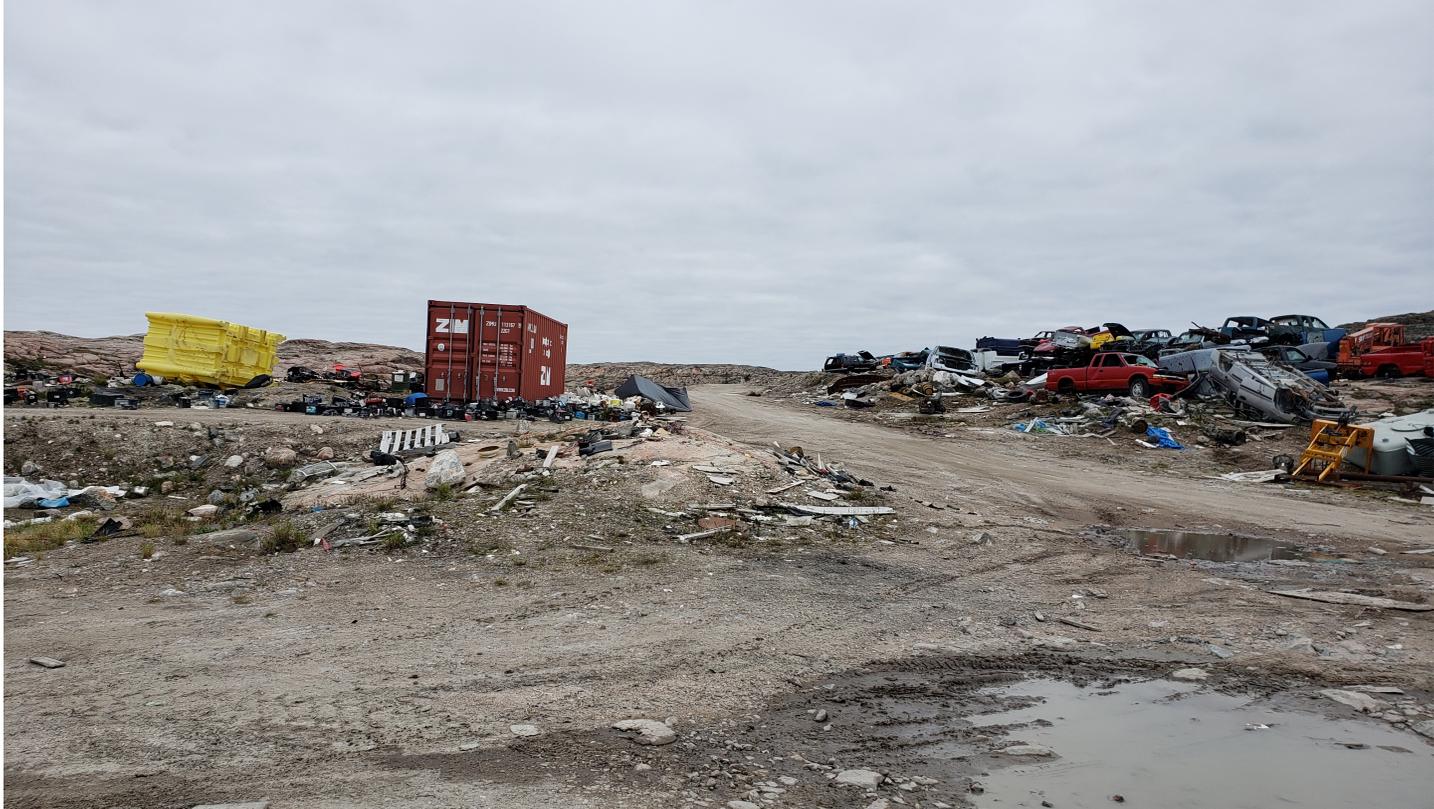
Photo #	Location:
2	Landfill

6. Segregation and appropriate storage for hazardous waste has been an issue with the limited space inside the Landfill.
7. The Landfill is not gated. Often community members remove discarded batteries from the secondary containment areas looking for batteries to re-use.

Collection of batteries at Bulky Metal Area of the Landfill.

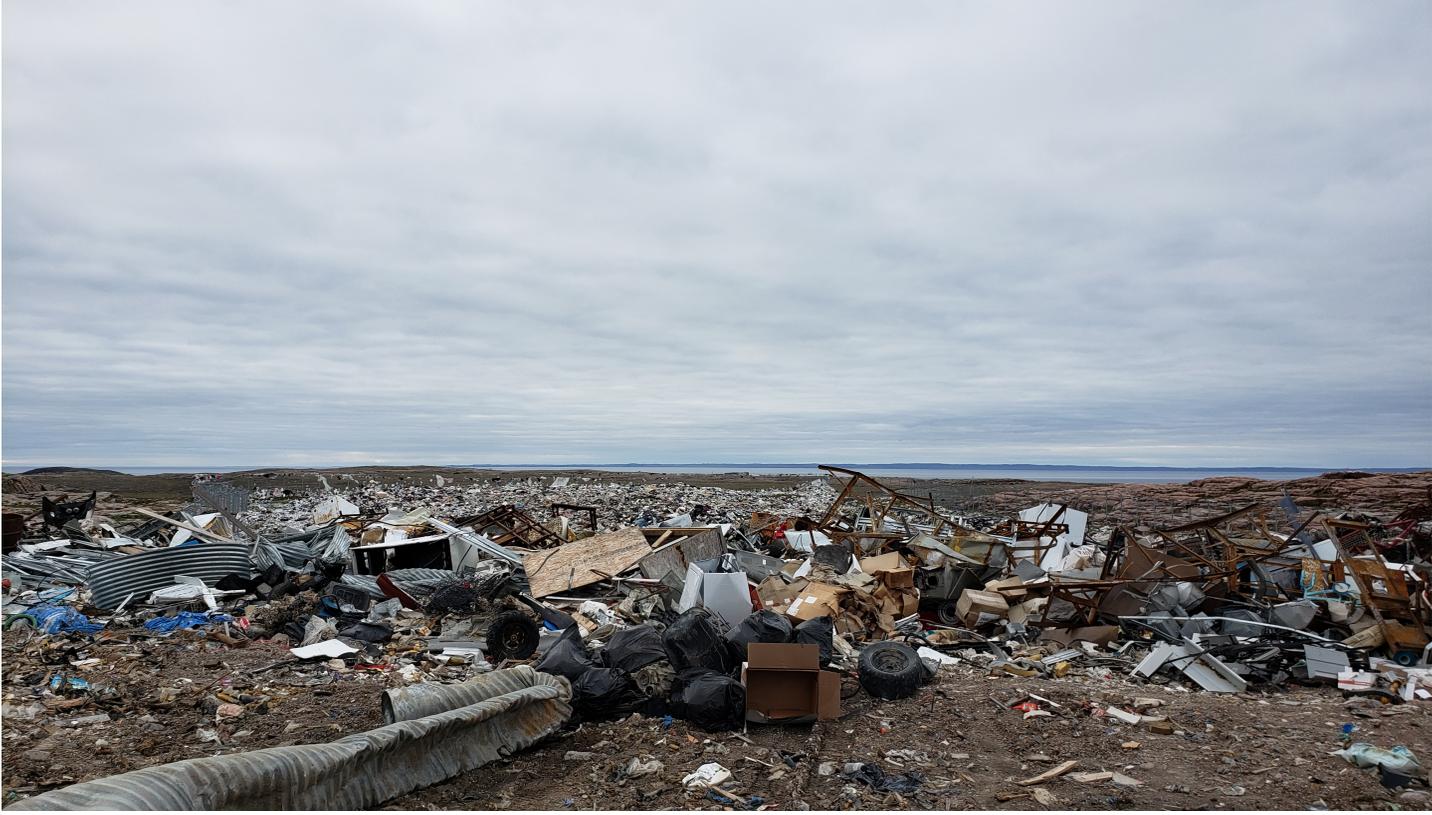
Photo #	Location
3	Landfill

5. The 2020 Annual Report noted that the Land fill has reached capacity. The Inspector observed limited available space for organization within the landfill foot.

Description	
View of landfill at capacity.
