WATER LICENCE INSPECTION FORM

Licensee		Licensee Representative	
Hamlet of Pangnirtung		Wayne Solomon	
Licence No. / Expiry		Representative's Title	
3BM-PAN0810 // Renewed to 3BMPAN1417		Acting Senior Administrative Officer	
Land / Other Authorizations		Land / Other Authorizations	
Date of Inspection		Inspector	
14/08/2014		A.Keim	
Activities Inspected			
<input type="checkbox"/> Camp	<input type="checkbox"/> Drilling	<input type="checkbox"/> Mining	<input type="checkbox"/> Construction
<input type="checkbox"/> Roads/Hauling	<input type="checkbox"/> Other: Water Discharge	<input checked="" type="checkbox"/> Other: Municipal	<input type="checkbox"/> Reclamation
<input type="checkbox"/> Fuel Storage

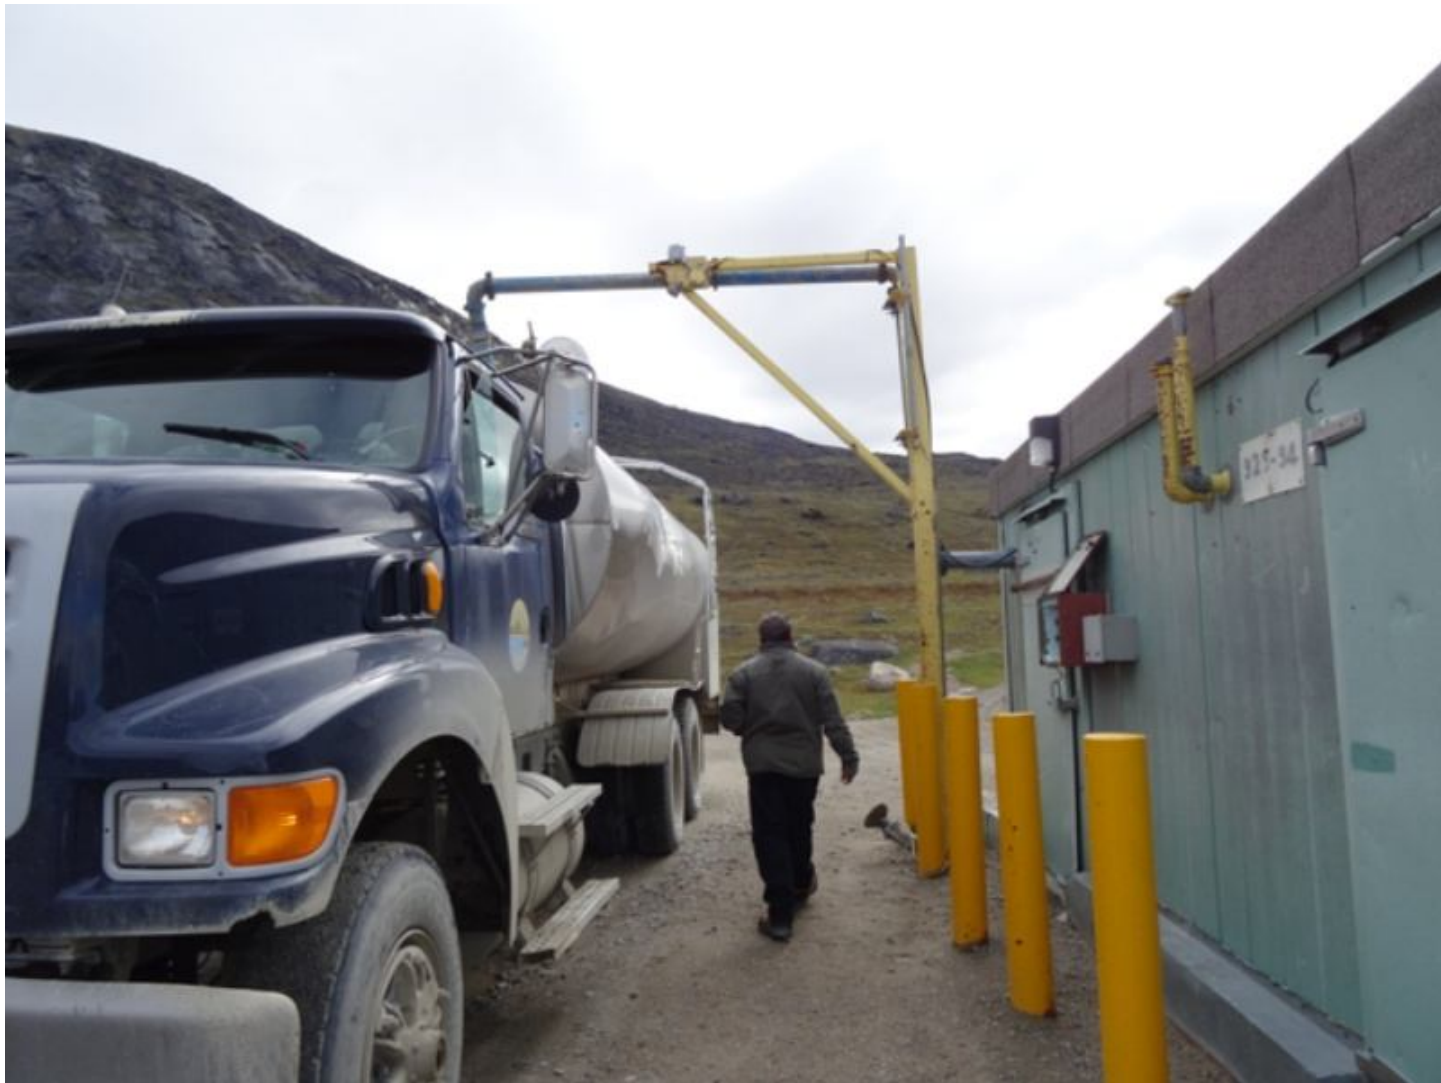
Figure 3 Water Pumping Station at Reservoir

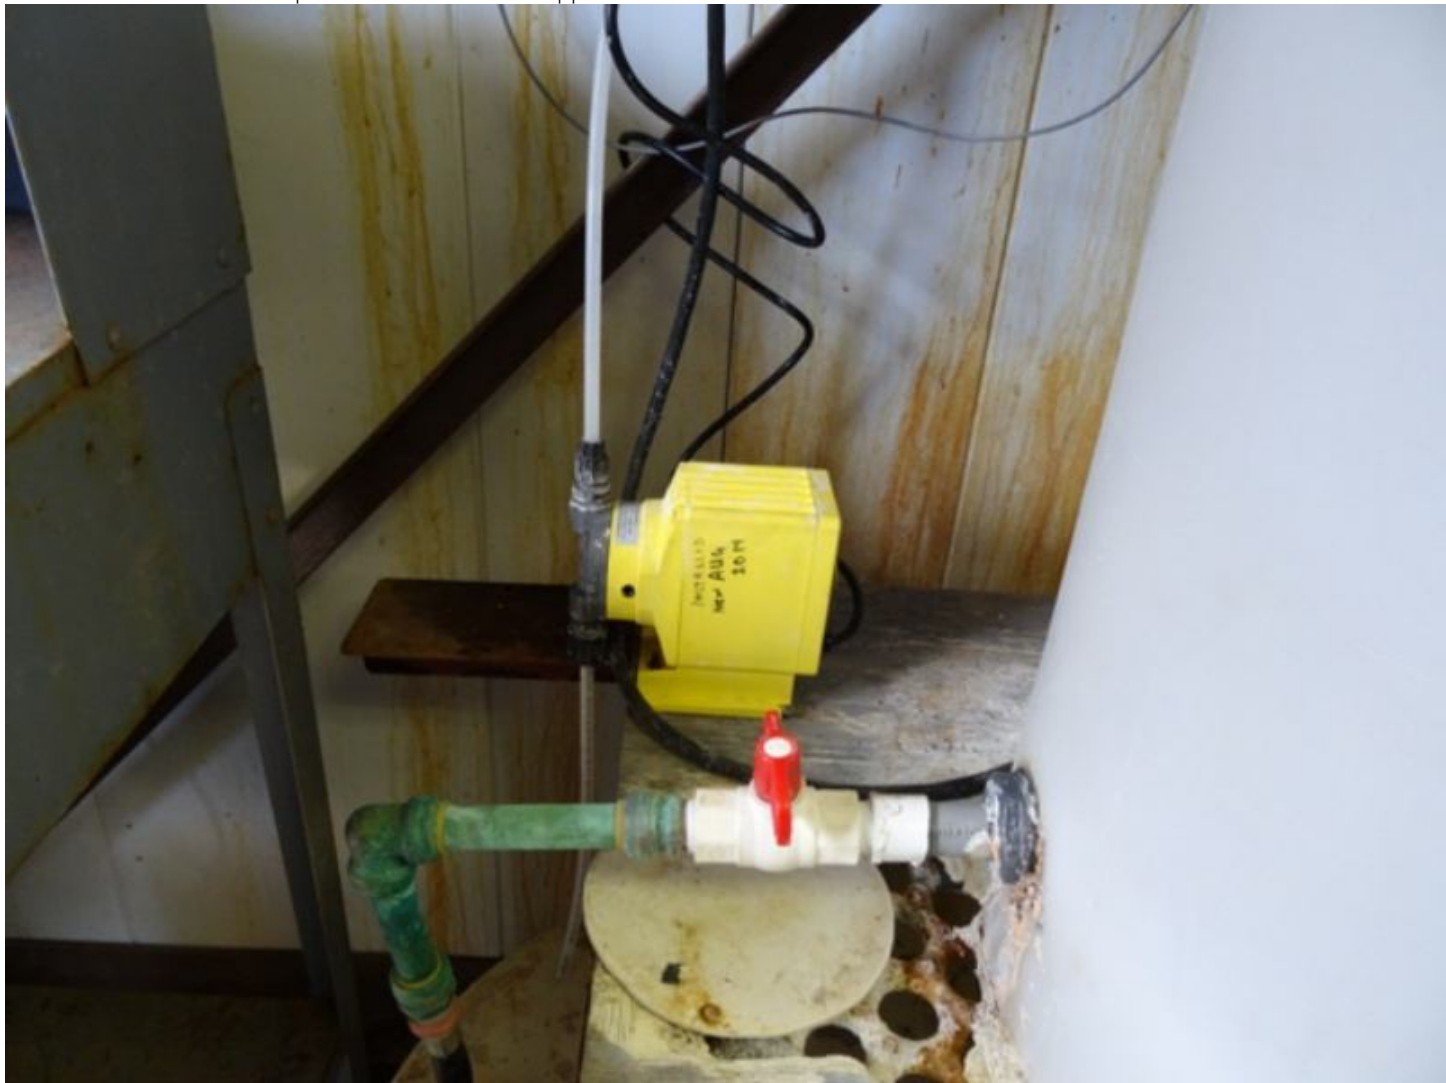
Figure 6 Chlorination pump

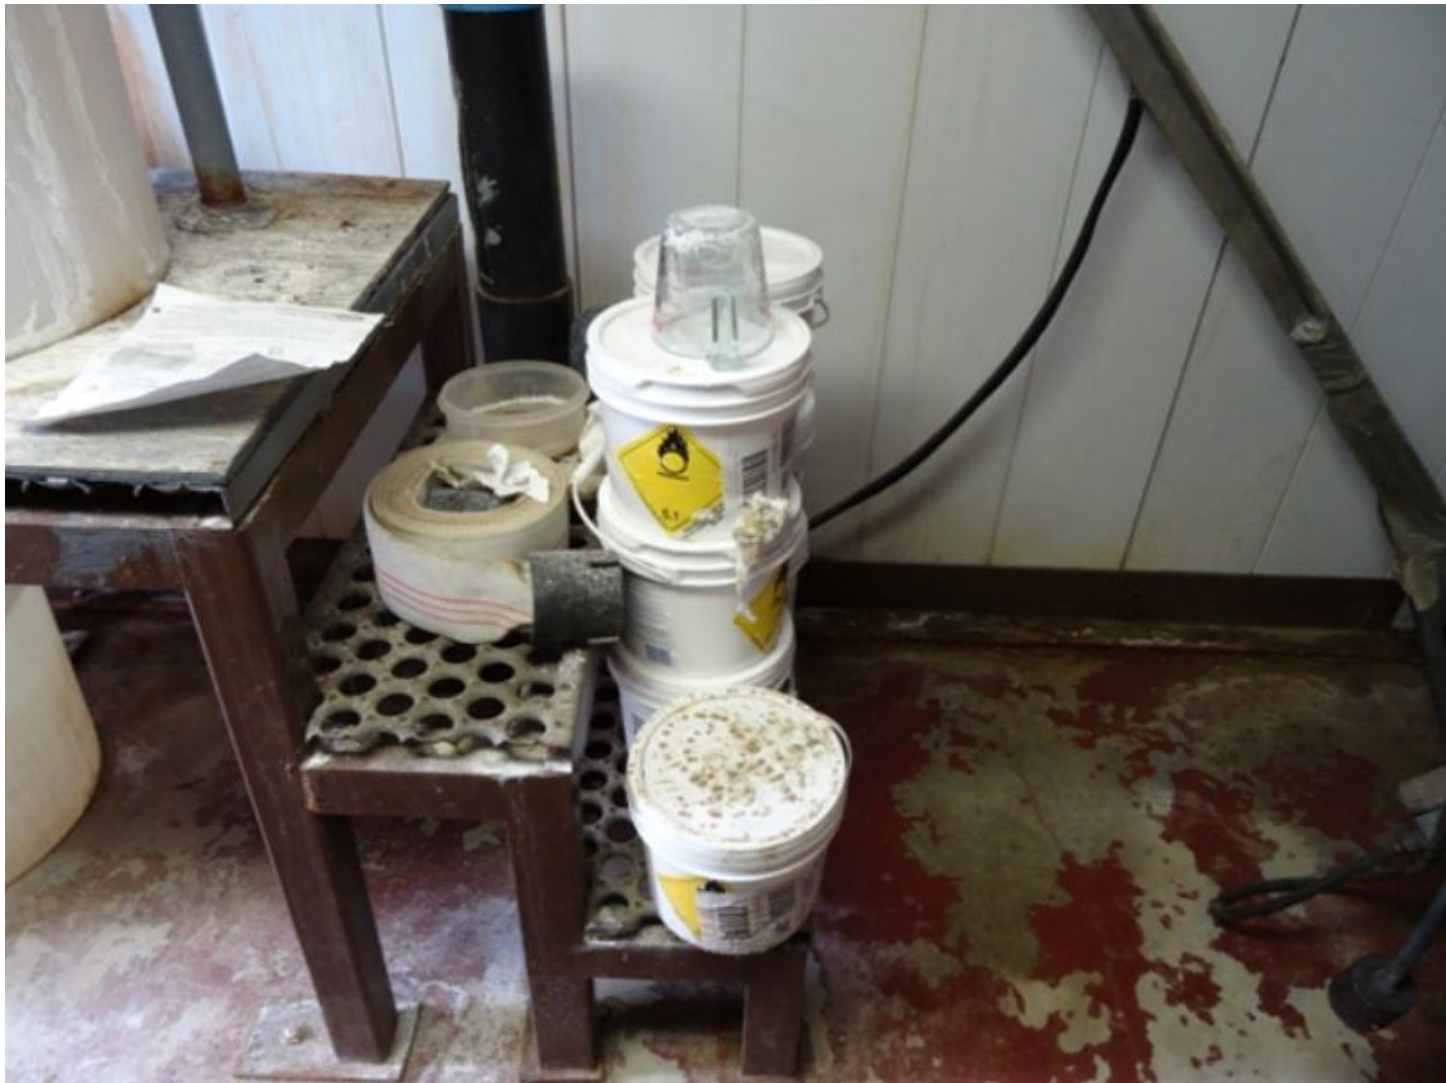
Figure 7 Chlorine Storage in Pumping station

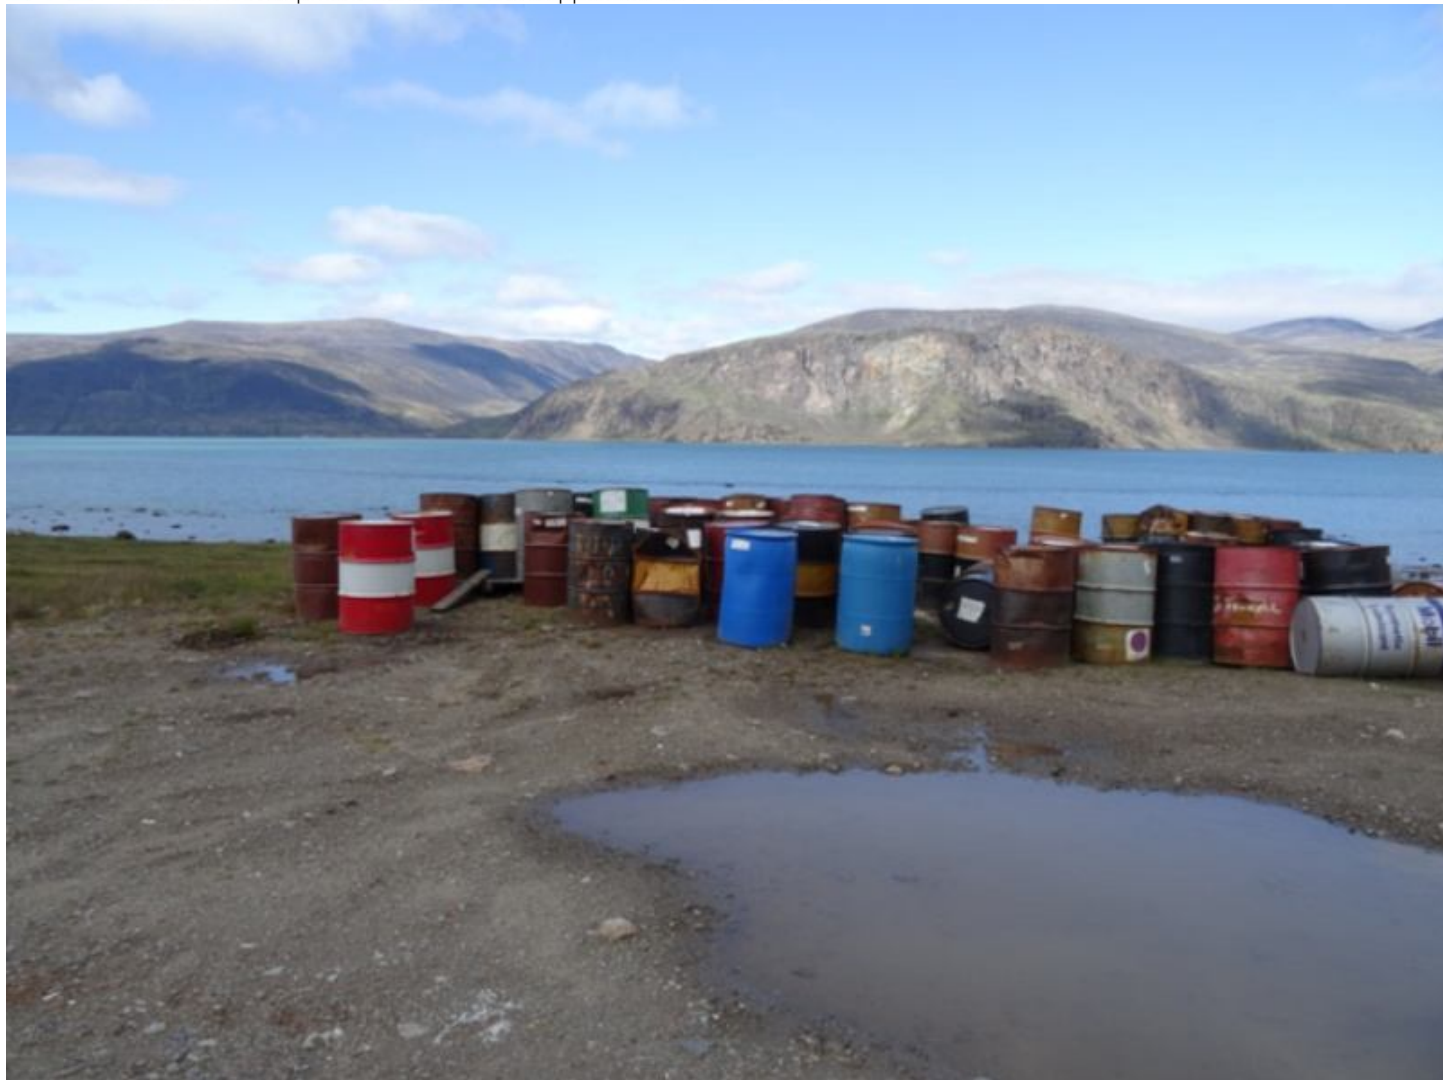
- Approximately 500 M from the fenced community solid waste management area, on the side of the roadway is a deposit of approximately 40 barrels and one 10 000 liter tank of unknown origin or contents. Some are marked waste oil and glycol but it is unclear if that is what is contained within that specific drum. It was noted that some drums are leaking and not on secondary containment.

Figure 8 Leaking barrels - No containment

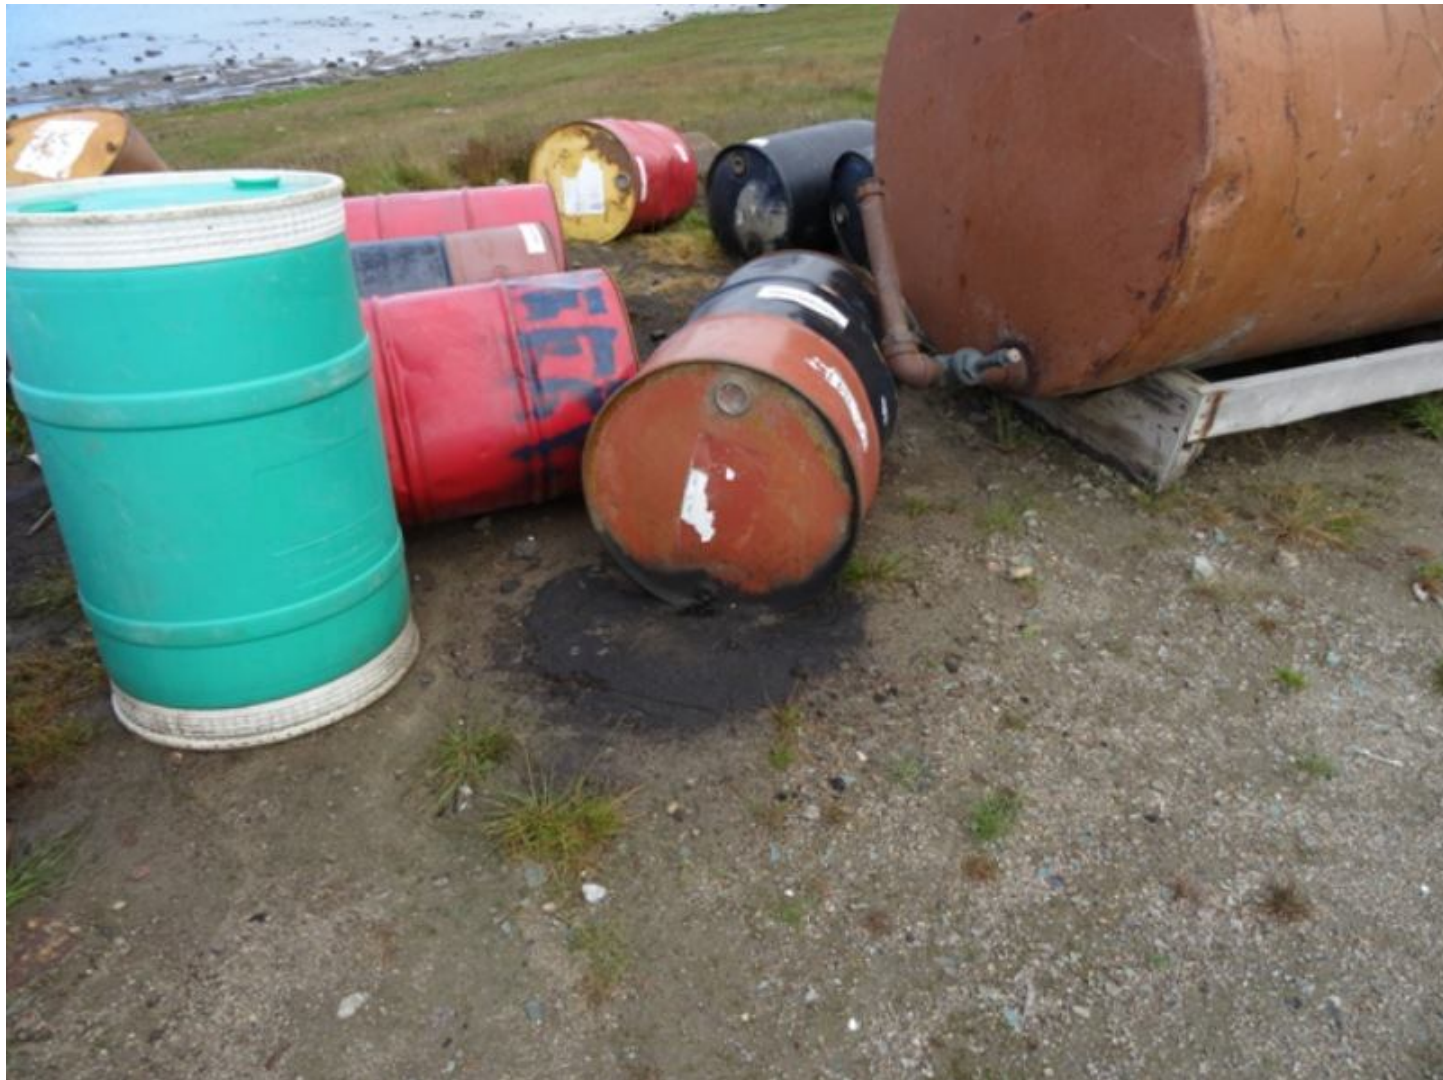
Figure 9 Barrels - requires containment and clean up

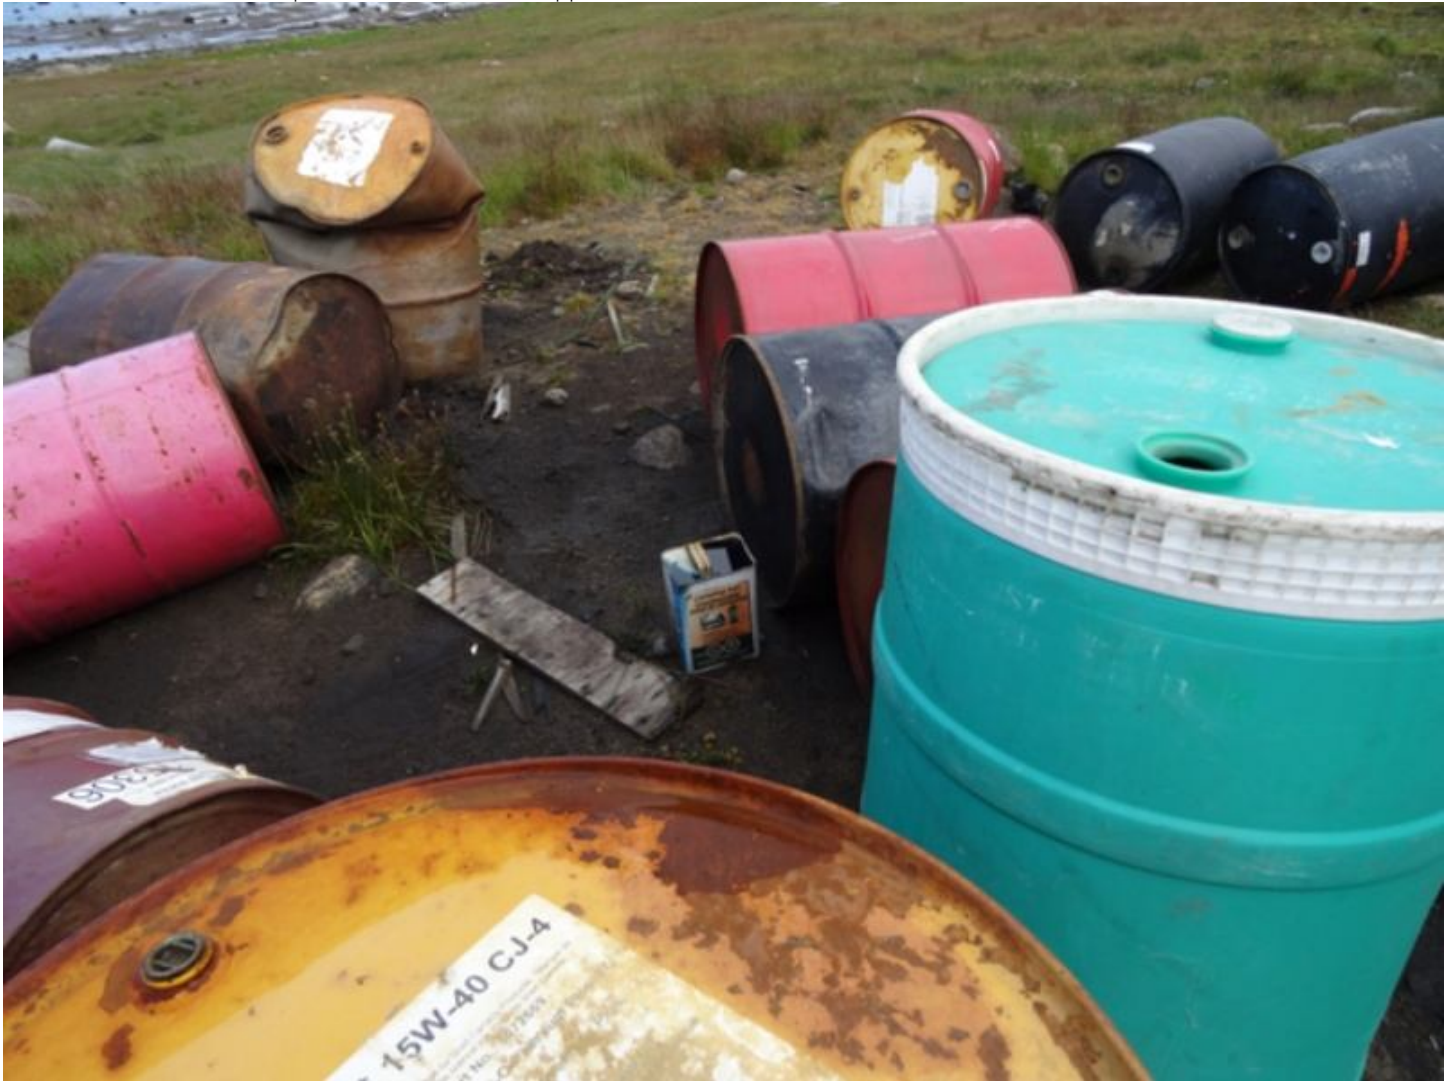
Figure 10 Barrels - Requires containment and clean up

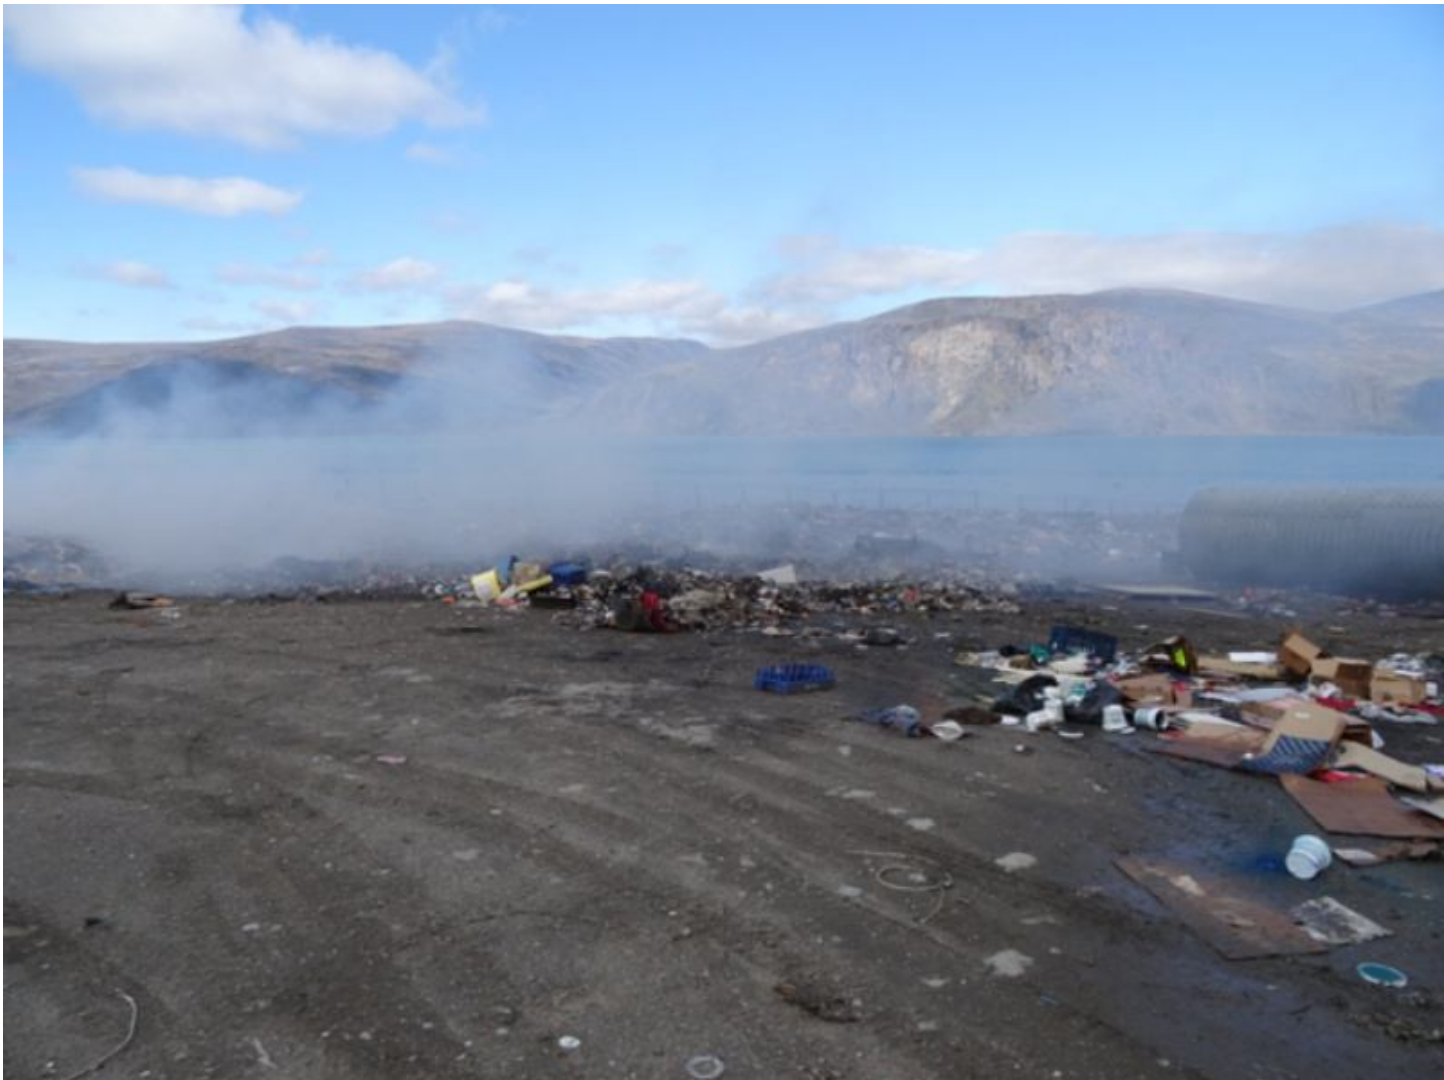
- Hazardous wastes within the fenced Solid Waste Management Area are not segregated and were found to be mixed in with municipal waste.
- At the site of the two new Solid waste management area's previously indentified in 2011 the following were noted;

Figure 11 Solid Waste Managment Area - Non Segregated

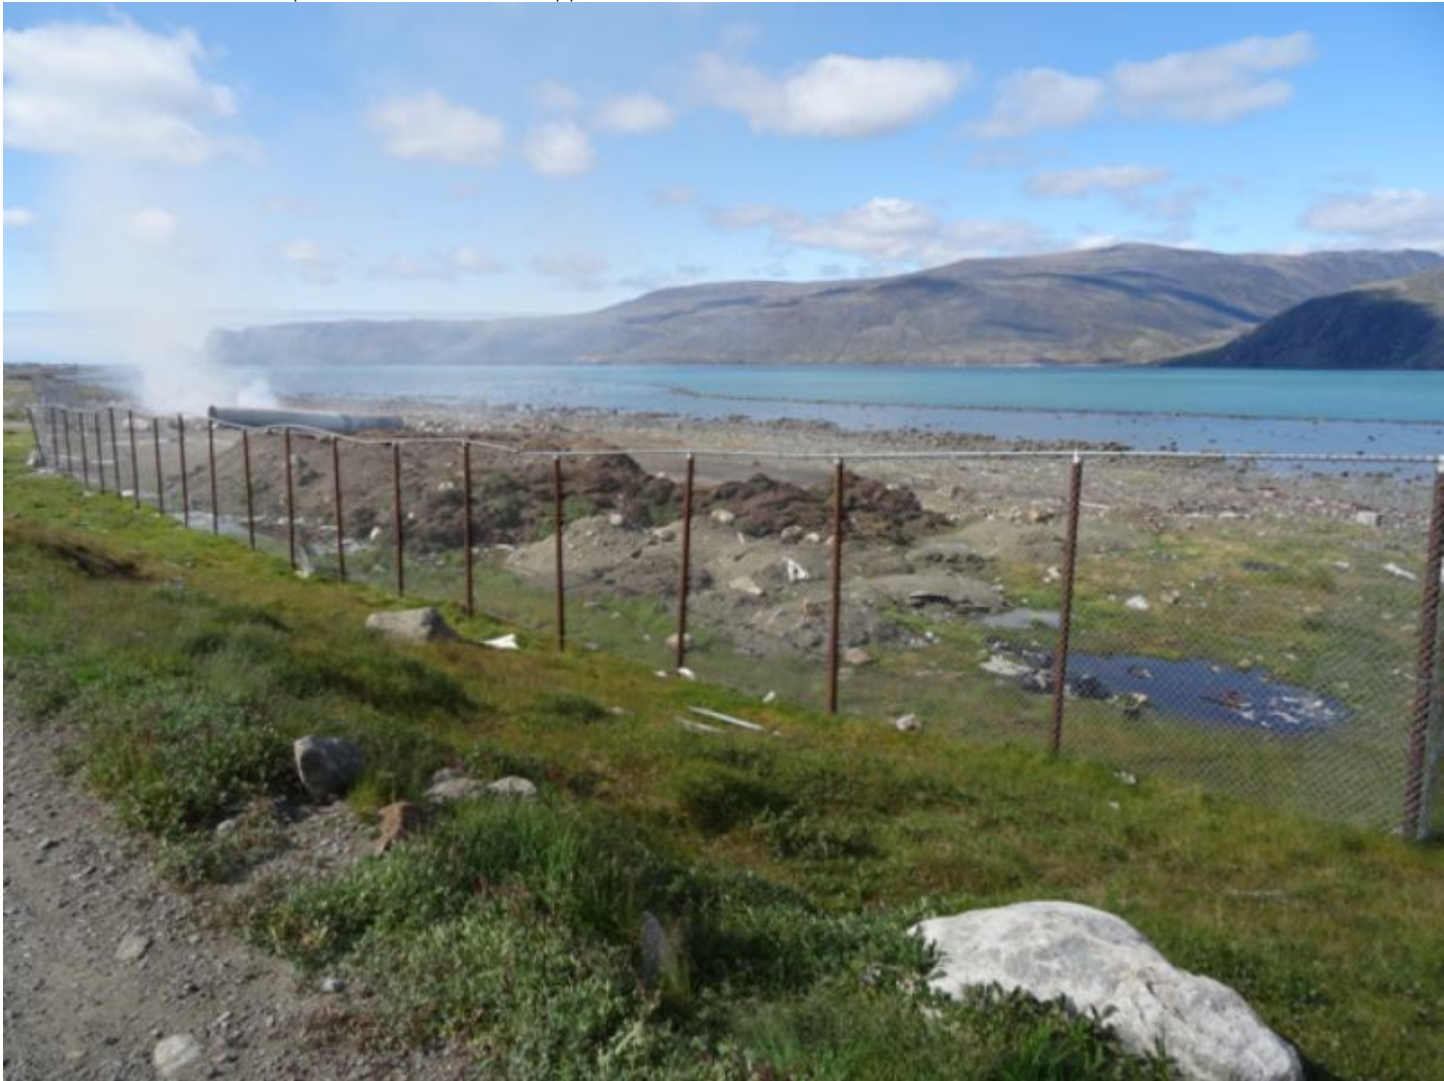
- Within the Solid waste Management Area at the site of the Municipal waste area the entire site was on fire. Large plumes of grey, black smoke were rising from the garbage. There does not appear to be any cover material added once the burn has been completed. More materials were brought in during the period of Inspection.

Figure 12 Solid waste managment area

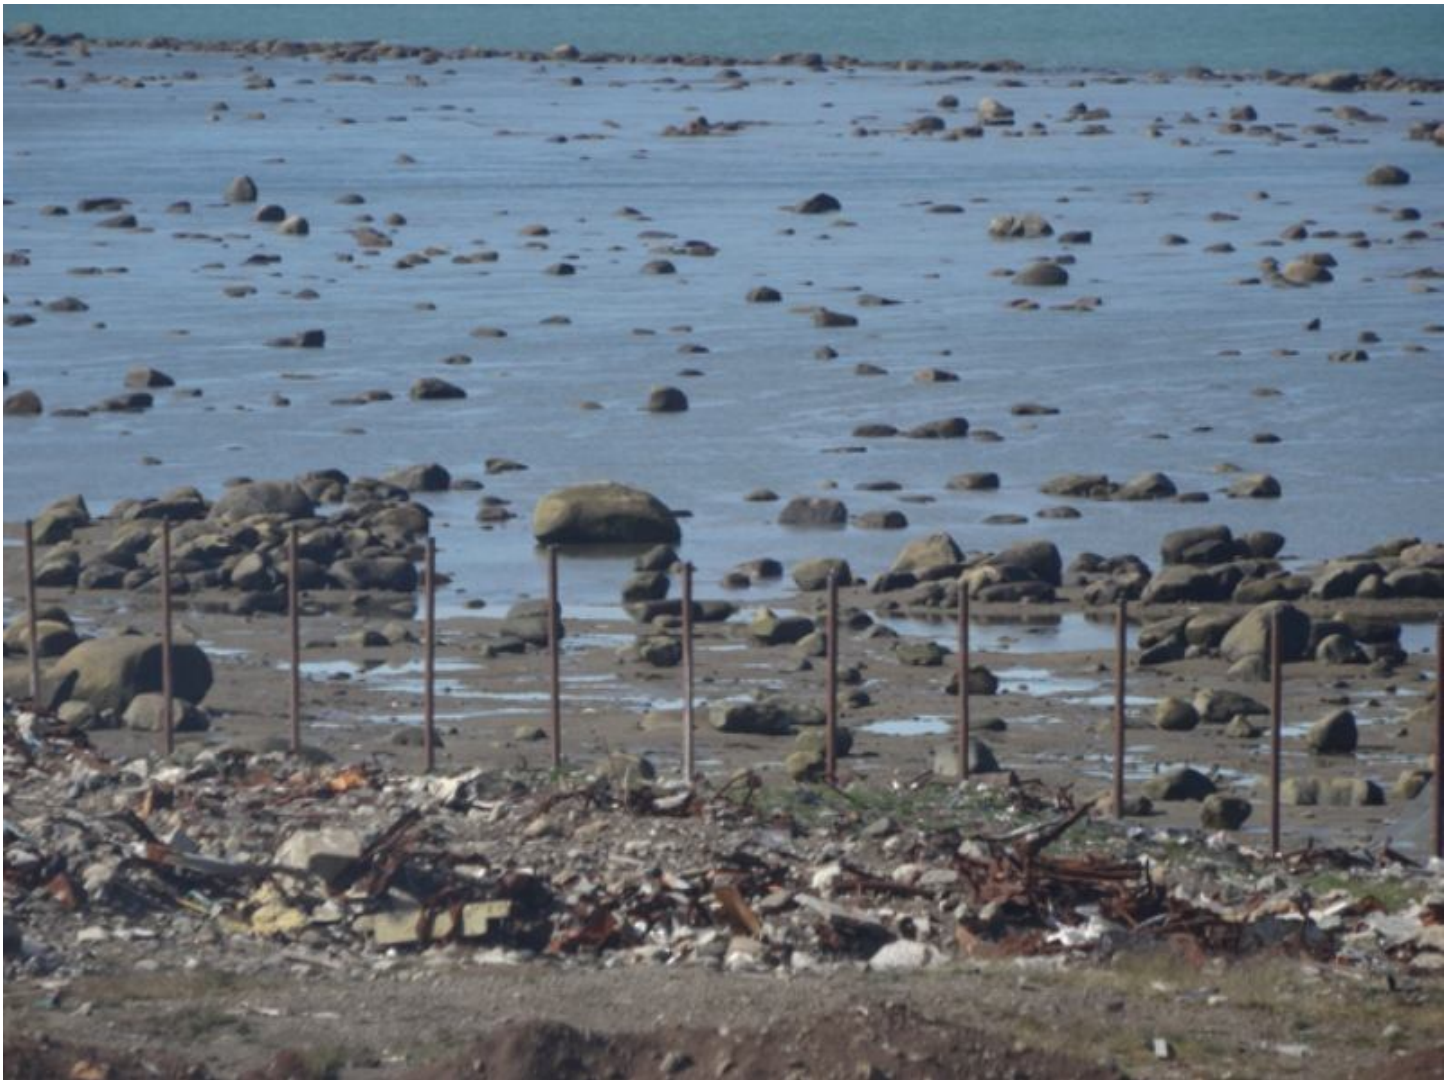
- The fence was down all along the back side (closest to the fiord) of the Waste Management Area.
- Samples were collected from two ponds ( 2 sets) below the Solid waste management Area)

Figure 13 Fencing is all down on the far side of the Solid Waste Management Area

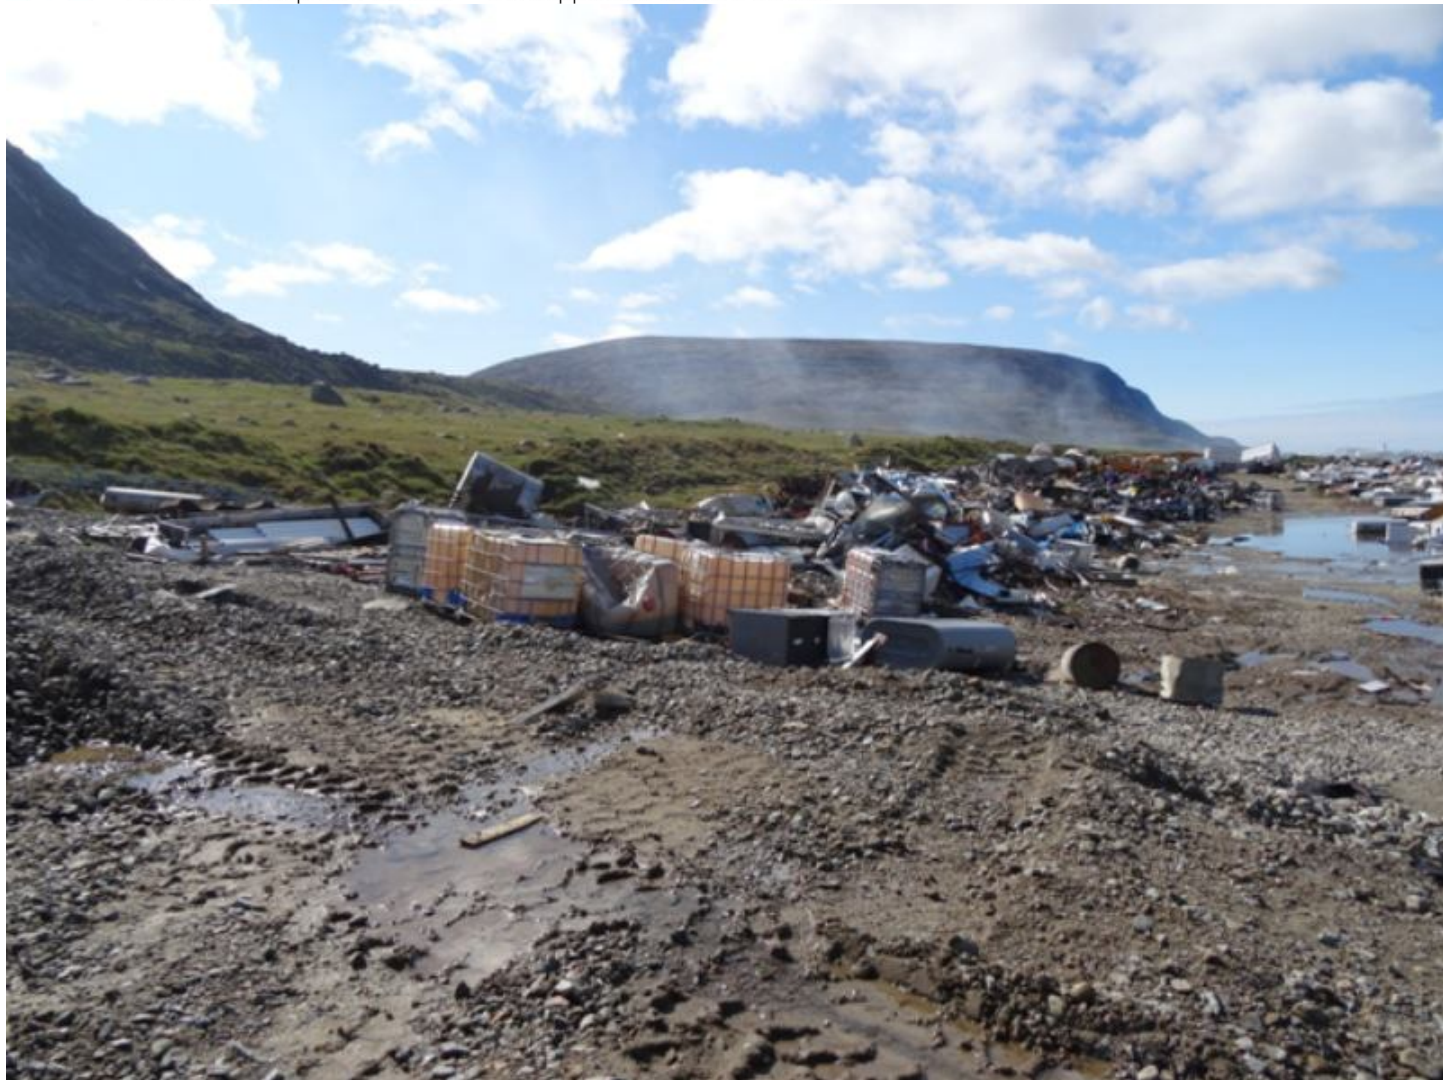
- The site is actually two areas with a common access.
  - The facility is unlined and unfenced.
  - The west end, close to the entrance to the Facility has a sea-can for batteries, electronics and Propane tanks on site but it is unclear how these batteries will be safely stored or contained for packaging and shipment off site.

- A manual for the operations and maintenance of the new sites was also not available for review when requested during the Inspection
- There are no measures to prevent run off or leachate from leaving any of these waste management facilities.

Figure 14 New Waste Management Site – No Segregation of Haz Wastes - no water management

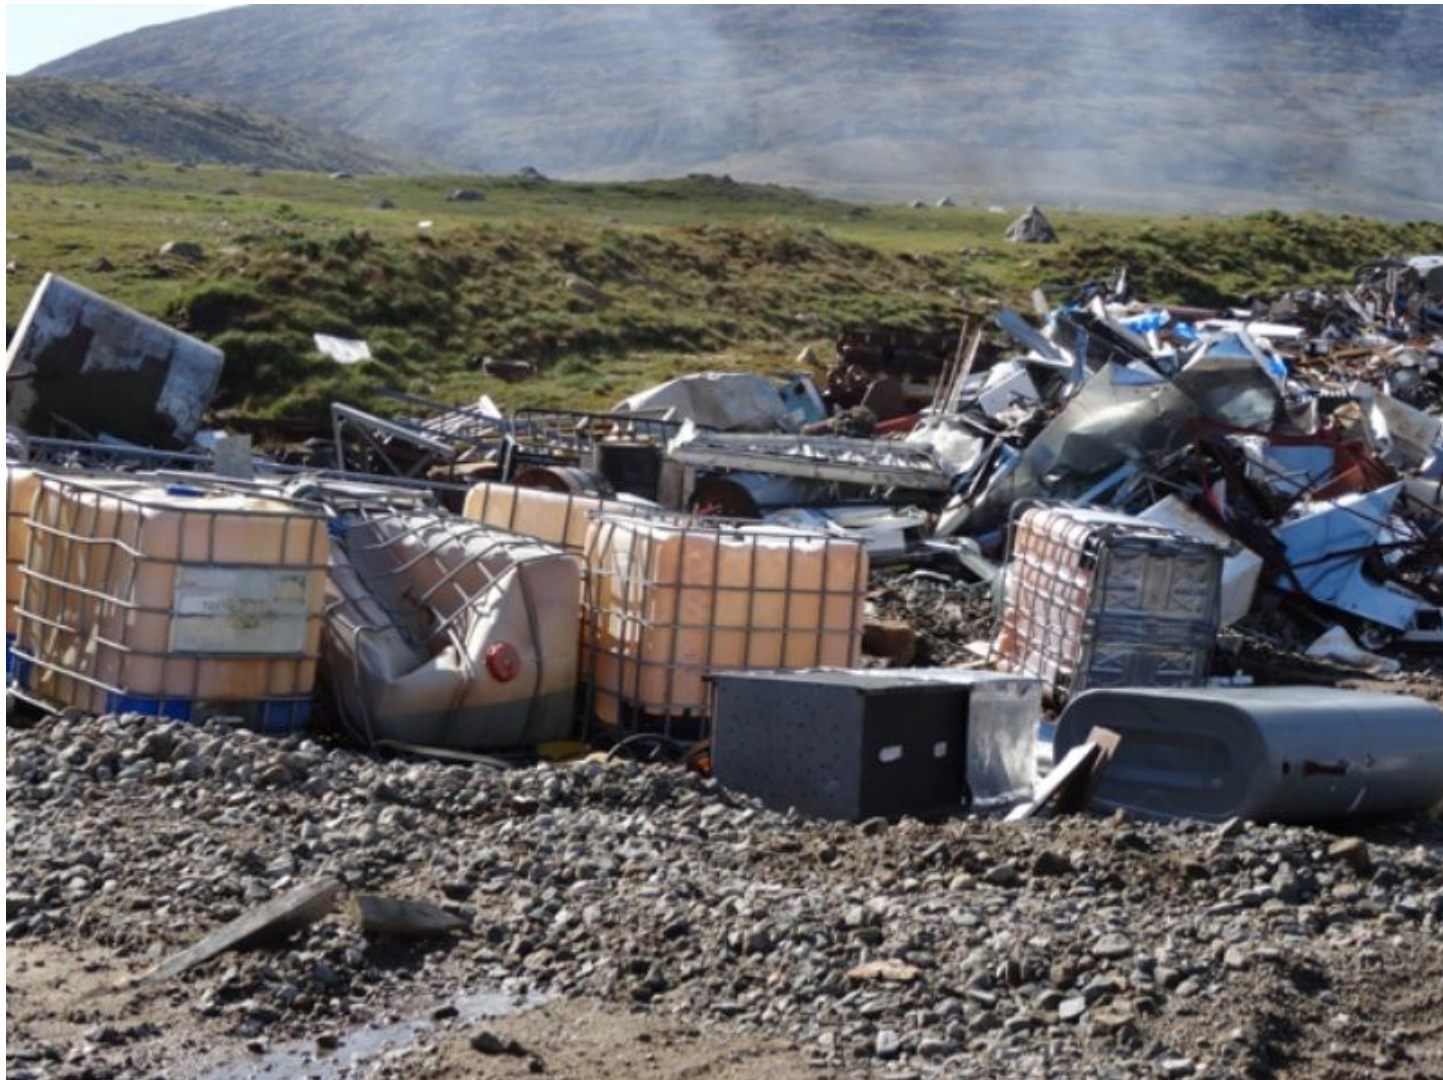
- The remainder of the area on the west side contains scrap metal including old appliances, house hold fuel tanks, old vehicles, an abandoned fuel delivery vehicle, large industrial parts from the Waste Water Treatment Facility that have been scrapped, Snow machines, and large 1 cube oil and transfer cubes from the Hamlet garage.

Figure 15 Totes of Oil - in new Solid Waste Managmne t Area

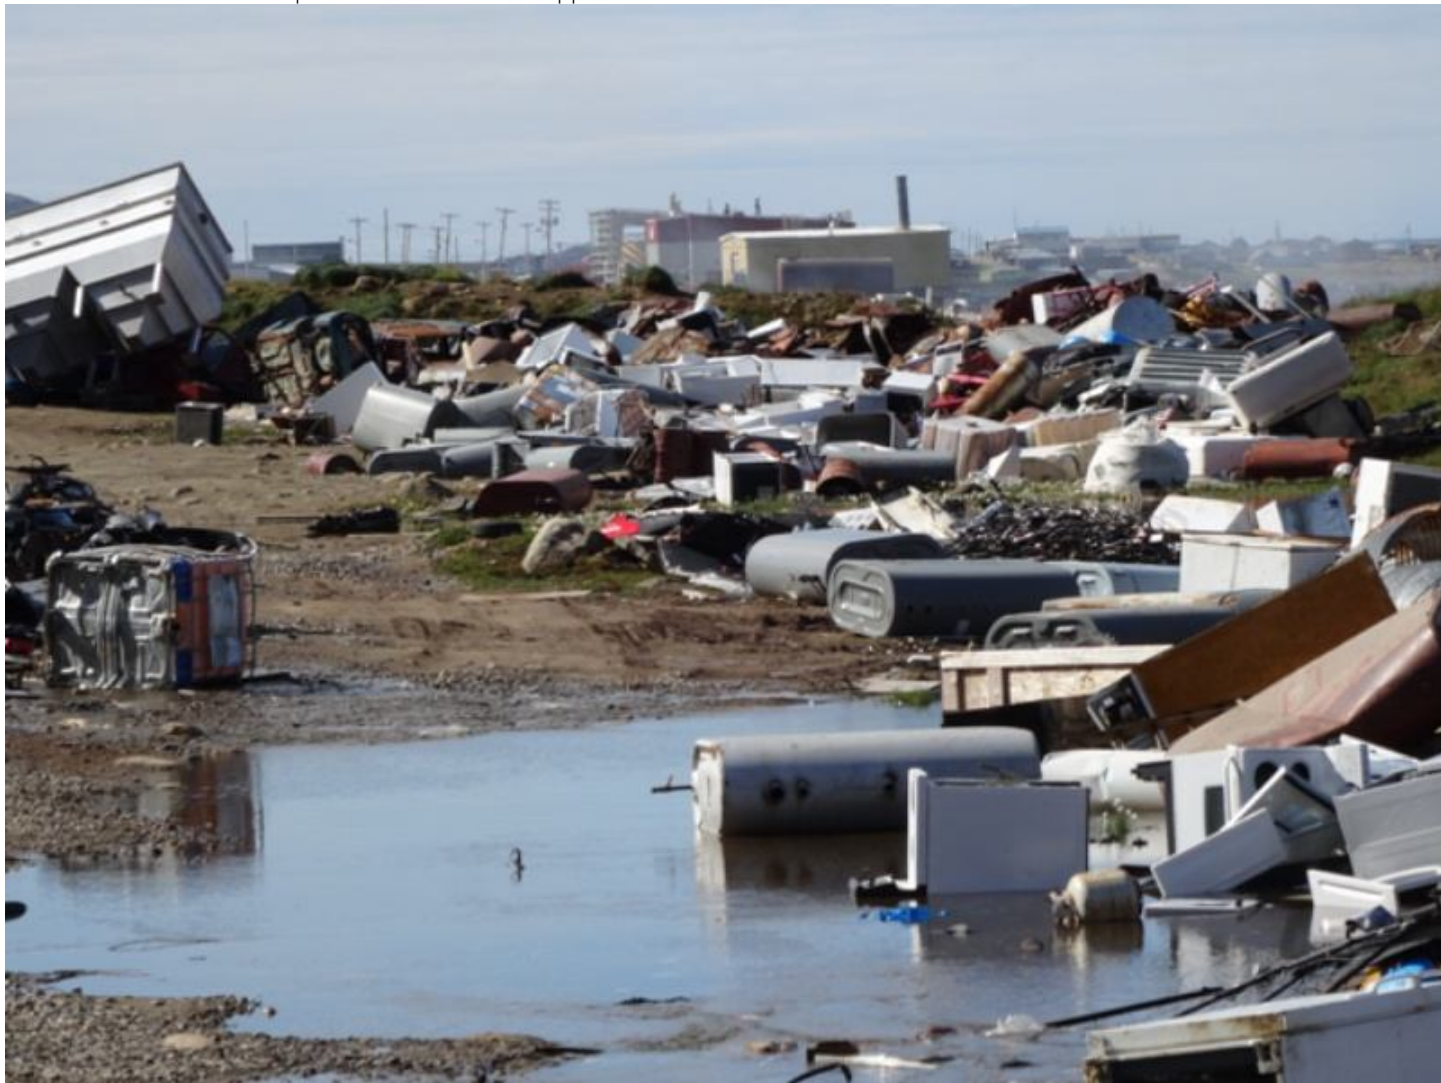
Figure 16 Old household fuel tanks, appliances and other waste metals

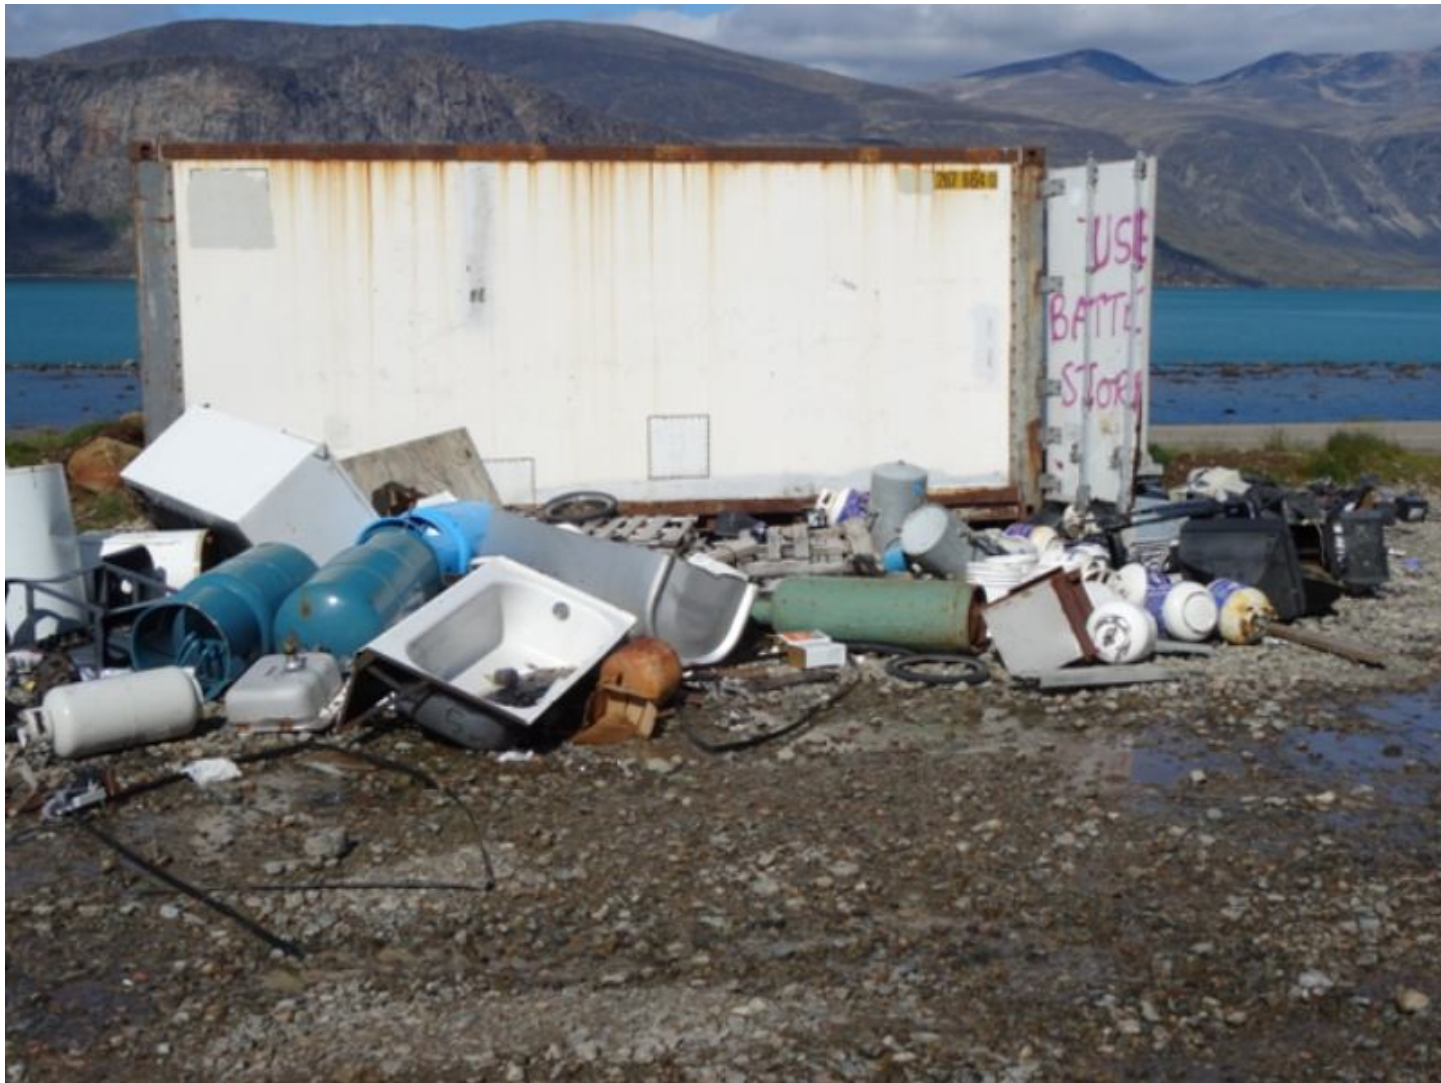
Figure 17 Haz Mat Storage

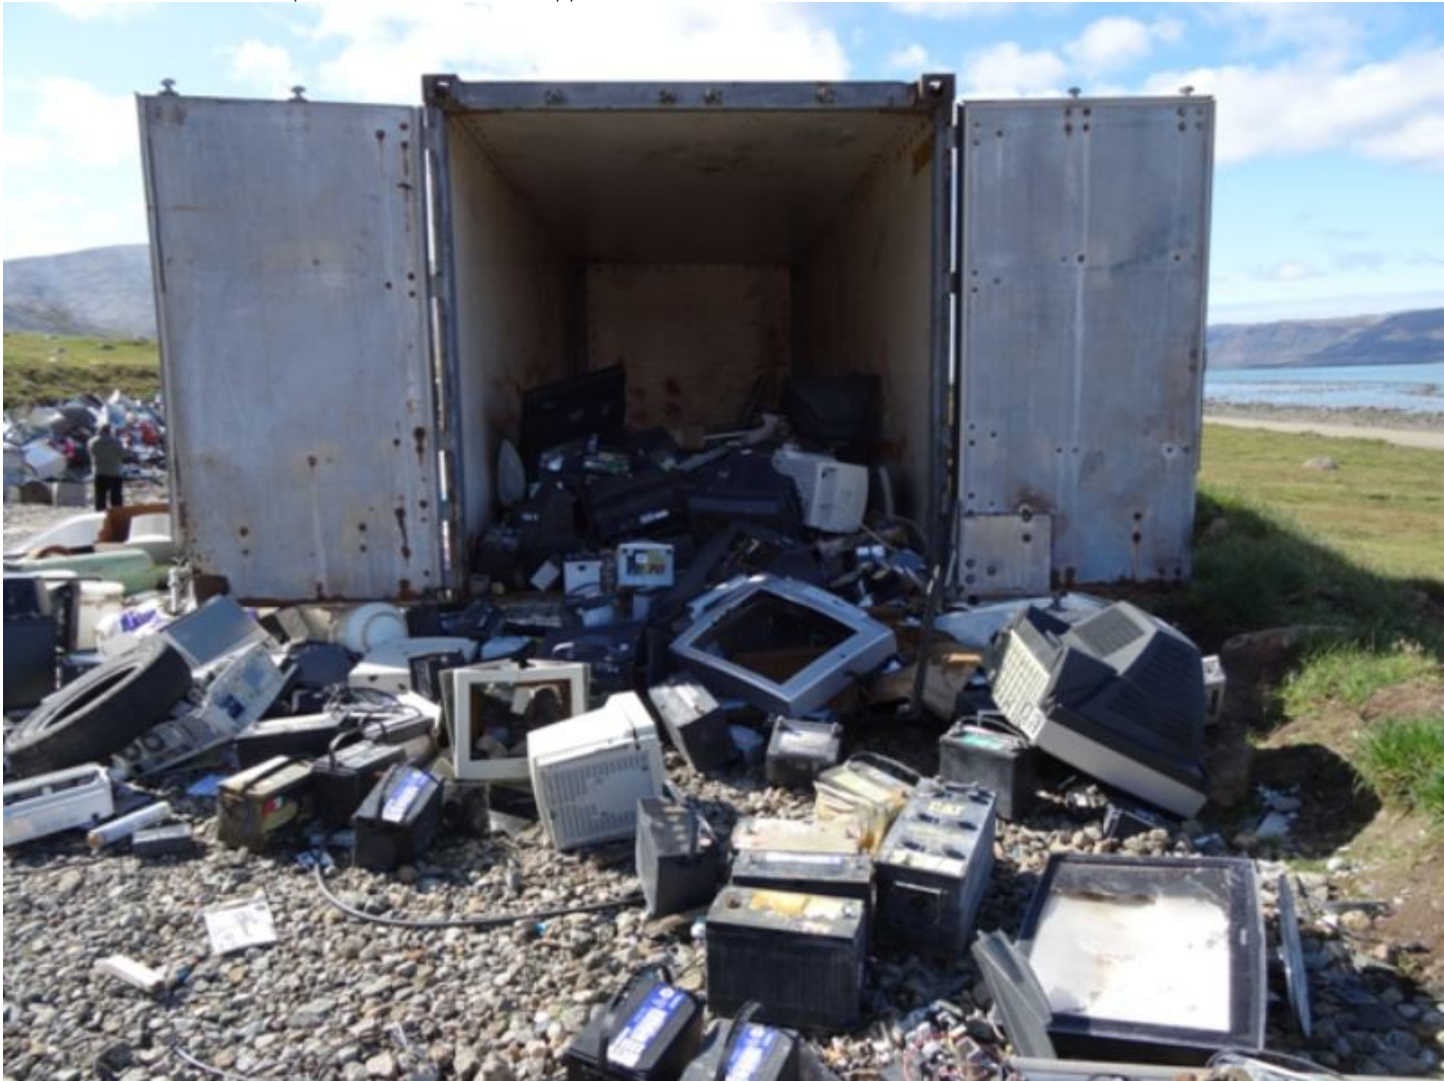
Figure 18 Haz Mat Storage
