WATER LICENCE INSPECTION FORM

Licensee		Licensee Representative	
Hamlet of Pangnirtung		Wayne Solomon	
Licence No. / Expiry		Representative's Title	
3BM-PAN0810 // Renewed to 3BMPAN1417		Acting Senior Administrative Officer	
Land / Other Authorizations		Land / Other Authorizations	
Date of Inspection		Inspector	
14/08/2014		A.Keim	
Activities Inspected			
<input type="checkbox"/> Camp	<input type="checkbox"/> Drilling	<input type="checkbox"/> Mining	<input type="checkbox"/> Construction
<input type="checkbox"/> Roads/Hauling	<input type="checkbox"/> Other: Water Discharge	<input checked="" type="checkbox"/> Other: Municipal	<input type="checkbox"/> Reclamation
<input type="checkbox"/> Fuel Storage

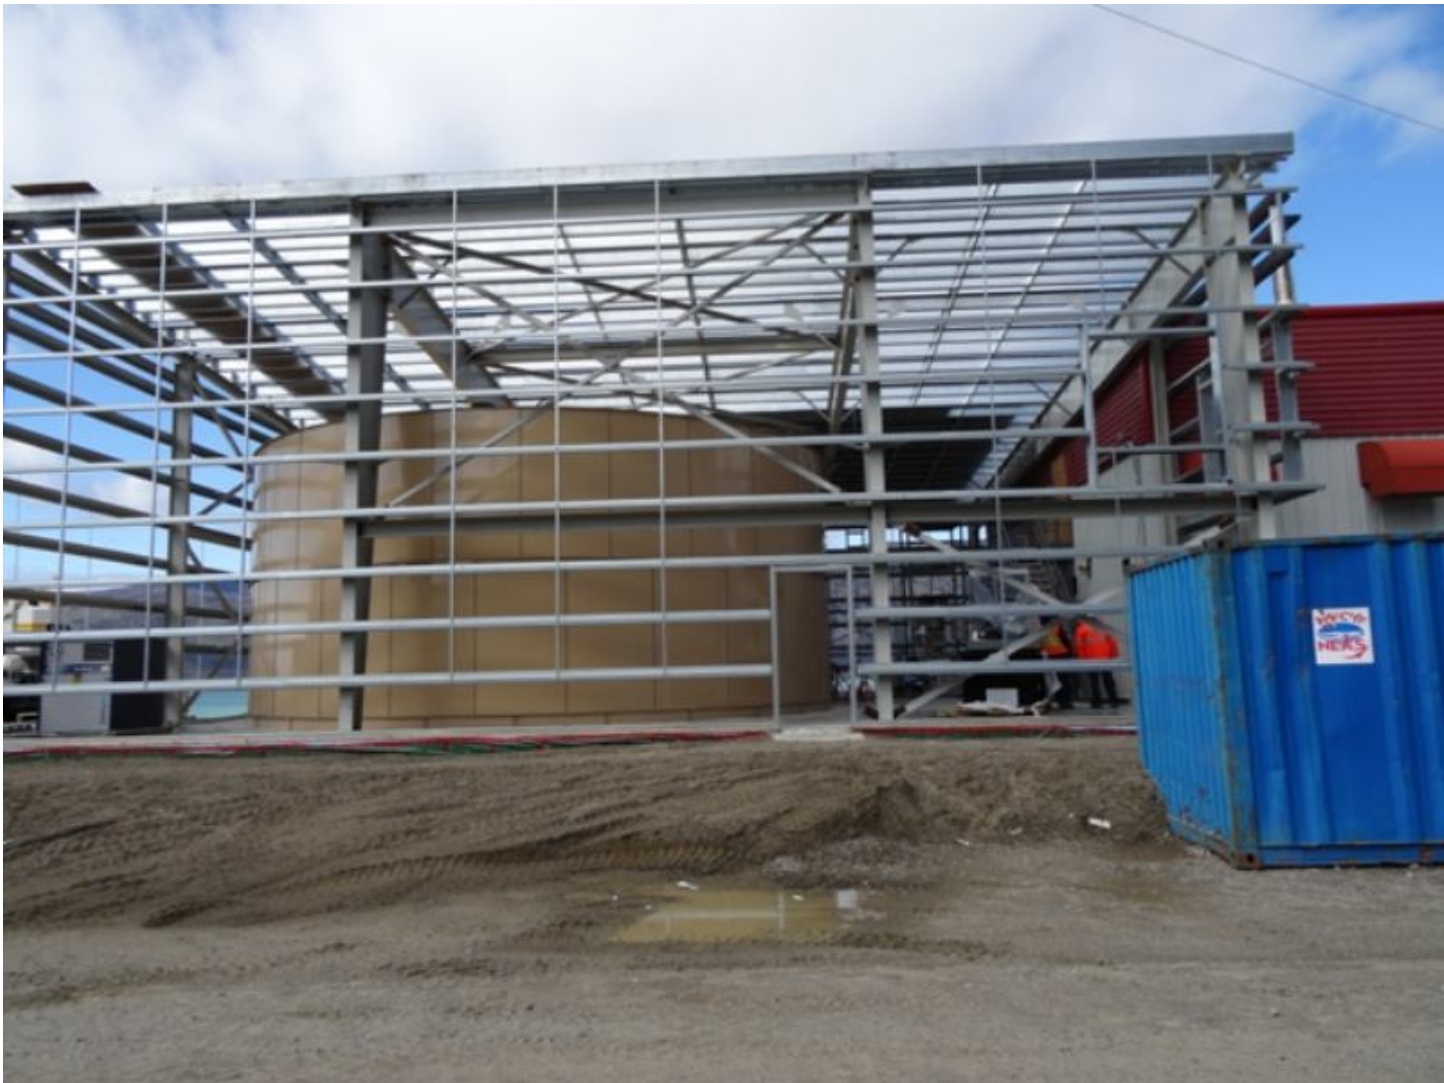
- No drainage diversions are in place to control contact water within the Municipal Waste Management Area.
- The Waste Water Treatment Plant was undergoing modifications during the period of Inspection. It was noted that a diversion had been installed past the solids removal process and a direct discharge to the dispersion field outside the building was occurring. Samples were collected down from the end of the discharge.

Figure 19 WWTF - on going renovations

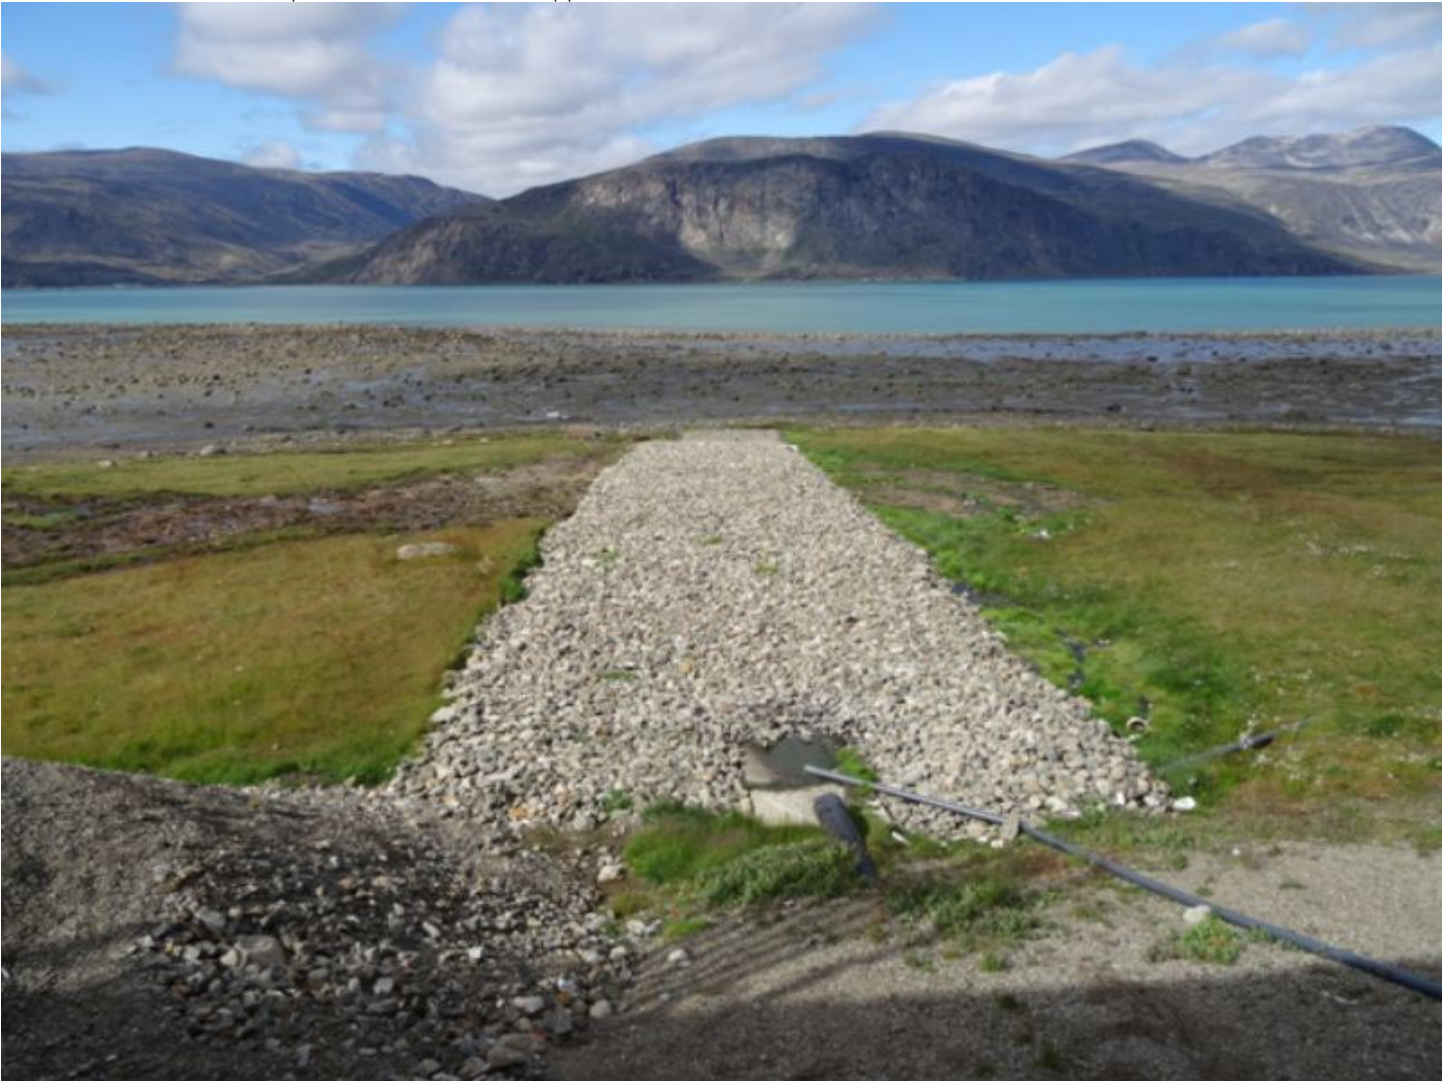
Figure 20 WWTF Dispersion field

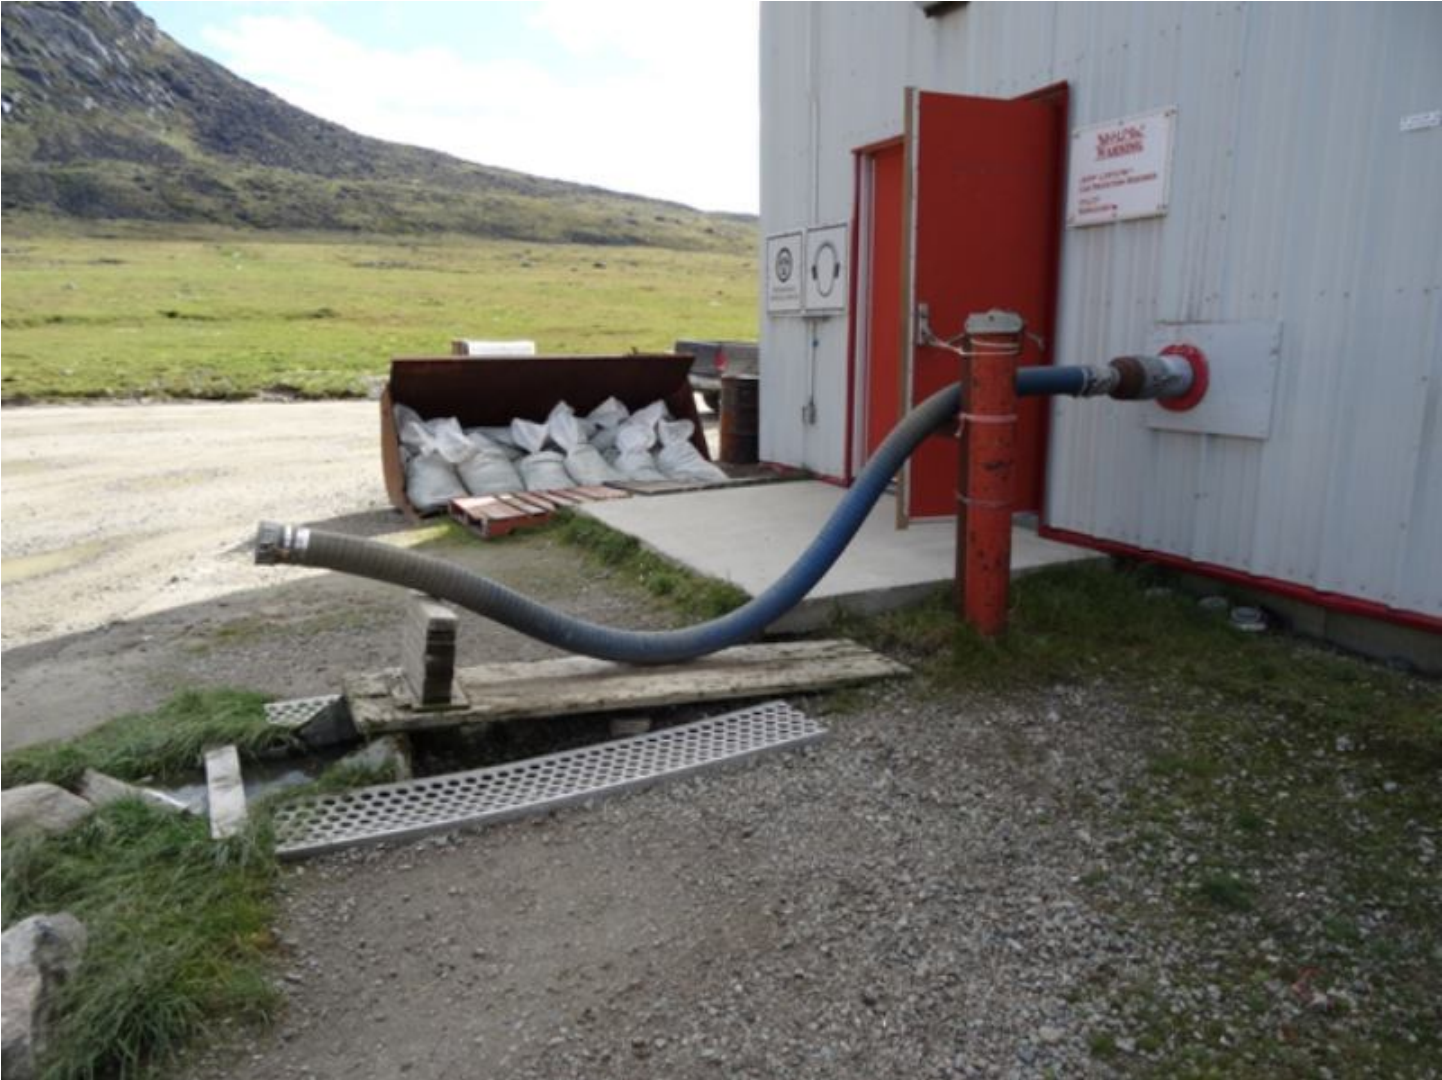
- Rocks and a long culvert have been installed to segregate the solids from the Waste Water treatment Plant. It was also noted that the bags of solid waste are being placed within a circle of dirt to prevent run off.

Figure 21 WWTF - Sludge bags awaiting transport to Solid Waste Managment Area
