Sewage and Solid Waste Sites, Kugaaruk, NU

Pre-Design, Phase 2

Dillon Consulting Limited

**Pre-Design Report - Phase 2, Kugaaruk Sewage and Solid Waste
Facilities Design**

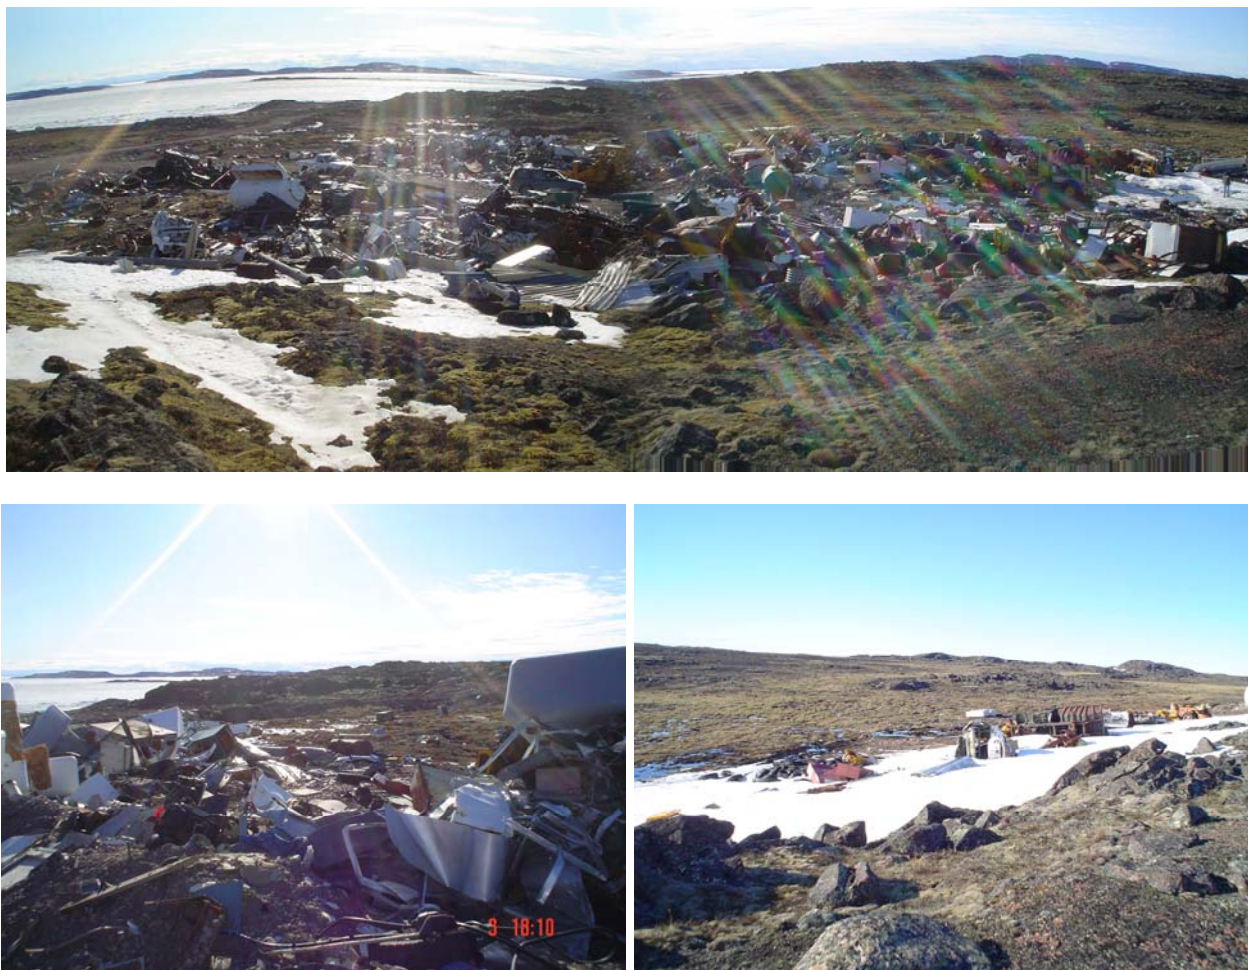
Figure 5.1: Existing Bulky Metals Disposal Area

Currently, the bulky metals area at the landfill is disorganized and unkept (see figure 5.1). Bulky metal wastes include fuel drums, discarded automobiles, decommissioned heavy machinery, scrap metals such as siding, pipes, frames and automotive parts, e-waste such as computers and monitors and white goods or residential appliances, which include refrigerators, stoves, dishwashers, dryers, laundry machines and hot water heaters. These wastes are stored separately from the general waste stream so that they may be shipped south for possible reclamation when sufficient quantities exist.

The existing materials at the site should be organized and sorted. Materials that may be re-claimed or recycled should be set aside to be shipped. The site should be re-organized to provide designated areas for specific types of waste. Figure 5.2 shows a sample layout for the re-organized bulky metal waste site.

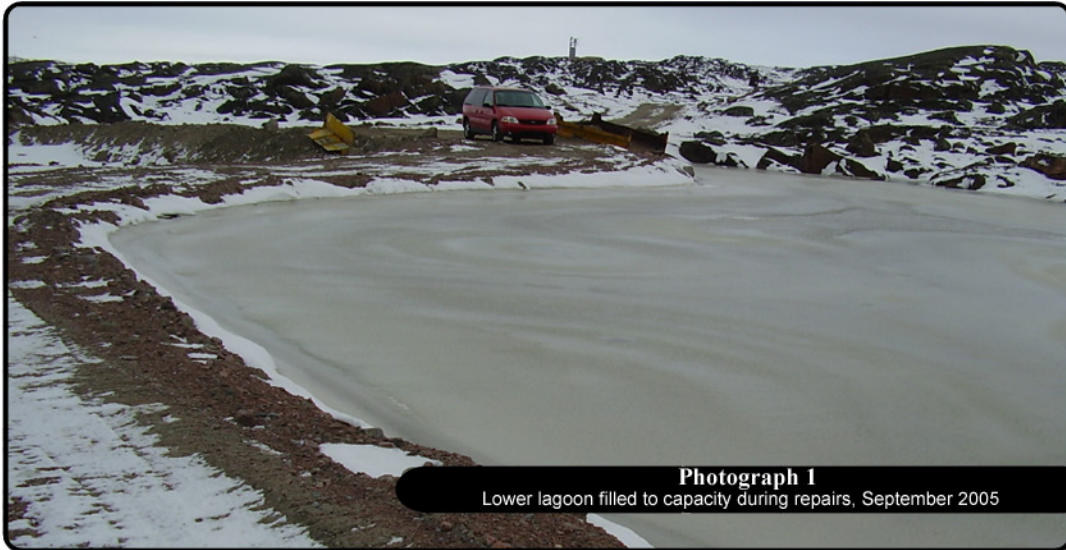
The berm containing the lower lagoon had actually been breached when it was filled to capacity during the repairs. This breach is located in the centre of the berm where most of the seepage is occurring and was repaired by the Hamlet. A culvert was installed at the end of the berm during repairs to accommodate overflow. It was observed that the rate of seepage out of the second lagoon had increased by visually comparing the current levels with the levels in the wetland area the year before. The higher rate of seepage that was observed coming out of the second lagoon may be attributed to increased head caused by the sewage from the first lagoon being pumped into the second lagoon without first draining the second lagoon into the receiving environment.

Photograph 1
Lower lagoon filled to capacity during repairs, September 2005

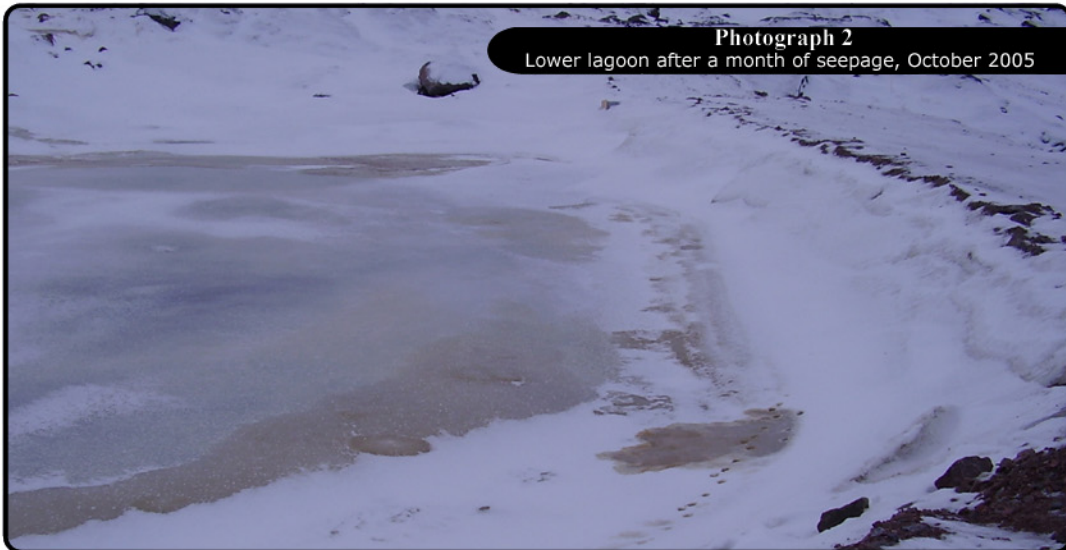
Photograph 2
Lower lagoon after a month of seepage, October 2005

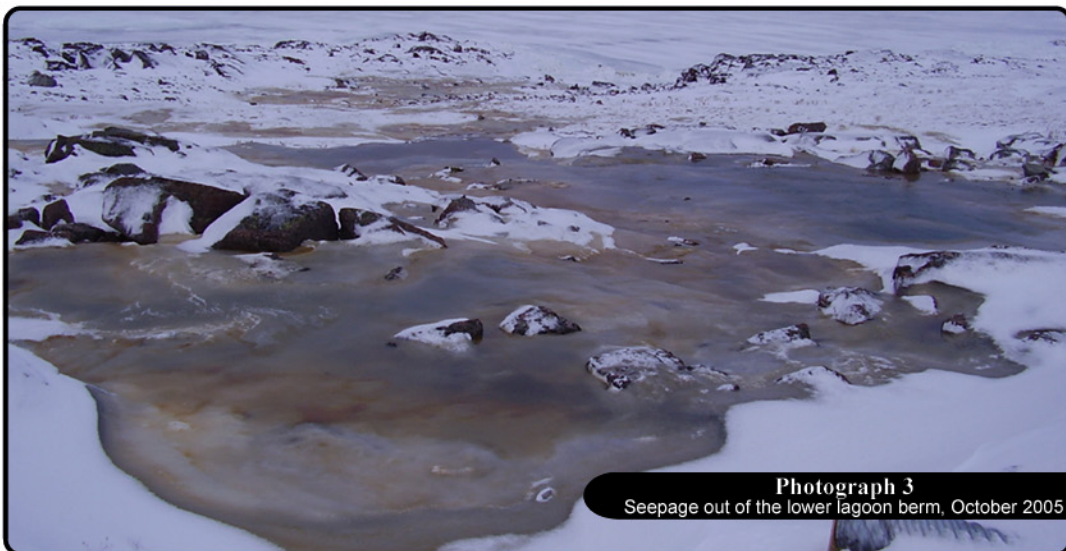
Due to the timing of construction late in the year, it is possible that the bentonite that was applied to seal the inside face of the berm froze before it could achieve maximum efficiency.

Photograph 3
Seepage out of the lower lagoon berm, October 2005

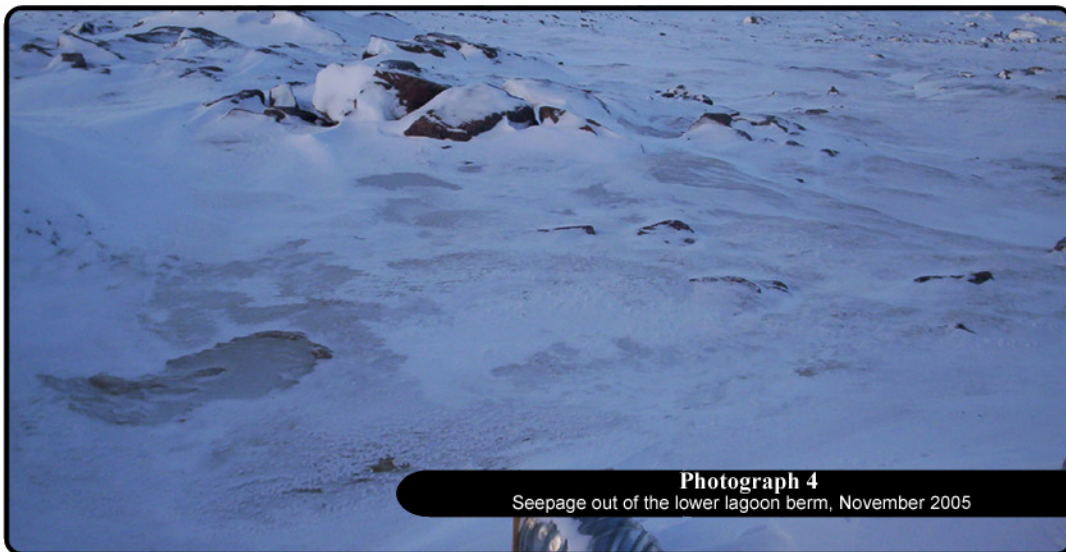
Photograph 4
Seepage out of the lower lagoon berm, November 2005

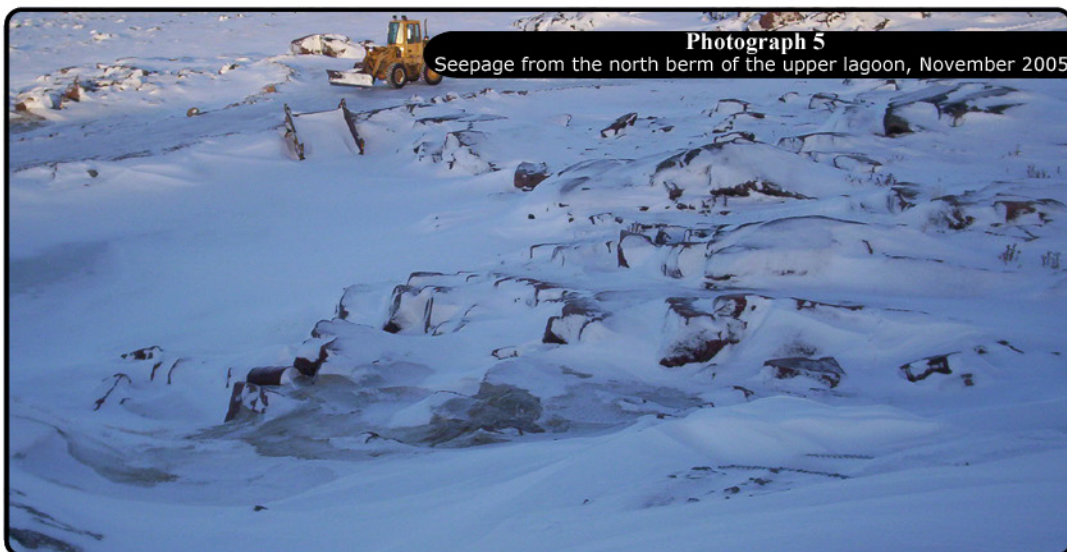
The site inspection took place on November 2. Janice was accompanied to the sewage lagoon site by Hamlet Foreman Gaetan Apsaktuan. Visual inspection of the north berm showed that leakage had occurred through the berm at the same locations that had leaked prior to the repairs on the berm. Upon inspection of the berm containing the second lagoon, which was not repaired by Kudlik Construction, leakage was observed coming from the centre of the berm and at both sides, also the same locations that had been leaking prior to the repairs. The leakage appeared to be coming from the base of the berms.

Photograph 5
Seepage from the north berm of the upper lagoon, November 2005
