WATER LICENCE INSPECTION FORM

Licensee		Licensee Representative	
Hamlet of Kugaaruk		John Ivey	
Licence No. / Expiry		Representative's Title	
3BM-PEL1419		Senior Administrative Officer	
Land / Other Authorizations		Land / Other Authorizations	
Date of Inspection		Inspector	
11 July 2018		Baba Pedersen	
Activities Inspected			
<input type="checkbox"/> Camp	<input type="checkbox"/> Drilling	<input type="checkbox"/> Mining	<input type="checkbox"/> Construction
<input type="checkbox"/> Roads/Hauling	<input type="checkbox"/> Other:	<input checked="" type="checkbox"/> Other: Municipal Water License	<input type="checkbox"/> Reclamation
<input type="checkbox"/> Fuel Storage

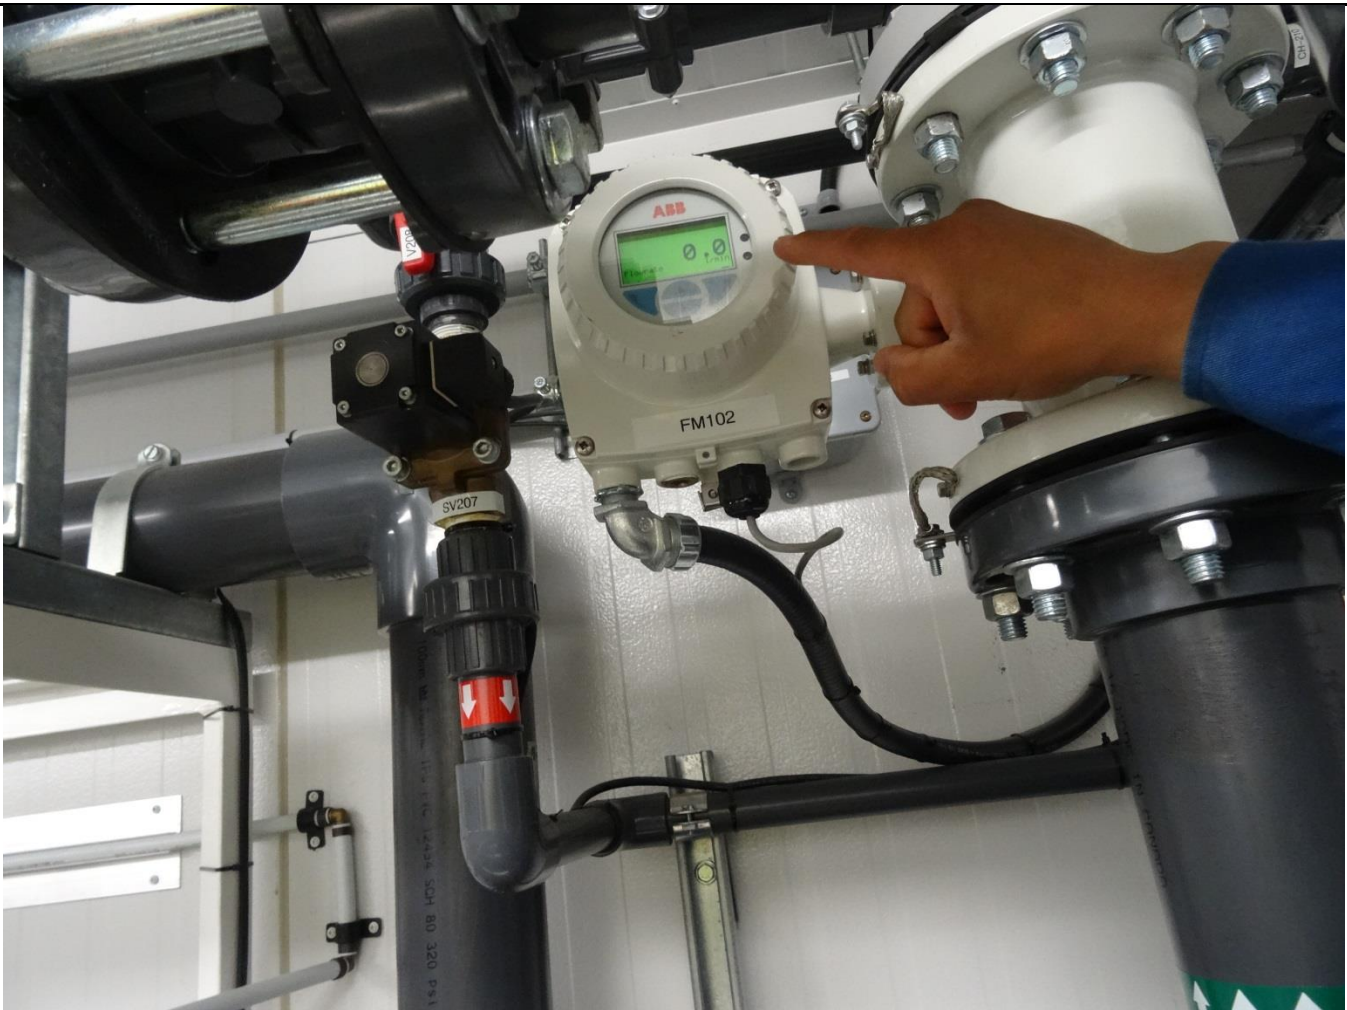
Photo 1

Description: Raw Water Flow Meter

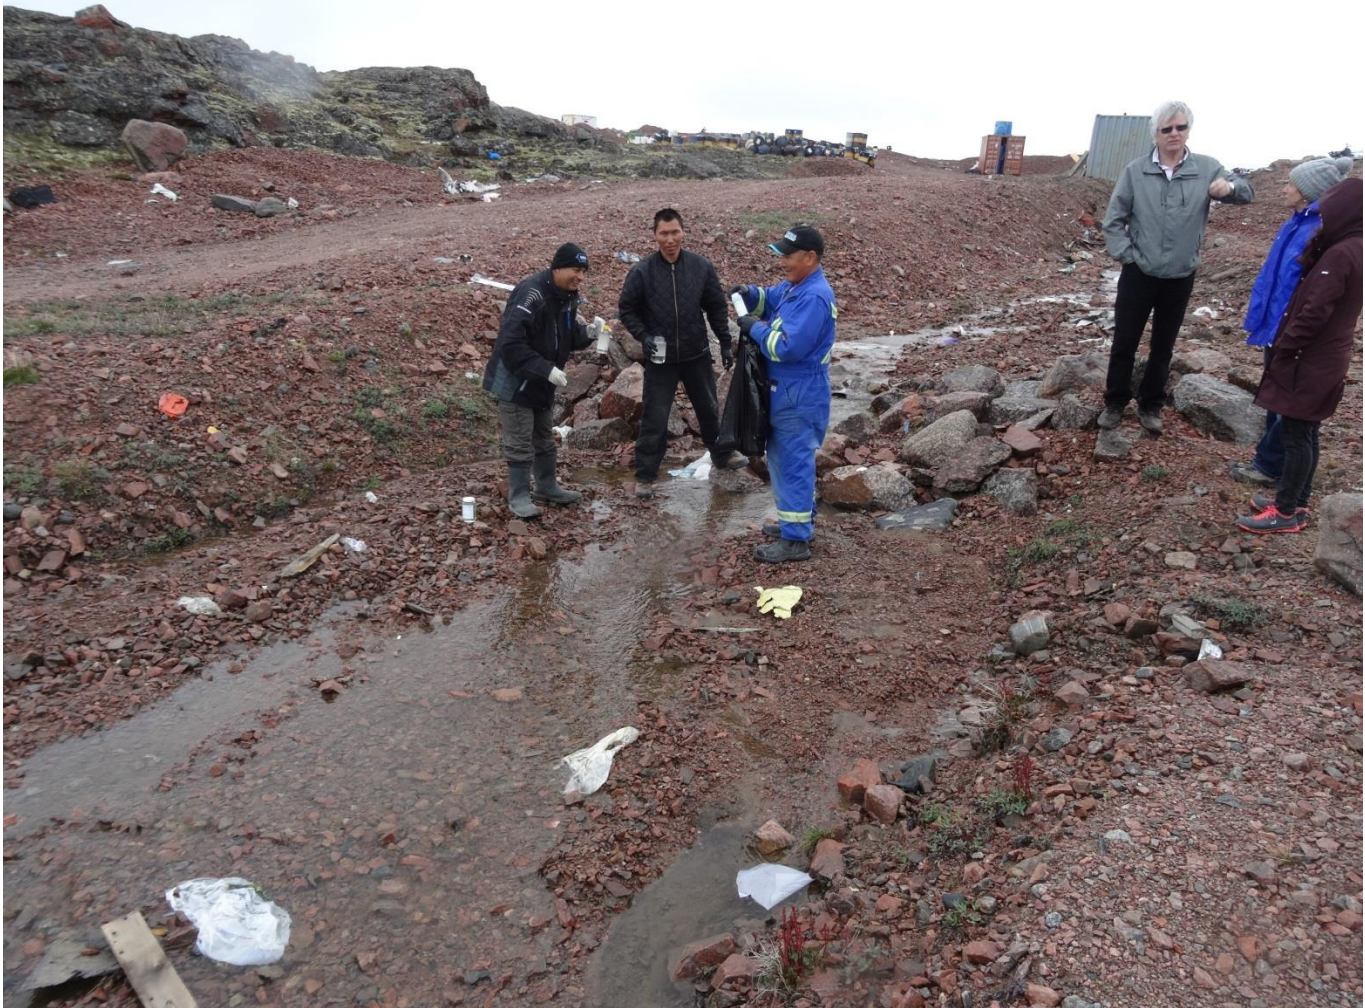
Photo 6

Description: Hamlet and GN CGS Staff taking Samples at Station PEL-7

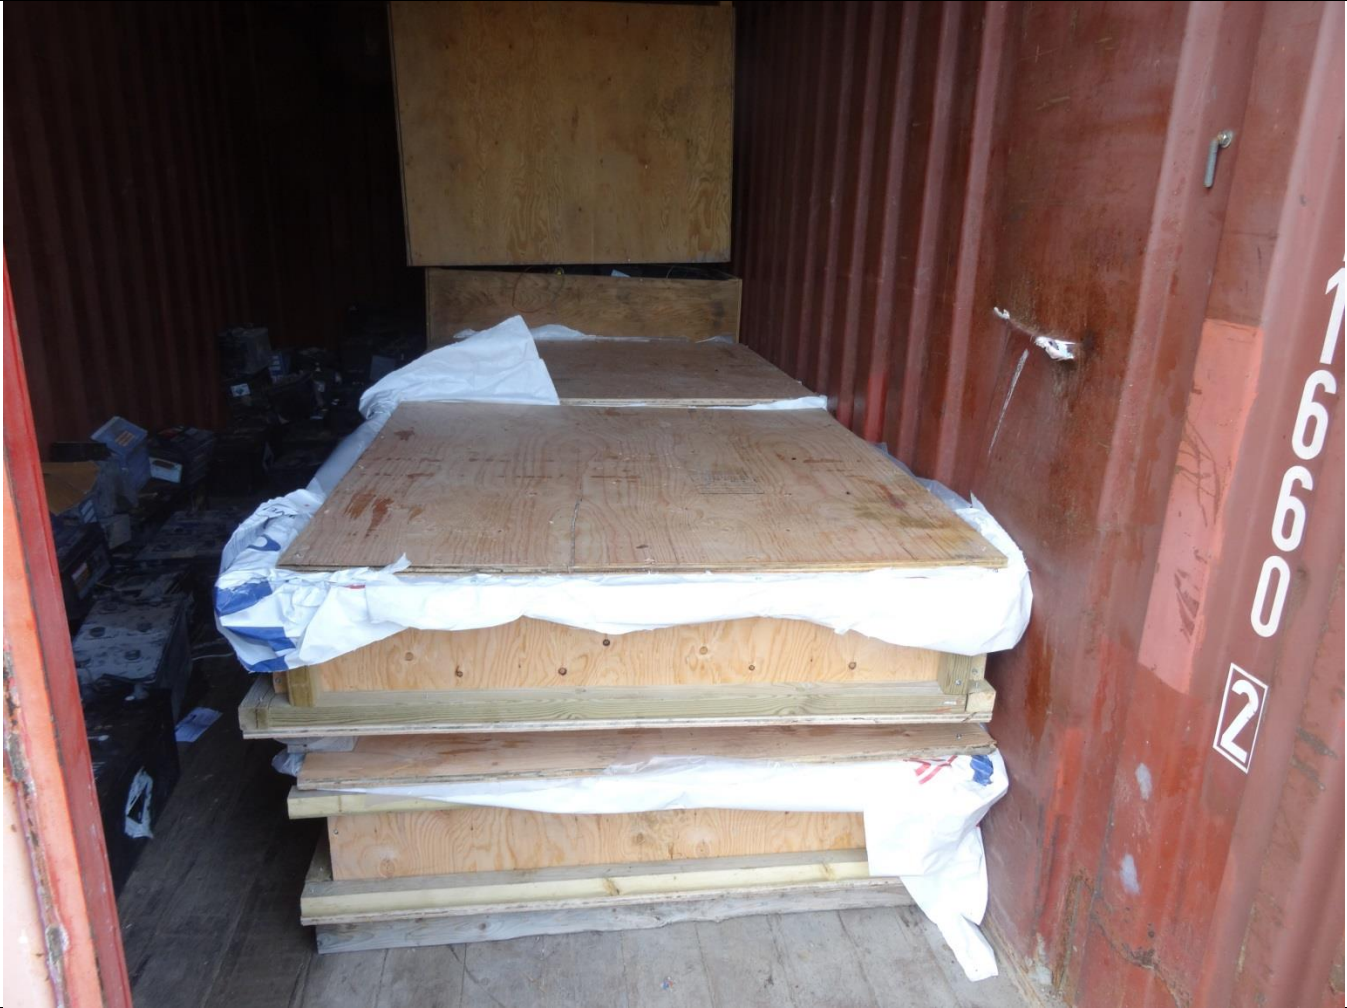
Photo 7

Description: Lined Wooden Crates of Discarded Batteries to be sent South for Disposal via 2018 Sea Lift Back Haul

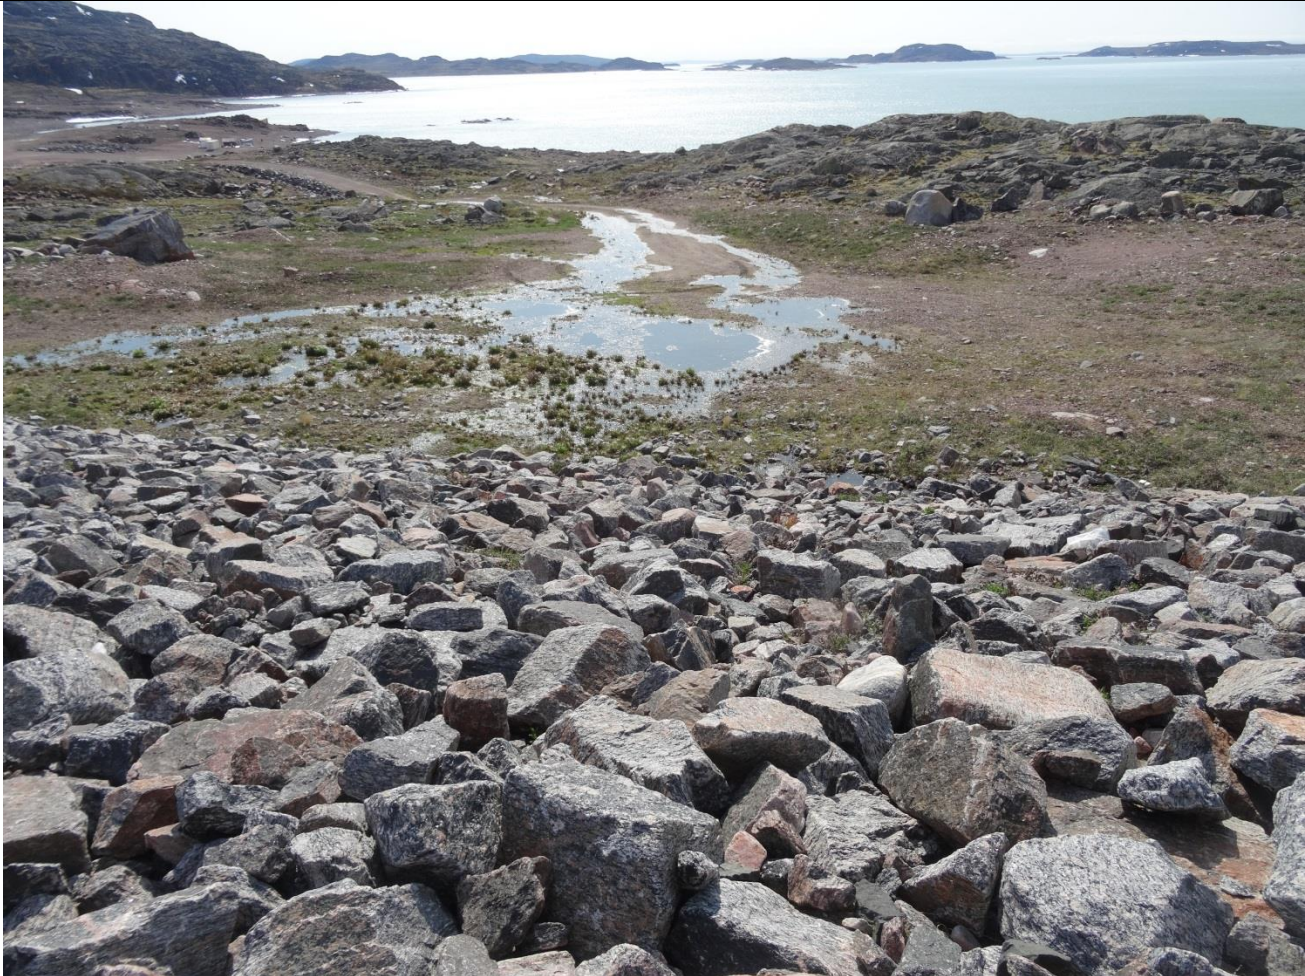
Photo 9

Description: View of Sewage Lagoon Leak #2 from top of Berm
