- **Hamlet of Kugaaruk**

Dam Safety Review

Project Name
Dam Safety Review
Sewage Lagoon
Kugaaruk, Nunavut

Date Submitted
November 14, 2014

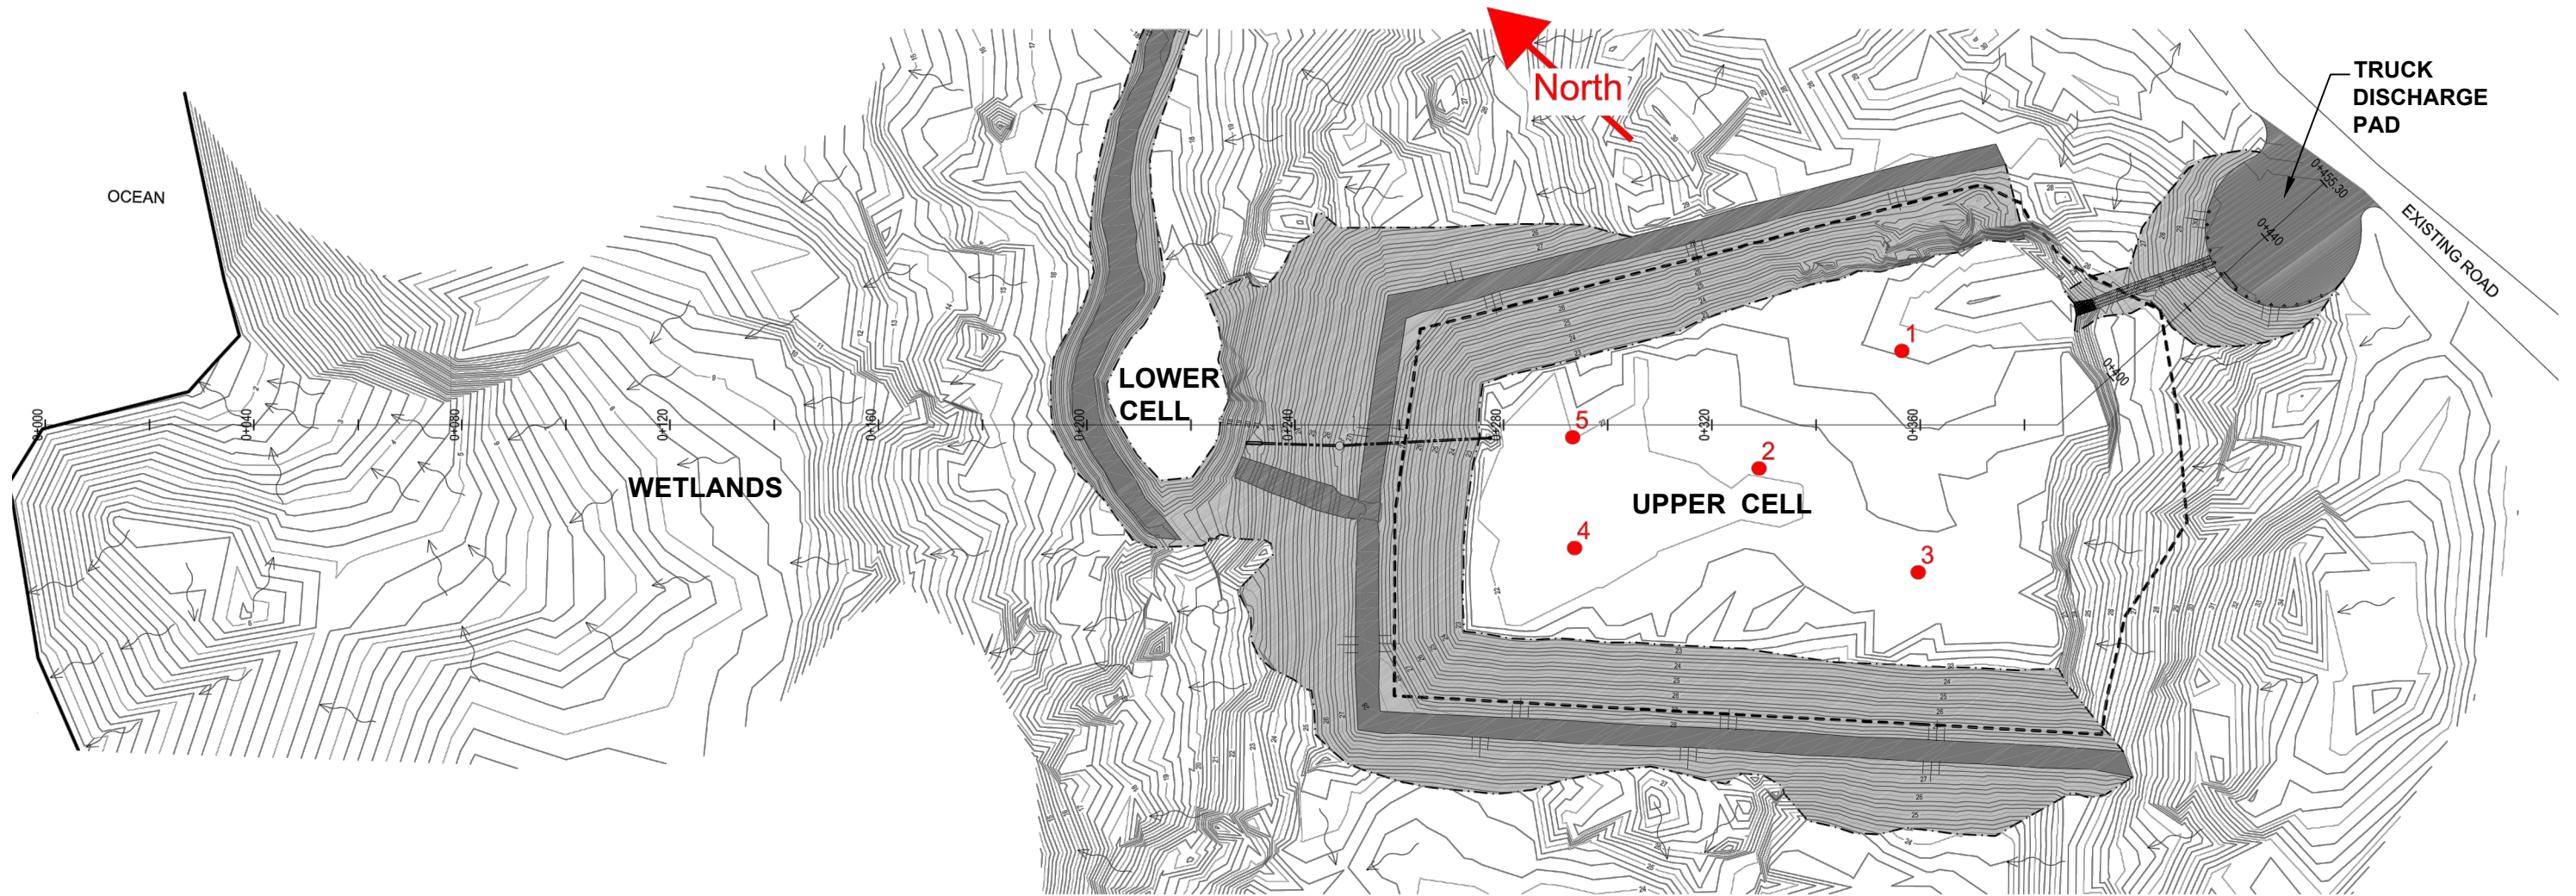
scale 1:1250	CLIENT: HAMLET OF KUGAARUK, NU	project no. OTT-00219538-A0
date NOV. 12, 2014	TITLE: GEOTECHNICAL INSPECTION, KUGAARUK SEWAGE LAGOON KUGAARUK, NU	FIG 3
drawn by M.N.

Measurements of the sludge blanket thickness were obtained at select locations as part of our assessment. The measurements were obtained to provide a basis for evaluating when clean out of the lagoon may be required. The approximate locations of the measurements are shown on the attached Figure 3.

Based on our measurements it is estimated that the sludge blanket at the time of our visit was about 0.3 m thick. Section 3.2.3.2 of the Operation Manual for the facility (prepared by Dillon and dated October 6, 2009), indicates that the sludge should be removed from the lagoon when it reaches a thickness of 0.5 m. Therefore, it is considered that sludge cleanout is not required at this time.

Based on accumulation rates to date, it is recommended that the sludge blanket thickness be re-evaluated in the summer of 2016 to determine if cleanout is required.

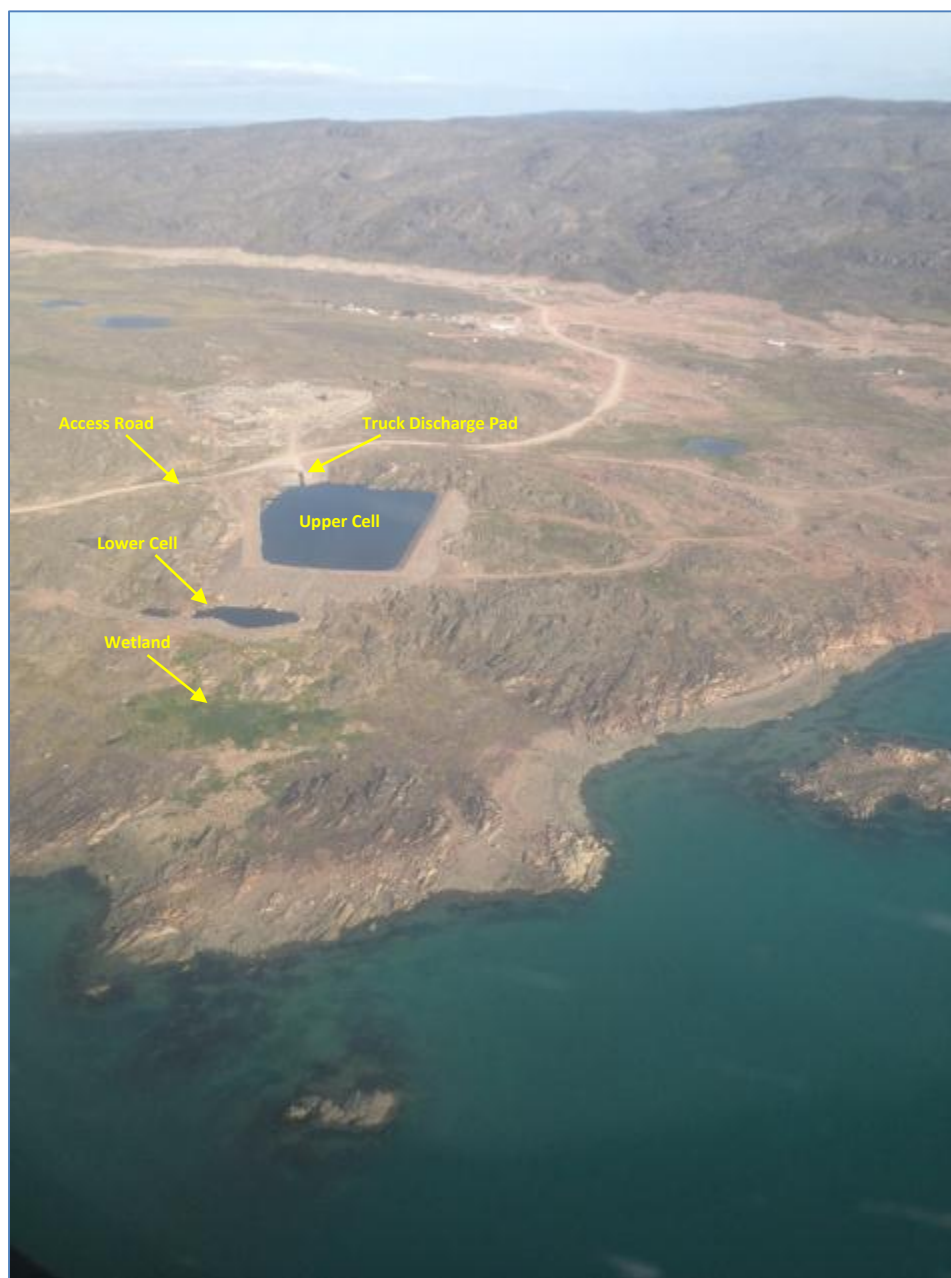
The existing sewage lagoon is located south of the community and is accessed by an approximately 1.3 km long roadway (Figure 2). The existing sewage lagoon comprises of two cells and utilizes the wetland downstream as part of overall sewage treatment. The general layout of the lagoon is shown on the appended Photo 1.

Photograph No. 1
Overview of existing sewage lagoon
(looking east)

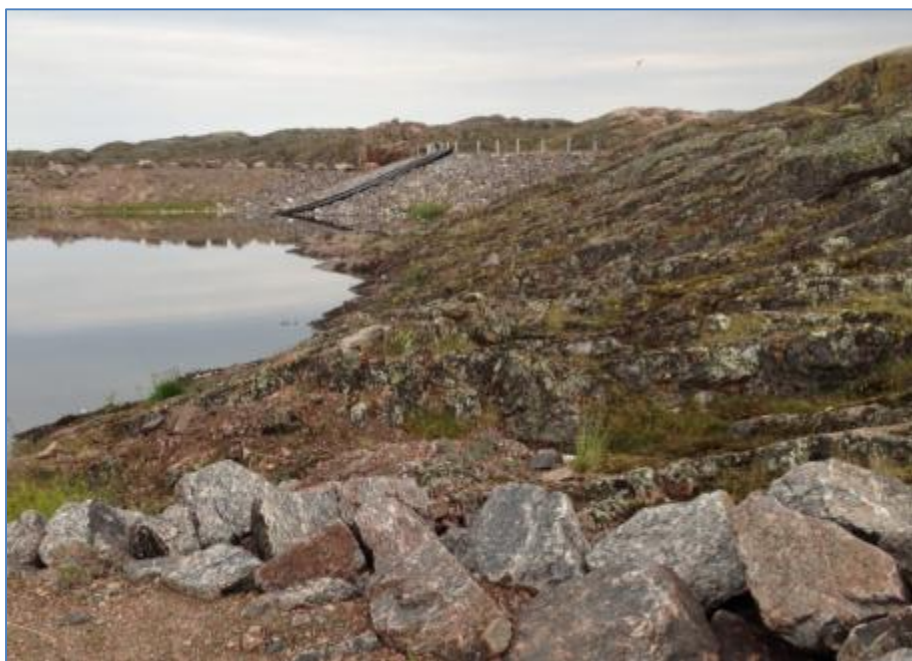
Photograph No. 2

- 2.) The three berms of the upper cell are approximately 5 m wide at the top, with upstream and downstream slopes of 3H:1V. The top of the berms are exposed silty sand and gravel fill and the slopes of the berm have been provided with enough rip rap that the silty sand and gravel core is not visible. The toes of the berms are predominantly founded on exposed bedrock. See appended Photos 2 and 3.

Exposed bedrock providing containment along the east side of the upper cell.
(standing at the southeast corner, looking north)

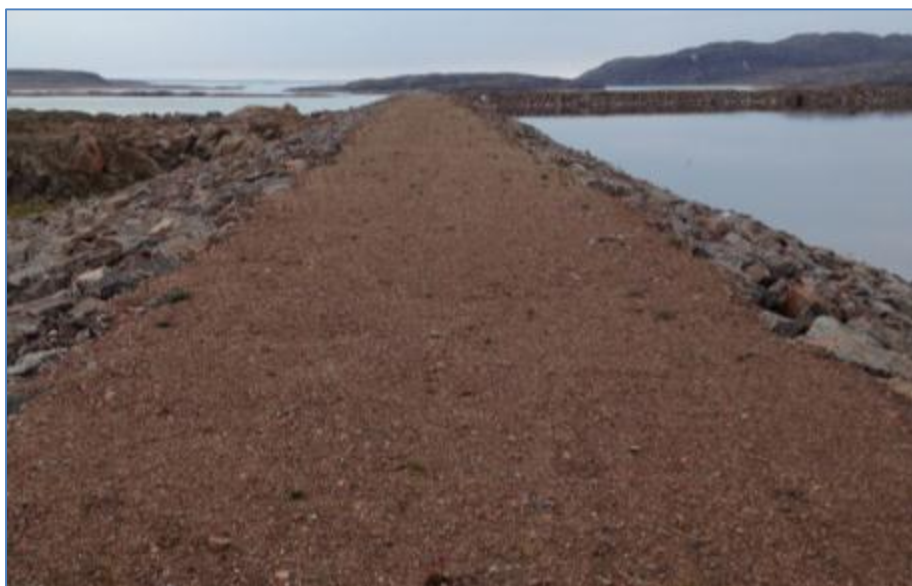
Photograph No. 3

Crest view of south berm; typical top of berm view
(standing at the southeast corner, looking west)

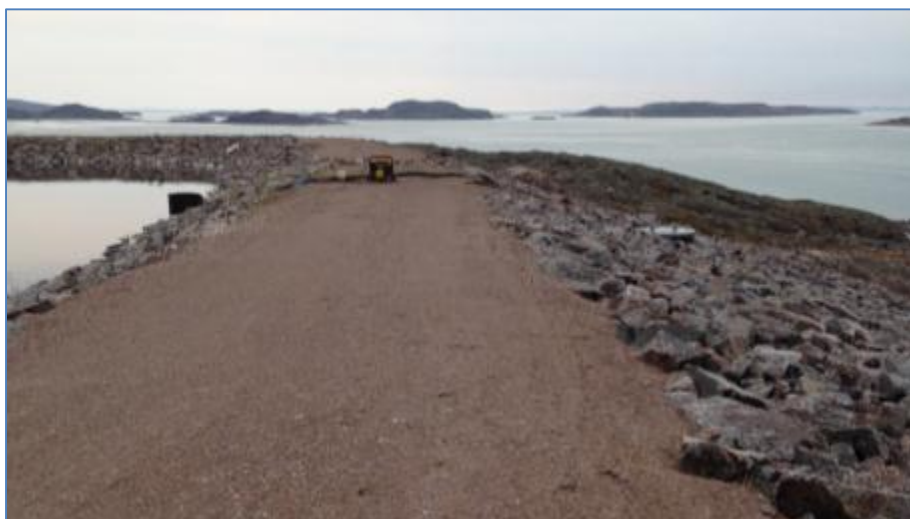
Photograph No. 4

- 4.) The emergency overflow weir was also observed to be in general accordance with the record drawings and was in good condition.
- 5.) A generator was positioned atop the west berm between the upper and lower cell. The generator was not operational during our time onsite; however, it was hooked up to a sump pump that was installed below the effluent surface in the upper cell and connected to a hose that extended over the top of the berm and down the downstream slope to the lower cell. See appended Photo 4.

Informal interviews held with Hamlet of Kugaaruk staff resulted in no major issues being identified regarding the performance of the lagoon. The Senior Administrative Officer (SAO) did indicate that the heat tracer of the discharge pipe was not operational when he took over the office and the valve had frozen shut. Therefore, the Hamlet staff had been using the sump pump and hose to discharge the effluent as outlined above.

The SAO reported that the required maintenance to bring the heat tracer back into operation had been carried out. However, local staff members were still discharging the effluent from the upper cell to the lower cell using the sump pump. To our knowledge it has not been confirmed that the valve is now operational.

Generator and sump pump setup used to discharge effluent from upper cell to lower cell
(standing near northwest corner of upper cell, looking south)

It is recommended that the discharge pipe be brought back into operation. The discharge pipe is part of the original design and is intended to provide a constant flow of effluent from the upper cell to the lower cell during the seasonal decanting process.

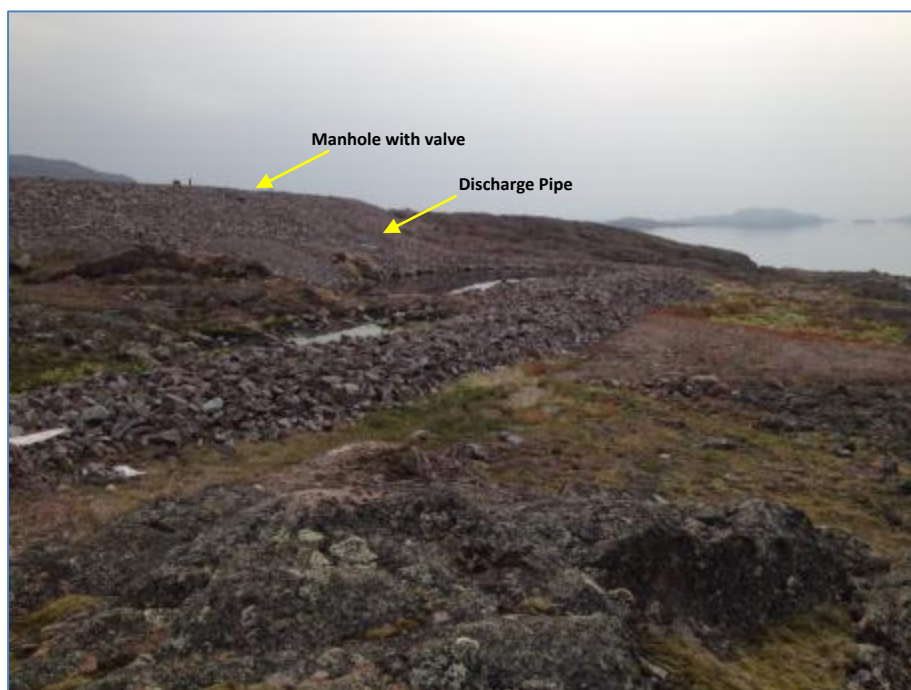
Photograph No. 5

- 6.) The lower cell was partially filled with effluent. Decanting of the effluent by overtopping the lower cell berm into the wetlands was not observed during our visit. See appended Photos 5 and 6.

Downstream slope of west berm of upper cell and view of lower cell.
(standing near northwest corner of lower cell, looking southeast)

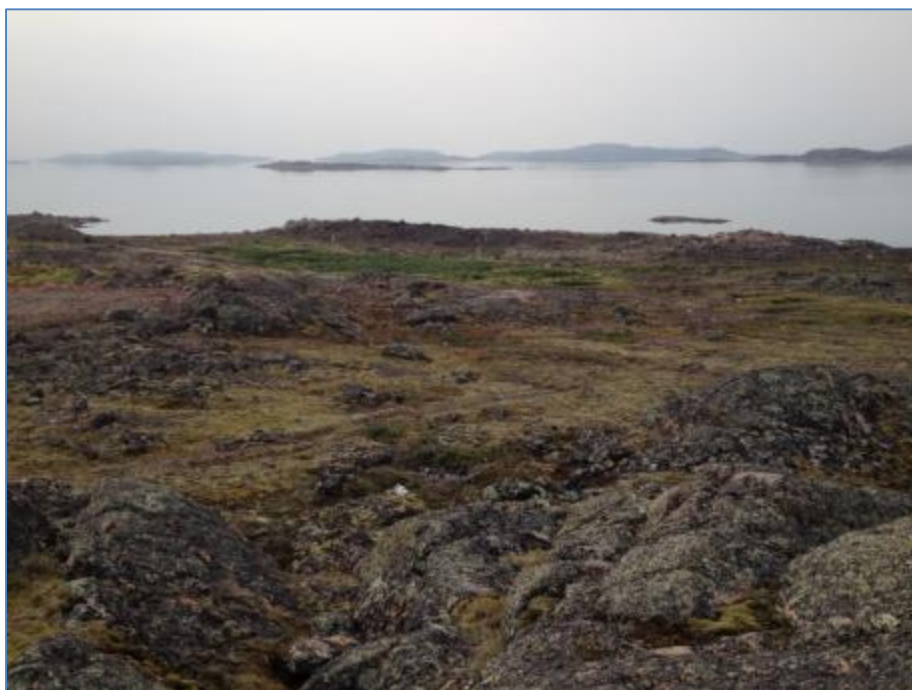
Photograph No. 6

Wetland downslope of Cell #2 of existing sewage lagoon
(standing near northwest corner of lower cell, looking southwest)

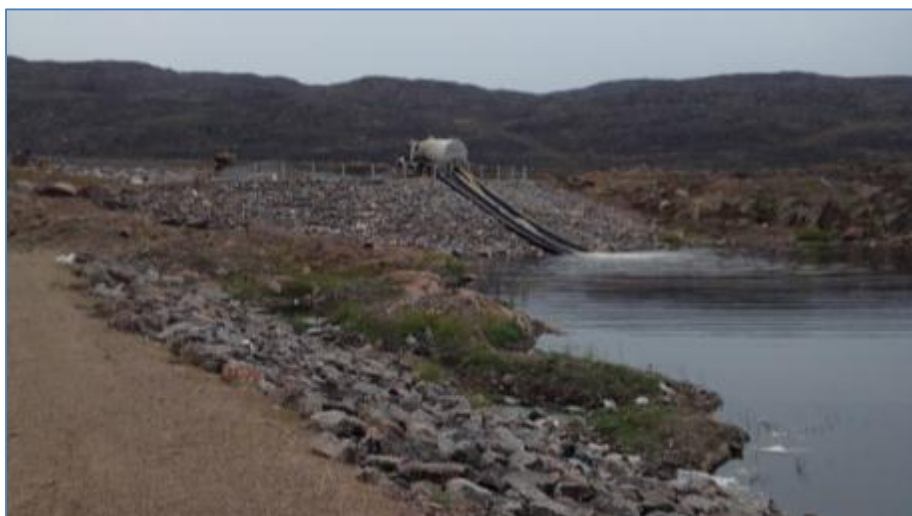
Photograph No. 7

- 8.) The truck turn around pad surface was in good condition, the slope of the pad was covered in rip rap and the discharge flumes were in good condition. See appended Photo 7.

Truck atop turn around pad discharging raw sewage down discharge flume
(standing on north berm, looking east)
