**Kugaaruk Sewage Lagoon
Dam Safety Review**

(FINAL)

Prepared for:
Government of Nunavut
Community and Government
Services

March 24, 2017

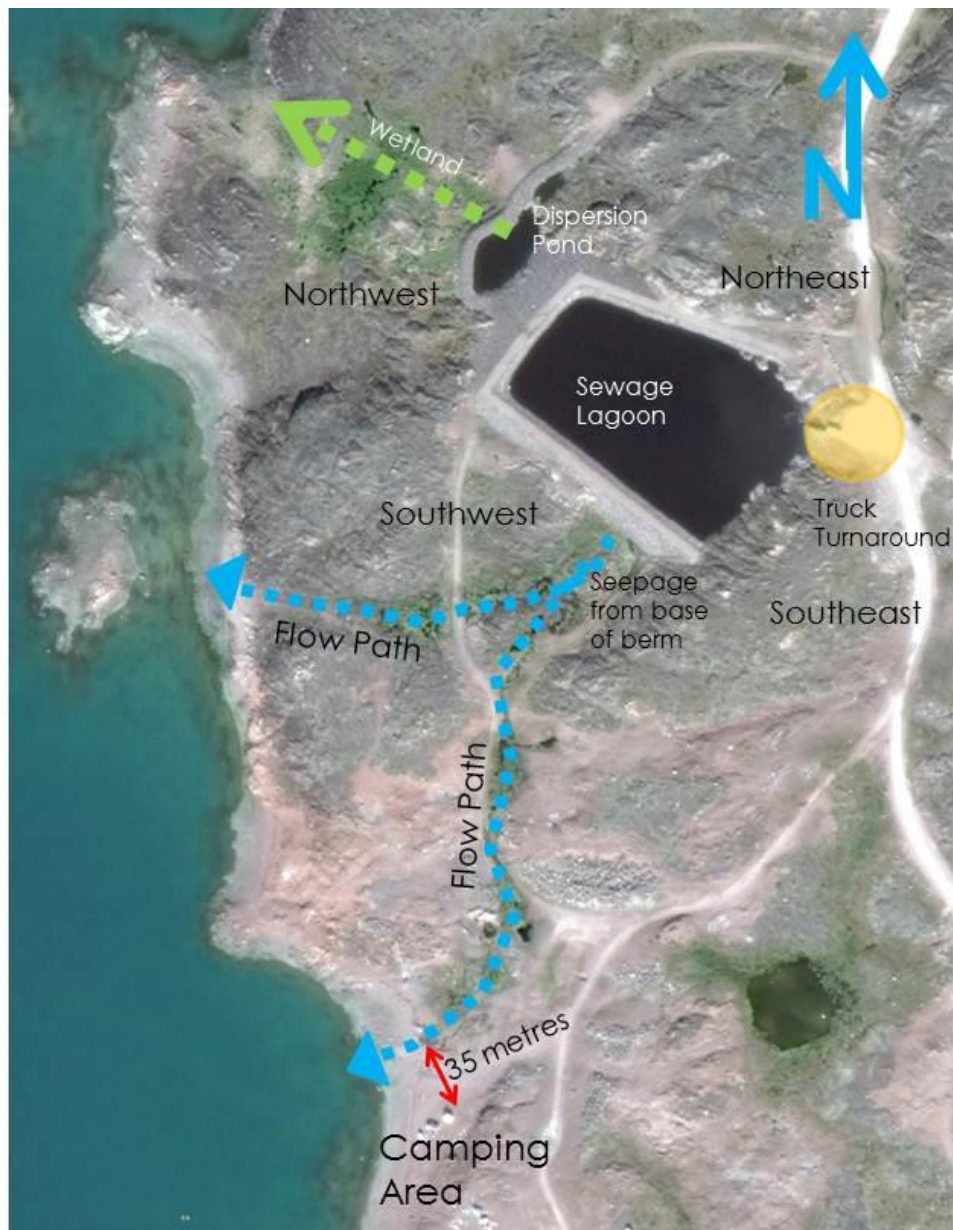
Figure 5-1: Potential flow-paths from a dam breach

- Loss of life: See above. There would be limited exposure time for people temporarily at risk.
- Environmental: A dam breach would release effluent into the Pelly Bay. This would result in a localized loss and deterioration of marine environments in the area. The Hamlet would have to fish in areas away from the effluent plume until it has dissipated sufficiently.

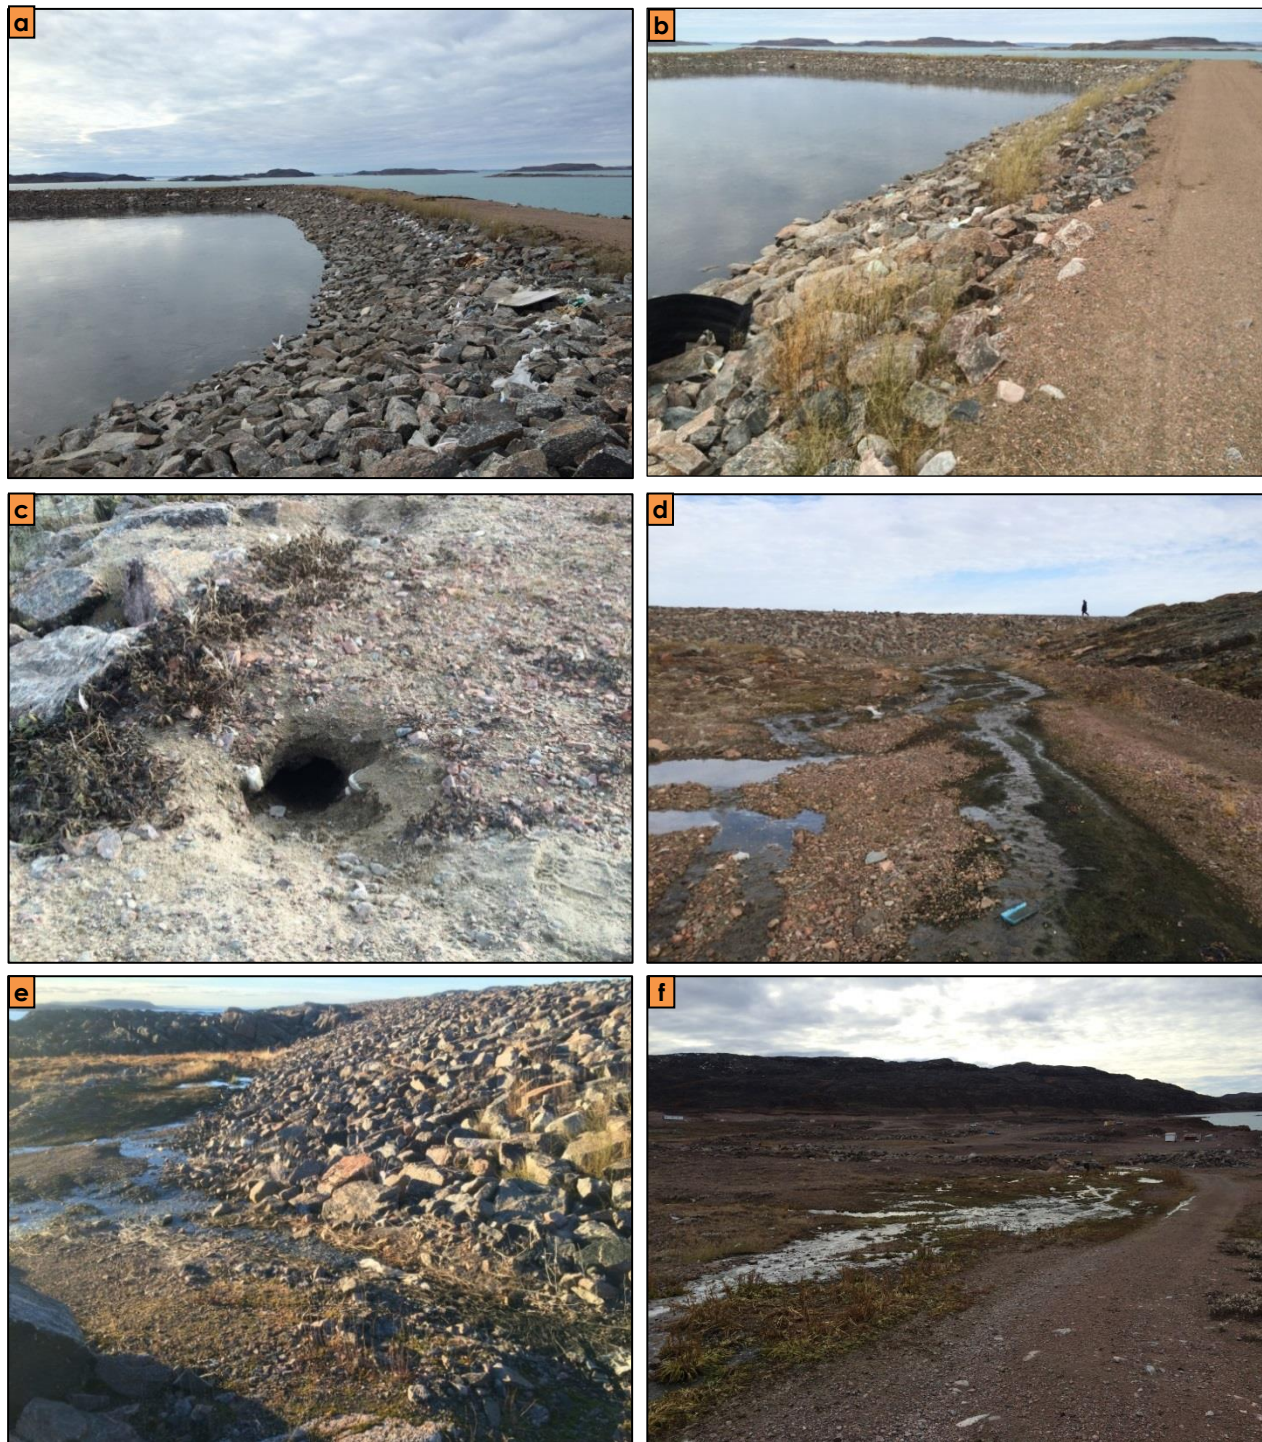
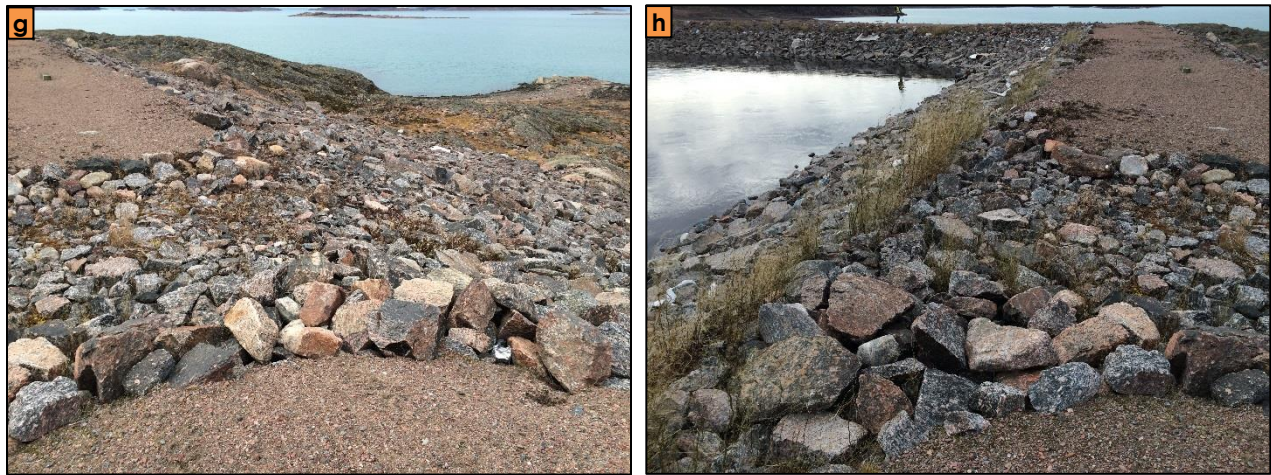
Figure 6-1: Observations from the site walkover

- The lagoon level was at El. 23.8 m, which was equivalent to 2 m freeboard. The sludge blanket could not be observed at the time of the inspection. (**Figure 6a**).
- No signs of cracking, bulging or sinkholes were observed. However, the presence of rock armour on the upstream and downstream slopes restricts visual confirmation of this.
- Numerous areas of grass vegetation (Figure 9b) were observed throughout the earthfill dam.
- Two animal borrows were observed on the upstream crest on the southwest berm (**Figure 6c**).
- The lagoon does not have an active geotechnical monitoring system in place.

The previously observed seepage was noted in the lower slope of the southwest berm (**Figures 6d and 6e**). This portion of the berm is 3.8 m high and was constructed across a valley between bedrock highs.

It is understood that seepage from the containment berm was first observed on October 2014 by Hamlet staff. This seepage has been ongoing for nearly two years. Although the rock armour restricts clear confirmation, there appears to be four zones of seepage (S1 to S4). The elevation of these seepage zones ranged between El. 22.0 and 22.8 m. The southernmost zones (S1 and S2) are flowing at a visually significantly higher rate than S3 and S4.

Although, a public safety assessment is beyond the scope of this DSR, the site visit noted that there were no fences surrounding the lagoon, there was one warning sign by the discharge flume and there were no life-buoys on the site.
