WATER LICENCE INSPECTION FORM

Licensee		Licensee Representative	
Hamlet of Kugaaruk		John Ivey	
Licence No. / Expiry		Representative's Title	
3BM-PEL-1419		Senior Administrative Officer	
Land / Other Authorizations		Land / Other Authorizations	
Date of Inspection		Inspector	
8 July 2016		Baba Pedersen	
Activities Inspected			
<input type="checkbox"/> Camp	<input type="checkbox"/> Drilling	<input type="checkbox"/> Mining	<input type="checkbox"/> Construction
<input type="checkbox"/> Roads/Hauling	<input checked="" type="checkbox"/> Other: Municipal	<input type="checkbox"/> Reclamation	<input type="checkbox"/> Fuel Storage

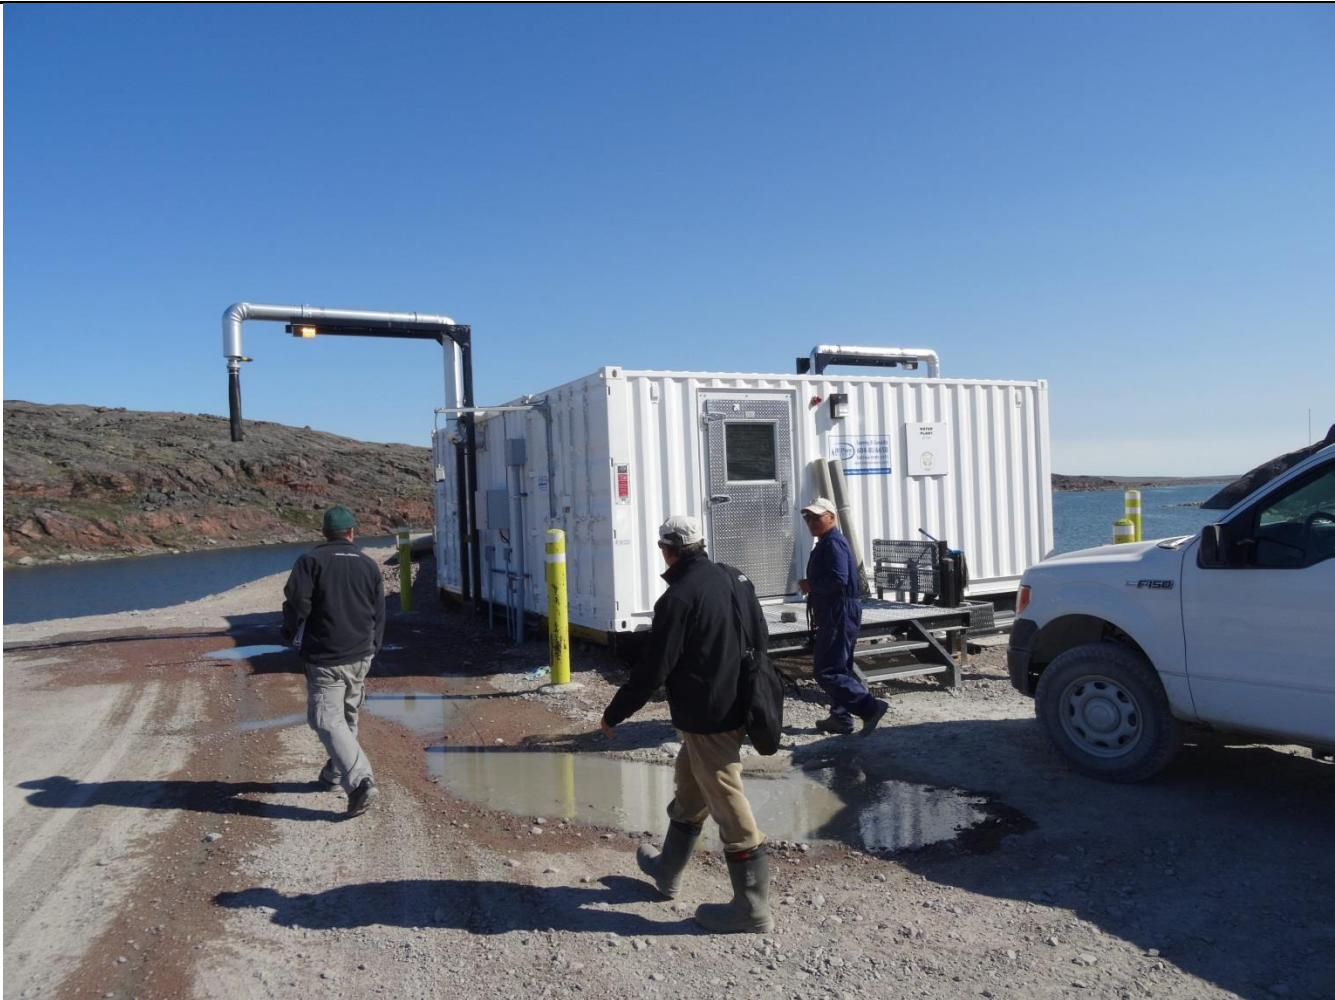
Photo 1

Description: Water Intake Building – Front View

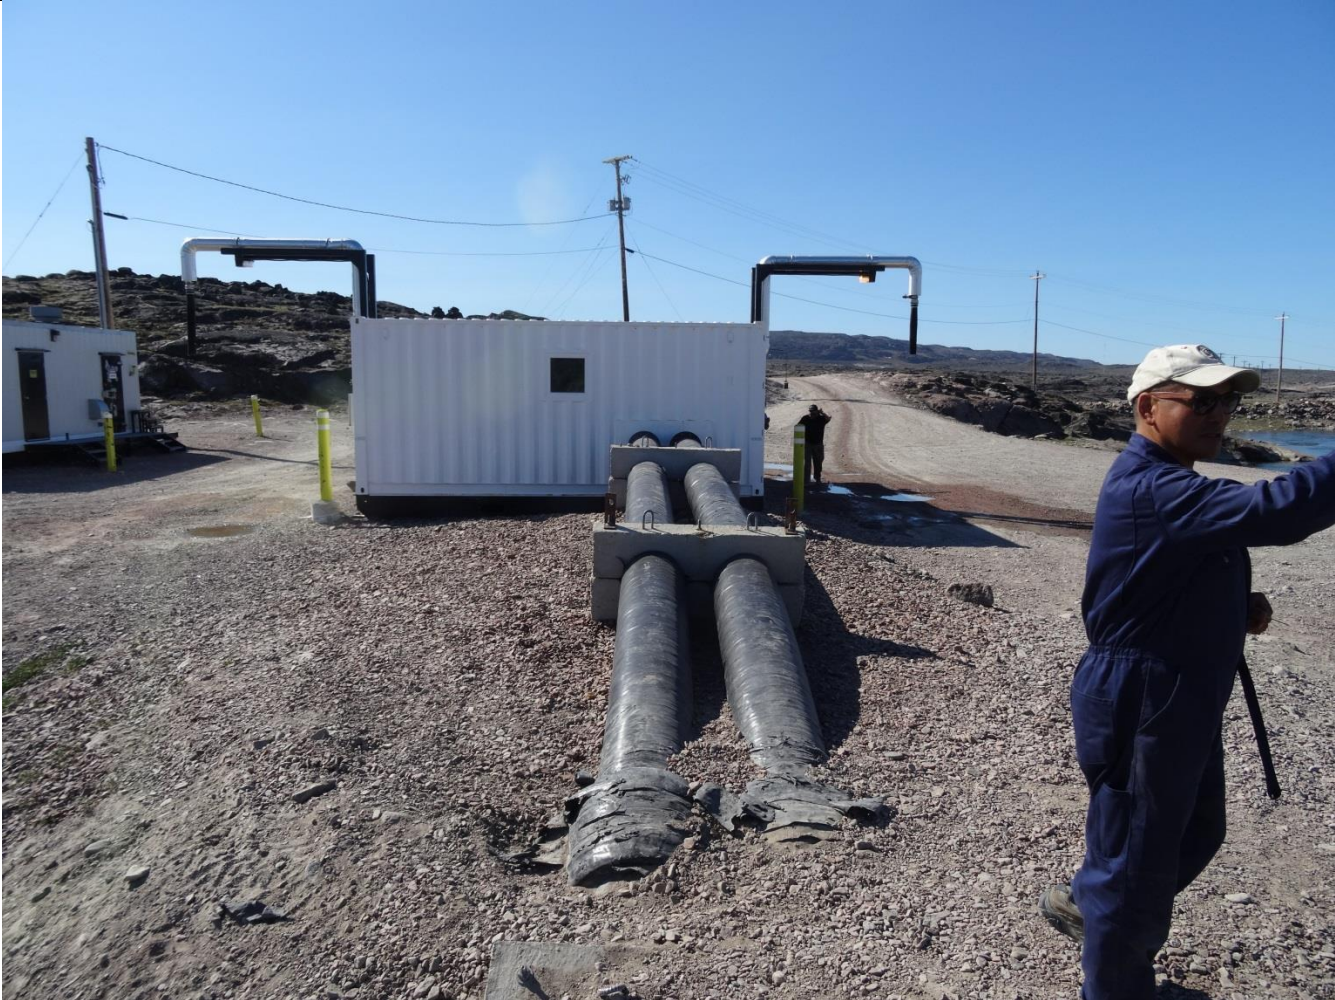
Photo 2

Description: Water Intake Building – Rear View

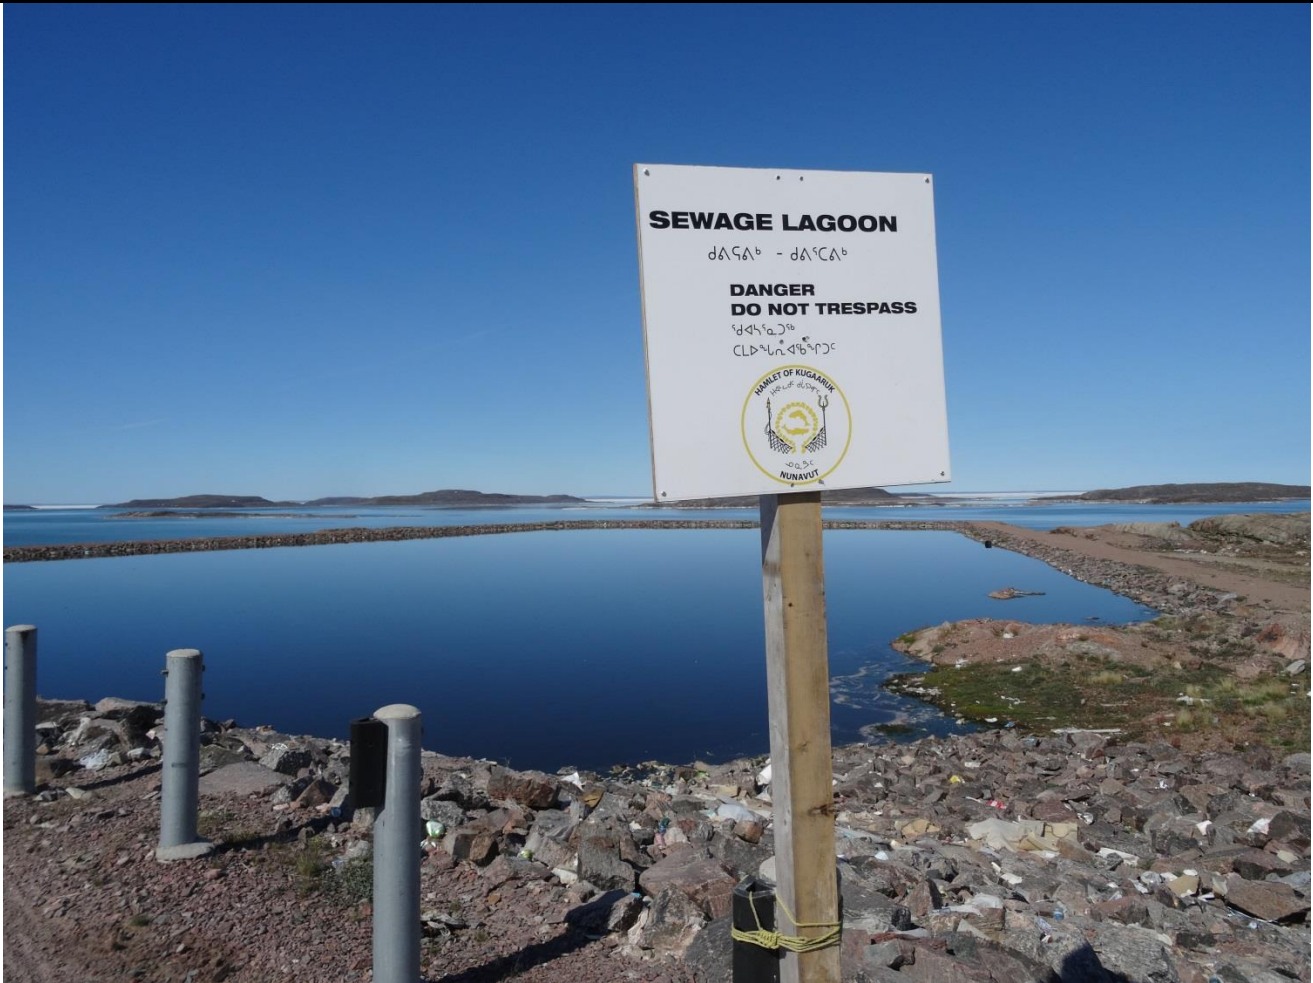
Photo 3

Description: Sewage Lagoon – From Truck Dumping Station – Very Nice Signage

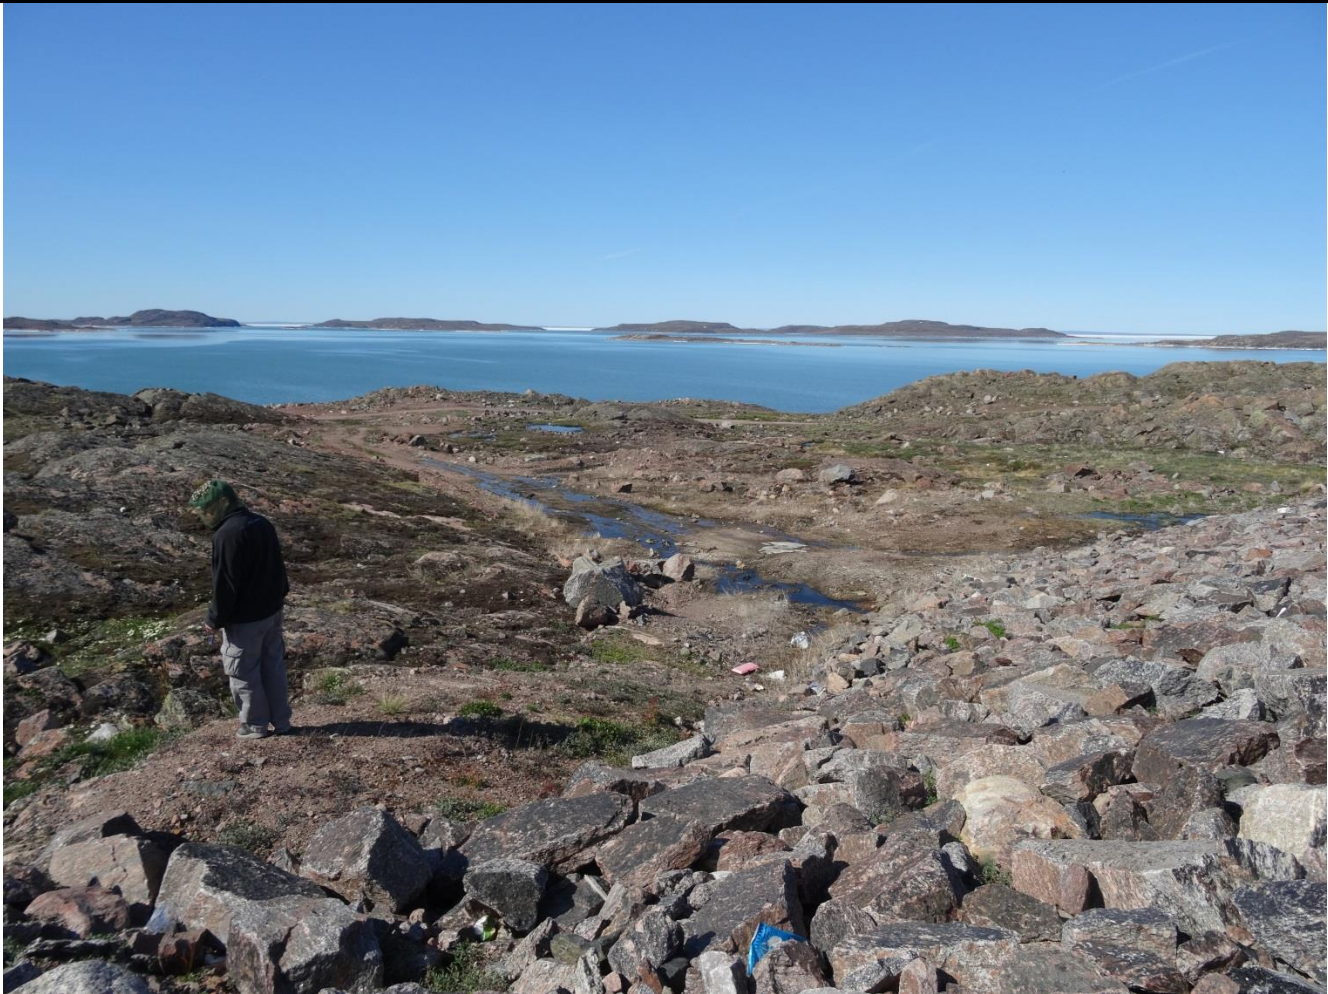
Photo 4

1. On site staff were only able to provide me with Daily Estimates of Water Usage. As per the Water Licence, Consumption Amounts MUST be able to be provided to the Inspector upon request. This needs to be rectified before next year's Inspection. 2. The Sewage Lagoon is still Leaking from 2 locations (Photos 4, 5 & 6), this was brought up in last year's Inspection. The Hamlet and the GN Engineer need to work together and come up with a Plan to fix this problem prior to next year's Inspection. 3. The Main Dump is Organized and Segregated. New Signage (Photos 3, 8, 9 & 14) has been installed as per my requests from last year's Inspection, thank you very much. 4. Full Drums of various Used Oils (Photo 12) are still being stored without any form of Containment in the Metal Dump. There is a 3 part Containment Cell (Photos 11 & 13) which has some Crushed and Cleaned Drums in it. All full Drums of Used Oil should be moved into this area prior to next year's Inspection.

Description: Sewage Lagoon – Leak #1 in Berm flowing toward ocean

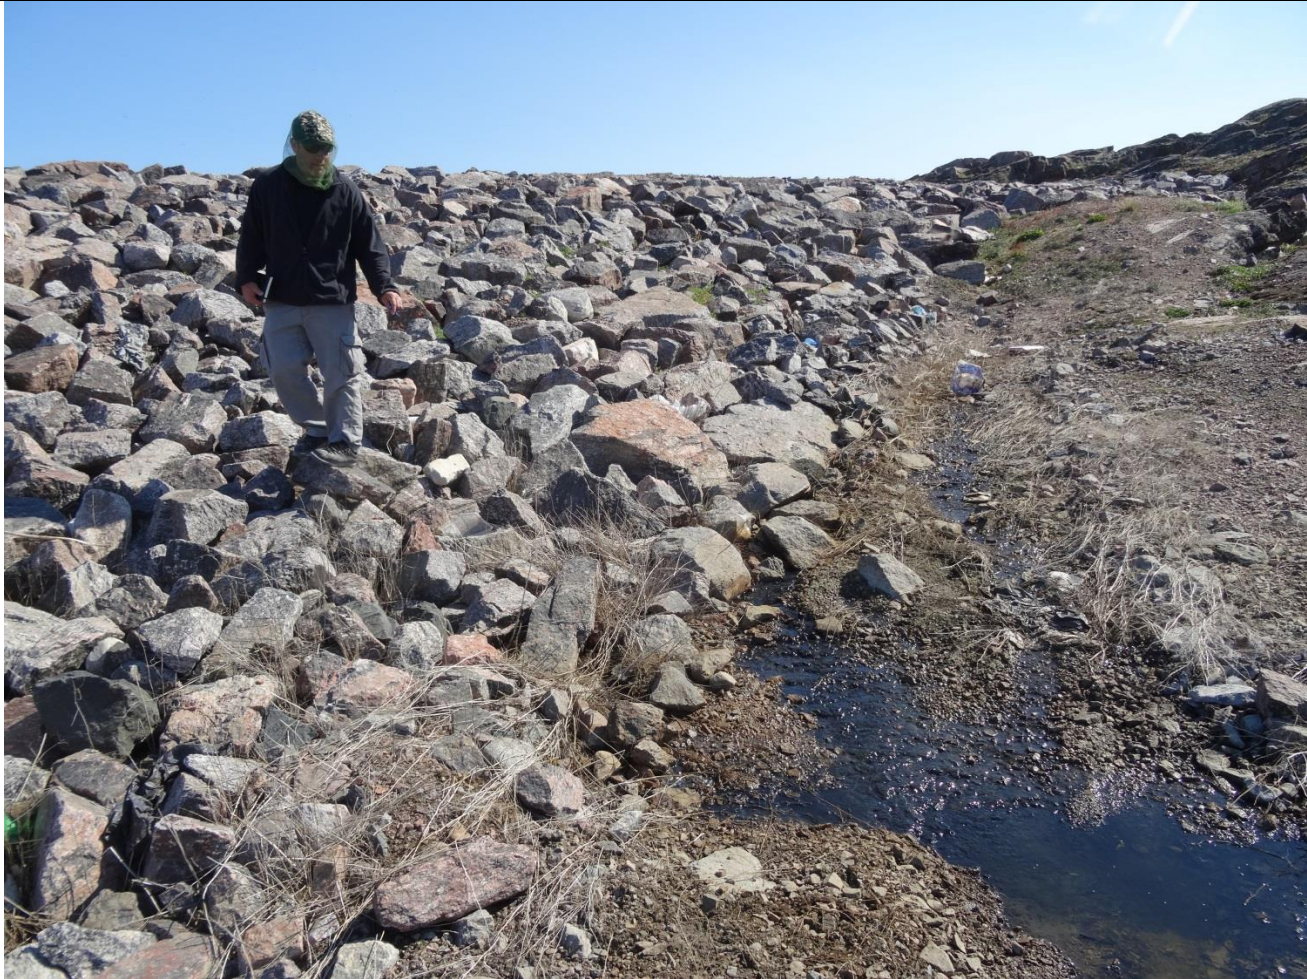
Photo 5

Description: Sewage Lagoon – Leak #1 in Berm – Bottom View

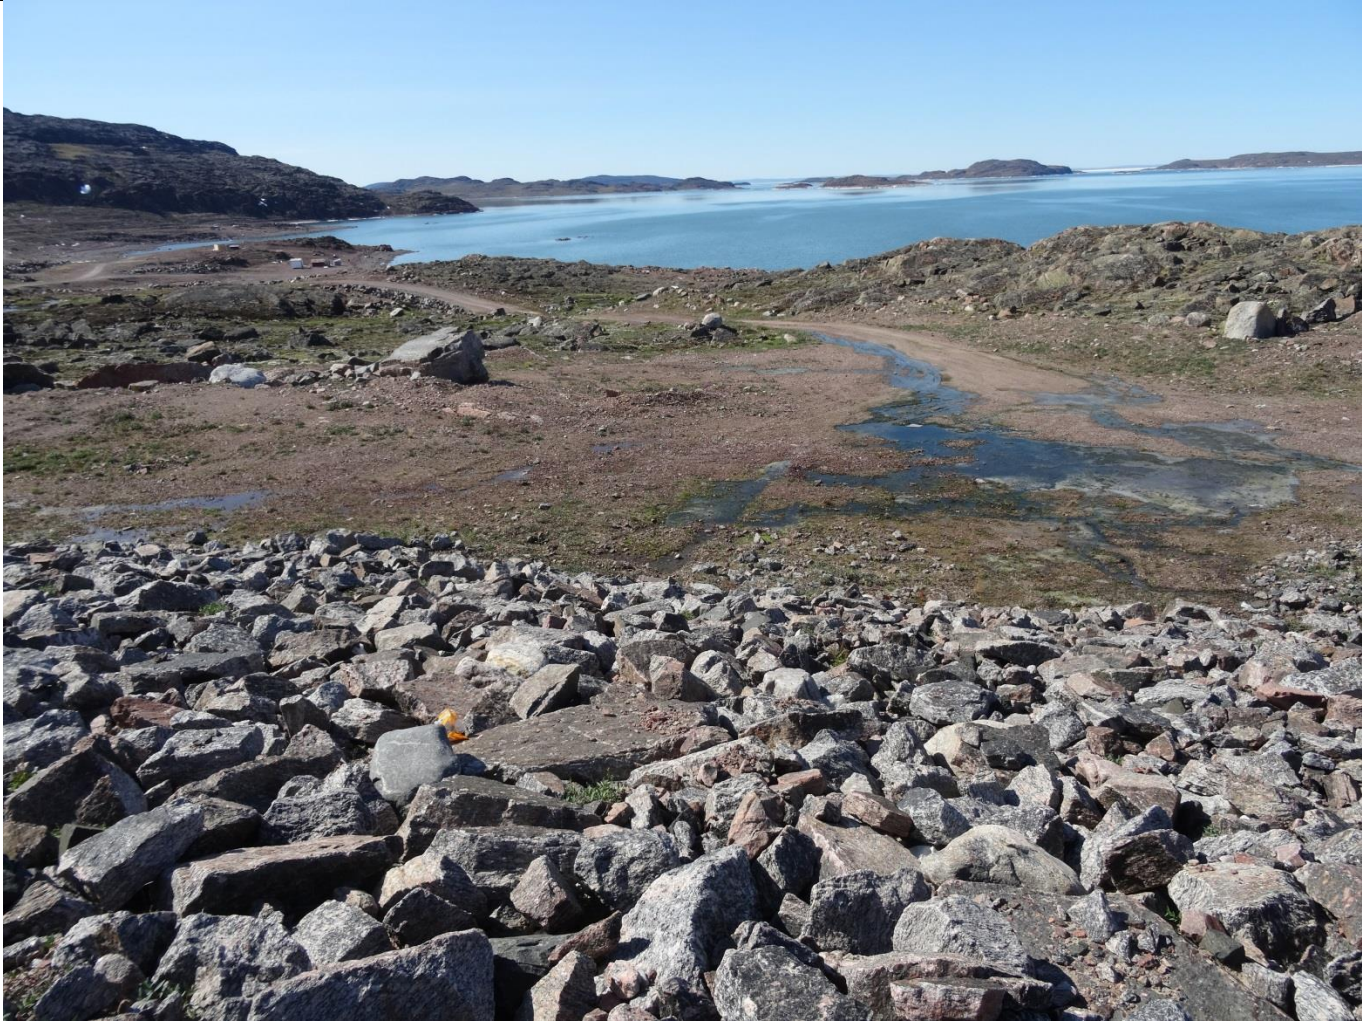
Photo 6

Description: Sewage Lagoon – Leak #2 in Berm flowing toward ocean

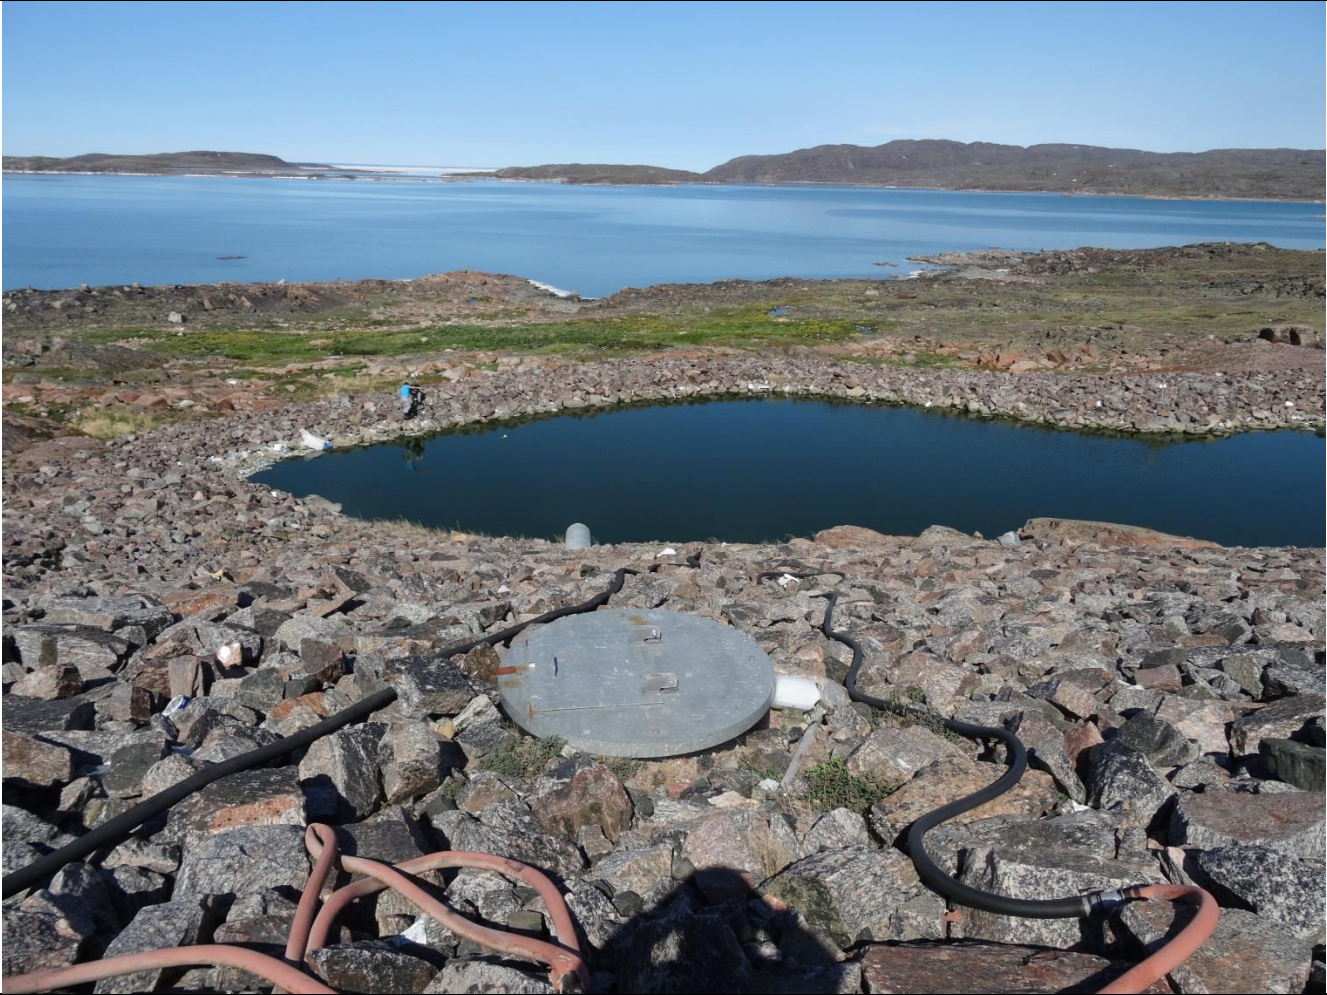
Photo 7

Description: Sewage Lagoon – Decant Pond

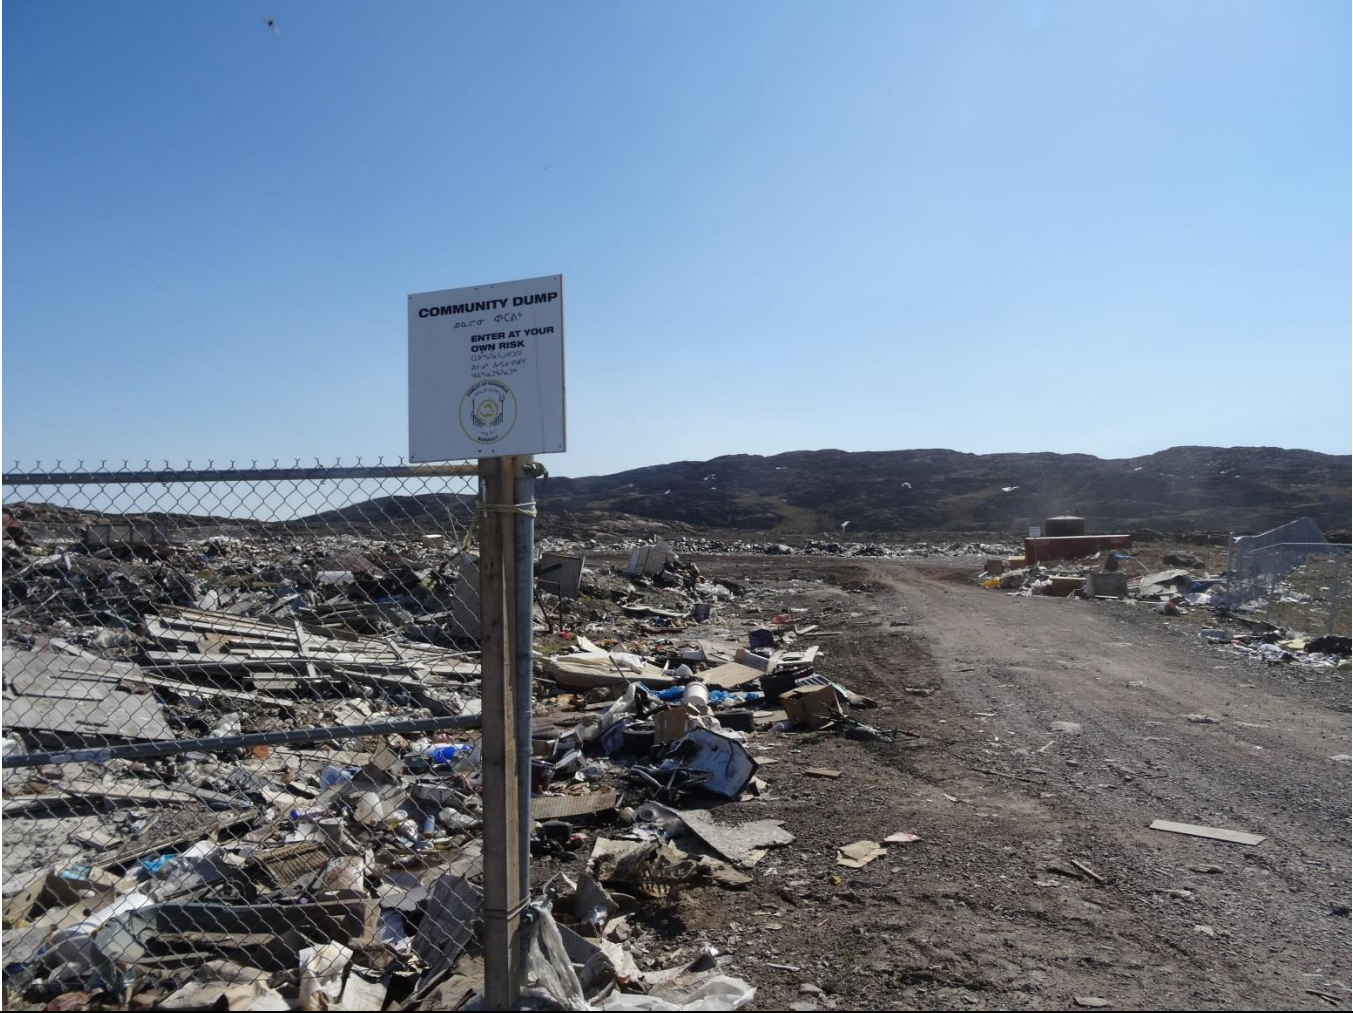
Photo 8

Description: Main Dump – Entrance – Very Nice Signage

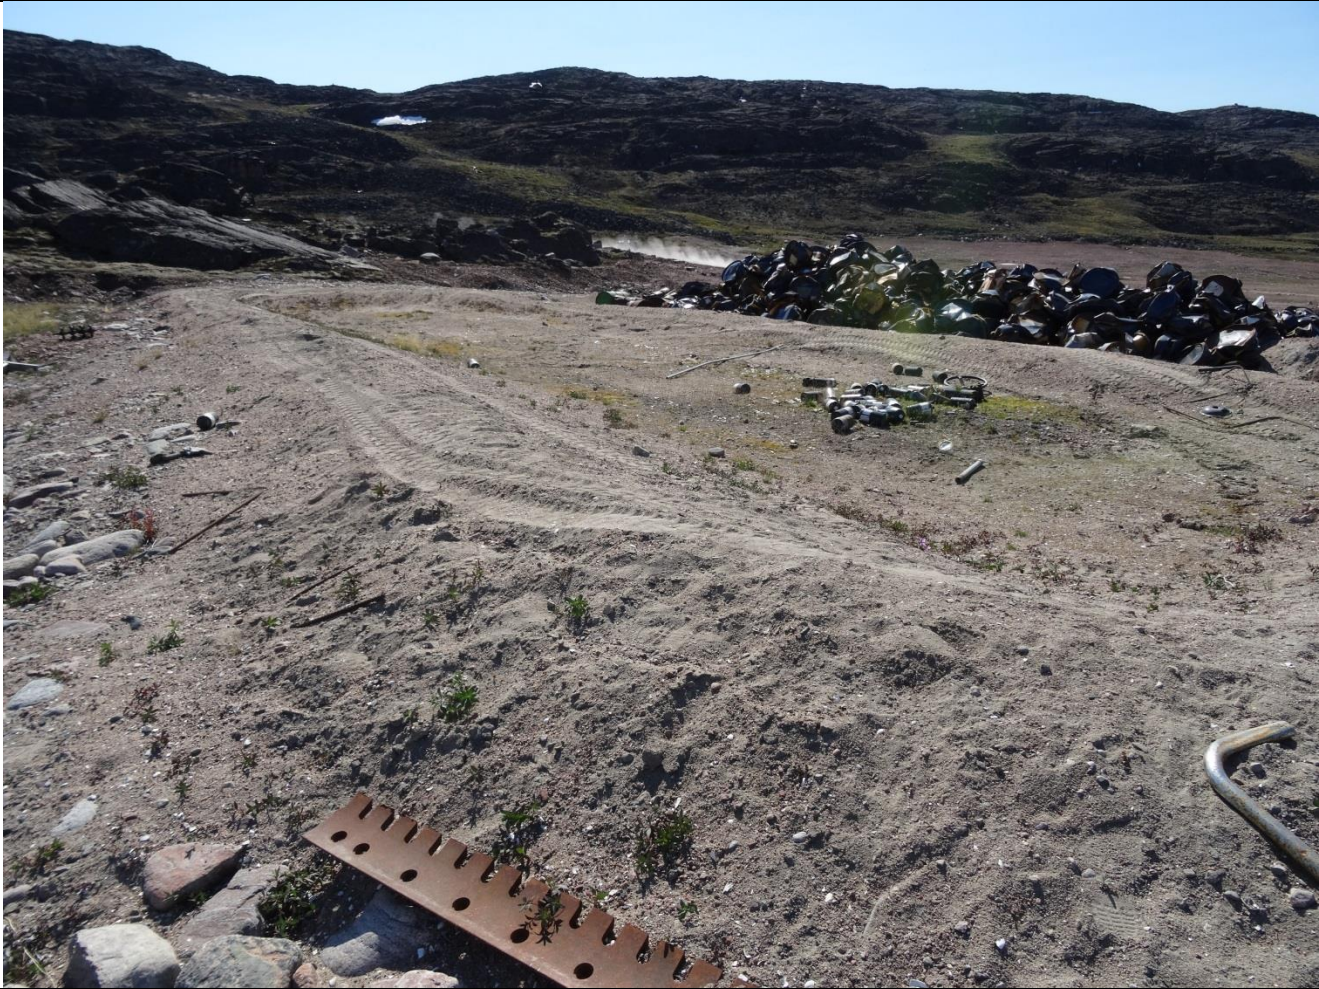
Photo 11

Description: Metal Dump – Lined Berm Area - Empty

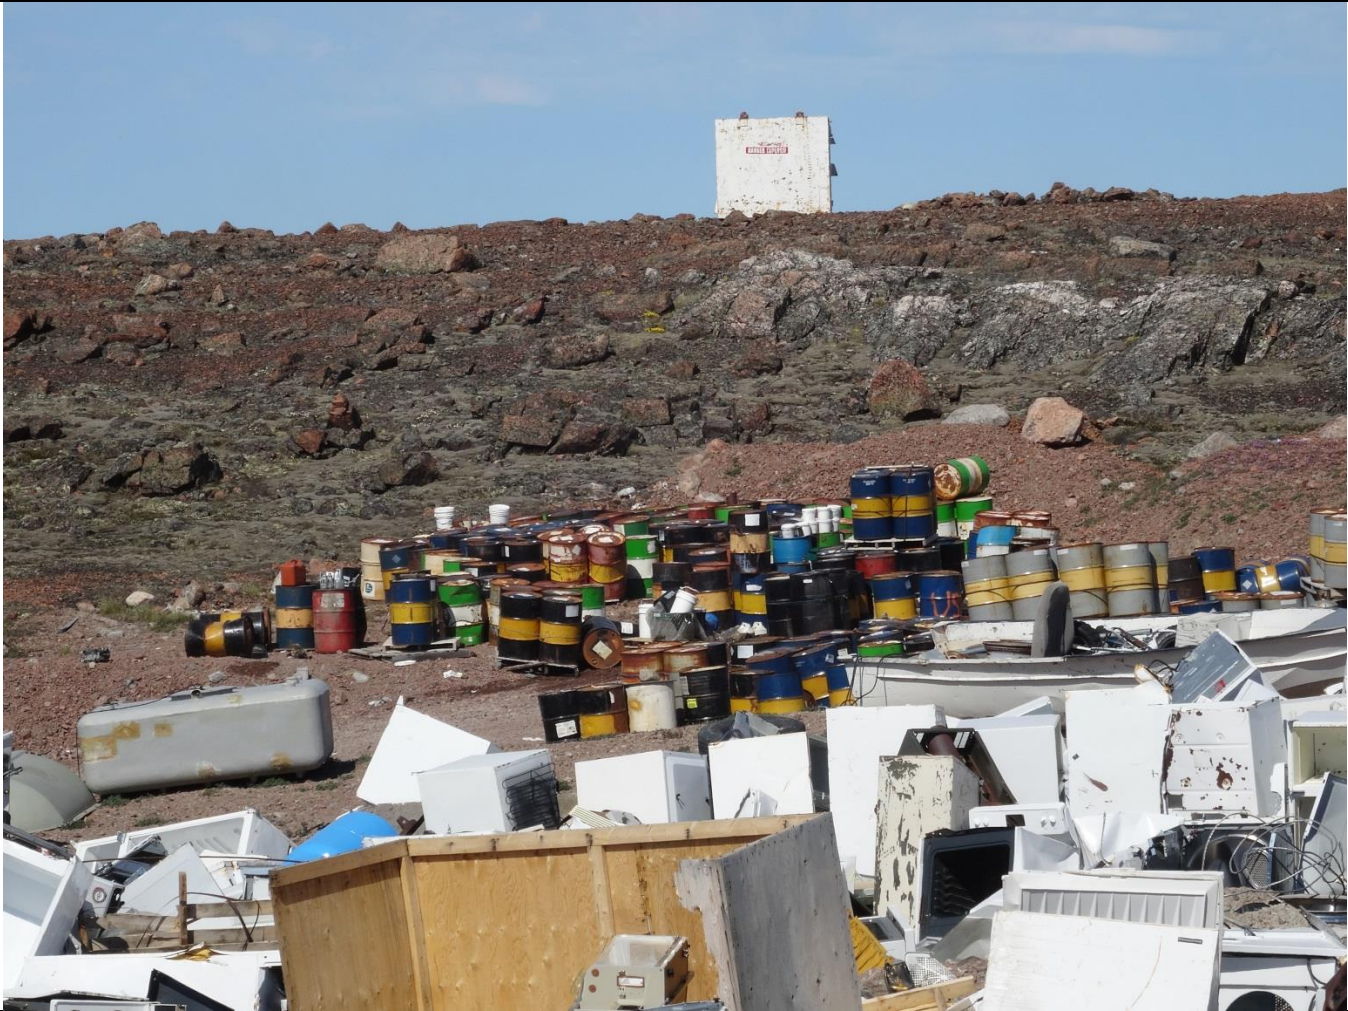
Photo 12

Description: Metal Dump – Drums Full of Used Oils

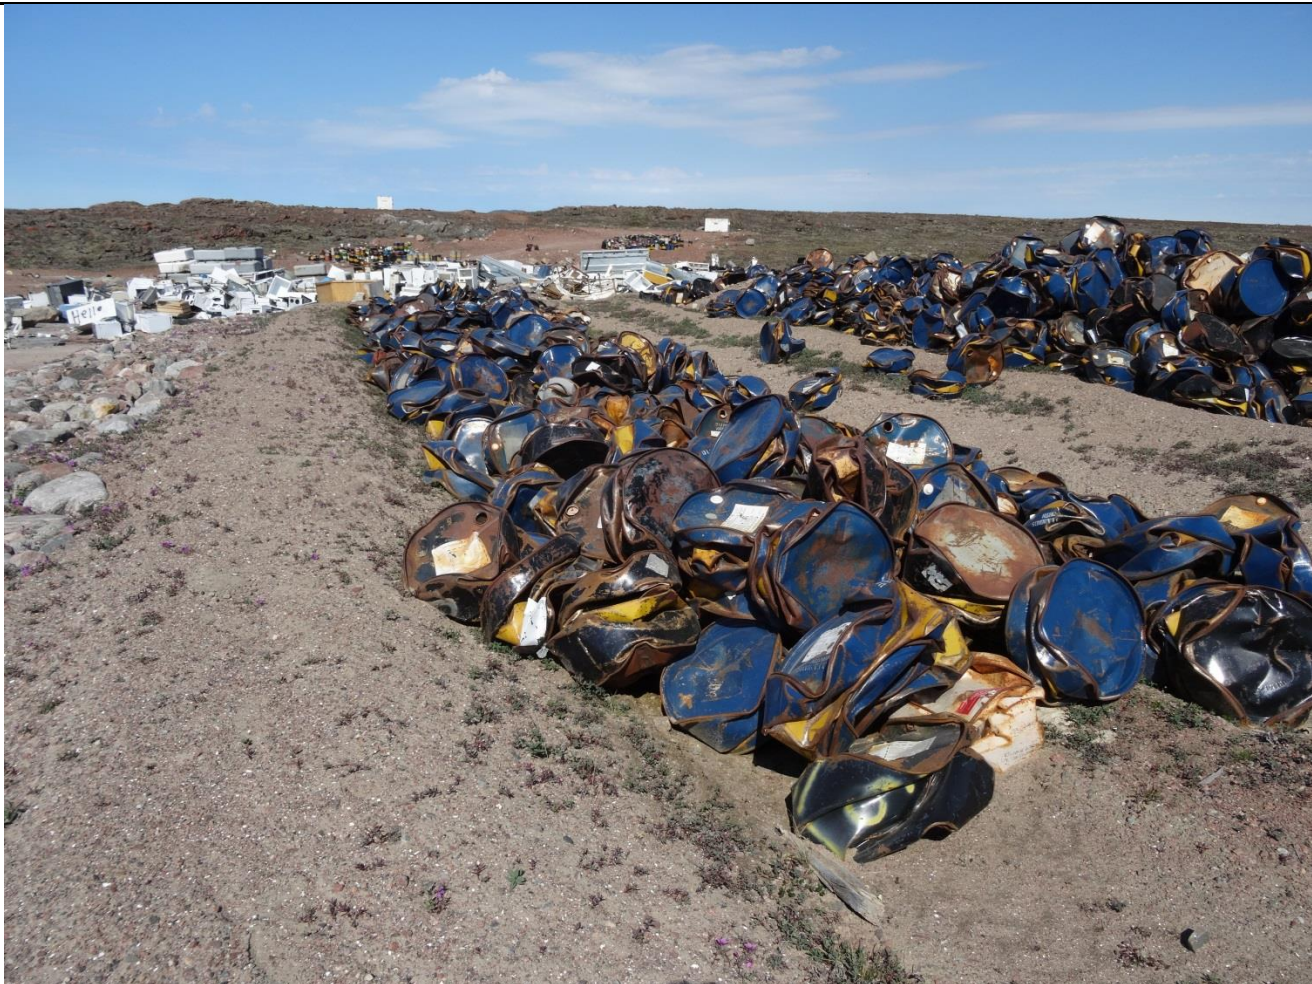
Photo 13

Description: Metal Dump – Crushed and Cleaned Barrels in Lined Berm Area

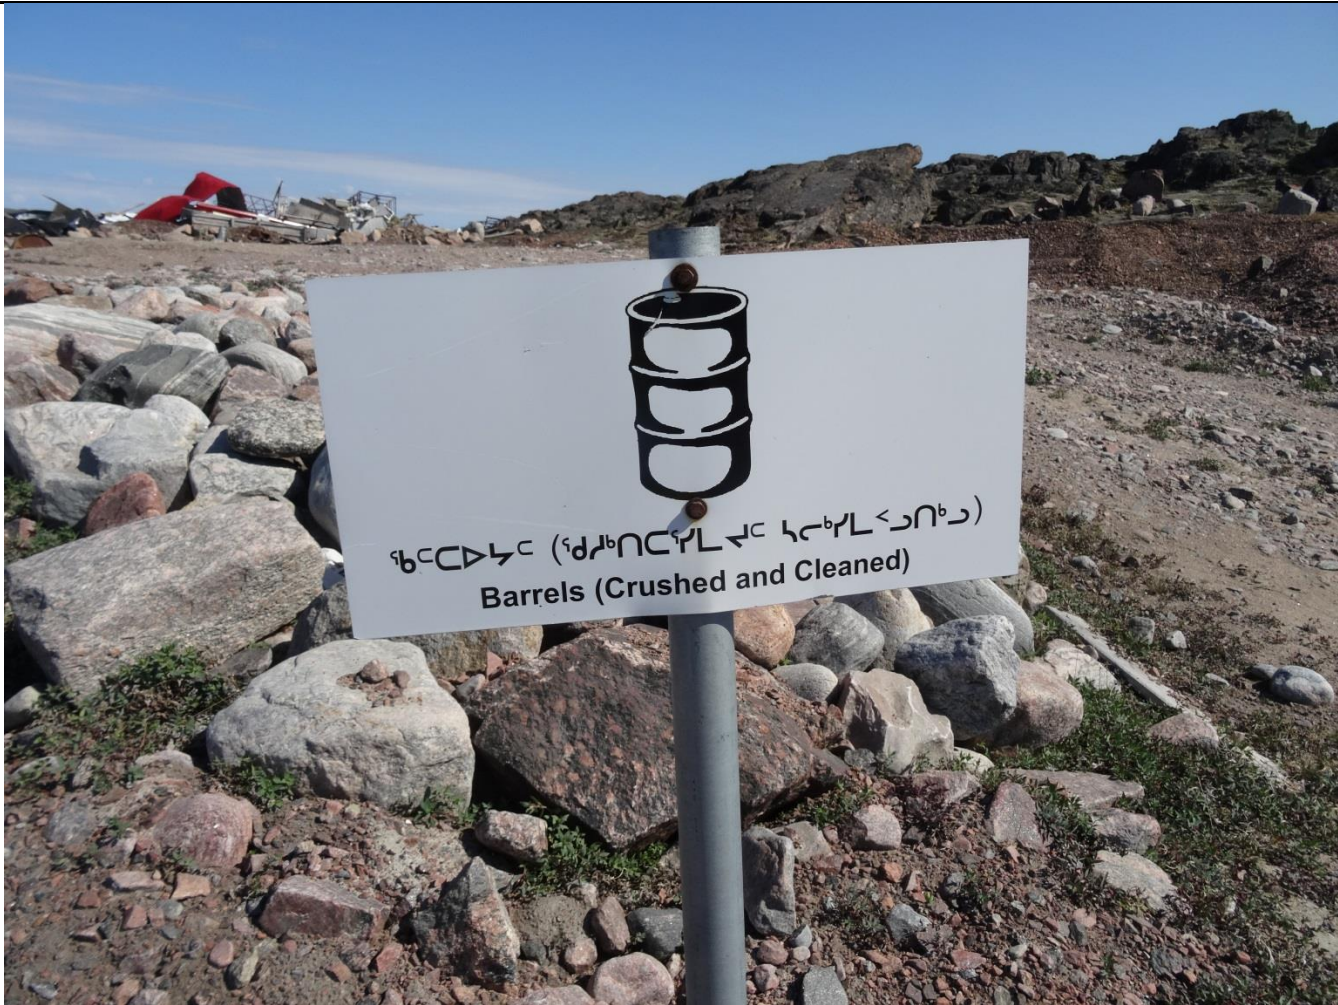
Photo 14

Description: Metal Dump – Signage for Crushed and Cleaned Drums
