WATER LICENCE INSPECTION FORM

Licensee		Licensee Representative	
Hamlet of Kugaaruk		Bobby Anaittuq	
Licence No. / Expiry		Representative's Title	
3BM-PEL1419		Acting Senior Administrative Officer	
Land / Other Authorizations		Land / Other Authorizations	
Date of Inspection		Inspector	
2019 July 3		Baba Pedersen	
Activities Inspected			
<input type="checkbox"/> Camp	<input type="checkbox"/> Drilling	<input type="checkbox"/> Mining	<input type="checkbox"/> Construction
<input type="checkbox"/> Roads/Hauling	<input type="checkbox"/> Other:	<input checked="" type="checkbox"/> Other: Municipal	<input type="checkbox"/> Reclamation
<input type="checkbox"/> Fuel Storage

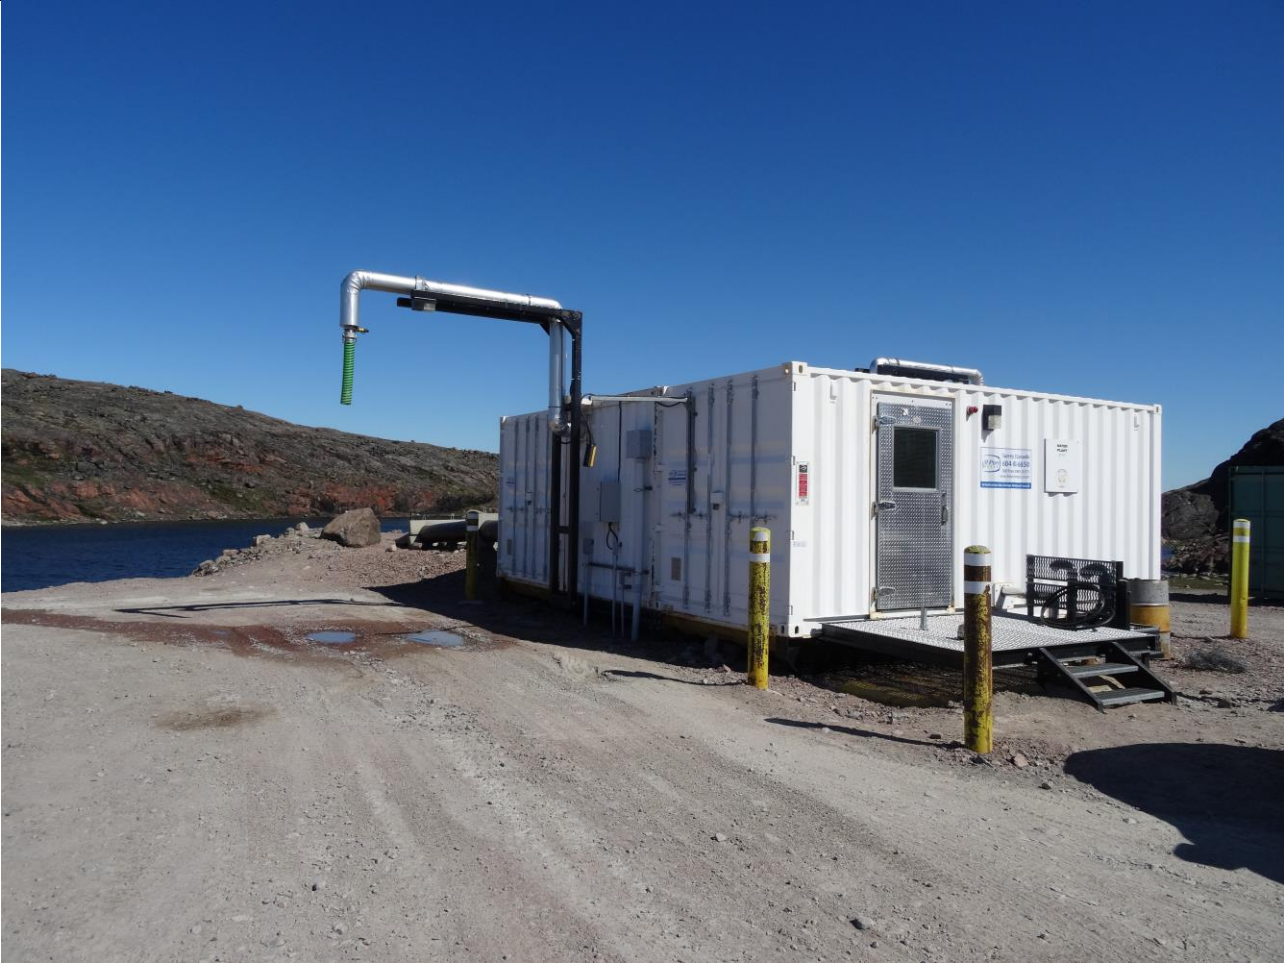
Date	Camera	Inspector	Authorization
2019 July 3	Sony DSC-HX50V	Baba Pedersen	3BM-PEL1419
Photo Log # DSC04857			
Photo 1

Description: The Raw Water Intake Pump House/Truck Fill Station			
Photo Log # DSC04862			
Photo 2

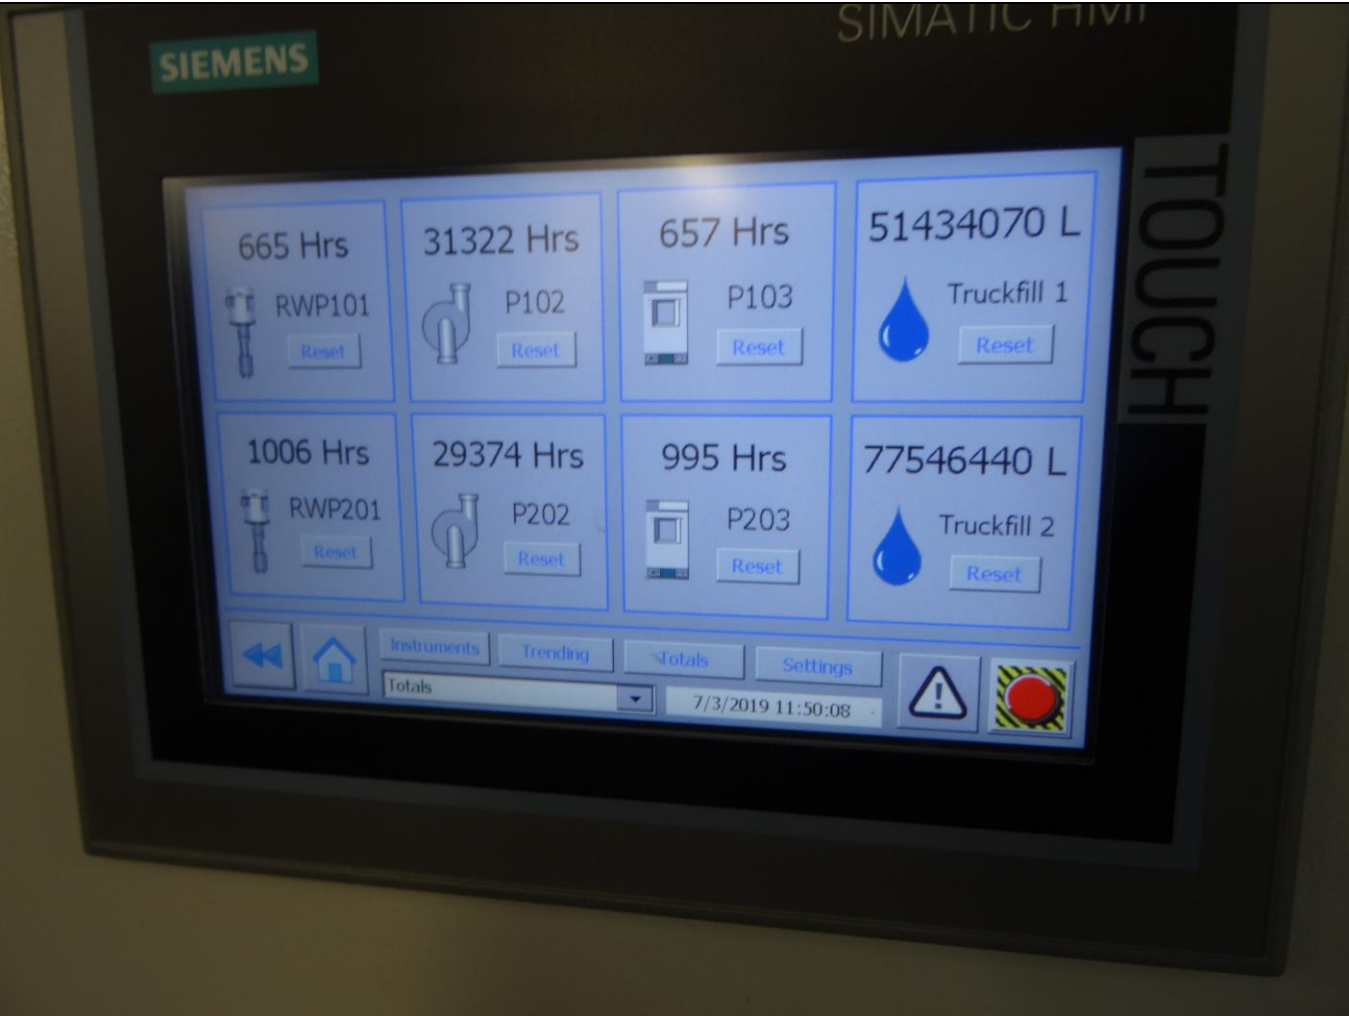
Description: The “Fluid Manager” Flow Meter screen inside the Raw Water Intake Pump House/Truck Fill Station

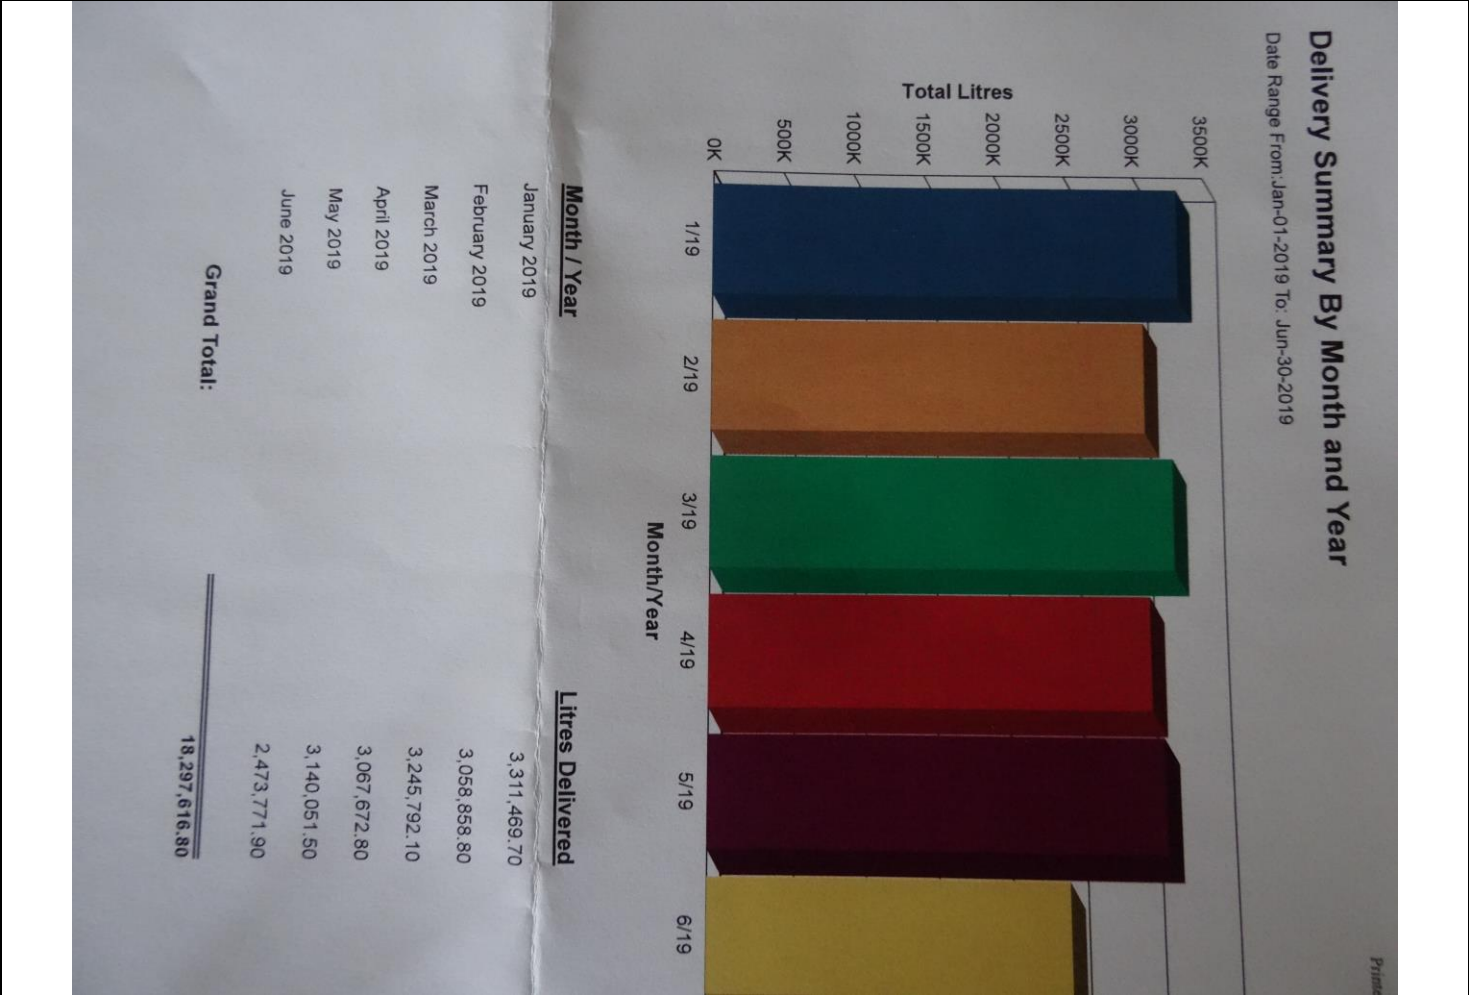
Photo 3

Description: The YTD Consumption Sheet showing 18,297 Cubic Meters in 6 months, produced from Daily Truck Delivery Sheets

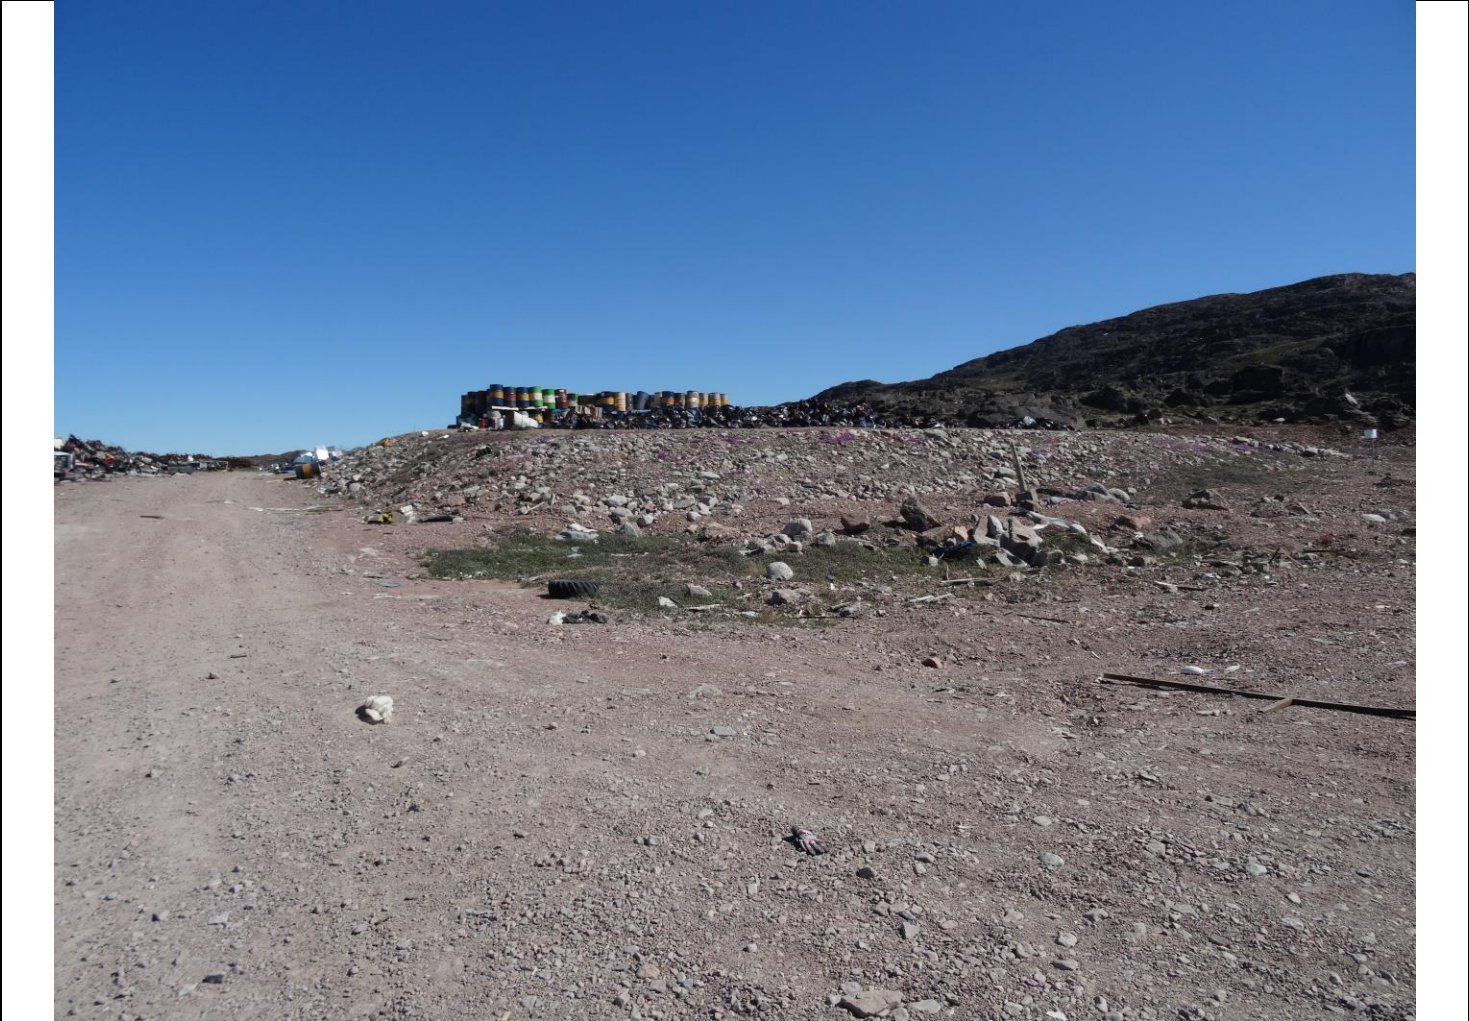
Photo 4

Description: 3 Bermed Cells in the Metal Dump containing Used Oil Drums in 1 Cell and Washed Crushed Drums in the other 2 Cells

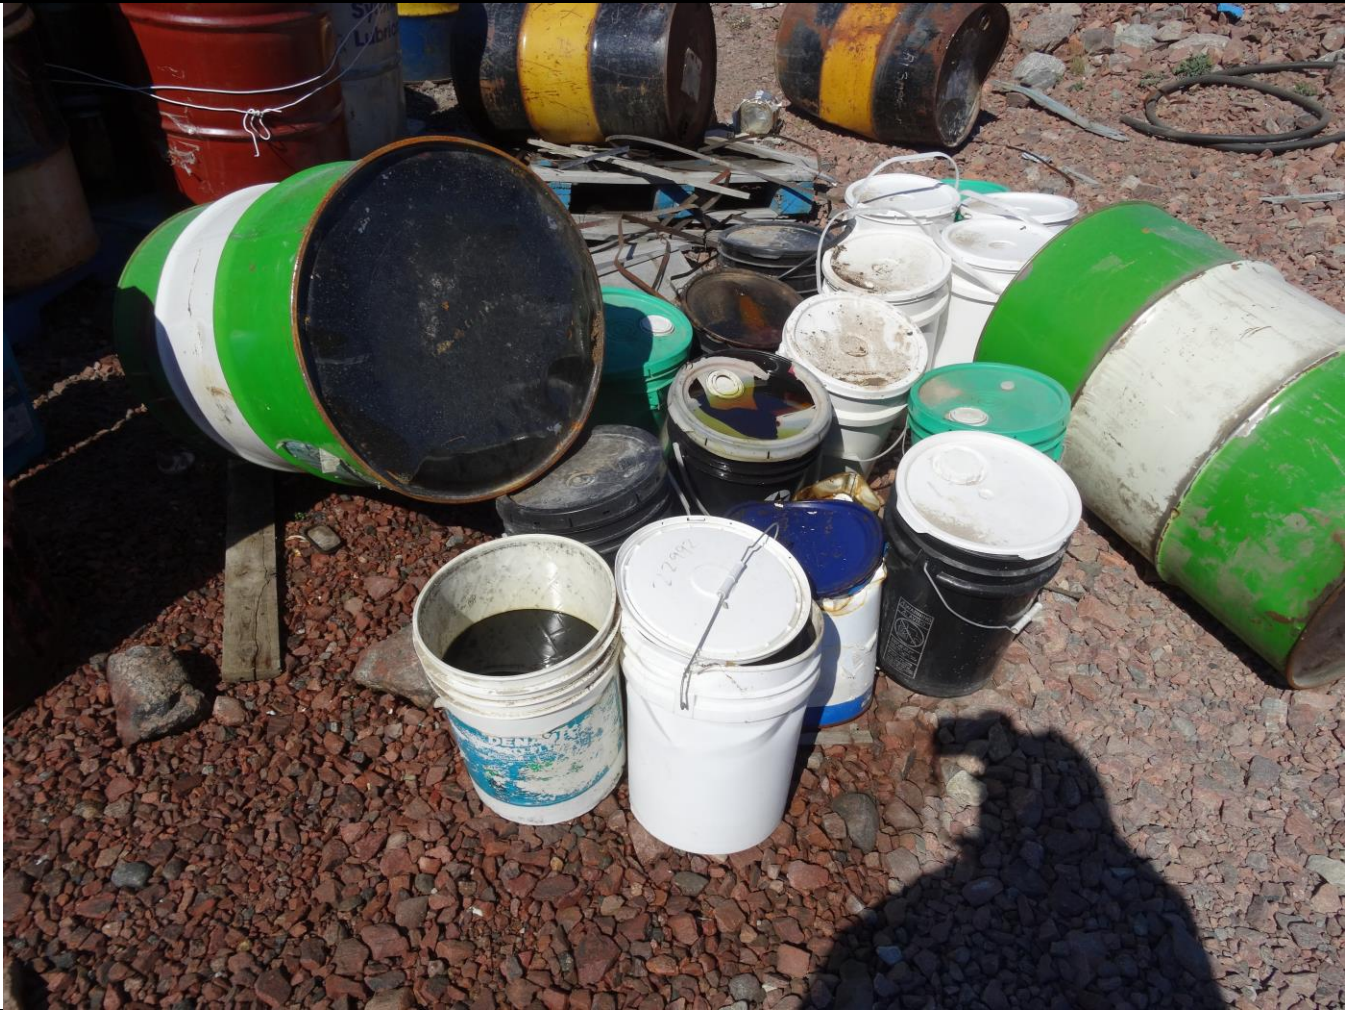
Photo 5

Description: Plastic Containers of Used Oil (some damaged) in the Metal Dump requiring clean-up

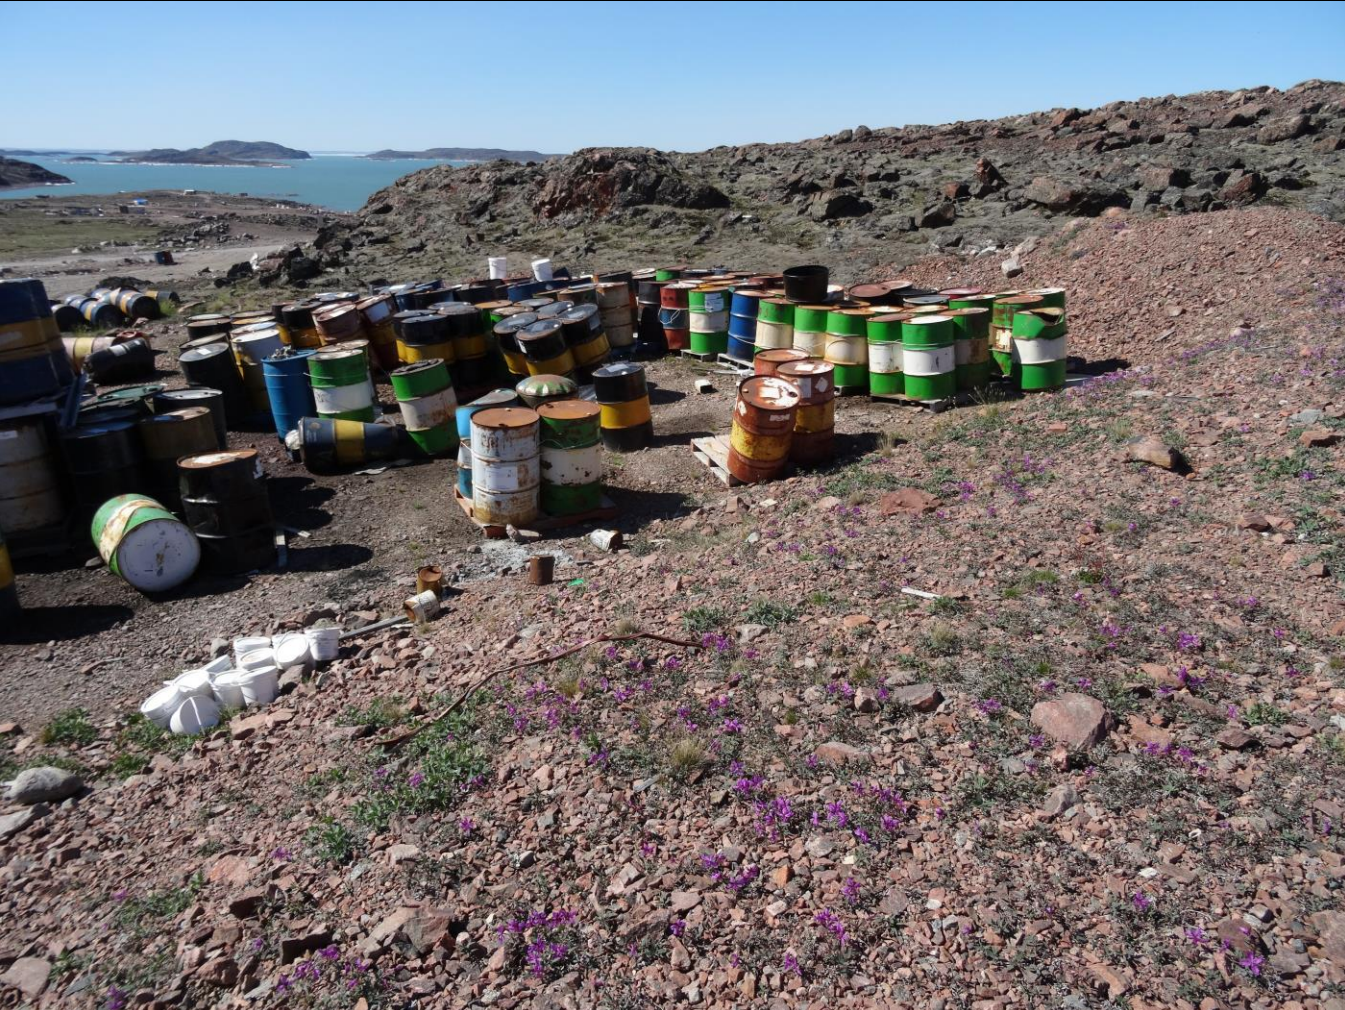
Photo 6

Description: Full Drums of Used Oils in the Metal Dump to be placed within the Bermed Cells

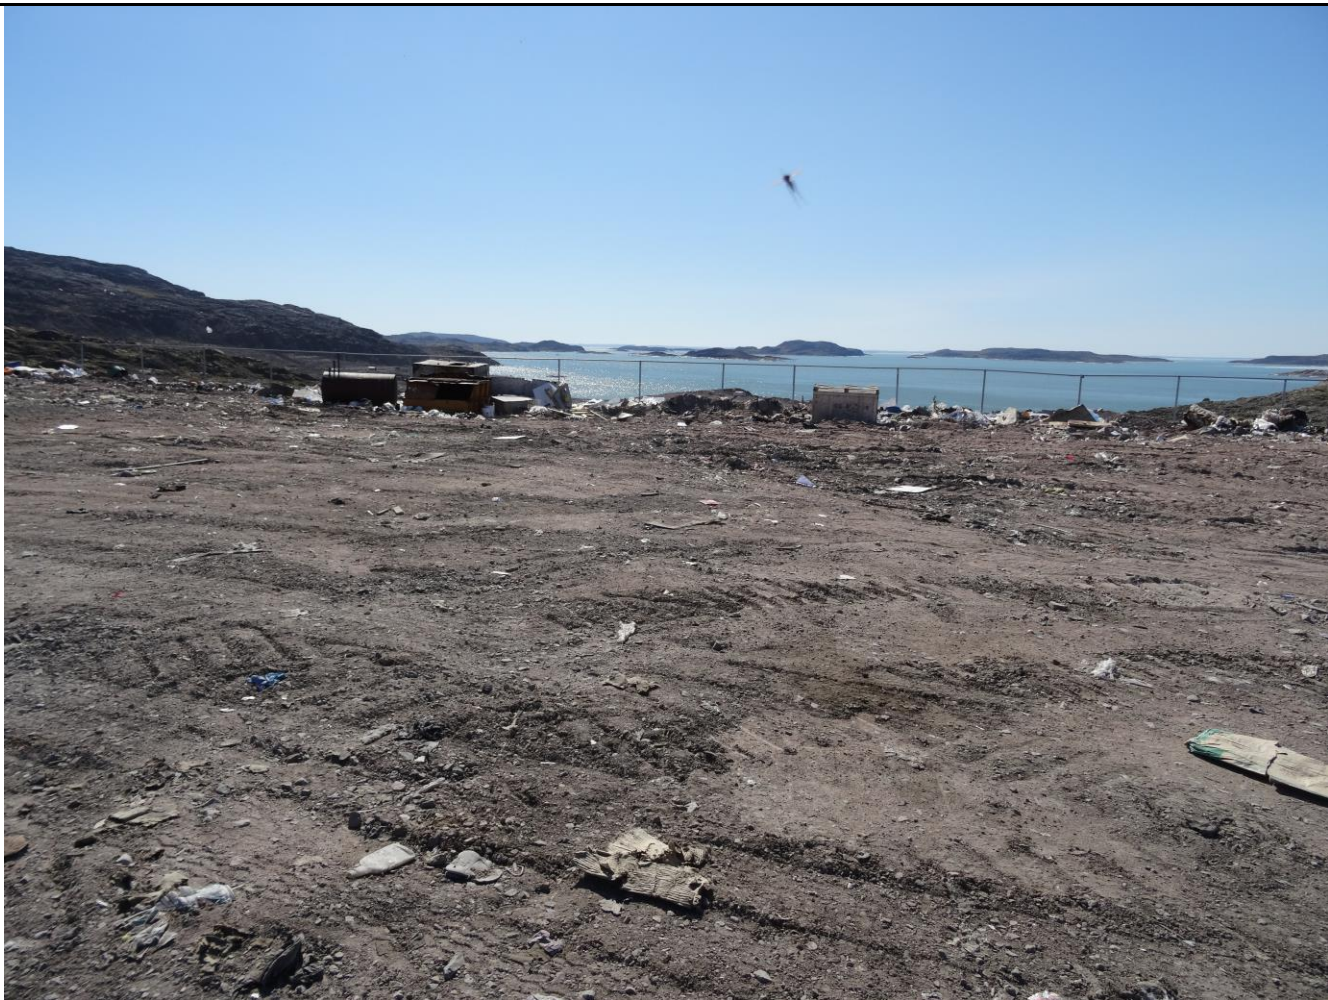
Photo 7

Description: Garbage Dump shown in a very nice clean and organized state

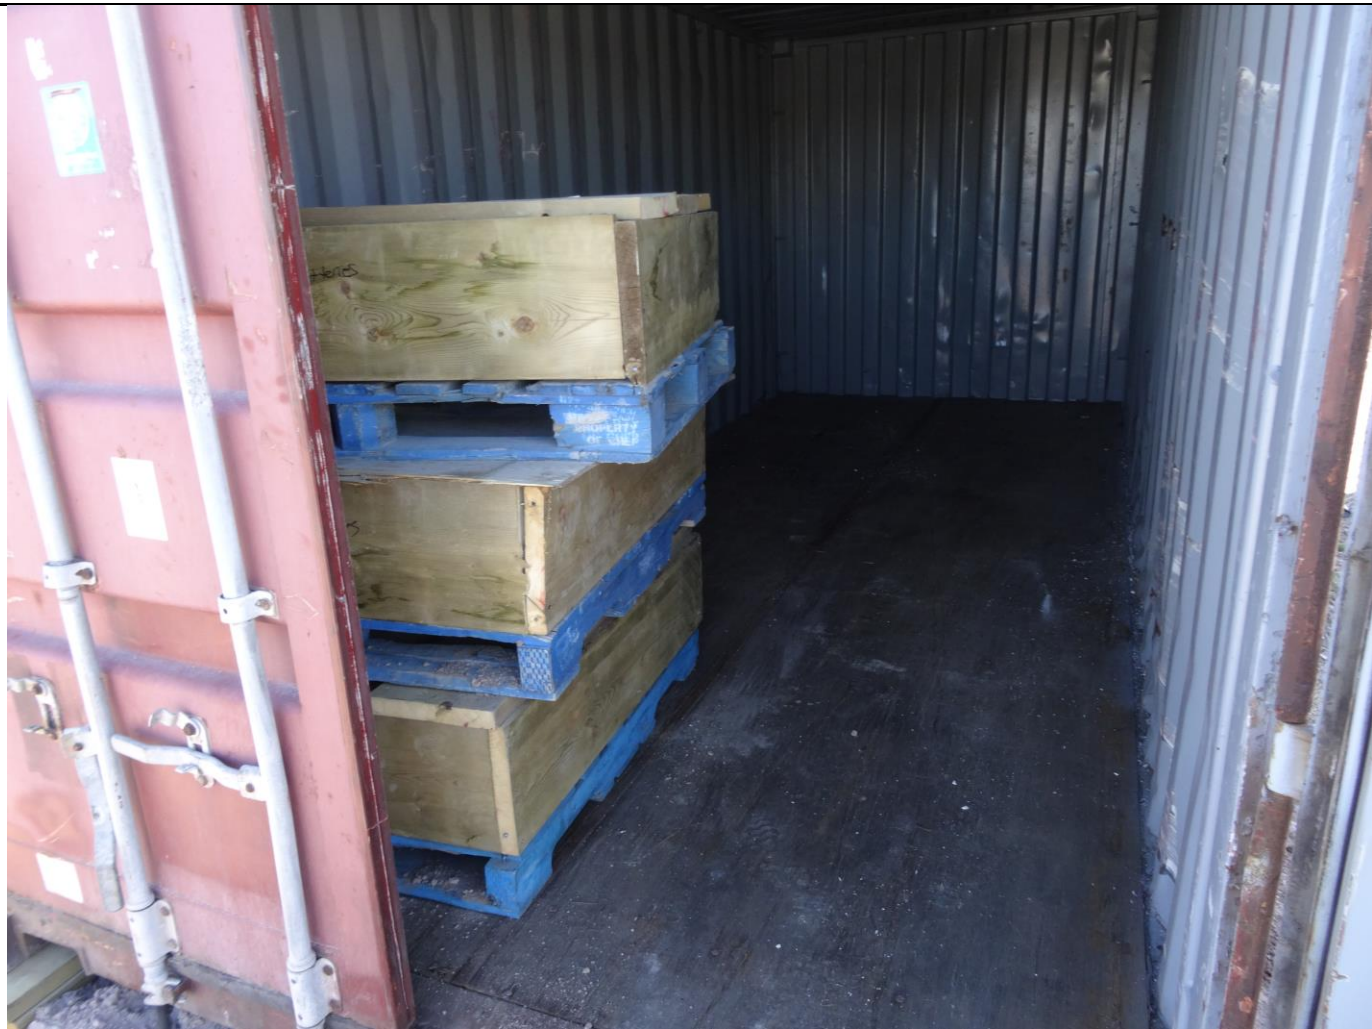
Photo 8

Description: Partial Container of Crated Used Batteries in the Garbage Dump

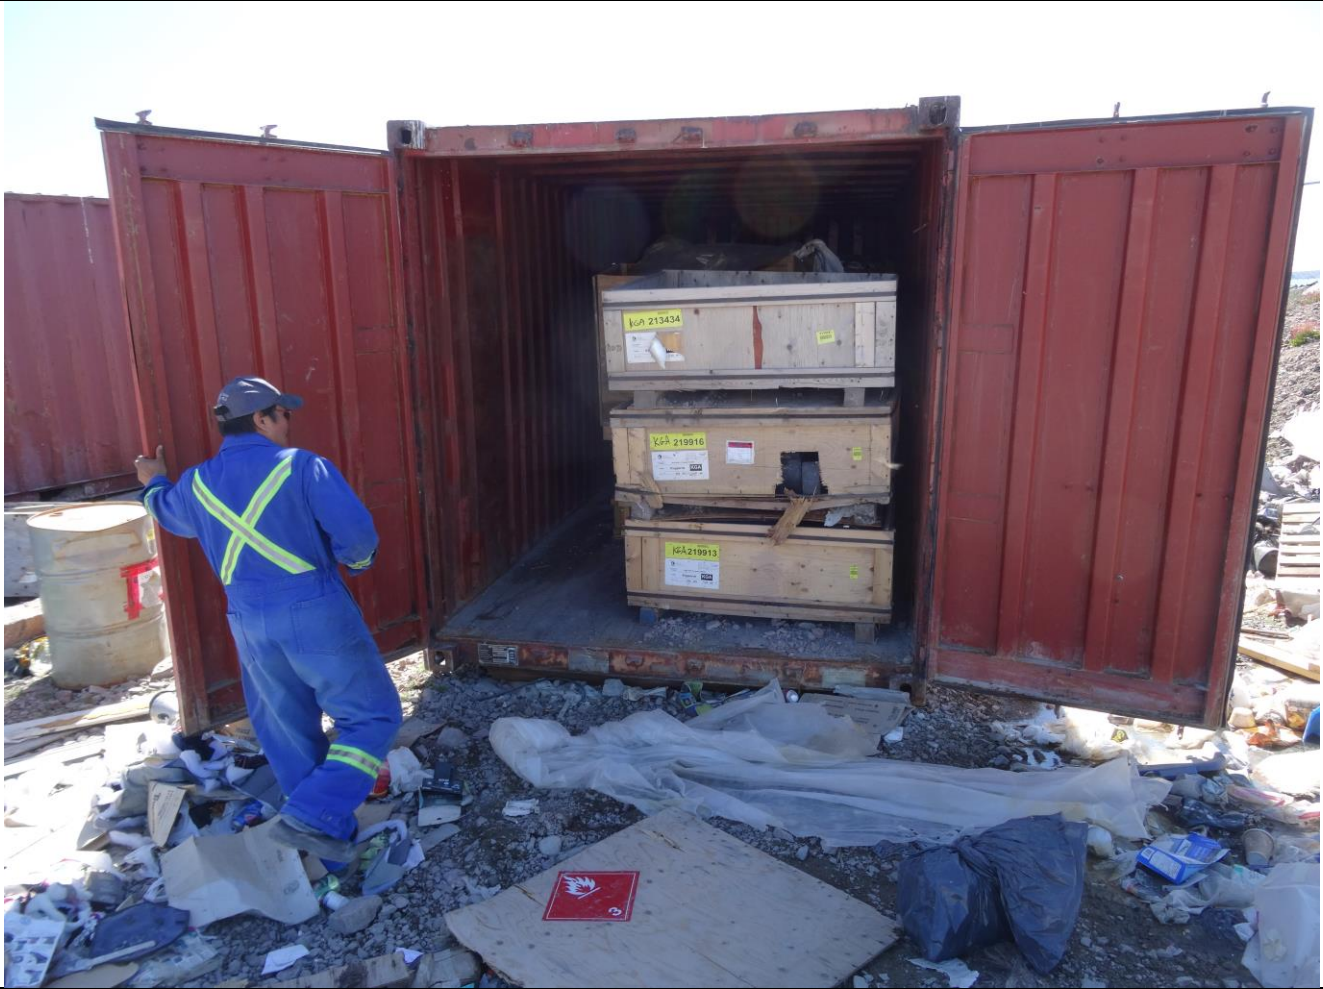
Photo 9

Description: Full Container of Crated Used Batteries in the Garbage Dump

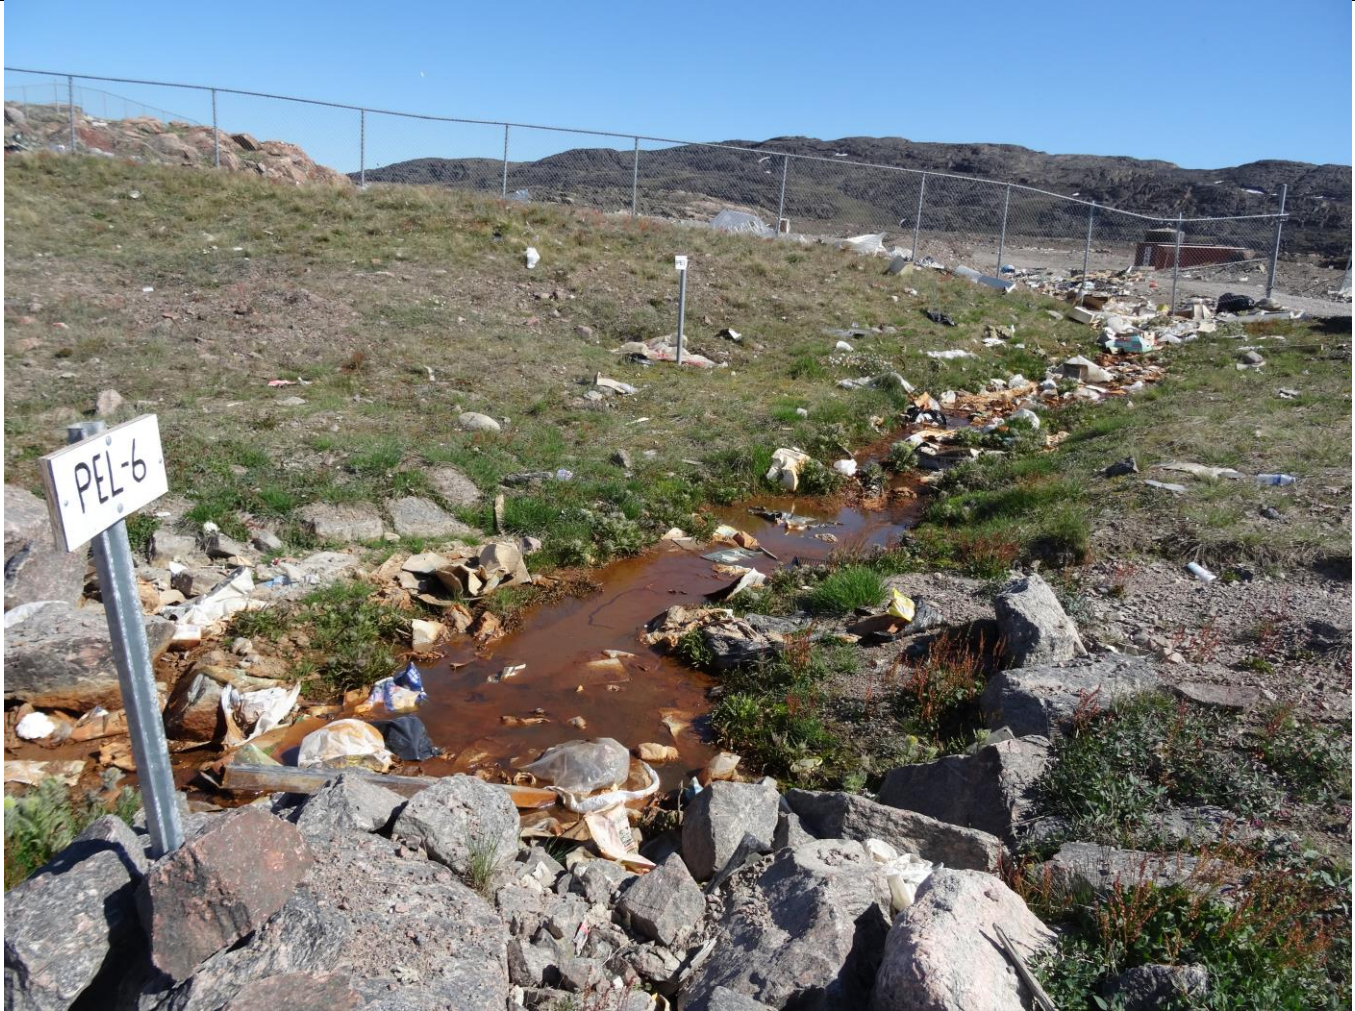
Photo 10

Description: Drainage Ditch outside the Garbage Dump requiring clean-up

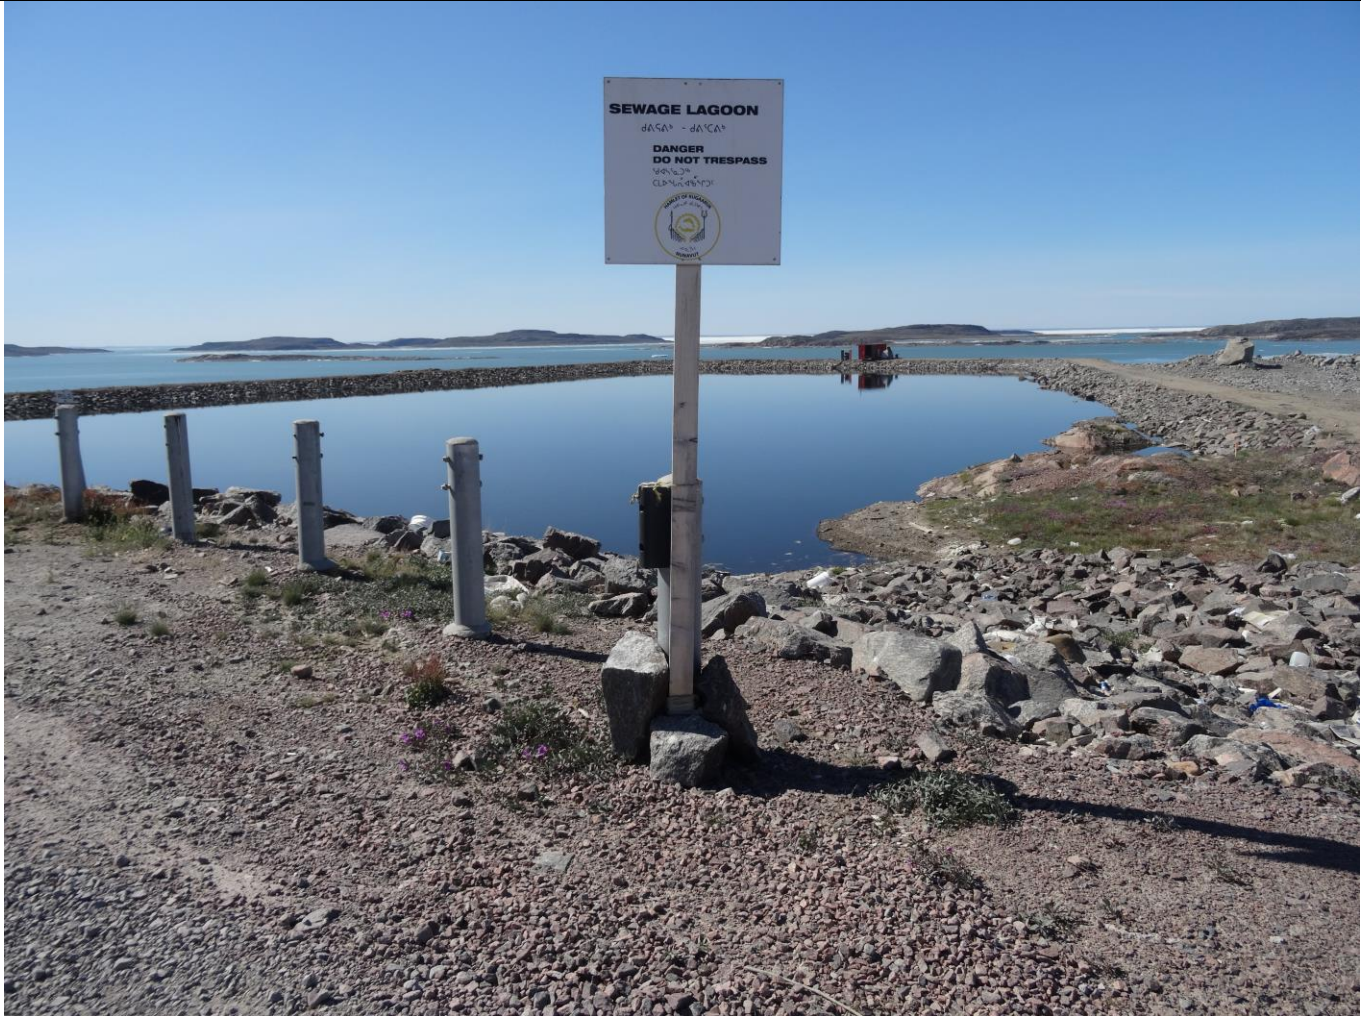
Photo 11

Description: Upper Cell of the Sewage Lagoon under repair construction

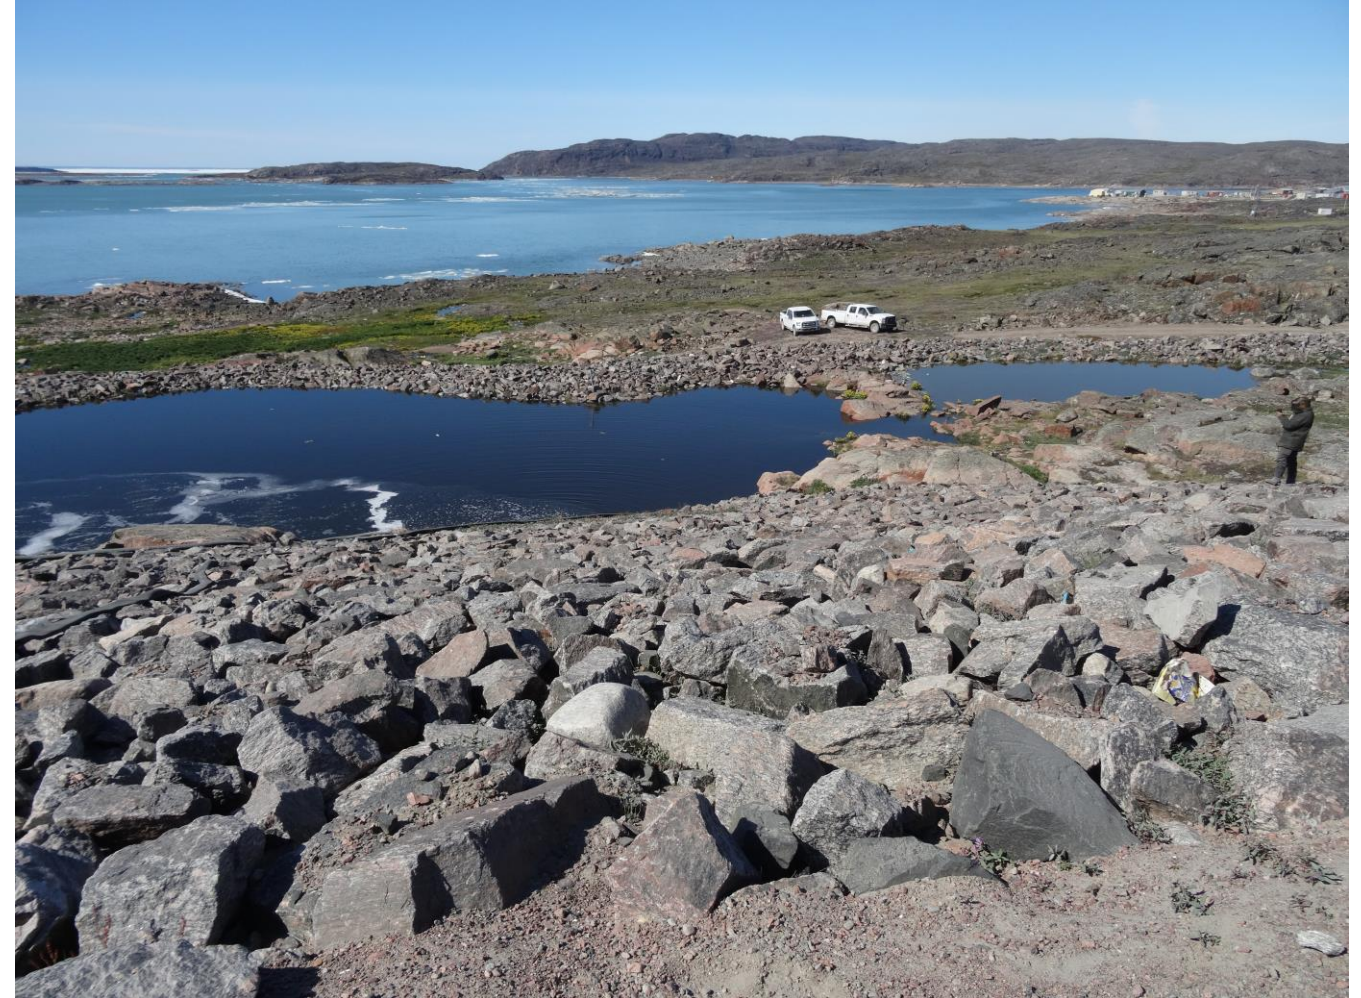
Photo 12

Description: Lower Cell of the Sewage Lagoon being used as the active main cell during repair construction
