Water Management Inspection - Hamlet of Pelly Bay, August 15, 1997

Inspection Report

Pelly Bay
Unlicensed

15 August 1997

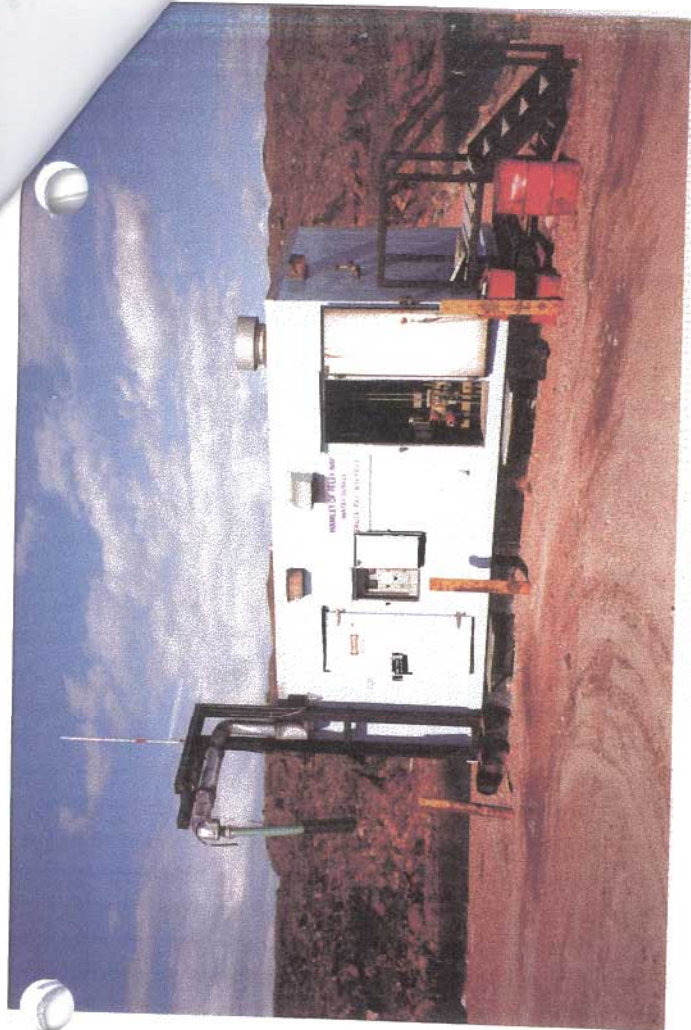
1. Truckfill station.
2. Aerial view. Arrow denotes location of truckfill station on river.
3. Creek where people go to collect water. Public Health had taken an interest in this source.
- 4-6. Waste disposal site. Accumulated garbage is due to Public Health's direction to the Hamlet not to burn the dump.
7. Trench to divert runoff water from entering the dump.
8. Waste oil - stacked and palletized.
9. Bulky metal disposal site.
- 10-14. Views of sewage disposal area. Note in 11+12 (arrow) an area of repair as lagoon washed out in June of last year. Photo 13 shows 'wetlands' area below lagoon. Photo 14 is reverse view.
15. Aerial view of community and waste disposal facilities (to show relative distances). Solid waste is on the left, sewage on the right.

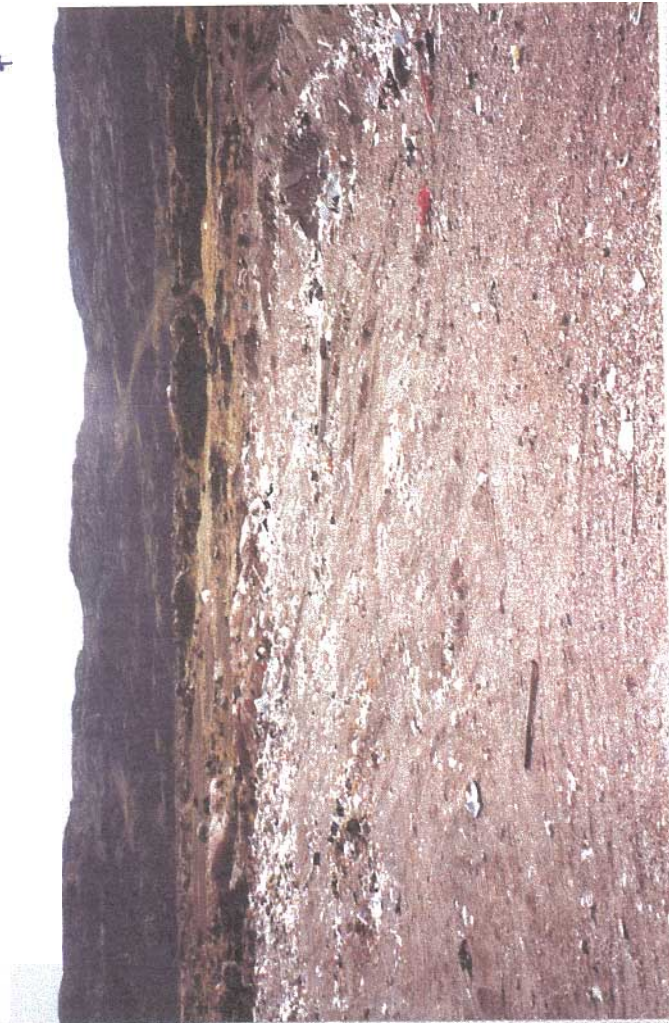
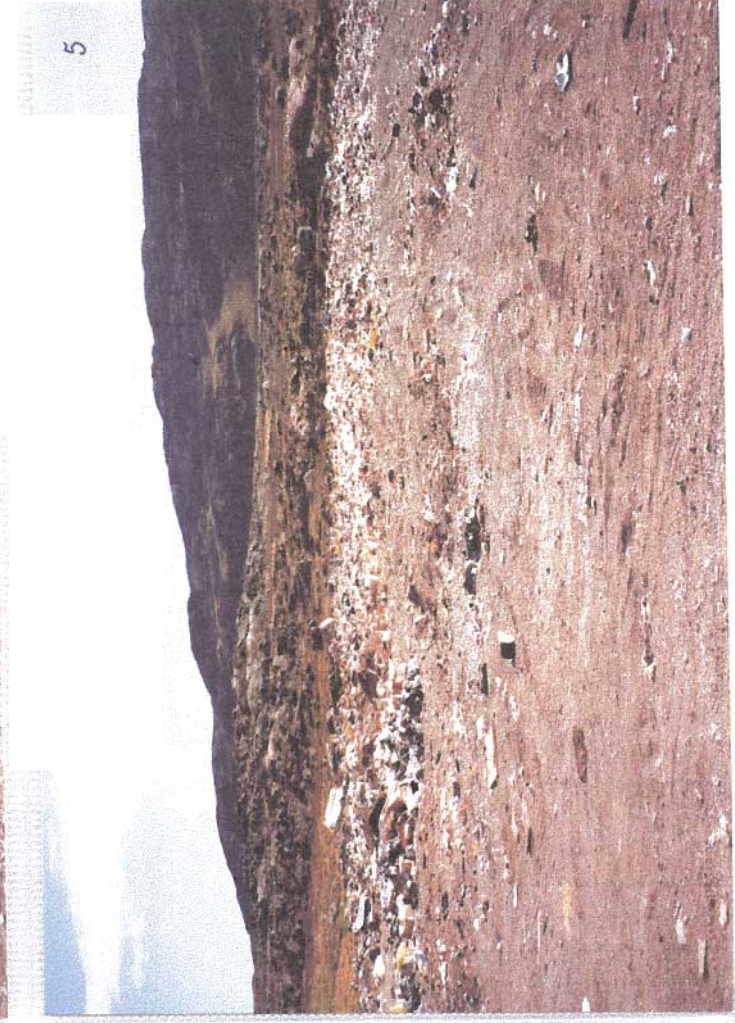
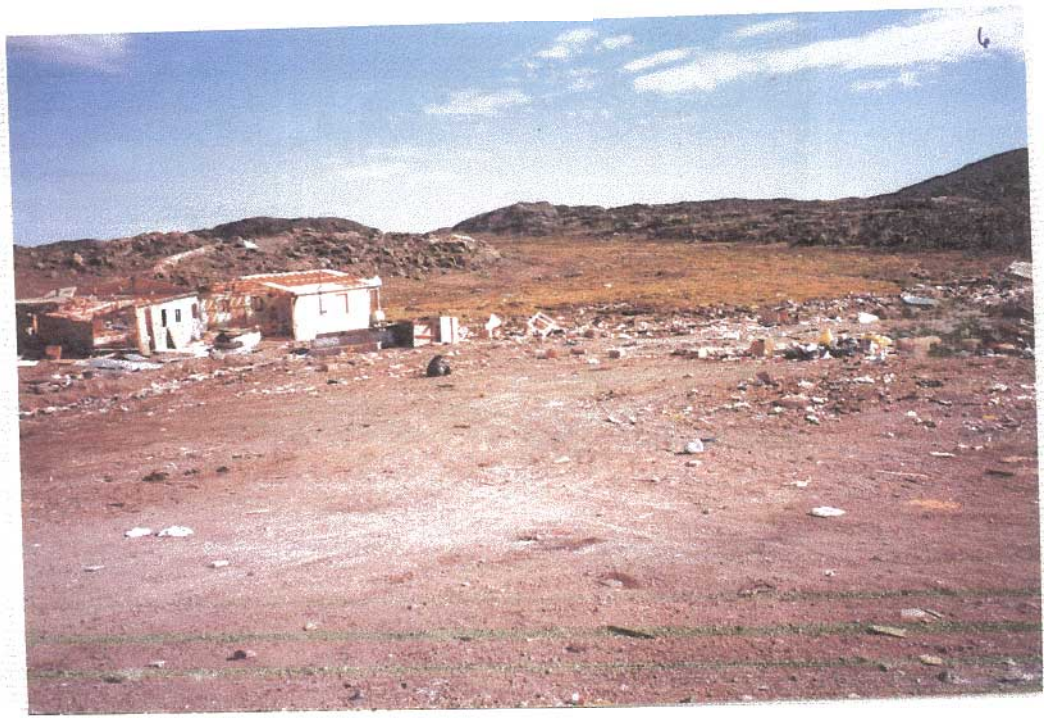
Note 2 - Solid Waste - The dump is a well contained, well run site. It is bordered by bedrock and an earthen berm. The Hamlet Foreman has also made a small diversion ditch to channel run-off water away from the dump. The site needs fencing and warning signs. The problem this past year is that on the advice of the Environmental Health Officer (EHO), the dump has not been burnt for a year. Since the facility is unfenced and there is a shortage of granular material for cover, unburnt garbage has quickly accumulated and has been scattered by the wind. This material needs to be picked up and burned or buried with the rest of the dump.
