RE: August 23, 2002 Municipal Water Use Inspection - Report

MUNICIPAL WATER USE INSPECTION REPORT

Date: August 23, 2002 Licensee Rep. (Name/Title): Quinn Ttaggart/ SAO
Licensee: Hamlet of Kugaaruk Licence No.: Unlicensed

Kugaaruk Inspection Pictures 2002

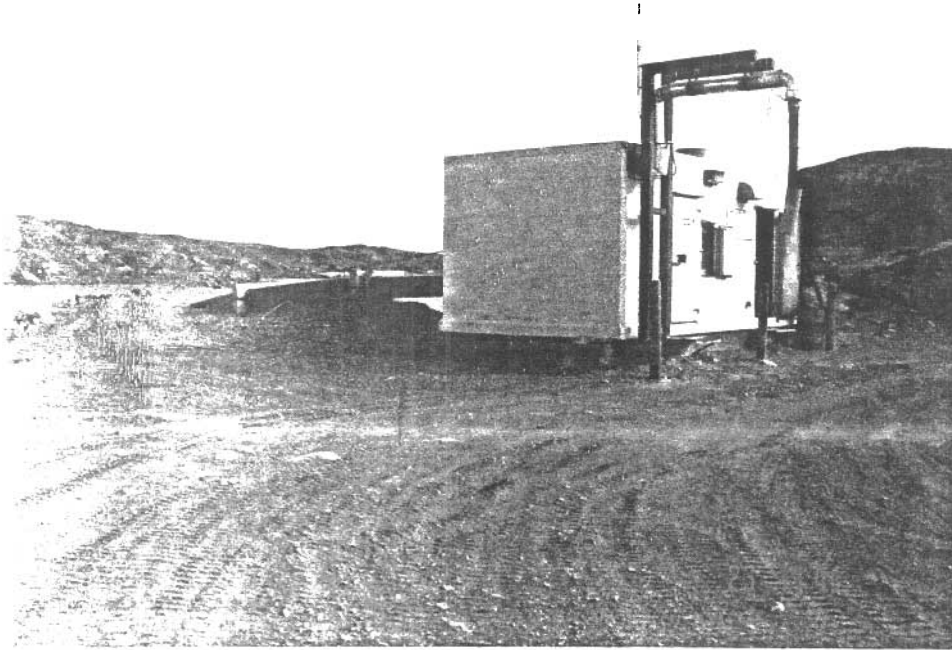
- ☐ **Water Supply:** It was noted during the inspection that there was an oil leak at the Water Intake Facility at the Kugurdjuk River (Photo 1). There was oil absorbent (floor dry) spread over the floor in the Water Intake Facility generator room to absorb the leak (Photo 3). The chlorination system was operational at the time of inspection (Photo 2). Attached analysis of samples taken at the Water Intake Facility indicate that Colour (5 TCU vs 15 TCU), pH (7.46 vs 6.5-8.5) and Nitrate + Nitrite (< 0.008 mg/l vs 3.2 mg/L) *Guidelines for Canadian Drinking Water Quality*.

Comments: Water Intake Facility was operating properly. The generator room floor was covered with oil absorbent material because there was a oil or fuel leak in the generator room. It was noted that there was garbage associated with fishing around the Water Intake Facility, fishing should be discouraged in the vicinity of the Water Intake Facility.

Photo # 1 Water intake Facility at the Kugurdjuk River.

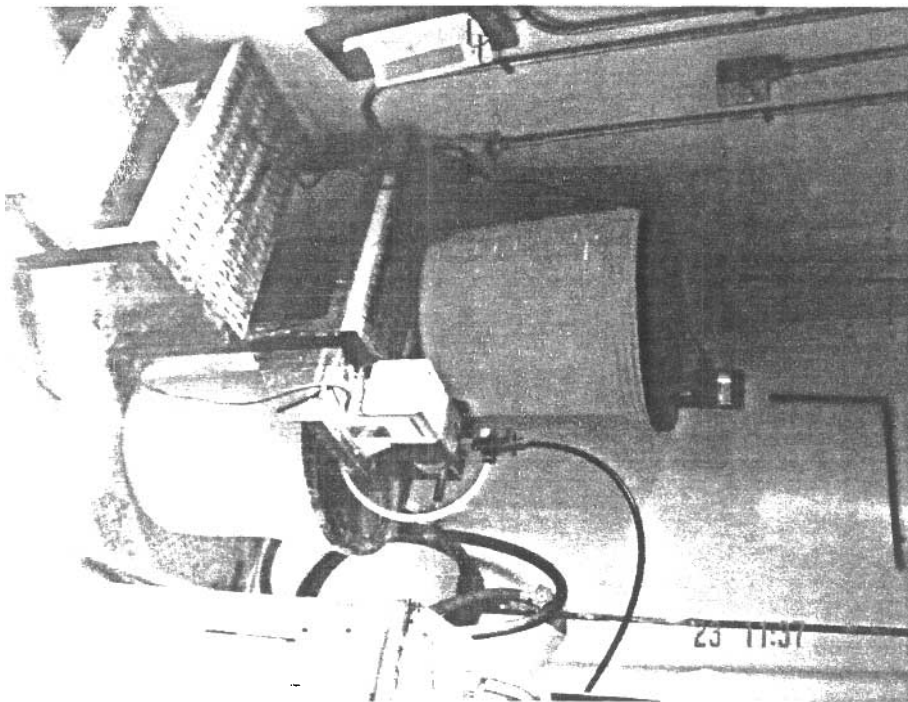
Photo # 2 Chlorination system at Water Intake Facility.

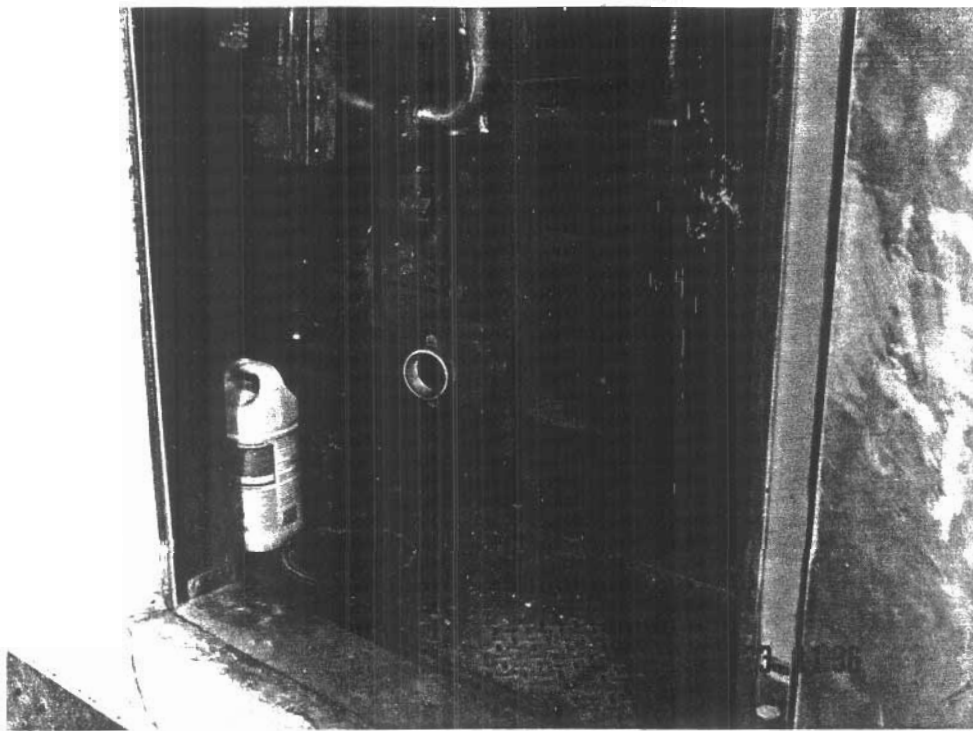
Photo # 3 Spilled or leaking oil in generator room at Water Intake Facility.

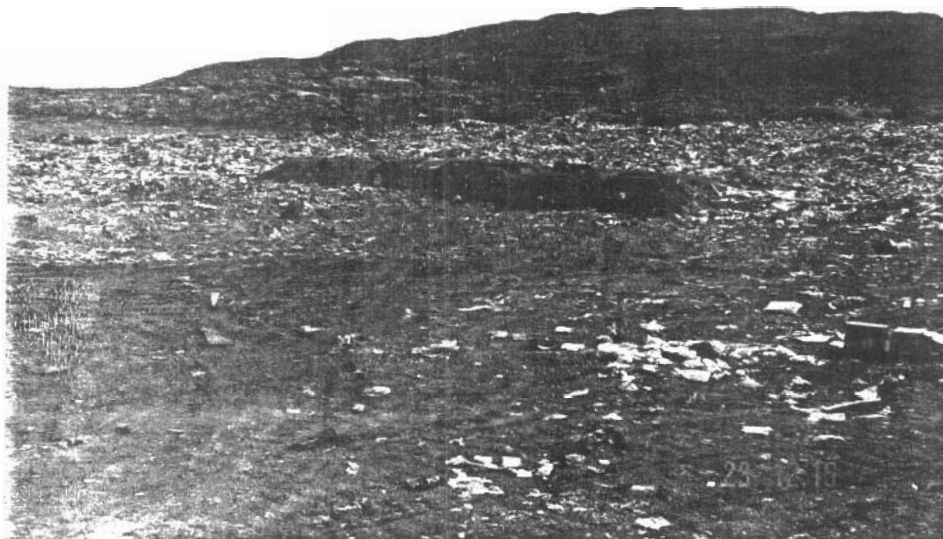
Photo # 5 Solid Waste Disposal Facility tipping face.

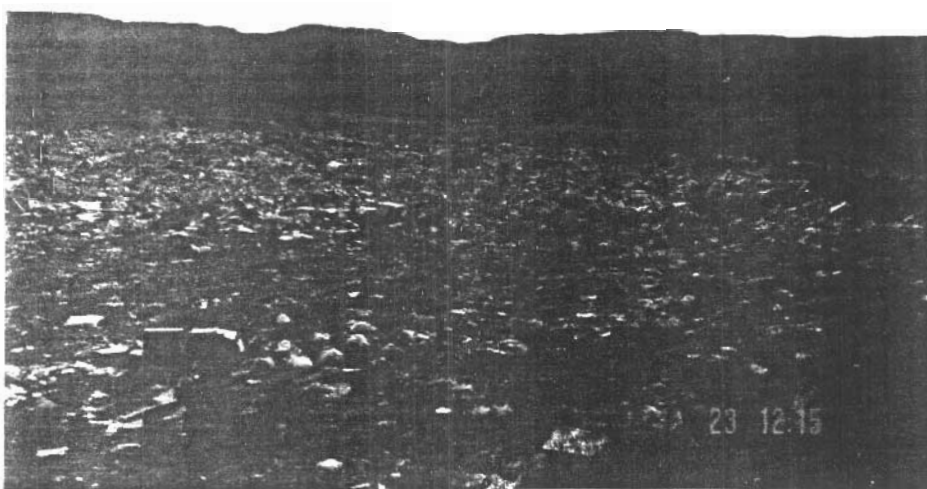
- ☐ **Solid Waste Disposal:** The Solid Waste Disposal Facility had no fencing but it was surrounded on 3 sides by rock hills. The surrounding hills help to reduce the wind blown garbage. The Solid Waste Disposal Facility appeared to have little burning or burrowing of waste practiced (Photo 6) The tipping face appeared to extend the entire length of the dump (Photo 5). Waste oil was stored by the entrance to the Solid Waste Disposal Facility (Photo 9). Consolidation of waste oil drums is required at the waste oil storage area.

Photo # 6 Solid Waste Disposal Facility.

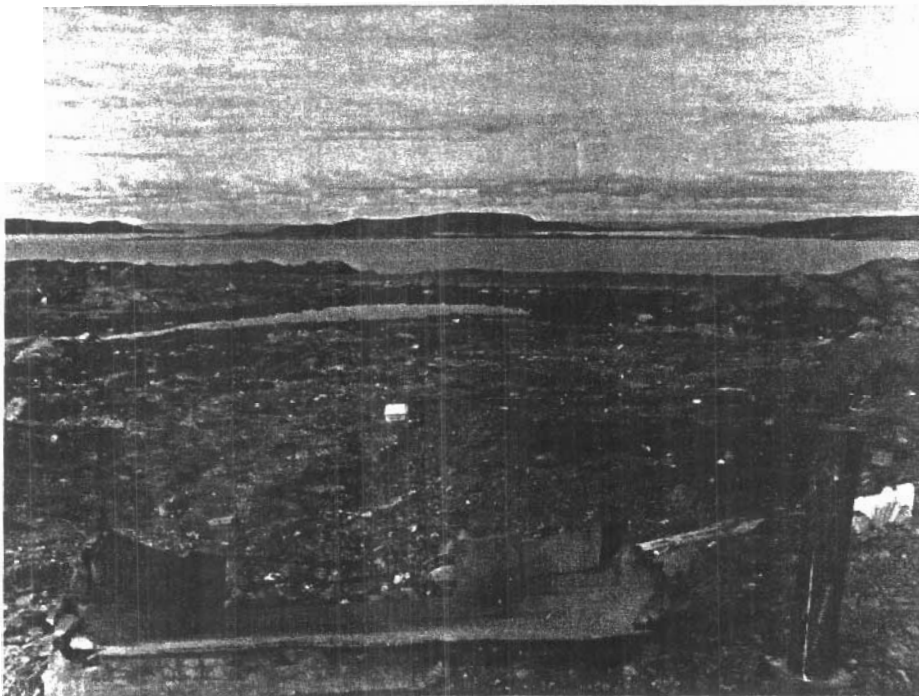
- ☐ **Sewage Disposal:** There was sufficient freeboard at the Sewage Lagoon. The sewage truck discharge structure appeared to control erosion at the Sewage Lagoon (Photo 8). Considerable seepage was noted emitting from the berm at the east end of the Sewage Lagoon. The sewage effluent flows from the Sewage Lagoon over land to the ocean. Enclosed analysis of sewage effluent from the Sewage Lagoon indicate that Total Suspended Solids (92 mg/L vs 120), pH (7.44 vs 6.5-9.0) and Total Phosphorous (9.6 mg/L vs 10 mg/L) are within the *Municipal Wastewater Effluent Quality Guidelines*. However analysis for Total Ammonia indicate that (69.4 mg/L vs 2.2 mg) exceed the *Municipal Wastewater Effluent Quality Guidelines*.

Photo # 8 Sewage truck discharge structure at the Sewage Lagoon.

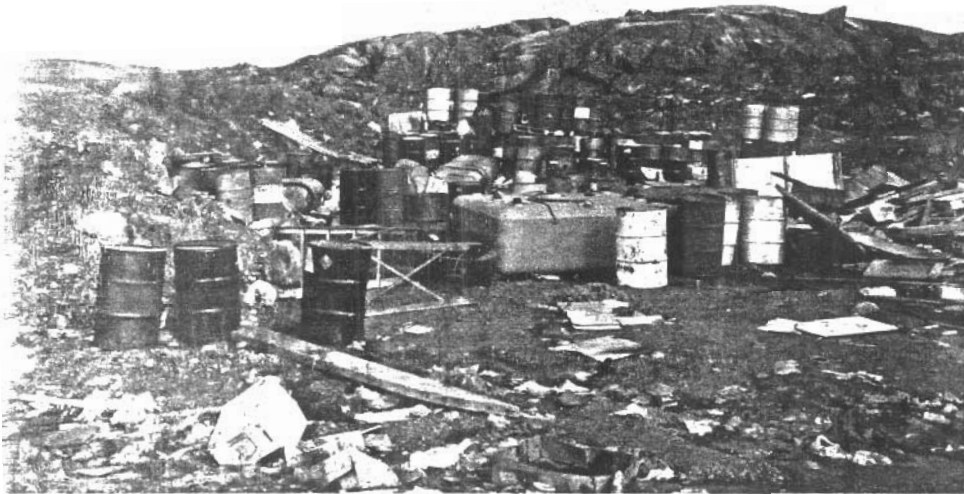
Comments: The Sewage Lagoon is decanted by seepage through the berm on the east side of the Lagoon. The sewage effluent then flows over land to the ocean. The Solid Waste Disposal Facility is partially fenced. Most of the dump is contained by hills that assist in reducing the wind blown garbage. A perimeter fence would reduce the amount of wind blown garbage observed at the site. Most of the bulky metal waste is taken to the metal waste dump. Hazardous materials (waste batteries) are not segregated from the general metal waste. The waste oil is stored by the entrance to the Solid Waste Disposal Facility, this area requires consolidation.

Photo # 9 Waste oil storage area, at entrance to Solid Waste Disposal Facility.

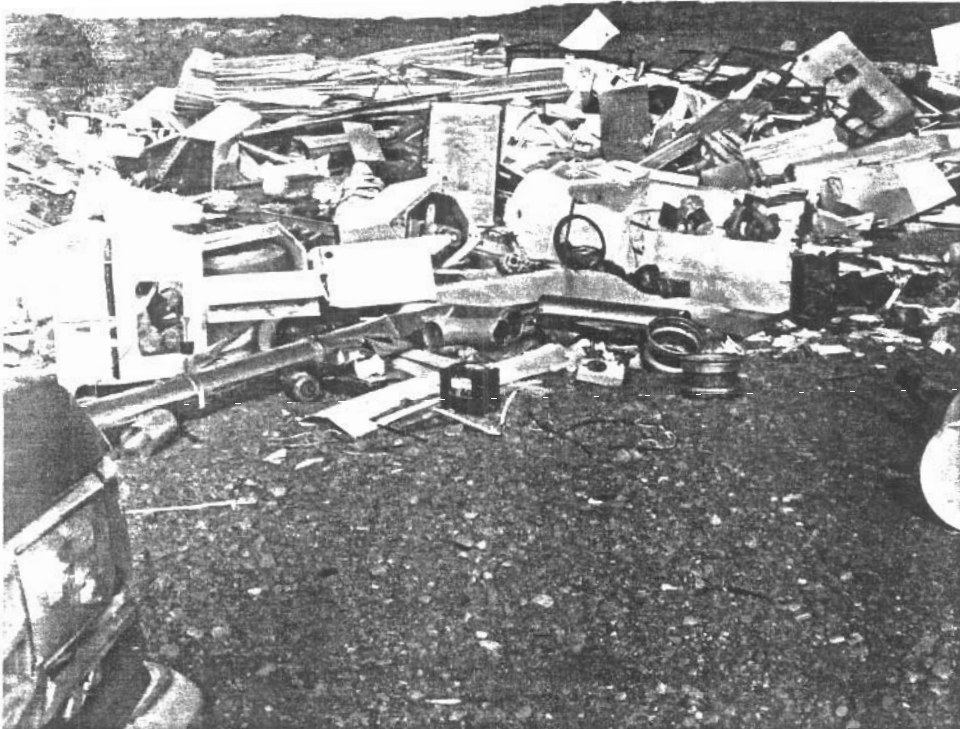
- ☐ **Bulky Metal Waste Disposal Site:** The bulky metal dump is located adjacent to the Solid Waste Disposal Facility. There is little segregation of waste at the bulky metal dump. Hazardous materials waste (batteries) were seen scattered throughout the dump (Photo 10). Enclosed analysis of seepage from the Bulky Metal Waste Dump (Photo 7) indicate that Total Ammonia (<0.005 vs 2.3 mg/L), Nitrate + Nitrite (0.105 mg/L vs 3.2 mg/L) and Total Phosphorous (0.1 mg/L vs 10 mg/L) are within the *Municipal Wastewater Effluent Quality Guidelines*. However attached analysis of Metal Dump seepage indicate that Total Suspended Solids (148 mg/L vs 100 mg/L) is in excess of *Municipal Wastewater Effluent Quality Guidelines* Maximum Concentrations.

Photo # 10 Waste batteries scattered throughout the Bulky Metal Waste Dump.
