WATER LICENCE INSPECTION FORM

Licensee		Licensee Representative	
Hamlet of Kugaaruk		John Ivey	
Licence No. / Expiry		Representative's Title	
3BM-PEL1419		Senior Administrative Officer	
Land / Other Authorizations		Land / Other Authorizations	
Date of Inspection		Inspector	
July 13, 2017		Baba Pedersen	
Activities Inspected			
<input type="checkbox"/> Camp	<input type="checkbox"/> Drilling	<input type="checkbox"/> Mining	<input type="checkbox"/> Construction
<input type="checkbox"/> Roads/Hauling	<input type="checkbox"/> Other:	<input checked="" type="checkbox"/> Other: Municipal Water License	<input type="checkbox"/> Reclamation
<input type="checkbox"/> Fuel Storage

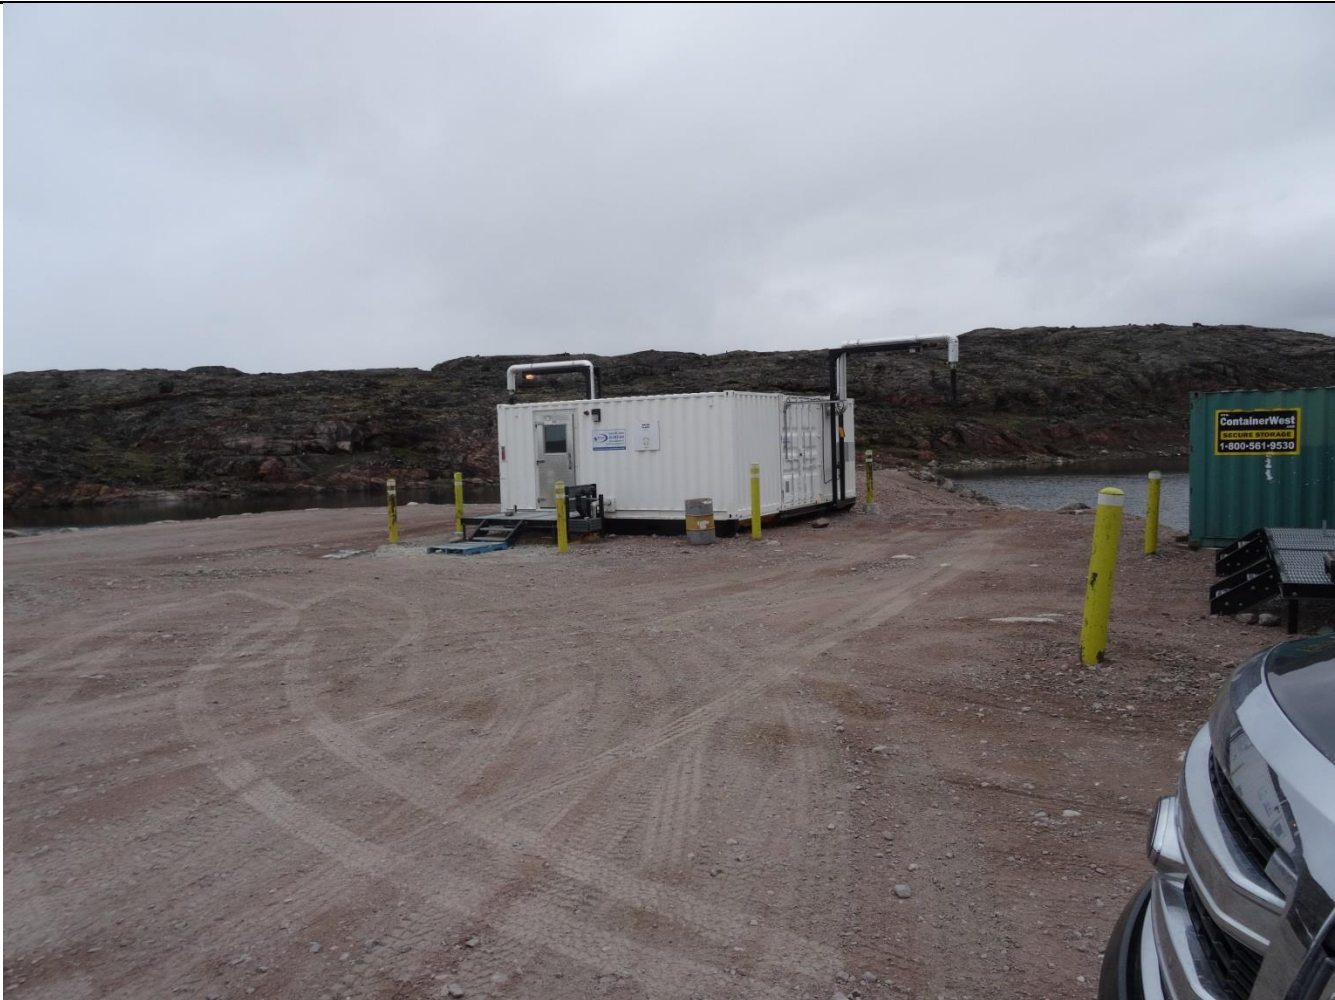
Photo 1

Description: Intake Pump Building and Truck Fill Station

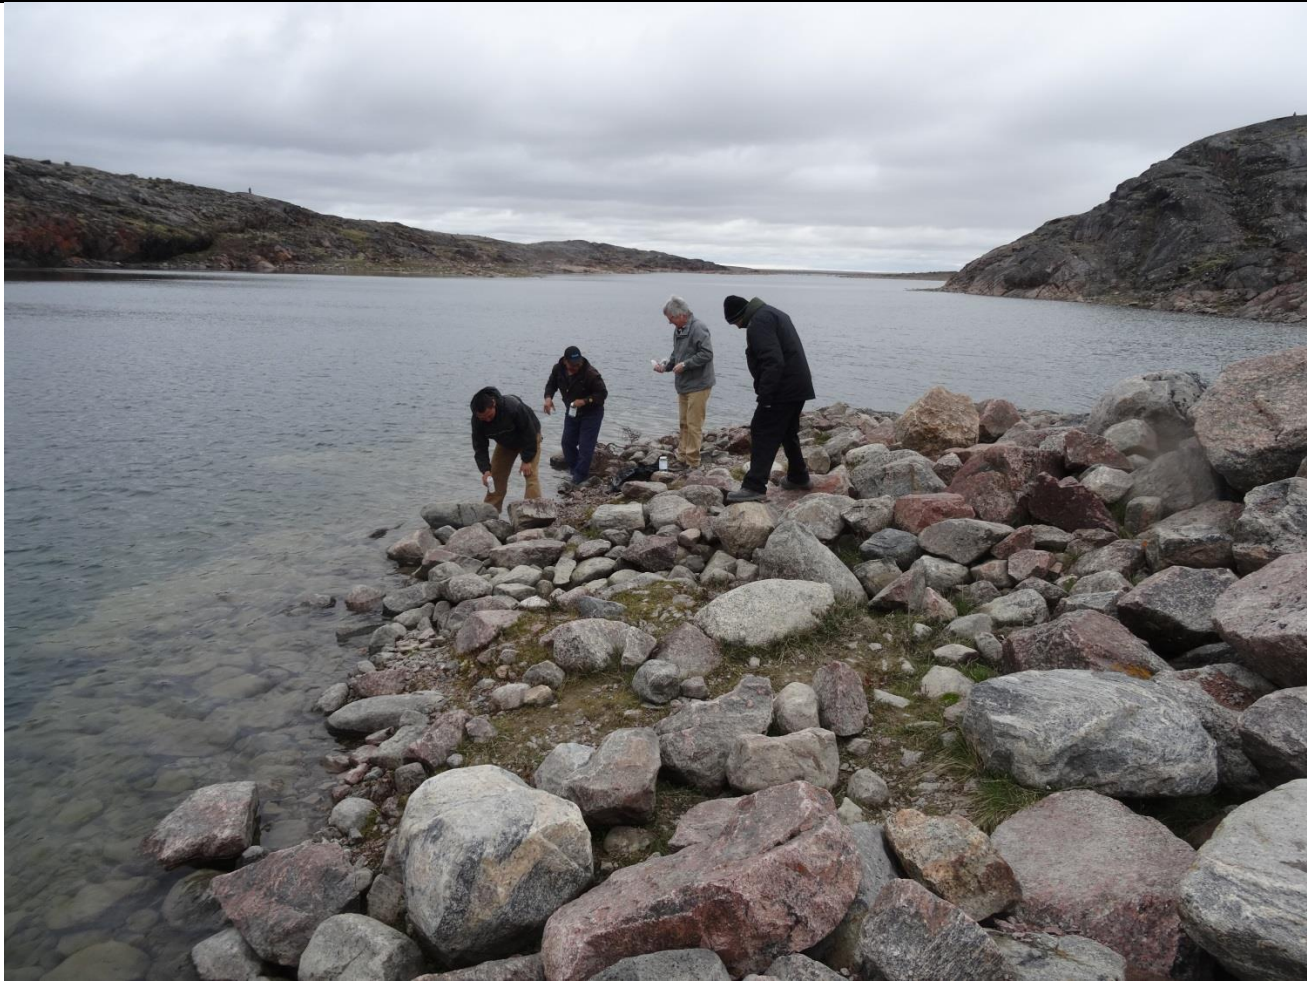
Photo 2

Description: PEL-1-1 Sample Location needs Signage

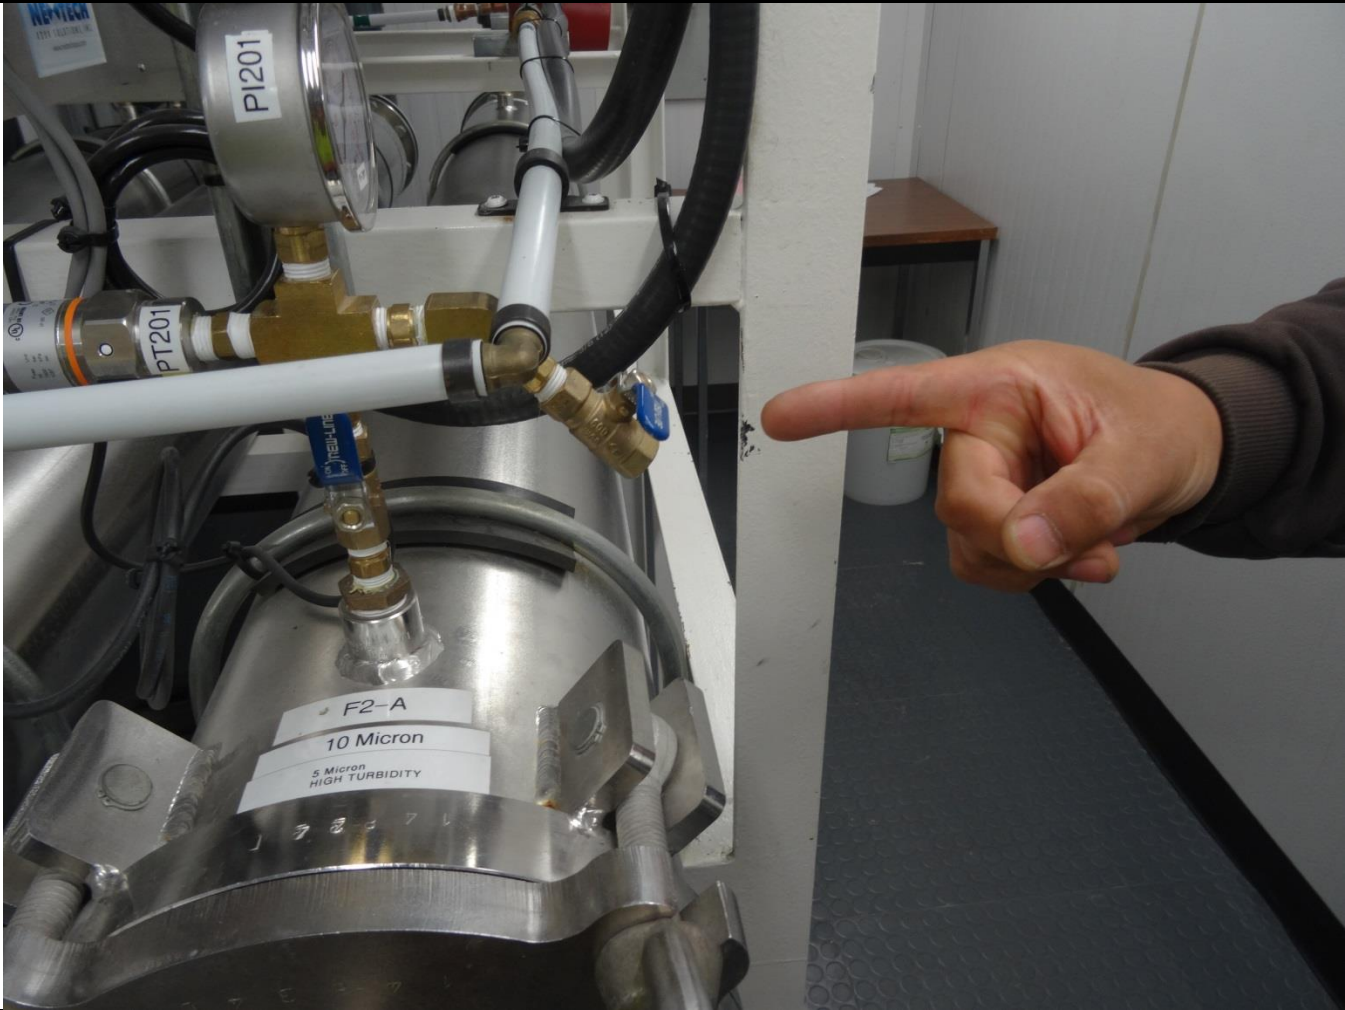
Photo 3

Description: PEL-1-2 Alternate Sample Location inside Intake Pump Building needs Signage

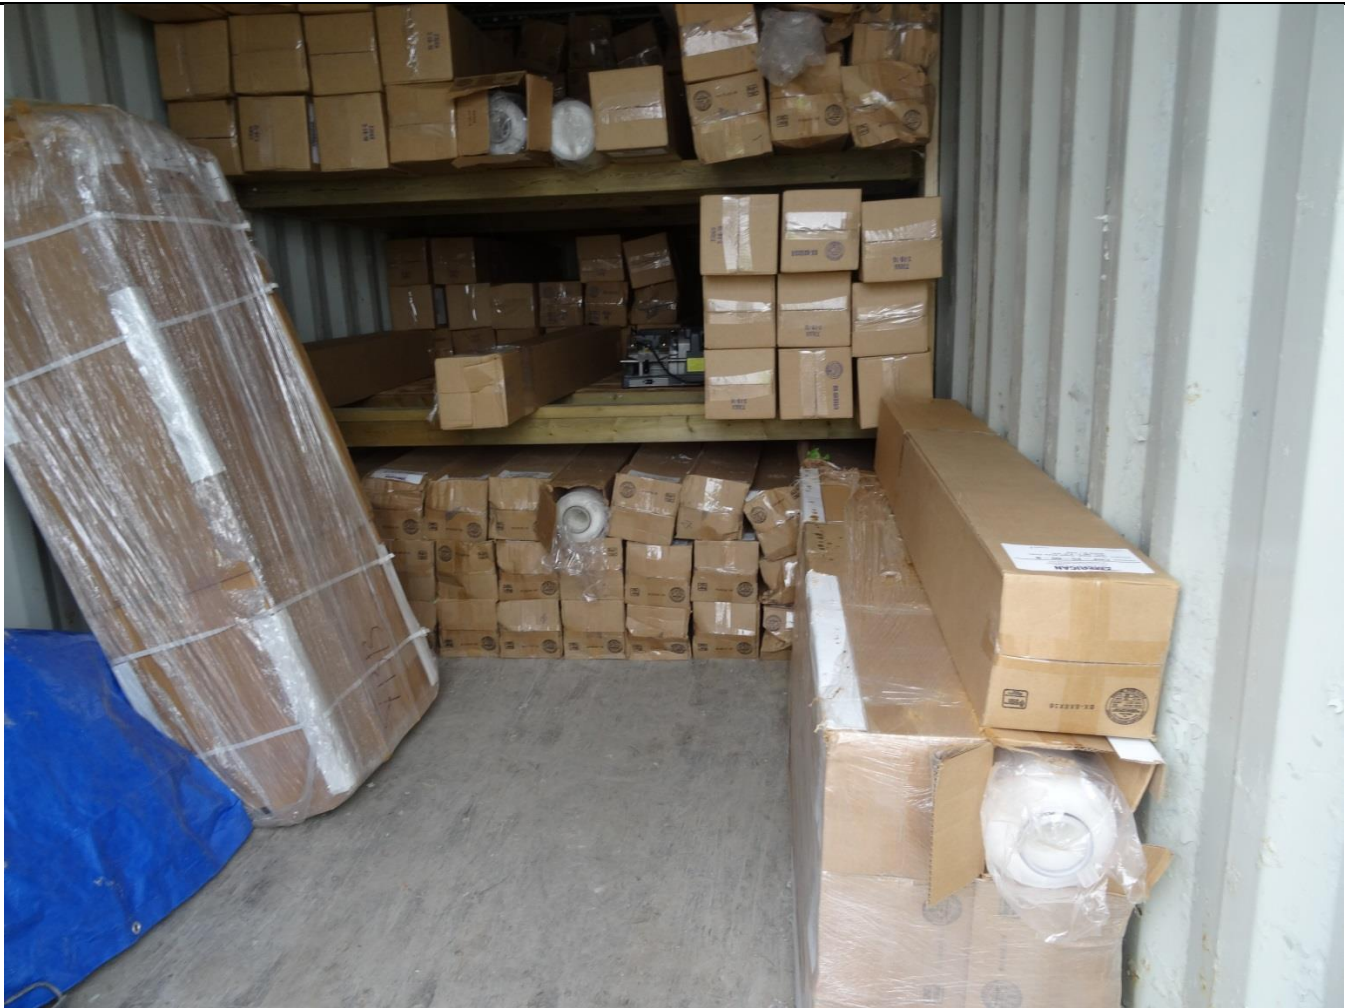
Photo 4

1. At the Kugajuk River Intake Pump Building and Truck Fill Station (Photo 1), I was shown the Disposable Filters used in the Water Treatment Process (Photo 4), and 2. The Flow Meter (Photo 5) on the Raw Water Intake and Water Consumption Records on request, they have used 17,371 cubic meters of Water so far, well within allowable limits, and 3. Sample Station PEL-1-1 (Photo 2), Hamlet Staff Sampled here, there was no visible Signage, and 4. The PEL-1-2 alternate Sample Station (Photo 3) inside the Building where there was also no visible Signage. 5. At the Sewage Lagoon I saw very nice Signage at Sample Station PEL-3-1 (Photo 6) @ N 68° 31’ 17.1” W 089° 50’ 05.6”, Hamlet Staff Sampled here, and 6. Leak #1 (Photo 7) @ N 68° 31’ 12.4” W 089° 49’ 58.3” and Leak #2 (Photo 8) @ N 68° 31’ 14.6” W 089° 50’ 04.2” where the Flow at both locations appears to have slowed down a little from last year. 7. At the Metal Dump (Photo 9) Hamlet Staff had started putting Drums of Used Oils inside the Lined Berm area as requested last year, good job so far! 8. At the Garbage Dump (Photo 10) Hamlet Staff have Cleaned Up and Segregated Contents very nicely as requested last year, again, good job!

Description: New Disposable Filters in Storage being used in Water Treatment Process

1. I recommend the Hamlet (and the GN) consider sending the used Water Filters South for Recycling to avoid putting them in the Garbage Dump and using up valuable space. 2. Thank you for having a critical part of the Water License requirements available on request, not all Municipalities have this capability. 3. Appropriate Signage needs to be installed to show the location of Sample Station PEL-1-1. 4. Appropriate Signage needs to be installed to show the location of Sample Station PEL-1-2. 5. Very nice Signage here and the rest of the Sample Stations, thank you very much. 6. That Hamlet must continue working with the GN to find a way to stop the 2 Leaks coming out of the bottom of the Sewage Lagoon. I want to see progress on this during my summer 2018 Inspection. 7. Hamlet Staff must continue, and complete, putting all Drums of Used Oil into the Lined Berm area. 8. Good Job! Continue having the Hamlet Staff Segregate Hazardous Materials, Batteries and Animal Carcasses from the rest of the Garbage Dump.

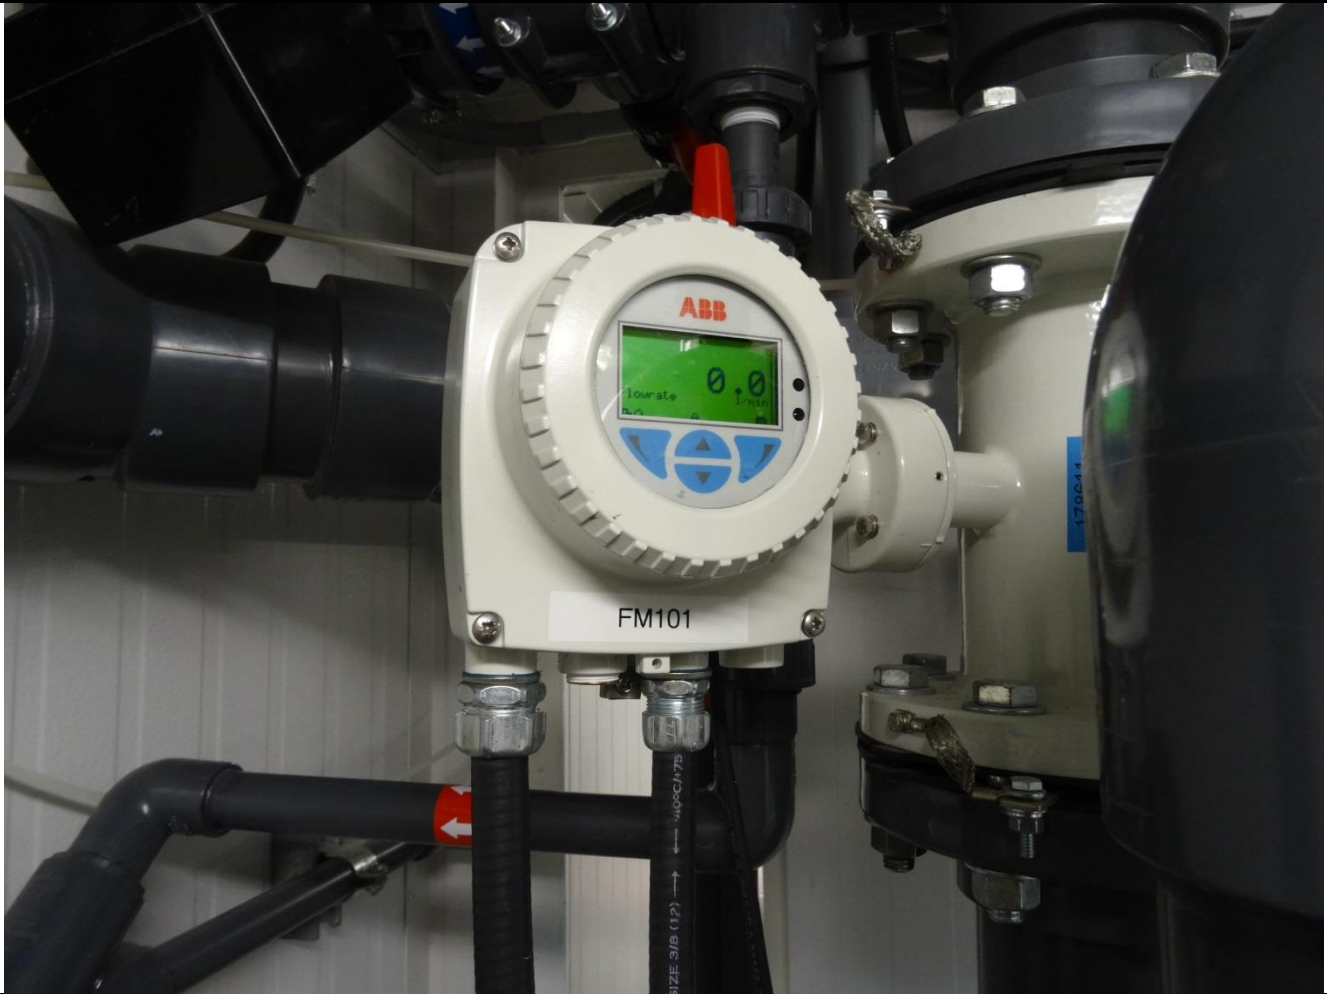
Photo 5

Description: Flow Meter on Raw Water Intake

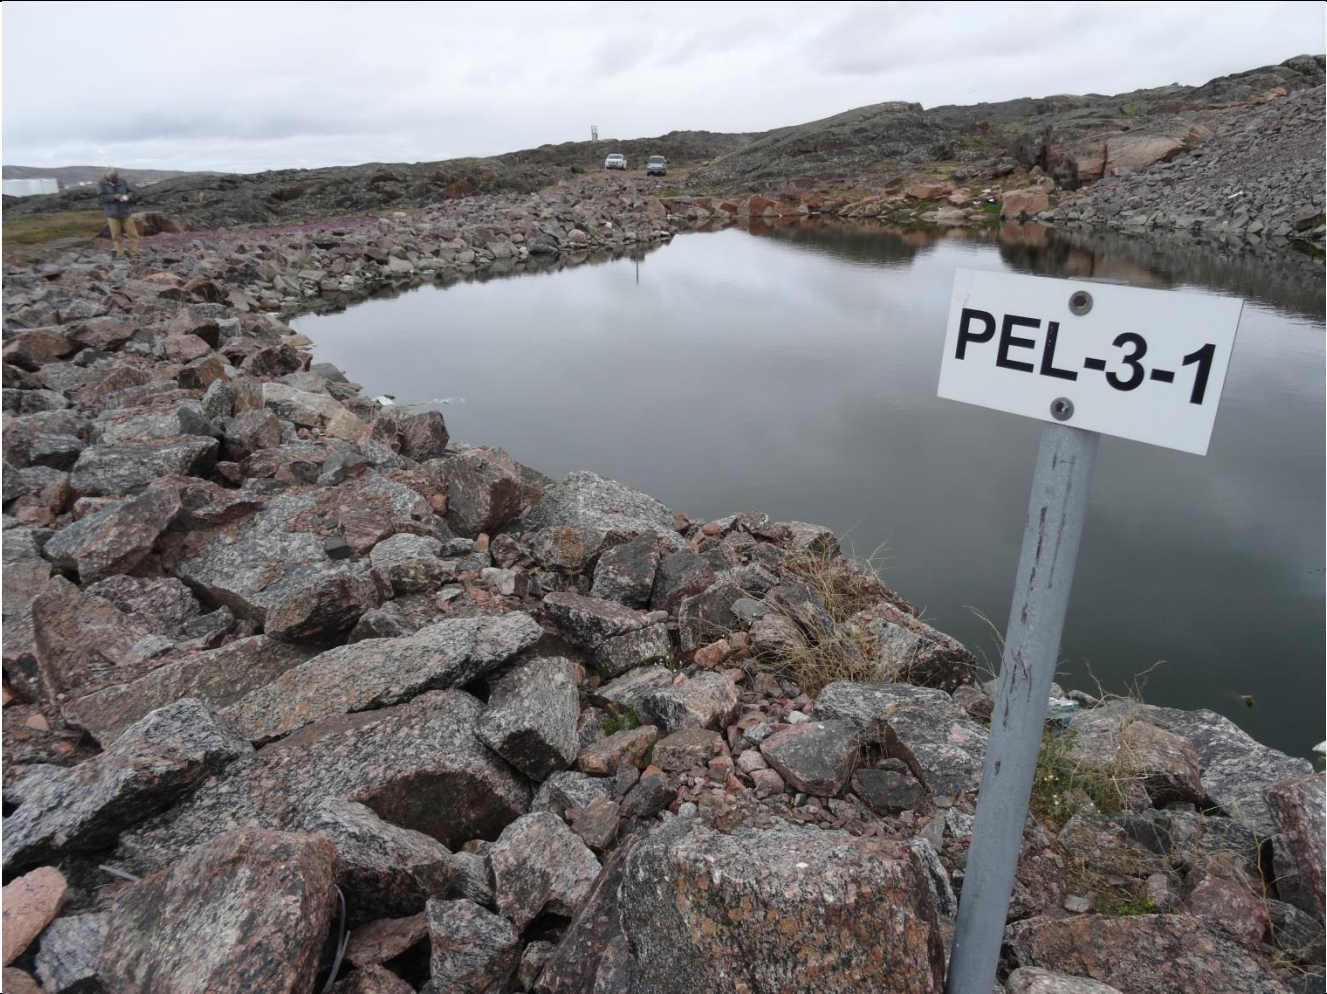
Photo 6

Description: Sample Location PEL-3-1 with very nice Signage

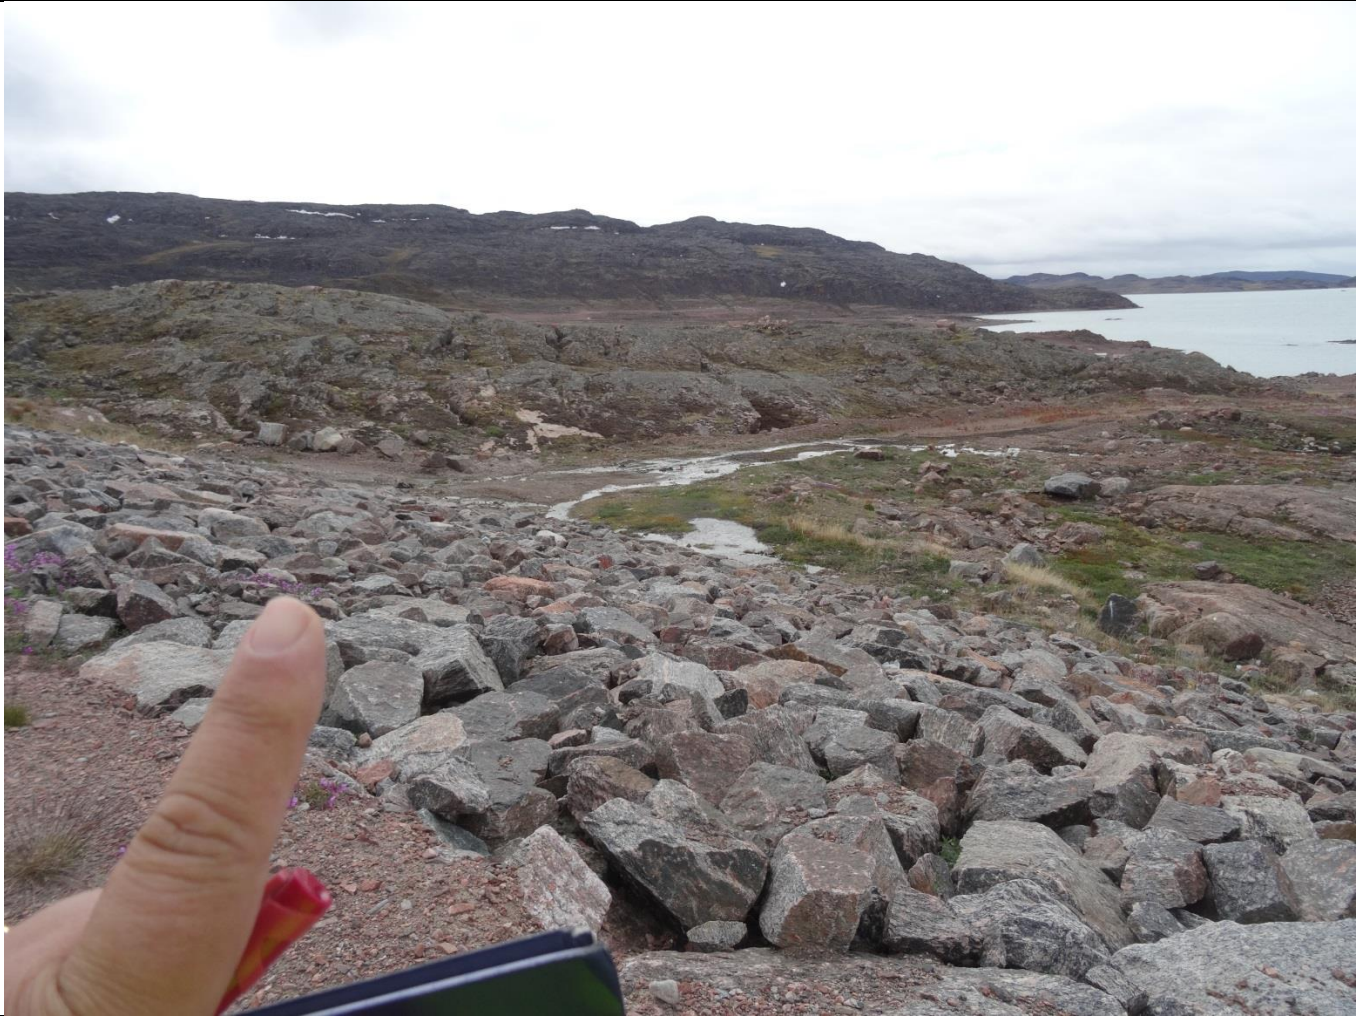
Photo 7

Description: View from on top of Sewage Lagoon Berm of Leak #1

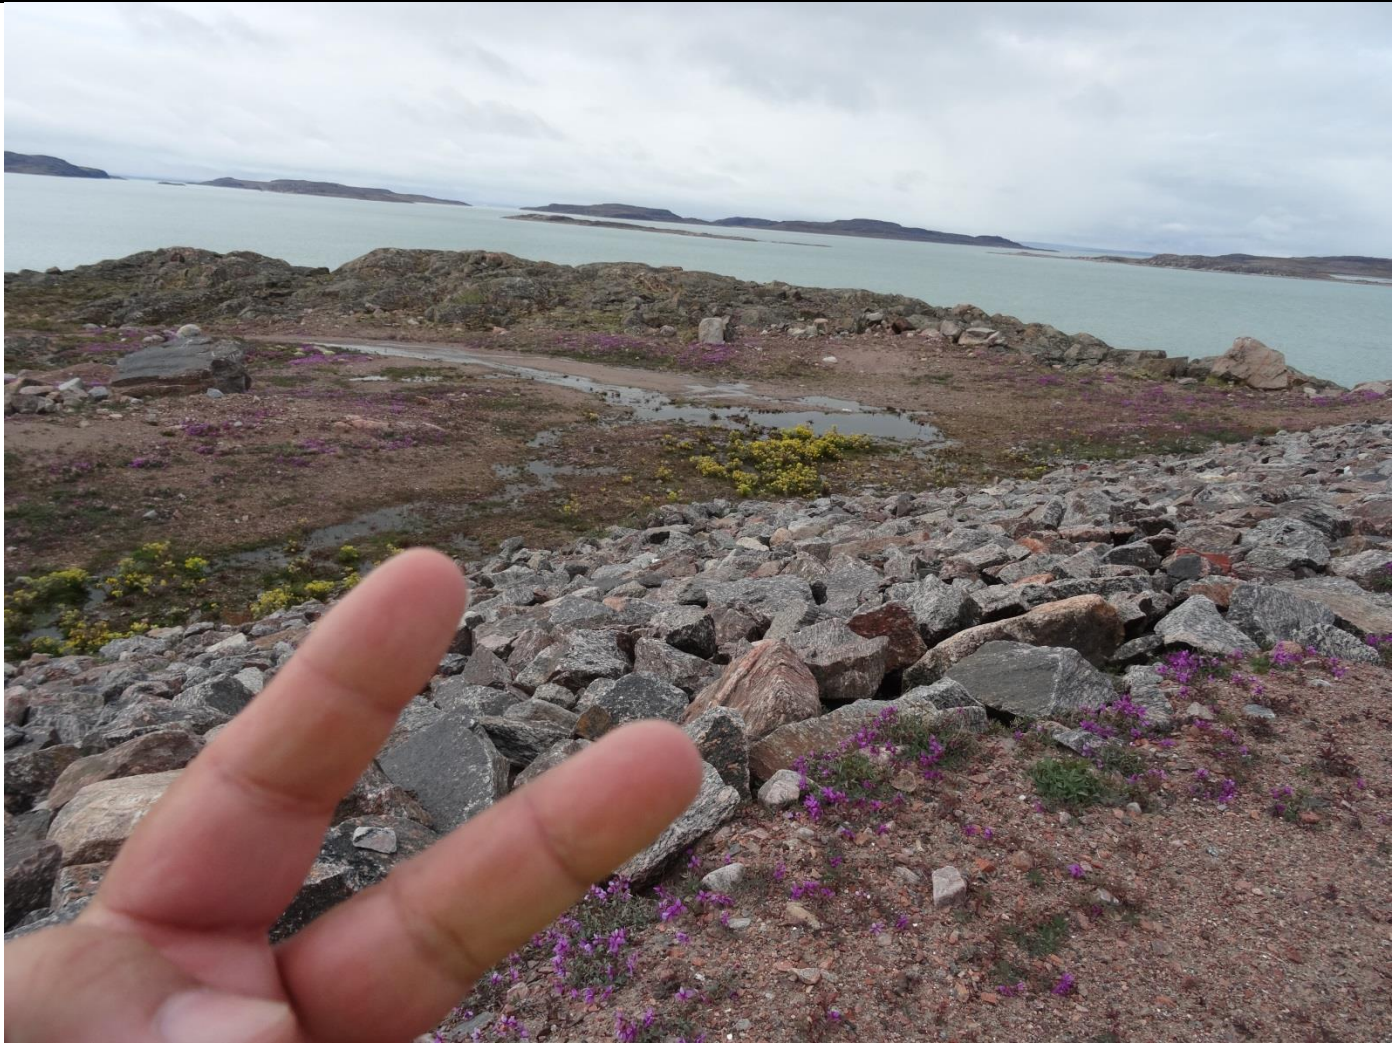
Photo 8

Description: View from on top of Sewage Lagoon Berm of Leak #2

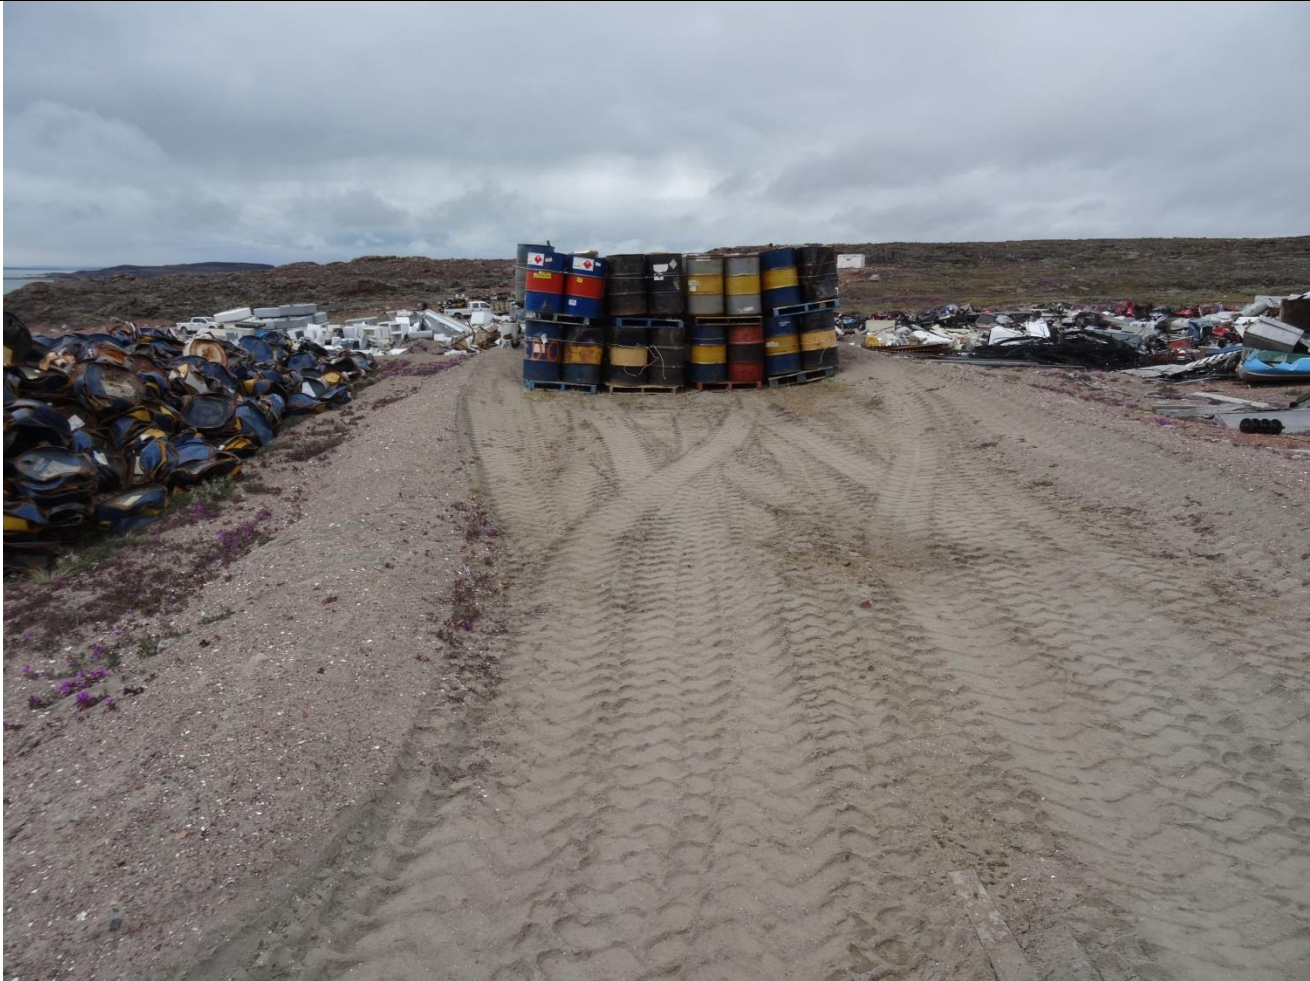
Photo 9

Description: Used Oil Drums being stored inside Lined Berm Area – Good Job – Continue putting ALL Used Oil Drums in this area

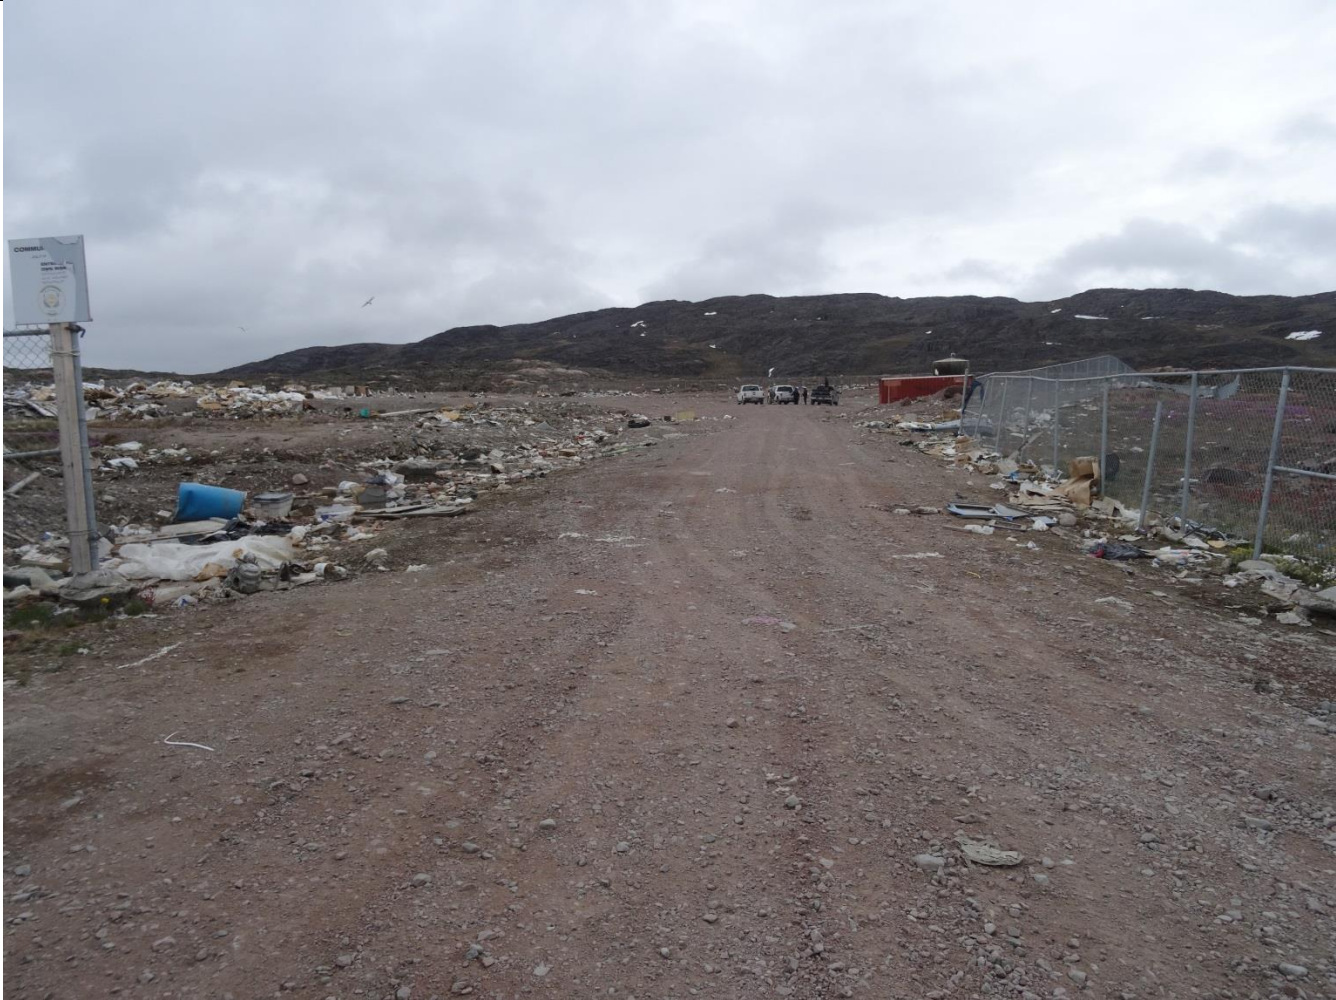
Photo 10

Description: View of Garbage Dump Entrance – Very nice job of cleaning up from last year
