WATER LICENCE INSPECTION FORM

| Hamlet of Kugaaruk | | John Ivey | |
| 3BM-PEL1419 | | Senior Administrative Officer | |
| 11 July 2018 | | Baba Pedersen | |

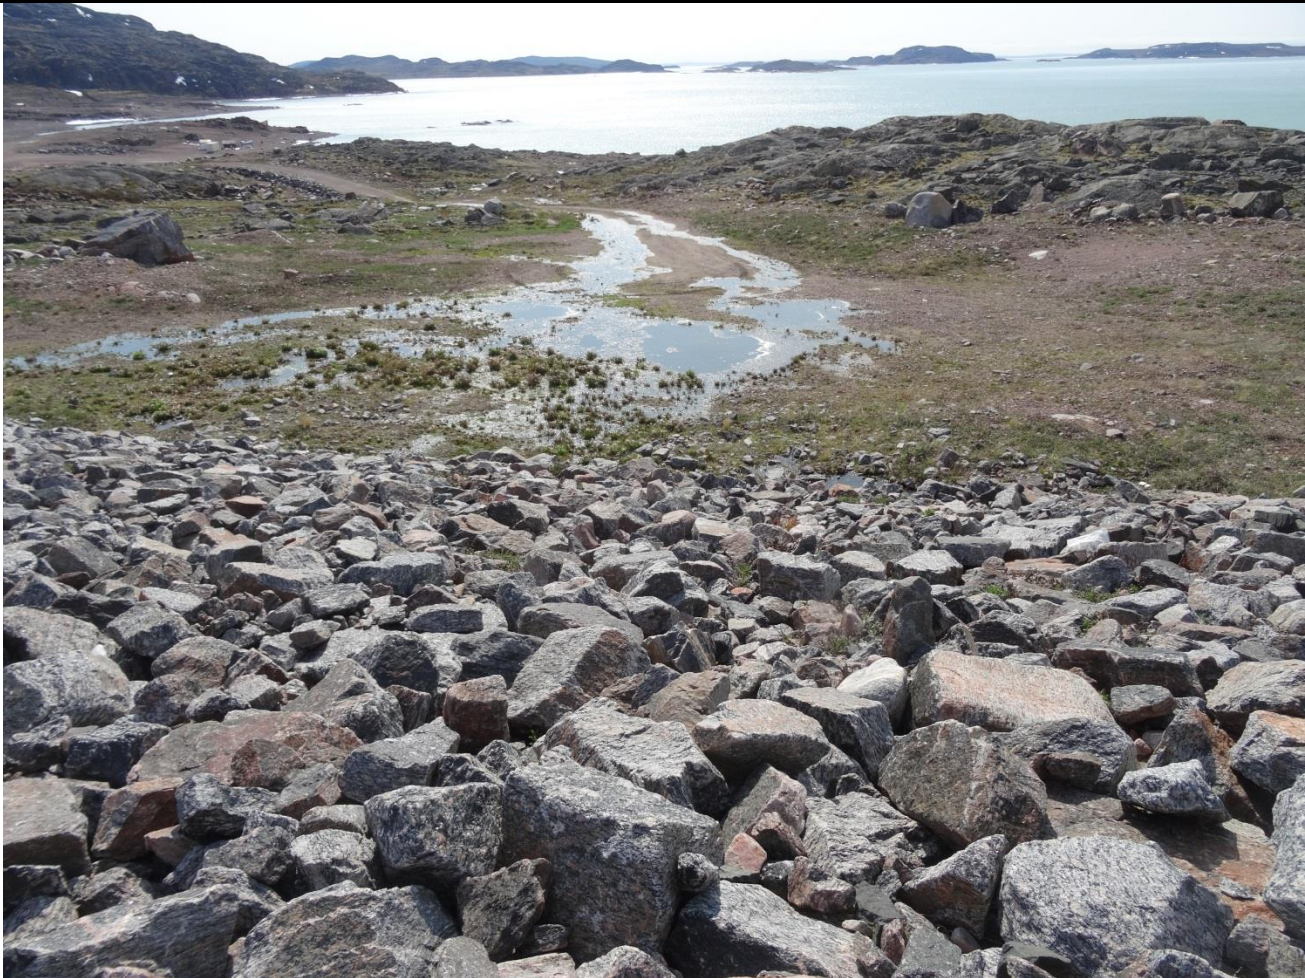
Photo 9

Description: View of Sewage Lagoon Leak #2 from top of Berm

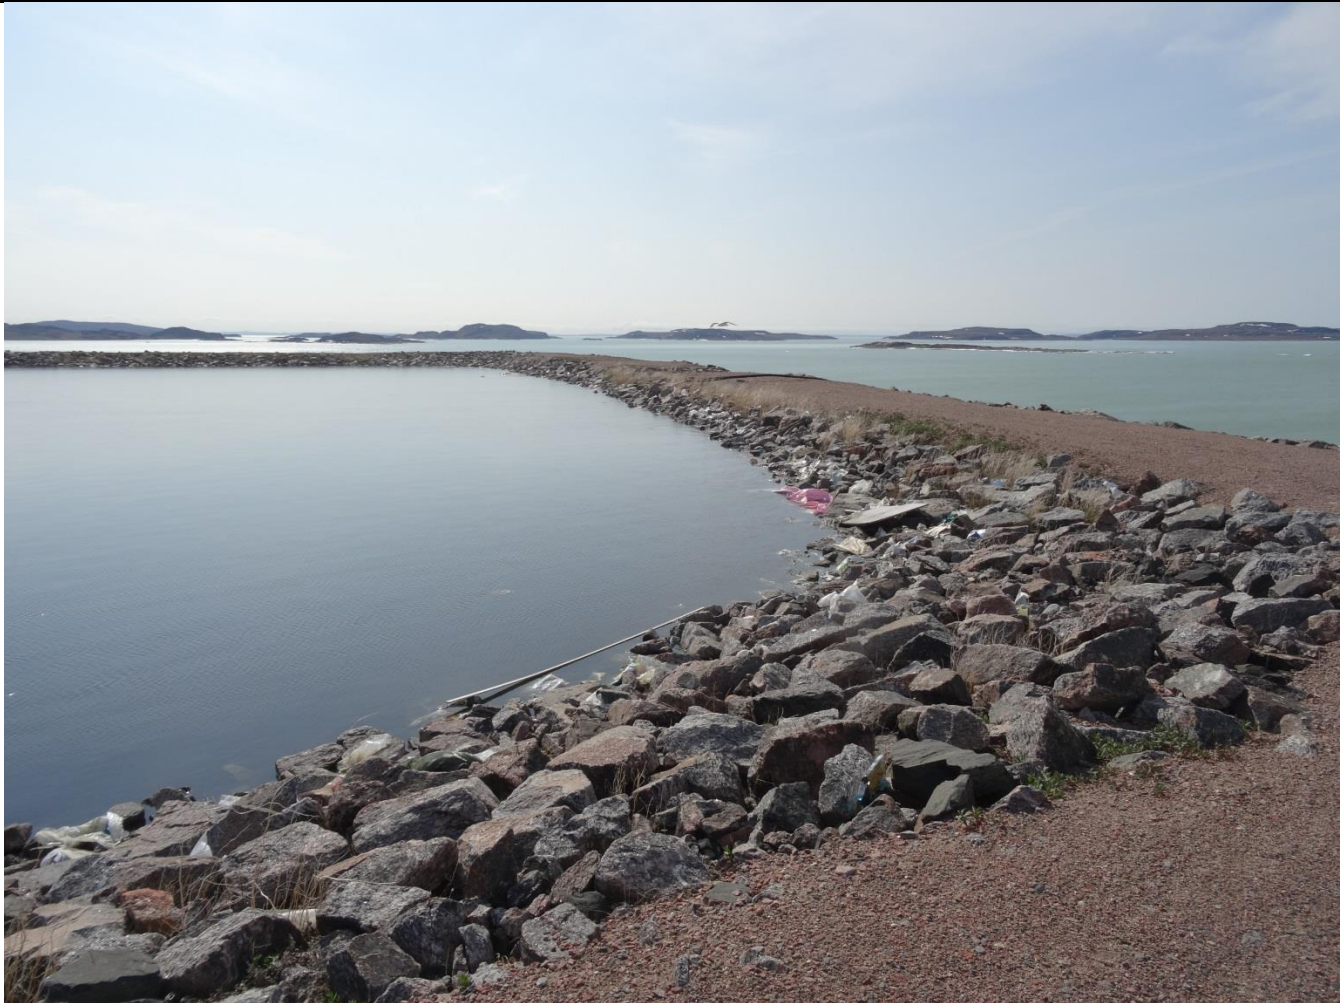
Photo 10

Description: Sewage Lagoon showing High Levels requiring Decanting

| 1. The Hamlet has used just over 7,000 Cubic Meters of Water in a 2 ½ Month Period which is well within their 45,000 Cubic Meter Annual Allowable Limit. 2. Thank you for installing appropriate Signage as requested in last year’s Inspection Report. 3. Thank you for installing appropriate Signage as requested in last year’s Inspection Report. 4. The 2 Cells of Piled Crushed Drums are to be combined into 1 Cell. 5. In order to minimize the Risk Factor, the 3 <sup>rd</sup> Empty Cell shall be filled with stacked Full Drums of Used Oils on Wooden Pallets. 6. Samples were taken by Hamlet and GN Staff at multiple locations, Thank You very much. 7. I applaud the Hamlet for this Recycling initiative in order to minimize the risk to the local environment. 8. The Hamlet and GN shall continue to work on and Monitor the 2 Leaks in the Sewage Lagoon Berm to try and find a permanent solution to this long ongoing issue. 9. The Sewage Lagoon MUST be Sampled and Decanted prior to Freeze Up. | | | |
