WATER LICENCE INSPECTION FORM

Licensee	Licensee Representative
Hamlet of Kugaaruk	Etienne Kakkianiun
Licence No. / Expiry	Representative's Title
3BM-PEL1929	Foreman
Land / Other Authorizations	Land / Other Authorizations
	--
Date of Inspection	Inspector
July 30, 2024	Jonathan MESHER
Activities Inspected	
<input type="checkbox"/> Camp	<input type="checkbox"/> Drilling
<input type="checkbox"/> Roads/Hauling	<input type="checkbox"/> Mining
	<input type="checkbox"/> Construction
	<input type="checkbox"/> Reclamation
	<input type="checkbox"/> Fuel Storage
	<input checked="" type="checkbox"/> Other: Hamlet waste storage.

On July 30, 2024 I Jonathan Mesher of CIRNAC conducted inspection of the below water licence facilities to ensure compliance with the licence 3BM-PEL1929.

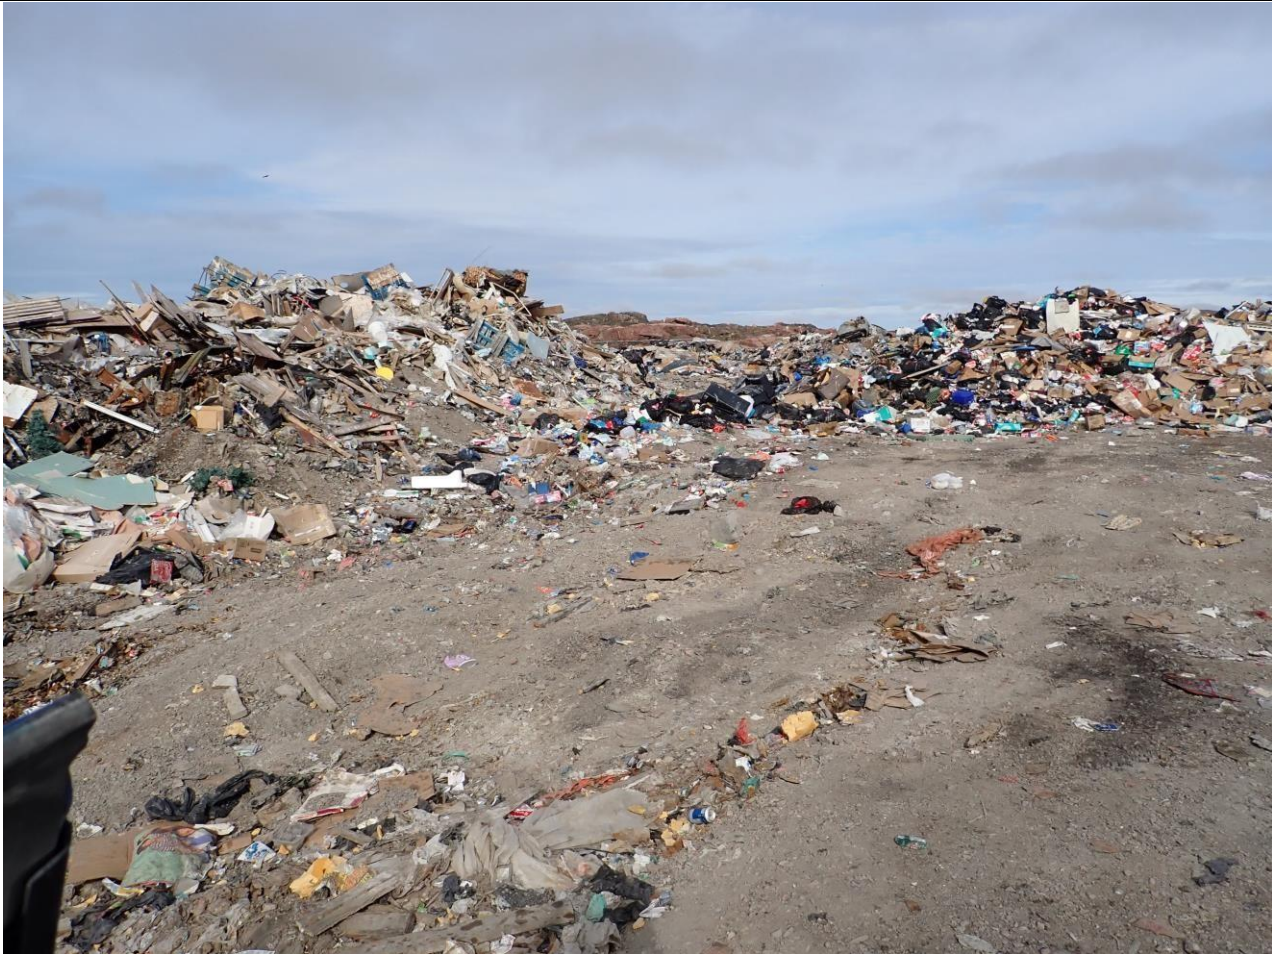
Date	Camera	Inspector	Authorization
July 30, 2024	Sony Cyber-shot	J.Mesher	3BM-PEL
Photo Log			
Photo 2

a) The licensee does not appear to be covering and compacting the waste as describe in “Figure 3-1. Area Method of Solid Waste Disposal in a Landfill”, see photos 1 and 2 for the uncovered and spread out waste at the landfill.

Description: not covered or compacted landfill.

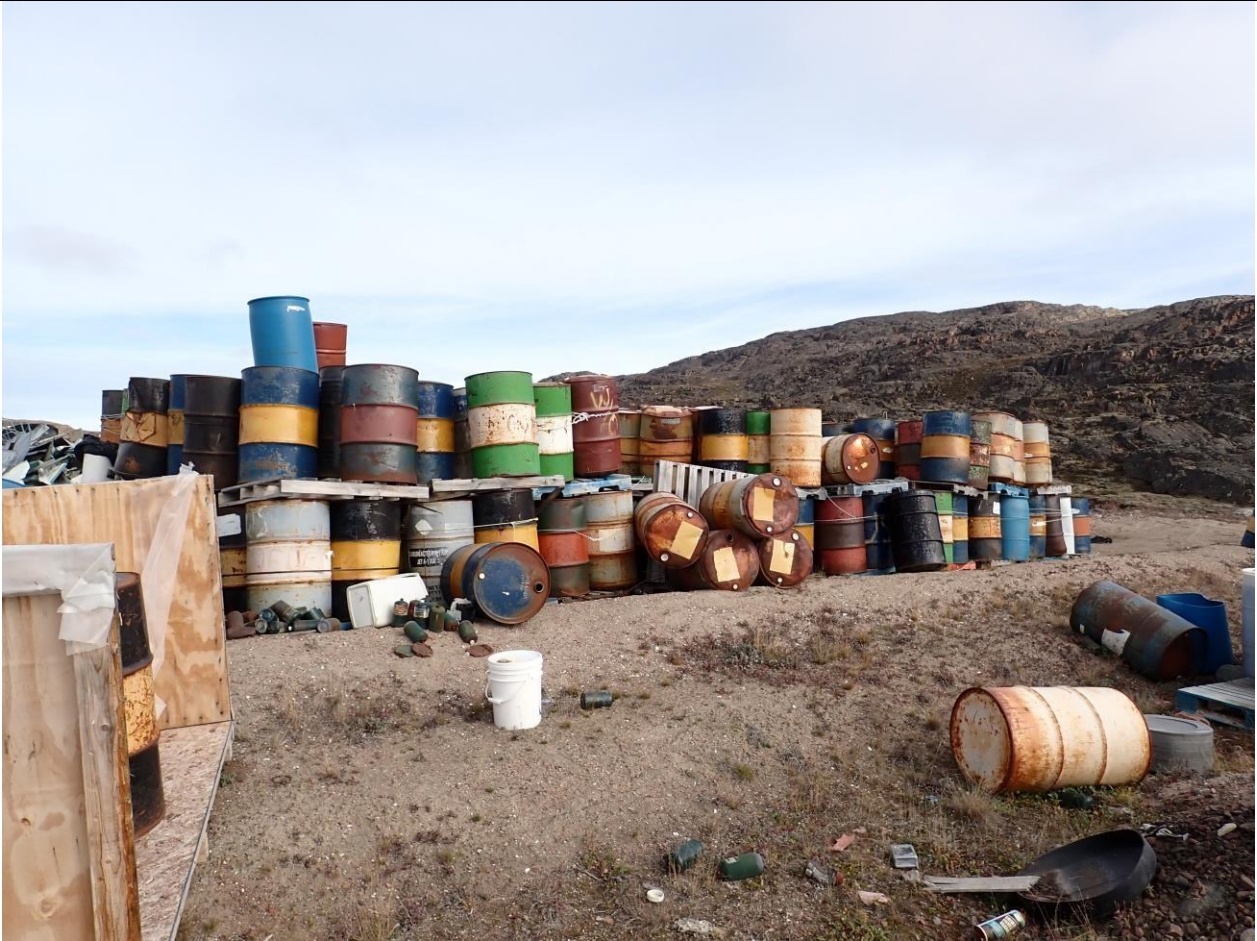
Photo 5

- a) There appears to be significantly more Hazardous materials on site than the facility is able to contain. Section 3.1.7 of the Hamlet of Kugaaruk, NU Solid Waste Facility Operation and Maintenance states; “Three lined cells have been built specifically for the storage of hazardous materials. Similar to the waste batteries, hazardous materials will be stored for up to one year and then shipped to a southern facility for proper disposal.” See photo 5 for the full secondary containment.

Description: Full hazardous waste containment.

- a. The licensee is to utilize the secondary containment on site to comply with the requirement to segregate the hazardous waste at the landfill and the metal dump.
- b. The licensee is to provide information on the last time Hazardous waste was shipped out of the community and provide a plan to ship hazardous waste to an approved disposal facility.
- c. The licensee is to start piling, compacting and covering the waste as described in the Hamlet of Kugaaruk, NU Solid Waste Facility Operation and Maintenance Manual.
- d. The licensee is to provide a plan to ensure the sewage lagoon is operating as intended and is containing the effluent.

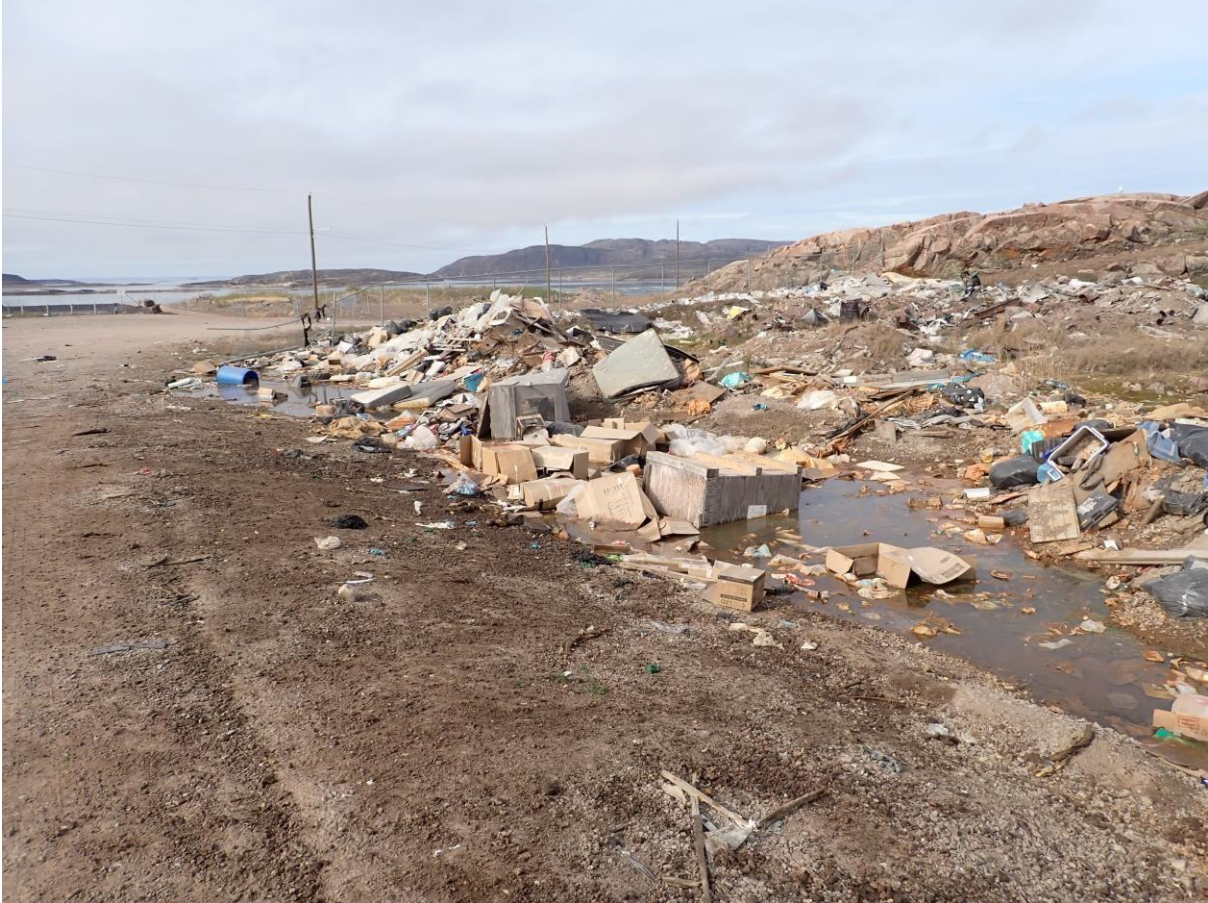
Photo 6

- a) There was leachate leaving the entrance of the landfill, entering ditches outside the facility. see photo 6 for the leachate leaving the facility.

Description: Leachate leaving the entrance of the landfill.

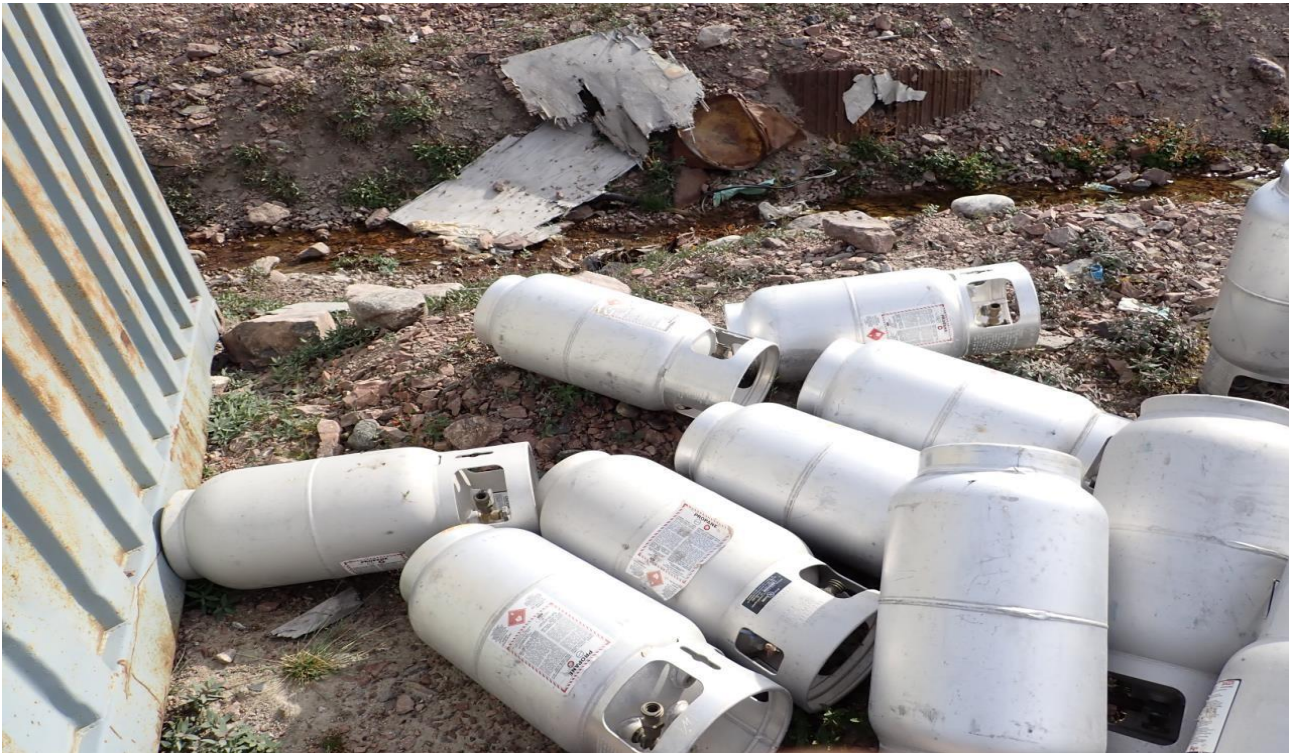
Photo 8

- b) There was a stream flowing through an area where the licensee has placed hazardous material outside secondary containment at the metal dump area. See photos 7 and 8 for photos of the stream flowing through hazardous material storage.

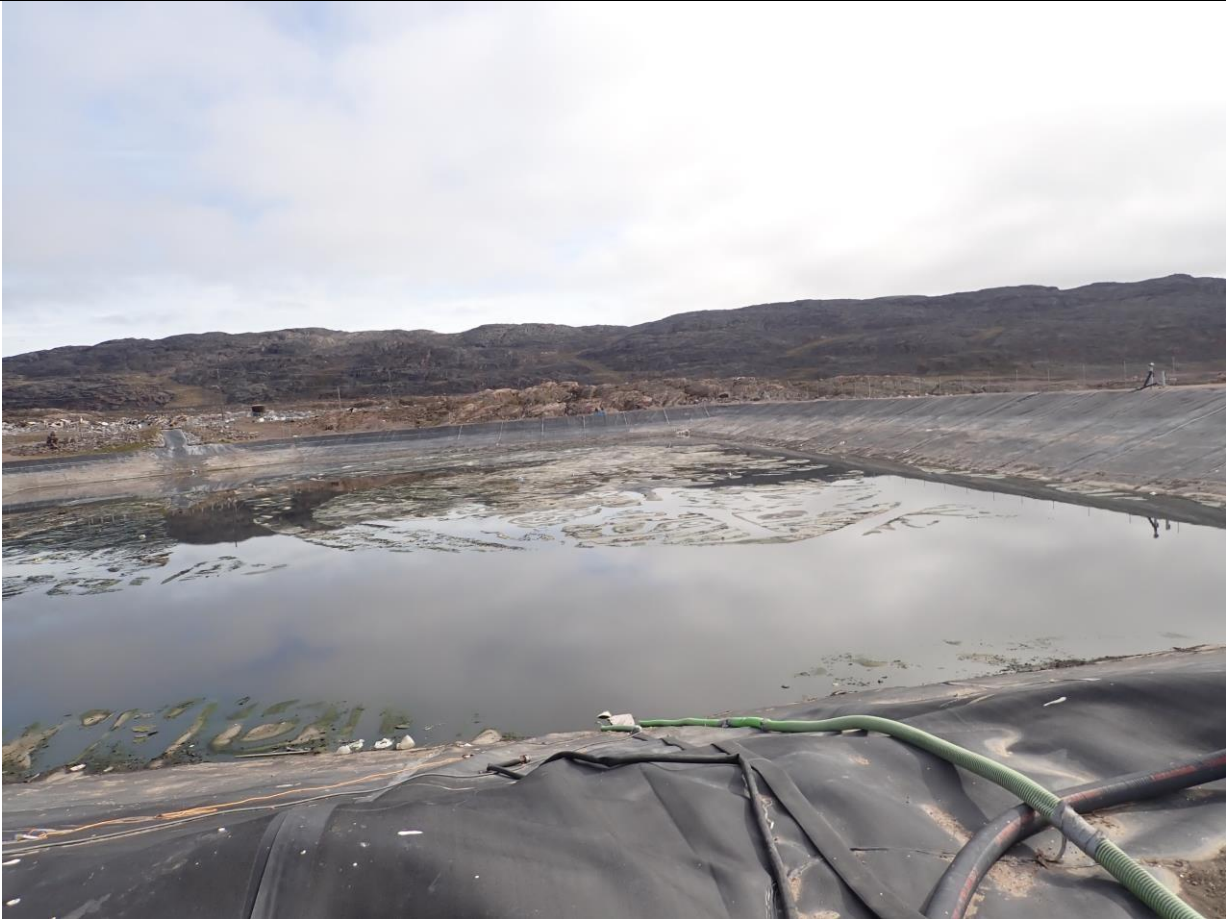
Photo 9

3. During the inspection of the Lagoon there was significant amounts of floating liner within the lagoon. See photo 9 for the floating liner.
4. At the time of the inspection the licensee informed the inspector that the that the lagoon was leaking, no leak was visible at the time potentially due to the low level of the lagoon.

Description: floating liner within the lagoon.
