Annual Report -2018

Water Licence: 3BM-PEL 1419

Hamlet of Kugaaruk, NU

AANDC Inspection Report- 2018

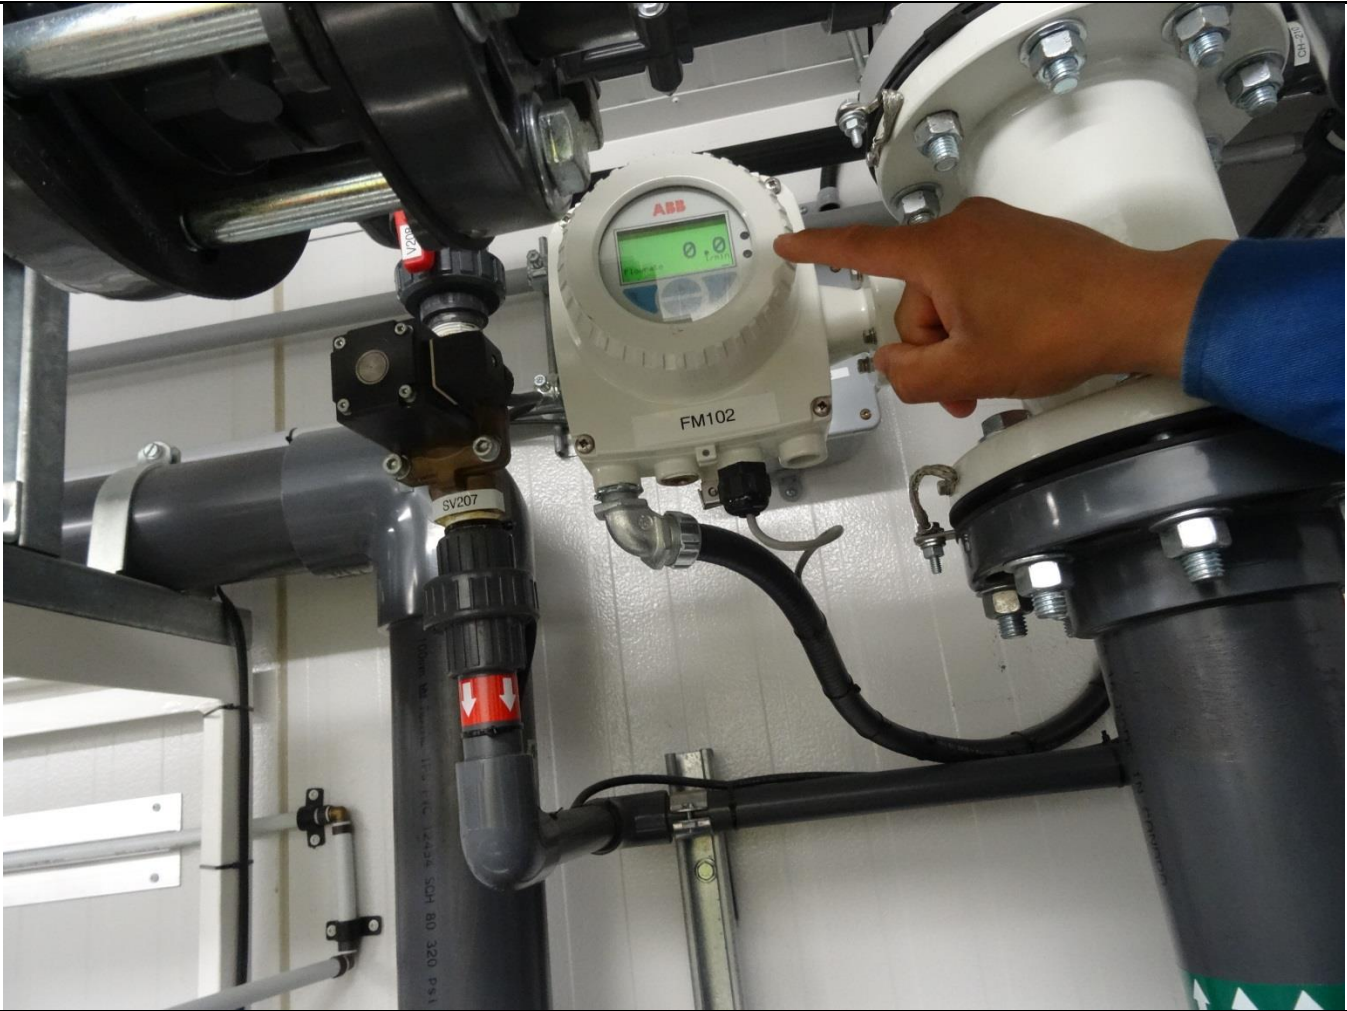
Photo 1

Description: Raw Water Flow Meter

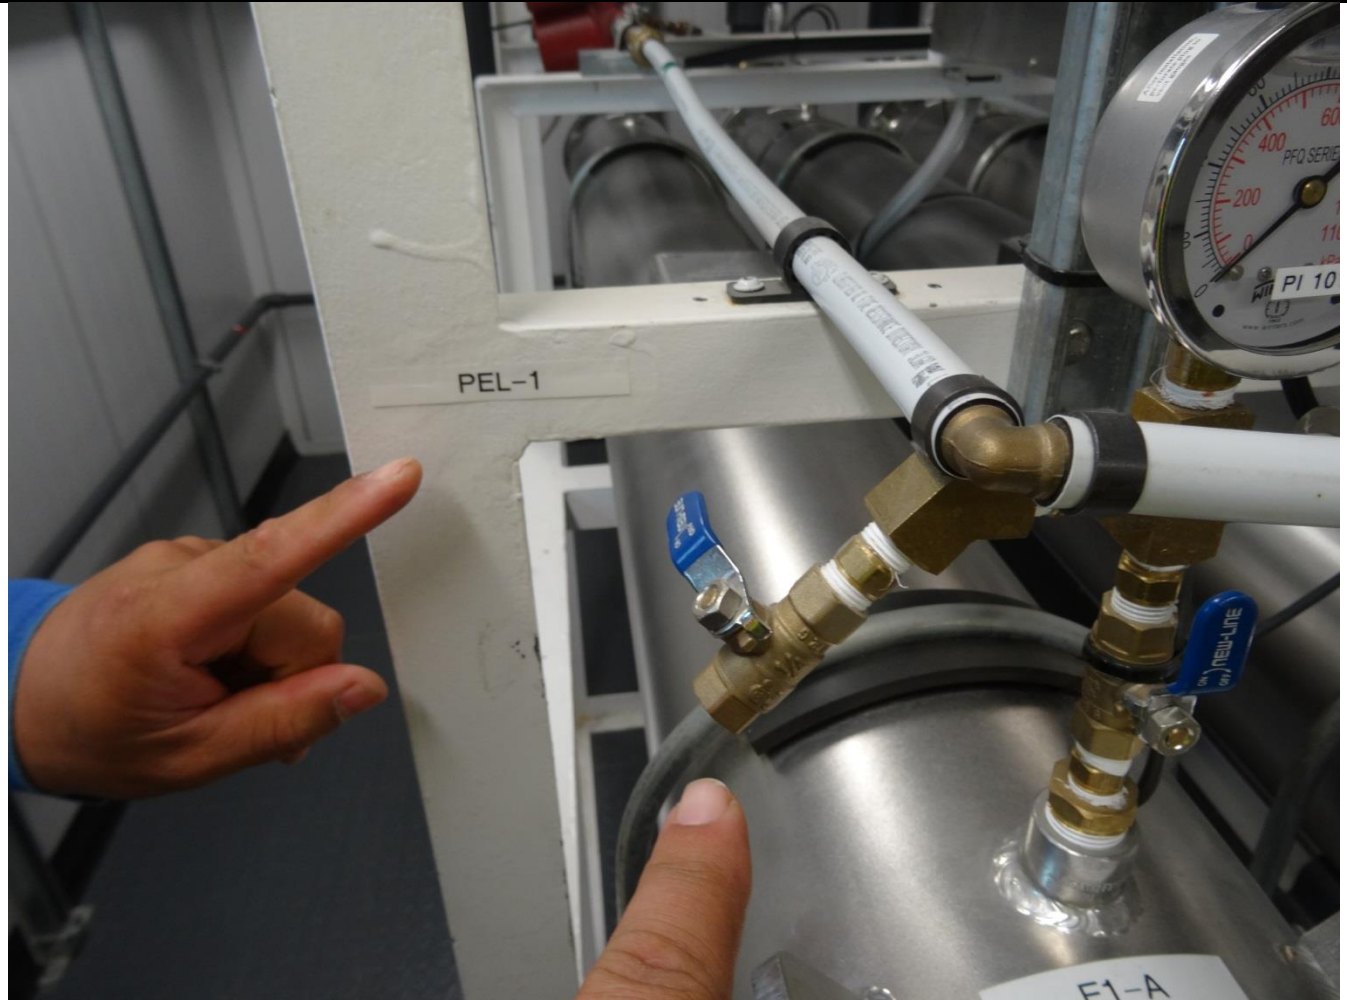
Photo 2

Description: PEL-1 Interior Sample Station when River is Frozen – Nice Signage – Thank You

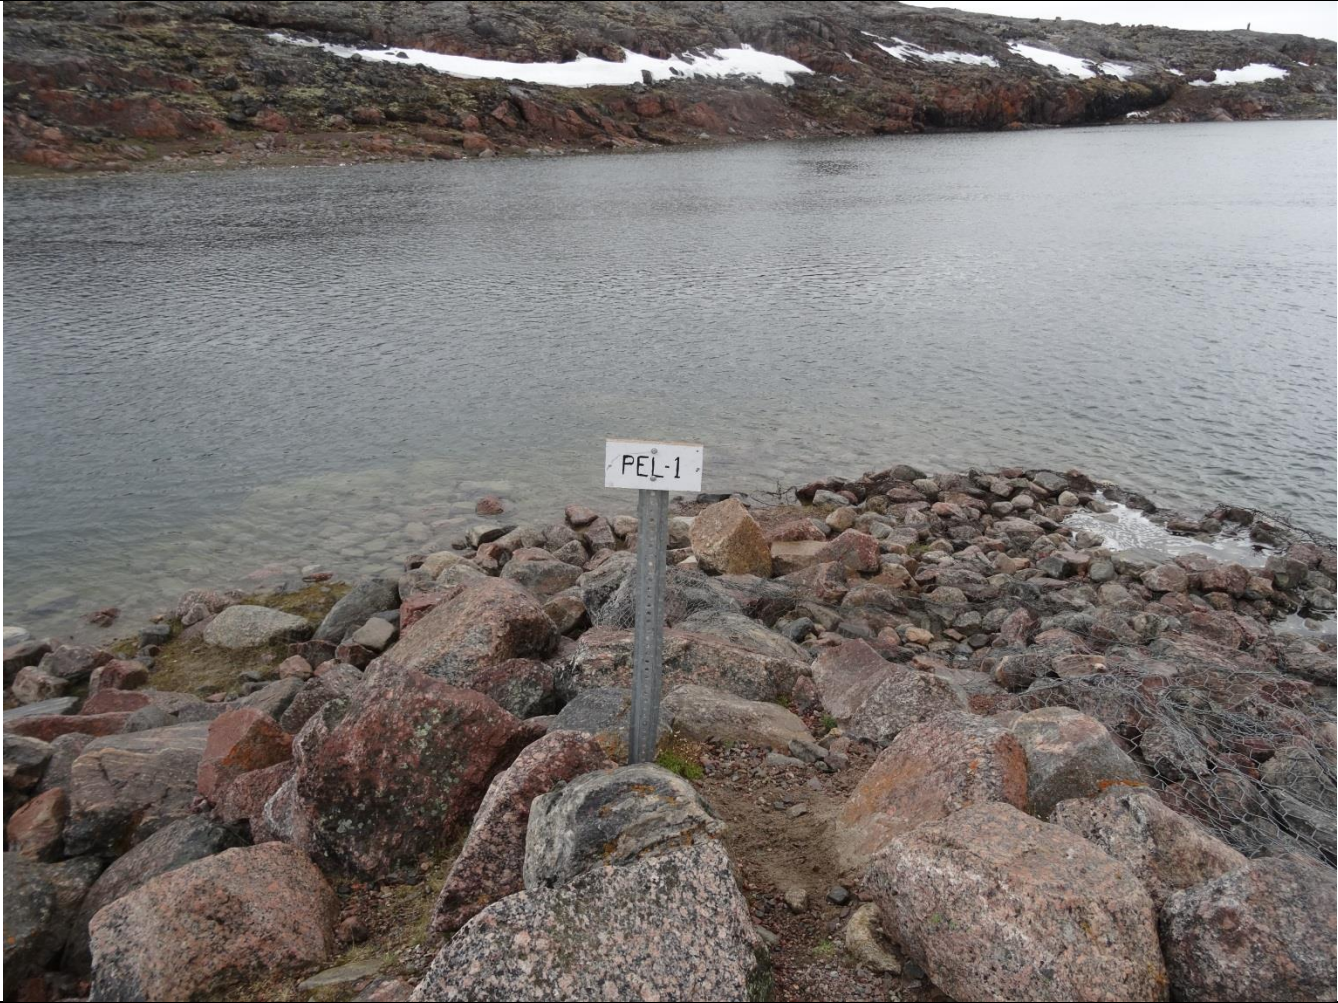
Photo 3

Description: PEL-1 Exterior Sample Station when River is NOT Frozen – Nice Signage – Thank You

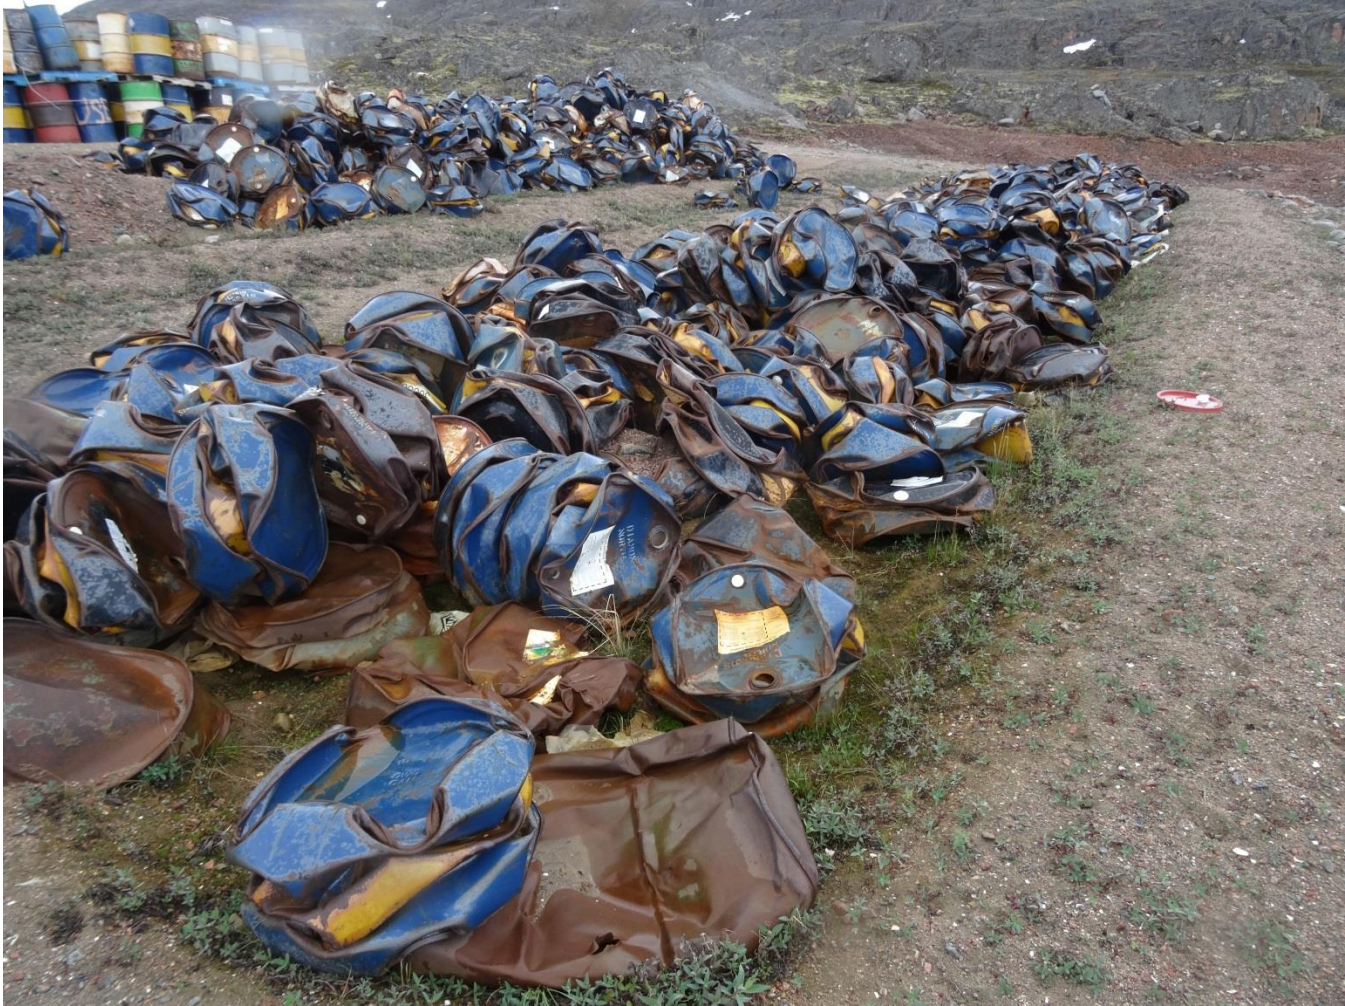
Photo 4

Description: 2 Cells of Crushed Drums in the Lined Berm Area in the Metal Dump to be combined into 1 Cell

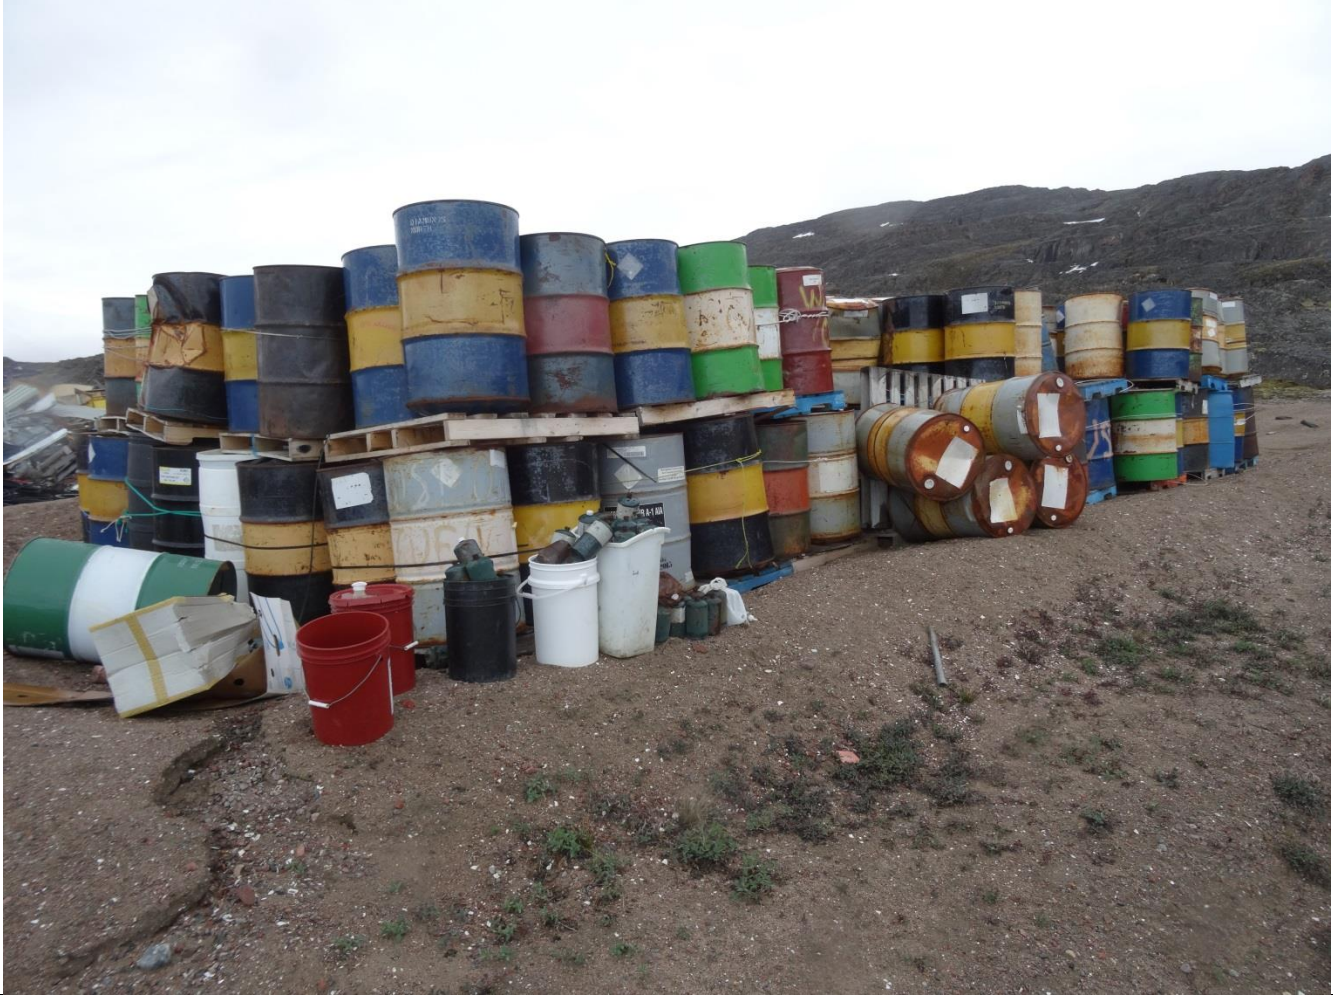
Photo 5

Description: 1 Cell of Stacked Full Drums of Used Oils in the Lined Berm Area

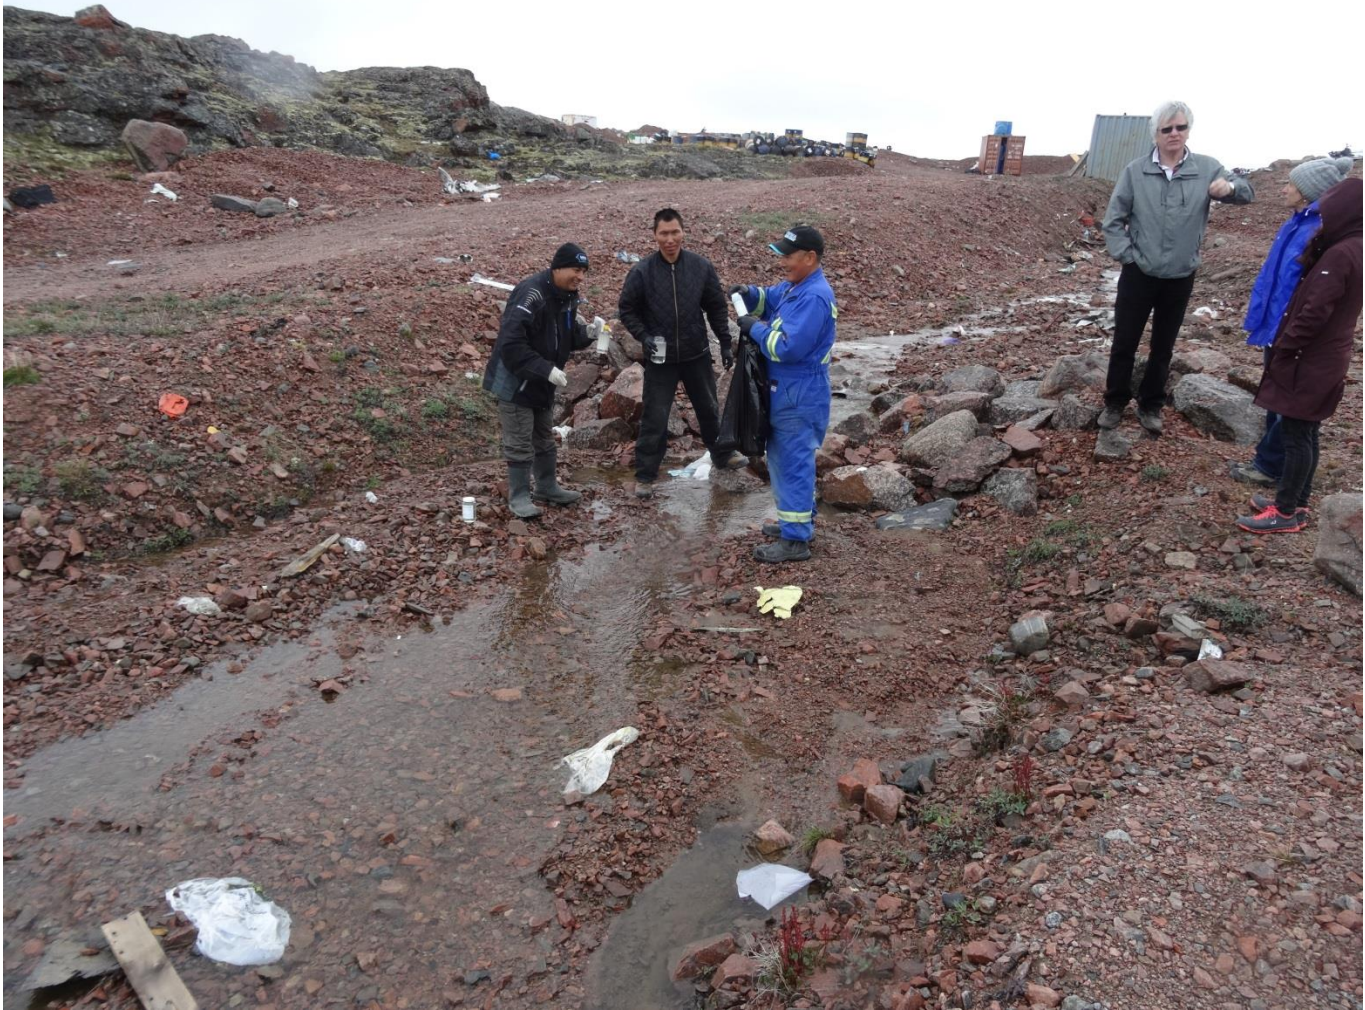
Photo 6

Description: Hamlet and GN CGS Staff taking Samples at Station PEL-7

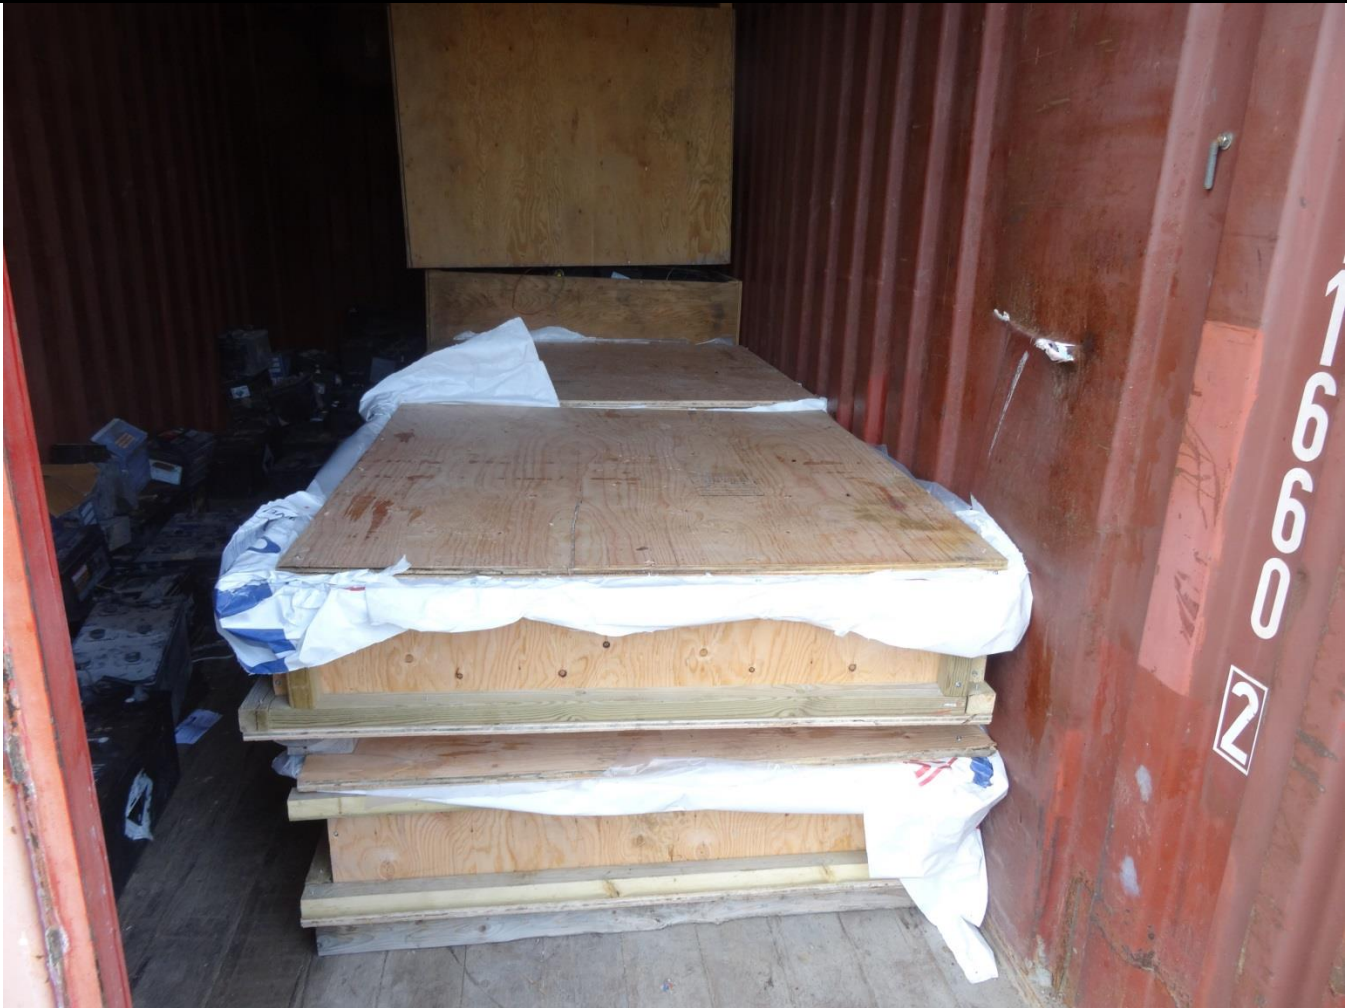
Photo 7

Description: Lined Wooden Crates of Discarded Batteries to be sent South for Disposal via 2018 Sea Lift Back Haul

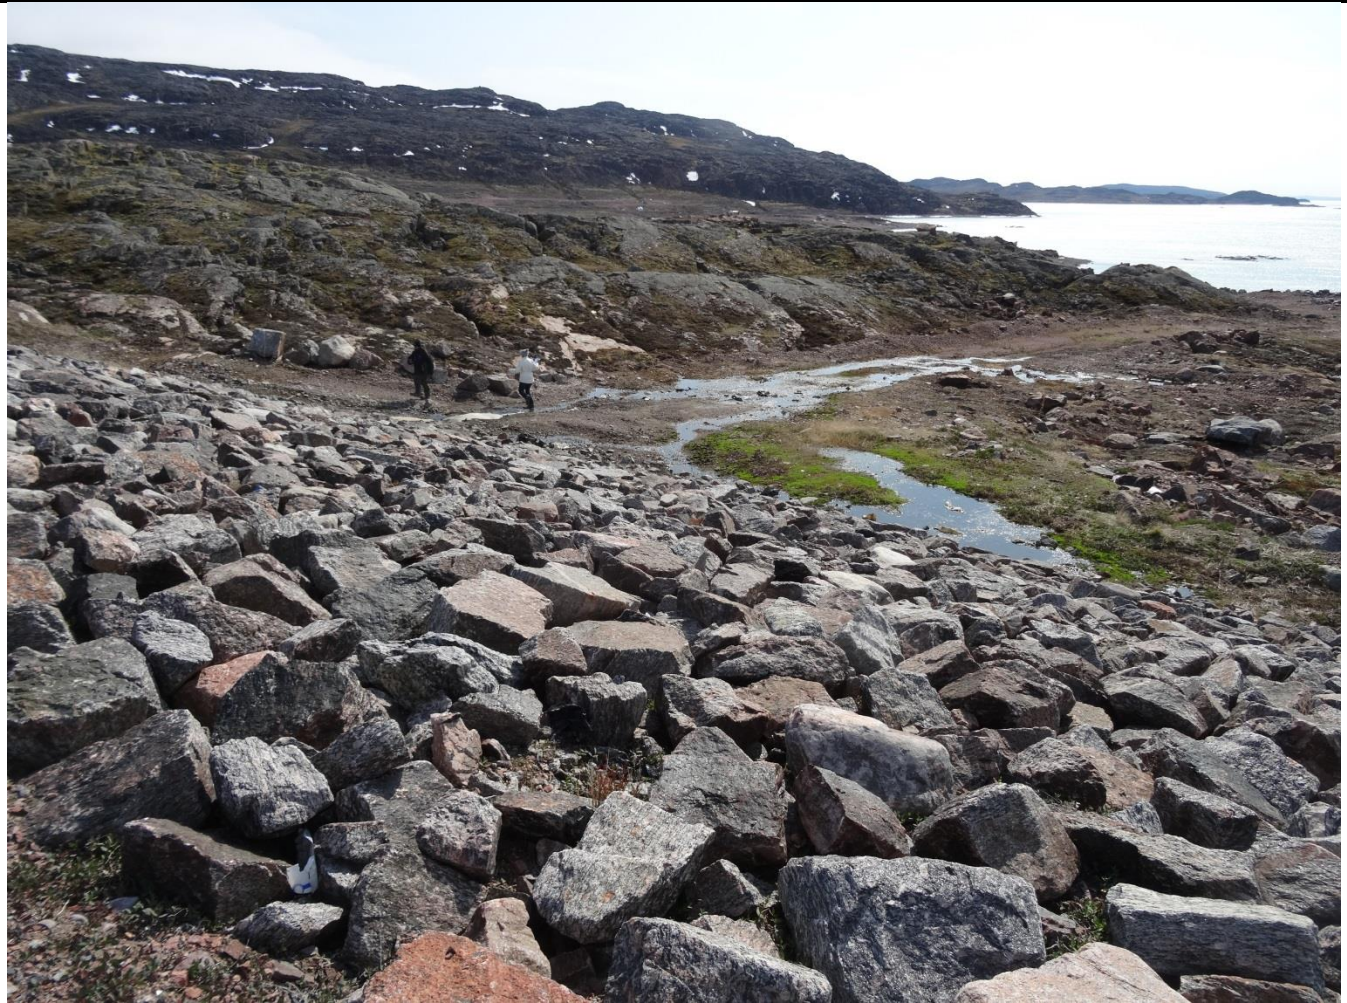
Photo 8

Description: View of Sewage Lagoon Leak #1 from top of Berm

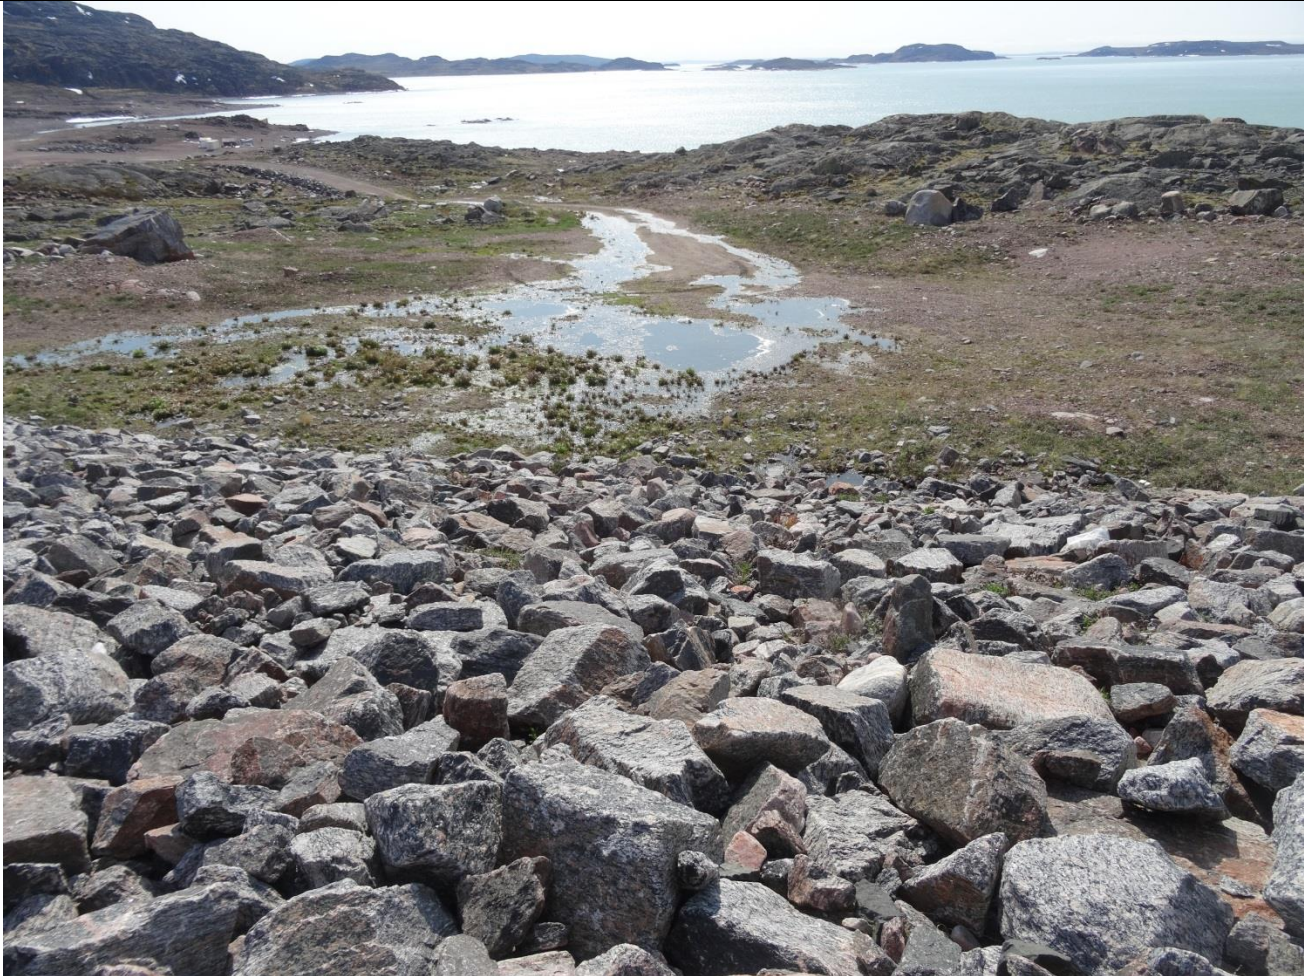
Photo 9

Description: View of Sewage Lagoon Leak #2 from top of Berm
