Kugaaruk Sewage Lagoon Study

Final Report

Prepared for:
Government of Nunavut
Community and Government
Services

Project No. 1101 26041

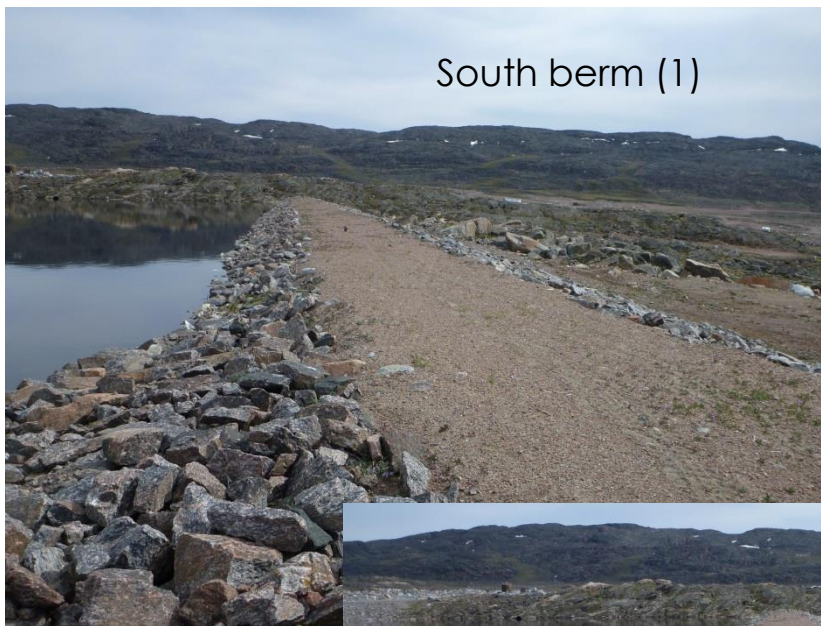
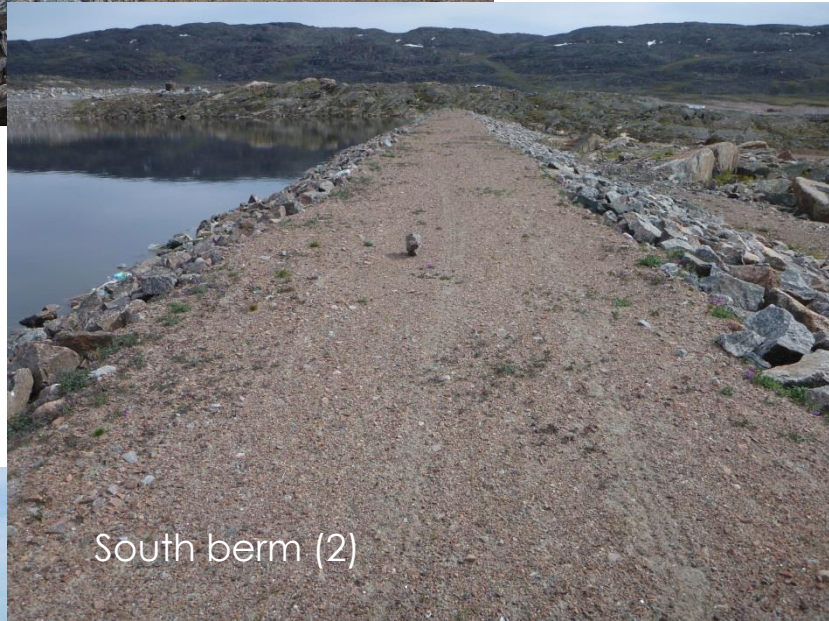
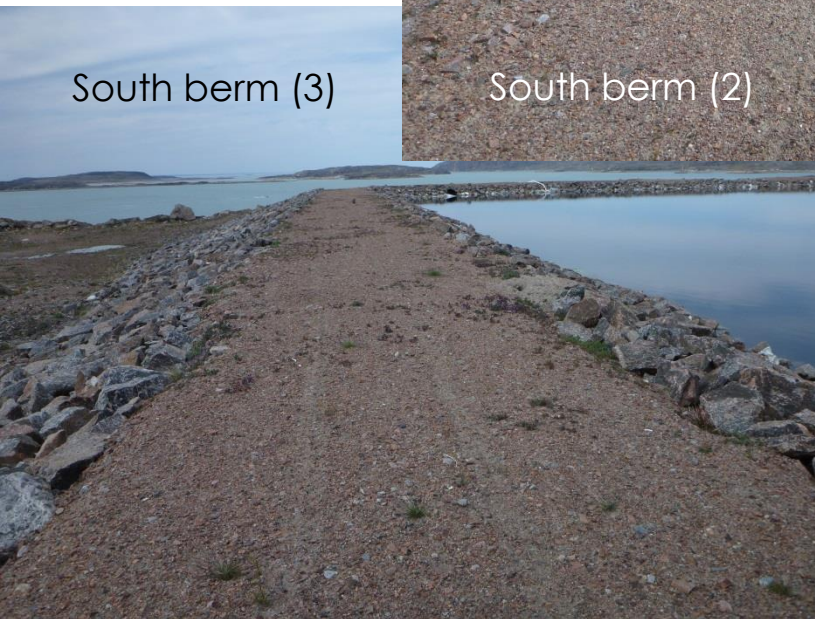
FIGURE 4. Berm Condition - South

A notable flow from the base of the lagoon on the south side was clearly visible. The flow originates from two general areas on the south berm, and from specific flow points in each area. The flow area in the south east corner has 4 distinct points of flow (See **Figures 7 and 8**), with varying degrees of flow that contribute to two channels of flow immediately downstream, that form one channel of flow. A single point of minor flow was observed in the south west corner, and this flow infiltrates into the ground within 20 metres of the toe of the berm.

South berm (1)

South berm (2)

South berm (3)

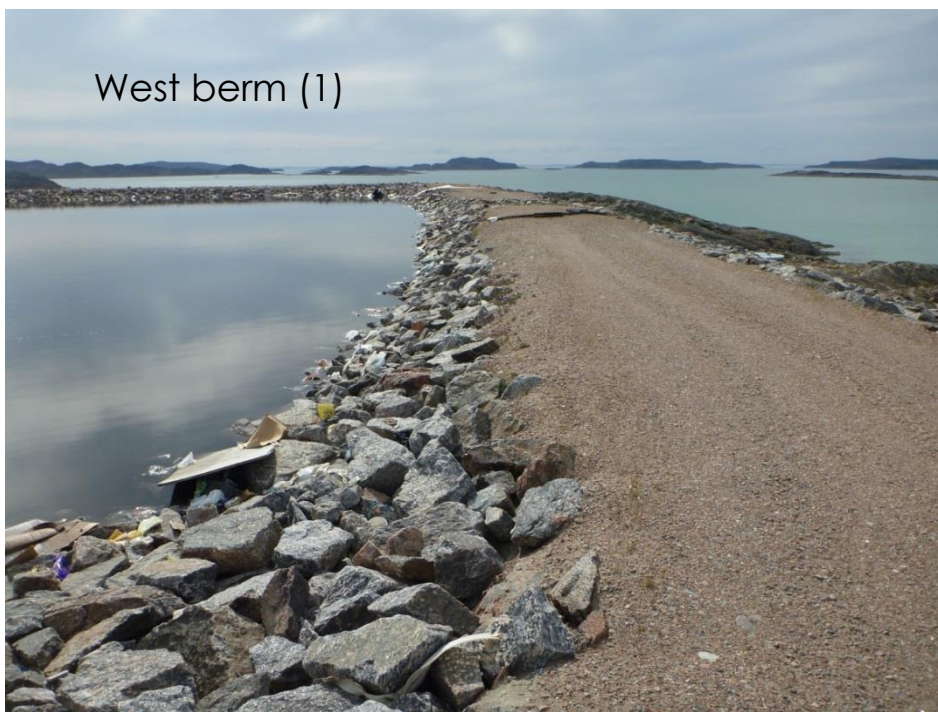
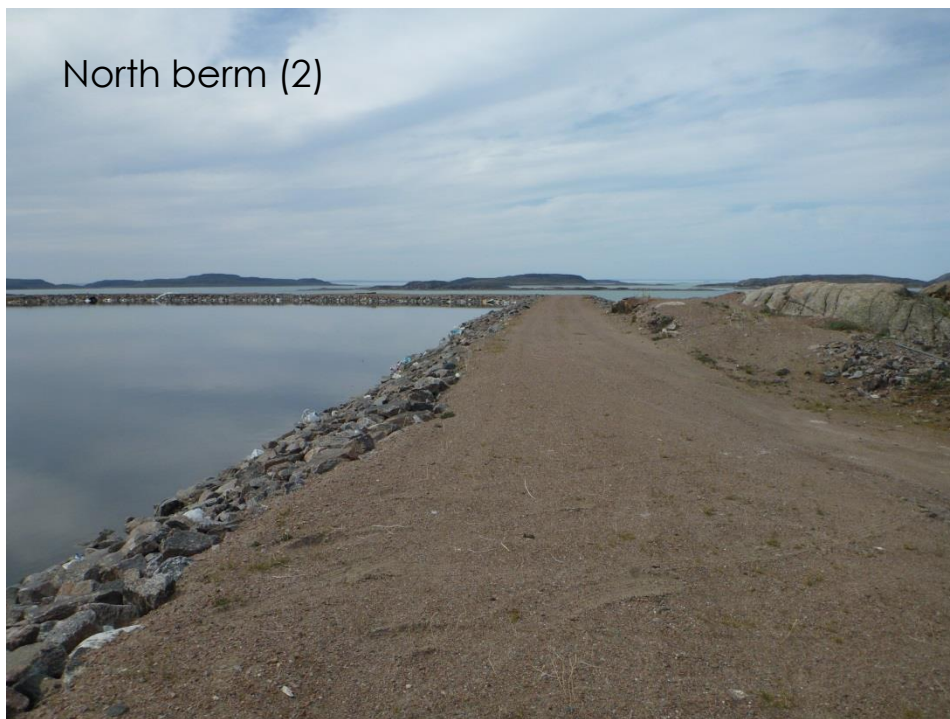
FIGURE 5. Berm Condition – North/West

Concerning the top of the berm, there was no visible deterioration in the berm structures along the north, west and south berms (See **Figures 4 and 5**). The east berm, where the truck discharge is located, shows visible bedrock and riprap armouring where the truck discharge is located. The proximity to bedrock is evident with visible bedrock outcrops in several locations around the lagoon perimeter, specifically in the east segment of the lagoon. The top of the berm structures have a 4 meter wide gravel surface. This gravel surface shows very little, if any, deterioration from surface erosion or other factors. The interior and exterior slopes are armoured with riprap with sizes generally greater than 30 cm in diameter.

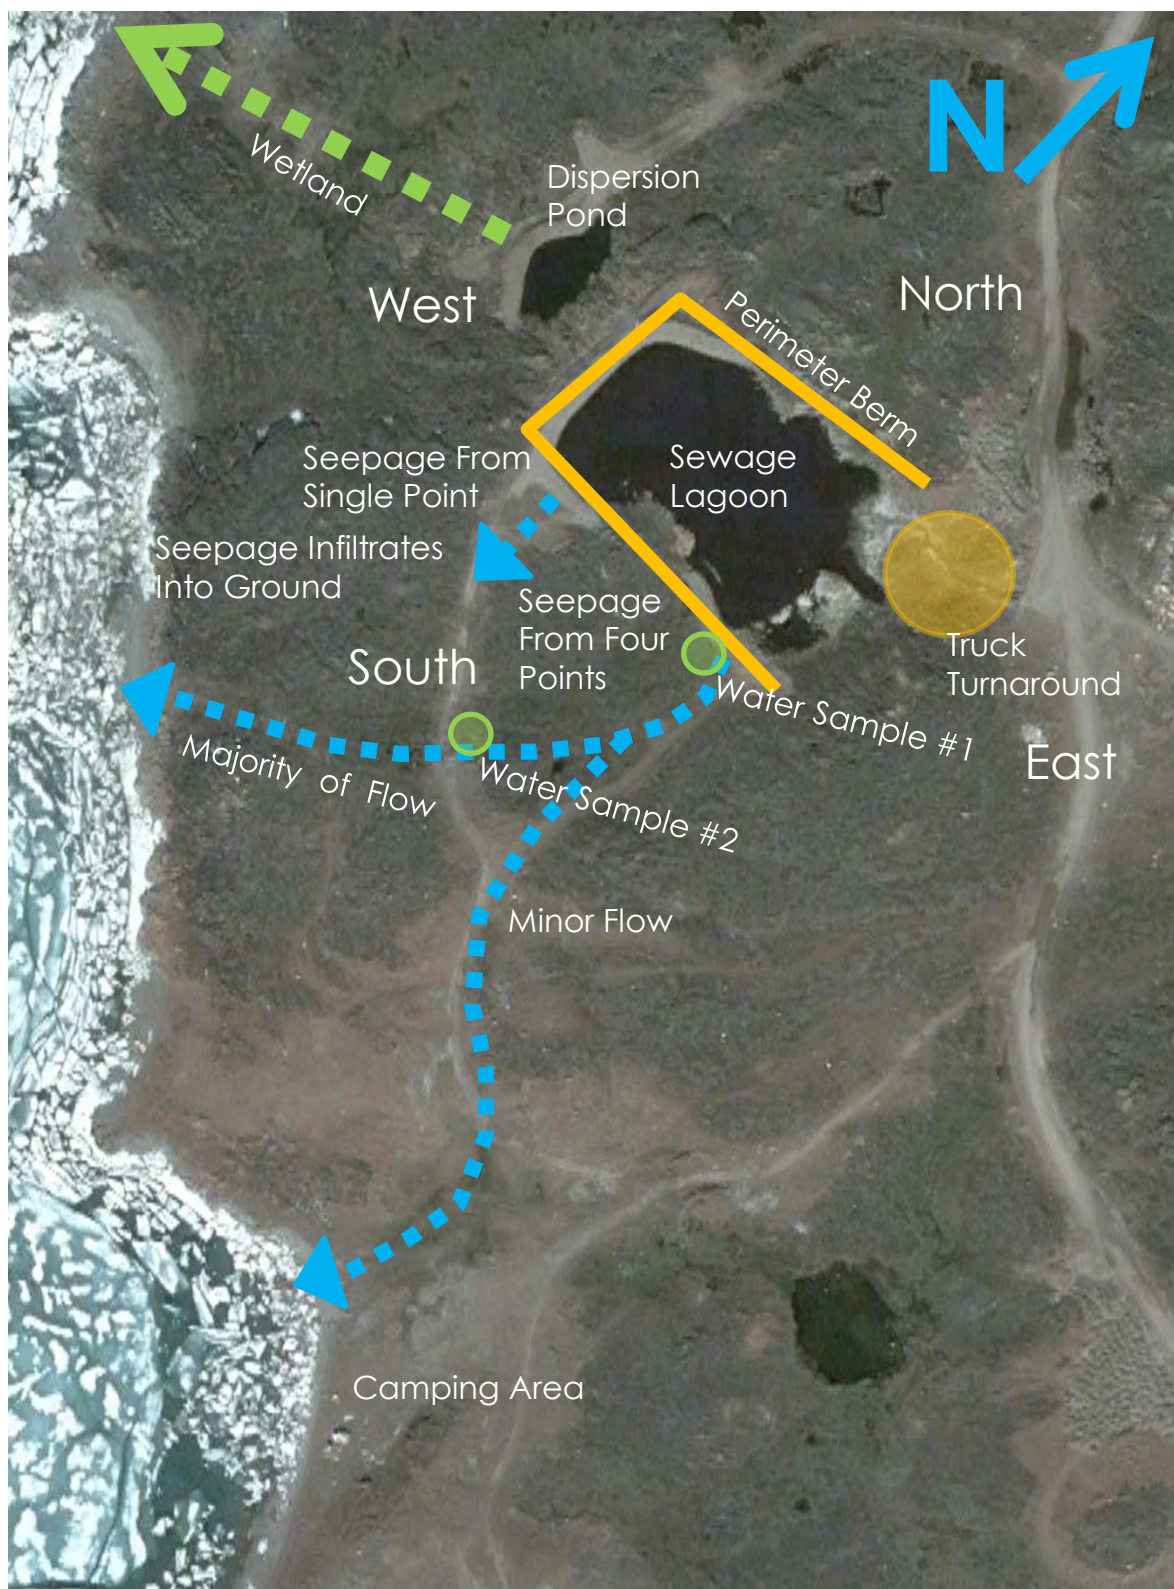
Hamlet of Kugaaruk, Nunavut
 Sewage Lagoon Assessment
FIGURE 9. Route of Seepage to Ocean
 Prepared by Ken Johnson, RPP, P.Eng. 2016 05 20

Further downstream, the flows from the south east corner separates into 2 channels once again (See **Figure 9**) with the majority of the flow travelling southwest (See **Figure 10**) and a minor flow travelling southeast. The flow travelling southwest ultimately discharges into the ocean, and the flow travelling southeast also discharges into the ocean. The ocean discharge of the southeast flow appears to be an area used for camping.

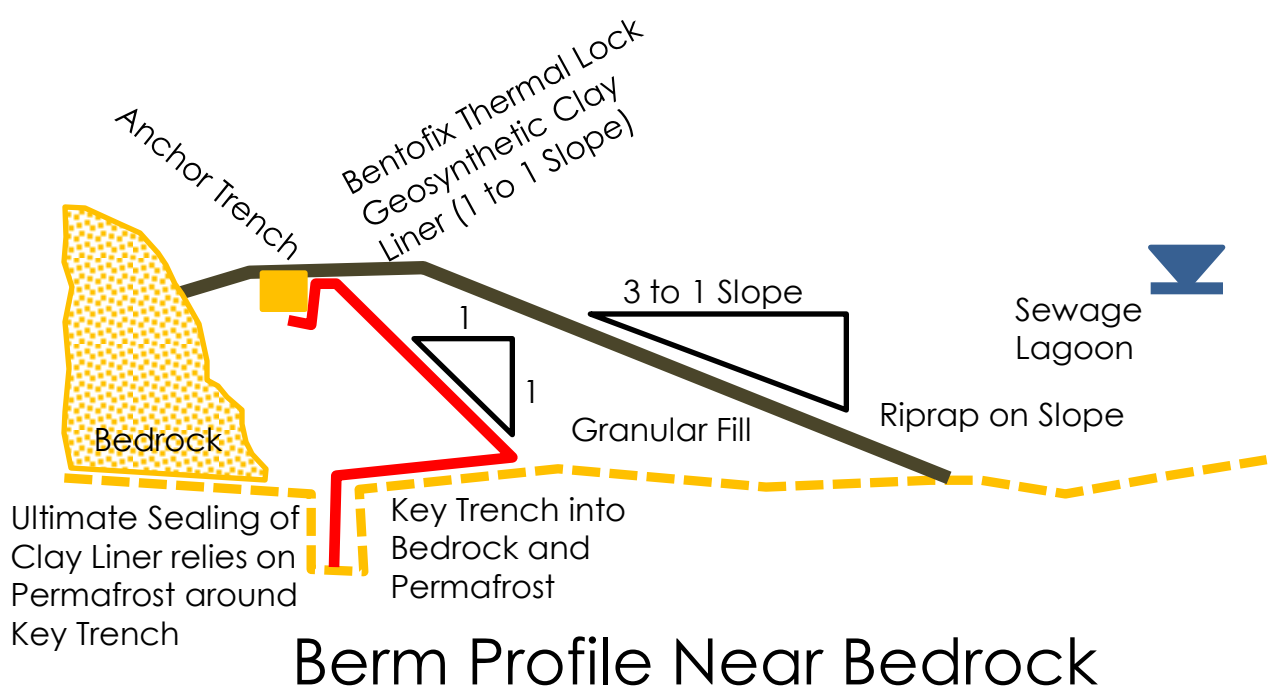
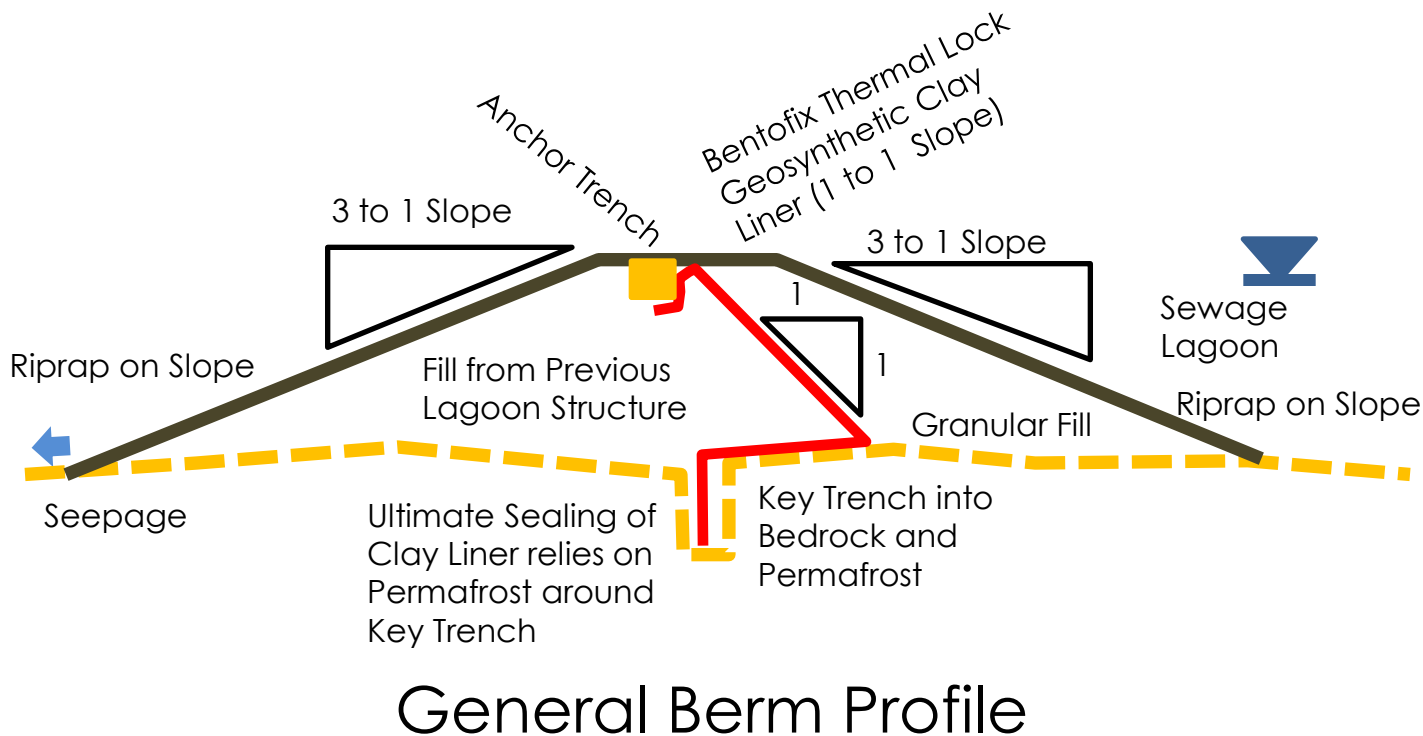
FIGURE 11. Potential Influencing Conditions

The presence of seepage from the perimeter berms reflects a loss of containment by the synthetic liner and/or its cut-off trench and not a containment failure of the perimeter berm itself (See **Figure 11**). The presence of seepage through the berms raises geotechnical integrity concerns for the berms as the seepage may lead to ground loss (piping) that could weaken or undermine the perimeter berms or reduce the geotechnical stability of the perimeter berms.

The design of the geosynthetic clay liner is shown in **Figure 11**; the design elements associated with the containment system are the liner itself, the liner keyed into bedrock and permafrost at the base, and an anchor trench at the top of the liner. The potential sources of leakage with this configuration may be a fault in the liner itself due to damage, or improper installation between panels of the liner, or a fault in the impermeability of the liner / bedrock / permafrost system at the base of the berm.

Note: 3.8 to 1 exterior slope measured in field on southeast segment of berm.

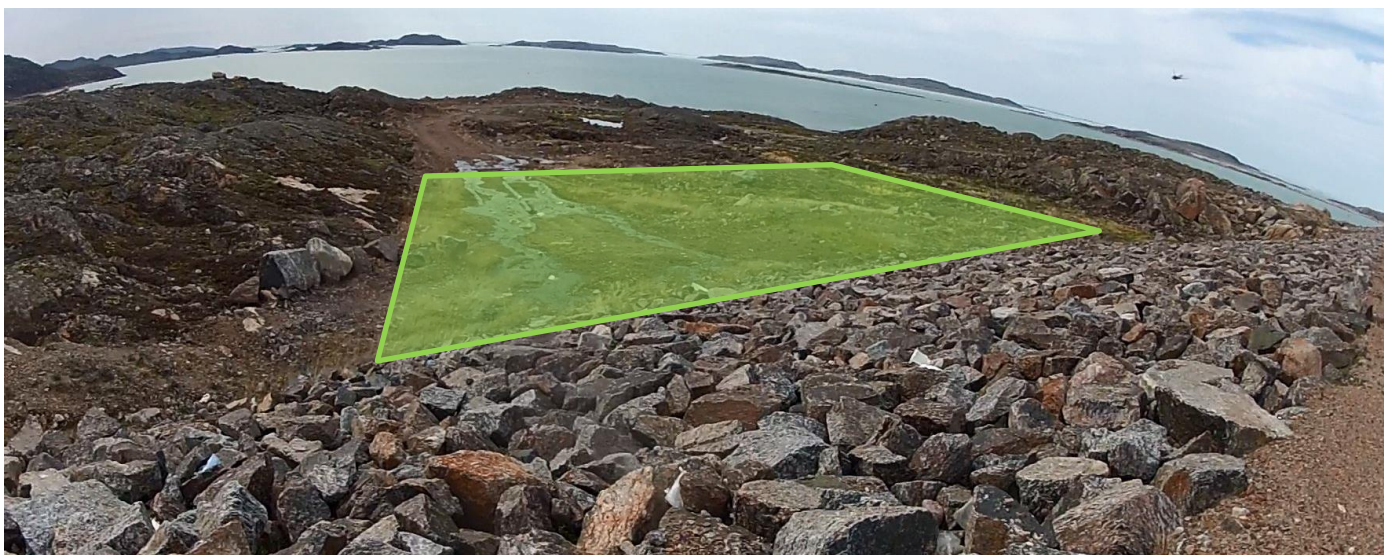
South East Seepage Area

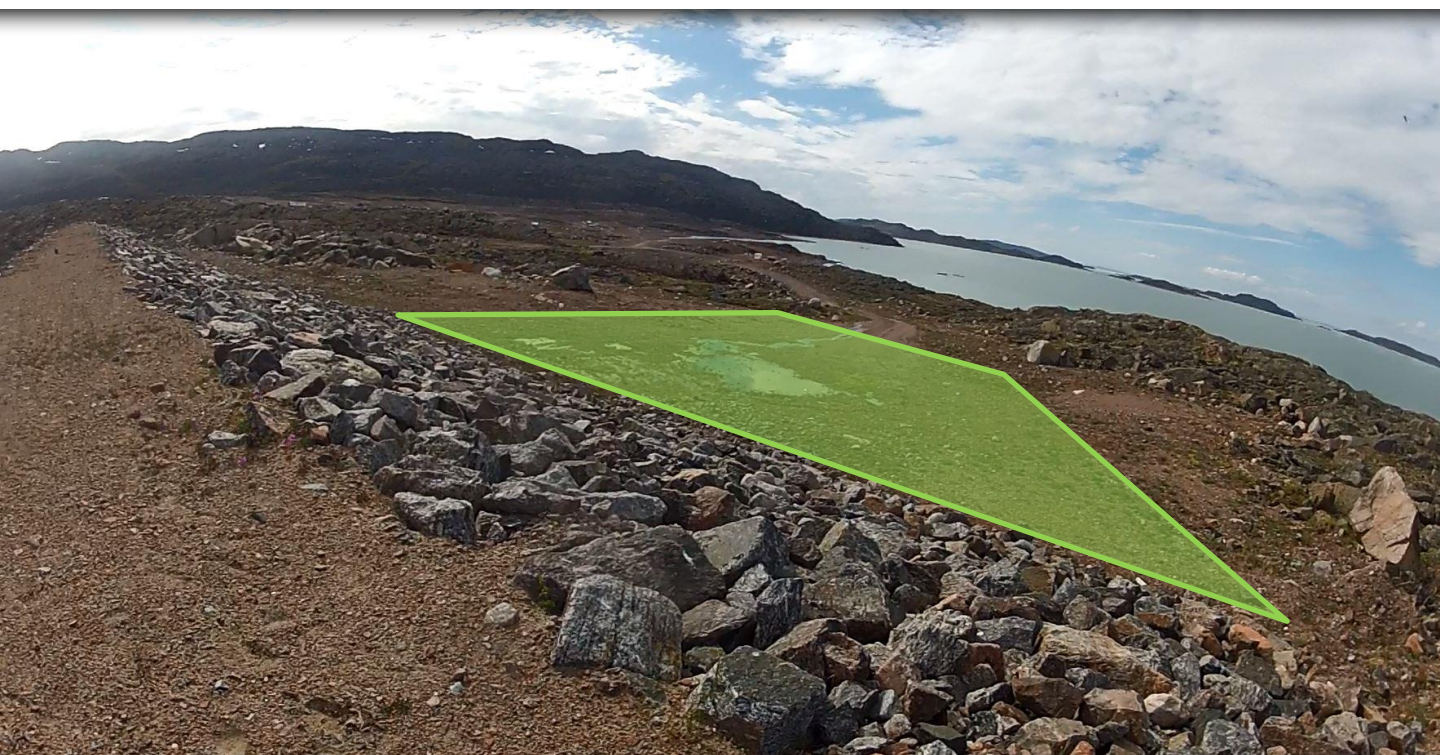
Southwest Seepage Area

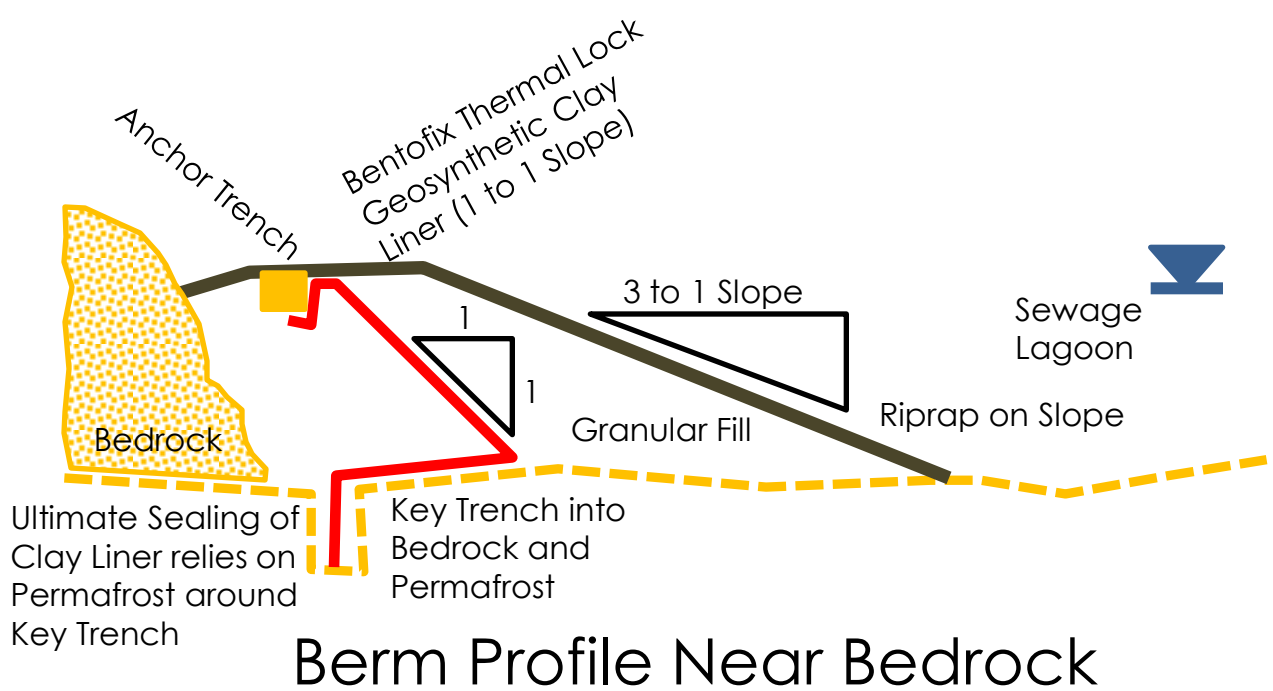
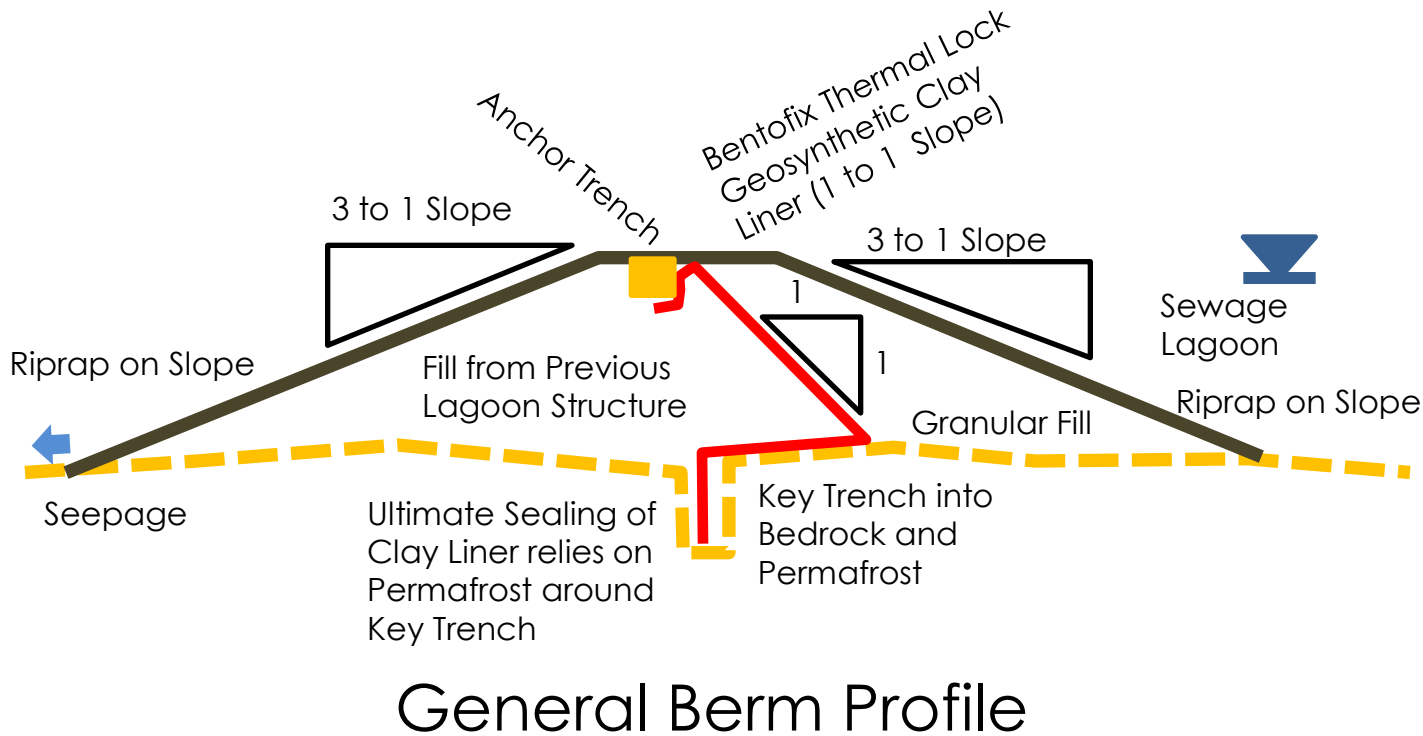
FIGURE 5. Potential Influencing Conditions

The presence of seepage from the perimeter berms reflects a loss of containment by the synthetic liner and/or its cut-off trench and not a containment failure of the perimeter berm itself. The presence of seepage through the berms raises geotechnical integrity concerns for the berms as the seepage may lead to ground loss (piping) that could weaken or undermine the perimeter berms or reduce the geotechnical stability of the perimeter berms.

The design of the geosynthetic clay liner is shown in **Figure 5**; the design elements associated with the containment system are the liner itself, the liner keyed into bedrock and permafrost at the base, and an anchor trench at the top of the liner. The potential sources of leakage with this configuration may be a fault in the liner itself due to damage, or improper installation between panels of the liner, or a fault in the impermeability of the liner / bedrock / permafrost system at the base of the berm.

Note: 3.8 to 1 exterior slope measured on southeast segment of berm.

Mitigation strategies may include excavation and repair of the liner, if liner seepage is at mid-height in the berm, or pressure grouting with bentonite slurry if the seepage is through the bedrock cut-off trench.

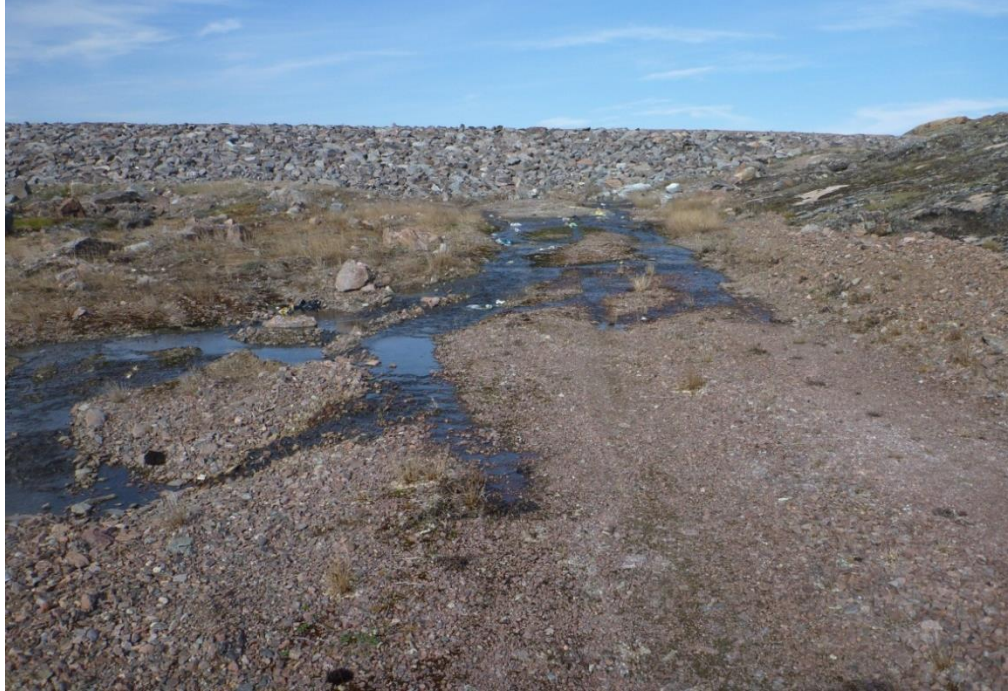
Seepage was observed flowing from the south perimeter berm at several locations.

Figure 2: Seepage from south perimeter berm, Kugaaruk waste water lagoon

Mitigation strategies may include excavation and repair of the liner, if liner seepage is at mid-height in the berm, or pressure grouting with bentonite slurry if the seepage is through the bedrock cut-off trench.

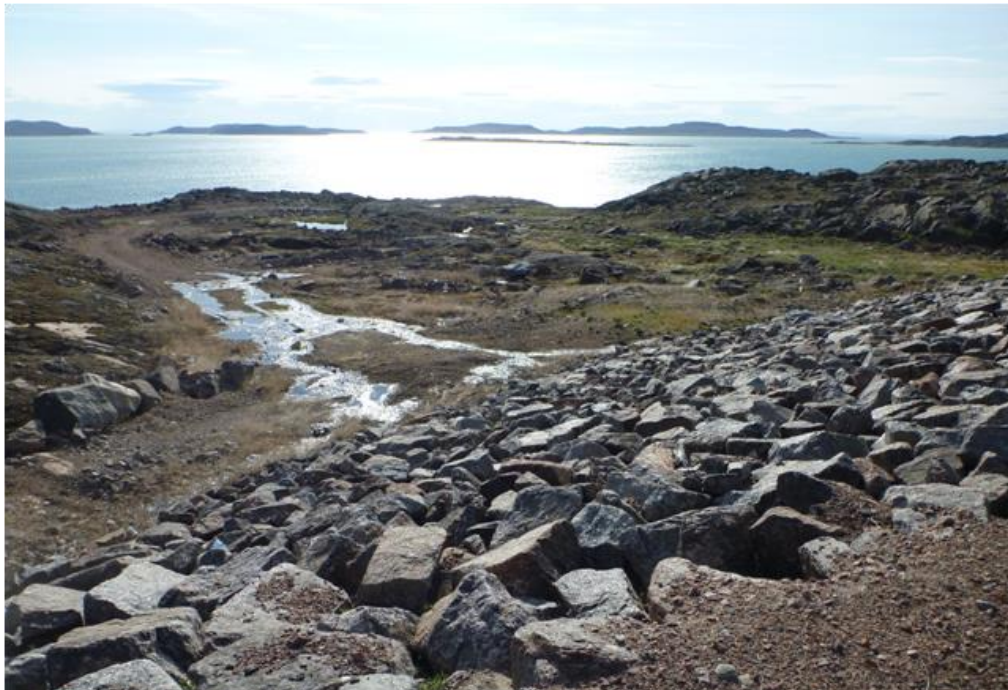
Figure 3: Seepage from south perimeter berm, Kugaaruk waste water lagoon
