24 November 2010
YX00828

Dillon Consulting Limited
P.O. Box 1409,
4920 47th Street
Yellowknife, NT X1A 2P1

**Re: Dam Safety Review for the Kugaaruk Sewage Lagoon,
Kugaaruk, NU**

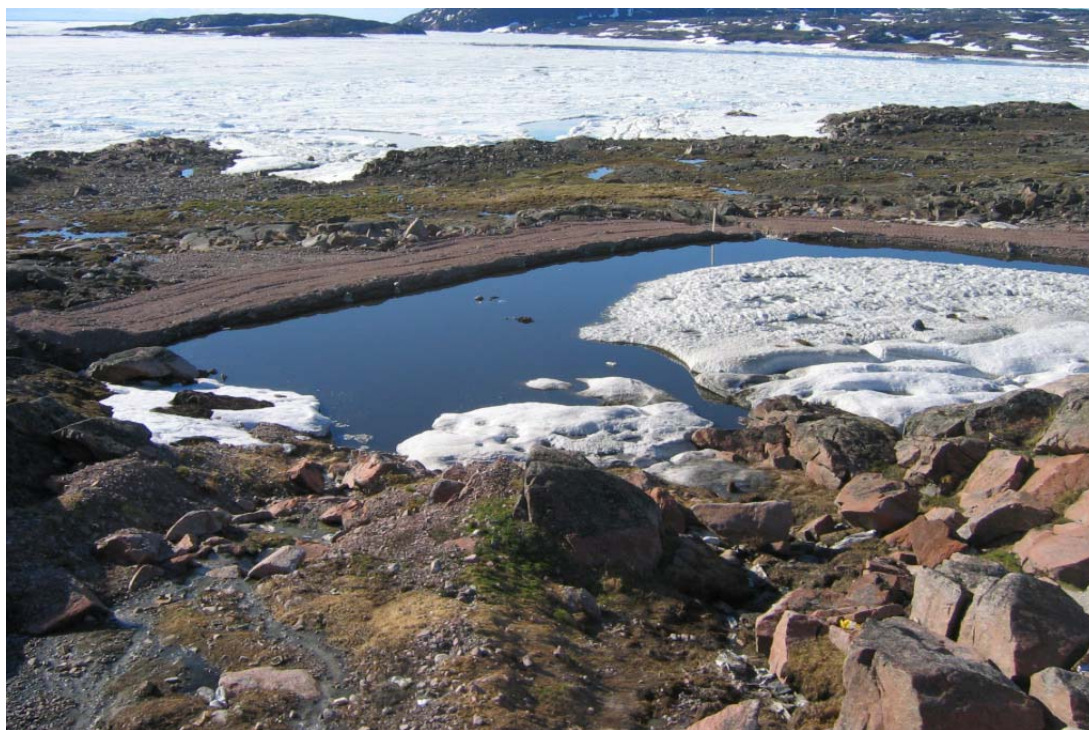
Plate 1: View looking east at existing downstream lagoon.
Note breach in dyke

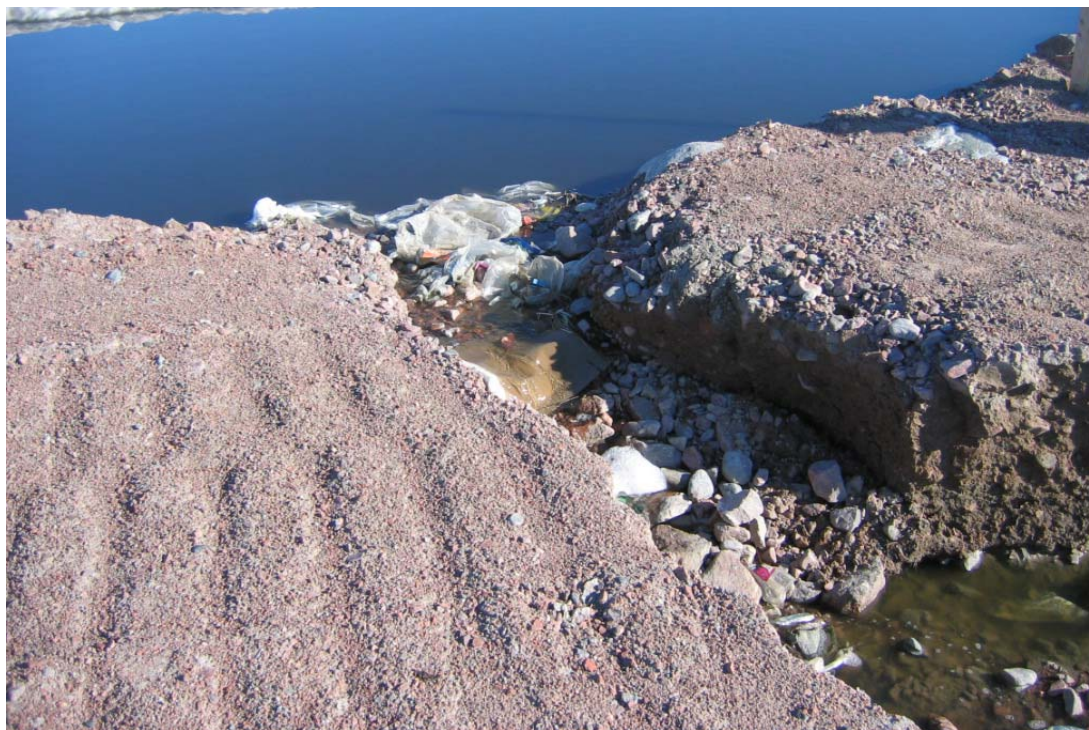
Plate 2: View looking west at existing downstream lagoon.
Note breach in dyke

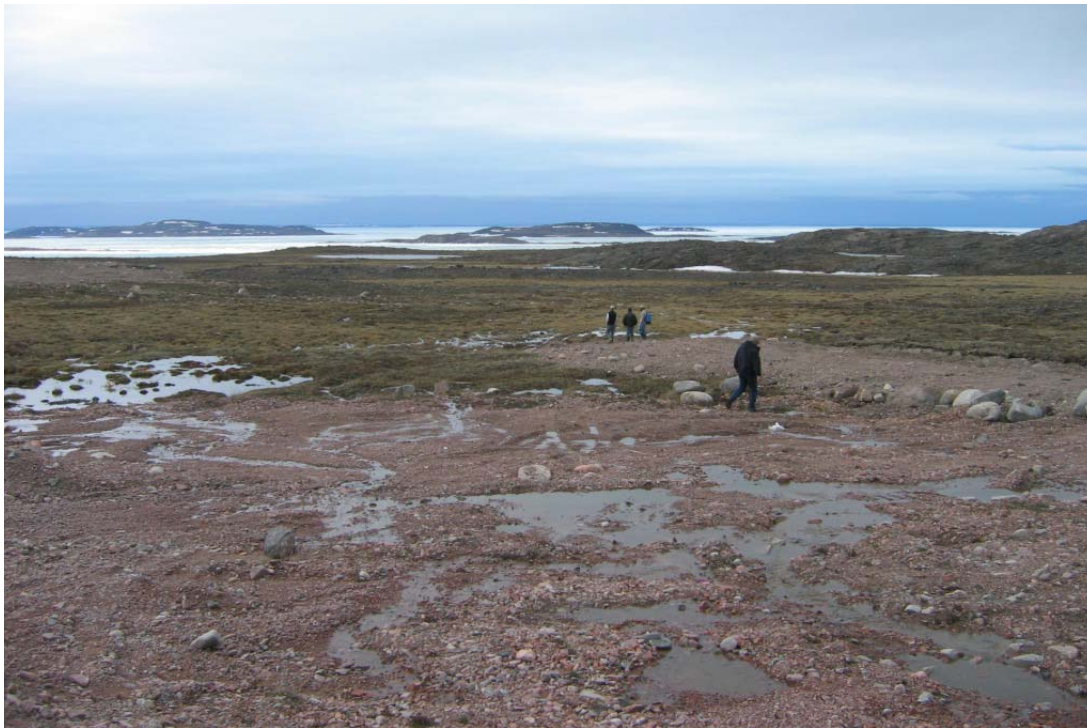
Plate 3: View looking west at potential site of new lagoon.
Note thin organic mat

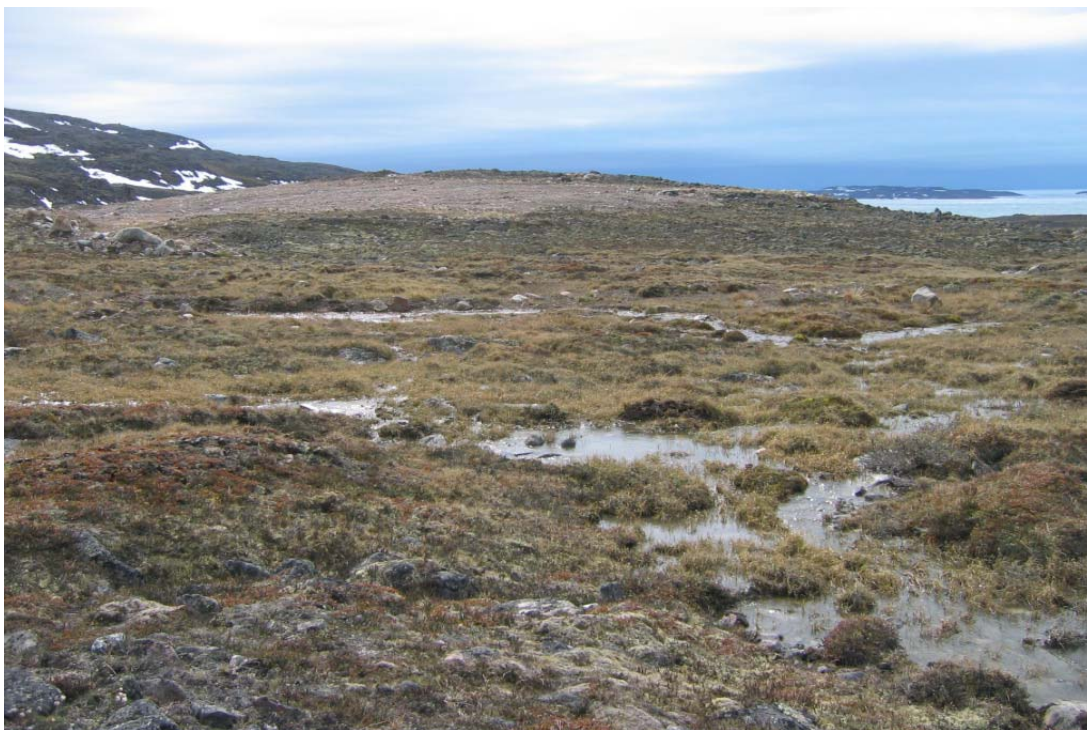
Plate 4: View looking southwest at potential site of new lagoon.
Note thin organic mat

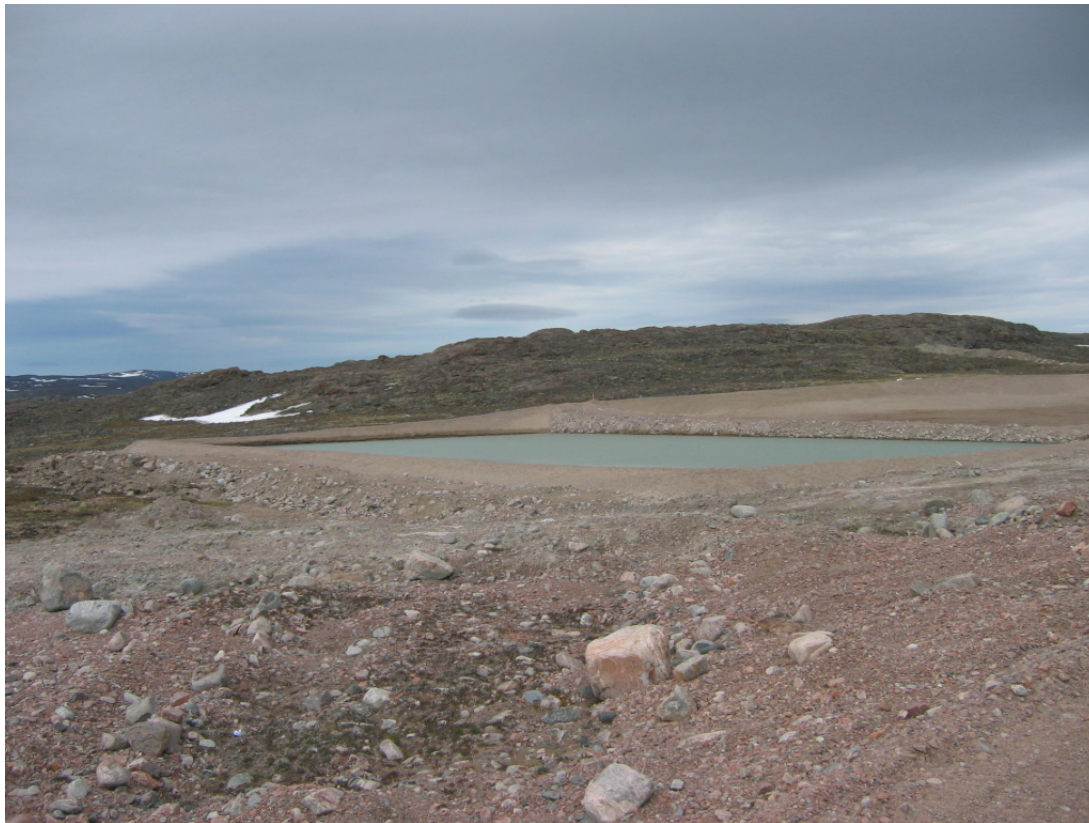
Plate 5: View looking northwest at potential site of new lagoon.
Note bedrock outcrops

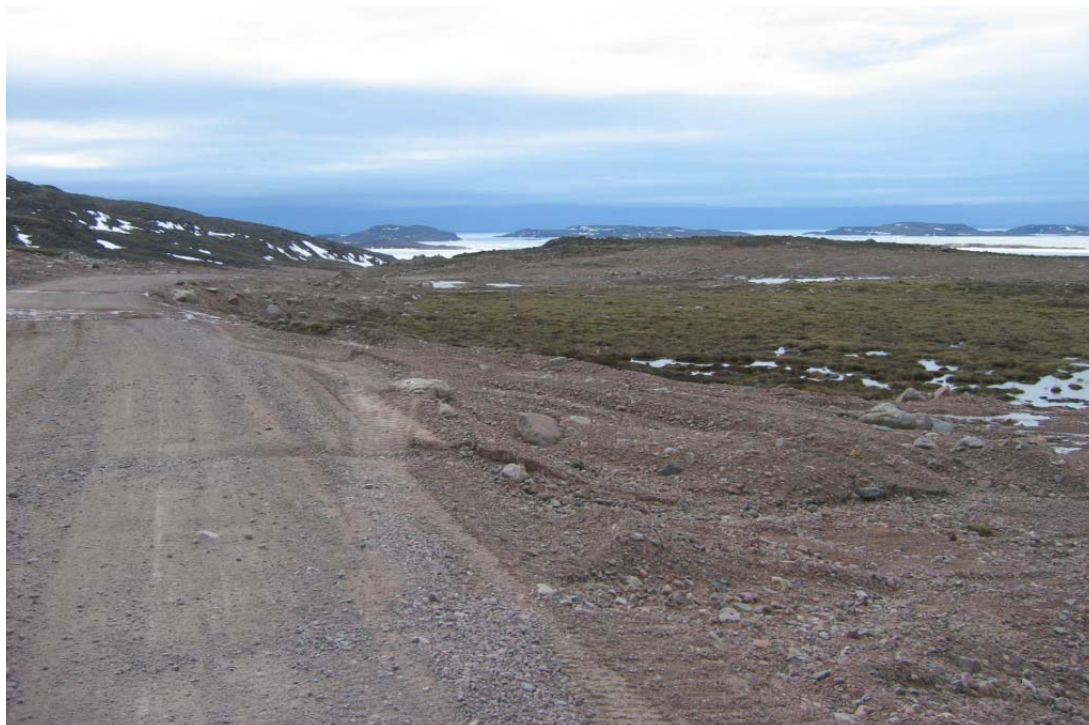
Plate 6: View looking southwest at potential site of new lagoon.
Note bedrock outcrops

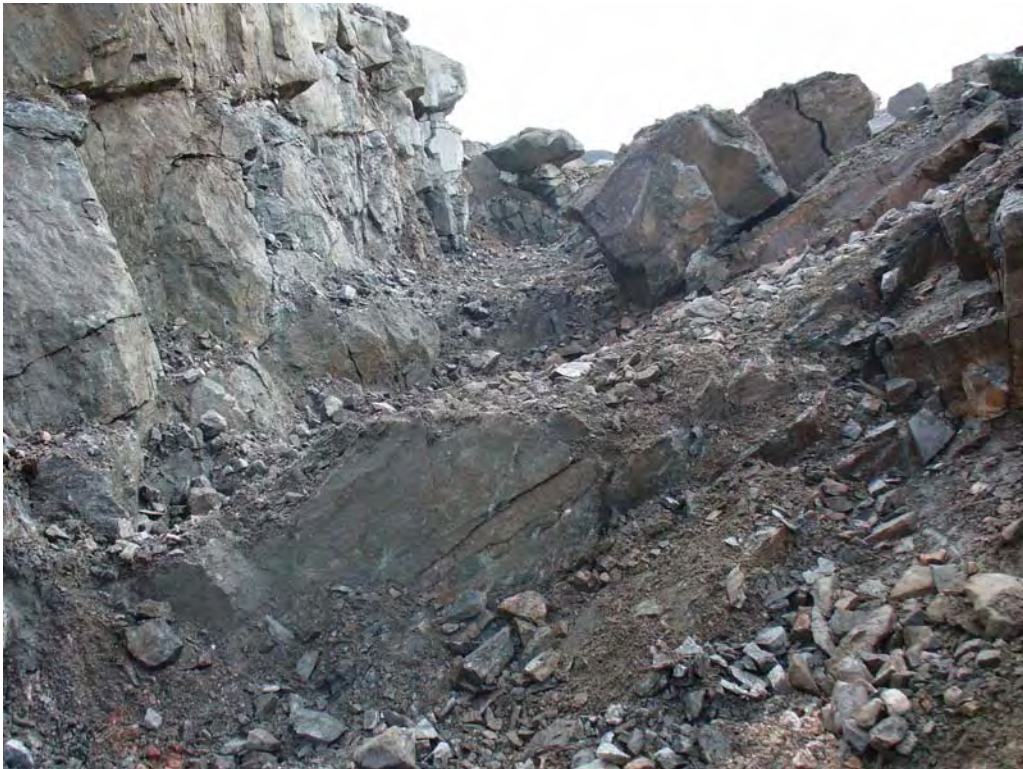
Photograph 2: Eastern segment of cut-off trench excavated in competent and jointed bedrock.

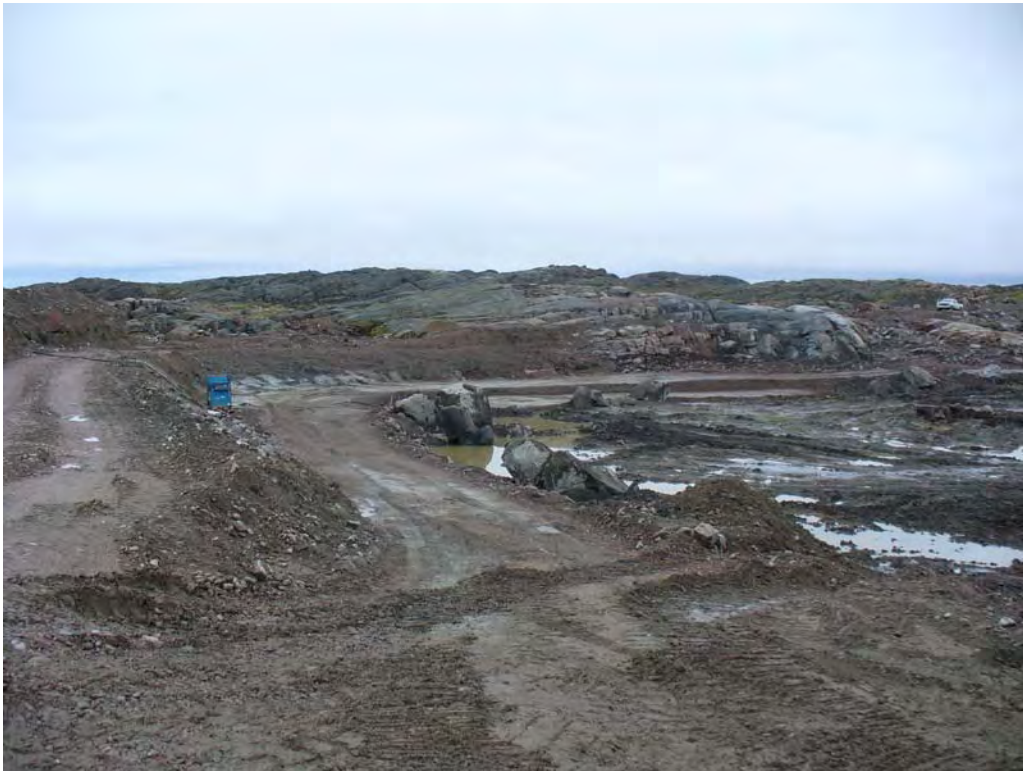
Photograph 3: Existing berm (at left) along northern segment of cut-off trench.

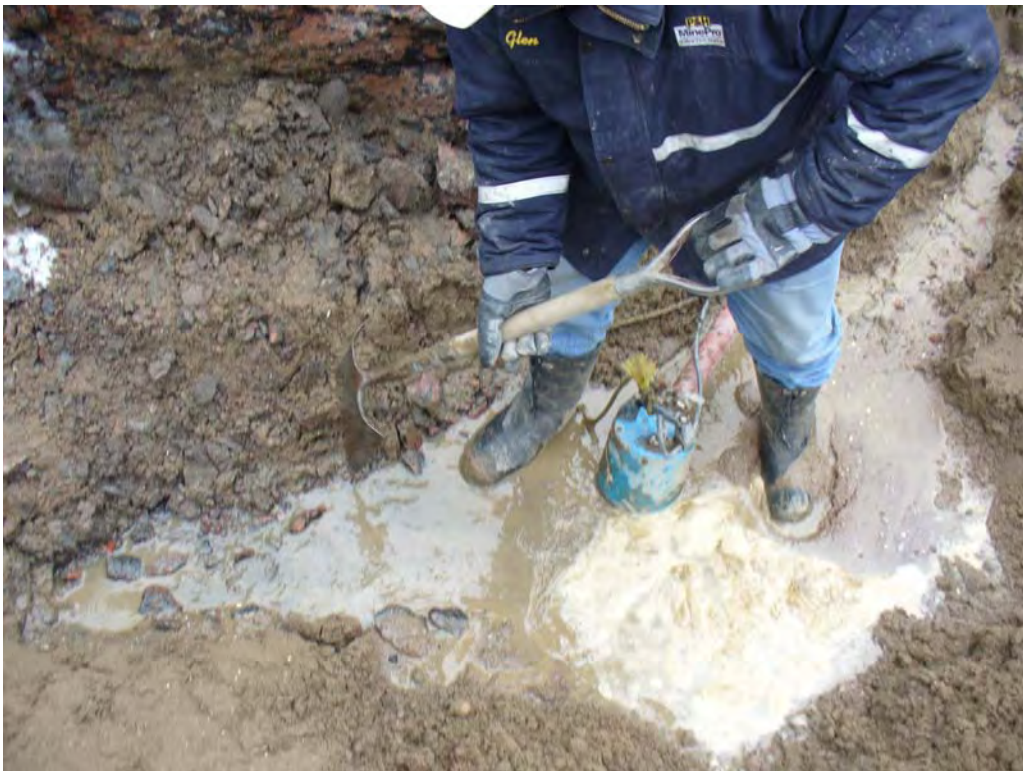
Photograph 6: Groundwater ingress along eastern segment of cut-off trench.

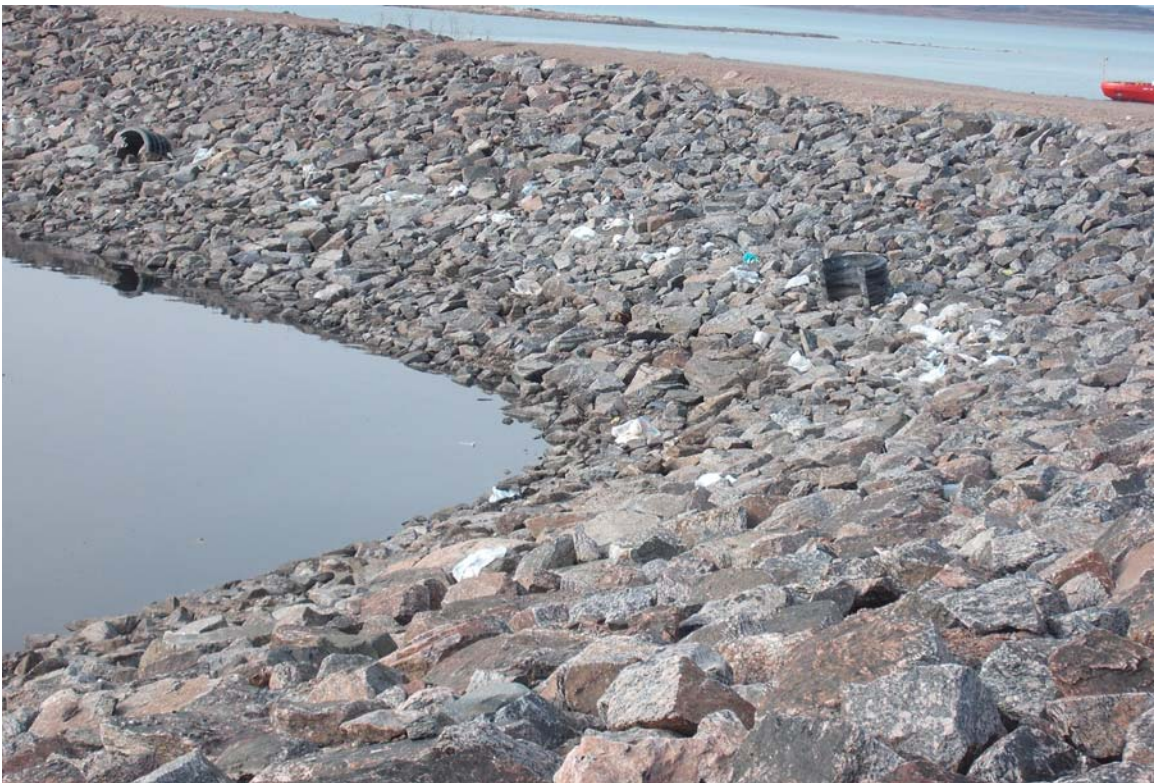
The effluent level along the northeast, northwest and southwest slopes of the dam was about 3.5 m below the dam crest. A general view of the internal slopes is provided in Photograph 2 and Photograph 4 through to Photograph 7, Appendix C. The internal slopes were found to be stable, consisting of rock fragments, up to 500 mm in size. The angle of the internal slopes was approximately 2.5H:1V, i.e. in a close agreement with the record drawings (Appendix B).

Photograph 2: Northwest berm of dam. Maximum effluent level represented as a broken line of white litter.

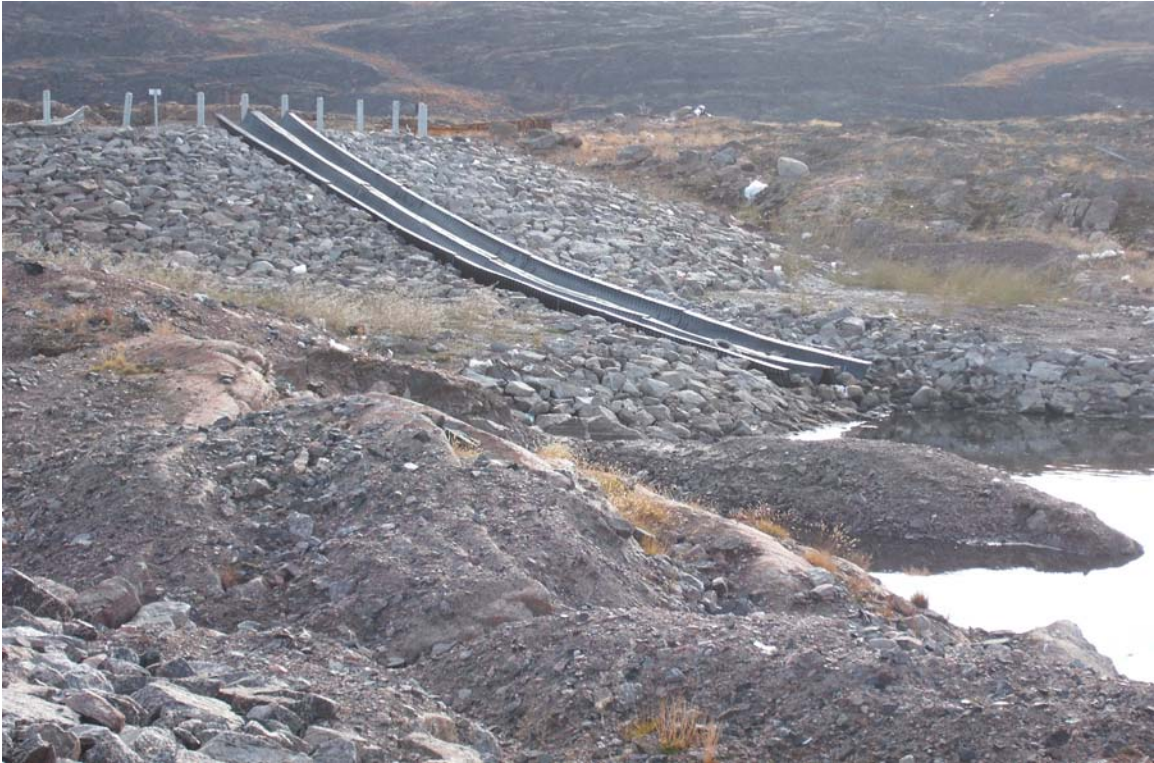
The fume culvert, consisting of two high density polyethylene half-pipe shells, was placed directly on the surface of the riprap blanket (internal southeast slope of the lagoon). The culvert extends from the truck turnaround pad down to an elevation approximately 0.5 m above the effluent level (Photograph 3, Appendix C). The culvert was found to be in good working condition with no visible cracks or holes along the shell invert (sliding surface).

Photograph 3: Southeast slope of lagoon with rip rap blanket and half culverts for unloading effluent from waste trucks into the pond.

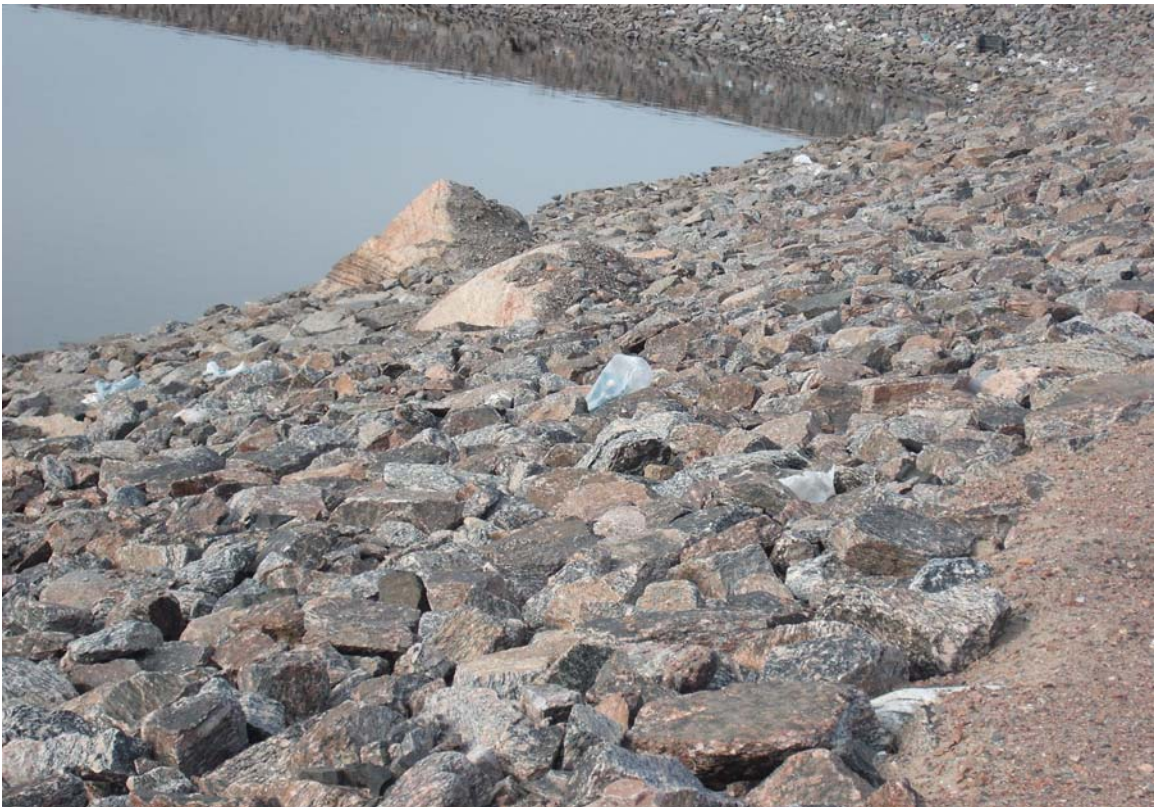
Photograph 4: General view of northeast internal slope.

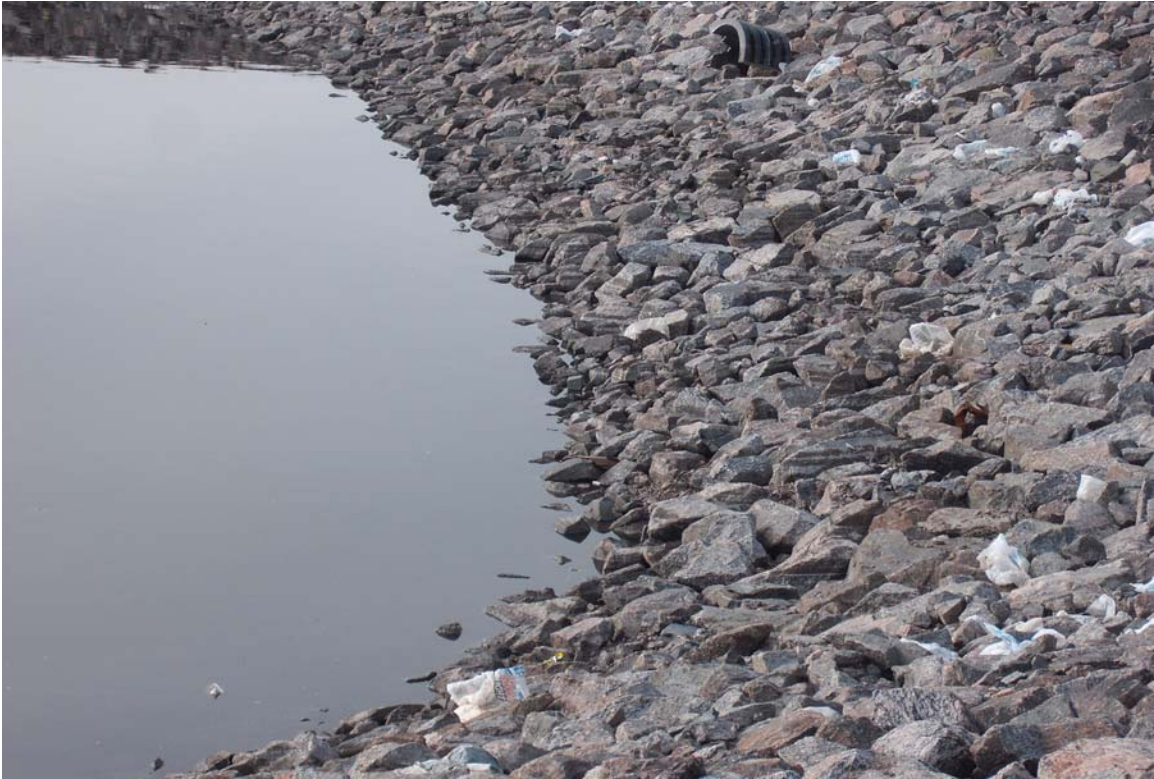
Photograph 5: Close up view of northwest internal slope.

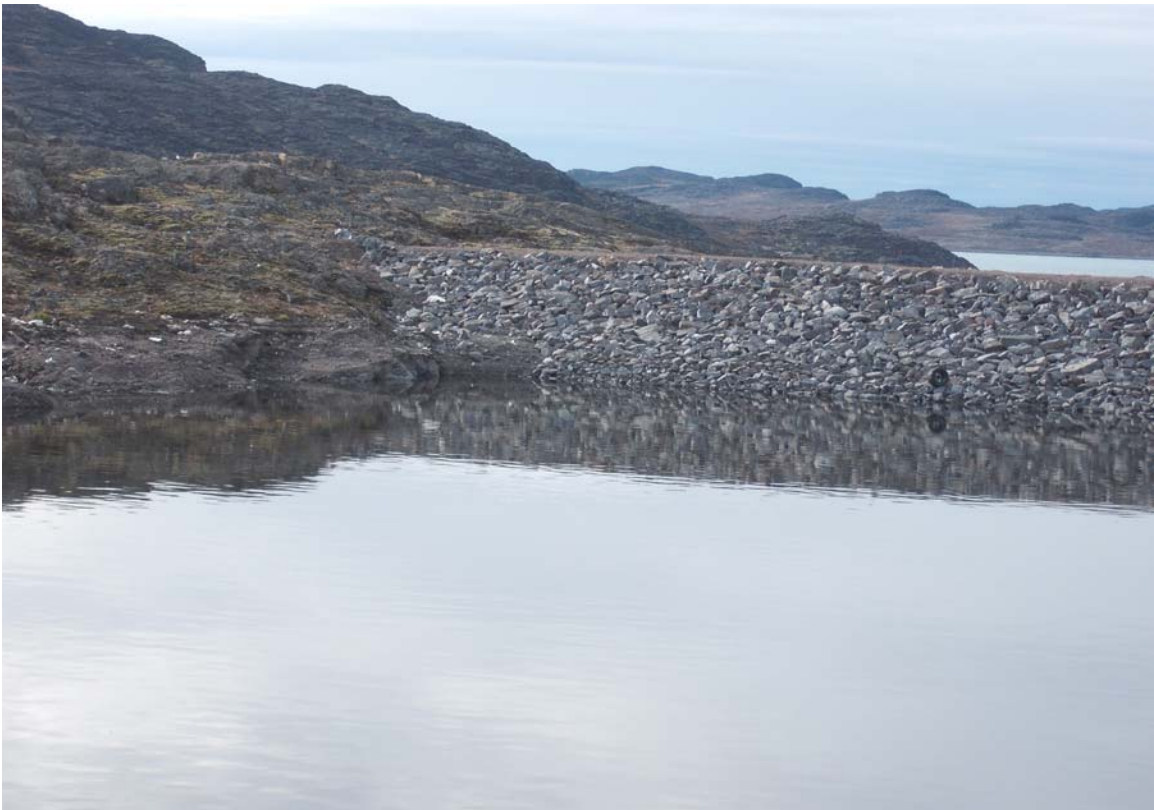
Photograph 6: General view of southwest internal slope.

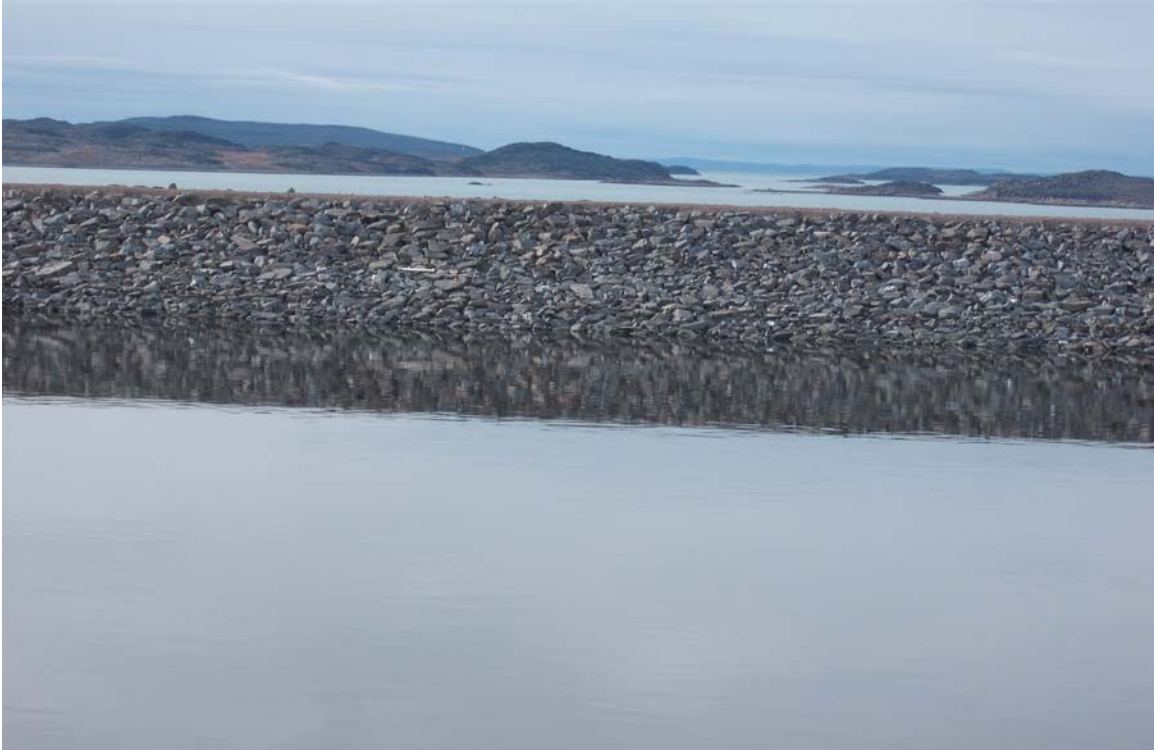
Photograph 7: General view of southwest internal slope with the Arctic Ocean in the background.

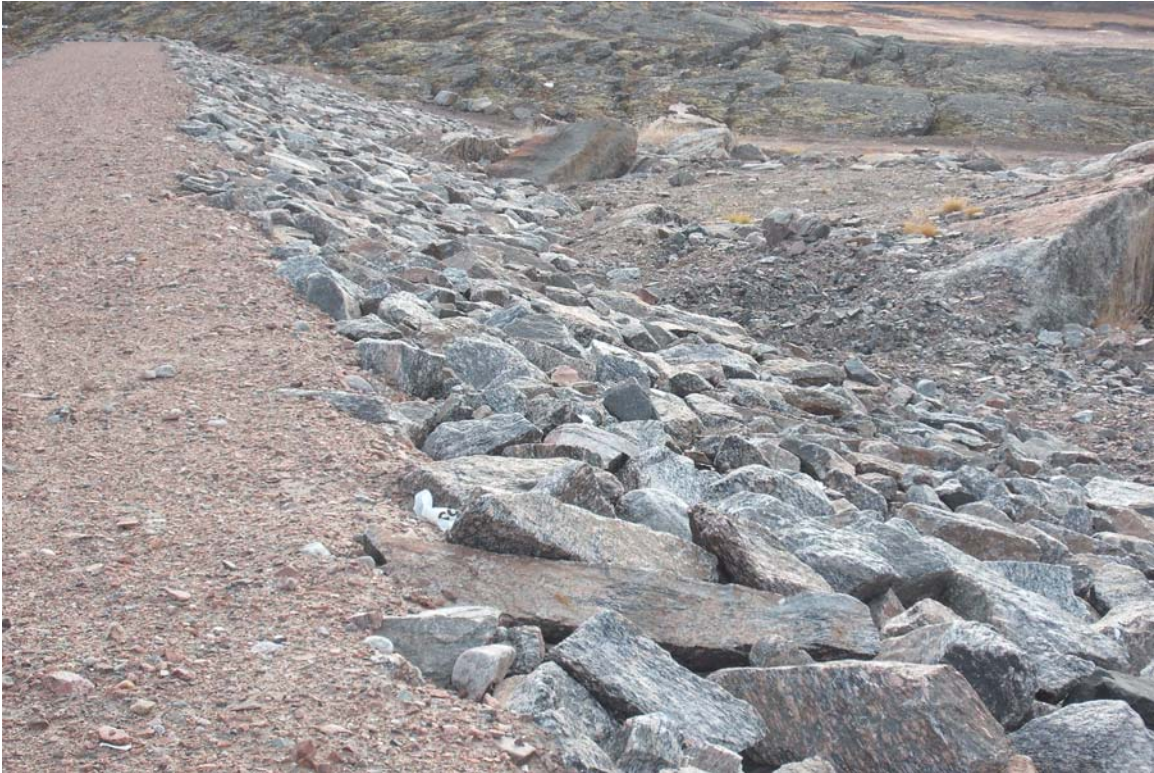
Depending on the topography of the surrounding natural terrain, the external slopes of the dam varied in height from about 1 m (central portion of the southwest slope, Photograph 8, appendix C), to about 10 m (central portion of the northwest slope, Photograph 9, Appendix C). Construction of the external slope was not required along the majority of the northeast slope, where the dam abuts with a relatively steep native rock outcrop (Photograph 10, Appendix C). Similar to the internal slopes, the external slopes were found to be stable with no indications of any erosion, moisture, slumps or rock falls. The angle of the external slopes was also about 2.5H:1V, i.e. in a close agreement with the record drawings (Appendix B).

Photograph 8: One meter high external slope along southeast berm.

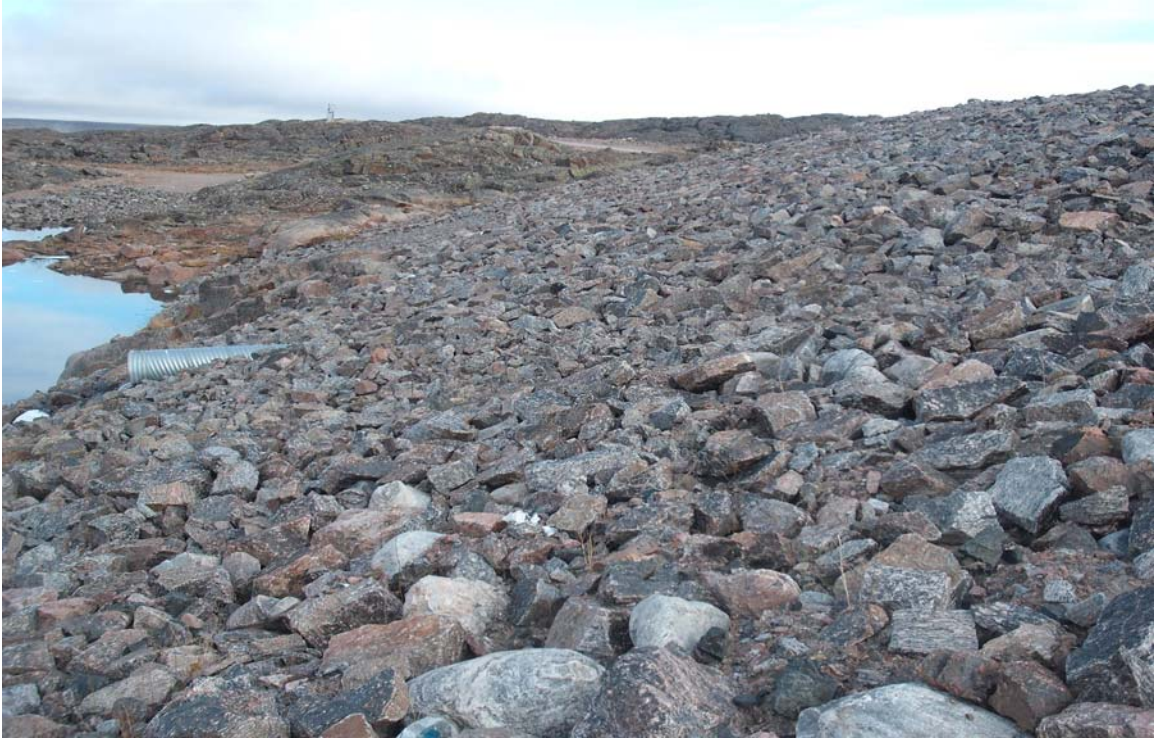
Photograph 9: About 10 m high external slope along northwest berm.

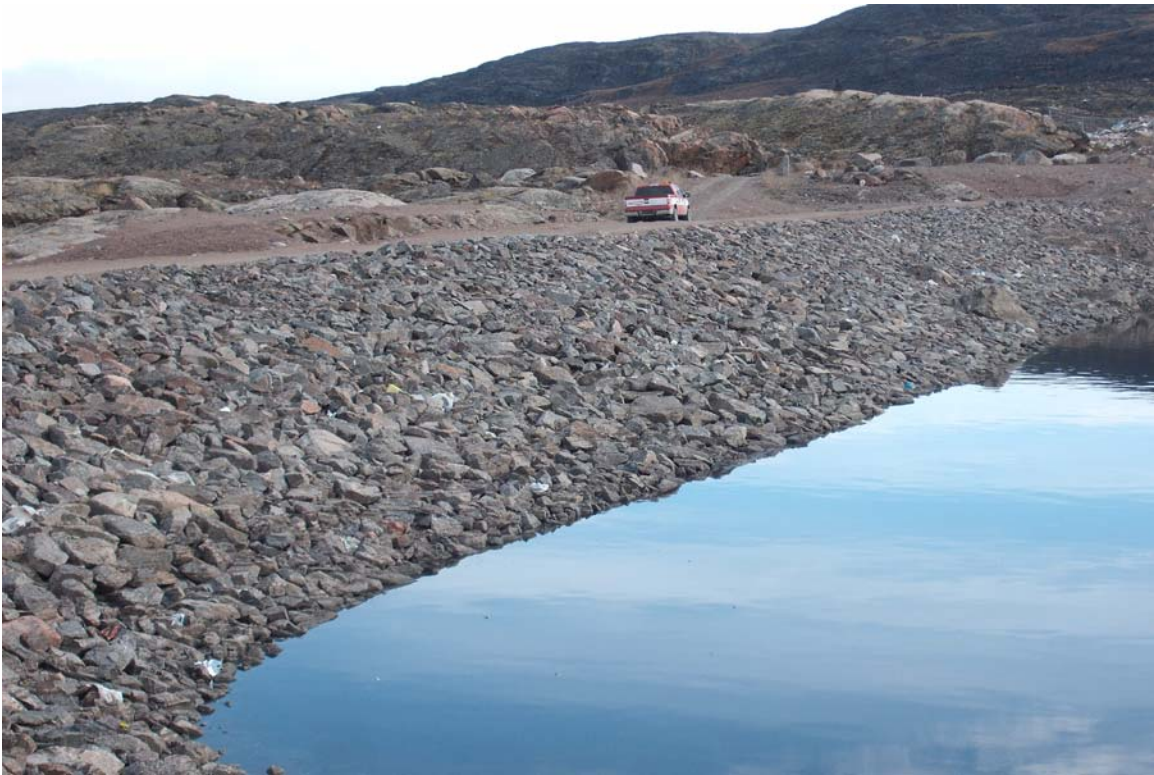
Photograph 10: A portion of northeast berm with rip rap blanket overlying a native rock outcrop.

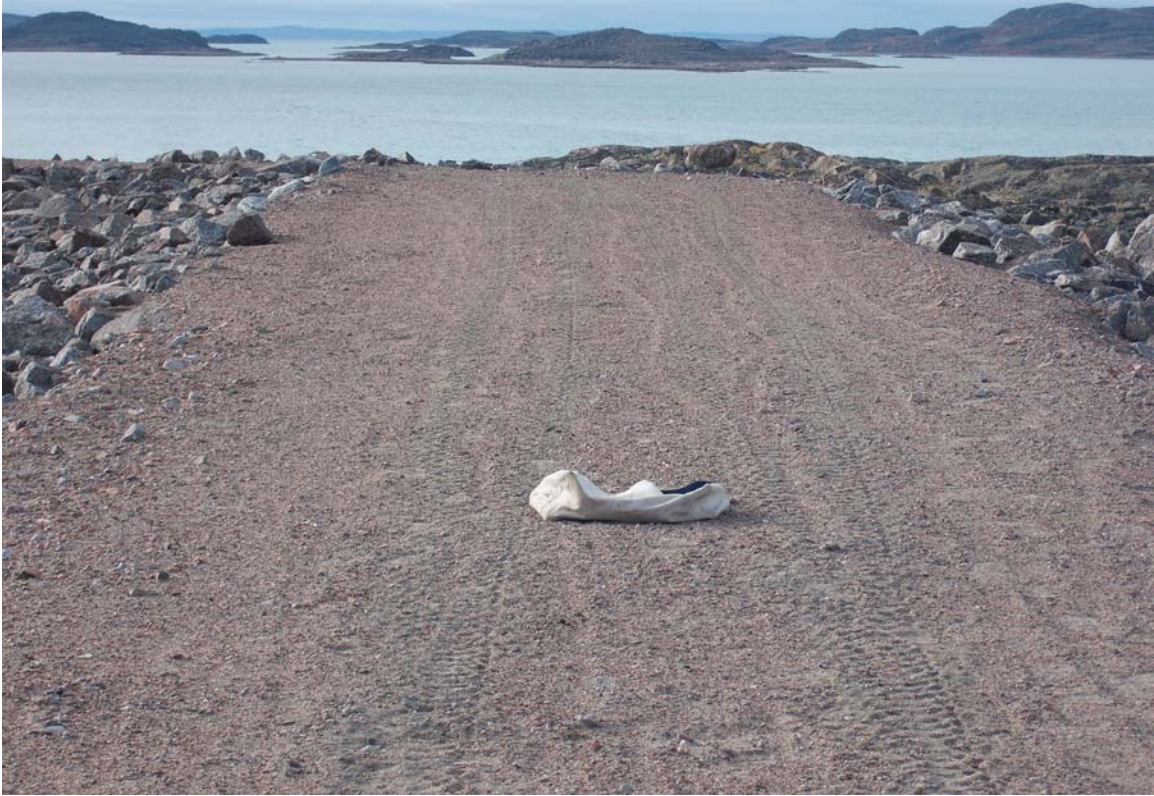
The crest of the dam was about 4.5 m to 5 m wide, and was surfaced with fine crushed gravel and sand. No depressions, which would have indicated possible settlement or erosion, were observed on the dam crest surface (Photograph 11, Appendix C).

Photograph 11: Crest of northwest berm.

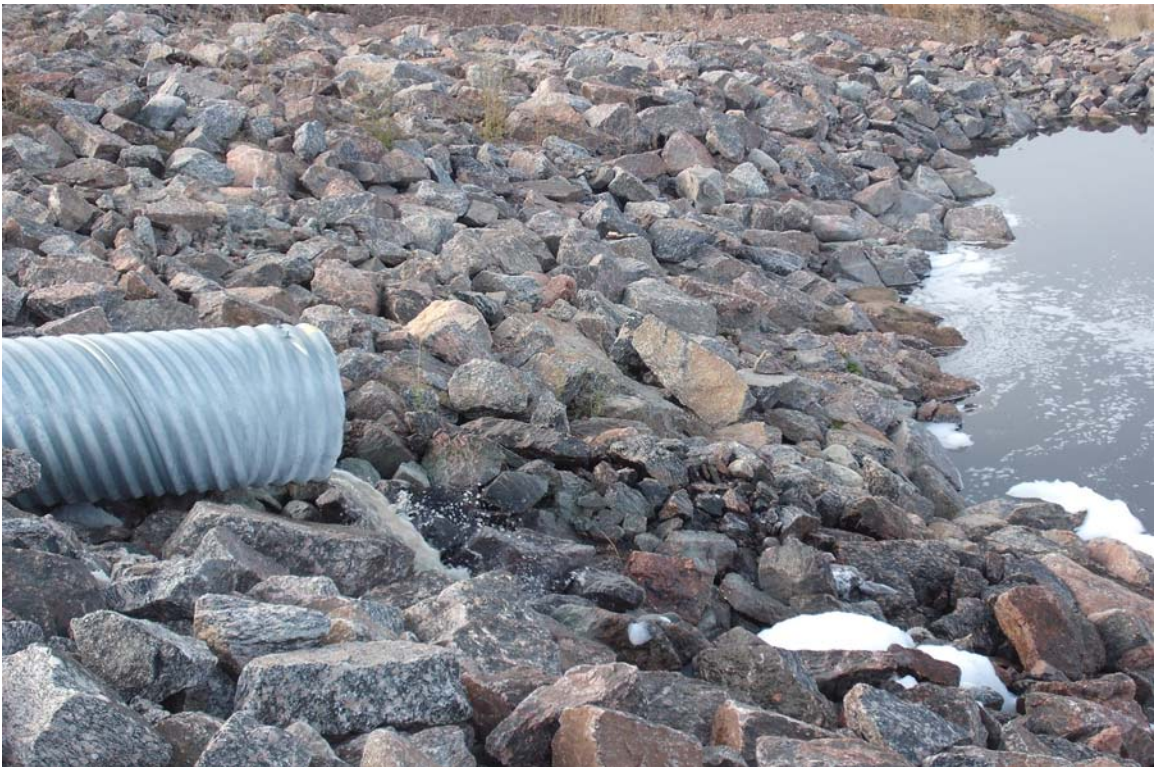
Photograph 12: Close up view of corrugated outfall pipe at external slope of northwest berm.

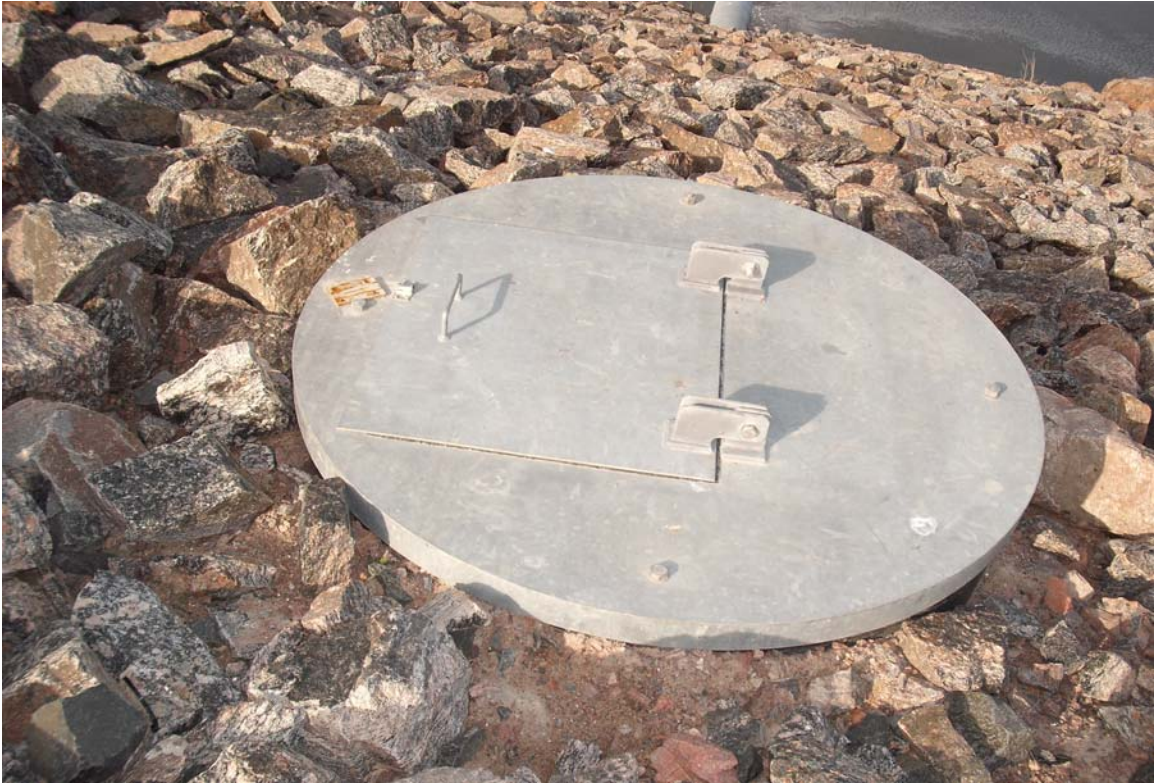
The control valve manhole, located in the northwest berm external slope, was also inspected. The manhole lid had no hasp for a padlock (Photograph 13, Appendix C), and the community public works foremen noted that the hasp was broken by unidentified persons in the spring of 2010. The manhole shaft was plumb, and no damage was observed either outside or inside of the manhole.

Photograph 13: Manhole lid with no hasp or padlock.

The hasp for the manhole lid should be replaced and the manhole lid should be kept locked. The community public works office should be provided with the sewage lagoon operation manual, including templates for records of the operation activities.

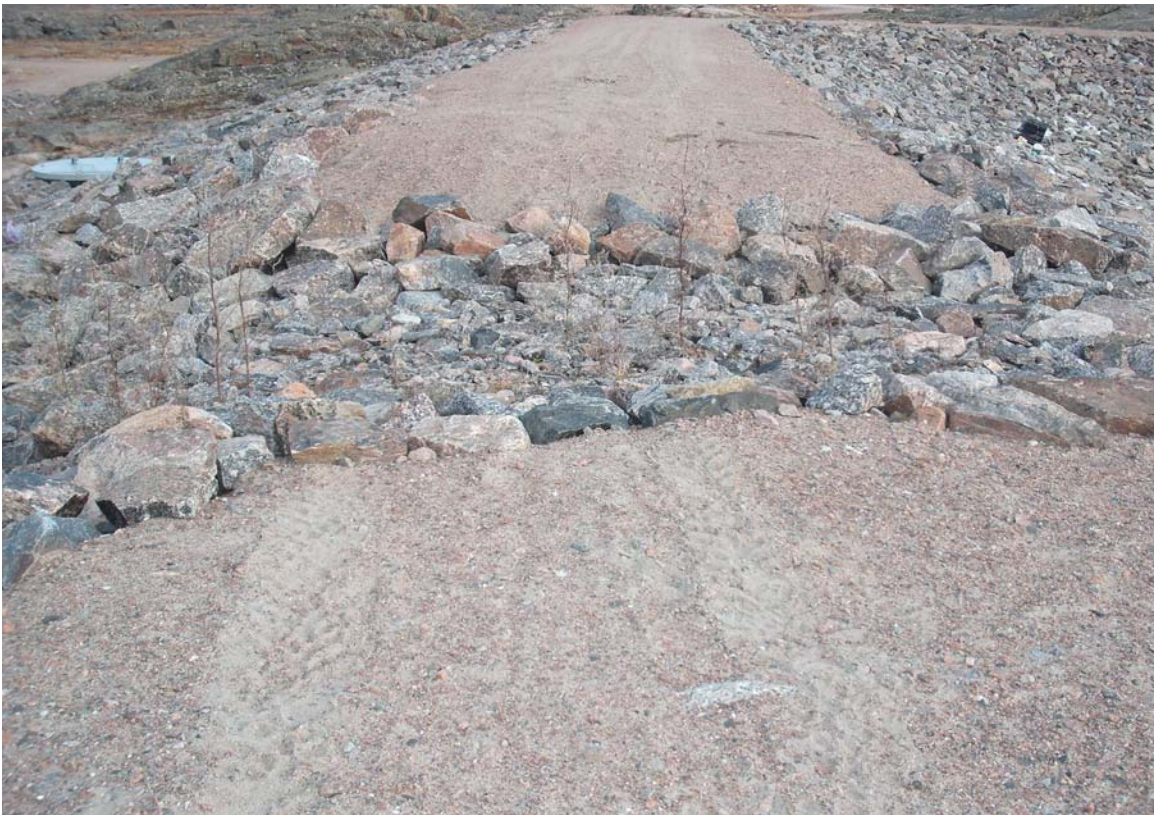
The emergency overflow weir is located at the crest of the northwest berm. The overflow weir consists of a ditch, approximately 0.3 m deep and 1 m wide, excavated across the crest of the northwest berm and along the external slope. The invert and slopes of the ditch are covered with riprap to reduce erosion potential (Photograph 14, Appendix C). The overflow weir was found to be dry during the site visit. It was also understood that the overflow weir has never been wet, meaning that there was no prior overflow of the lagoon to the date of the site visit. No settlement depressions or erosion features were observed along the overflow weir, meaning that the overflow weir has not impacted the overall stability of the northwest berm.

Photograph 14: General view of overflow weir.

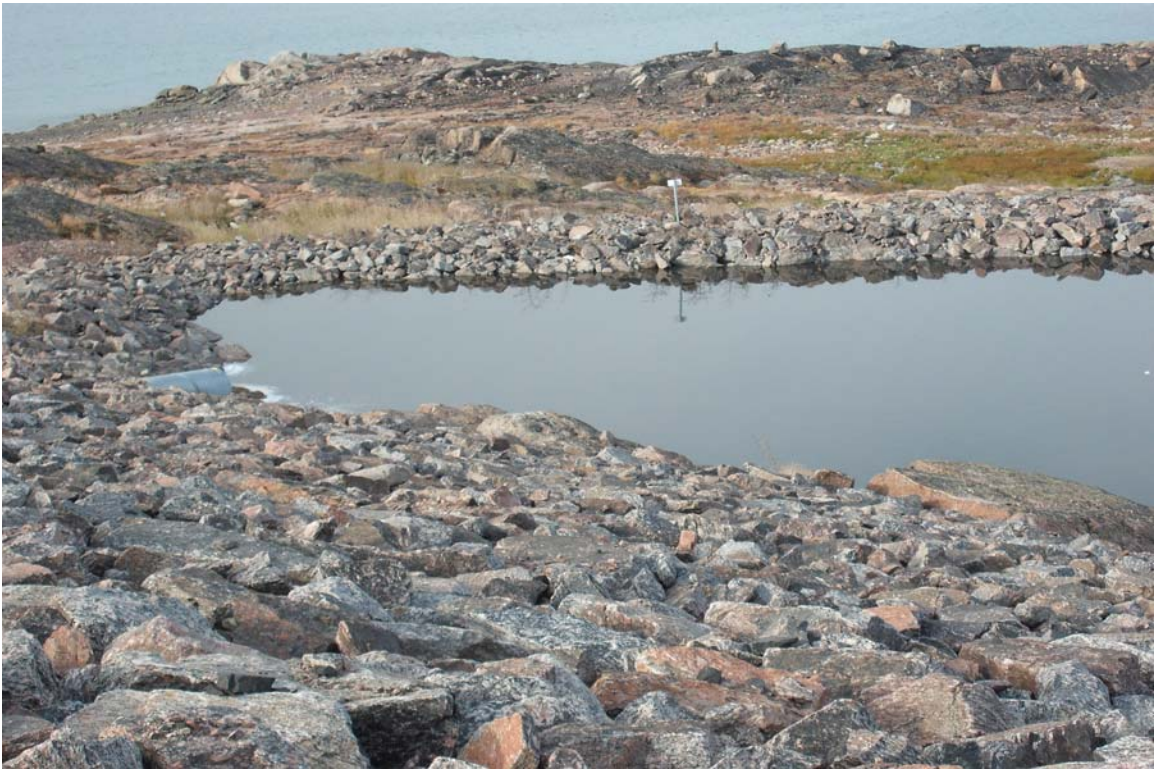
Photograph 15: General view of lower pond and outfall pipe.

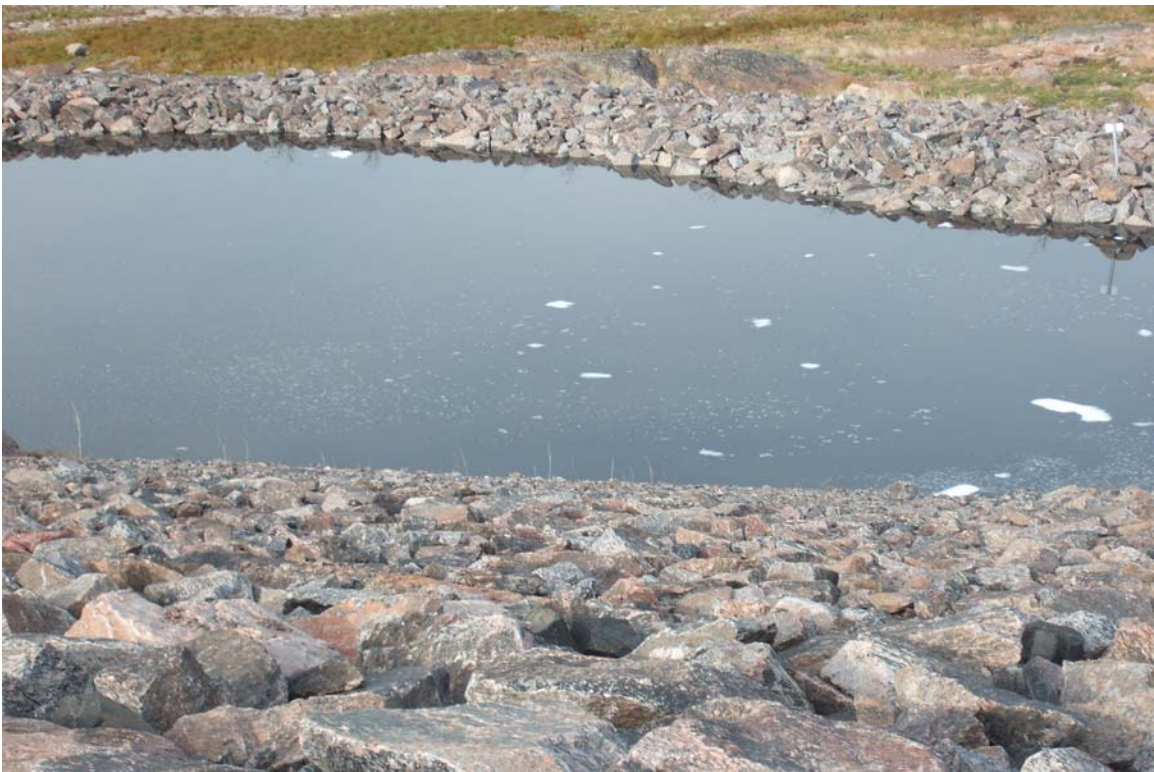
Photograph 16: Close up view of lower pond.

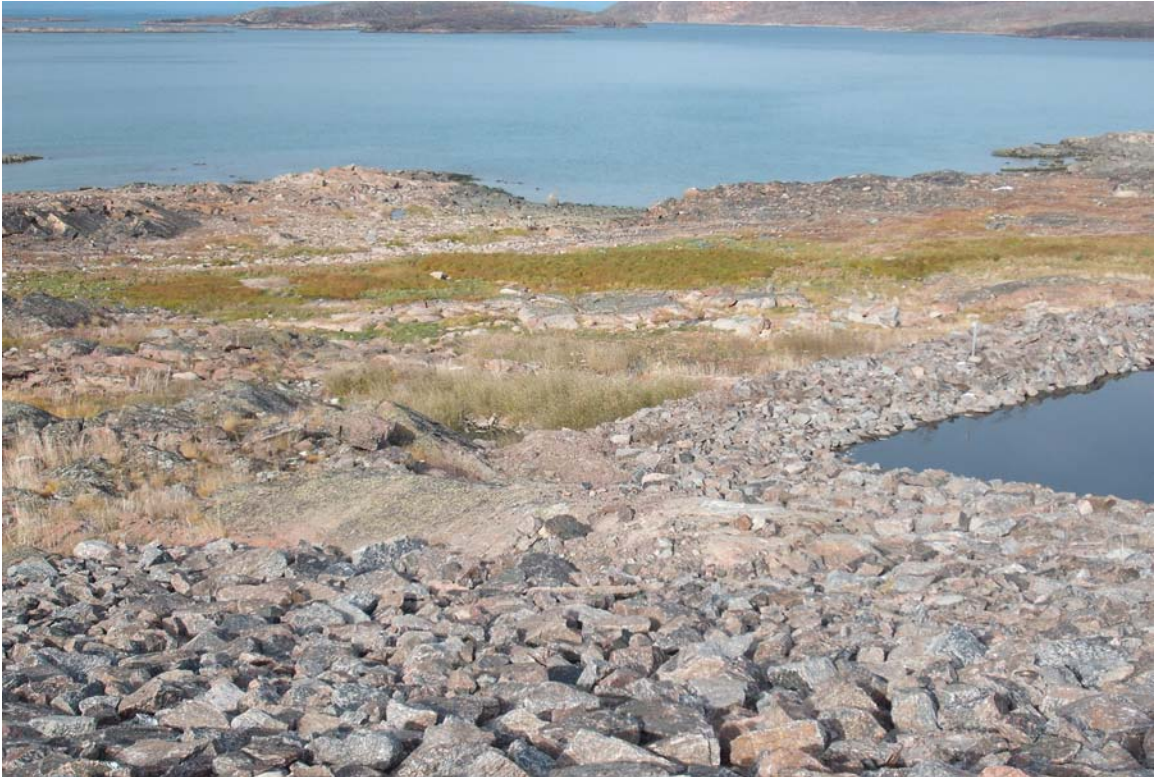
Photograph 17: Terrain downstream from lower pond. Green grass shows area where effluent is seeping below lower pond embankment.
