24 November 2010
YX00828

Dillon Consulting Limited
P.O. Box 1409,
4920 47th Street
Yellowknife, NT X1A 2P1

**Re: Dam Safety Review for the Kugaaruk Sewage Lagoon,
Kugaaruk, NU**

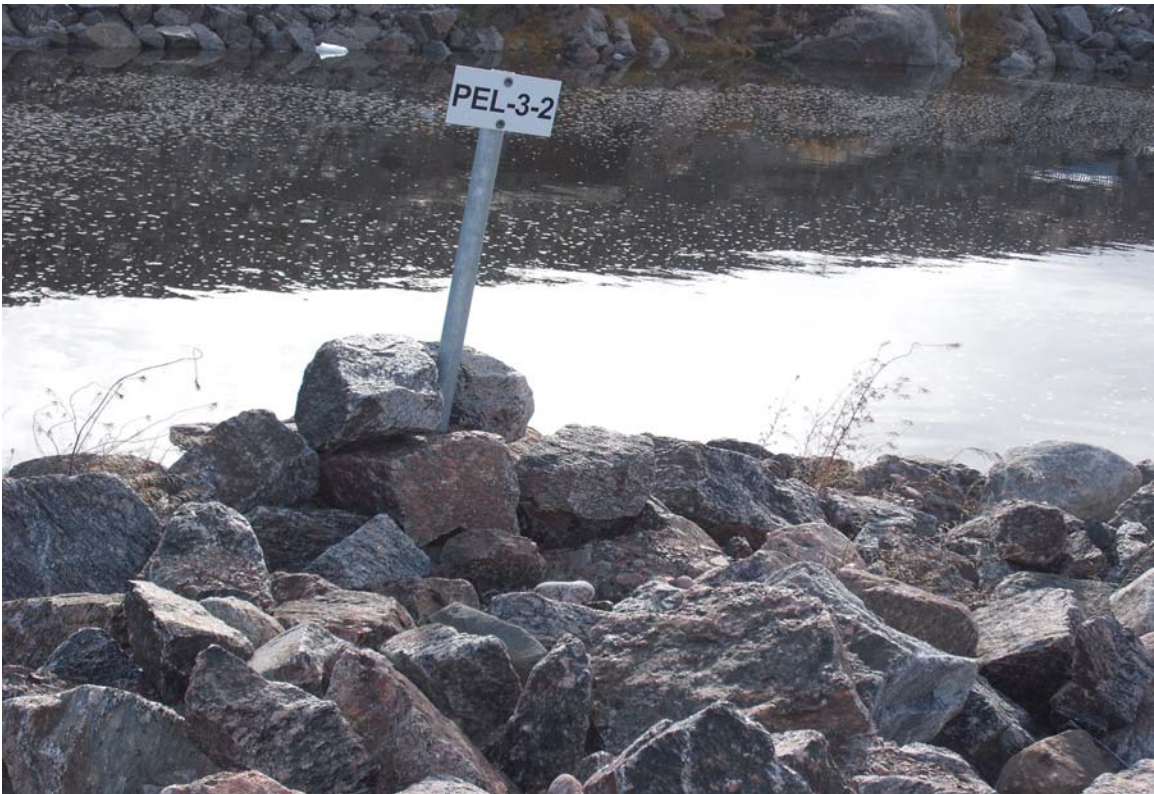
Photograph 18: Lower pond berm with post.
