# Kugaaruk Sewage Lagoon Spills Report

## March 26, 2015

Site visit by: Shah Alam,  
Municipal Planning Engineer

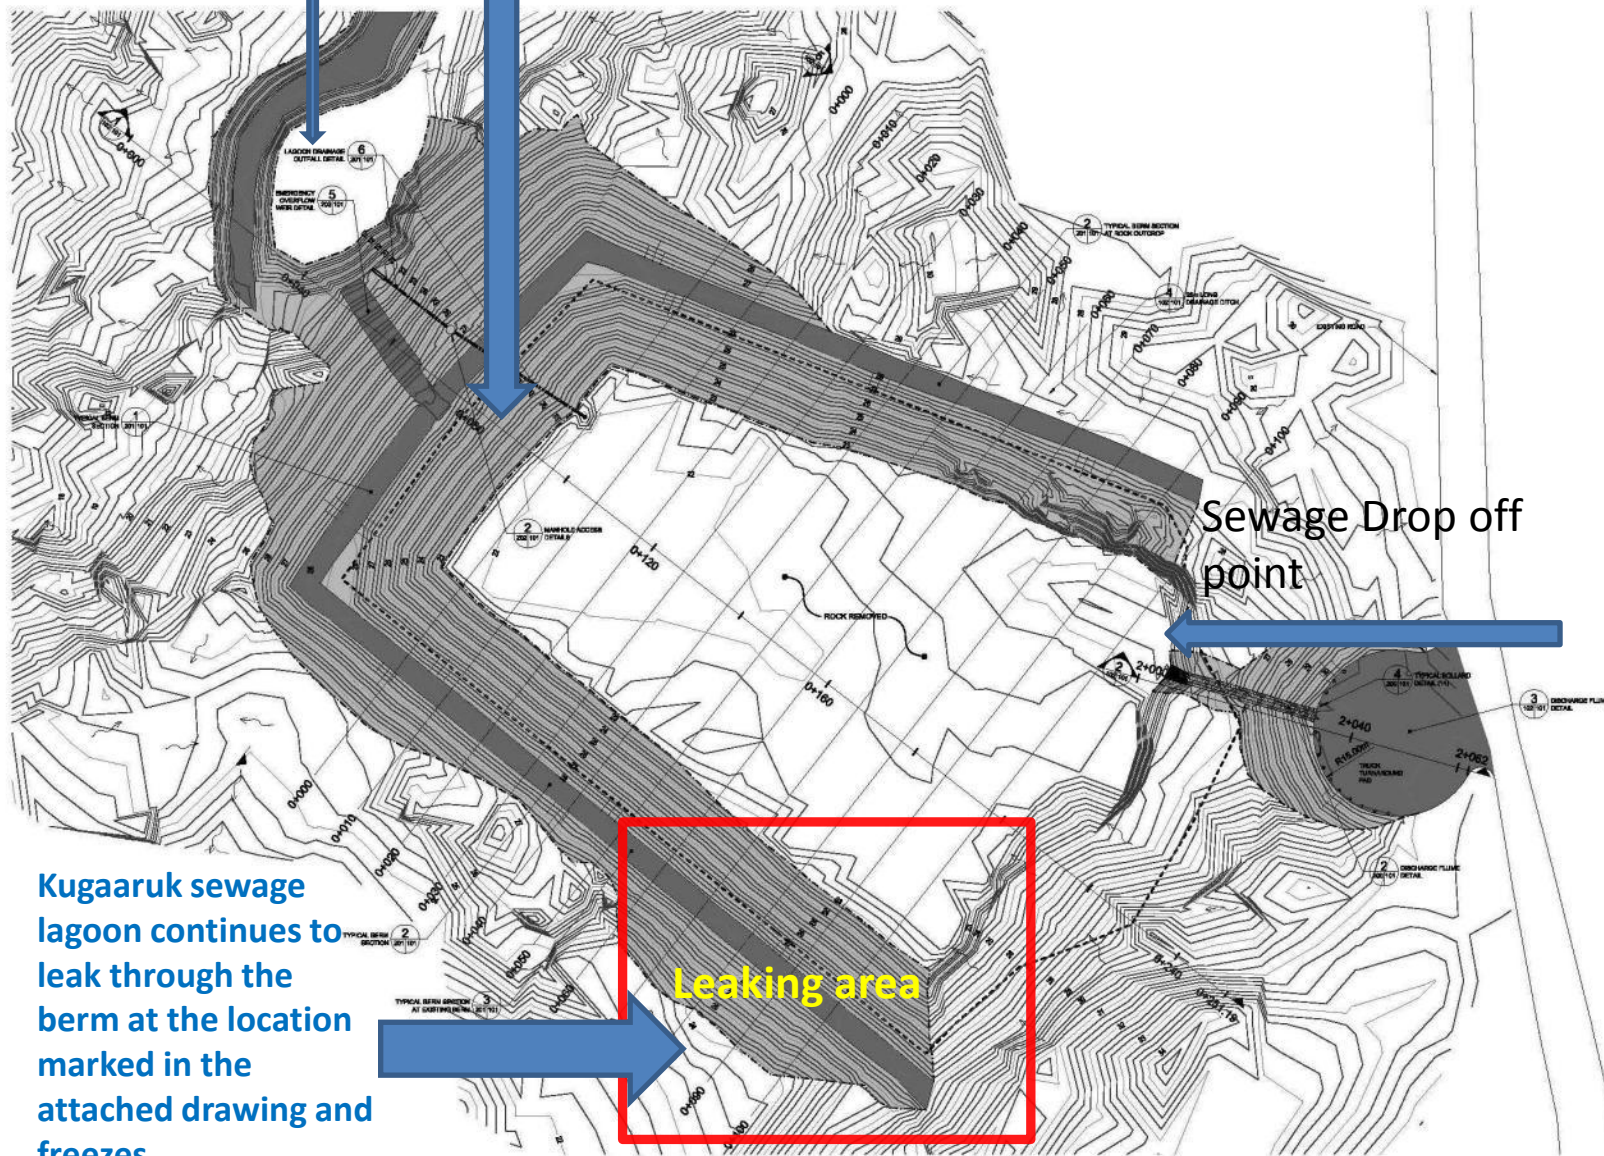
- The lagoon leaks observed at the location of newly built gravel berm with the existing bedrock sloped section (drawing attached ).
- Substantial amount of sewage exposed outside of the main cell and freeze up there for harsh cold, but smells out.
- Loose crack line in between the frozen sewage heap signs continuous leaking from the main cell towards outside through the berm.
- The leak only observed within an area at the section of new gravel berm with existing bed rock. It is not confirm for any leaking at any other section until an inspection which can be possible when raw sewage starts melting in summer time.

Kugaaruk sewage lagoon continues to leak through the berm at the location marked in the attached drawing and freezes.

Leaking area

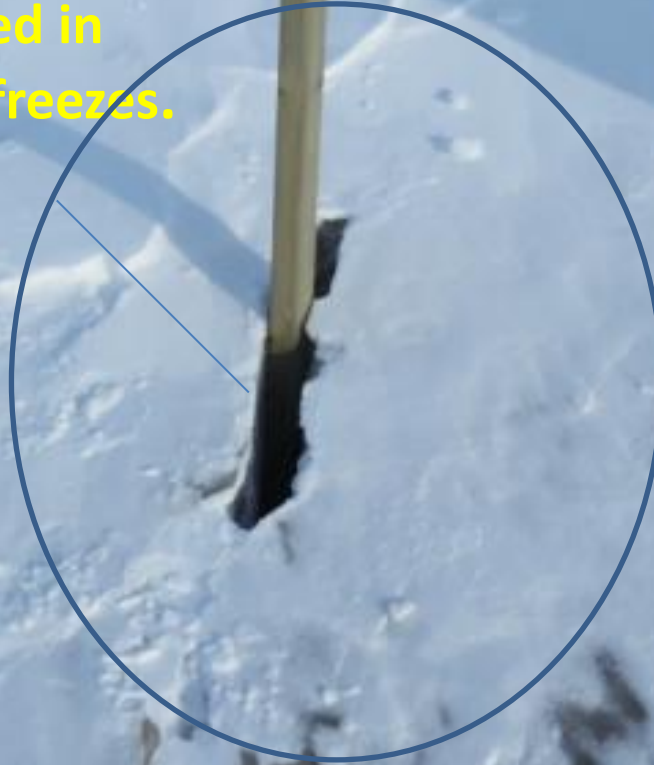
Leaked frozen sewage displays crack line, leaking continues at Kugaaruk Sewage lagoon.

2-3 feet deep crack line

Cracks

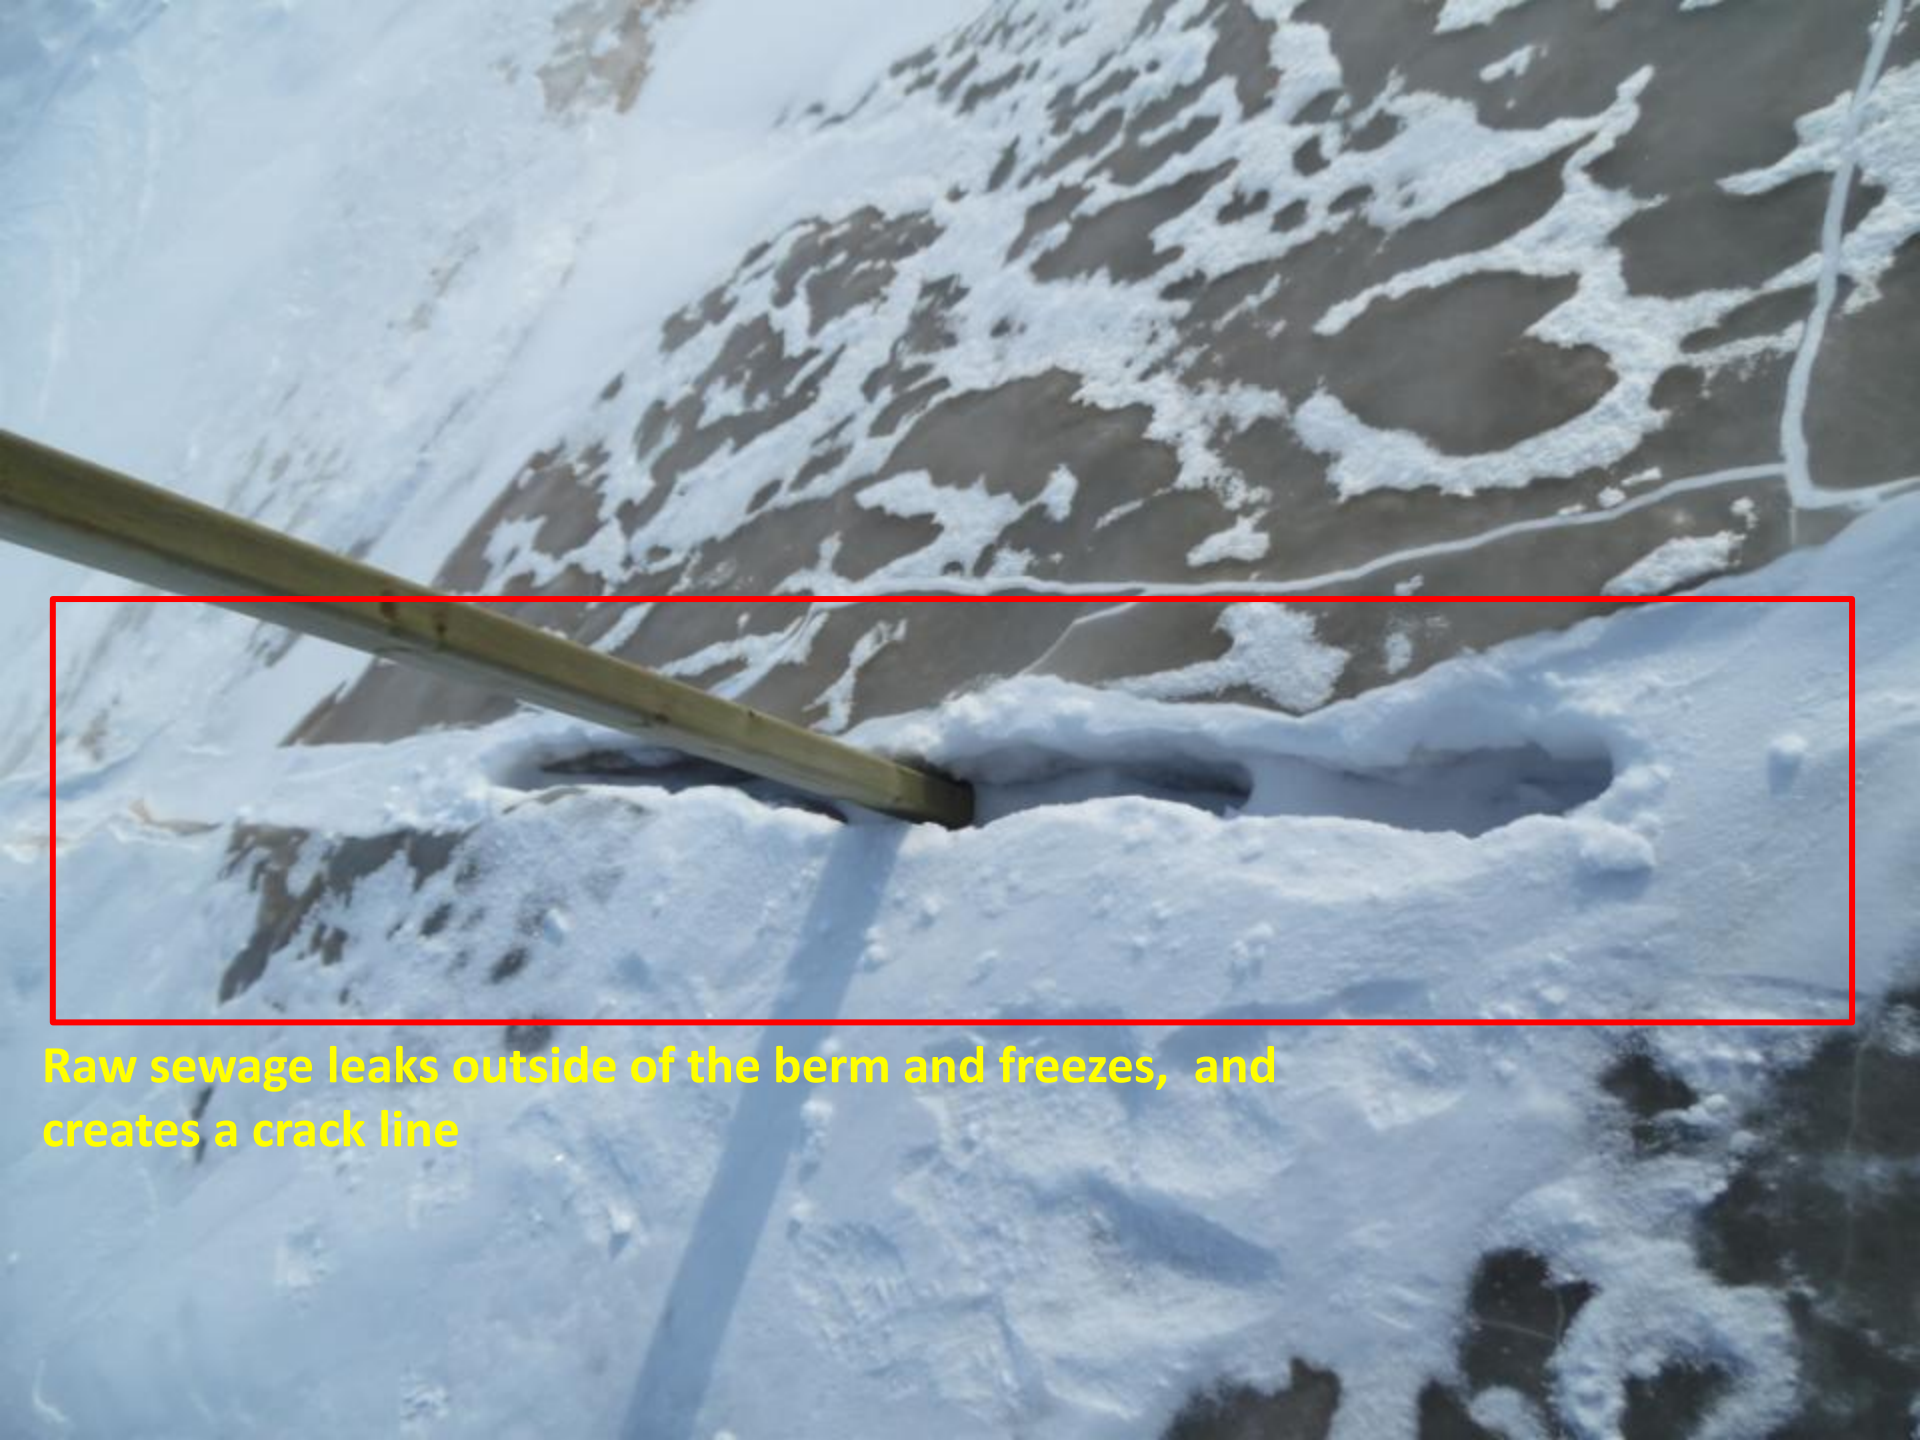
Raw sewage leaks outside of the berm and freezes, and creates a crack line
