FISHERIES ASSESSMENT OF HABITAT STRUCTURES AT THREE WATERCOURSE CROSSINGS NEAR KUGAARUK, NUNAVUT

Jivko Engineering Ltd.
Yellowknife, NT

October 2002
022-7026

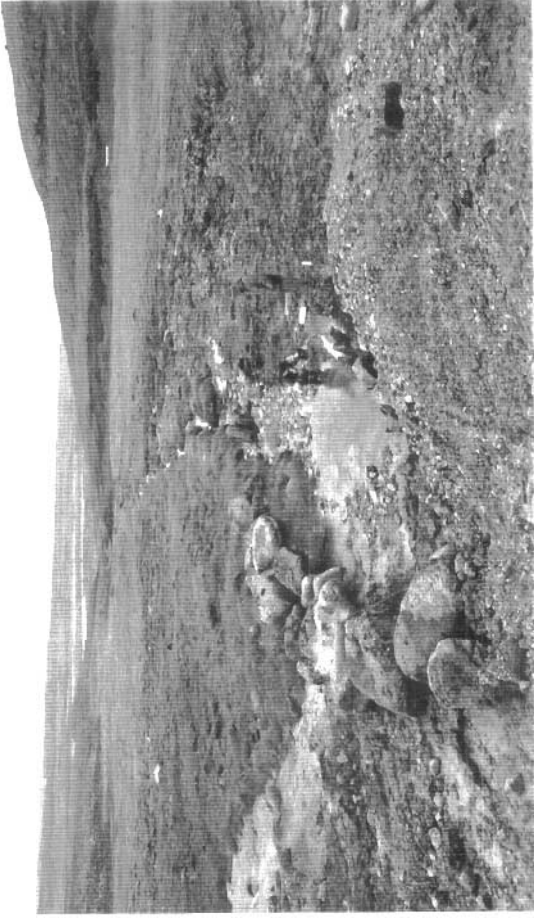
At the time of the assessment, the deflecting dyke was situated outside the wetted channel. However, the resting pool below the culvert remained functional (Plates 1 and 2); a juvenile lake trout was observed in the pool. Due to the very low flows (Plate 1), it is very unlikely that this fish would have been able to migrate to suitable overwintering habitat upstream or downstream of the crossing before freeze-up. Because of the low flows, the natural sections of the stream channel between the small headwater lake (Plates 3 and 4) and the Alliarusiq River, would have been largely impassable to fish even if the culvert was not present. Fish (unknown size) were observed rising in the headwater lake, indicating that either these fish overwintered there or had migrated at higher flows during the spring. However, there is some uncertainty regarding fish passage through the culvert during high flow periods, particularly for small fish (<150 mm). Based on the swimming capabilities of fish with a subcarangiform shape, which includes char (Katopodis and Gervais 1991; Appendix A), a fish less than 150 mm in length could not maintain a prolonged swimming speed of 0.55 m/s over a distance of 15 m; a velocity of 0.55 m/s is possible during high flows. Based on Manning's uniform flow equation, velocities up to 1.2 m/s could be developed in the culvert (i.e., 50% flow capacity, slope of 0.3% and a diameter of 1.2 m) (equation cited in Newbury and Gaboury 1993; Appendix B). Given this, it is evident that this culvert could represent a movement barrier to small fish (<150 mm) at moderate velocities (e.g., 0.55 m/s) and possibly to larger fish (400 mm) at higher velocities (e.g., 1.2 m/s).

Plate 2 Km 18 Culvert, 7 August 2002. Resting pool and deflecting dyke below culvert. Note: juvenile lake trout observed within the pool.

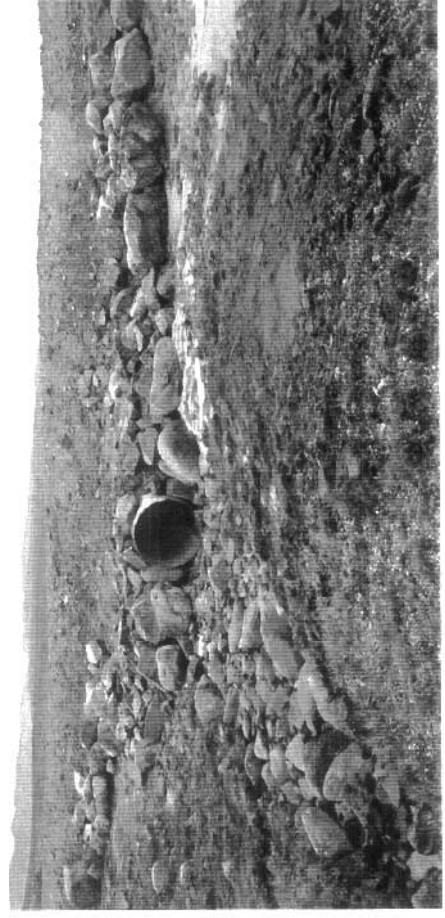
Plate 4 Km 18 Culvert, 7 August 2002. Stream channel at upstream end of culvert. Note: rip-rap placement to protect the road slope.

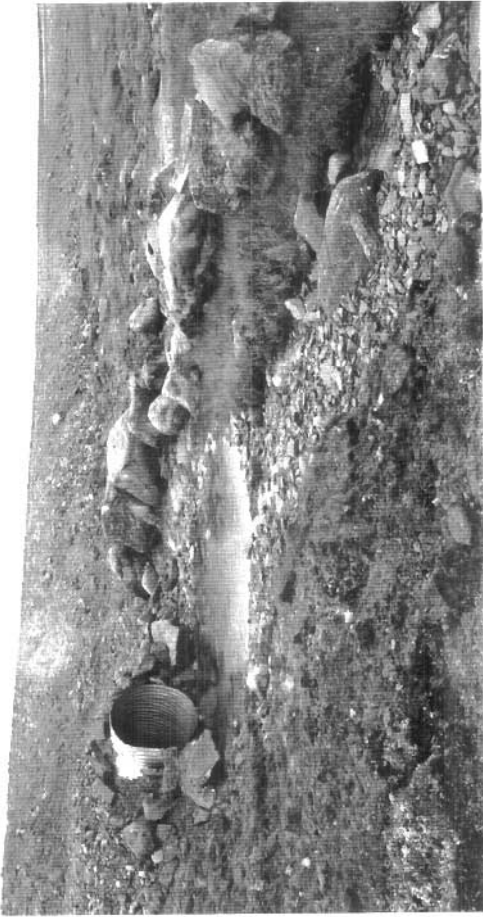
Plate 1 Km 18 Culvert, 7 August 2002. Resting pool on downstream end of culvert. Note: the deflecting dyke situated outside of wetted channel and very little flow through the culvert and in downstream channel.

To ensure that the culvert does not begin to "hang" and prevent fish passage, this culvert should be inspected each year following the spring meltwater period. Also, water velocities in the culvert should be determined during the high flow period to address fish passage issues.

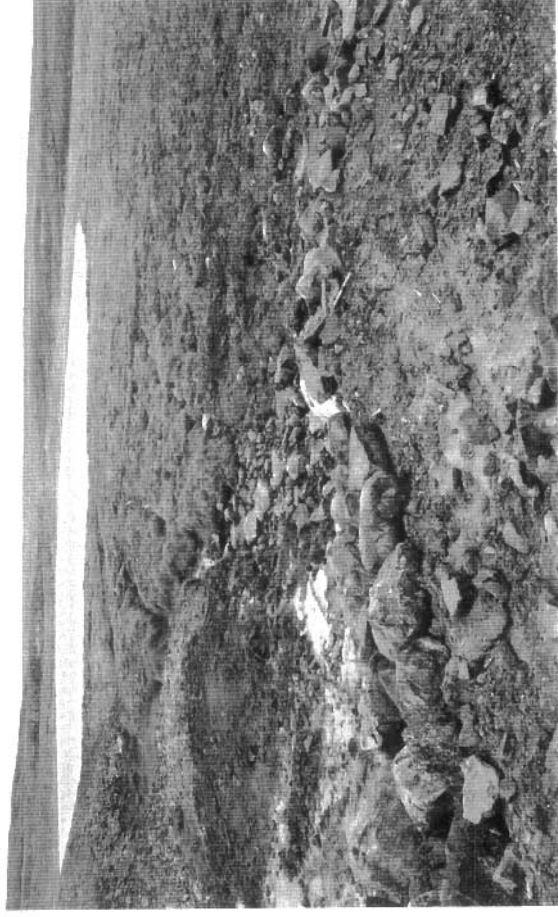
Plate 3 Km 18 Culvert, 7 August 2002. Outlet of headwater lake upstream of the culvert (upstream view). Note: very little water flowing through channel.

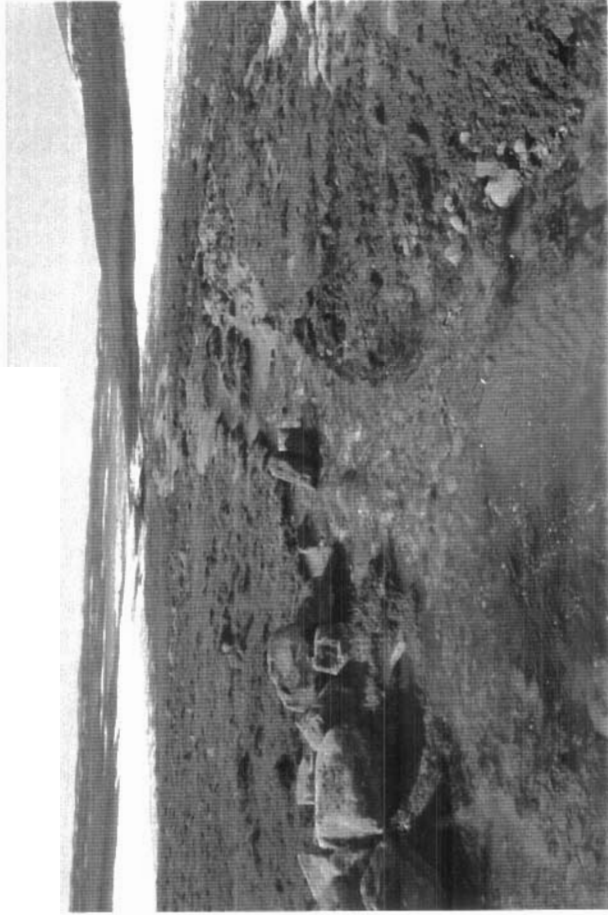
At high flows the deflective dyke was effective in creating a resting pool (Plates 5-7). It also aids in preventing water from dispersing over the tundra as it exits the culvert (particularly on the left downstream bank area). At high flow, the area of the resting pool would be 22 m², and during the present survey the wetted area was 20 m². Maximum water depth in the pool was 0.54 m.

Plate 5 Km 18 Culvert, 30 June 2002. Resting pool on downstream end of culvert during high flow. Note: flowing water allowing fish passage to and from the Alliarusiq River.

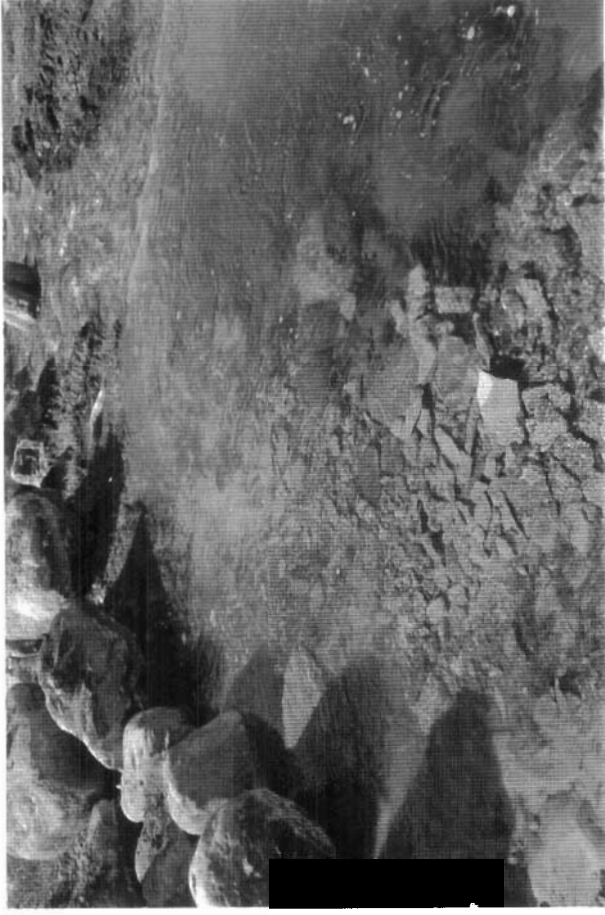
Plate 7 Km 18 Culvert, 30 June 2002. Resting pool downstream of culvert. Note: water up to edge of deflecting dyke.

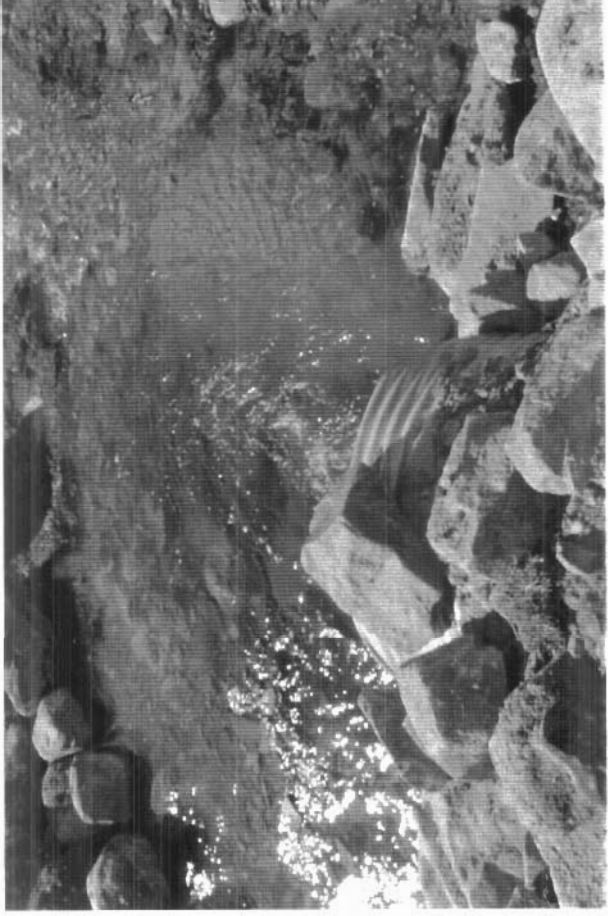
Plate 6 Km 18 Culvert, 30 June 2002. Resting pool on downstream end of culvert during high flow.

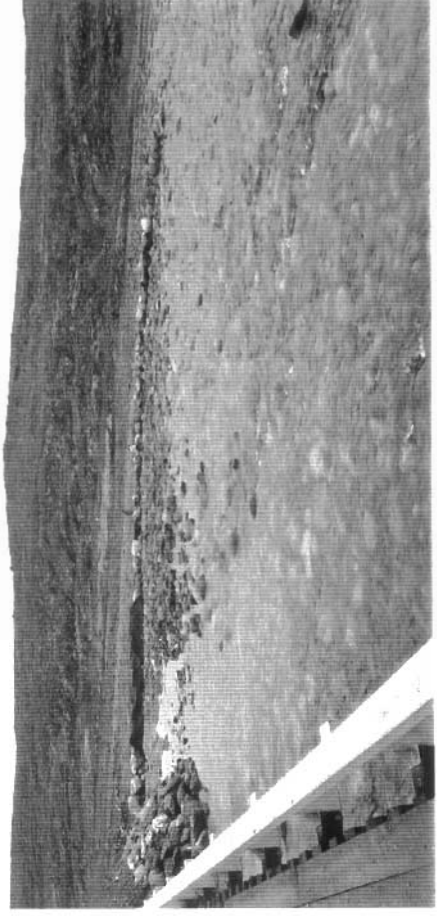
At the time of the survey (7 August), most of the spur dyke was located outside the wetted channel (Plates 8 and 9). Although this structure appeared to provide useable fish habitat at high flows (Plate 10), the effective period may be restricted to a two to three week window each year (end of June to beginning of July). During the August survey, there was evidence that a backwater habitat was present at higher flows (i.e., based on the deposition of fines observed at the upstream end of the spur). This backwater habitat was also evident in photos taken during late June of this year (Plate 10).

Plate 8 Second Bridge (Alliarusiq River), 7 August 2002. Spur dyke on left downstream bank below the bridge.

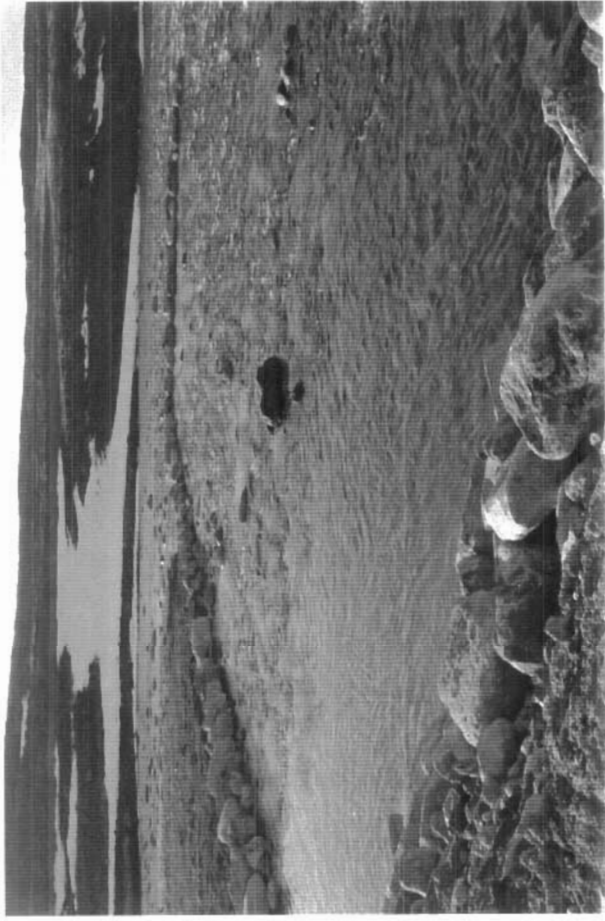
Plate 10 Second Bridge (Alliarusiq River), 30 June 2002. Spur dyke below bridge during high flow. Note: spur dyke is effective during this time period and has created a backwater holding area (bottom left).

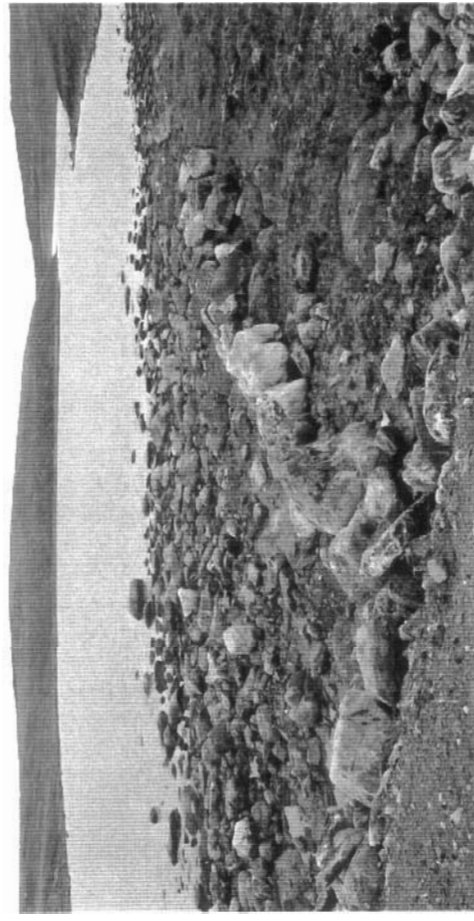
Plate 12 Second Bridge (Alliarusiq River), 7 August 2002. Spur dyke on left downstream bank above bridge. Note: during high flow, this structure may aid in preventing erosion to road bank, but likely does not provide fish habitat.

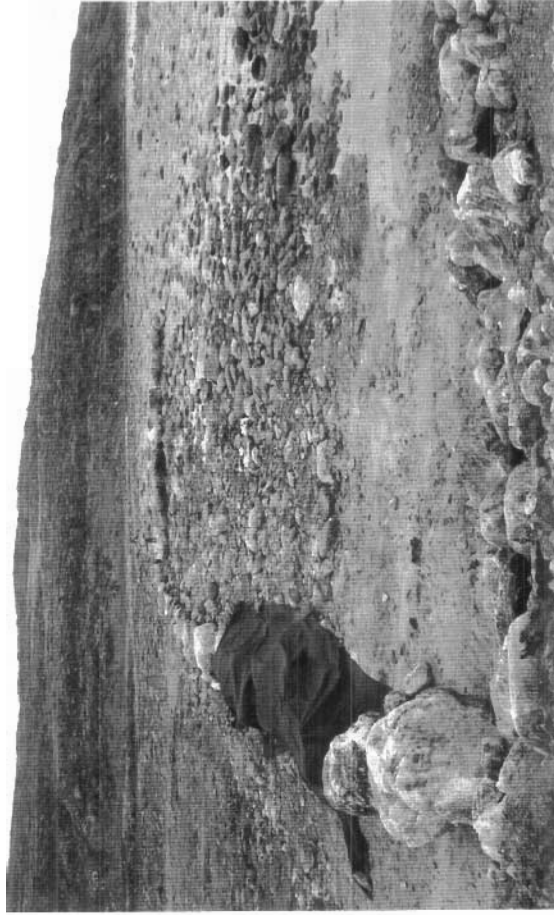
Plate 9 Second Bridge (Alliarusiq River), 7 August 2002. Spur dyke on left downstream bank below the bridge. Note: numerous young-of-year (y-o-y) char observed along the shoreline amongst boulders.

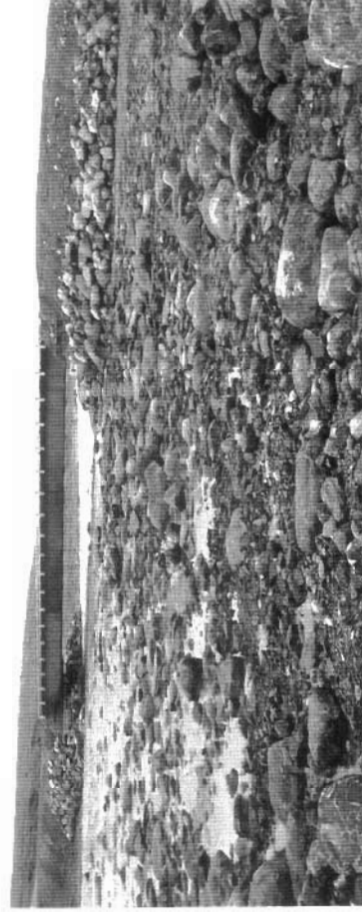
Plate 11 Second Bridge (Alliarusiq River), 7 August 2002. Upstream view of area of spur dyke which is dry. Note: boulder garden habitat along shoreline providing cover for y-o-y and juvenile fish in shallow water.

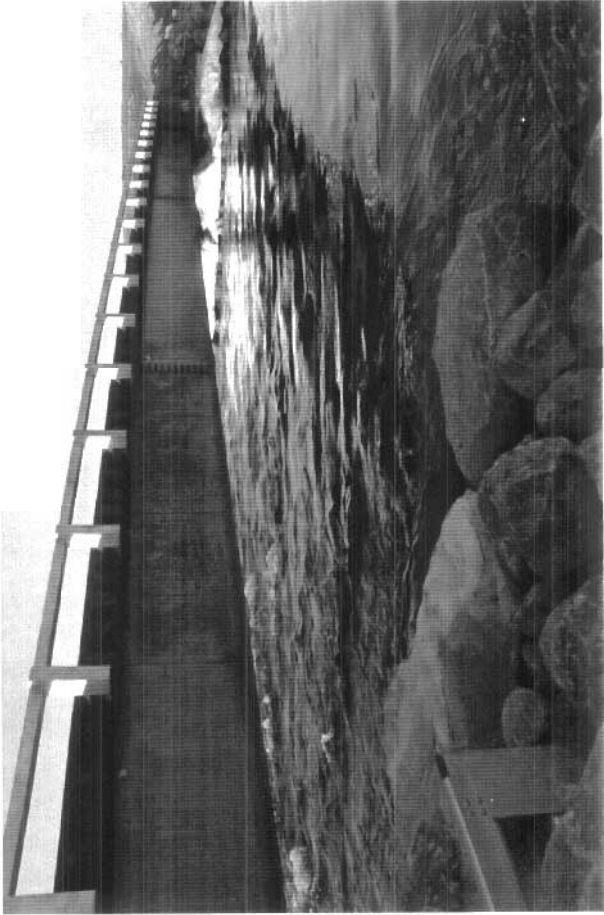
Plate 13 Second Bridge (Alliarusiq River), 30 June 2002. Photo indicating water level below the bridge during high flow.

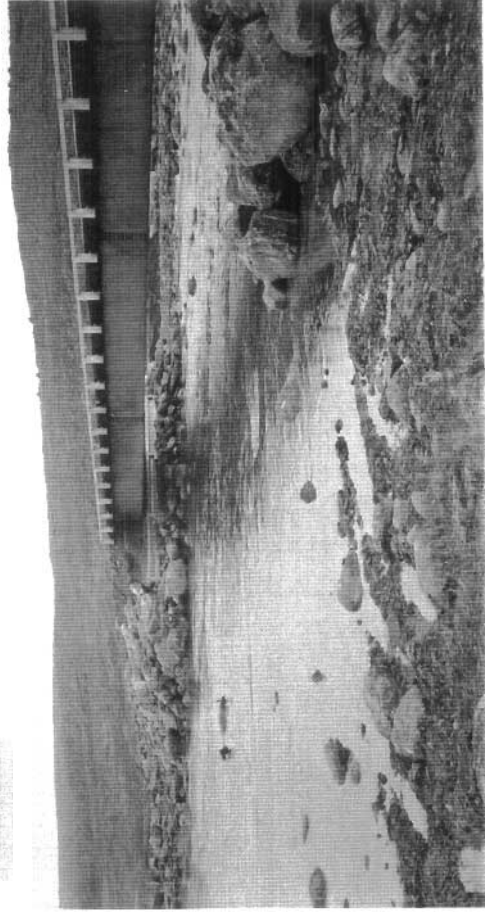
Plate 15 Second Bridge (Alliarusiq River), 7 August 2002. Snorkelling survey of the Alliarusiq River. Note: one adult lake trout (approx. 300 mm in length) was observed 100 m downstream of bridge.

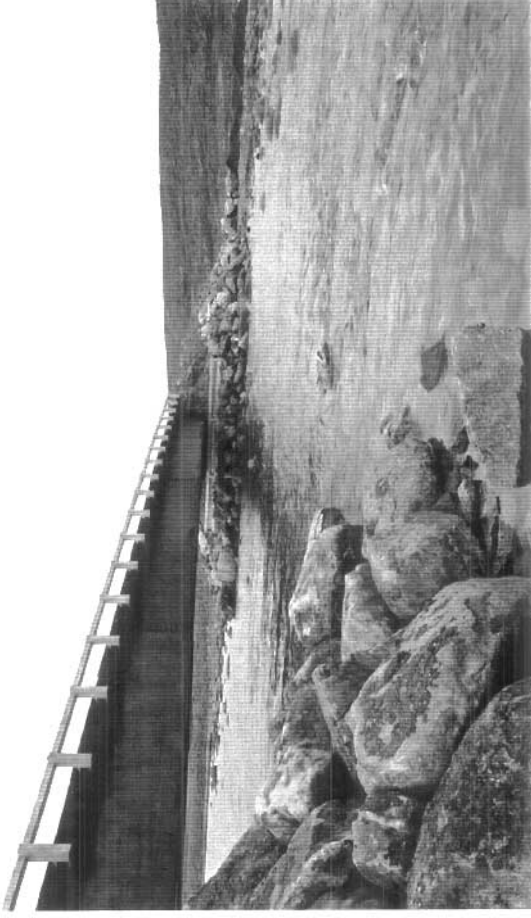
Plate 14 Second Bridge (Alliarusiq River), 7 August 2002. Photo indicating water level below the bridge during base summer flow.

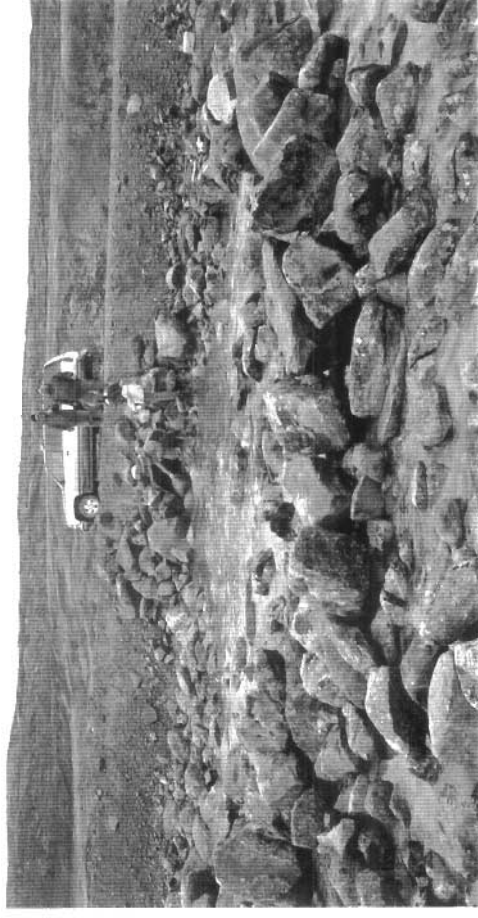
One culvert was in place at this site, although a second culvert is expected to arrive on the barge in September 2002 (pers. comm. Quinn Taggart, Senior Administrative Officer). At the time of the survey, the culvert appeared to be passable by fish (Plates 16 and 17); the culvert would likely to also be passable at high flows (Plate 18). The second culvert should be installed before the next spring melt to prevent water flowing over the road and introducing sediment into the stream. At high flows (30 June 2002, Plate 18) the culvert was almost entirely filled with water, and during August there was still water ponding on the upstream end of the culvert (Plates 19 and 20).

The deflective dyke appeared to assist in the development of the resting pool below the culvert (Plates 16 and 17). At the time of the survey (low flow), the area of the resting pool was 87 m². During higher flow periods (e.g., July), this pool could cover at least twice this area (i.e., 174 m²). Numerous y-o-y char (predominantly lake trout) were observed along the wetted perimeter of the resting pool, indicating that the structure was providing good quality rearing habitat at these flows. Placement of a few more large rocks (boulder/cobble) could be considered to provide additional cover in the middle of the pool. Good quality rearing habitat was also noted below the deflective dyke. This area was a dispersed boulder garden (25 m across the channel; Plate 17) and provided habitat for numerous y-o-y and a juvenile char.

Plate 16 Km 24 Culvert, 7 August 2002. Overflow channel between tributary to the Alliarusiq River and Barrow Lake. Photo of resting pool at downstream end of culvert. Note: placement of boulder (foreground) in a semi-circle formation which aids in holding water in the pool.

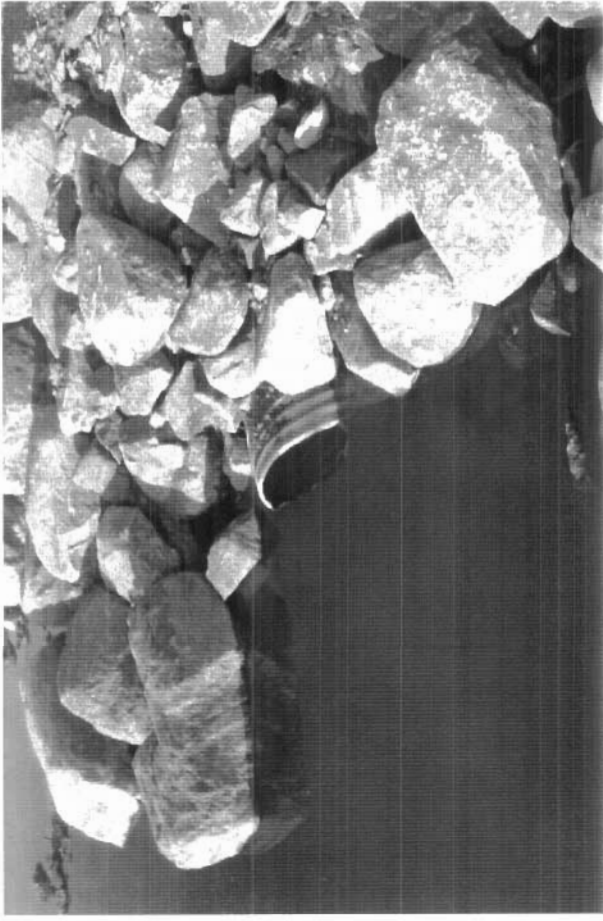
Plate 18 Km 24 Culvert, 30 June 2002. Ponding of water on upstream side of culvert. Note: additional culverts are needed to maintain flow between the river and the lake. Fish passage possible through the culvert.

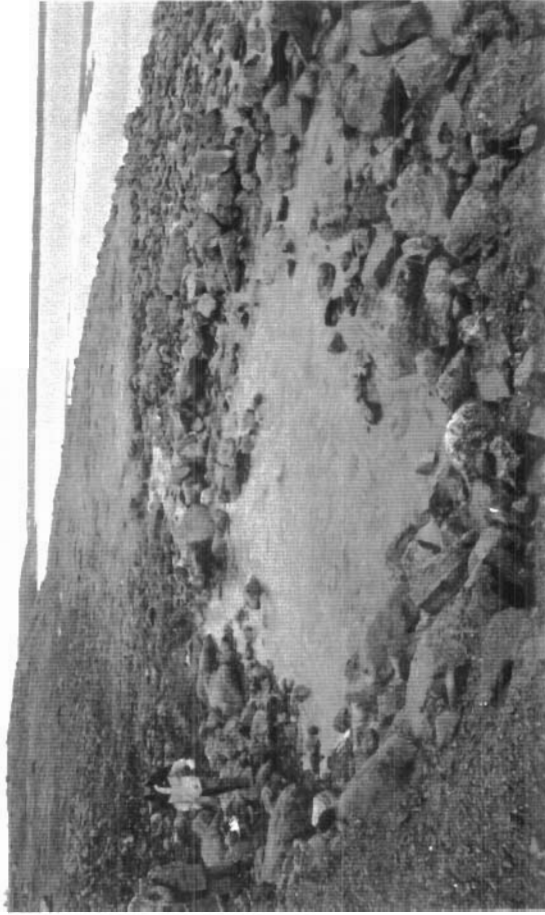
Plate 17 Km 24 Culvert, 7 August 2002. Resting pool below culvert. Note: numerous y-o-y char were observed inside and outside of resting pool area. Most fish observed were located along the edge of the pool.

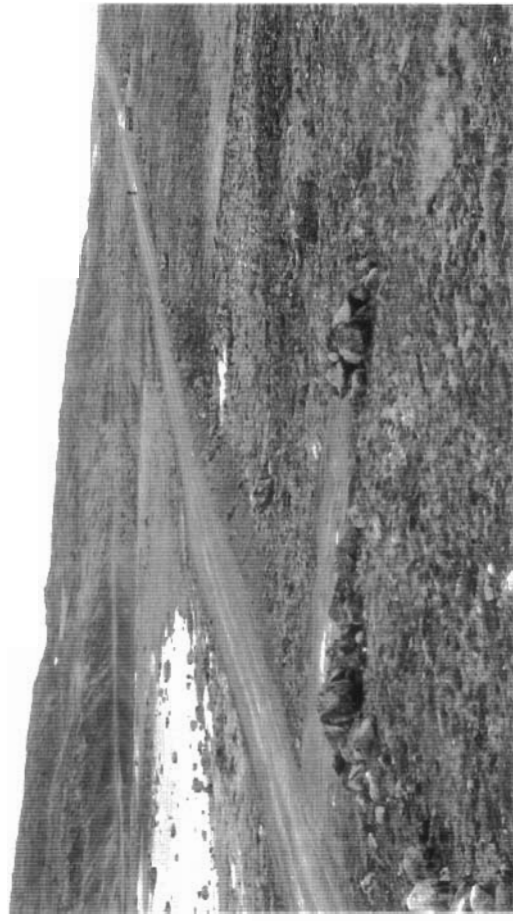
Plate 20 Km 24 Culvert, 7 August 2002. Overview photo of culvert crossing at the overflow channel to Barrow Lake. The resting pool is located on the right side of the road.

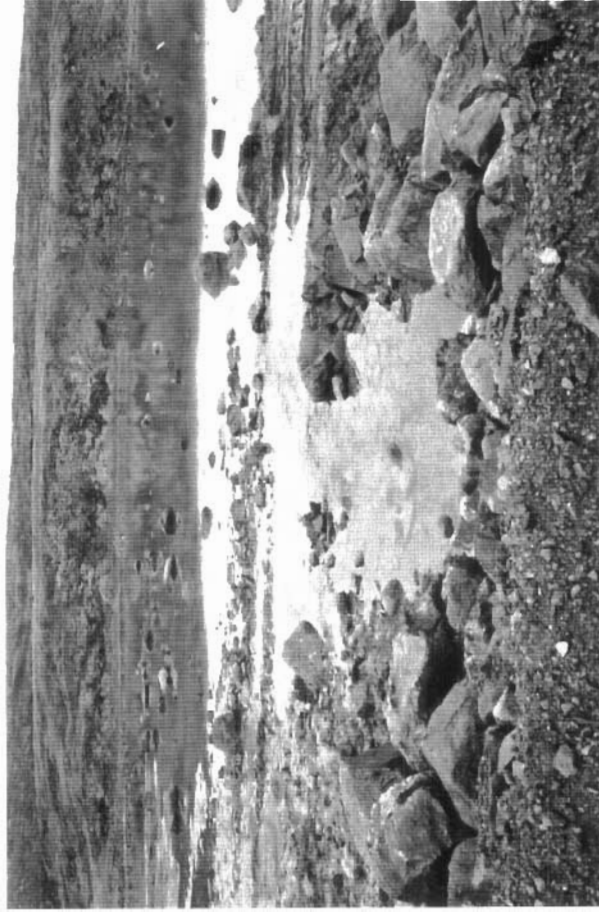
Plate 19 Km 24 Culvert, 7 August 2002. Upstream end of culvert. The river in the background is in a lowland area and has very little flow.
