**Re: OTT-00020662-A0      Slope Inspection  
Waste Water Treatment Facility  
Pond Inlet, Nunavut**

Company: Government of Nunavut  
Re: Slope Inspection – Waste Water Treatment Facility  
Pond Inlet, Nunavut  
Project Number: OTT-00020662-A0  
Date: July 18, 2011

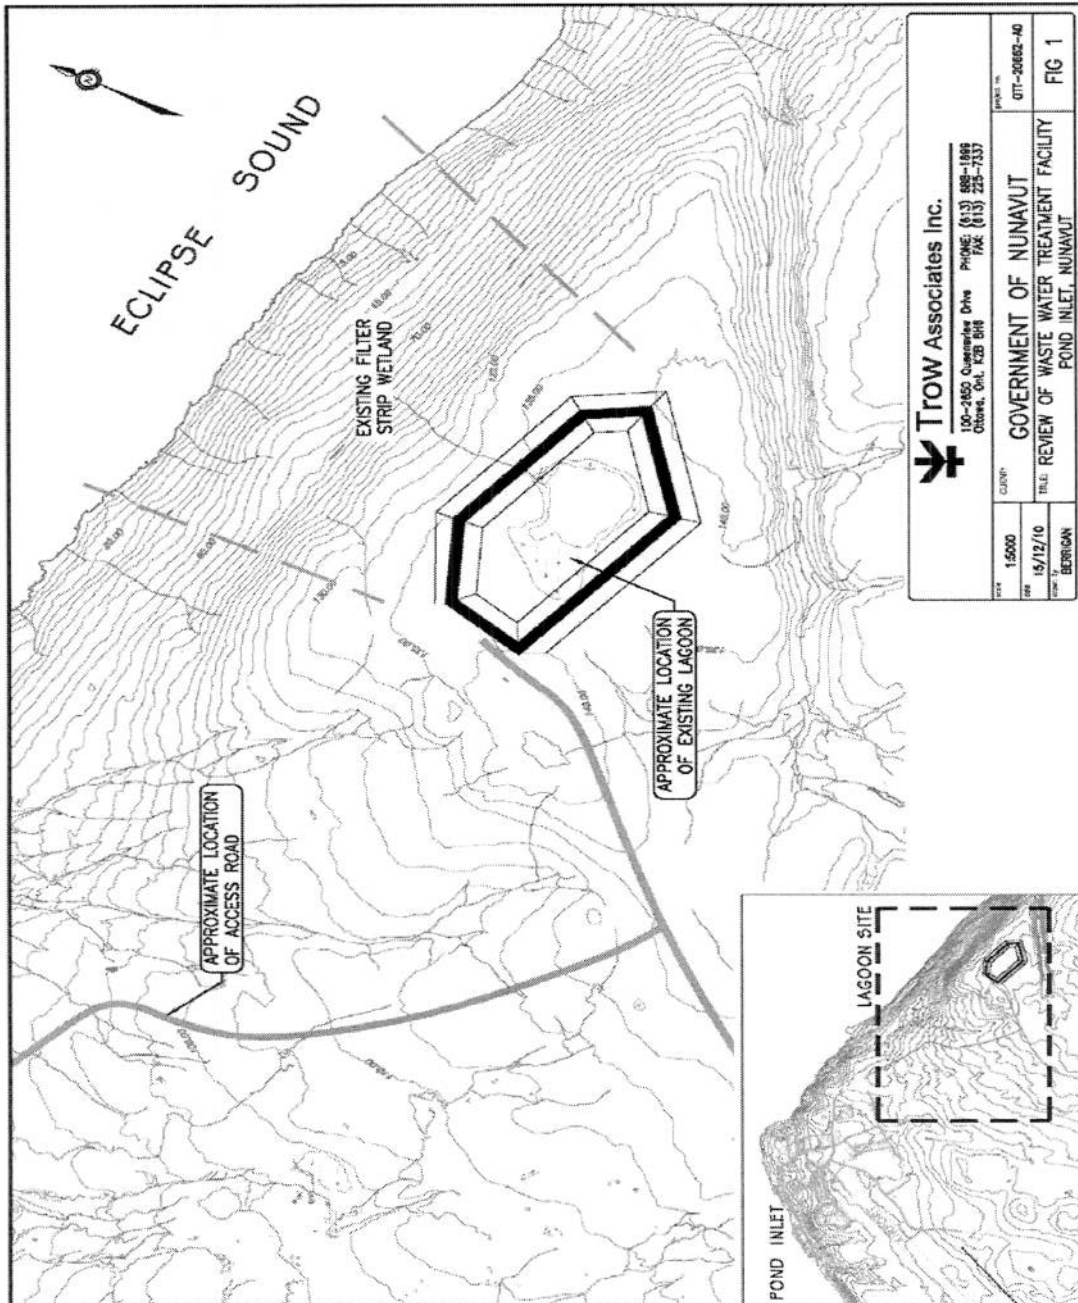
Available information indicates that the lagoon is located in a low spot with higher ground on the east, south and west sides. The site was previously a natural pond prior to the construction of the lagoon. The pond had an overflow to the north which drained to the Ocean (Figure 1). It is noted that prior to the 2003/2004 rehabilitation, ponding of the water immediately outside the east end of the south dyke was observed.

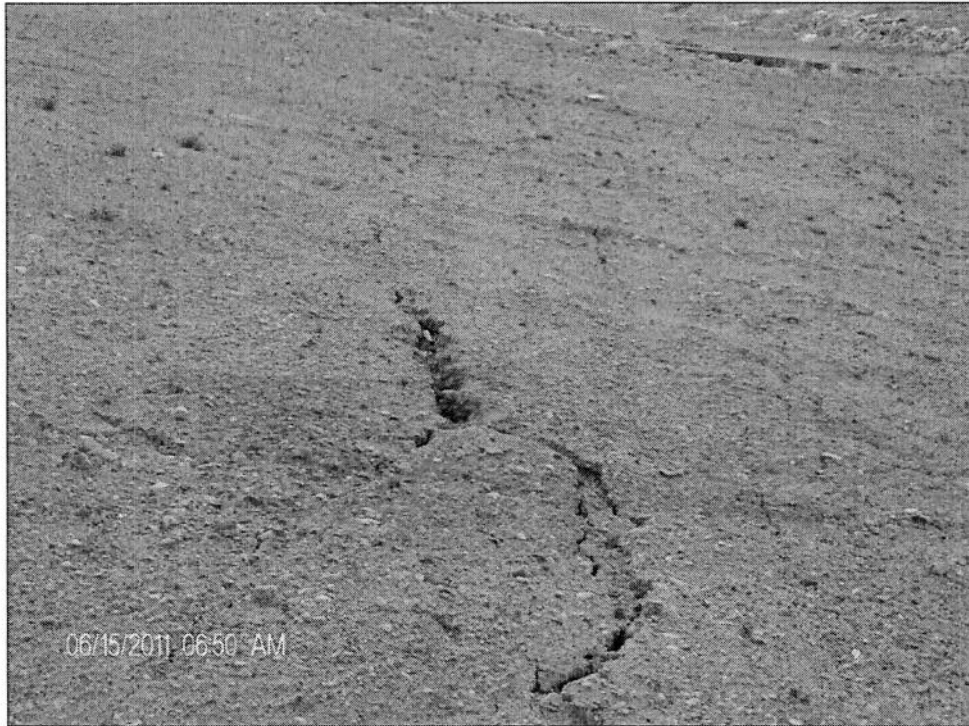
A visual review of the lagoon was undertaken. It revealed that the north berm is sliding downhill. A number of longitudinal cracks have developed in the downstream slope of the north berm. These cracks are parallel to the toe of the berm and are located in the bottom third height of the berm. In addition, some settlements of the crest of the berm were also observed.

The onsite observations confirm that the exterior slope of the north berm is unstable and prone to downhill movement. As indicated previously, in our report, the most likely cause of sliding of the north berm is seepage under the berm. The flow of subsurface water under the sewage lagoon is likely to have degraded the permafrost under the berm thereby causing settlements and cracking of the berm.

Photo 1: Longitudinal cracks in north berm at east end close to toe of berm.

It is considered that the berm is in a state of 'incipient' failure and measures should be undertaken as soon as possible to stabilize the berm. Any attempt to stabilize the berm by merely flattening the slope is not expected to be successful since steady seepage under the berm would result in continued cracking and downhill movement of the berm due to degradation of the permafrost until it eventually fails. However, temporary remedial measure of placing additional material close to the toe of the berm to create a bench is recommended since it will temporarily increase the stability of the berm.

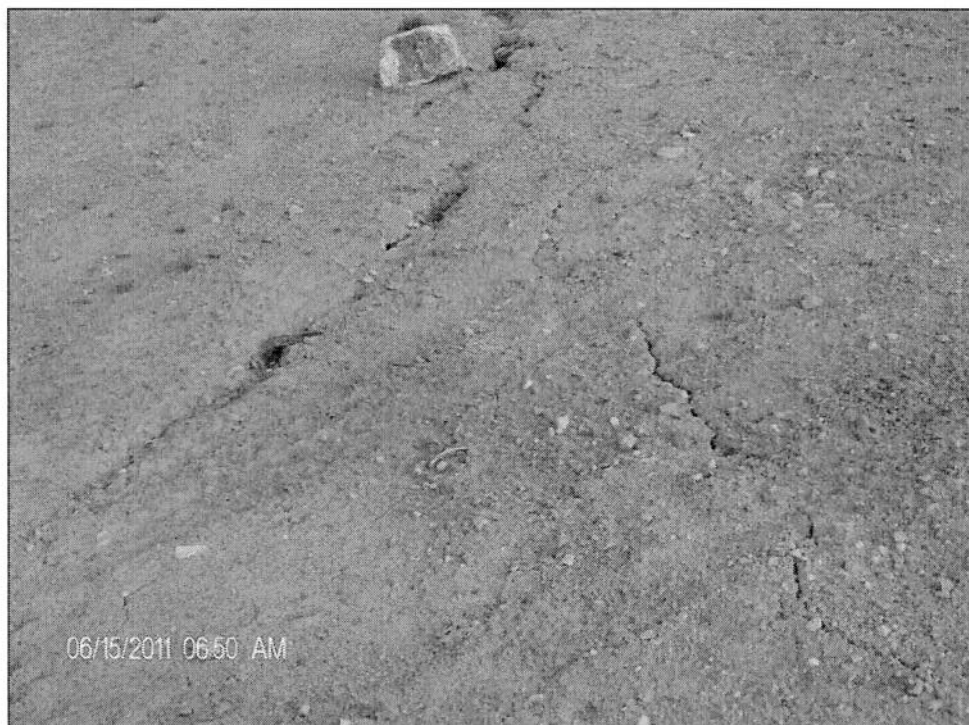
Photo2 : Longitudinal cracks in north berm at east end close to toe of berm.

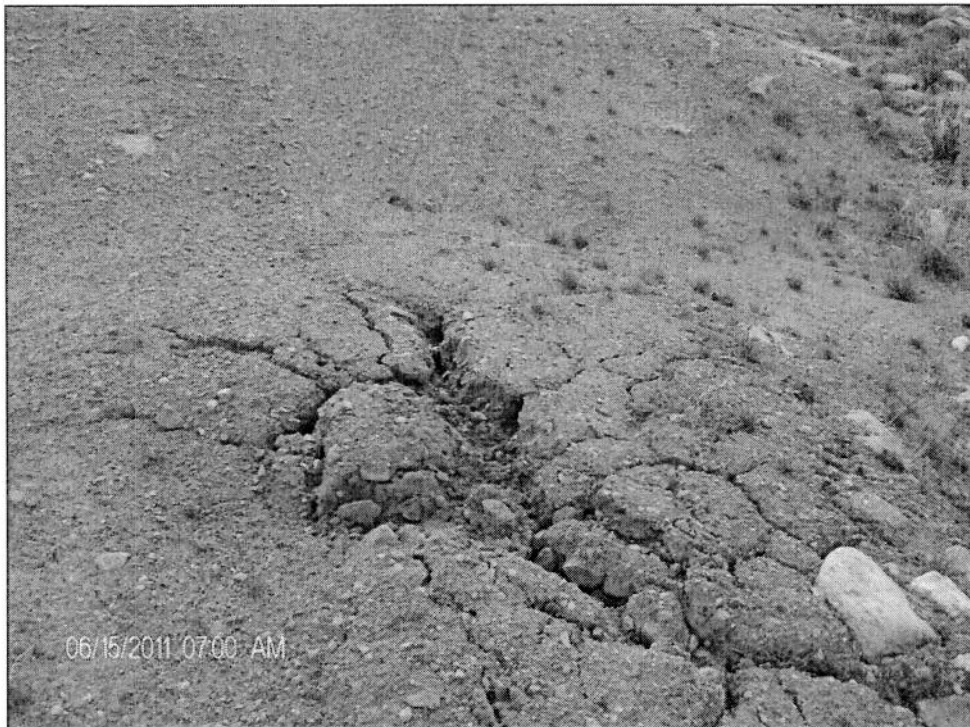
Photo 3: Longitudinal cracks in north berm extending from emergency flow to mid length of berm.

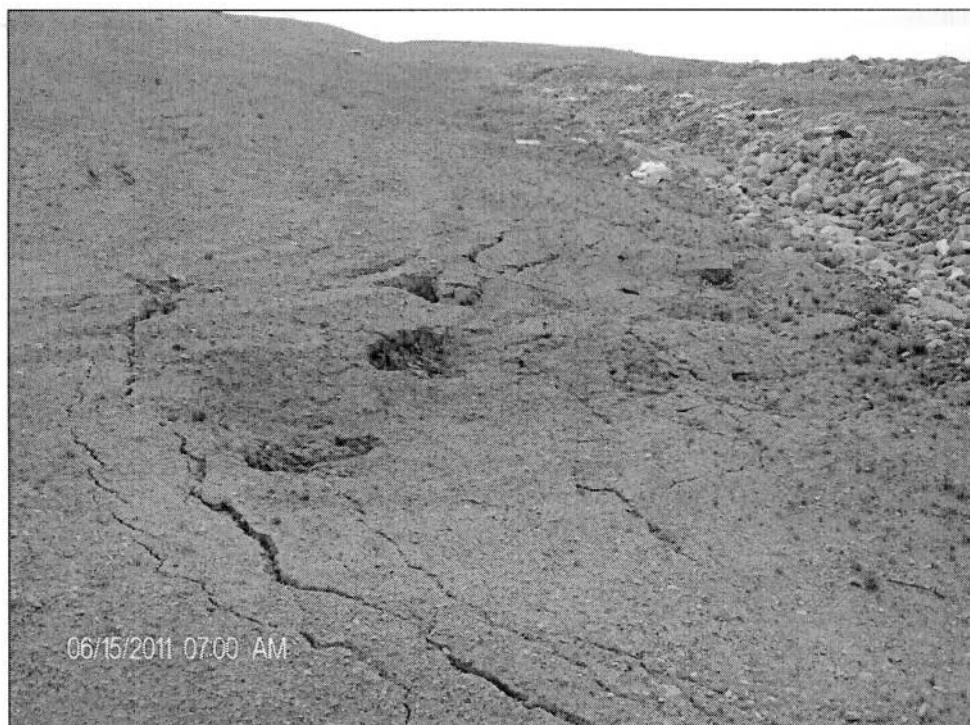
Photo 4: Longitudinal cracks in north berm extending from emergency flow to mid length of berm.

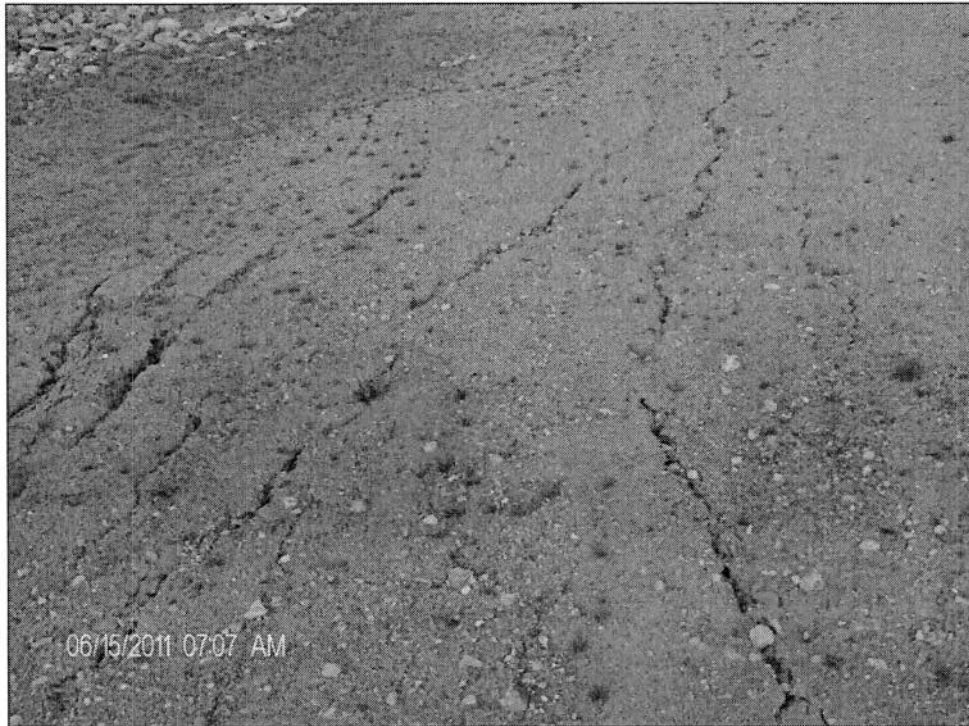
Photo 5: Longitudinal cracks in north berm extending from emergency flow to mid length of berm.

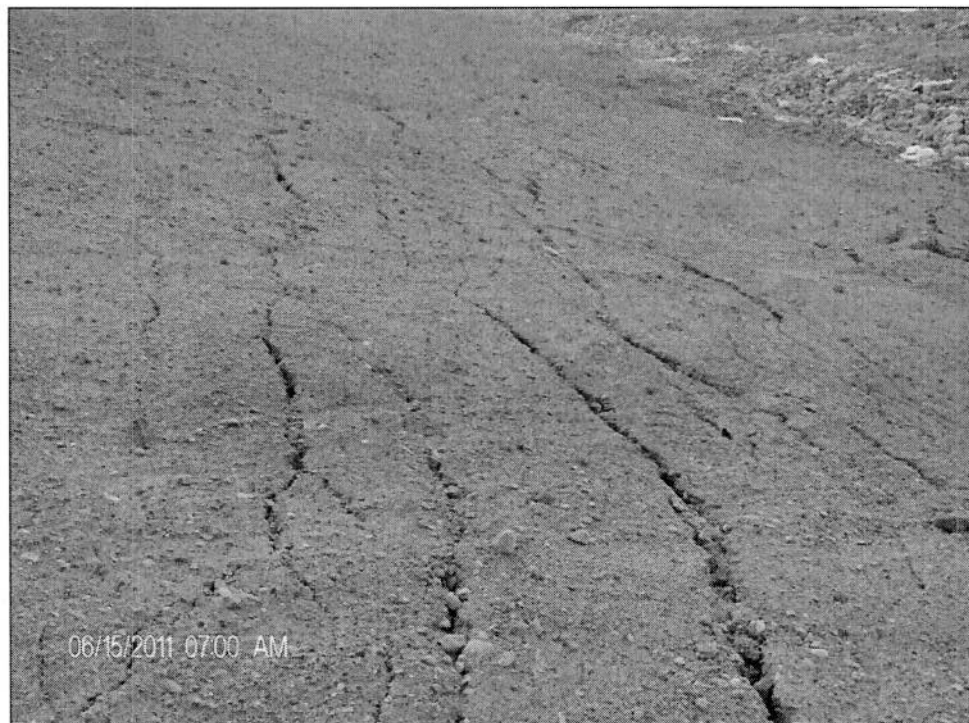
Photo 6: Longitudinal cracks in north berm extending from emergency flow to mid length of berm.

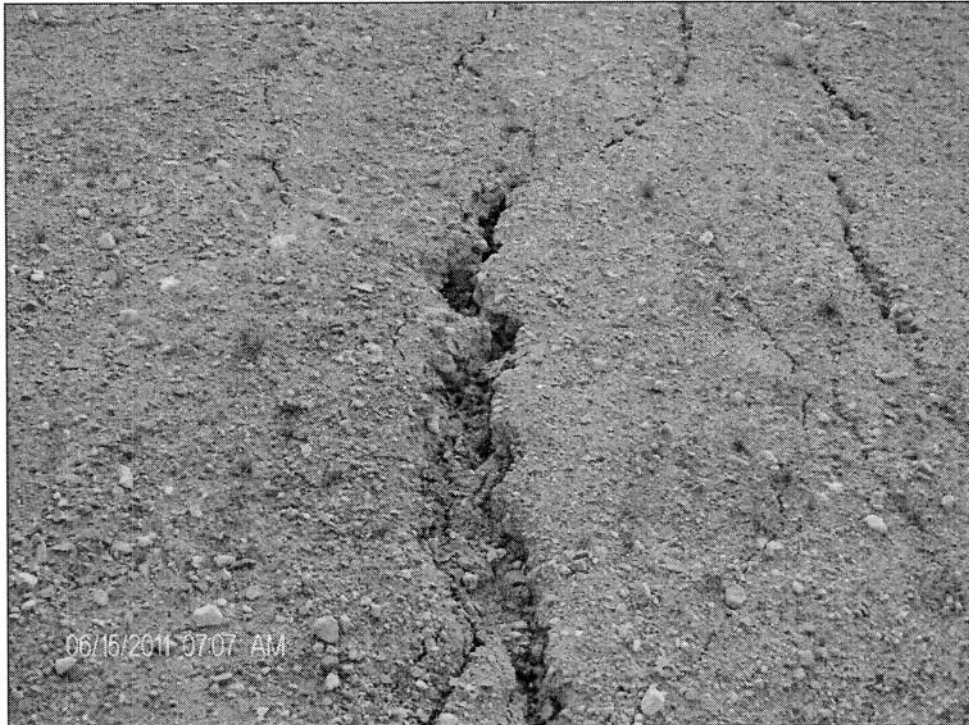
Photo 7: Longitudinal cracks in north berm extending from emergency flow to mid length of berm.

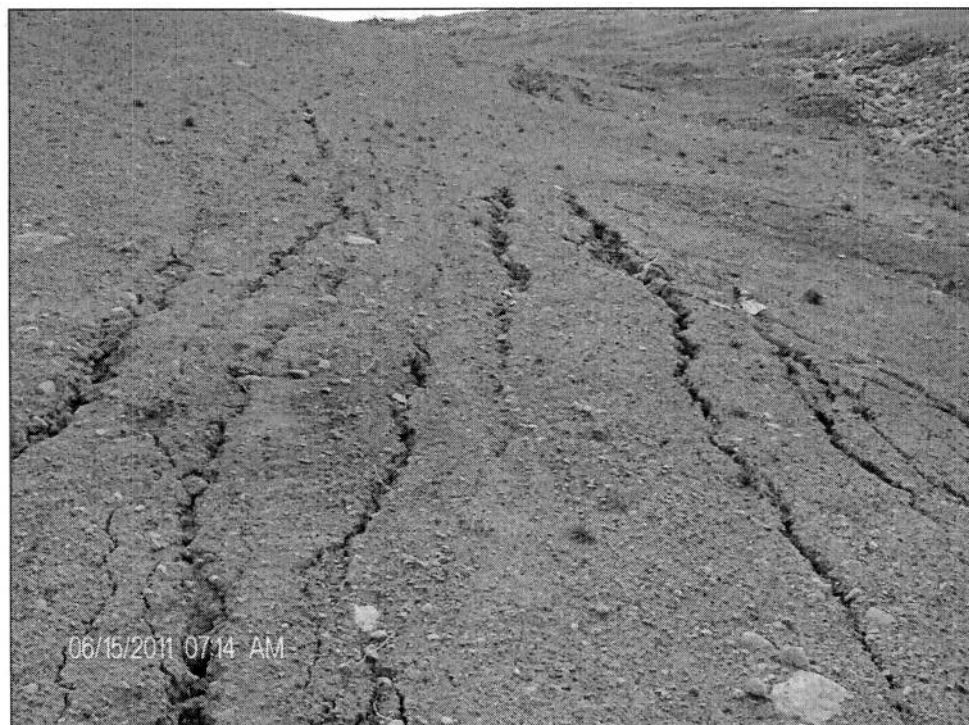
Photo 8: Longitudinal cracks in west half of the north berm close to toe of the berm.

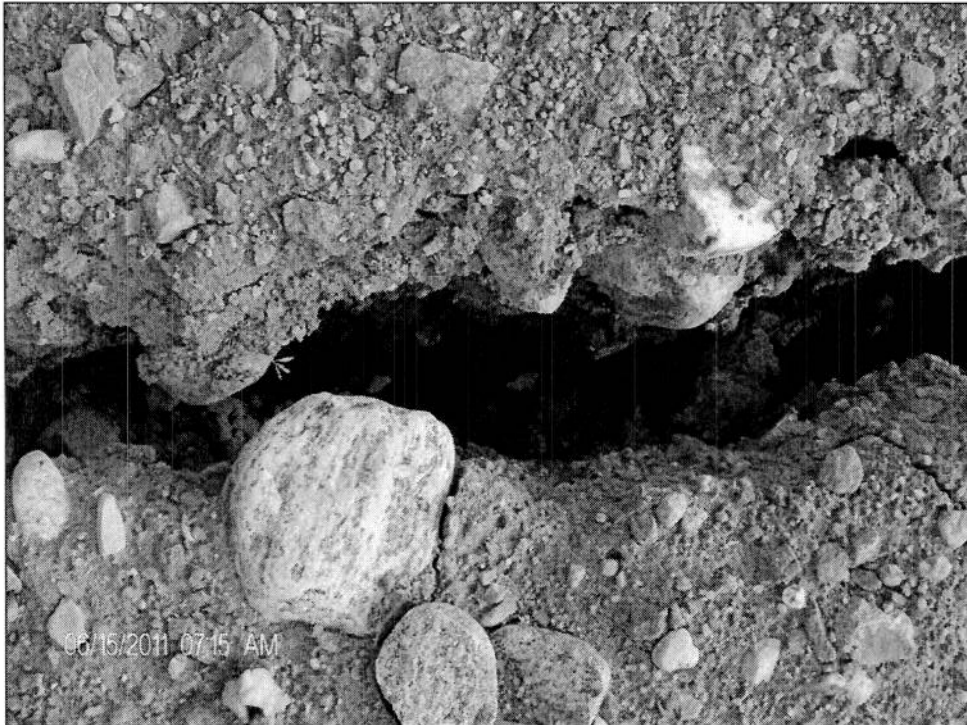
Photo 9: Longitudinal cracks in west half of the north berm close to toe of the berm.

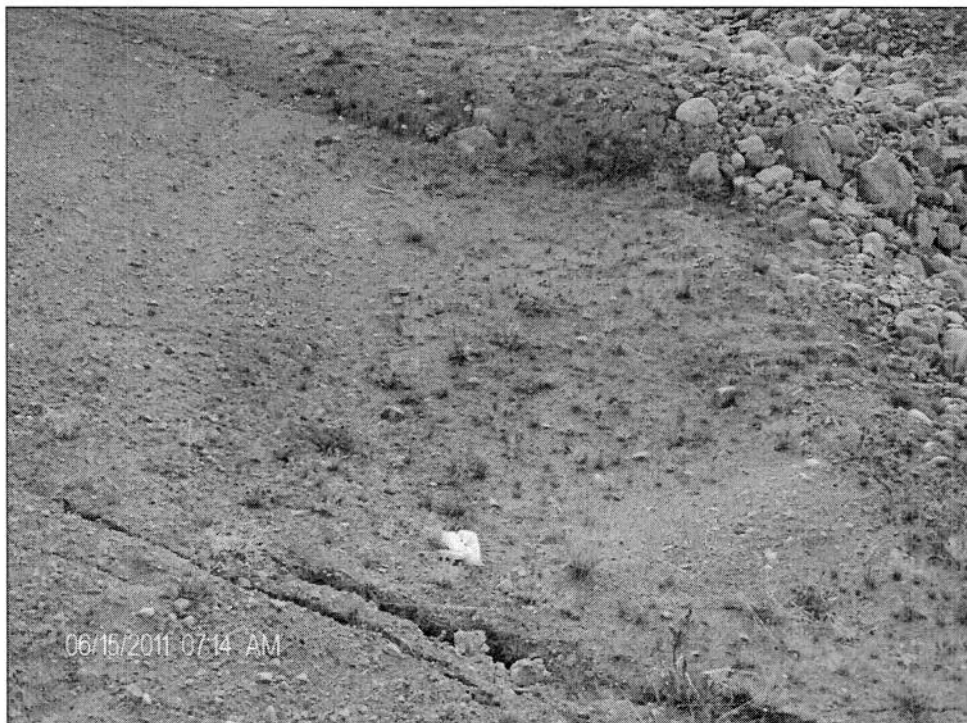
Photo 10: Longitudinal cracks in west half of the north berm close to toe of the berm.

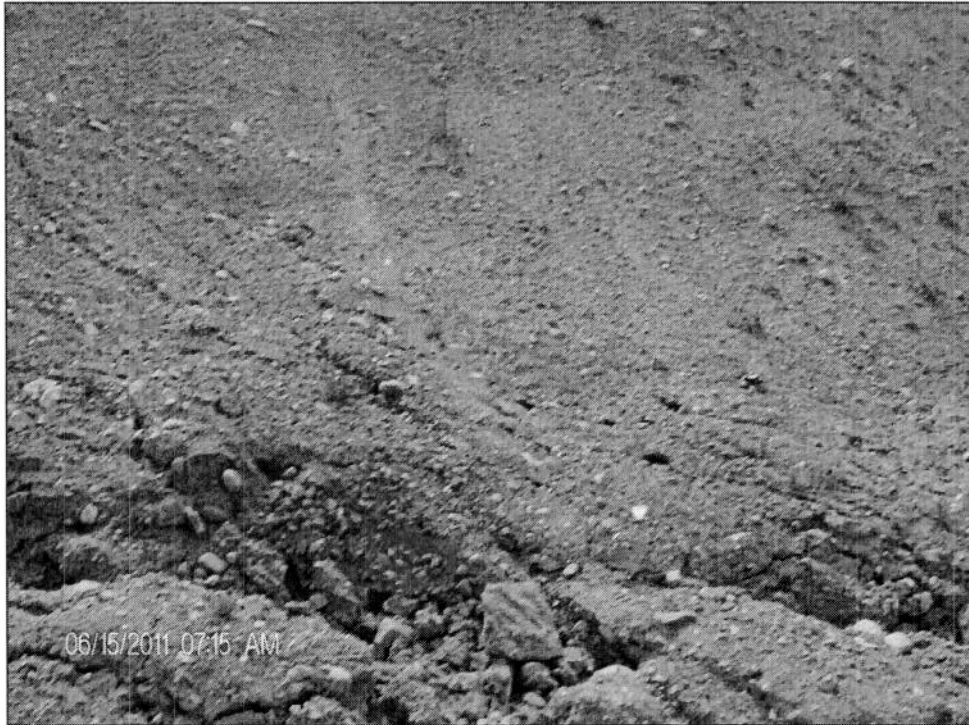
Photo 11: Longitudinal cracks in west half of the north berm close to toe of the berm.

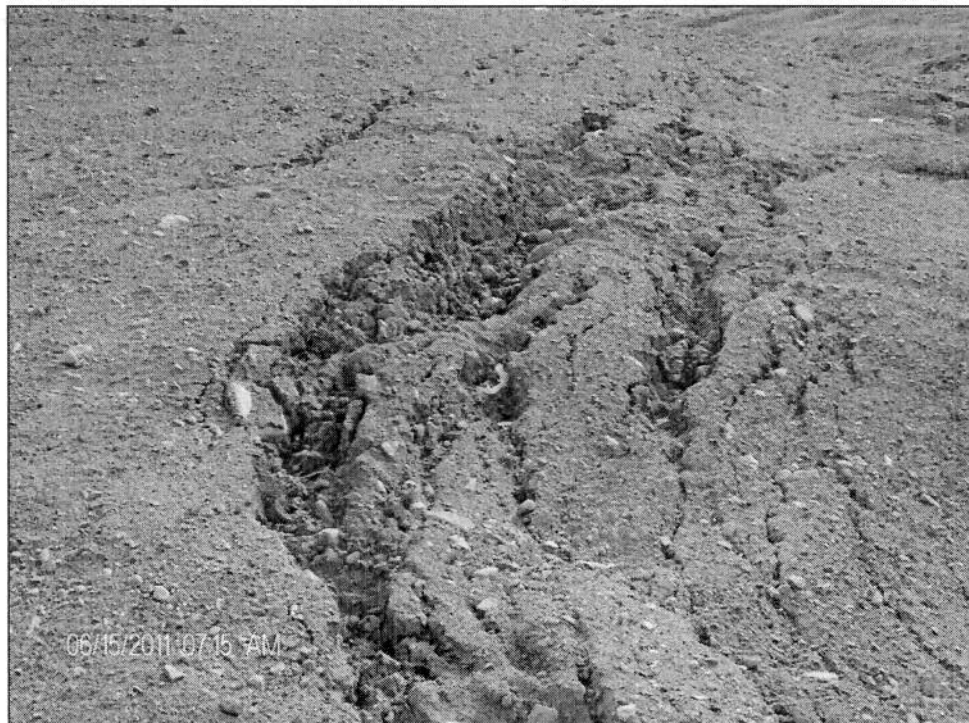
Photo 12: Longitudinal cracks in west half of the north berm close to toe of the berm.

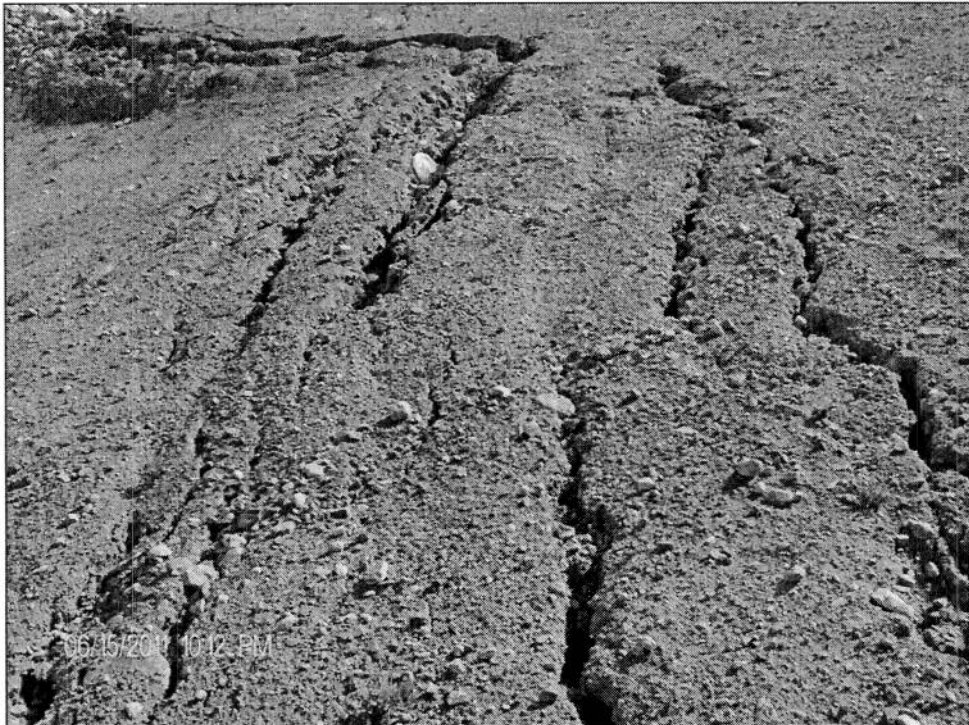
Photo 13: Longitudinal cracks in west half of the north berm close to toe of the berm.

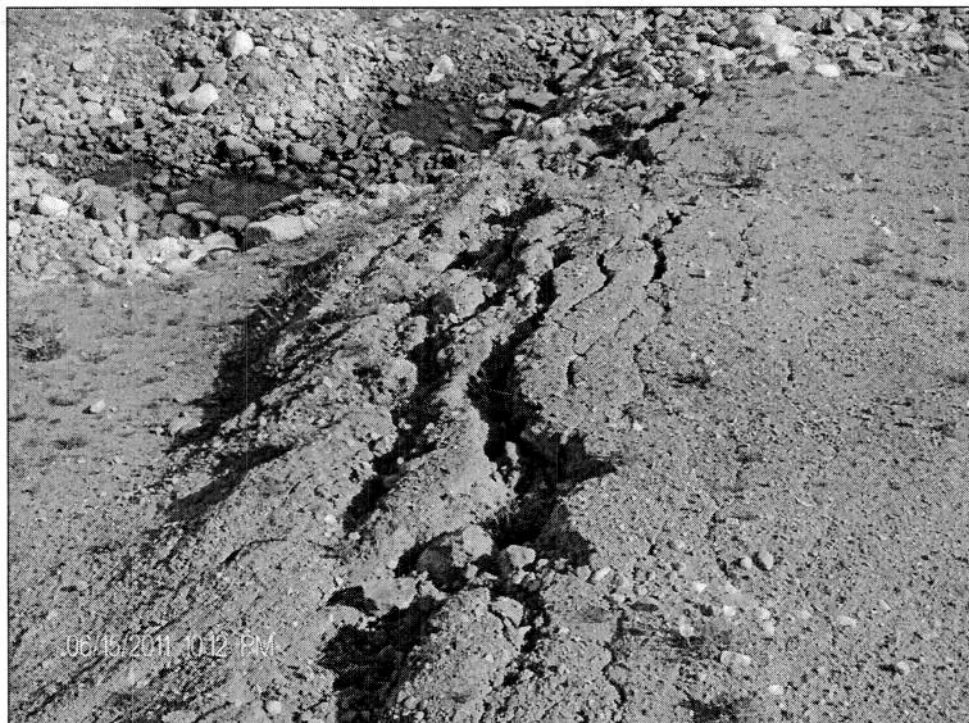
Photo 14: Longitudinal cracks in west half of the north berm close to toe of the berm.

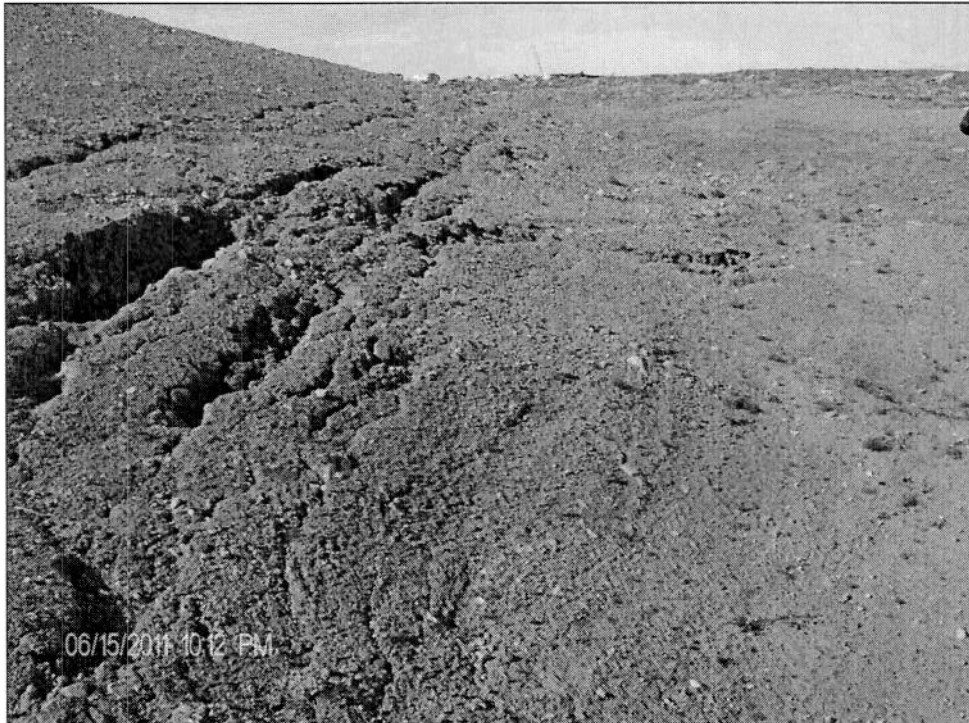
Photo 15: Longitudinal cracks in west half of the north berm close to toe of the berm.

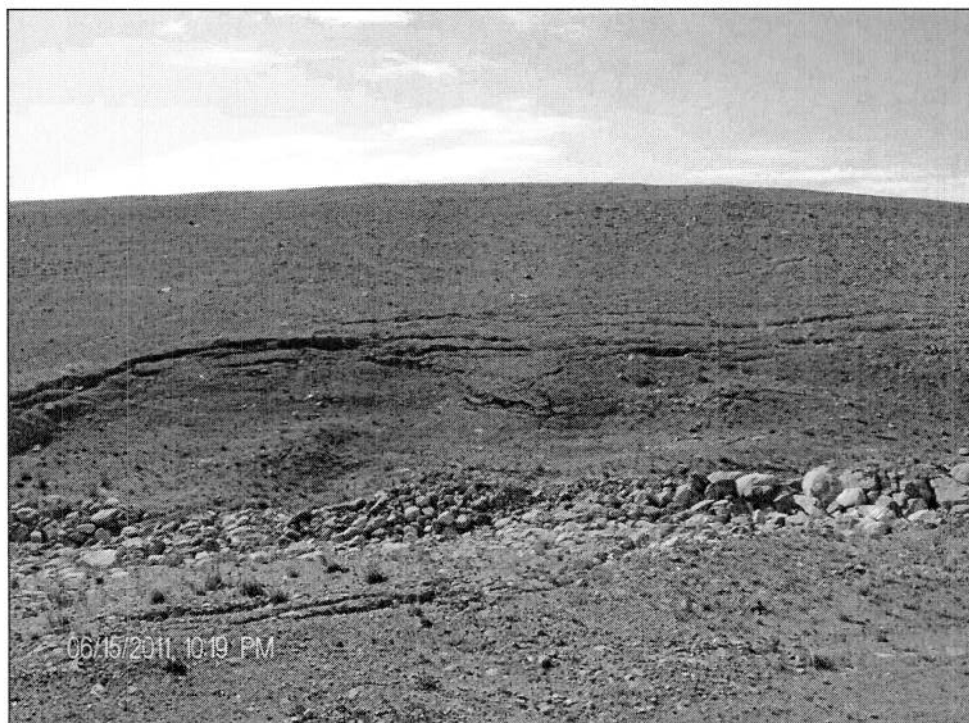
Photo 16: Longitudinal cracks in west half of the north berm close to toe of the berm.

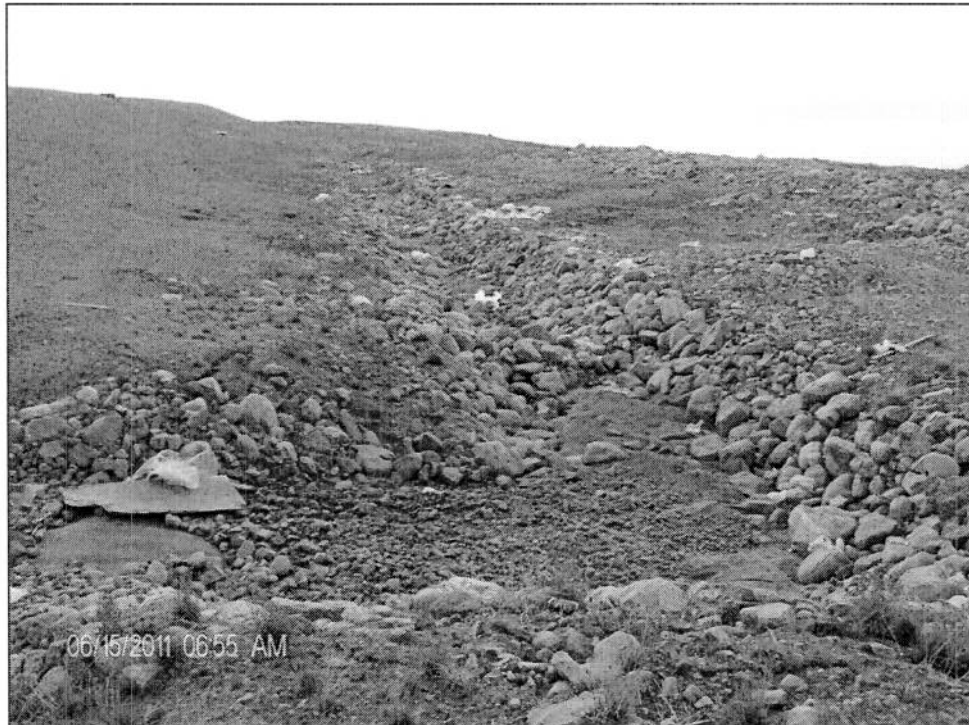
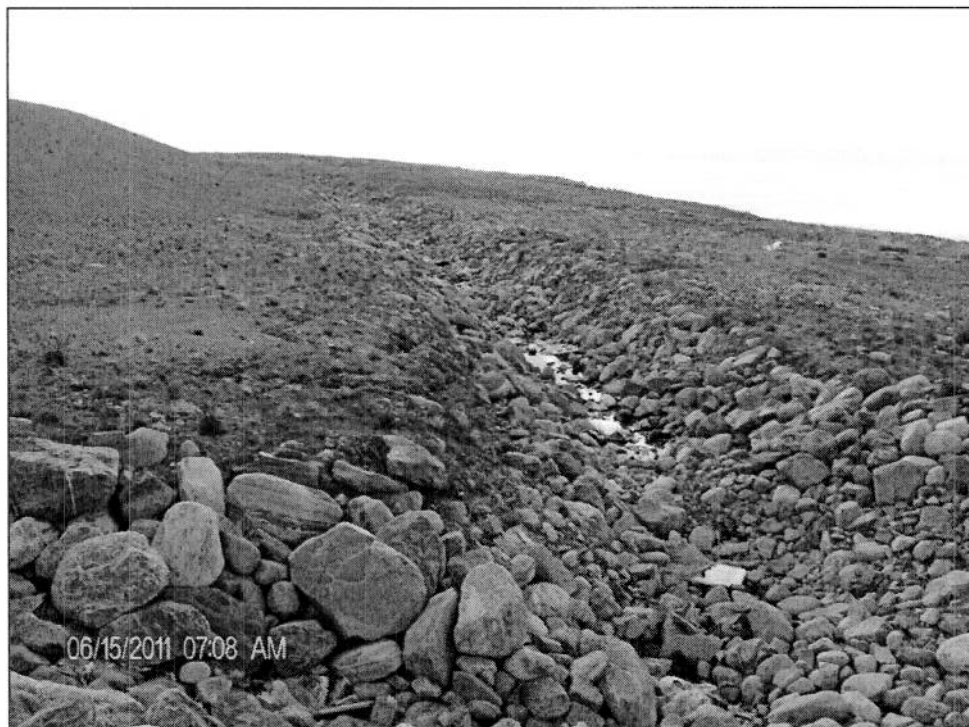
Progressive degradation of the permafrost under the lagoon is expected due to the continuous flow of subsurface water under the lagoon. The flow of water in the drainage ditch located at the toe of the north berm would also degrade the permafrost close to the toe of the berm. It is therefore considered that merely repairing the reported leakage of the liner of the lagoon is not a solution to the problem.

Photo 17: Drainage ditch at toe of north berm.

Photo 18: Drainage ditch at toe of north berm.

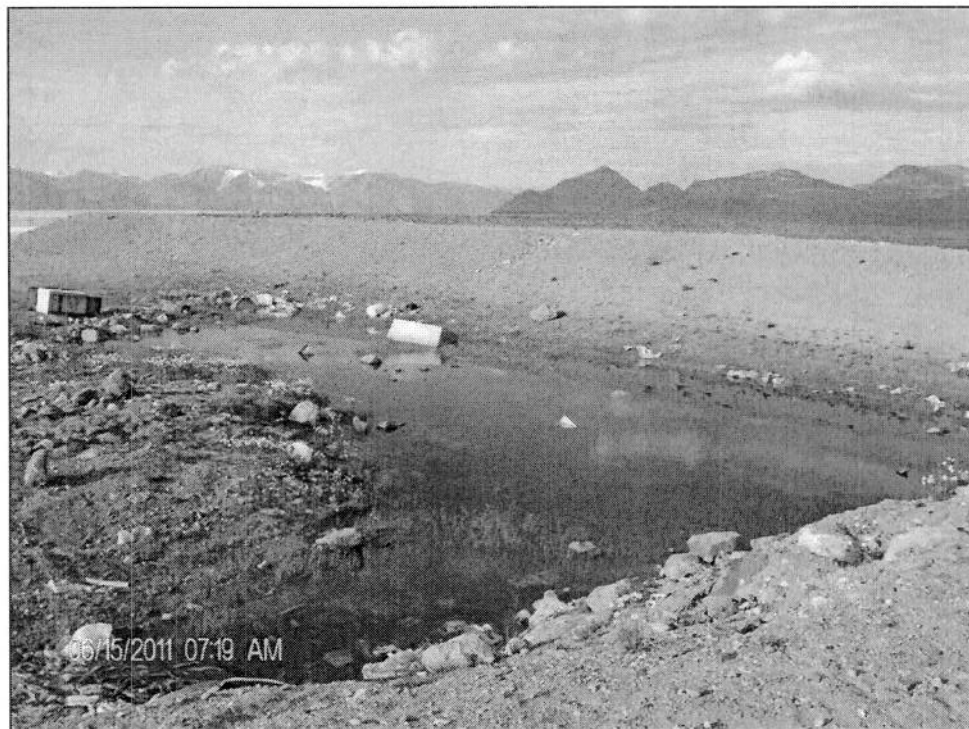
Photo 19: Ponded water close to southwest corner of lagoon.

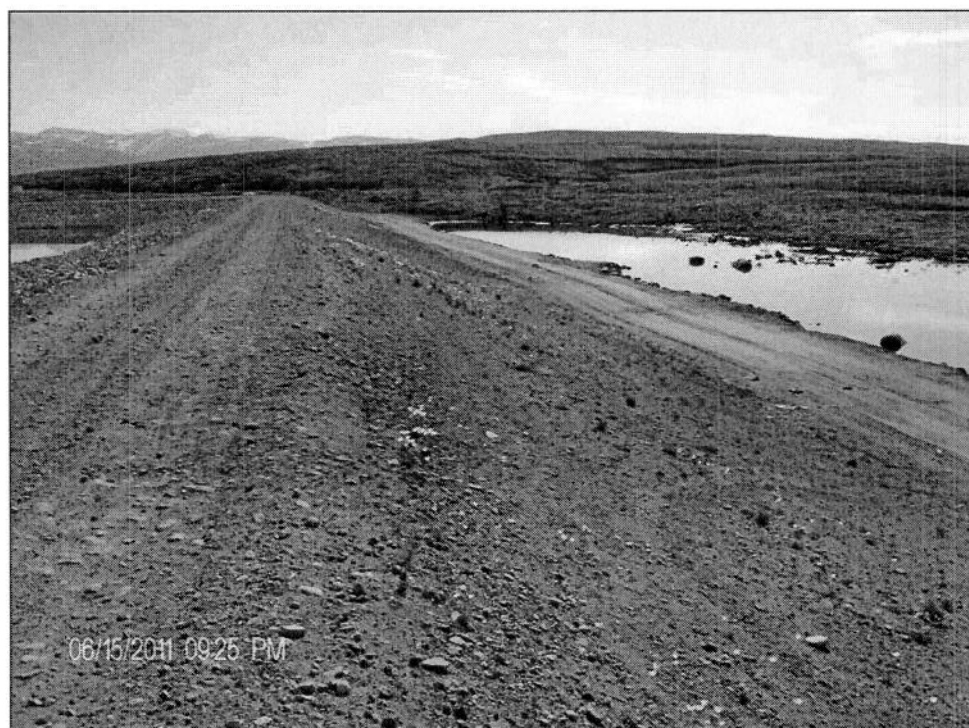
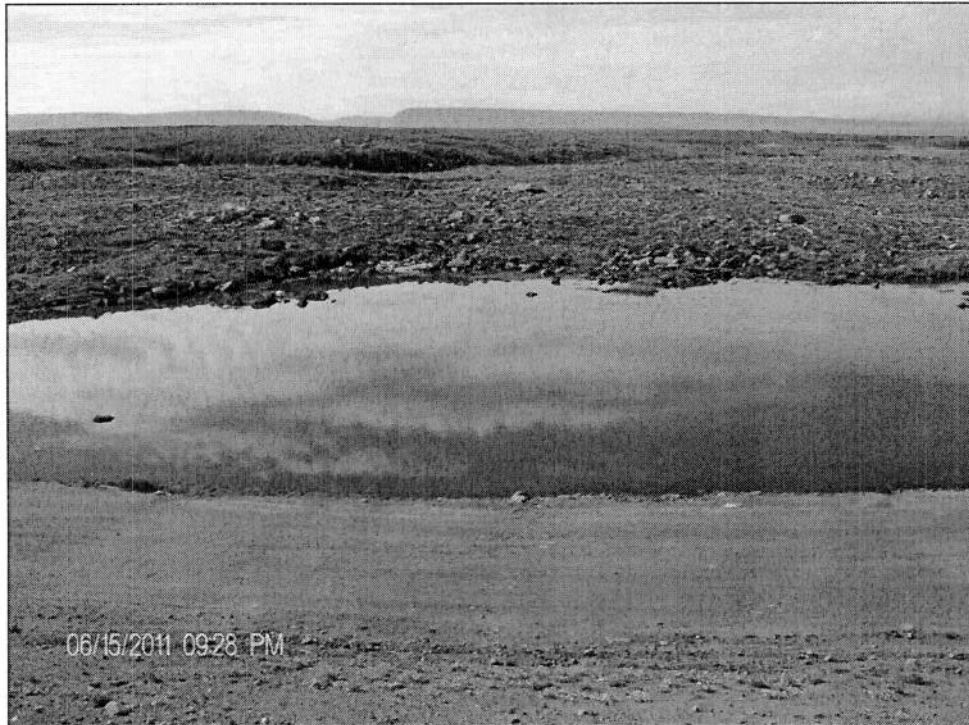
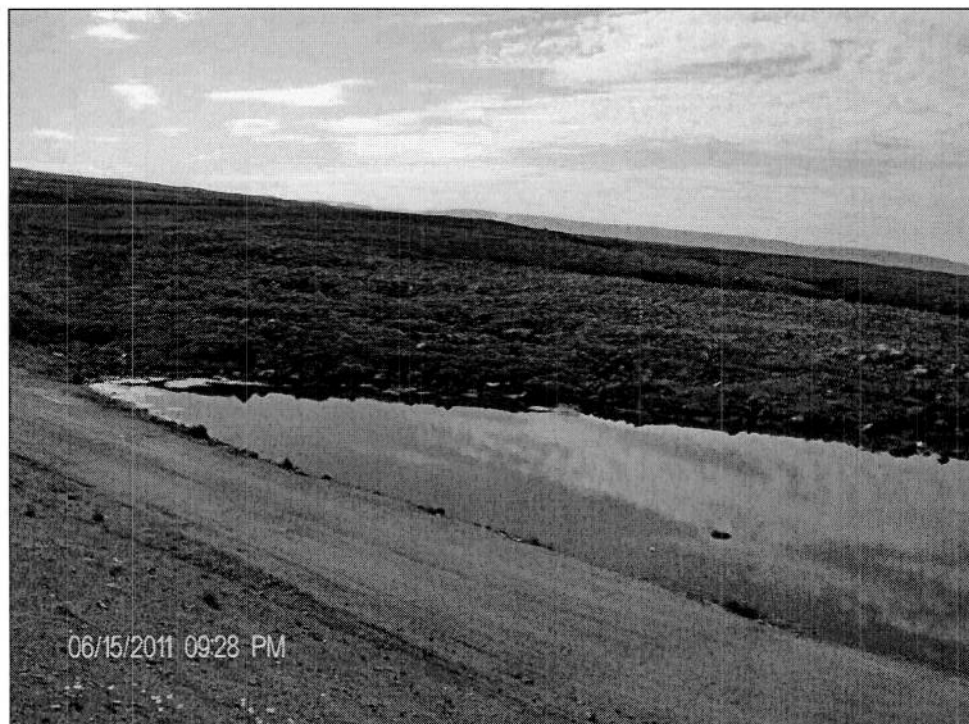
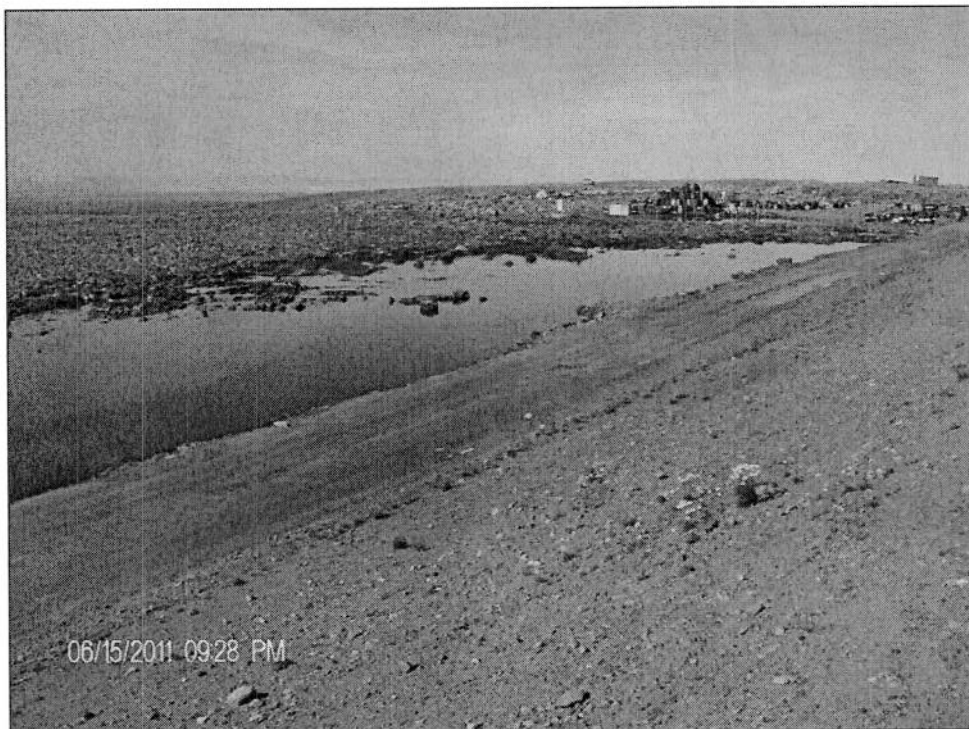
During the site visits of October 2010 and July 2011, ponding of the water close to the east end of the south berm and adjacent to the east berm close to its mid length was observed. It is recommended that this ponded water should be drained. This may be achieved by construction of a drainage ditch from the ponded area to the ravine located on the east side of the lagoon.

Photo 20: Ponded water close to southeast corner of lagoon.

Photo 21: Ponded water close to southeast corner of lagoon.

Photo 22: Ponded water close to southeast corner of lagoon.

Photo 23: Ponded water close to southeast corner of lagoon.
