June 26, 2001 Water Licence Inspection - Report

MUNICIPAL WATER USE INSPECTION FORM

Date: 2001/06/26 Licensee Rep. (Name/Title): Joanasie Naqitarvik / acting-Foreman
Licensee: Hamlet of Pond Inlet Licence No.: NWB3PON9904

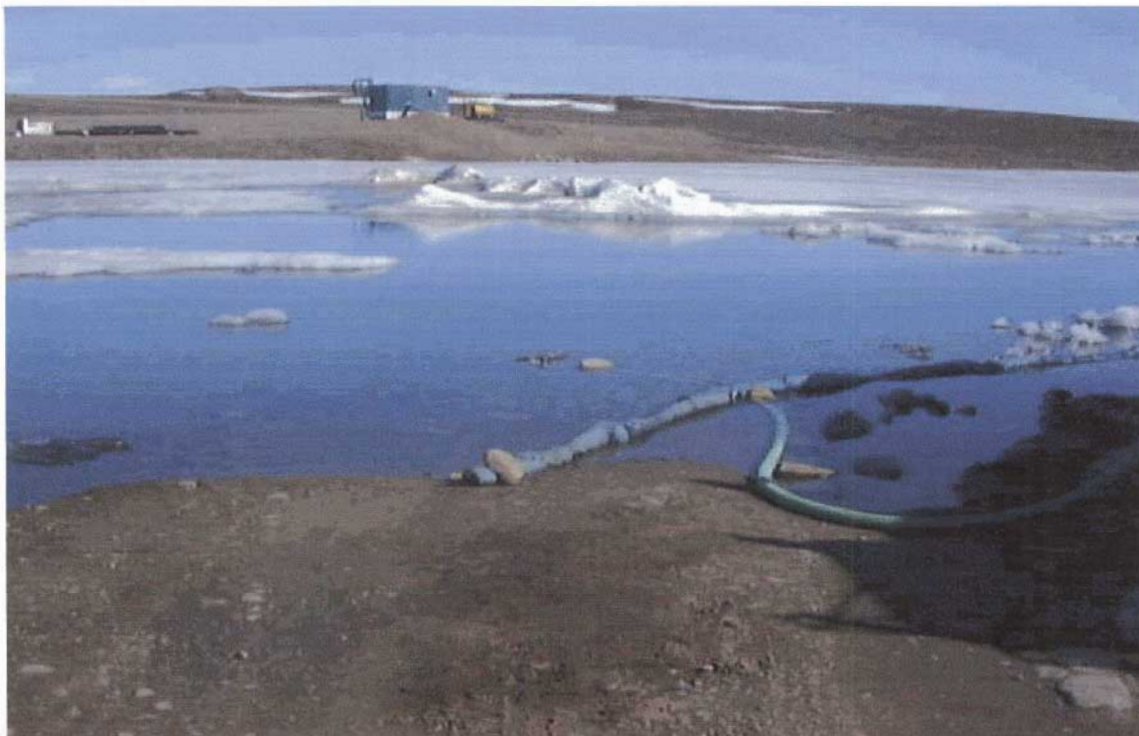
- **Water supply:** Due to the recurring failure of the generator at the water supply facility, direct truck intake has been relocated to the shoreline of Salmon reservoir (figure 1). Although absorbing pads and booms have been deployed at the temporary intake station, patches of oil sheen were nonetheless observed on the surface of the water supply. It was therefore mentioned at the time of the inspection that the Licensee ought to take measures to prevent further deposit of waste into the reservoir. Accordingly, the Licensee has since approached the Nunavut Water Board (NWB) to use Salmon Creek as a water source, likely until the expected new generator arrives on the summer's sealift. This being said, the attached analytical results indicate that the water at the temporary truckfill station meets the *Guidelines for Canadian Drinking Water Quality*, save for a slight exception: a turbidity value of 1.9 Nephelometric Turbidity Unit (NTU), which rests above the 1 NTU maximum acceptable concentration but below the 5 NTU aesthetic objective.

Comments: The generator at the water supply facility has been in disrepair since springtime. Direct truck intake has been relocated to the shoreline of the reservoir; absorbing pads and booms are deployed, but some oil sheen was nonetheless noted on the surface of the water. A mixture of rusty water and oil has accumulated in the secondary containment of the fuel tank by the generator shed.

figure 1. Temporary truckfill station on shoreline of Salmon reservoir; 2001/06/26.

- 01-183: unknown volume of hydraulic/transmission oil and/or antifreeze leaking from water trucks into the water supply. The ice on which the spill occurred has since melted, and corrective measures have been undertaken to ensure that no additional waste be deposited into the municipal water supply; expected to revert to the truckfill station once new generator received on summer's sealift. Recommend file closure.

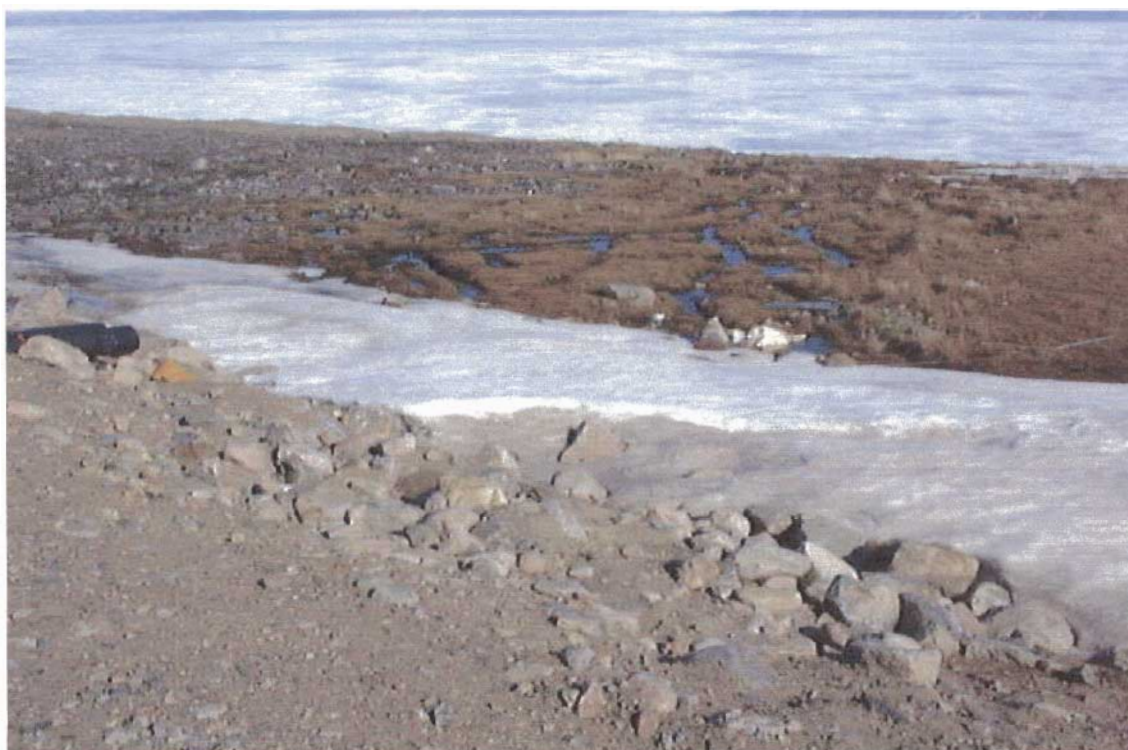
- **Sewage disposal:** Discharge from the area around the sewage lagoon's decant structure was ongoing at the time of the inspection (figure 2). While a berm had been erected in the vicinity, it did not appear to extend to where remained patches of frozen effluent along the hillside downslope of the decant. The attached analytical results relating to a sample taken thirty metres below the lagoon decant reveal that the level of ammonia (6.6 mg/L vs 2.2 mg/L) exceeds the *Canadian Water Quality Guidelines for the Protection of Freshwater Aquatic Life*. However, due to scheduling delays, bacteriological parameters could not be analysed.

figure 2. Path of discharge from the sewage lagoon's decant area; 2001/06/26.

- 01-184: unknown volume of raw sewage leaking from berm around the lagoon's decant structure and freezing downslope. Cannot recommend file closure before repairs on the decant structure have been completed, or the lagoon has been decommissioned.

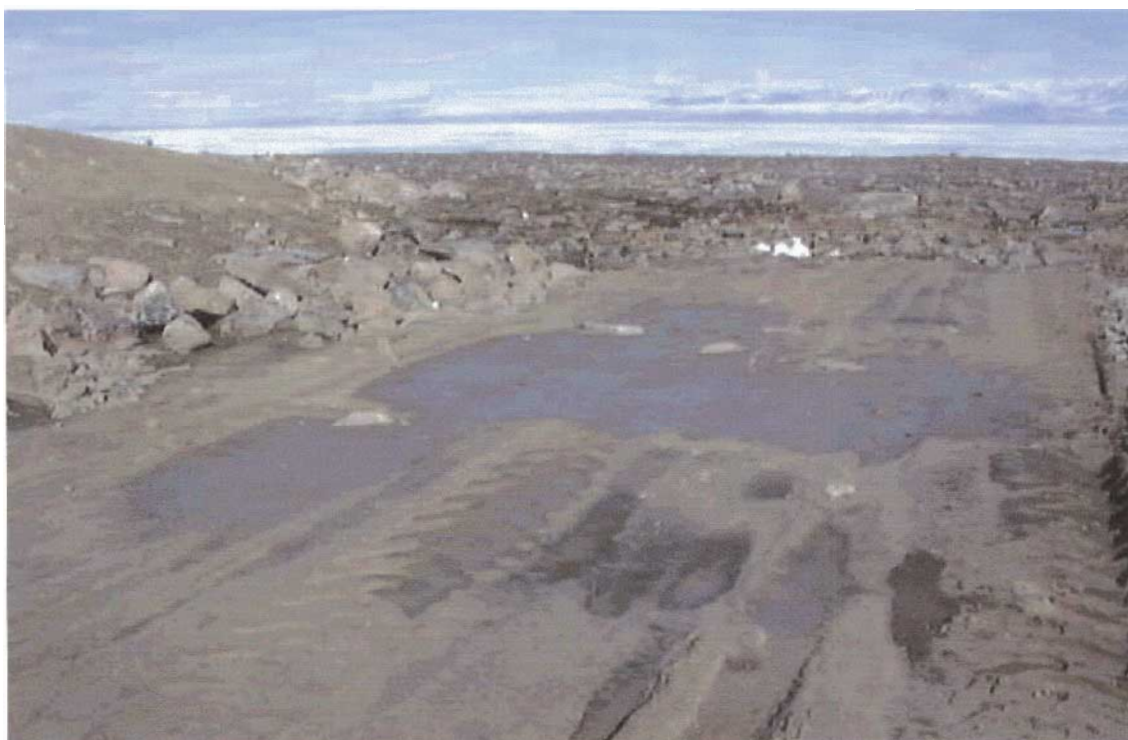
Also noticeable was trickling seepage from the saturated material at the base of the sewage lagoon's NE corner (figure 3). In addition to the slumping and cracking of the sewage lagoon berm in the NE corner, the presence of pooled water adjacent to the sewage lagoon's berms alongside the waste oil cell and the toe of the dump poses some concerns. In fact, this might lead to the migration of fluids through the berms, and/or the weakening of the sewage lagoon's containment structures. In related matters, the old sewage disposal facility was discharging through the decant notch in the northern berm (figure 4), and flowing overland towards the ocean (figure 5). The attached analytical results relating to a sample taken at the point of discharge reveal that the level of ammonia (2.95 mg/L) faintly exceeds the *Canadian Water Quality Guidelines for the Protection of Freshwater Aquatic Life*. However, as was the case for the new sewage lagoon, the microtox sample did not attribute toxicity to the effluent.

figure 3. Seepage from the NE corner of the sewage lagoon; 2001/06/26.

- 01-233: an estimated 500 L of raw sewage seeping through the lagoon's berms. Corrective measures have been undertaken, as well as a geotechnical inspection of the facility. However, cannot recommend file closure before the issue of recurring seepage at the sewage lagoon is definitely addressed.

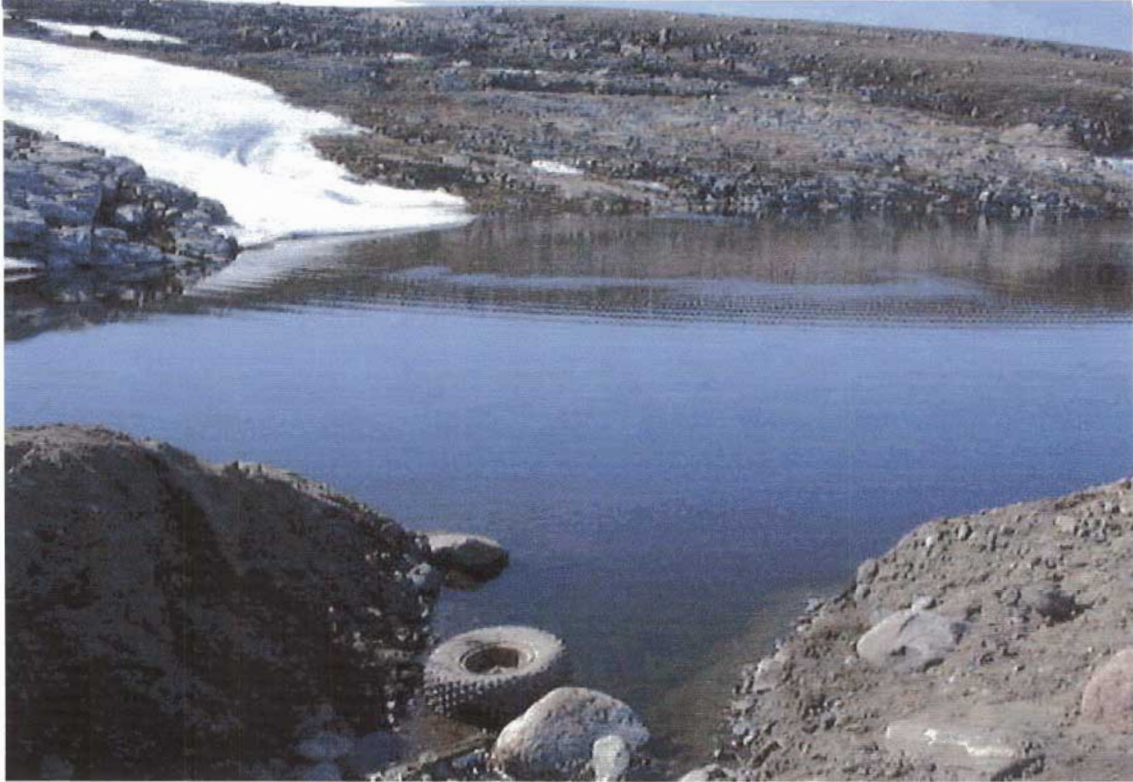
figure 4. Old sewage disposal facility; 2001/06/26.

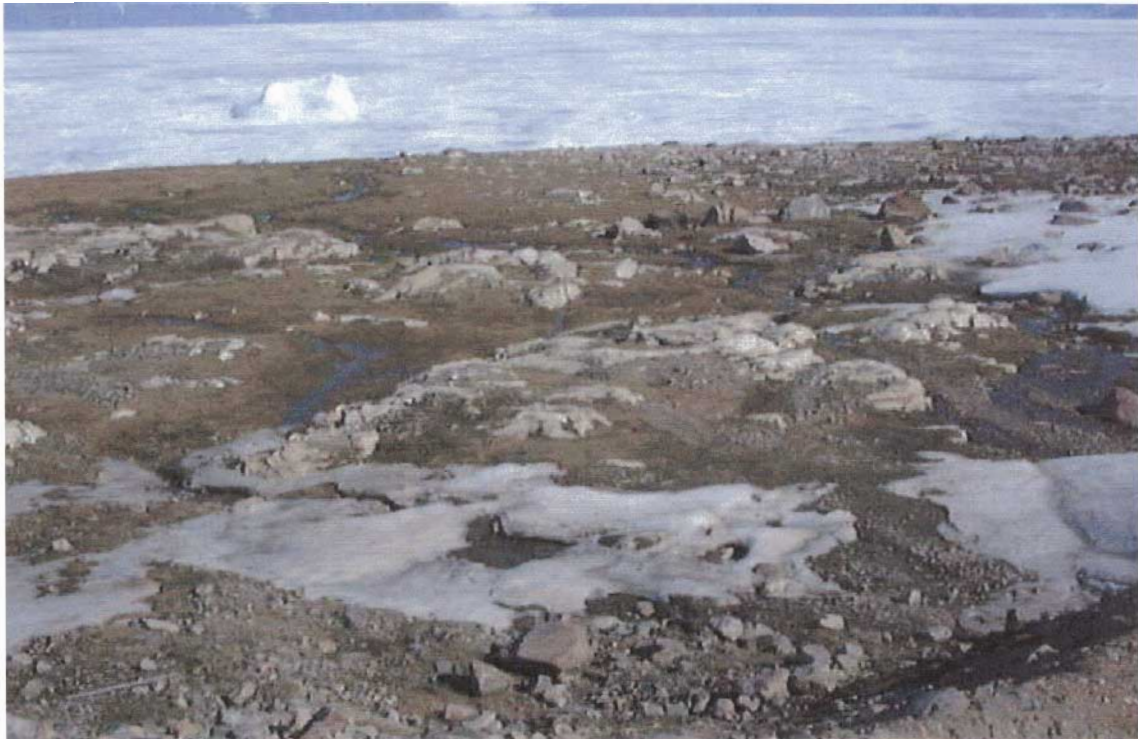
figure 5. Path of discharge from the old sewage disposal facility; 2001/06/26.

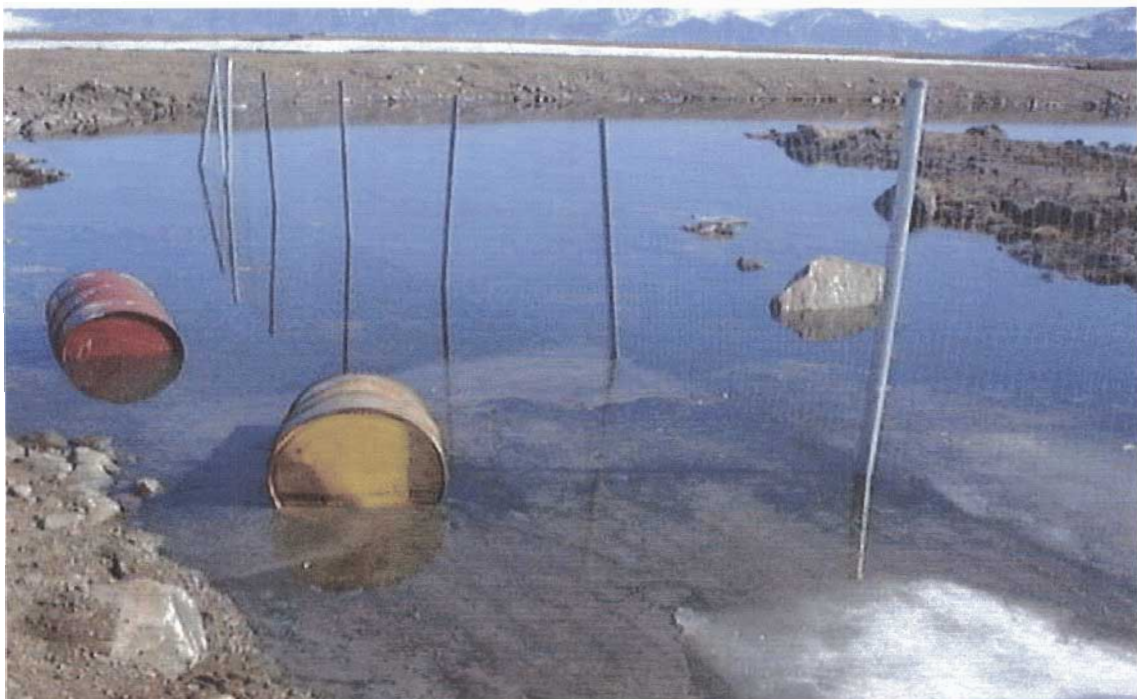
- **Waste oil disposal:** The state of the waste oil storage cell has deteriorated since the previous inspection. Indeed, waste oil drums, some of which have toppled and are now leaking into nearby waters (figure 6), are still being stockpiled in and around the cell (figure 7). Further, in addition to the oil obviously contained within the cell, several sheen patches were also noted on the water pooled along the toe of the solid waste disposal facility (figure 8). During the inspection, it was related that a waste oil furnace is available in the community, but remains unused for unknown reasons. In light of this, disposing of the accumulated waste oil in such a manner would prevent more leakage to compound to the problem before the waste oil storage cell is properly reclaimed.

figure 6. Pooled water alongside the waste oil cell and the sewage lagoon; 2001/06/26.

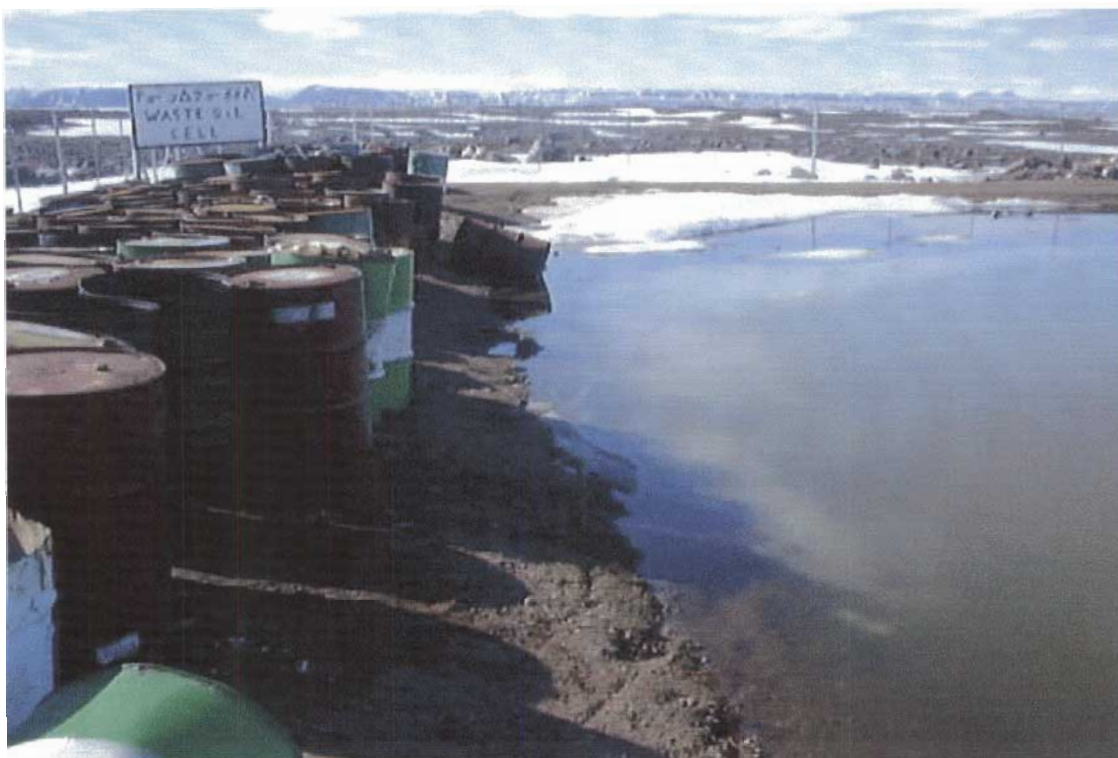
figure 7. Waste oil storage cell; 2001/06/26.

- 01-213: unknown volume of waste oil spilled from the waste oil storage cell. Cannot recommend file closure until the waste oil storage cell and associated waste oil drums, the likely source of the spill, have been adequately decommissioned. The Hamlet has requested assistance concerning possible reclamation options for the site.

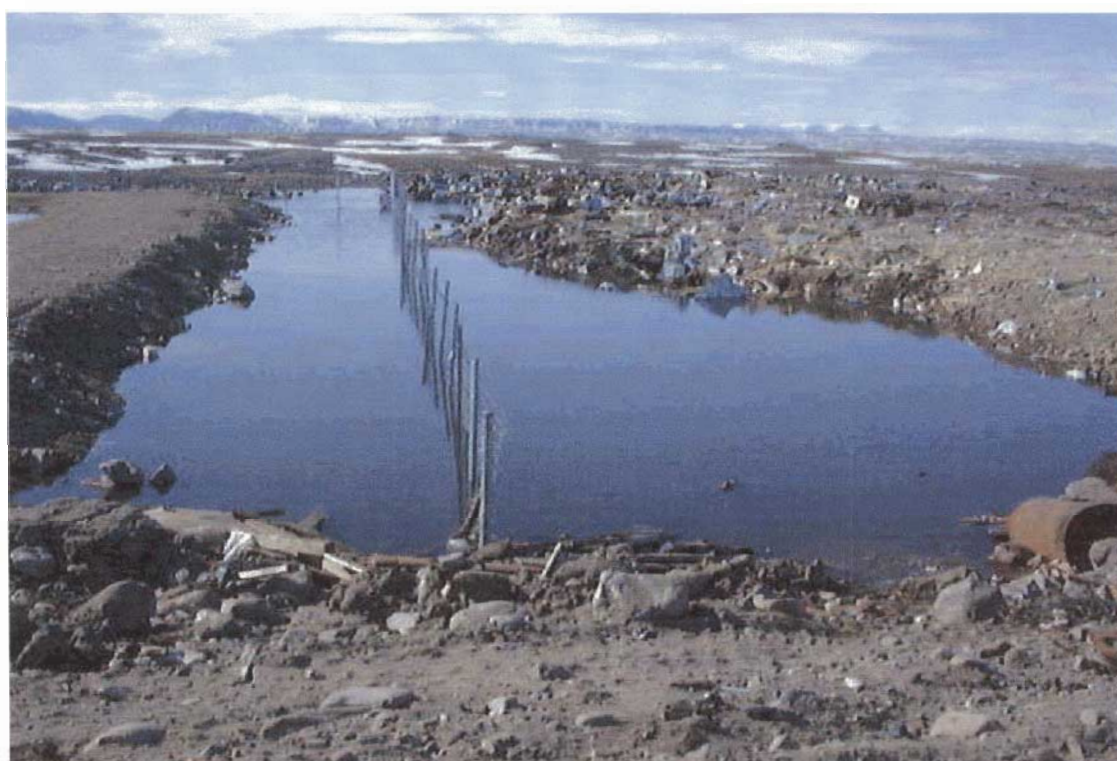
figure 8. Pooled water between the waste oil cell and the dump; 2001/06/26.

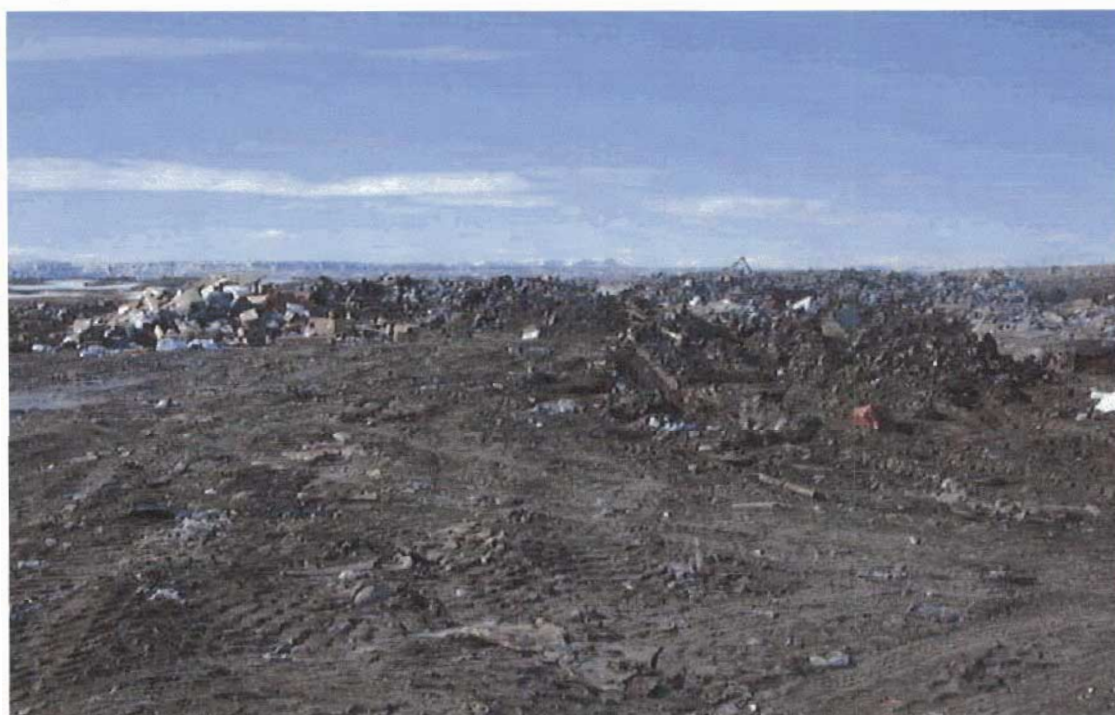
- **Solid waste disposal:** The solid waste disposal facility seems well managed, as waste is segregated and appropriately handled (figure 9). However, the pooled water along the toe of the wastepile may imply leachate considerations. In parallel, the attached analytical results relating to a sample of runoff flowing through the bulky metal wastes disposal facility reveals the following: levels of chromium (65 µg/L vs 8.9 µg/L), copper (57 µg/L vs 4.0 µg/L), iron (3.51 mg/L vs 0.3 mg/L), lead (69 µg/L vs 7.0 µg/L), and zinc (375 µg/L vs 30 µg/L) exceed the *Canadian Water Quality Guidelines for the Protection of Freshwater Aquatic Life*.

figure 9. Solid waste disposal facility; 2001/06/26.
