WATER LICENCE INSPECTION FORM

Licensee	Licensee Representative
Hamlet of Pond Inlet	Bhabesh Roy, and Samuel Ootoova
Licence No. / Expiry	Representative's Title
3BM-PON2025	Engineer, Community Forman, Engineer Assistant
Land / Other Authorizations	Land / Other Authorizations
Date of Inspection	Inspector
July 23, 2021	Joseph Monteith
Activities Inspected

On July 23, 2021, a water licence was conducted by Water Resource Officer (WRO) Joseph Monteith on 3BM-PON1520 at the Hamlet Pond Inlet, Qikiqtani Region, Nunavut.

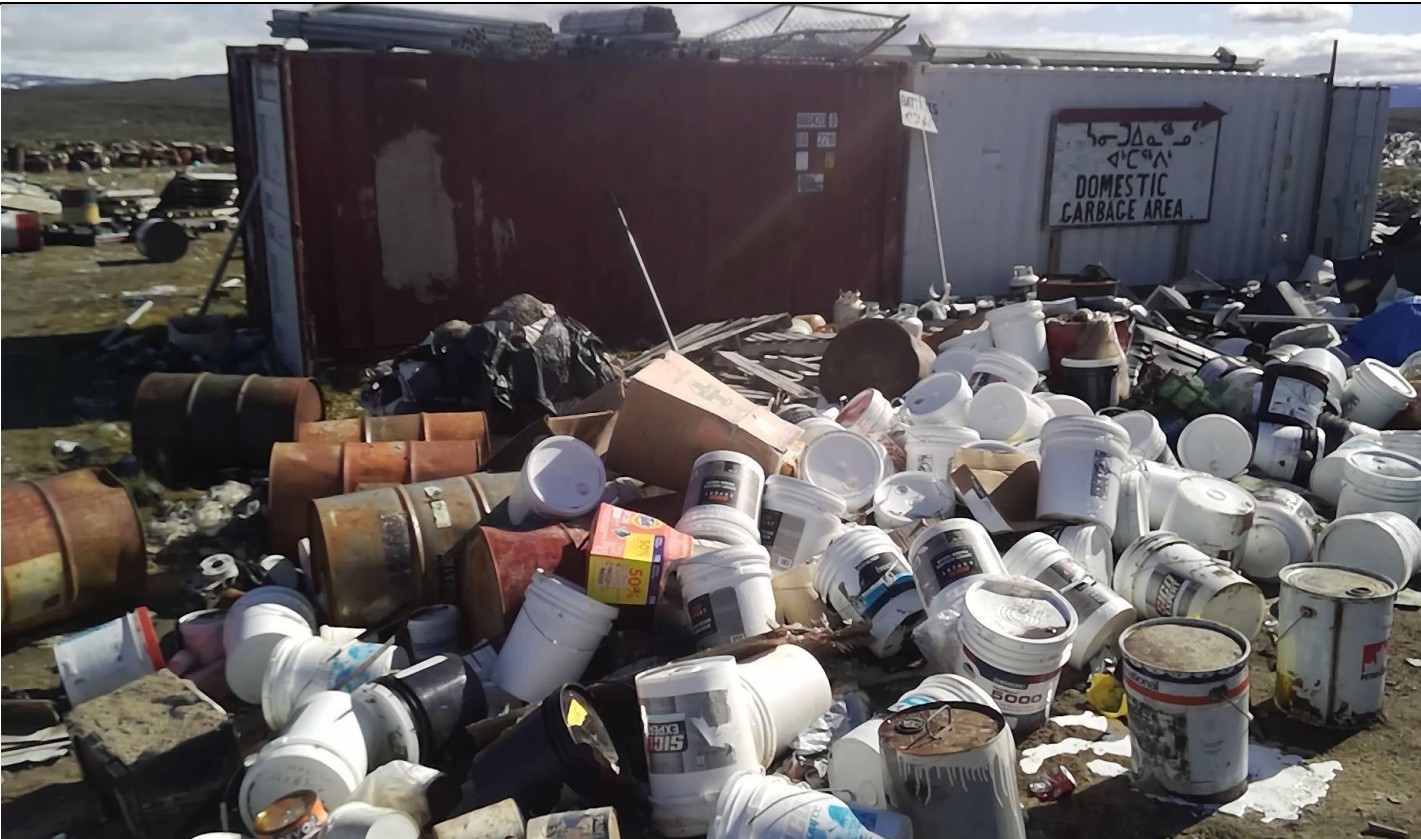
Photo Log	Location
Photo 10	Pond Inlet, NU

- 17. The hazardous Waste is separated in 3 areas. On the far side of the waste water facility is a couple of sea cans, open, and exposed to the elements titled Hazardous Waste sea can 1. In the middle of the hazard waste section titled Hazardous Waste Drums (photo 8-9). All the drums surrounding the water body is noncompliance with Part D: Item 2. And Part D: Item 14. The drums appear to be scattered around that area, and form a line up towards the front section of the Hazardous Waste Sea Can 2 as titled in (photo 10). A wire gate is put in place to prohibit the public from depositing any hazardous waste deeper into the hazardous waste area. The front of the hazardous waste sea can 2 has two sea cans both with signage (photo 10).

Description: Hazardous Waste Sea Can 2.

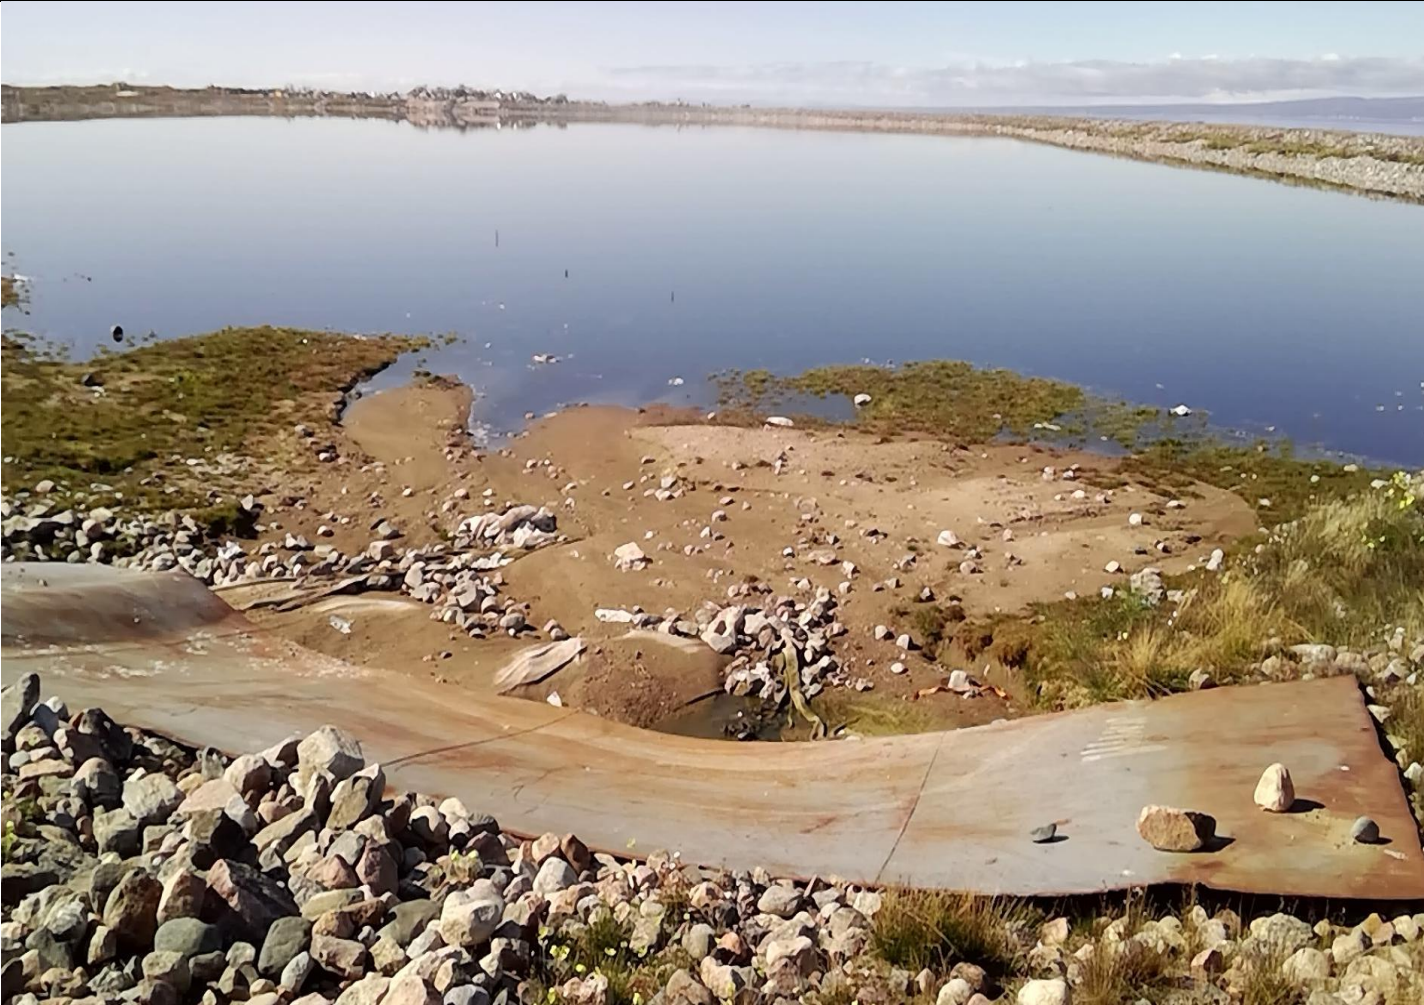
Photo Log  
Photo 13

- 7. At the time of the inspection the sewage lagoon was in-use. The amount of sewage in the lagoon was low due to a leak in the berm walls of the sewage lagoon (photo 13). On the North East side, lots of sewage was laid across the landscape (photo 12). A large metal slab appears to be covering the leak in the sewage lagoon (photo 13).

- 18. Spill Report 2020-288 was submitted on August 24, 2020, with an occurrence date of August 18, 2020. The report was submitted because of an unauthorized discharge from a suspected leak the East side of the Sewage Lagoon. The estimated amount spilt was 20,000 m<sup>3</sup> of sewage. The Hamlet stated they would work with CGS on leak detection, and remedial action.
- 19. Spill Report 2021-130 was submitted on August 20, 2021, with an occurrence date of April 14, 2021. The report was submitted because of an unauthorized discharge from a suspected leak the East side of the Sewage Lagoon. The estimated amount spilt was half the amount of water withdrawn from 2020 as stated in an email from Bhabesh Roy. The Hamlet stated they would work with CGS on lead detection, and remedial action(photo 6, 11, 12, 13).

Description: The leak in the sewage lagoon appears to be under the metal slab.

- Repair the Sewage Disposal Facility in such a manner to prevent structural integrity;
- remove the waste drums located at the hazardous waste drums area as indicated in photos 8 & 9; 31 metres away from the water body, and store at the Hazardous Waste Facility in a manner to prevent the deposit of deleterious substances into any water, until such time that the drums will be removed for proper disposal;

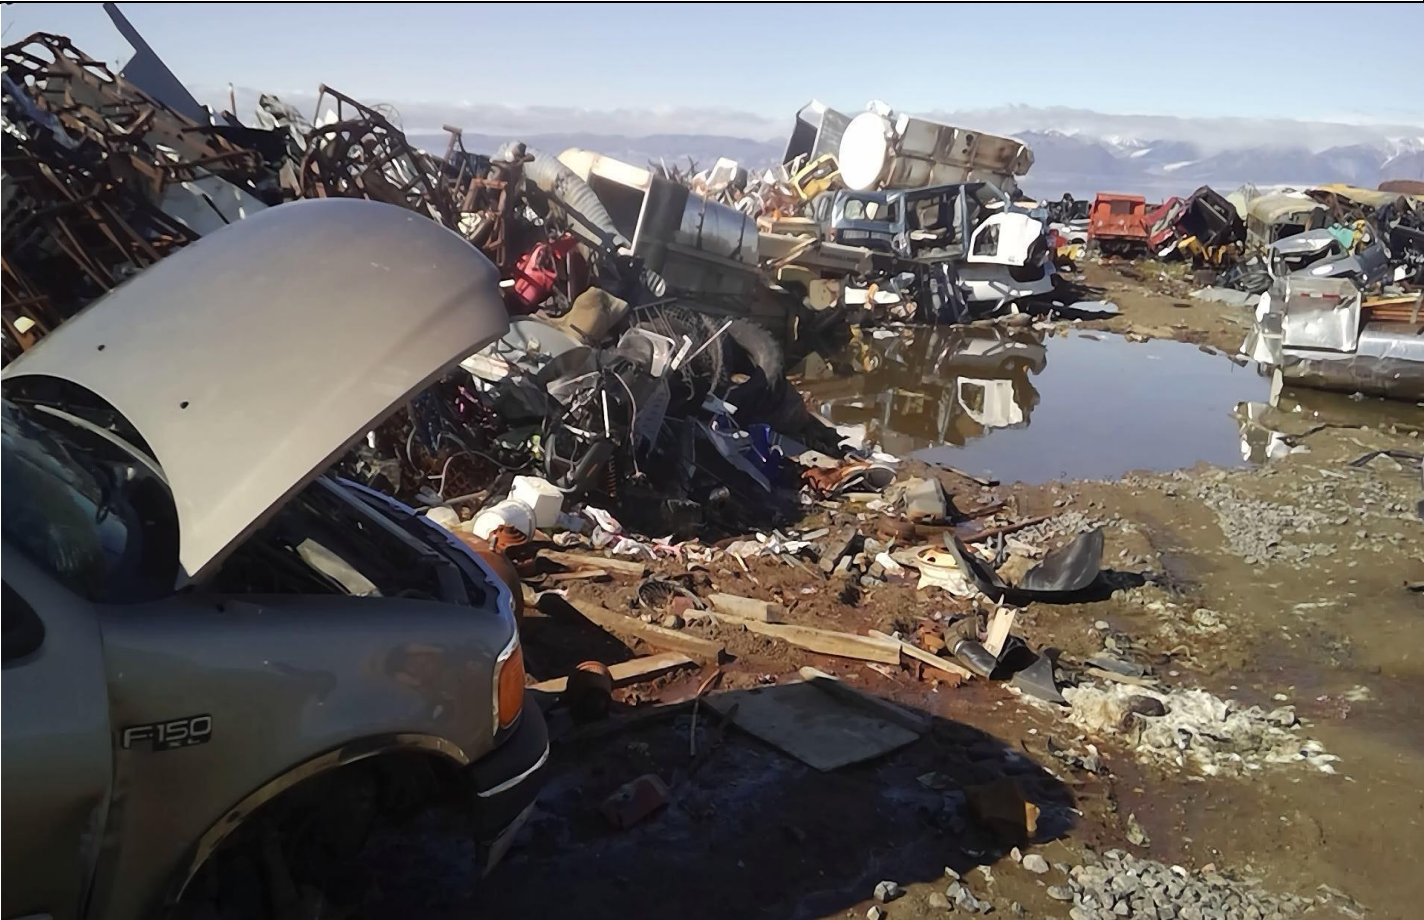
Photo Log  
Photo 14

- 10. The licensee manages the domestic waste by open burning, and capping. But, does not do it often due to the direction of the prevailing winds, which cause the smoke to blanket the community which in turn causes complaints by the community. The fire department tend to go up and extinguish the dump fires.
- 11. The community land fill has proper signage.
- 12. The land farm does segregate all their waste into bulk metal, woods, and hazardous waste(photo 6).
- 13. A secondary containment structure, with secondary containment sits empty with only windblown debris in the solid waste facility (photo 15).
- 14. Standing water in the bulk metals facility (photo 14).

Description: Surface water accumulates in the Bulk Metal. Lots of signs of sheening.
