July 18, 2011

**Re: OTT-00020662-A0 Slope Inspection
Waste Water Treatment Facility
Pond Inlet, Nunavut**

Company: Government of Nunavut
 Re: Slope Inspection – Waste Water Treatment Facility
 Pond Inlet, Nunavut
 Project Number: OTT-00020662-A0
 Date: July 18, 2011

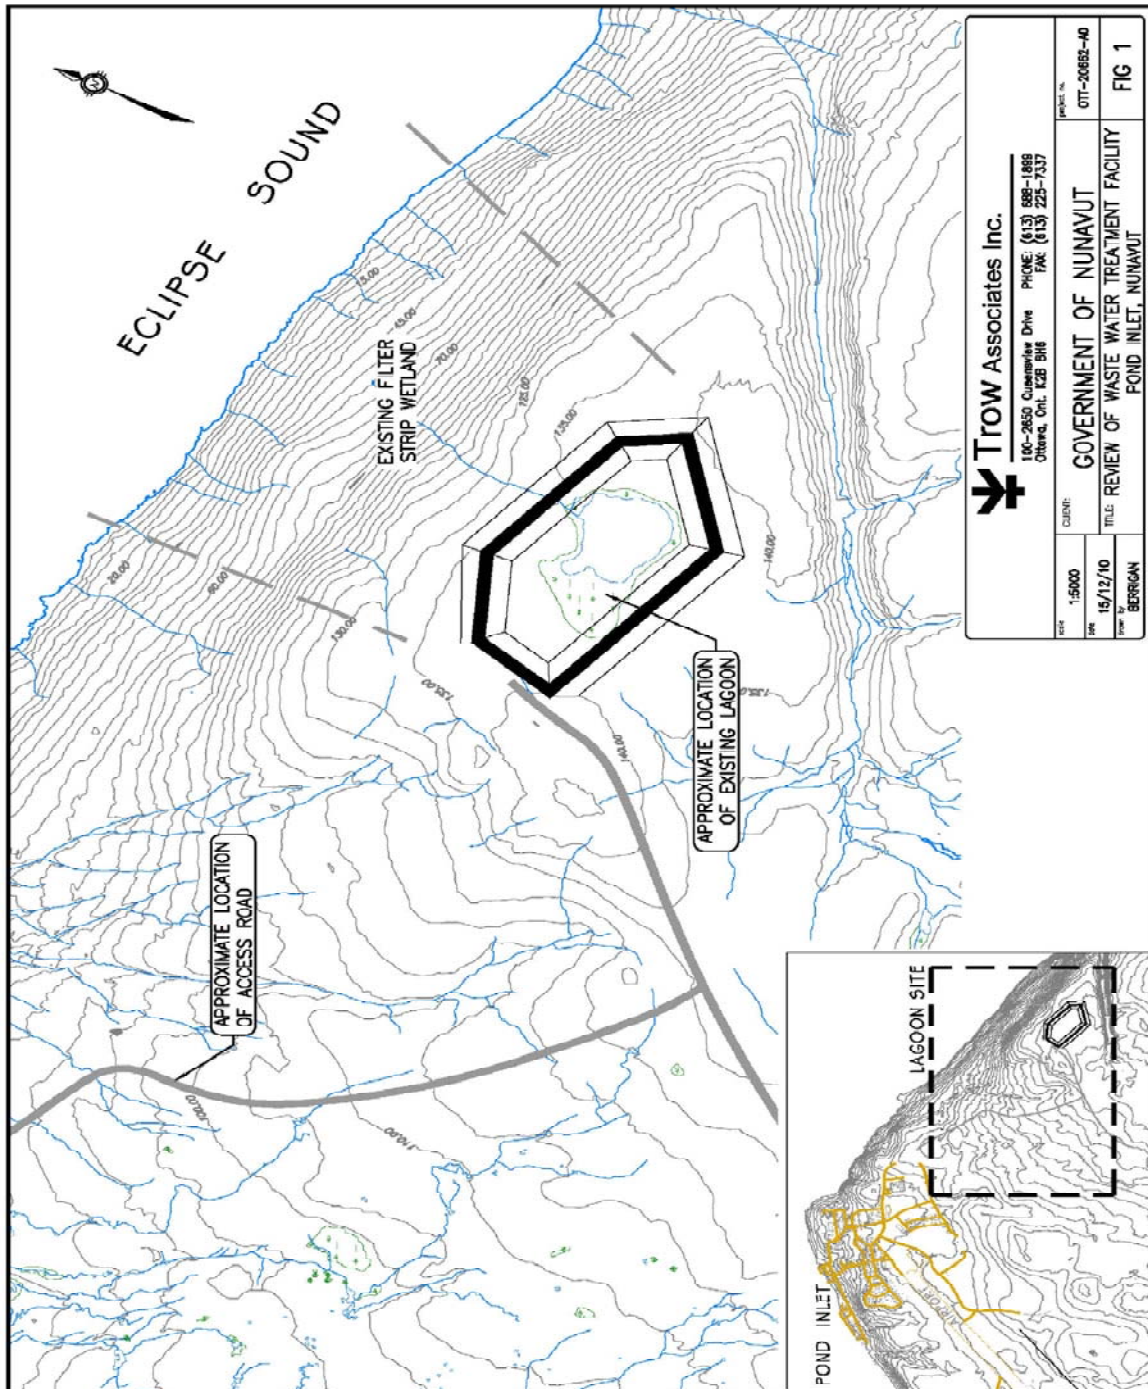
Available information indicates that the lagoon is located in a low spot with higher ground on the east, south and west sides. The site was previously a natural pond prior to the construction of the lagoon. The pond had an overflow to the north which drained to the Ocean (Figure 1). It is noted that prior to the 2003/2004 rehabilitation, ponding of the water immediately outside the east end of the south dyke was observed.

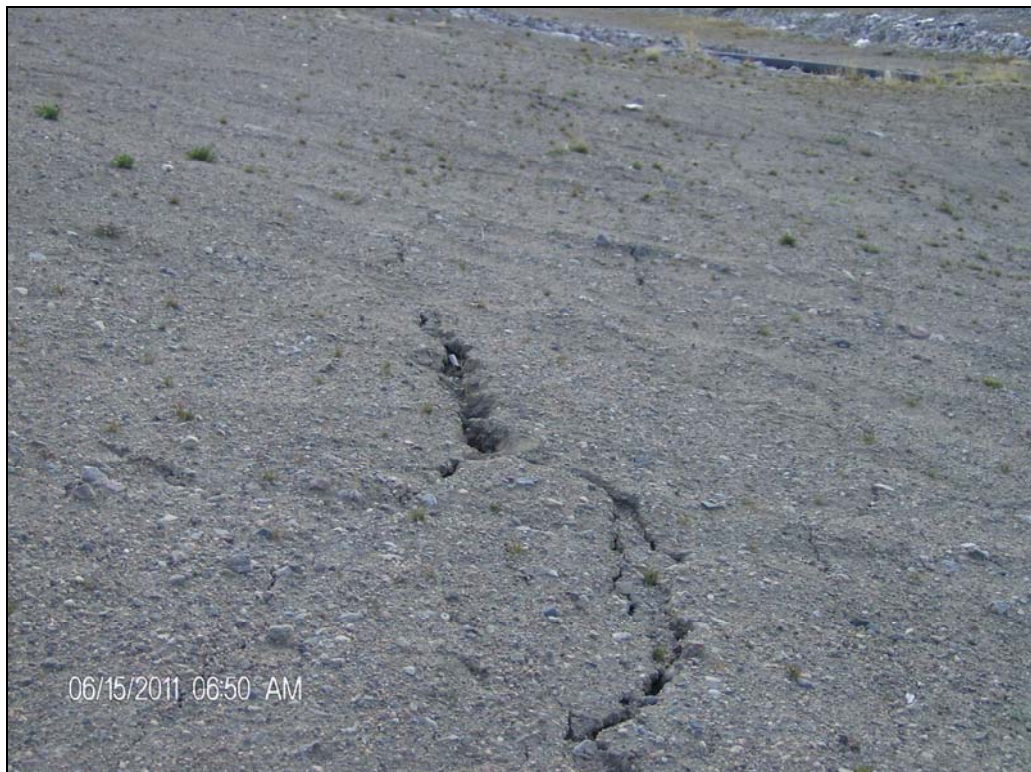
A visual review of the lagoon was undertaken. It revealed that the north berm is sliding downhill. A number of longitudinal cracks have developed in the downstream slope of the north berm. These cracks are parallel to the toe of the berm and are located in the bottom third height of the berm. In addition, some settlements of the crest of the berm were also observed.

The onsite observations confirm that the exterior slope of the north berm is unstable and prone to downhill movement. As indicated previously, in our report, the most likely cause of sliding of the north berm is seepage under the berm. The flow of subsurface water under the sewage lagoon is likely to have degraded the permafrost under the berm thereby causing settlements and cracking of the berm.

Photo 1: Longitudinal cracks in north berm at east end close to toe of berm.

It is considered that the berm is in a state of 'incipient' failure and measures should be undertaken as soon as possible to stabilize the berm. Any attempt to stabilize the berm by merely flattening the slope is not expected to be successful since steady seepage under the berm would result in continued cracking and downhill movement of the berm due to degradation of the permafrost until it eventually fails. However, temporary remedial measure of placing additional material close to the toe of the berm to create a bench is recommended since it will temporarily increase the stability of the berm.

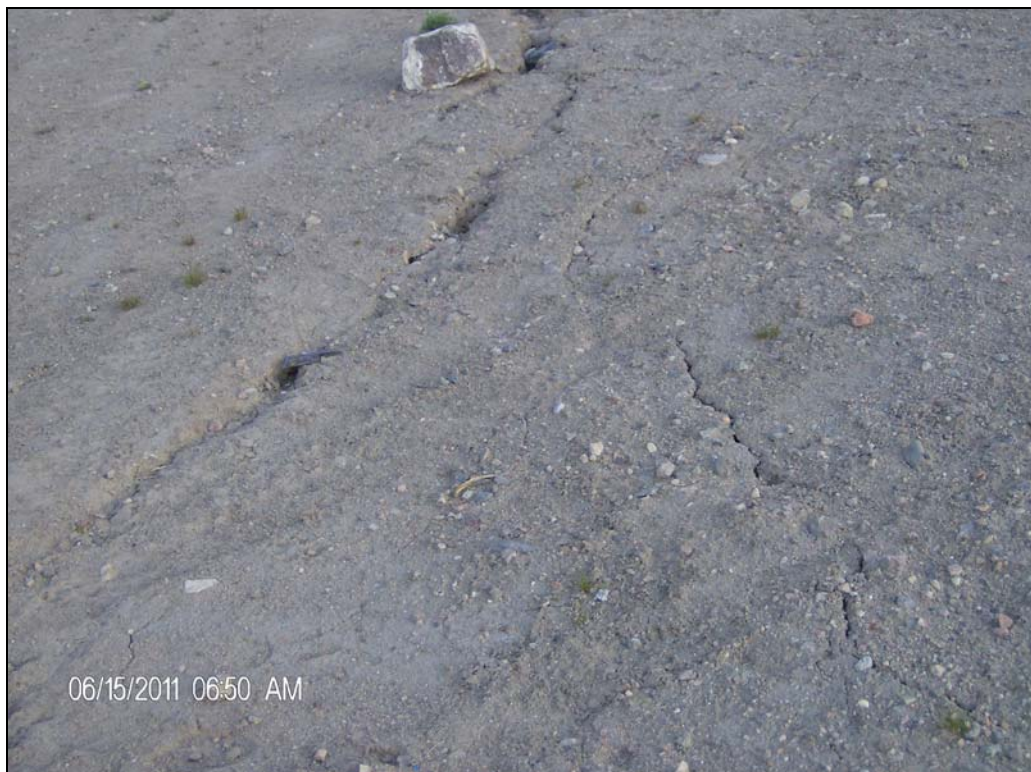
Photo2 : Longitudinal cracks in north berm at east end close to toe of berm.

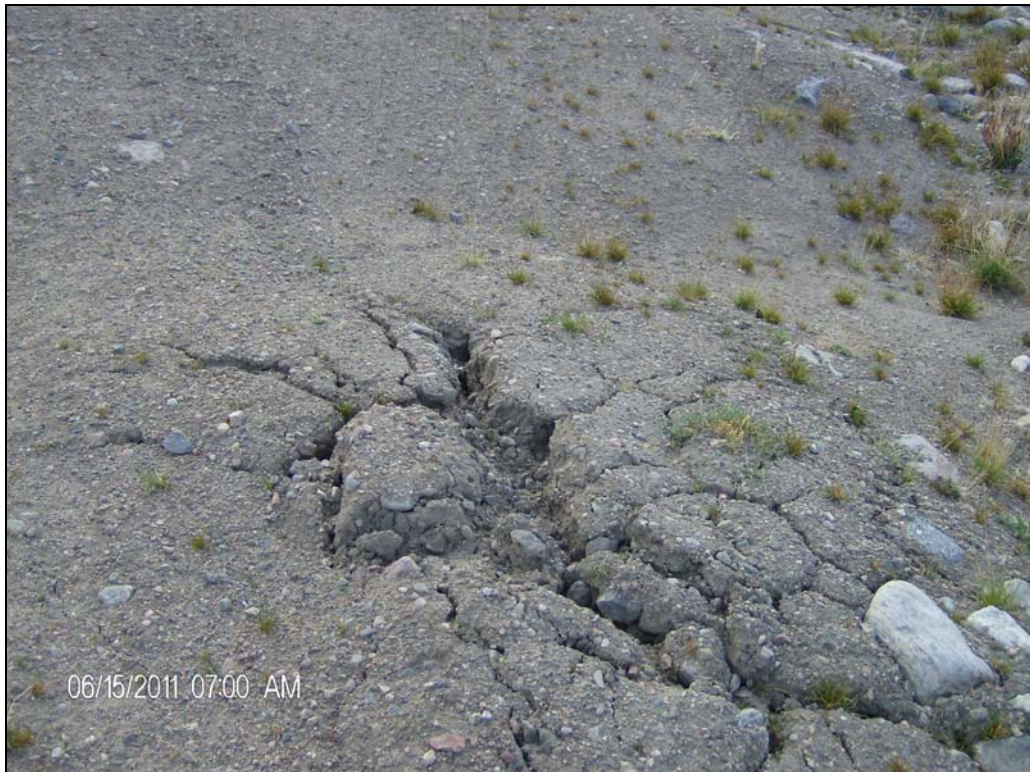
Photo 3: Longitudinal cracks in north berm extending from emergency flow to mid length of berm.

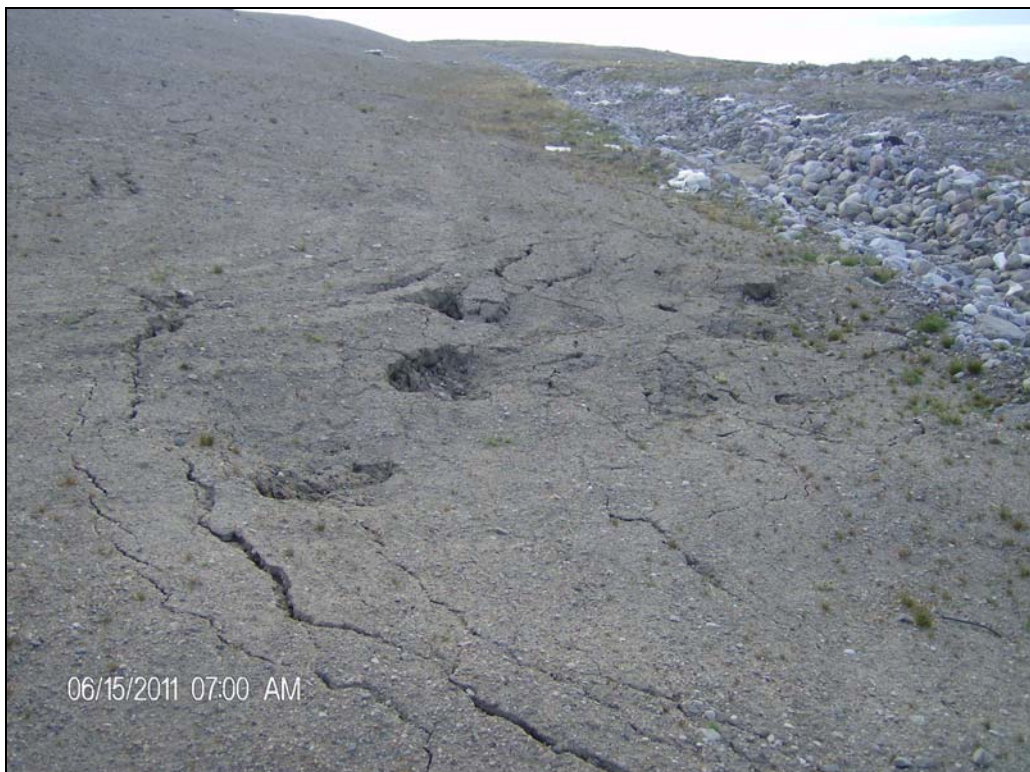
Photo 4: Longitudinal cracks in north berm extending from emergency flow to mid length of berm.

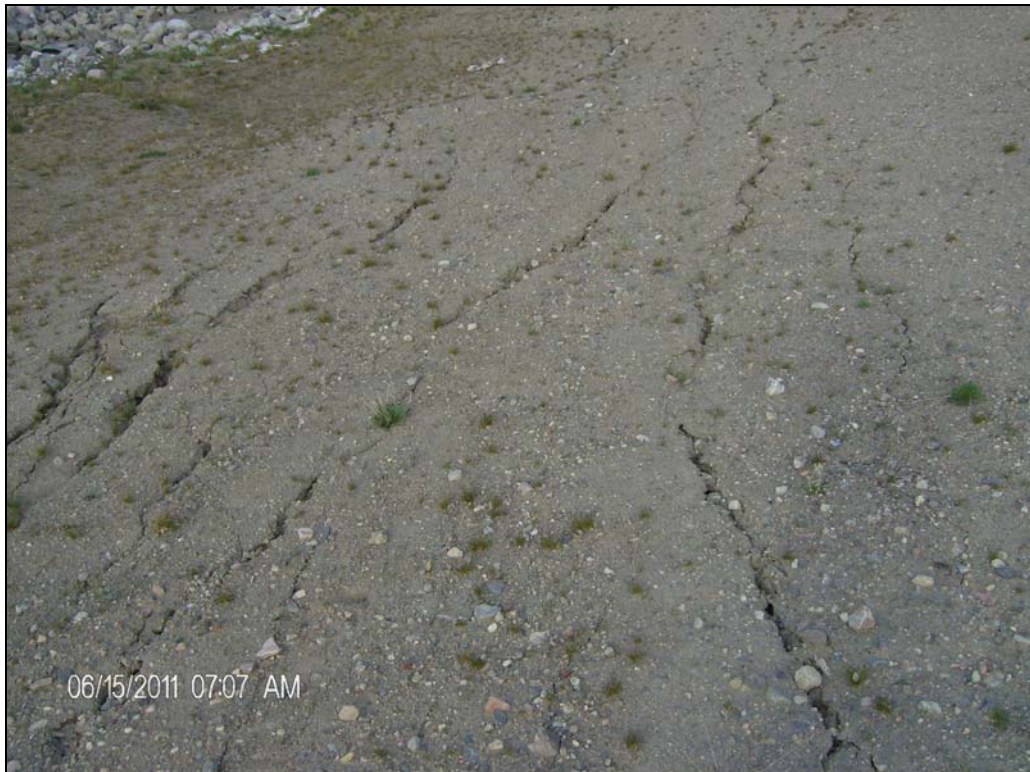
Photo 5: Longitudinal cracks in north berm extending from emergency flow to mid length of berm.

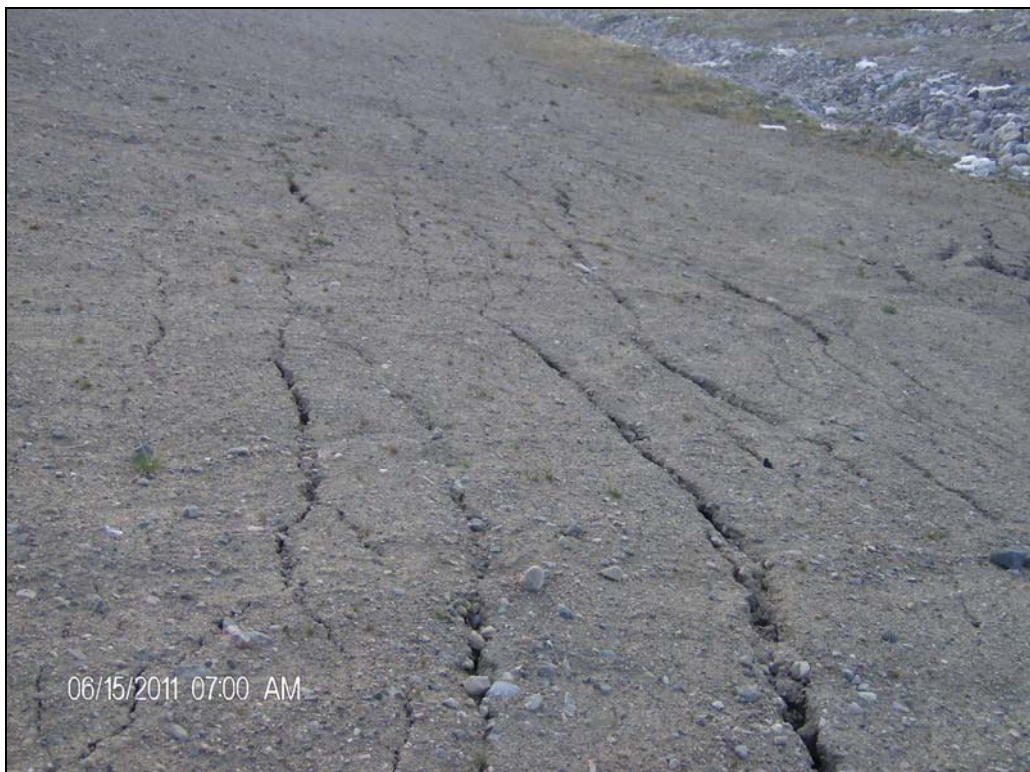
Photo 6: Longitudinal cracks in north berm extending from emergency flow to mid length of berm.

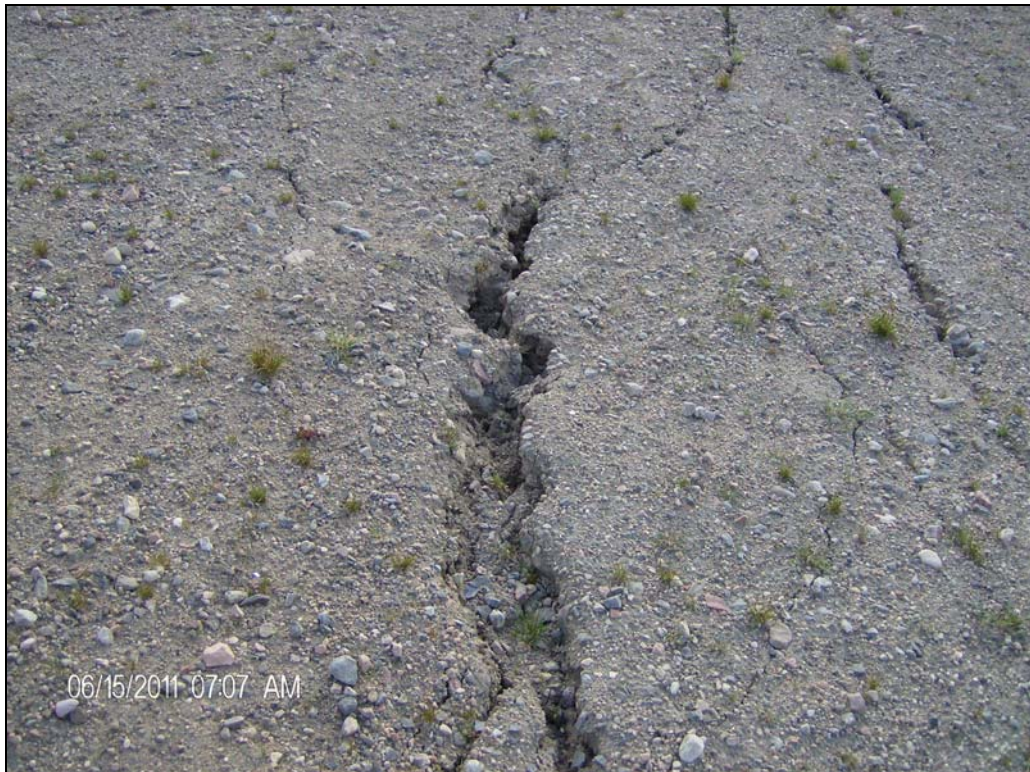
Photo 7: Longitudinal cracks in north berm extending from emergency flow to mid length of berm.

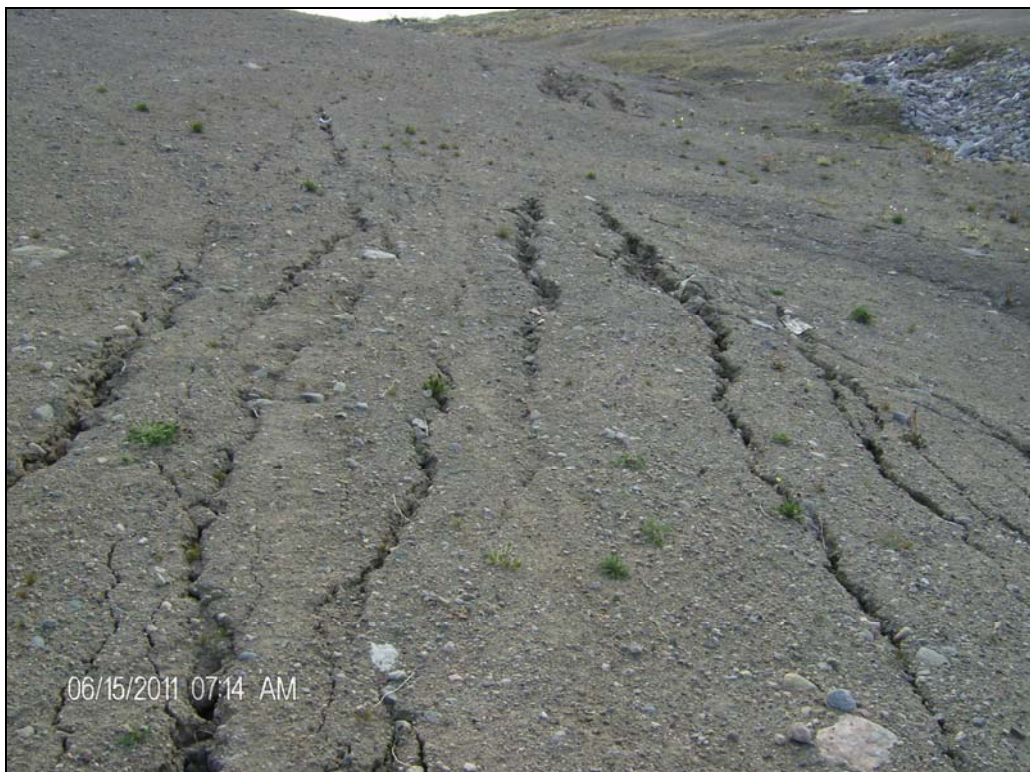
Photo 8: Longitudinal cracks in west half of the north berm close to toe of the berm.

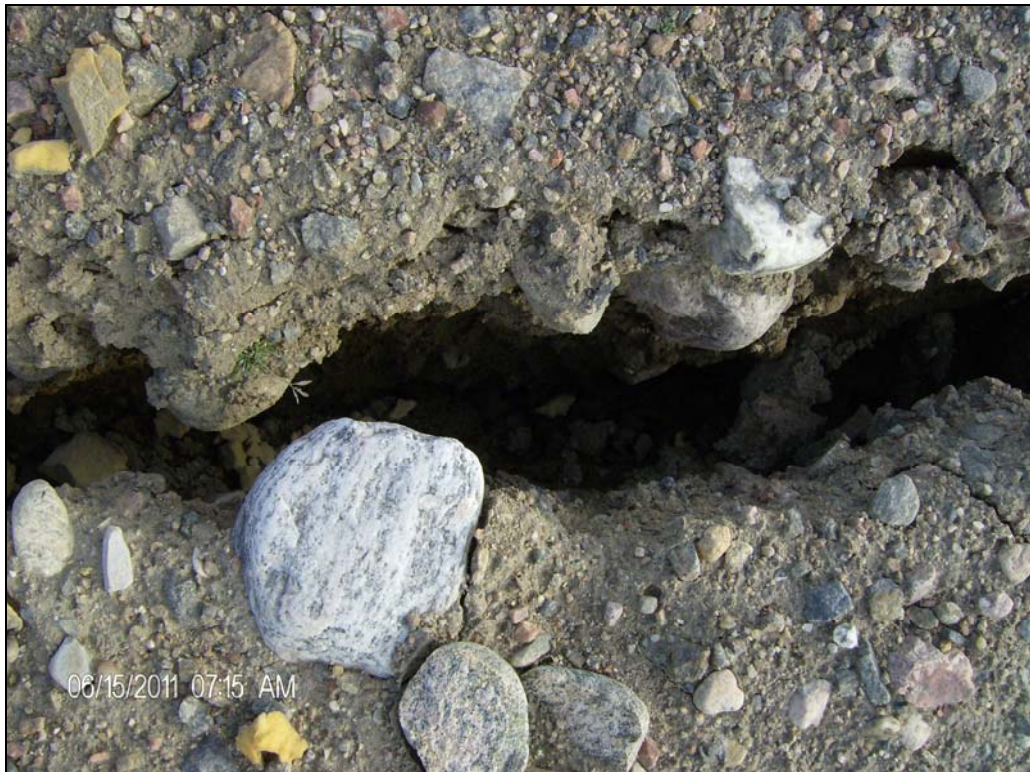
Photo 9: Longitudinal cracks in west half of the north berm close to toe of the berm.

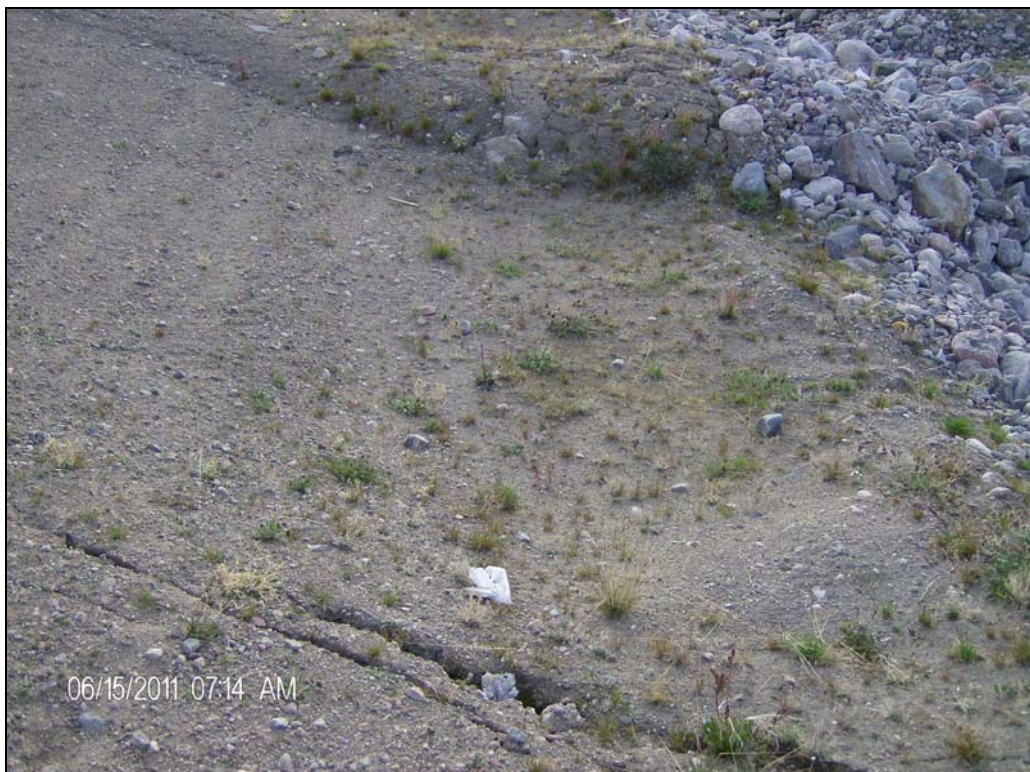
Photo 10: Longitudinal cracks in west half of the north berm close to toe of the berm.

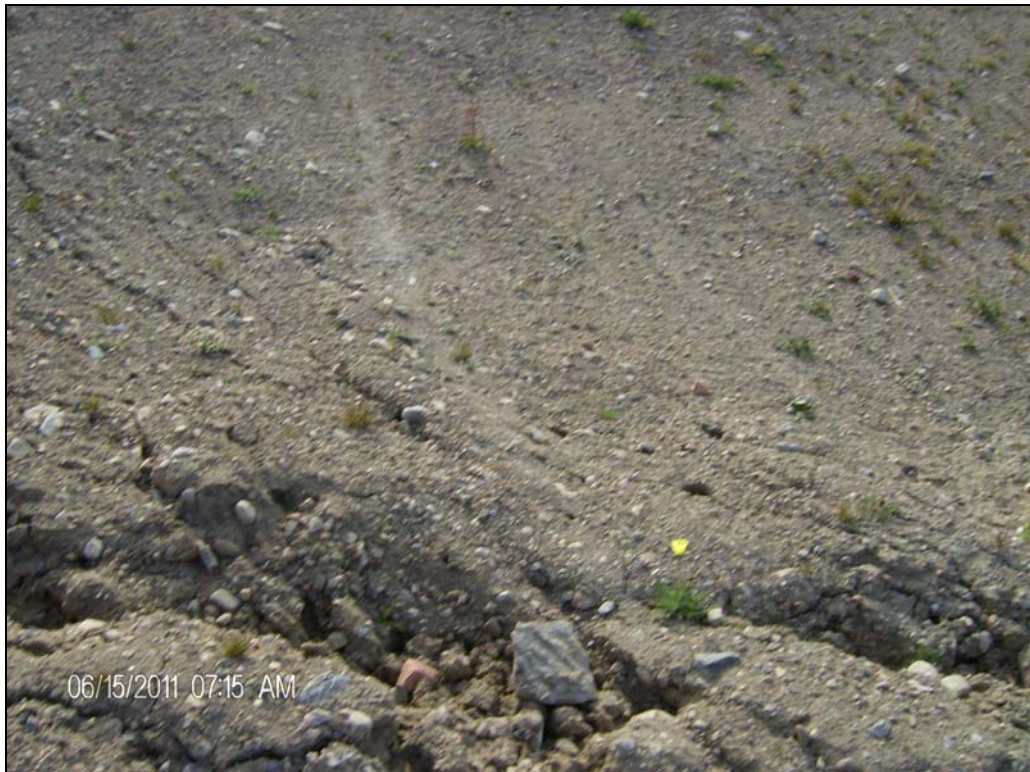
Photo 11: Longitudinal cracks in west half of the north berm close to toe of the berm.

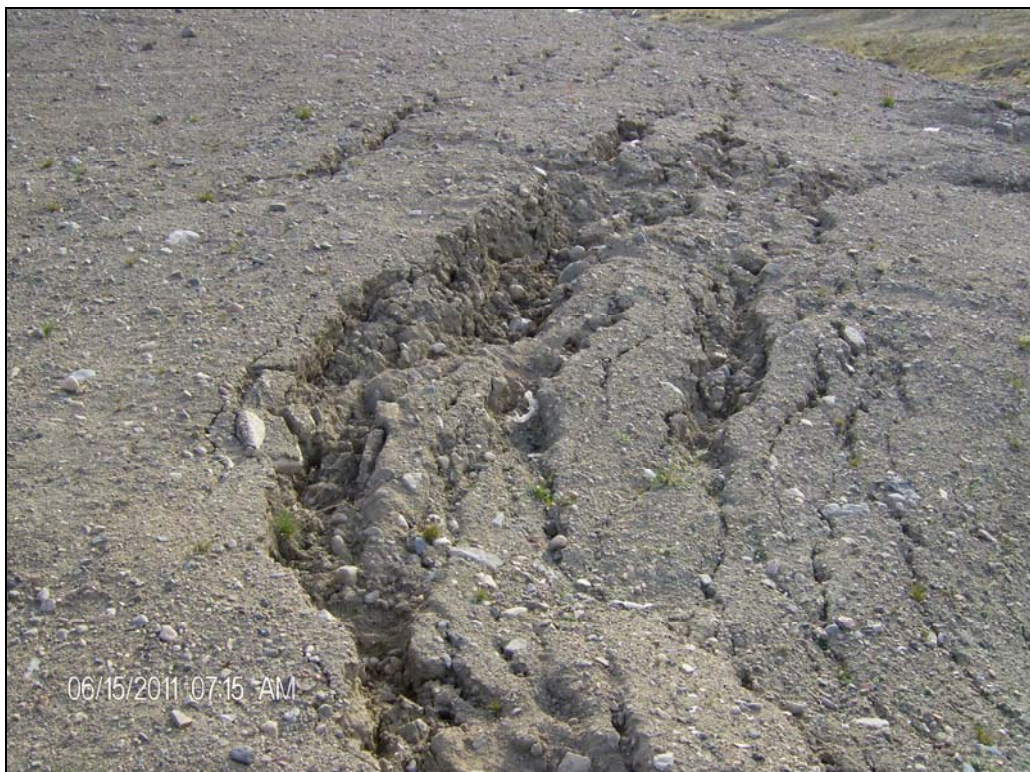
Photo 12: Longitudinal cracks in west half of the north berm close to toe of the berm.

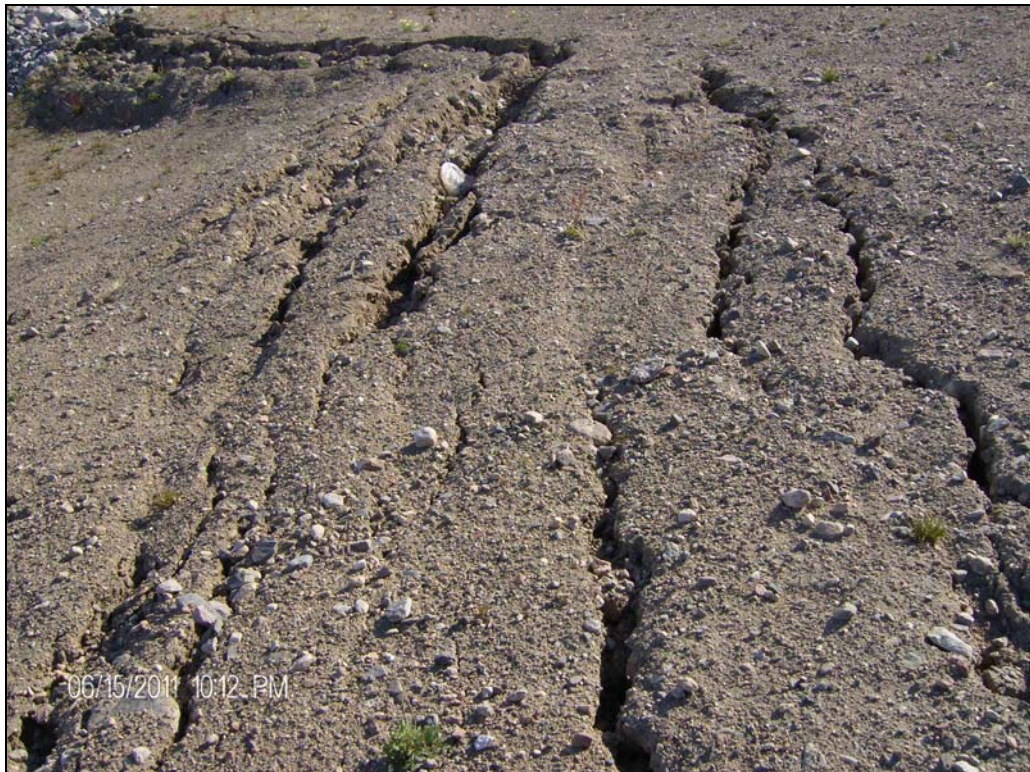
Photo 13: Longitudinal cracks in west half of the north berm close to toe of the berm.

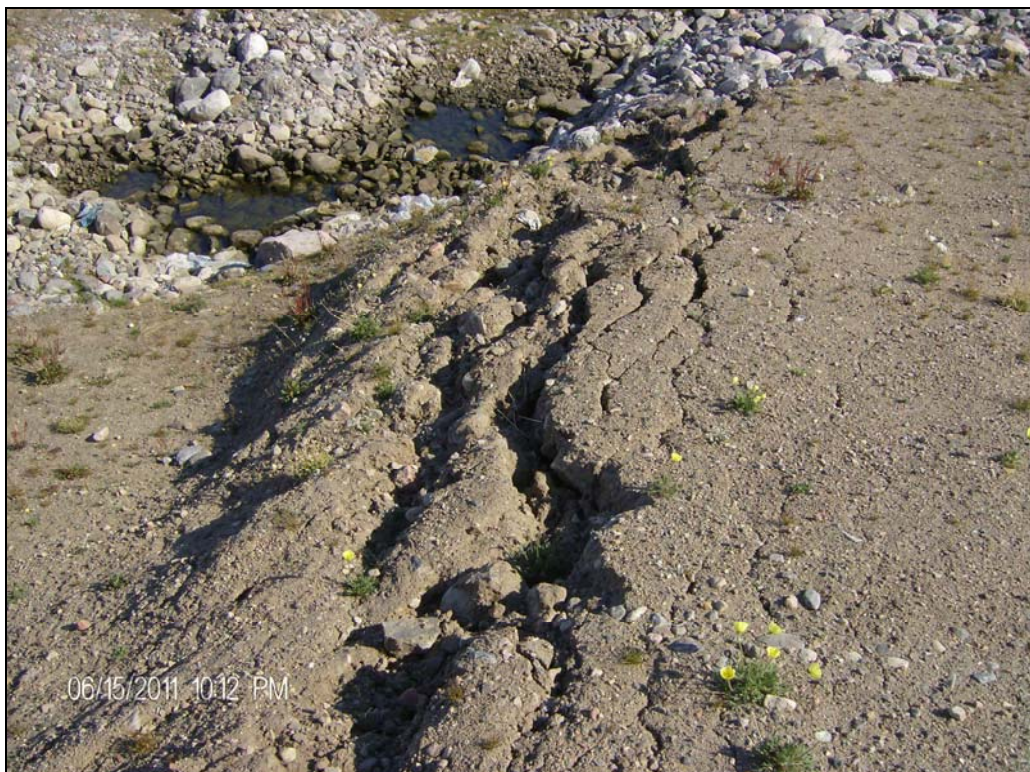
Photo 14: Longitudinal cracks in west half of the north berm close to toe of the berm.

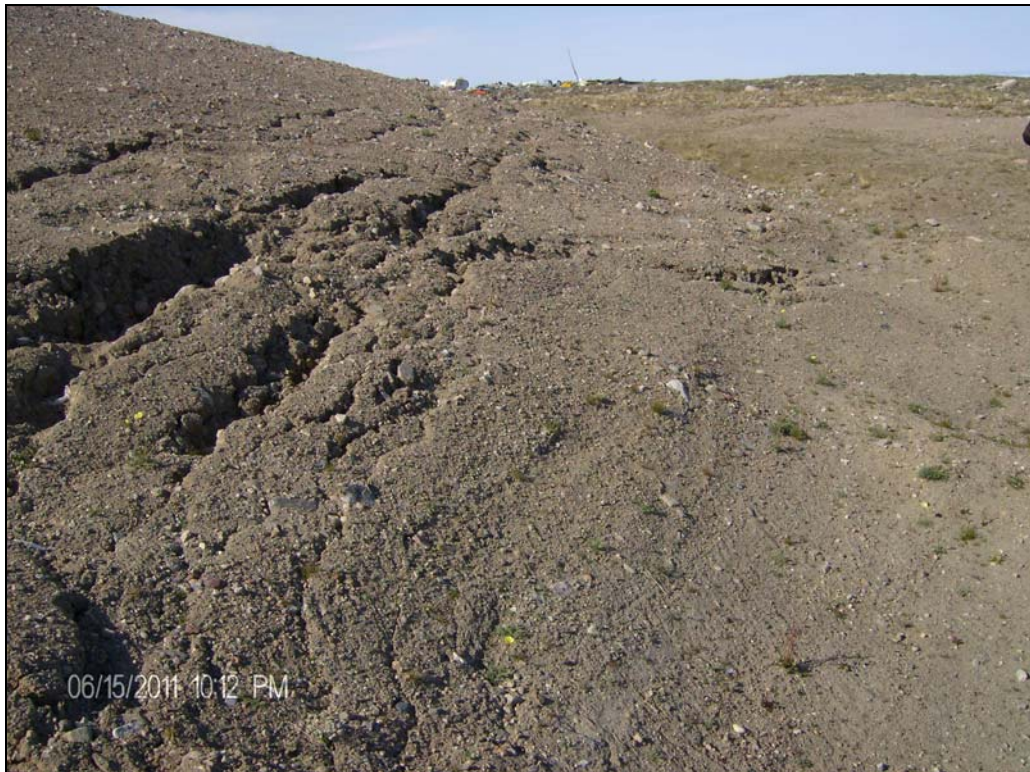
Photo 15: Longitudinal cracks in west half of the north berm close to toe of the berm.

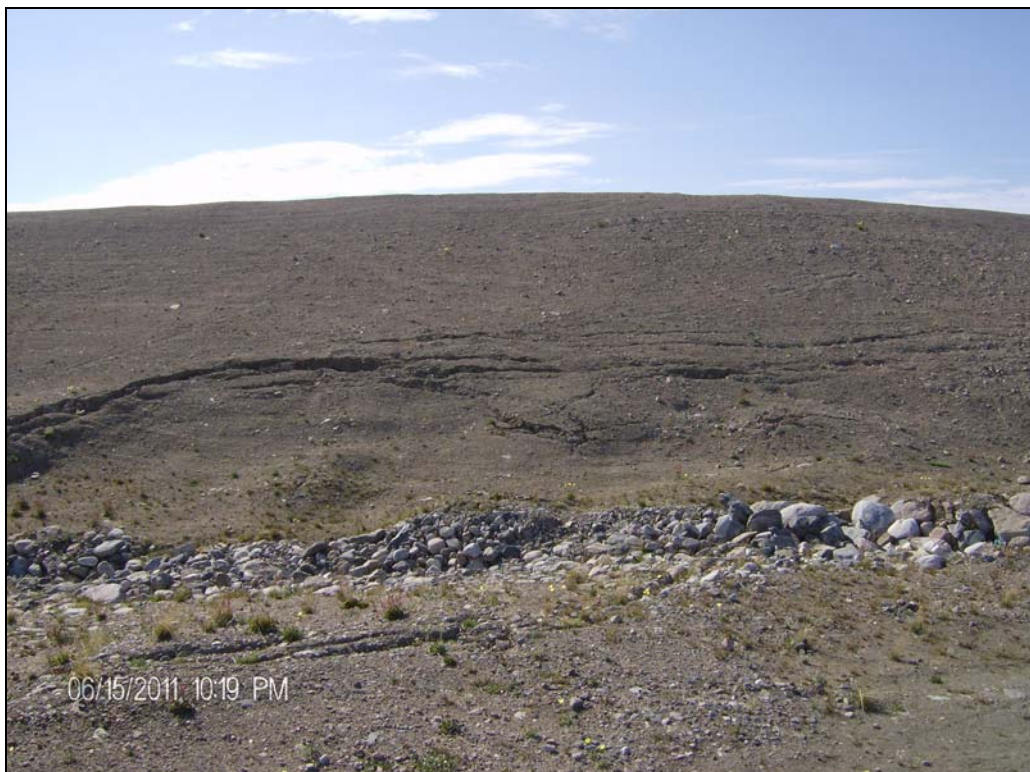
Photo 16: Longitudinal cracks in west half of the north berm close to toe of the berm.

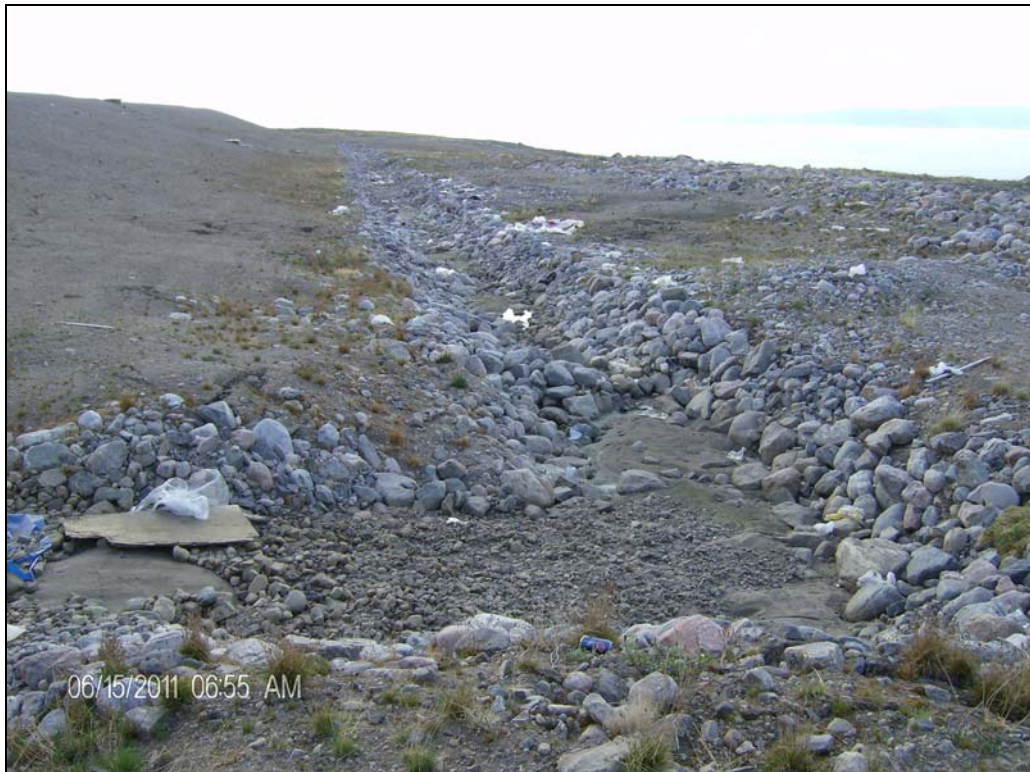
Progressive degradation of the permafrost under the lagoon is expected due to the continuous flow of subsurface water under the lagoon. The flow of water in the drainage ditch located at the toe of the north berm would also degrade the permafrost close to the toe of the berm. It is therefore considered that merely repairing the reported leakage of the liner of the lagoon is not a solution to the problem.

Photo 17: Drainage ditch at toe of north berm.

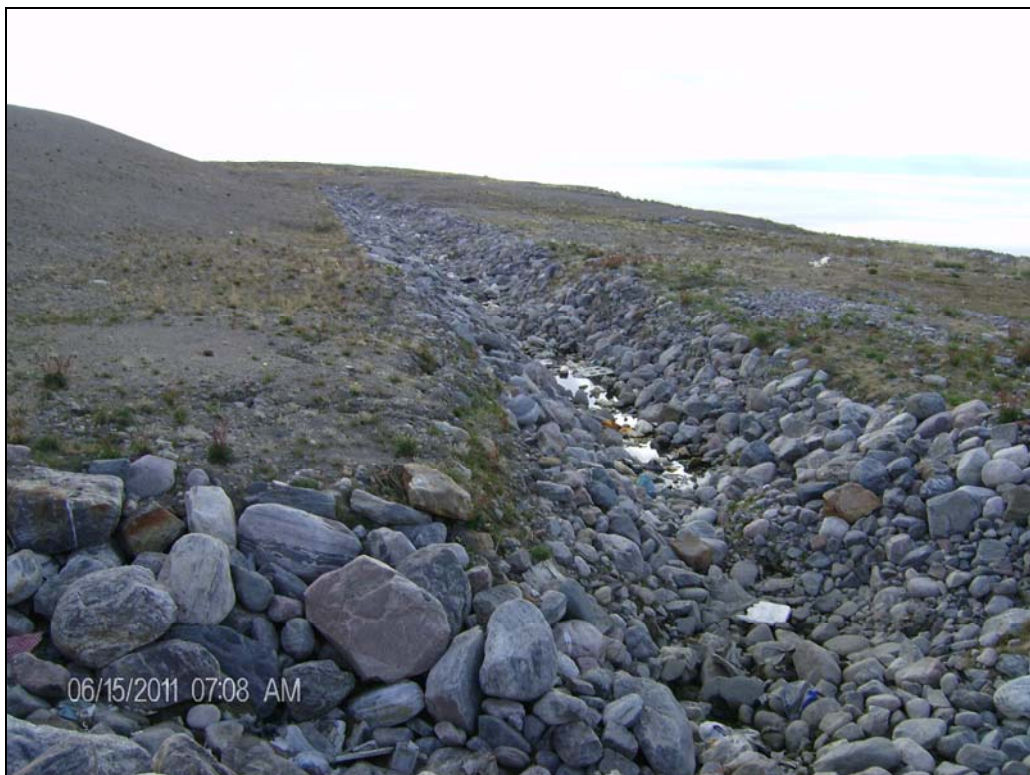
Photo 18: Drainage ditch at toe of north berm.

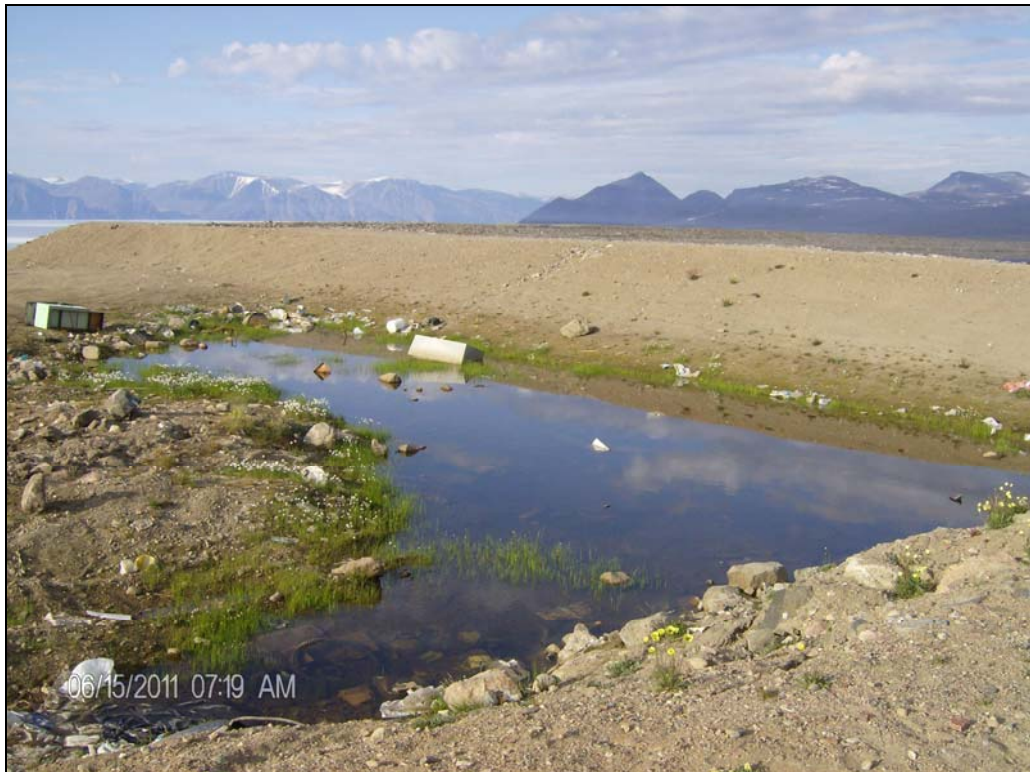
Photo 19: Ponded water close to southwest corner of lagoon.

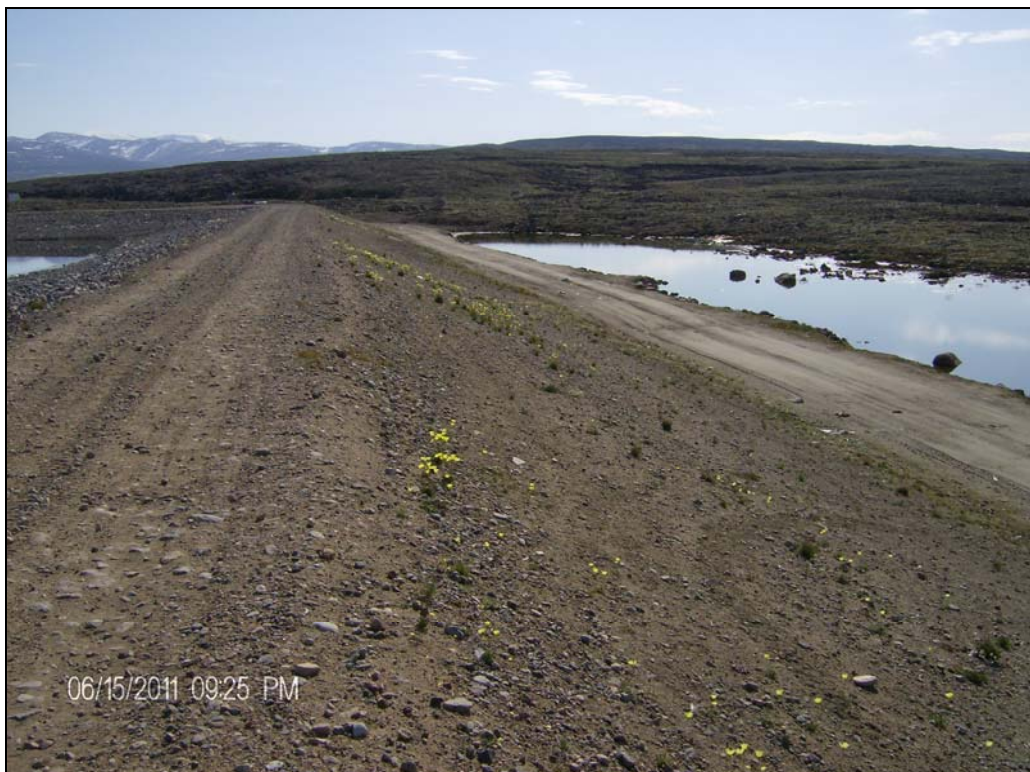
During the site visits of October 2010 and July 2011, ponding of the water close to the east end of the south berm and adjacent to the east berm close to its mid length was observed. It is recommended that this ponded water should be drained. This may be achieved by construction of a drainage ditch from the ponded area to the ravine located on the east side of the lagoon.

Photo 20: Ponded water close to southeast corner of lagoon.

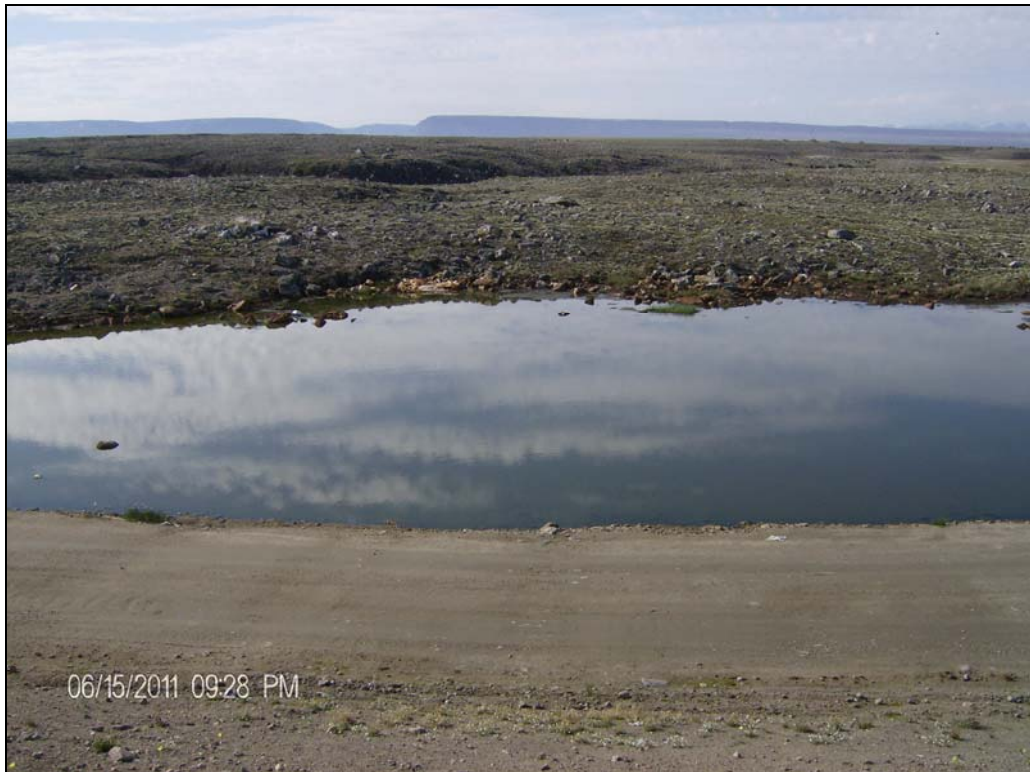
Photo 21: Ponded water close to southeast corner of lagoon.

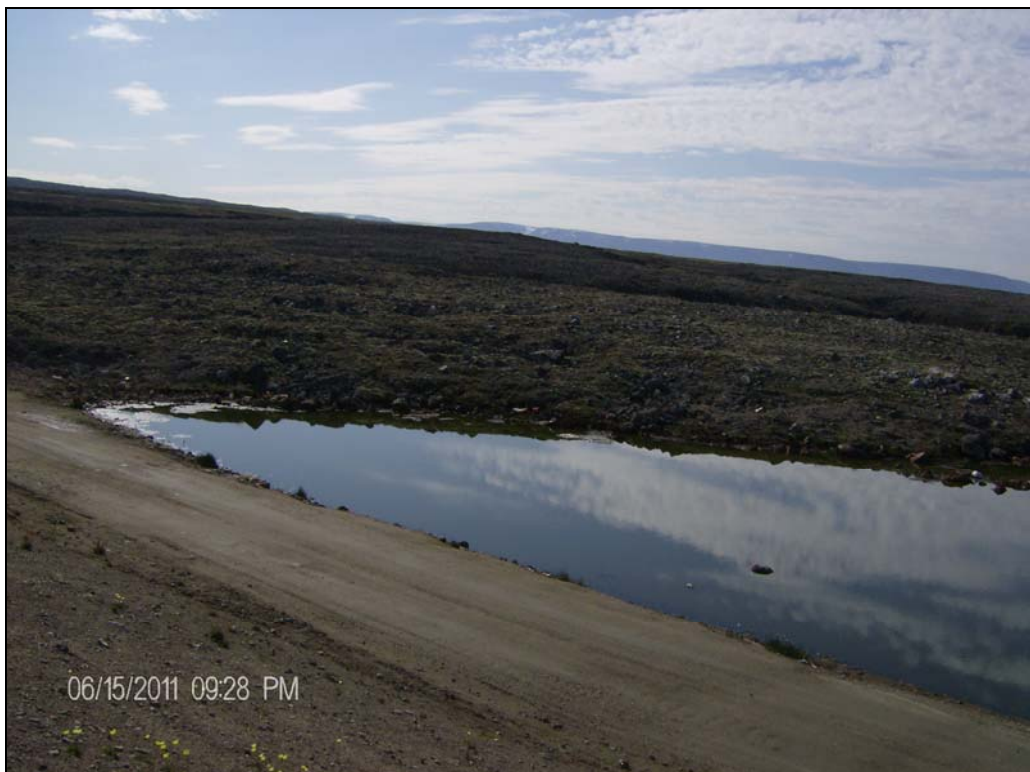
Photo 22: Ponded water close to southeast corner of lagoon.

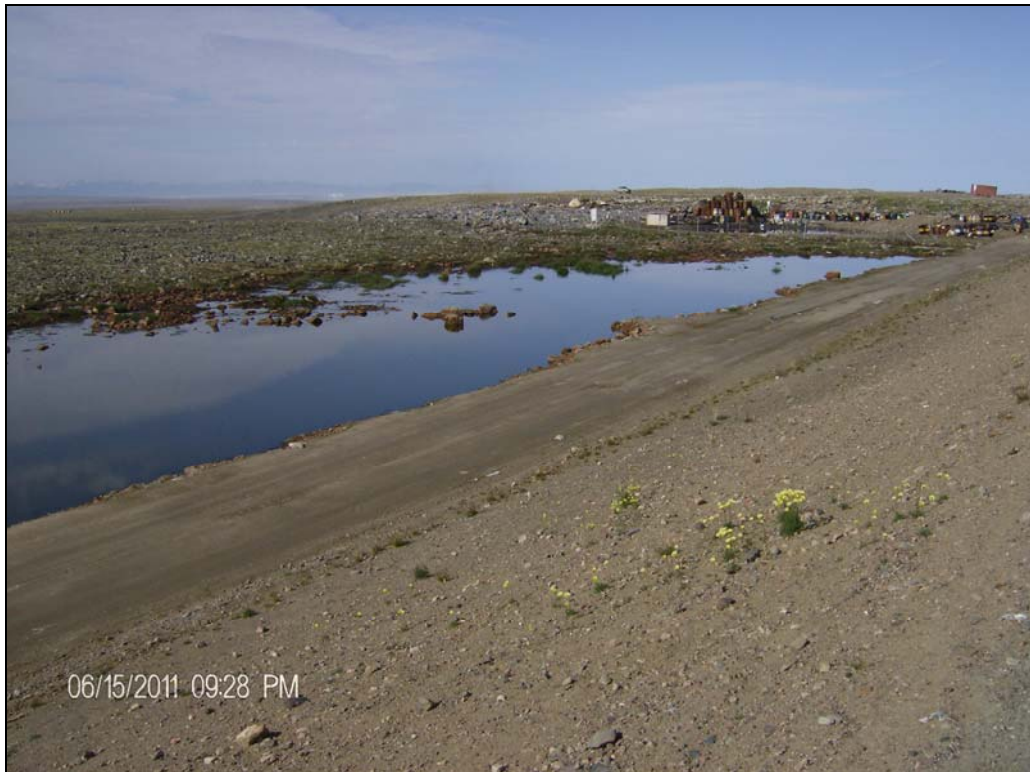
Photo 23: Ponded water close to southeast corner of lagoon.
