From: Phyllis Beaulieu
Sent: Friday, March 04, 2011 3:00 PM
To: Richard Dwyer
Subject: FW: Pond Inlet - Lagoon
Attachments: Sewage Lagoon Pond inlet.docx

From: Andrew Keim [<mailto:Andrew.Keim@inac-ainc.gc.ca>]
Sent: Tuesday, March 01, 2011 11:32 AM
To: Wilma Pike
Cc: Bhabesh Roy; Bernie MacIsaac; Peter Kusugak; Phyllis Beaulieu
Subject: Re: Pond Inlet - Lagoon

Sewage Lagoon Pond inlet.

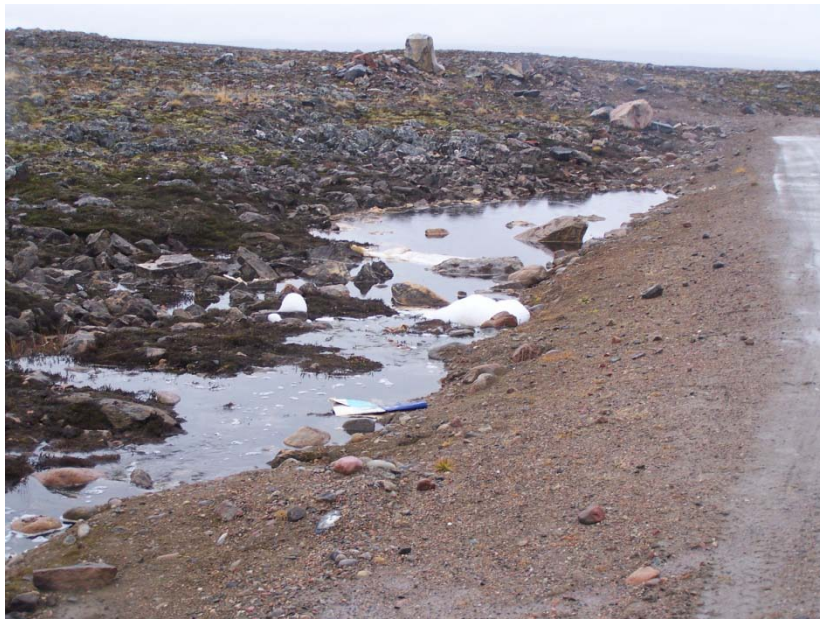
Fig #1

This initiate an investigation into the statement. We visited the location a half hour later and found an area on the East berm of the lagoon that water is coming to the surface in between the rock, the water colour and odour strongly suggest that we have a leak from the sewage lagoon.

Conclusion: The lagoon has started to leak because the level of the water has reached a point where the liner is not welded or overlap properly by the original contractor or the liner is not existent in that area.

The stream of affluent been spill from the lagoon, lagoon is located across from the road on the side of the picture.

The sewage lagoon need to be repaired, the time to do the work should be next spring, for now the lagoon should be decanted, it our understanding from the meeting with the SAO that INAC has given the permission to decant sometime ago. The community was waiting for some scientist to come from Yellowknife that is the information that the Municipal Engineer Bhabesh Roy has pass along to the Hamlet staff. After the lagoon is decanted the leakage should stop for the year.

During the process of decanting special attention must be given to find at what level of the lagoon the water stop flowing out, that will give an indication where the hole is on the berm. Next spring the cover on the berm will need to be removed scraping the sand until the lined is located find the area that has given out or rupture, anew piece of liner should be place and overlap to secure a containment will be achieve with the repair, then place the material previously removed back in place and add fill as necessary.

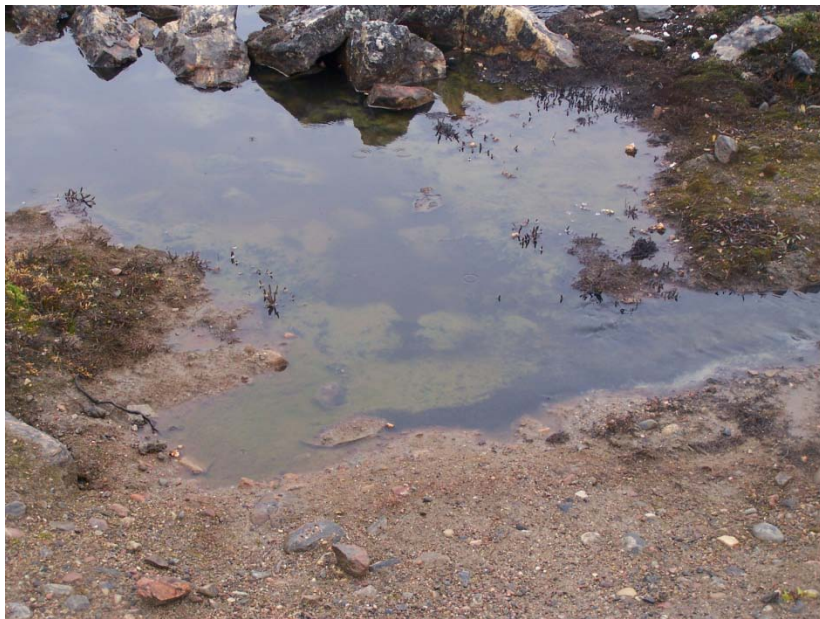
Fig #2

Close up on the stream from fig #1

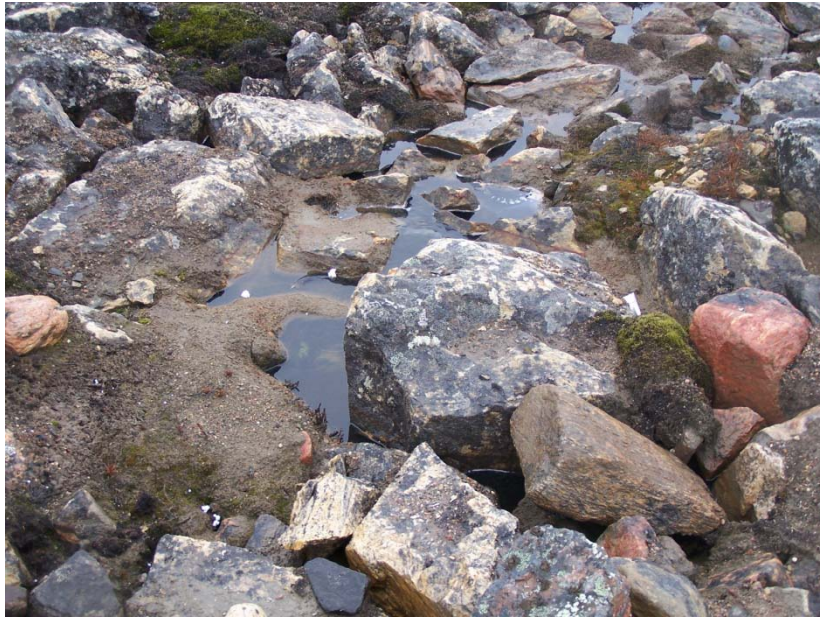
Fig #3

The spill start to show on the surface from under the rock on the picture

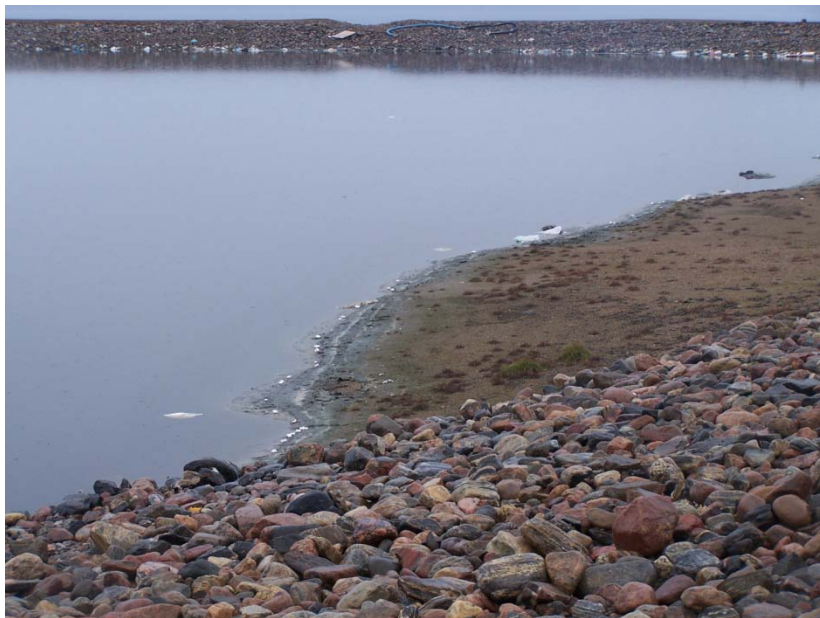
Fig #3

This shows the level inside the lagoon and the high level water mark are evident on the different colour on the berm, this indicate that about 3" to max 6" of water has been spill thought the berm

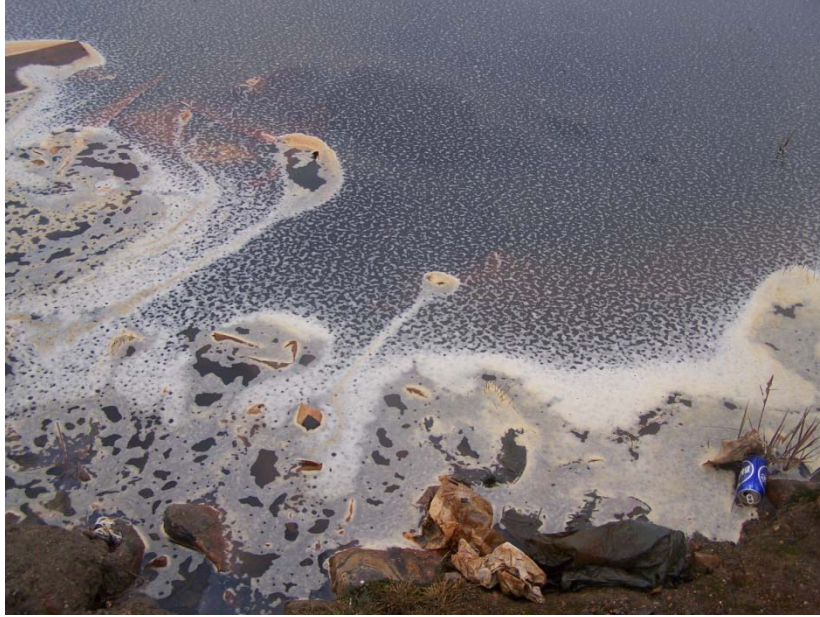
Fig #4

Show the part of the spill accumulated on a pond adjacent to the sewage lagoon to the south side of the facility.

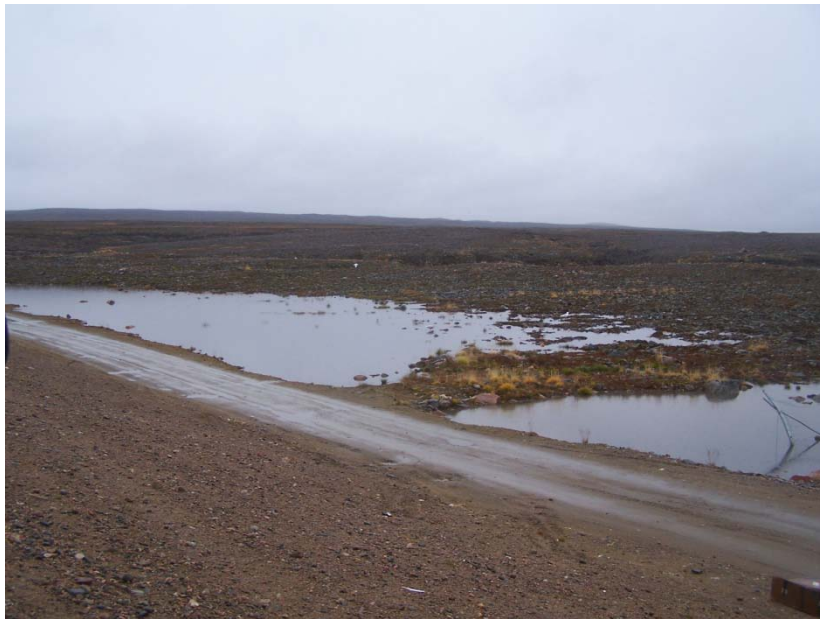
Fig #5

Second view of the pond to the south side this is a combination of material spill and rain water
