**RE: Sewage Treatment Lagoon Sub-Grade Drainage Modification (Part E, Item 1)**

### Photos of Sewage Lagoon Rehabilitation

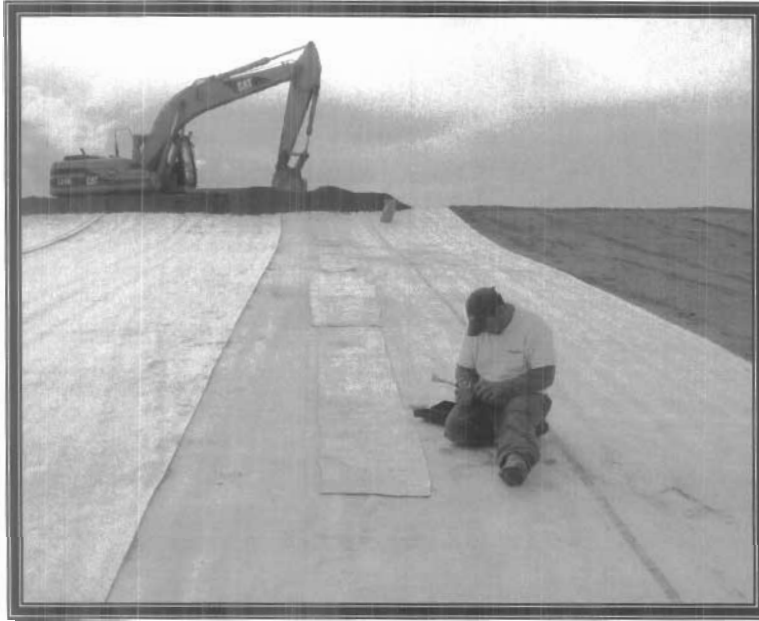
Photo # 1.  
Laying down Bentomat ST GCL

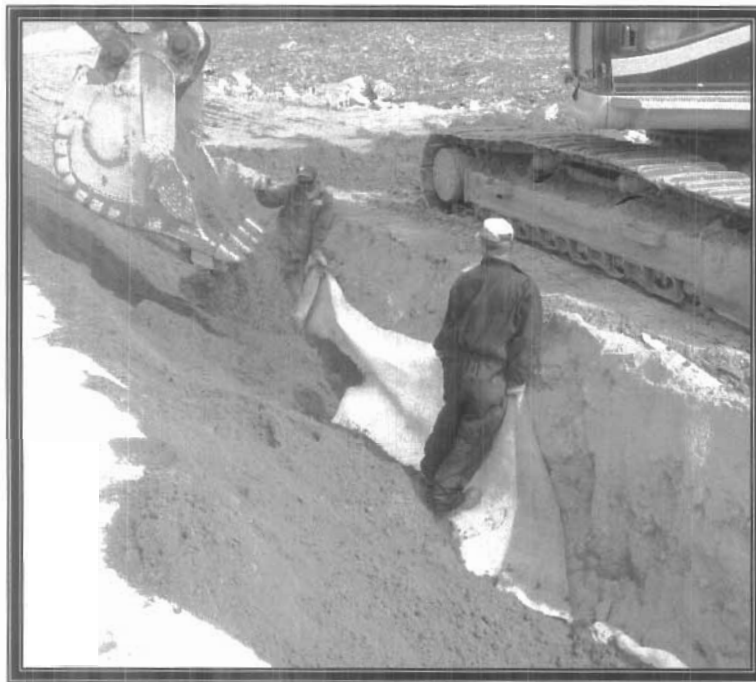
Photo # 2.  
Construction of French drain

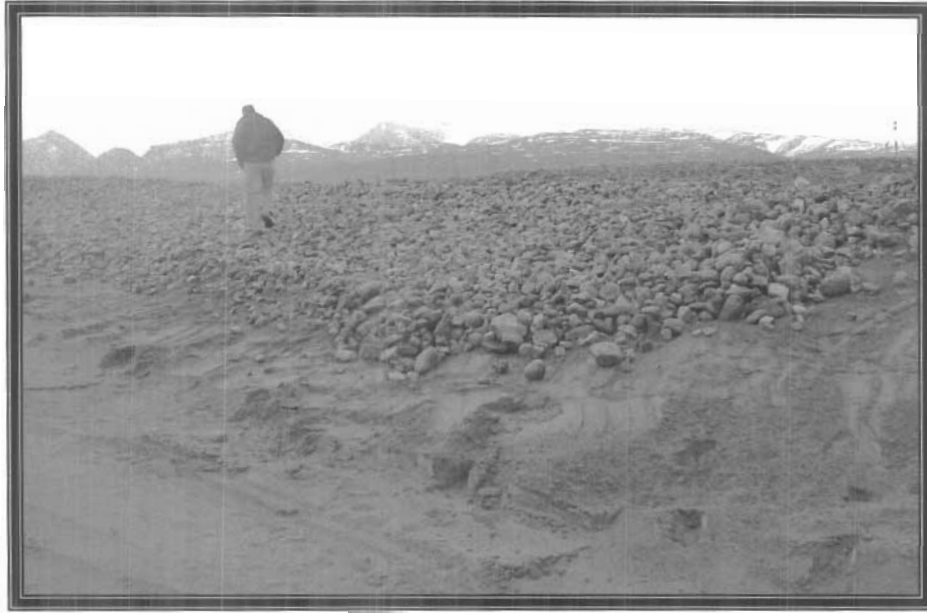
Photo # 3.  
Rip-rap along berm

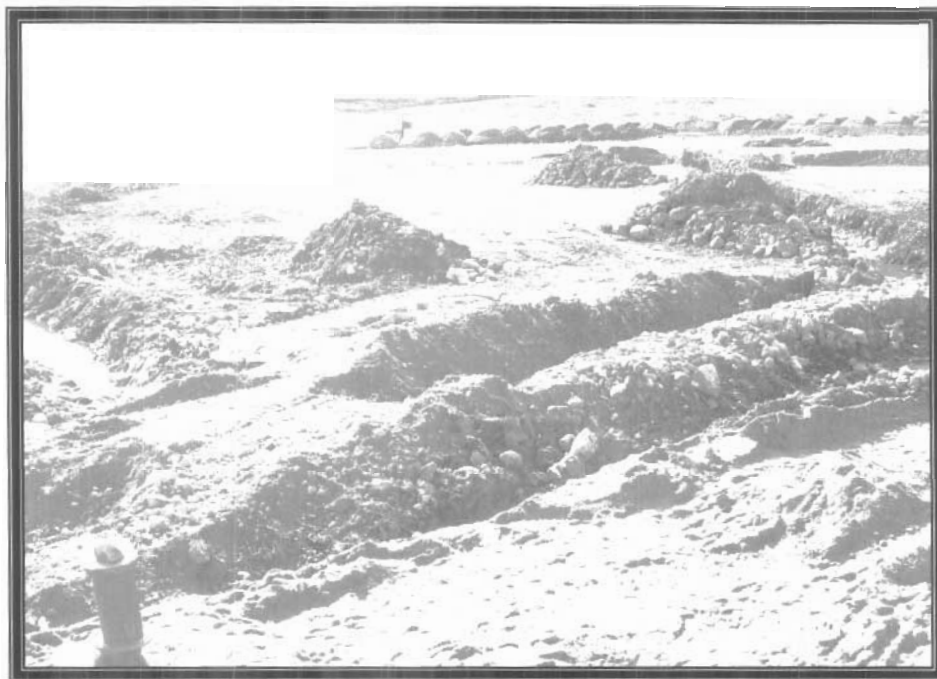
Photo# 5.  
Excavation of sub-drains
