**Geotechnical Evaluation of
Options for Improvements to the
Water Reservoir, Wastewater Lagoon, and
Solid Waste Disposal Facility
Supplement to the Schematic Design Report
(September 2005)
The Hamlet of Qikiqtarjuaq, Nunavut**

November 2005

File No: N-O 09439

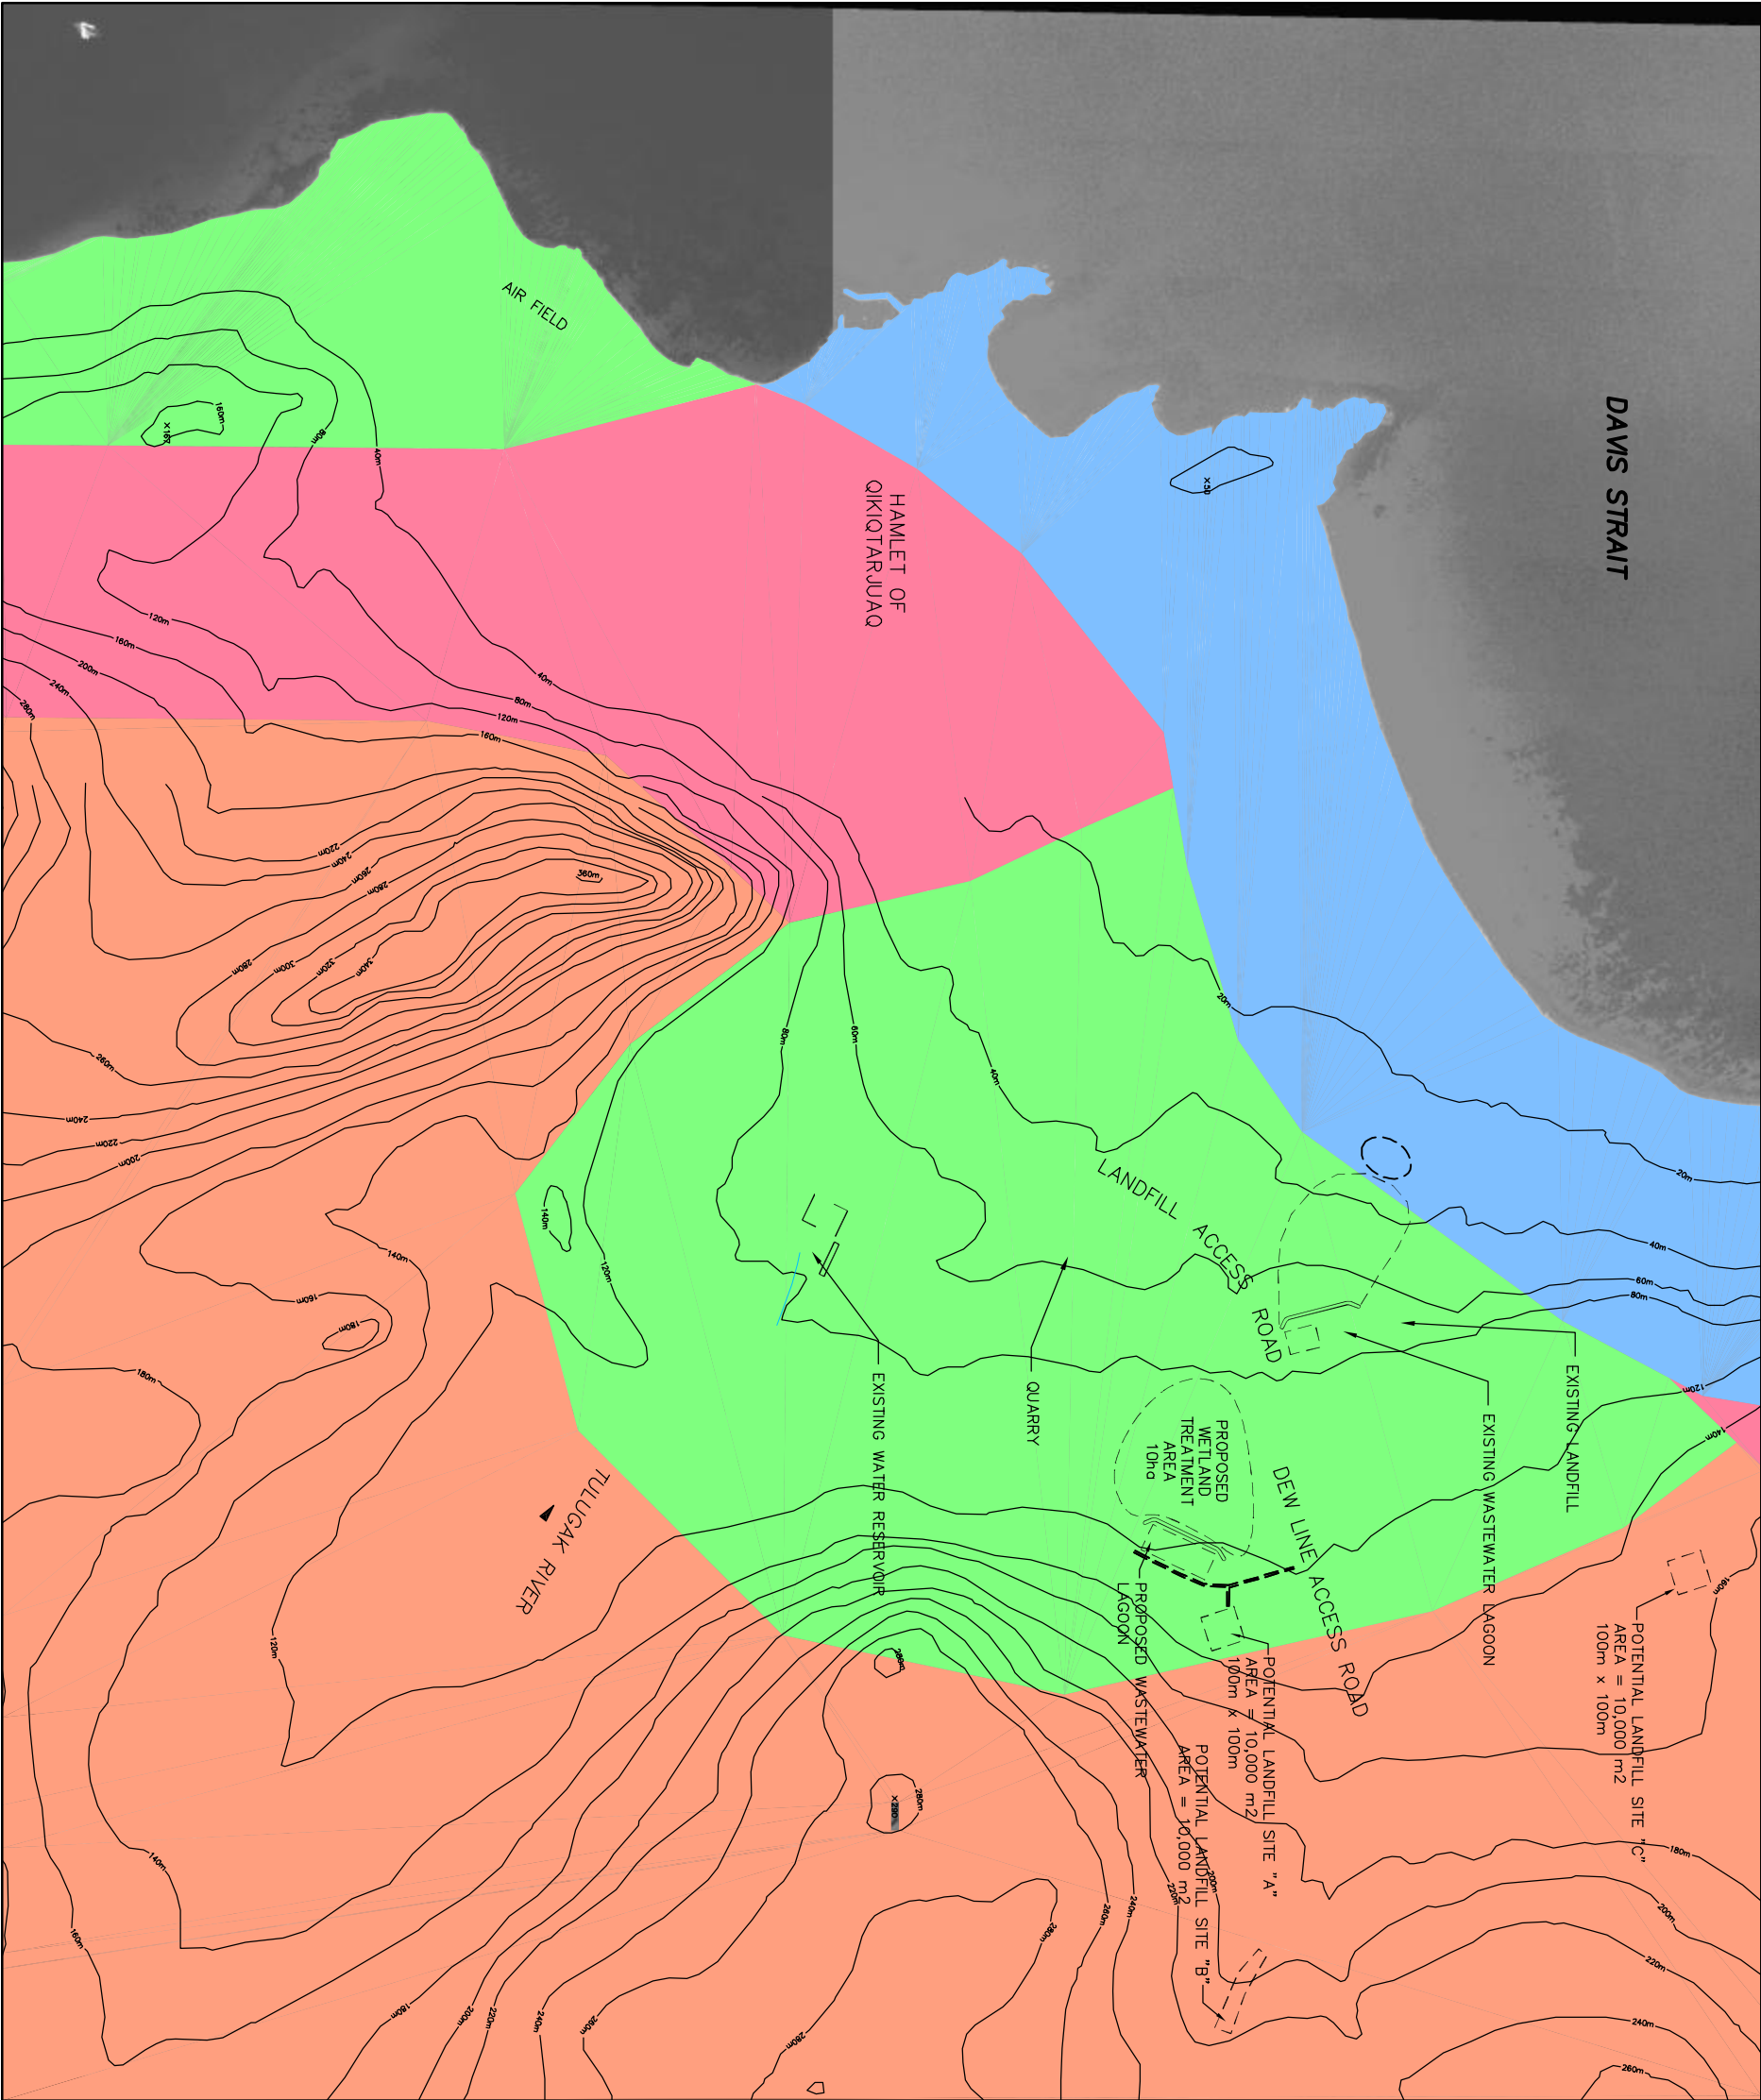
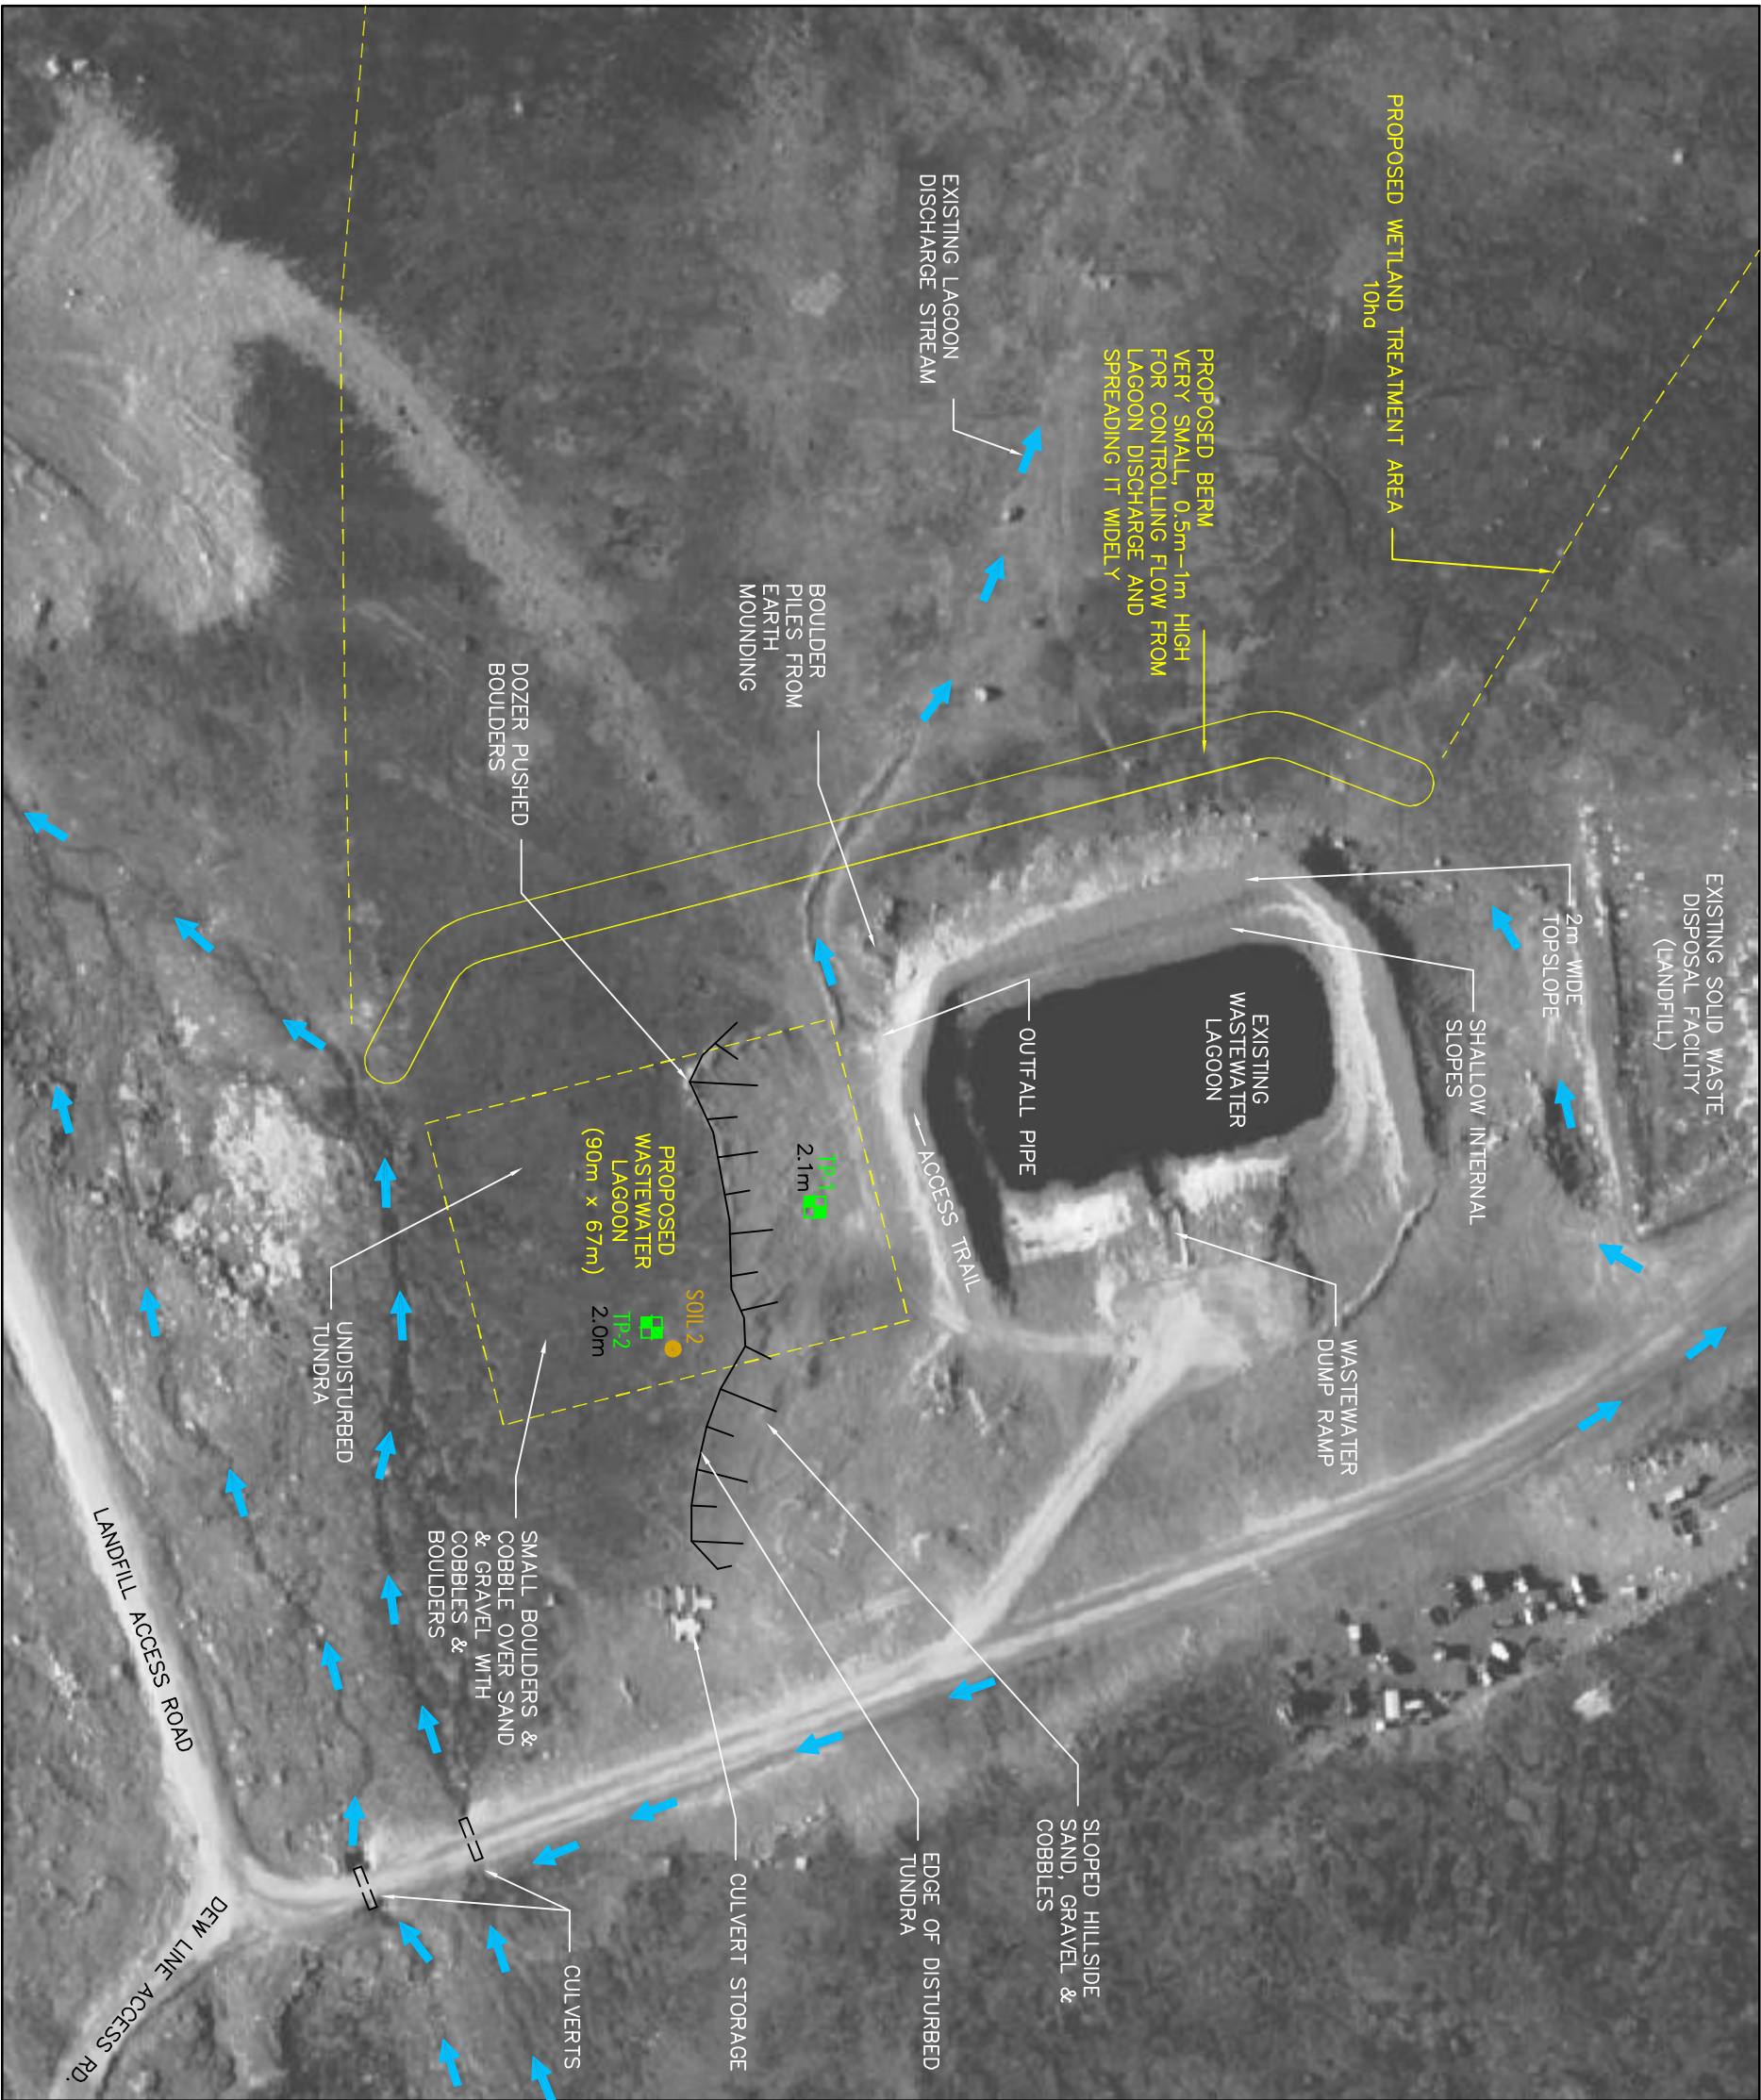
FIGURE 4
THE HAMLET OF OKIOTARIUAQ
GEOTECHNICAL EVALUATION
EXISTING WASTEWATER
LAGOON

Figure 4 displays the existing wastewater lagoon and surrounding area. The existing lagoon currently operates by discharging from an outfall through the berm in the late summer. The discharge is confined to a meandering stream and shows strong green vegetation growth around its course.

Two test pits were excavated using a rubber-tired backhoe as shown on Figure 4. Test pit logs are included in Appendix A. The test pits revealed poorly sorted medium to coarse sand and gravel, with cobbles and small boulders to approximately 2.0 m where digging was halted by permafrost. Photographs are included in Appendix B. The results of the laboratory analysis for a representative soil sample (Soil 2) are included in Appendix C.

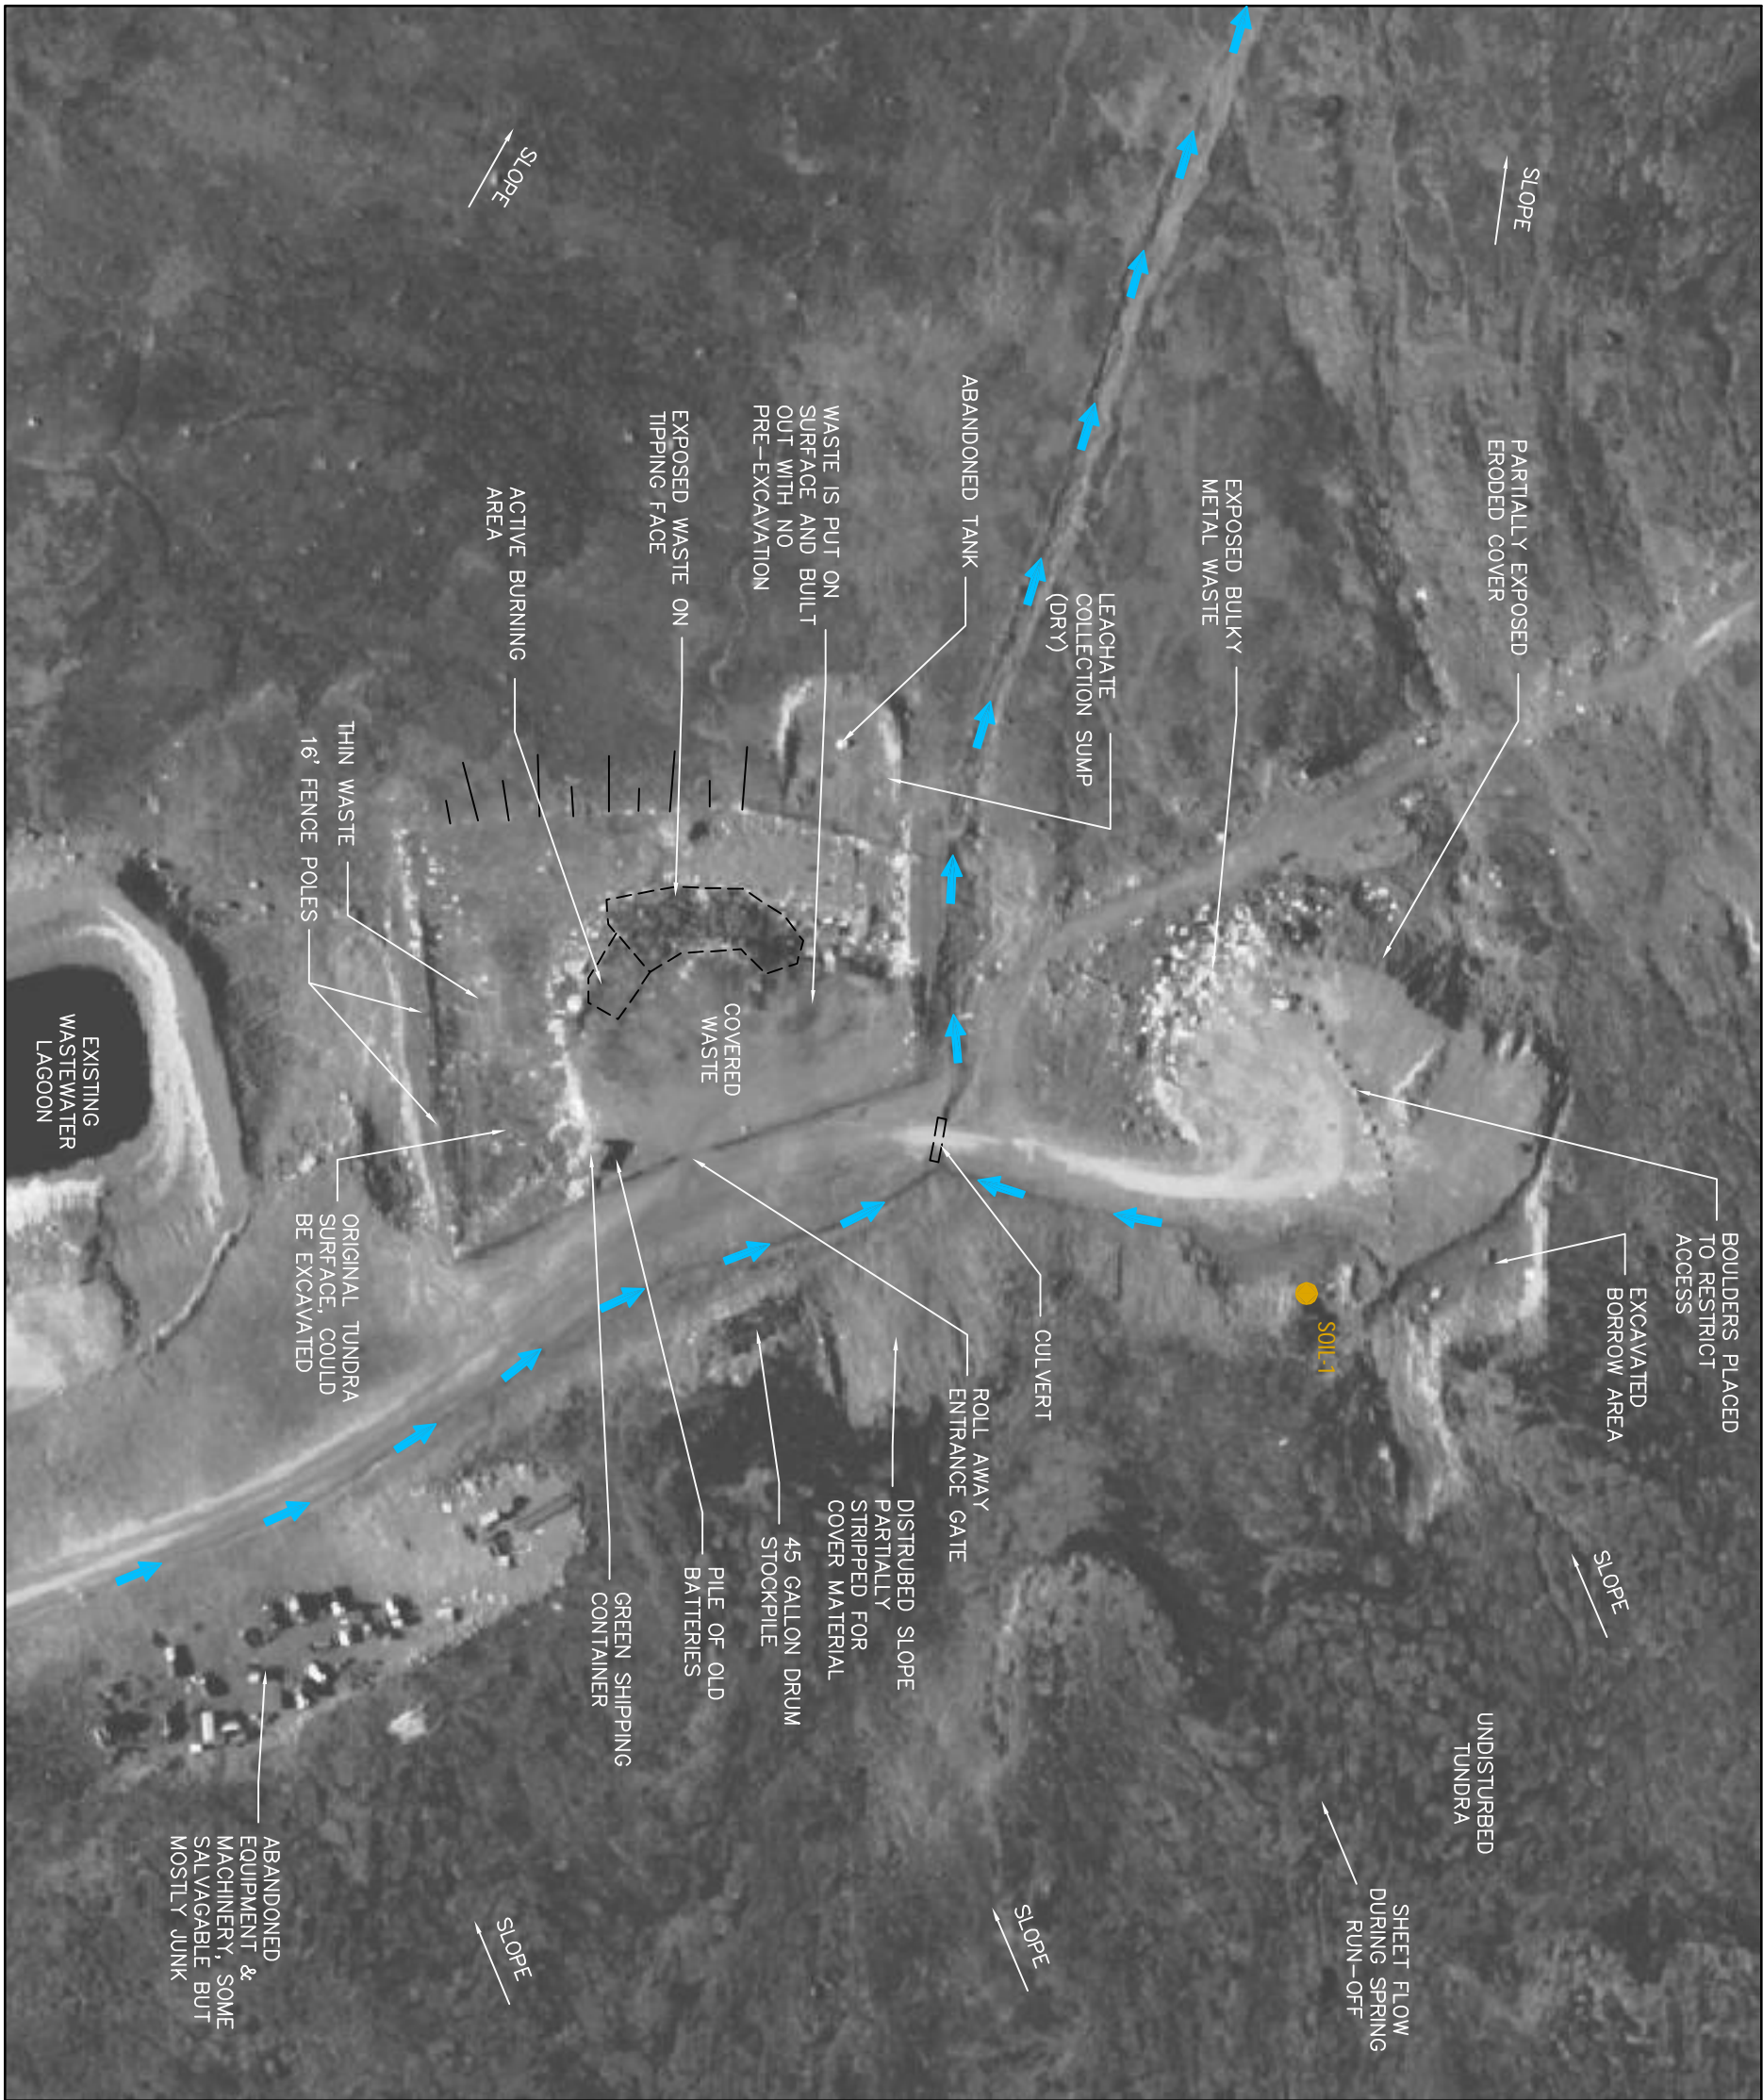
FIGURE 5
THE HAMLET OF OIKIOTARUAQ
GEOTECHNICAL EVALUATION
EXISTING LANDFILL

The landfill and area around the landfill was traversed, and the soil and topography mapped. See Figure 5 for site details and Appendix B for photographs.

The site is operated in two parts. The putrescible waste disposal area is enclosed by a fence, and an open bulky metals disposal area is located immediately to the north of the fenced area. This results in two active fill faces. Both areas operate by filling outwards on a down slope on top of the original ground surface.

The landfill site area is on a long slope, which tends to be well drained. The upgradient slope to the east was observed to be covered with sheet flow during spring run off. This requires effective ditching to control the flow around the landfill rather than across it.

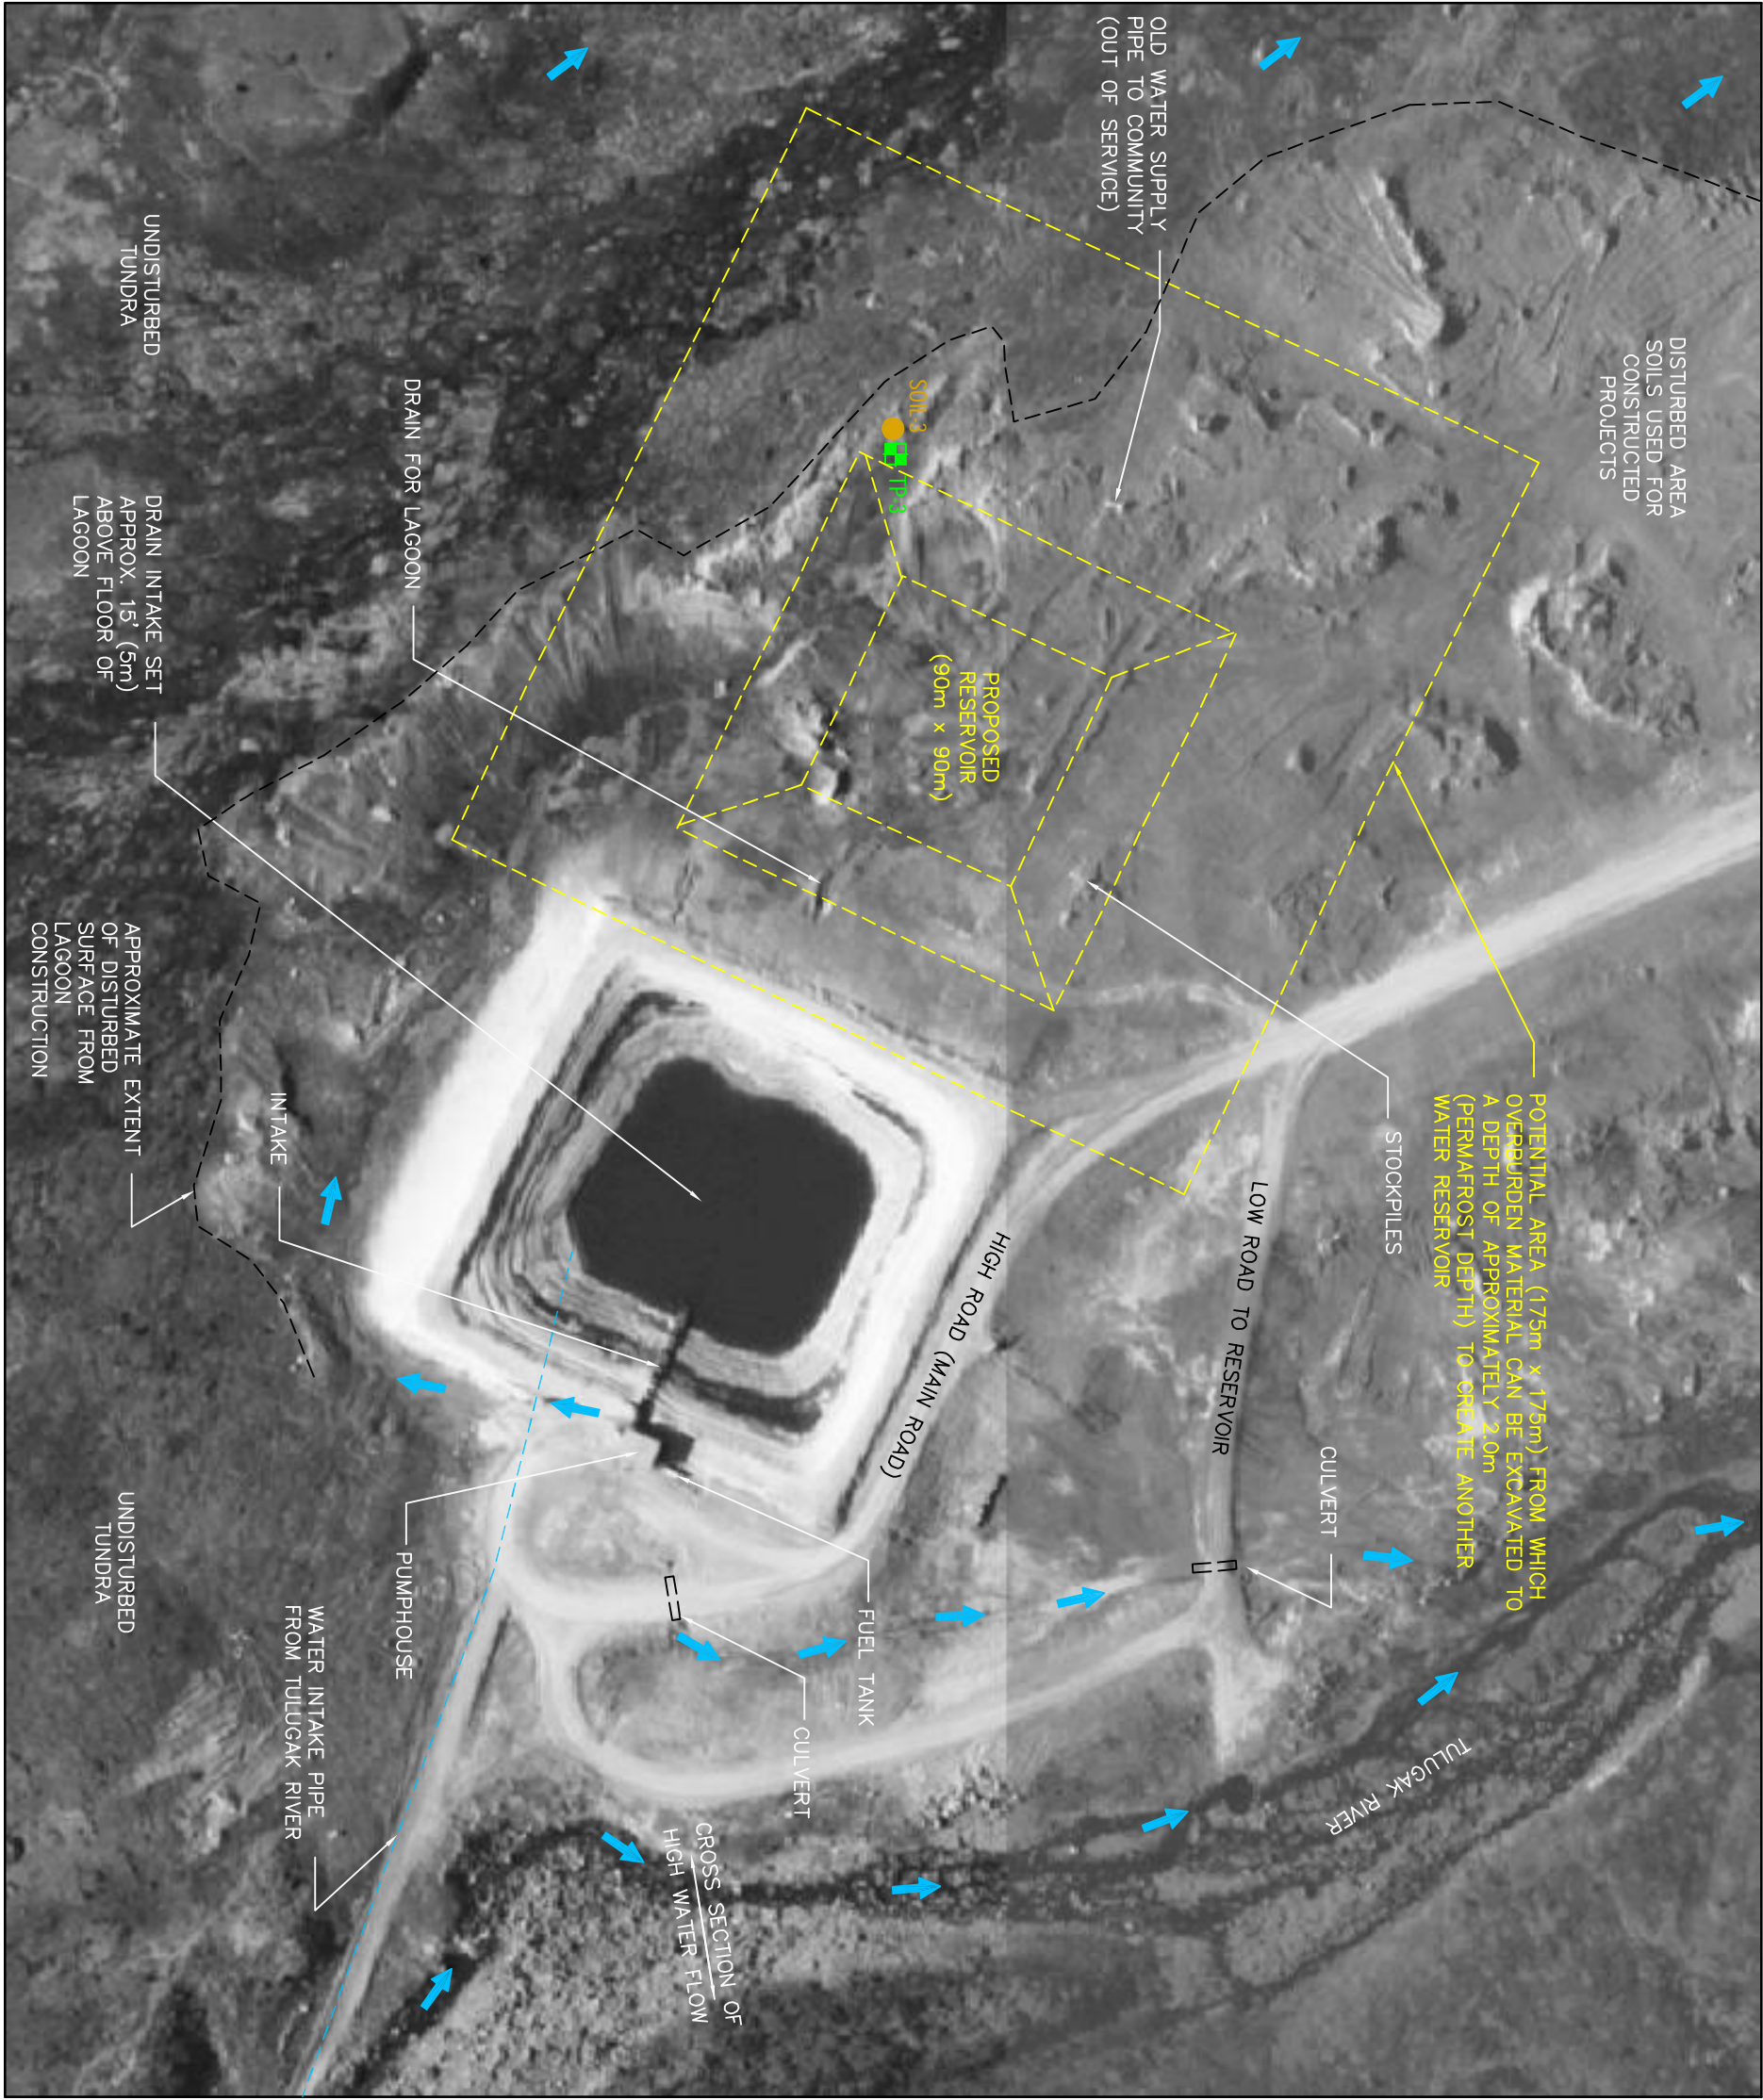
FIGURE 6
THE HAMLET OF OIKIOTARUAQ
GEOTECHNICAL EVALUATION

Figure 6 displays the existing water reservoir and surrounding area. The Schematic Design Report outlines three potential viable options to address the need for expanded reservoir capacity. All of the options involve developing increased storage capacity at the existing site. Regardless of whether the existing reservoir is expanded in some fashion or if an entire new reservoir is constructed, berm material and a suitable base is required.

Currently the reservoir is filled during the summer by laying pipe over the ground up hill to the Tulugak River as shown on Figure 6. Filling was observed underway September 15, 2005, however the flow in the river and resulting flow through the pipe was low. Hamlet staff indicated the river should continue to flow sufficiently to fill the reservoir until early October.

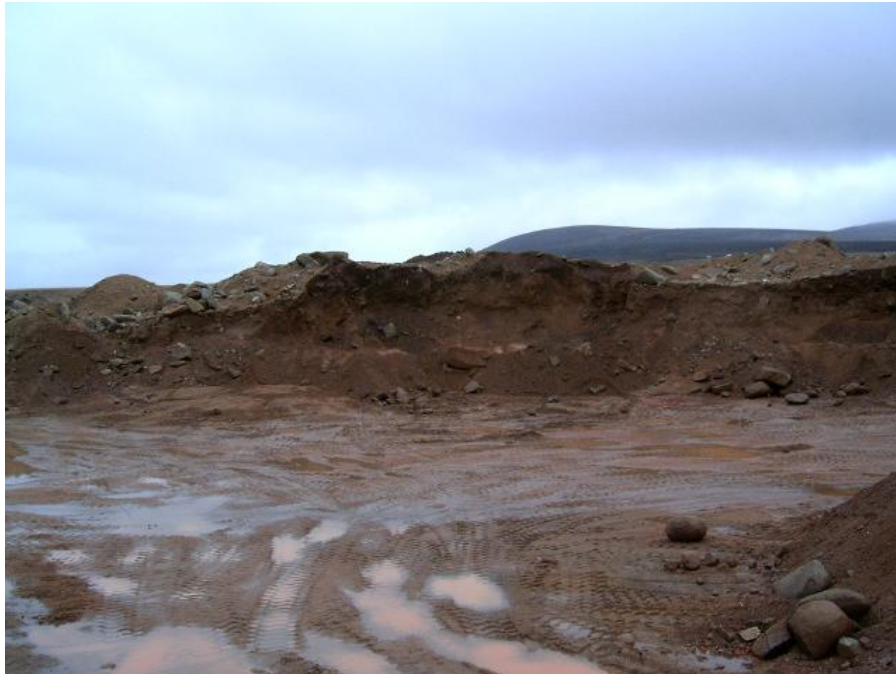
Photo 1 Overburden stockpiled in quarry area.

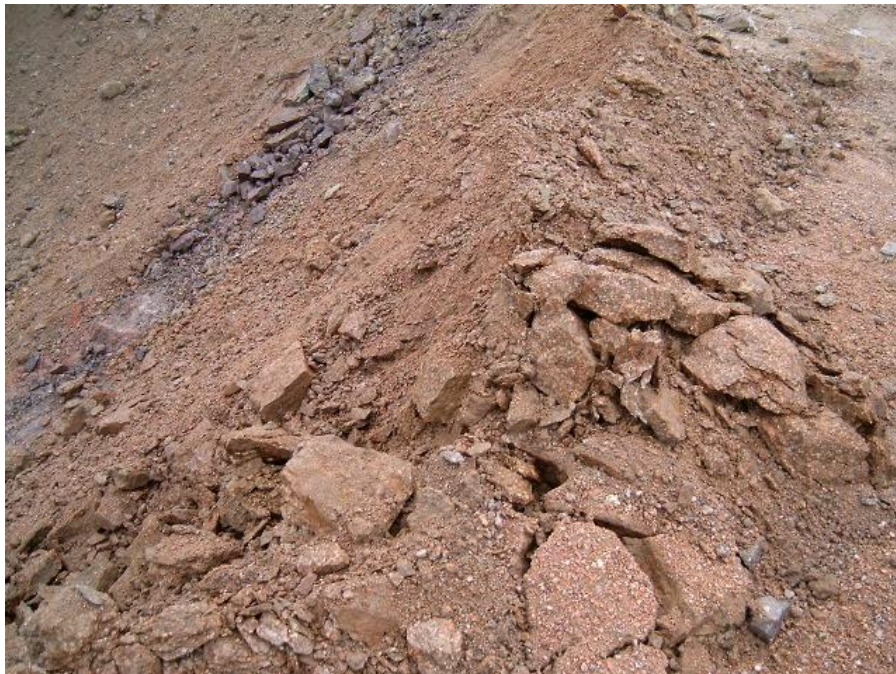
Photo 2 Close up of broken bedrock float weathering to sand and gravel at the quarry site.

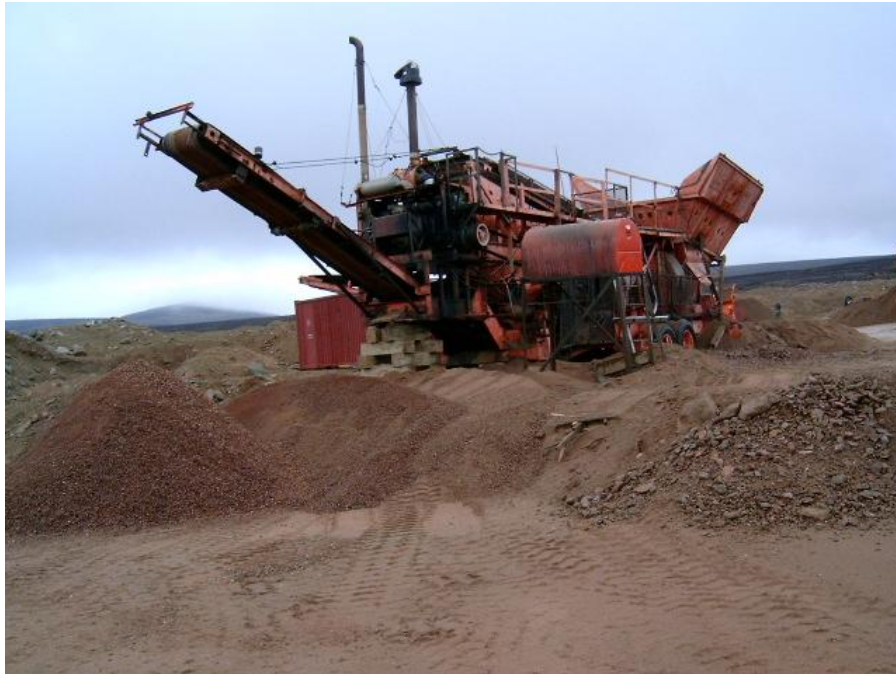
Screening equipment, an excavator, a loader, and a dump truck were noted in operation at the quarry site.

Photo 3 Screening equipment at the quarry site.

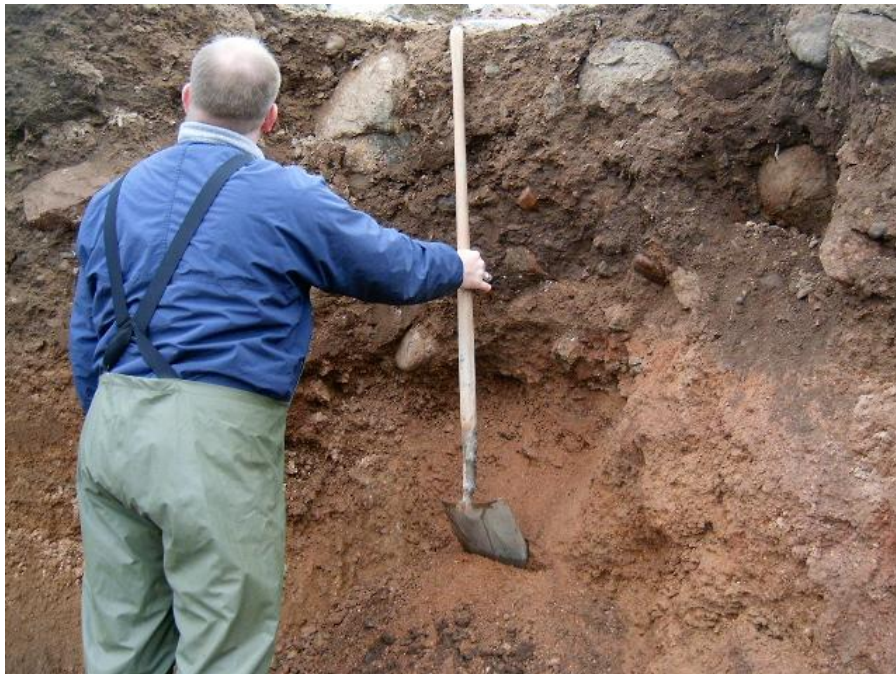
The quarry has been excavated sufficiently to create vertical excavation faces exceeding 2.0 m, which can be excavated easily as water drains and the permafrost melts back. See photographs in Appendix B.

Photo 4 Typical excavation face at the quarry site.
Permafrost at approximately 2.0 m below surface.

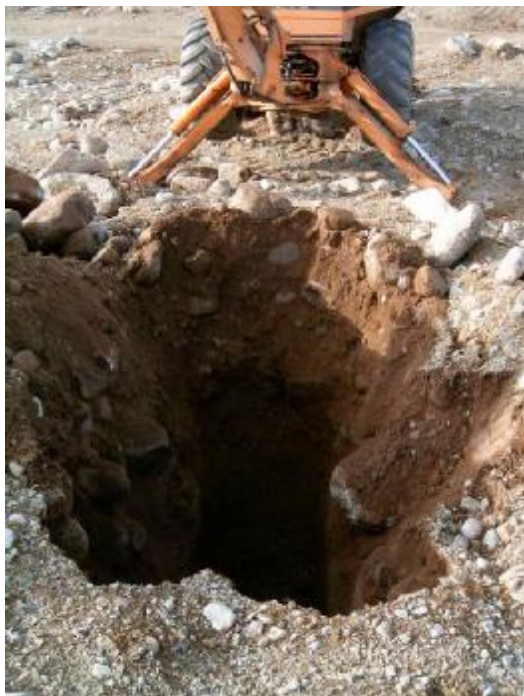
Photo 5 Test Pit #1 near existing
wastewater lagoon.

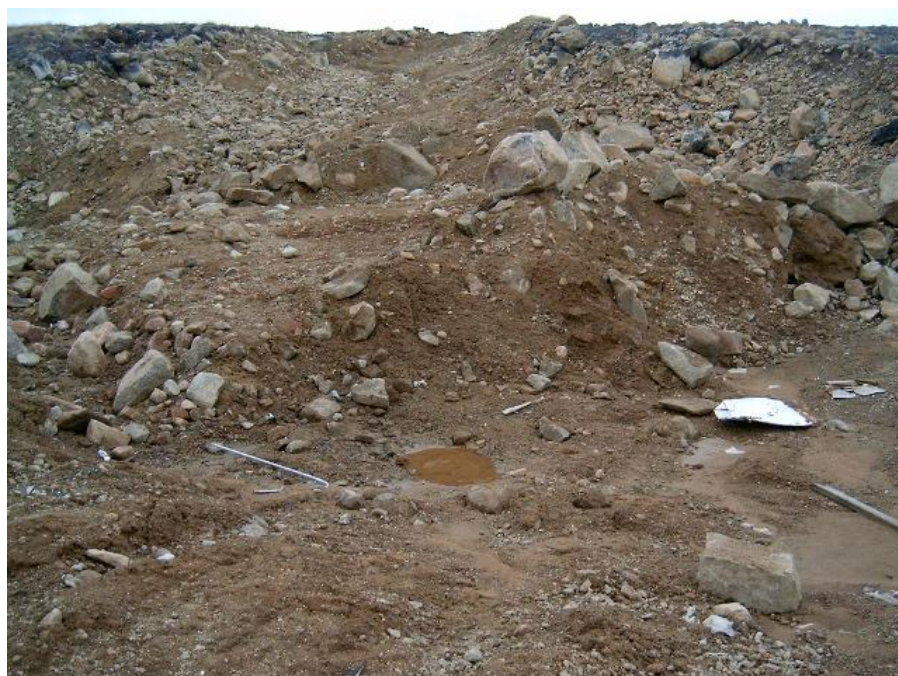
The excavated slope face east of the bulky metal waste disposal area was examined. This area has been excavated into the hillside to acquire cover material for the landfill. An estimated 2.0 m of overburden is able to be quarried above the permafrost line. Excavation into the hillside indicates the soil is coarse and well drained. It appears the permafrost retreats as the excavation advances. Although the material is coarse with many boulders, it is easily excavated and is suitable for landfill cover. There appears to be an abundant amount of available cover material, as the hillside can be excavated eastwards for many hundreds of meters. The results of the laboratory analysis of a representative soil sample (Soil 1) is included in Appendix C.

Photo 6 Face of borrow area behind landfill.

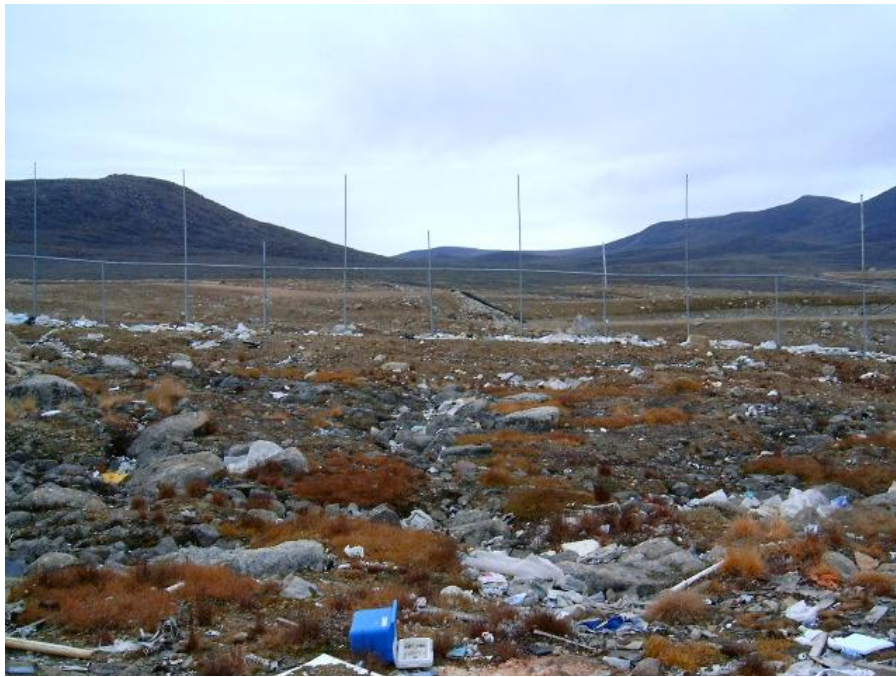
Within the landfill enclosure, the unfilled areas on the south side and the west side (in front of the waste face) are the original ground surface. Based on local test pitting, these areas could be excavated to approximately 2.0 m to the top of the permafrost. Excavation of a fill footprint below surface would greatly increase the vertical thickness of deposited waste without creating a steep slope face.

Photo 7 South side of landfill site.

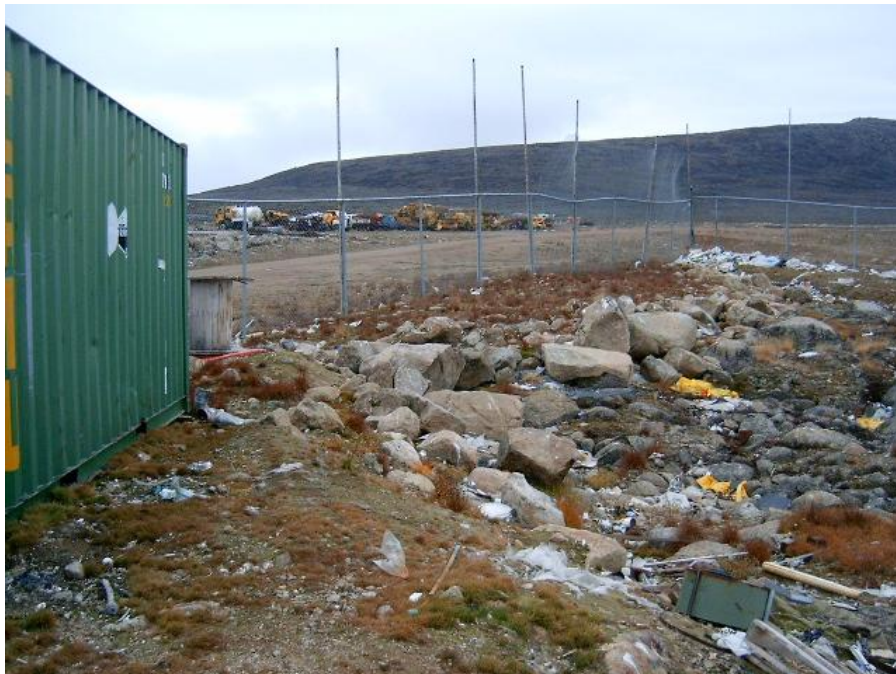
Photo 8 South side of landfill site.

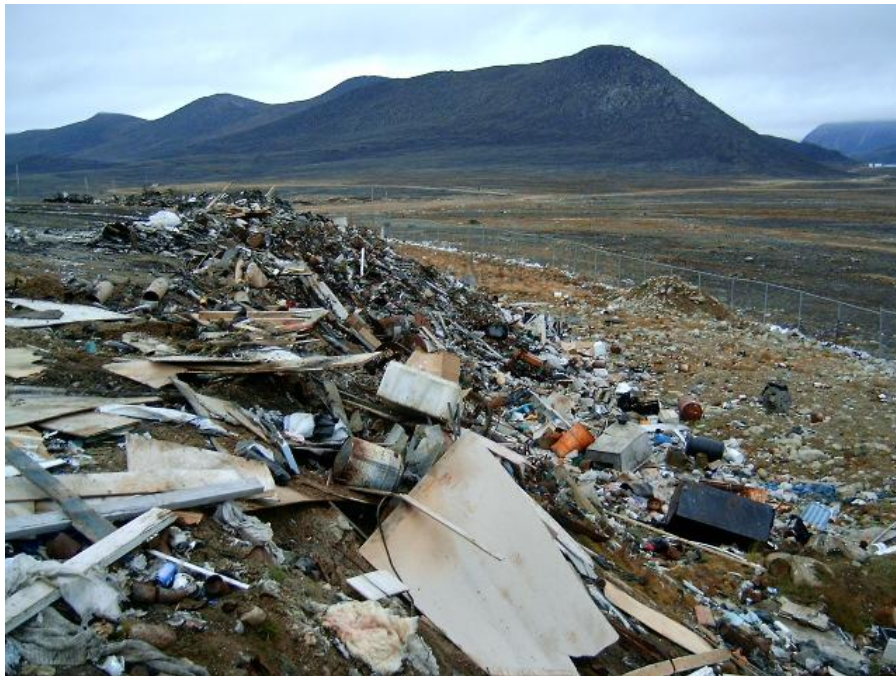
The landfill currently has operational issues with exposed waste and steep tipping faces. The landfill site and the surrounding area consists of boulder and cobble armored tundra surface, underlain by a poorly sorted till consisting of medium to coarse sand and gravel, with abundant cobbles and small boulders.

Photo 9 Looking south across tipping face of landfill.

Sufficient excavatable material is available on site to create berms to better enclose the fill area and reduce problems such as:

- Blown litter
- Steep tipping face
- Expanding footprint of the waste
- Visual appearance.

The fencing could be established on top of the berms to increase the height of the fence and achieve better capture of wind blown litter.

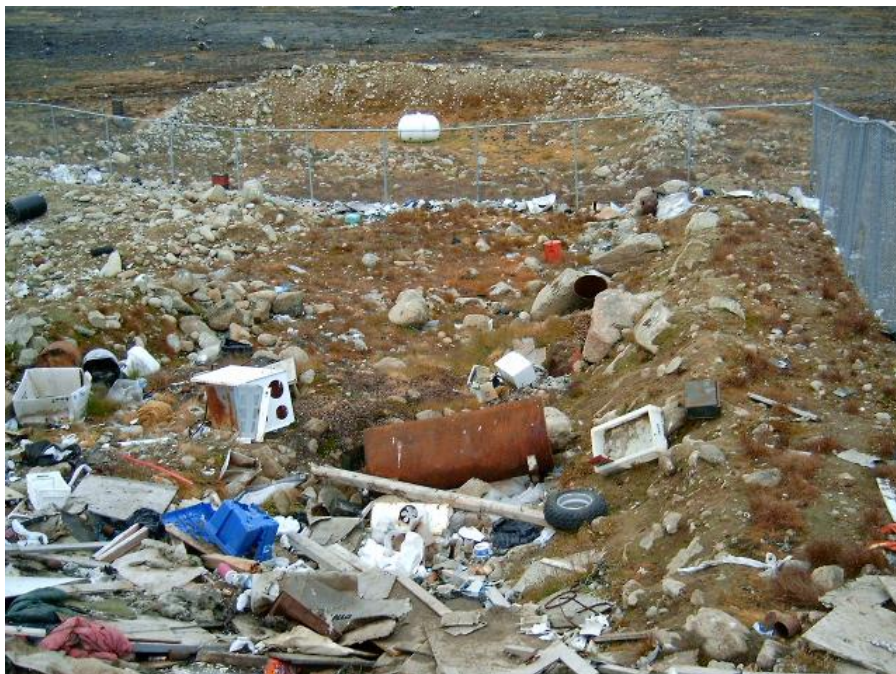
Photo 10 Dry leachate collection pond at base of landfill.

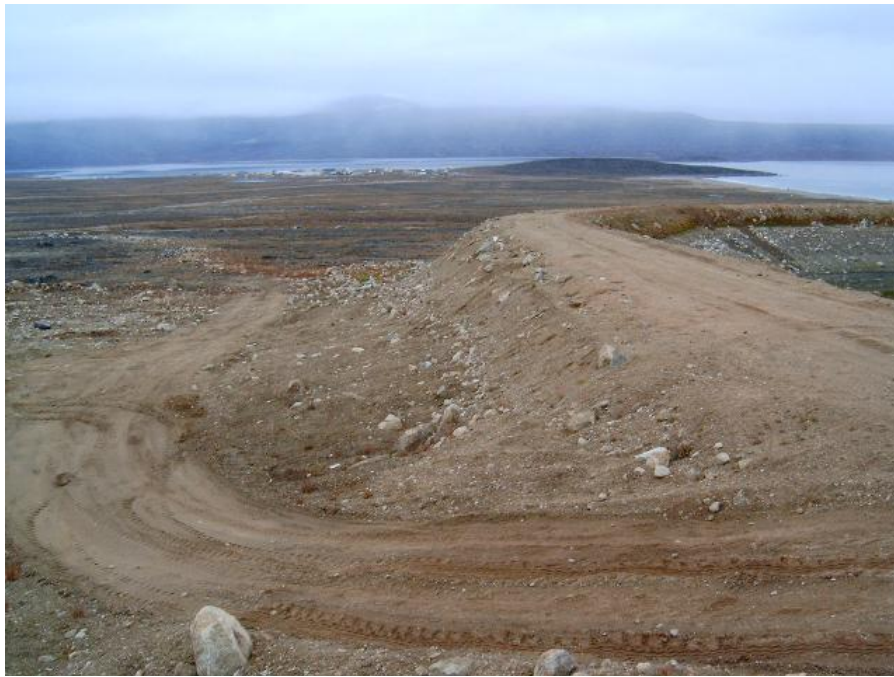
Photo 11 South side of wastewater lagoon.
