**Geotechnical Evaluation of
Options for Improvements to the
Water Reservoir, Wastewater Lagoon, and
Solid Waste Disposal Facility
Supplement to the Schematic Design Report
(September 2005)
The Hamlet of Qikiqtarjuaq, Nunavut**

November 2005

File No: N-O 09439

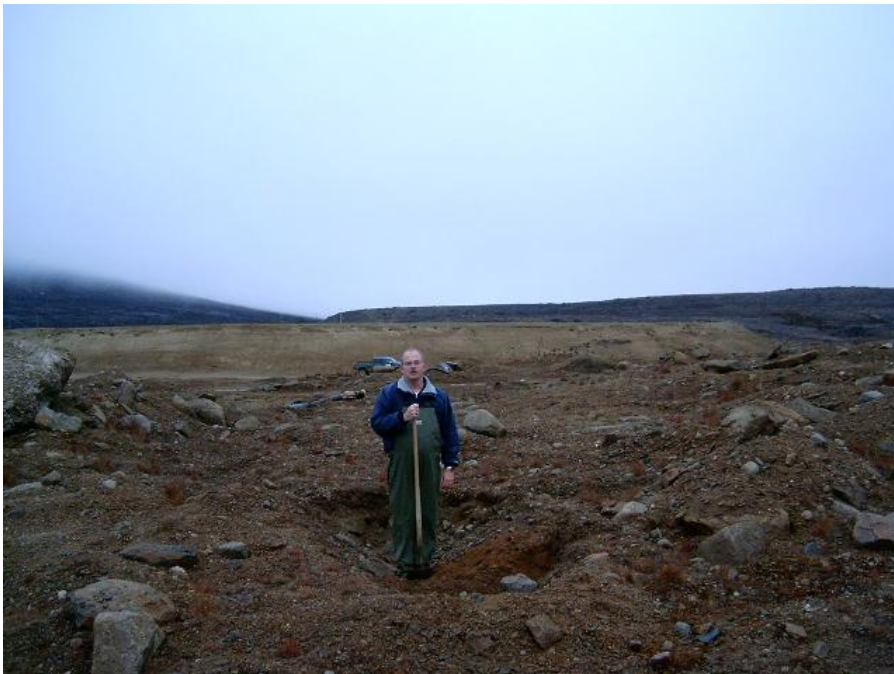
The area slopes towards the northwest away from the existing reservoir. Sufficient area exists to place another similar sized reservoir next to the existing reservoir. An examination of the soil around the potential new reservoir identified sufficient suitable overburden material to create the berms, and provide the raw material that could be crushed and sorted to provide the needed sand and gravel. The laboratory results of the analysis of a representative soil sample (Soil-3) are included in Appendix C.

Photo 12 Bull dozed surface and test pits west of the water reservoir.
Approximately 2.0 m of overburden to permafrost.

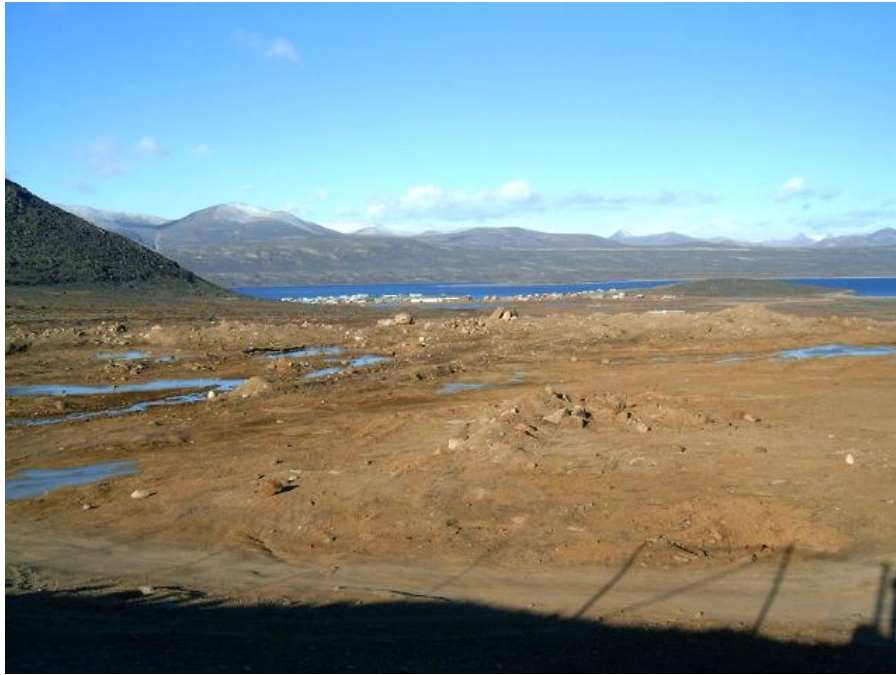
Surficial material in the area south of the existing wastewater lagoon appears to be very similar to the material used to construct the existing lagoon. Sufficient resources of overburden material are available on site to create a second similar sized lagoon using a similar construction technique.

Photo 13 Looking west from wastewater lagoon across disturbed area of overburden from which existing lagoon berms were constructed.
