WATER LICENCE INSPECTION FORM

Licensee		Licensee Representative	
Hamlet of Qikiqtarjuaq		Geela Kunilusie & Phillip Sanguya	
Licence No. / Expiry		Representative's Title	
3BM-QIK1417		Senior Administrative Officer and Hamlet Foreman	
Land / Other Authorizations		Land / Other Authorizations	
Date of Inspection		Inspector	
August 15 2014		A. Keim	
Activities Inspected			
<input type="checkbox"/> Camp	<input type="checkbox"/> Drilling	<input type="checkbox"/> Mining	<input type="checkbox"/> Construction
<input type="checkbox"/> Roads/Hauling	<input type="checkbox"/> Other: Water Discharge	<input checked="" type="checkbox"/> Other: Municipality	<input type="checkbox"/> Reclamation
<input type="checkbox"/> Fuel Storage

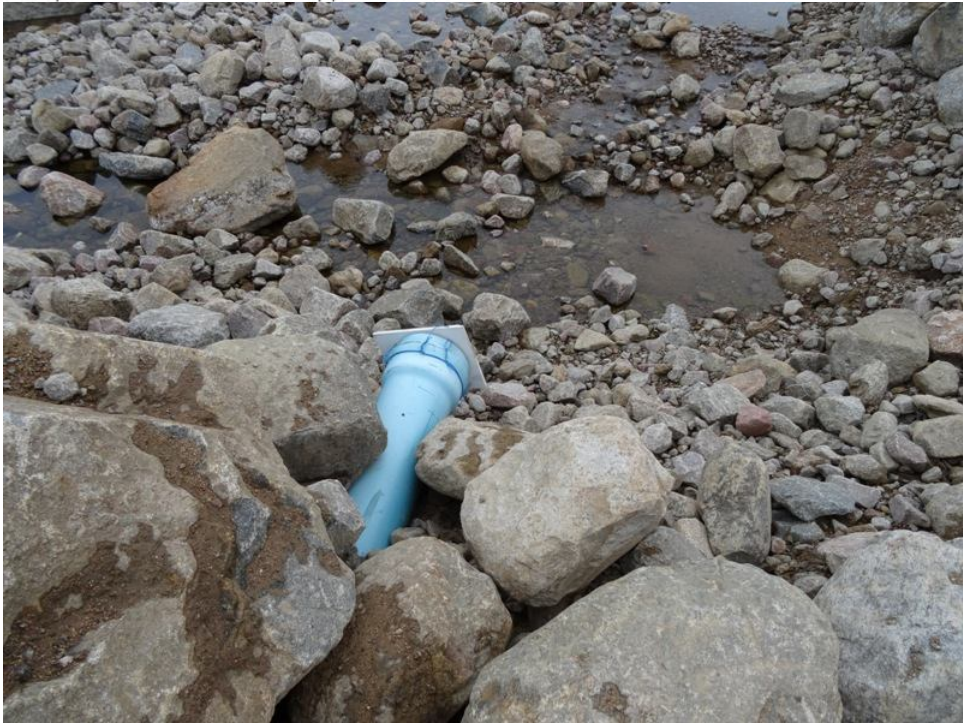
During the period of Inspection the Tulugak River was not flowing high enough to facilitate filling of the Reservoir. It was expected that the rain and final melt would raise water levels in the river sufficiently to fill the community reservoir. It was noted that the intake pipe did not have a mesh or grill over the end of it to prevent rocks and other items from entering the end of the pipe and being transported to the Reservoir.

Figure 2 Tulugak River Intake

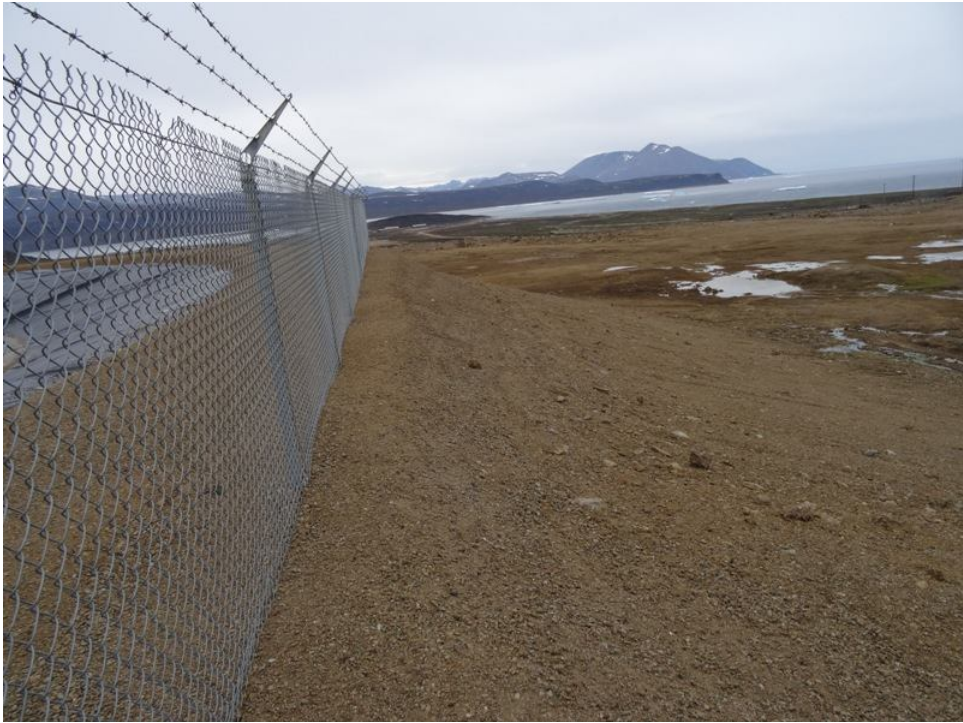
The reservoir was found to be at less than the 20m m level. On the North west exterior wall an area of saturated ground was identified during the Inspection. The top of the berm wall of the Reservoir also showed signs of settling and subsidence. There appears to be a flow originating from either the holding area within reservoir or under the bed of the reservoir with the flow exiting

Figure 6 Reservoir - outside wall showing slumping

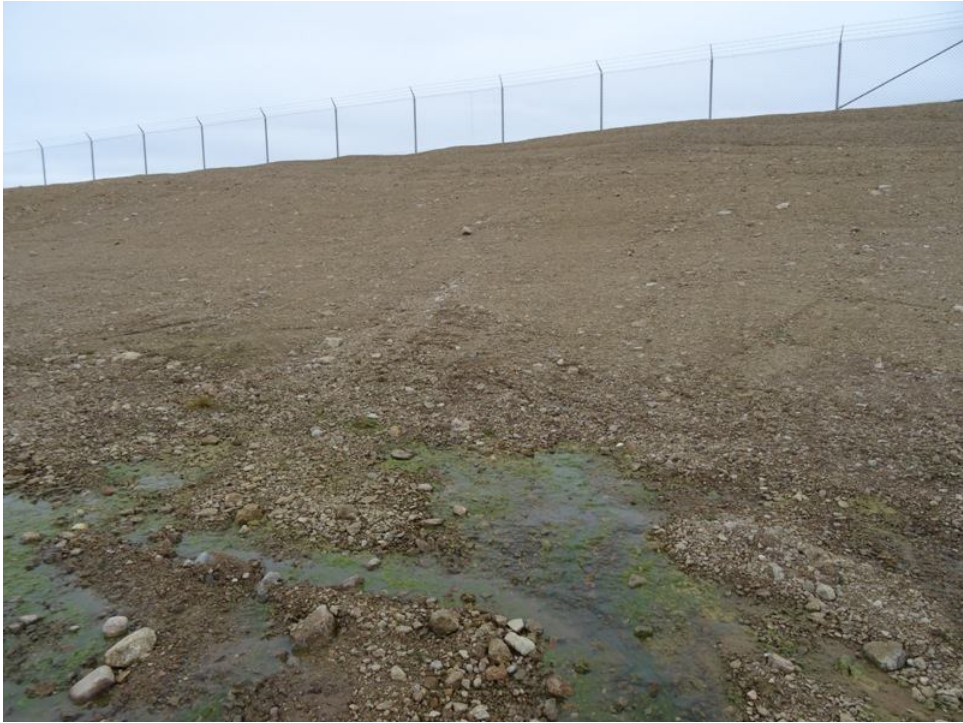
from that North west corner at the toe of the berm wall. (see attached Photos)

Figure 7 Reservoir - flow from toe

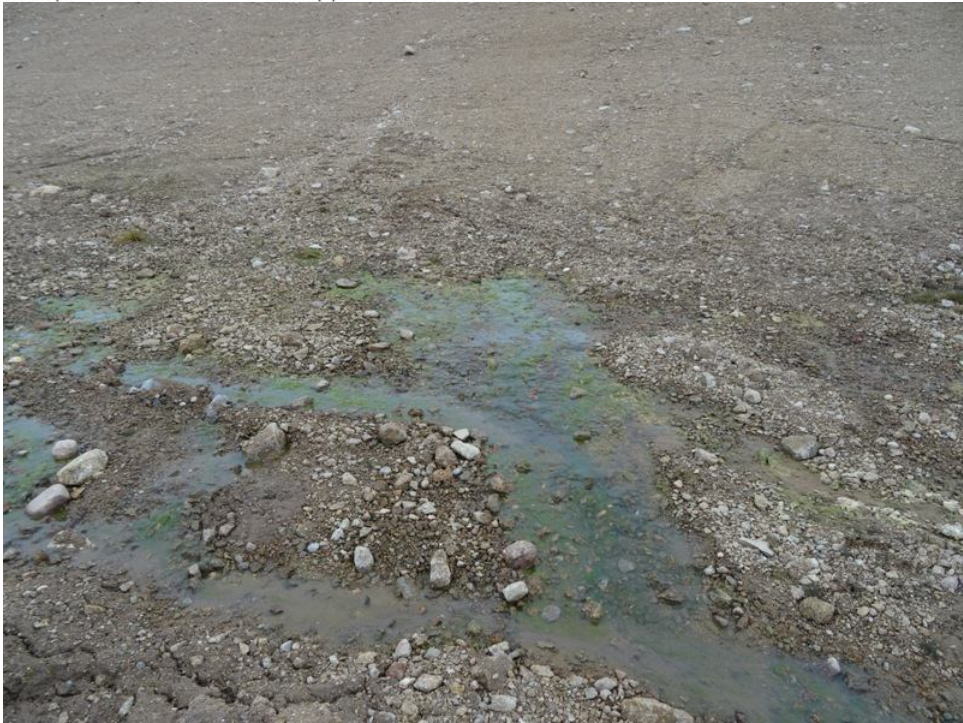
Figure 8 Reservoir – water from under toe

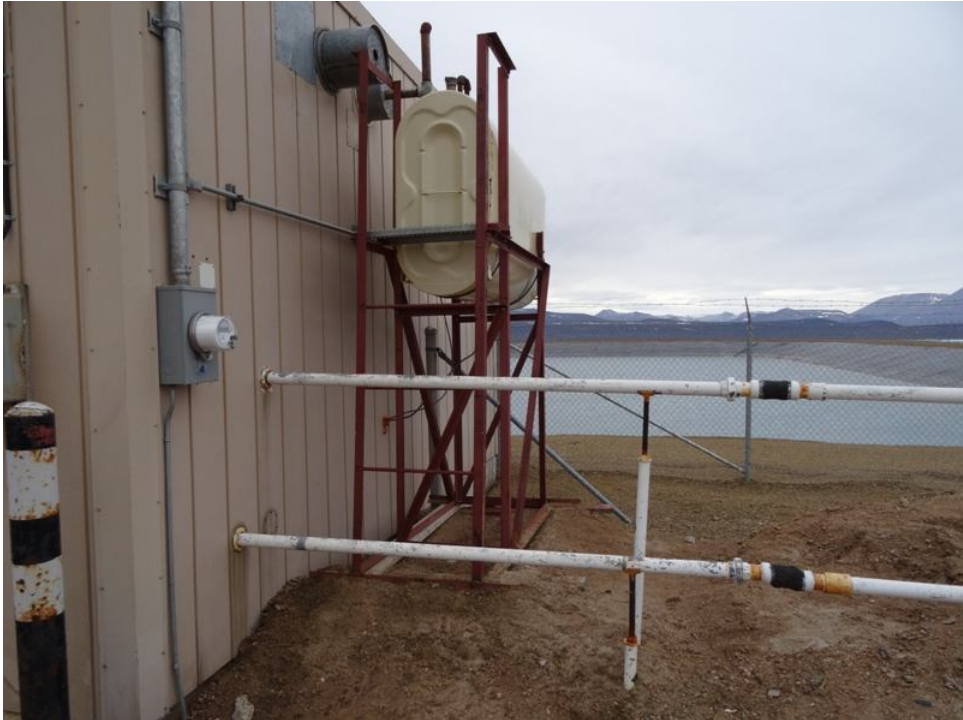
- Tank 1 is a single walled house hold 250 gallon fuel tank on a 6 foot metal stand. The tank appears to be piped in through the wall of the Transfer station with quarter inch copper tubing.. There is no evidence of secondary containment around this tank.
- Tank 2 is a large 1000 gallon tank that appears to be a double walled tank that is sitting in a depression with a liner under it. There also appears to be a tracked vehicle track/ pathway that has been cut or worn into the side of the berm wall that channels run off or water from within the berm out. This appears to defeat the purpose of the liner. It was also noted that the tank is piped into the building with single walled 1 inch black iron piping.

Figure 10 Pump Station - Single walled piping from 1000 gal tank

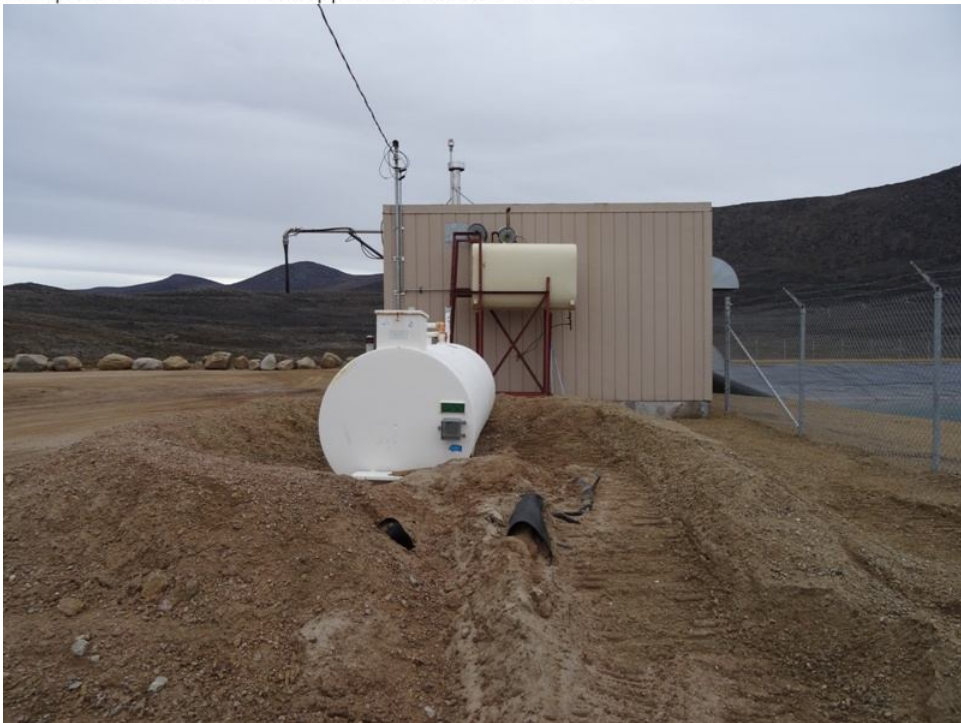
Figure 11 Pumping/ Transfer Station with two fuel tanks and crushed berm wall

It is unclear which tank is currently in-use; however it appears that the household, unsecured tank with no secondary containment is actually the one being used at the time of the Inspection. This tank sits less than 50 ft from the community's potable water source. This must be addressed and a report on what was done submitted with the 2014 annual report.

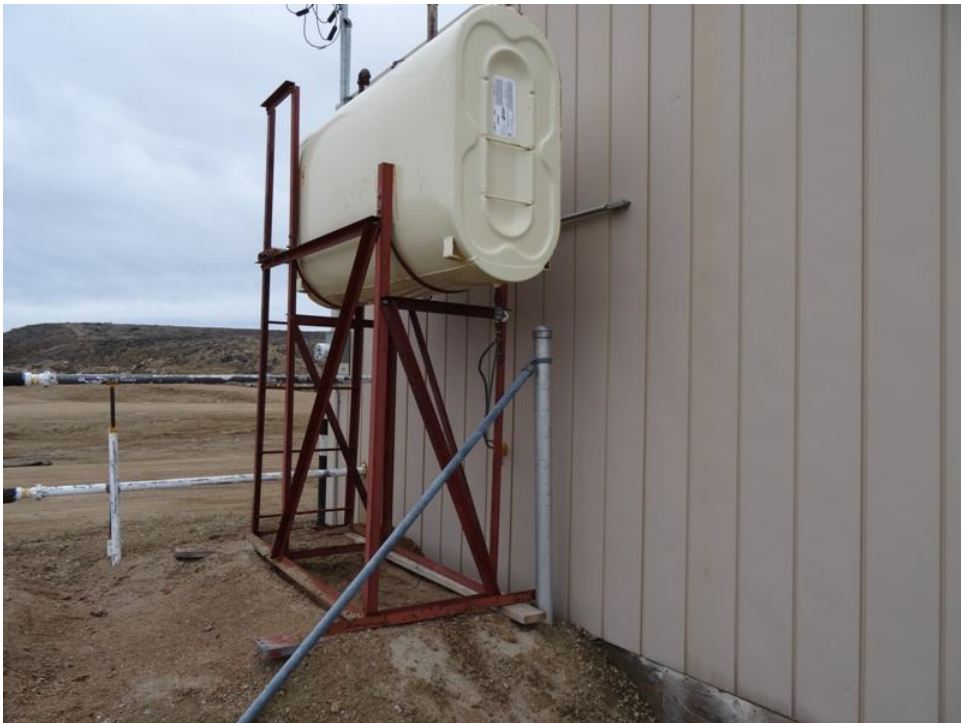
Figure 12 Pump Station with household fuel tank - unsecured to building

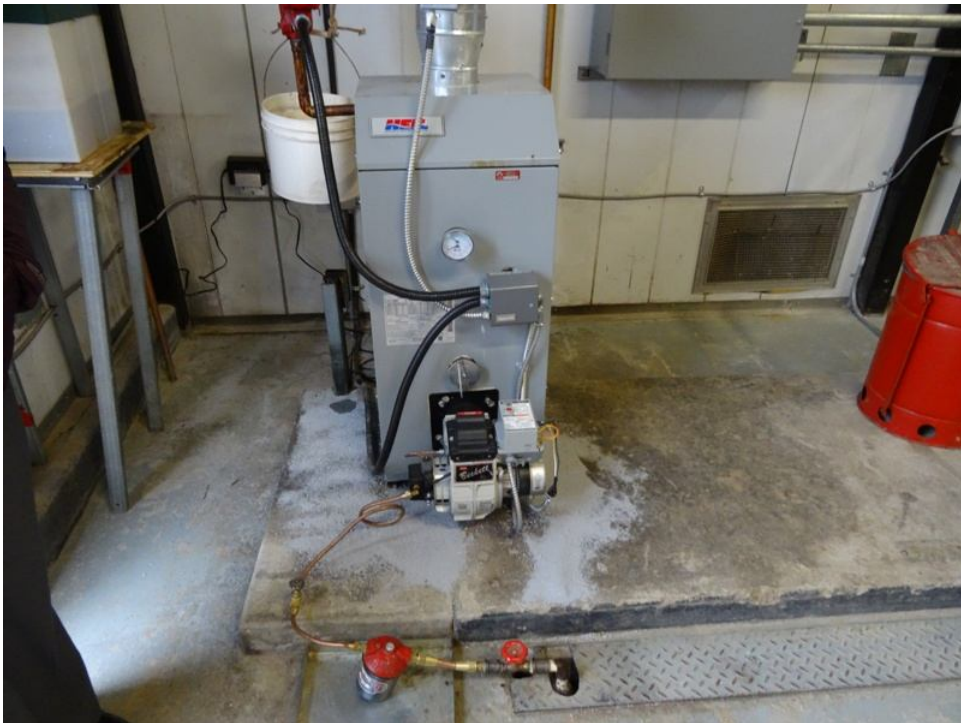
Figure 13 Fuel leaks inside pumping station

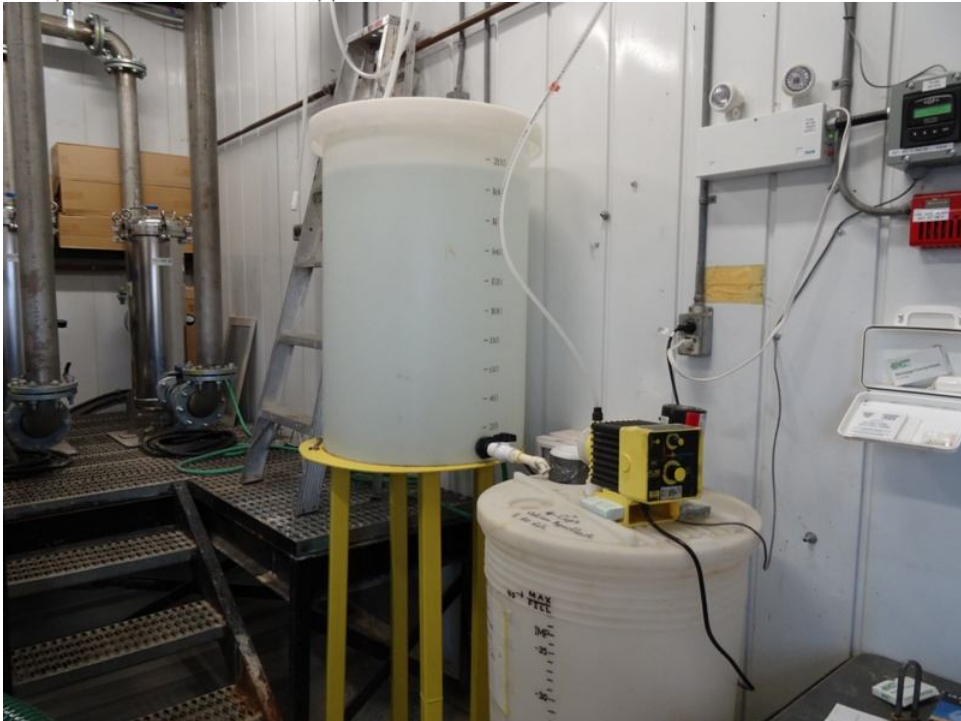
The transfer station was found in fair condition however it was again noted that the filters are not being used in the last three years. Chlorination and other records were found on site and in order. The chlorination system was functioning and in good repair.

Figure 14 Chlorination system

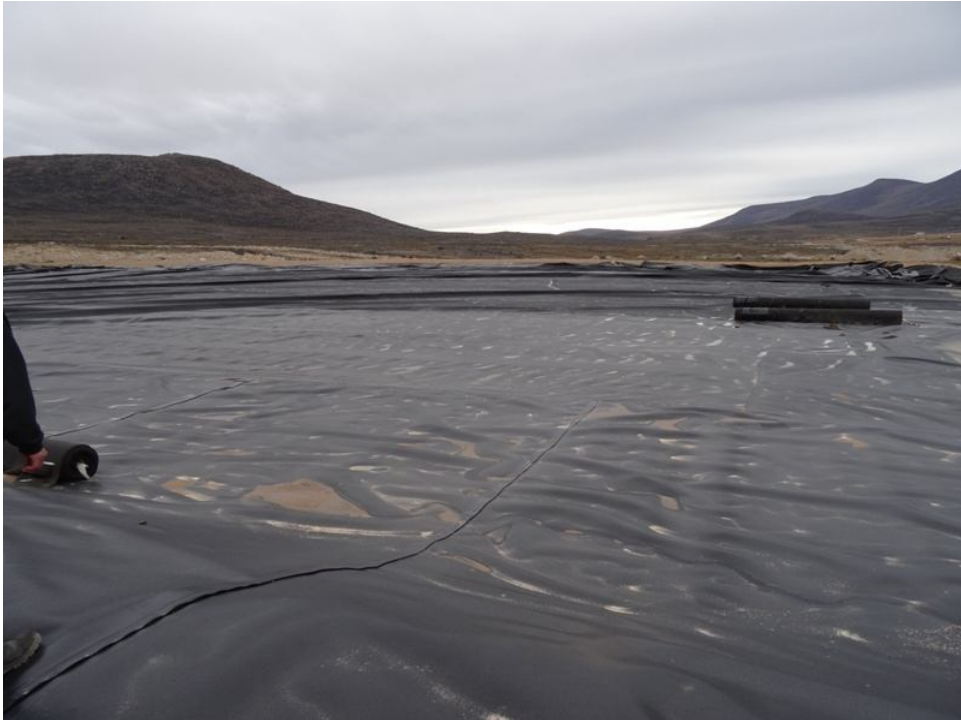
No further work on the facility has been undertaken since the period of the last inspection conducted in 2011. The facility remains unfinished and water has build up within the area intended to be used as a sump. The exposed liner remains in place but has been windblown and may be ripped and damaged in places. When questioned the staff on site indicated that the Party Responsible for the contaminated soils has agreed at one point to assist with the construction of the facility but had subsequently reneged on the commitment and had left the municipality without the resources to complete the construction of the facility. The Government of Nunavut had no input at the time of the Inspection.

Figure 16 Land Farm Facility

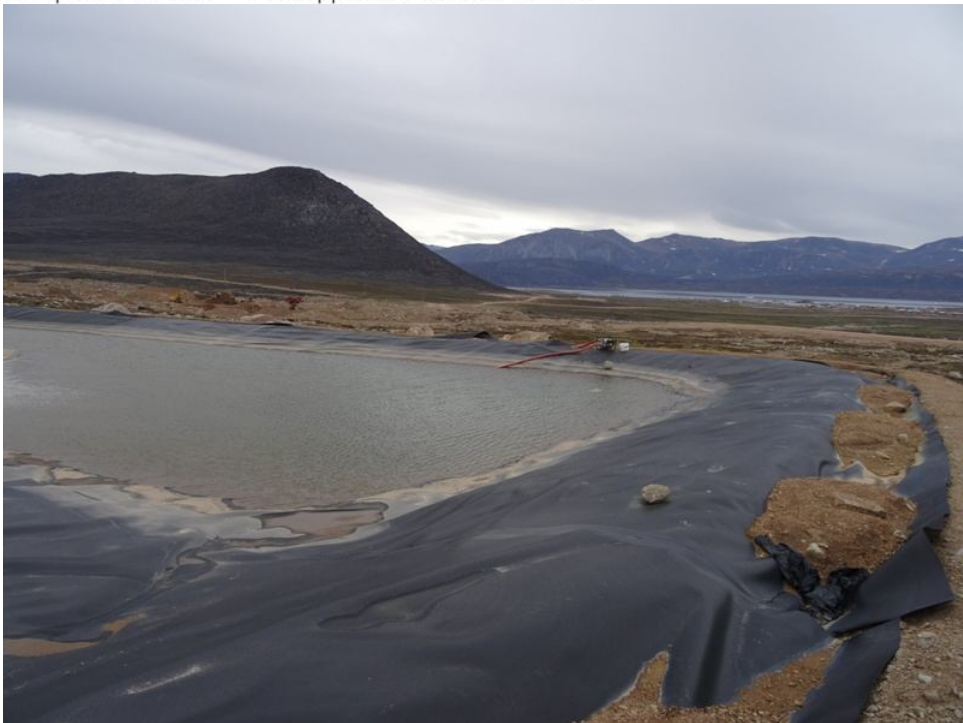
Figure 17 Land farm facility - Sump

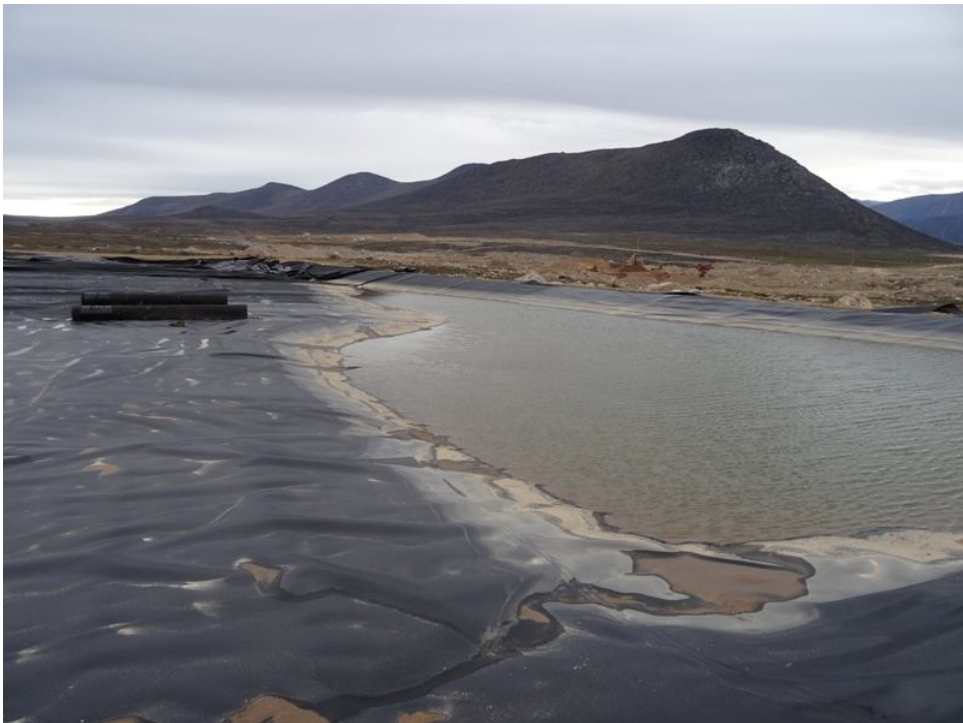
Figure 18 Land Farm facility - Sump 2

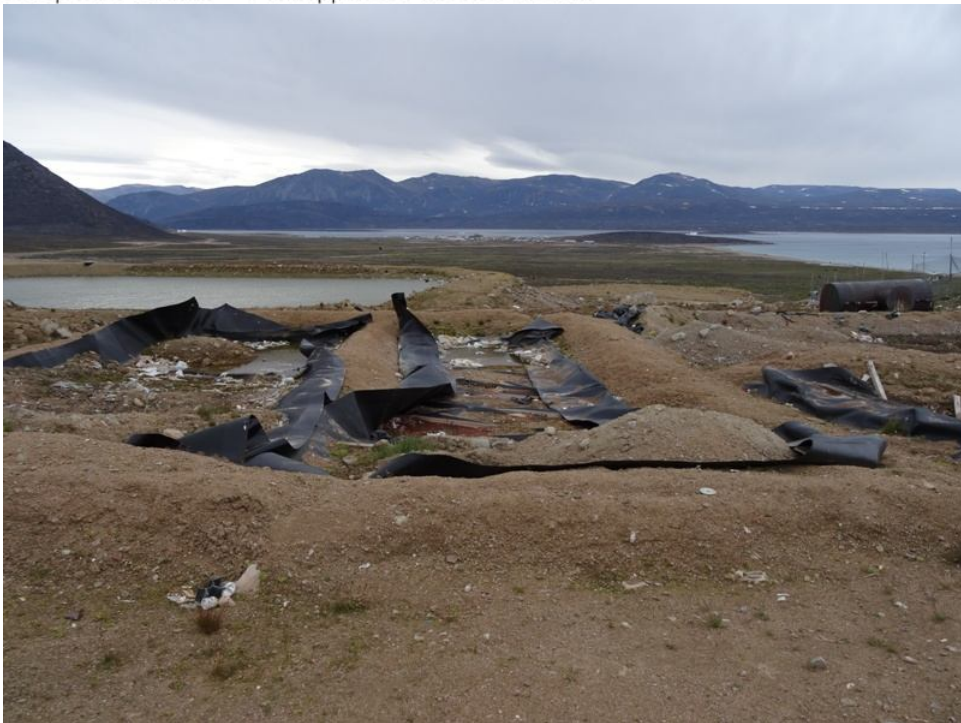
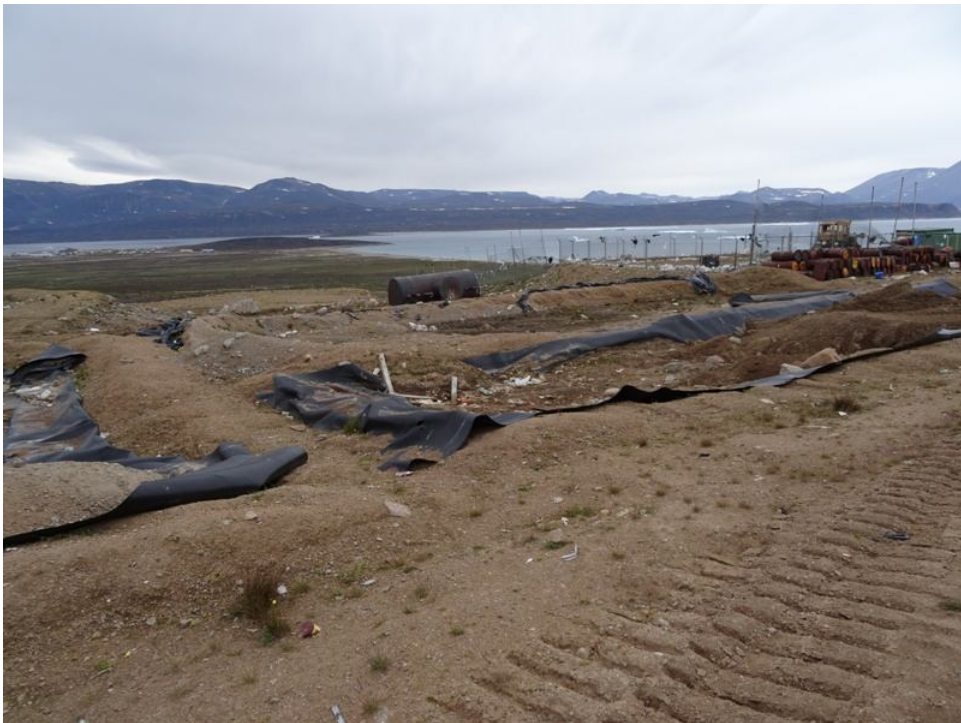
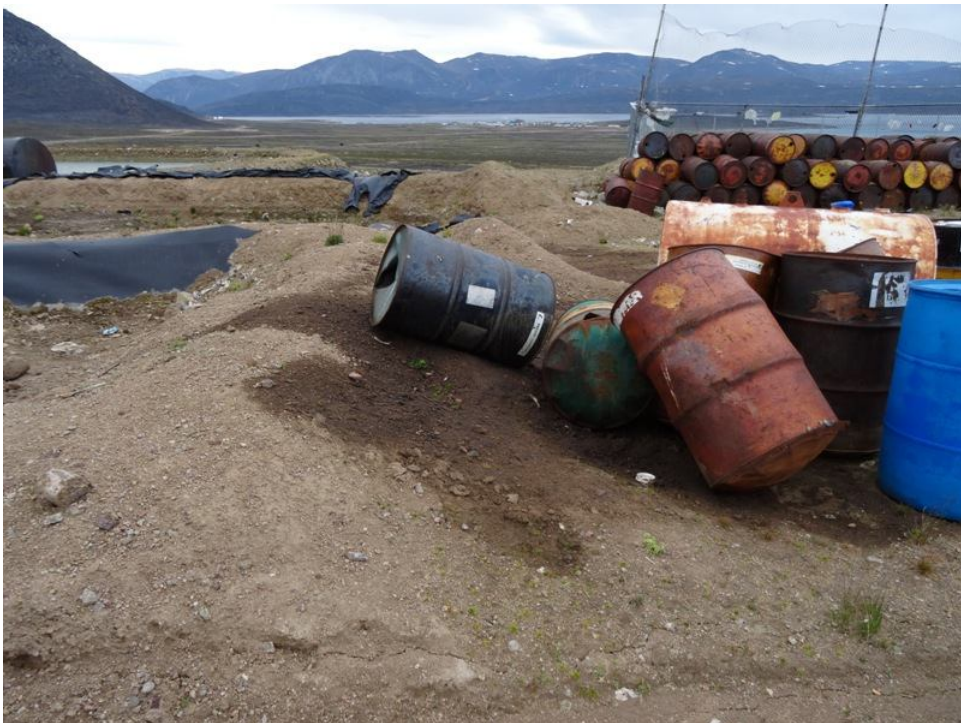
Contaminated soils were found to have been deposited at the solid waste management area and other areas within the municipality. None of those sites is lined and none are being actively managed by either the party responsible for the spill or the Government of Nunavut or the Municipality.

Figure 20 Contaminated soils at Solid Waste Management Area

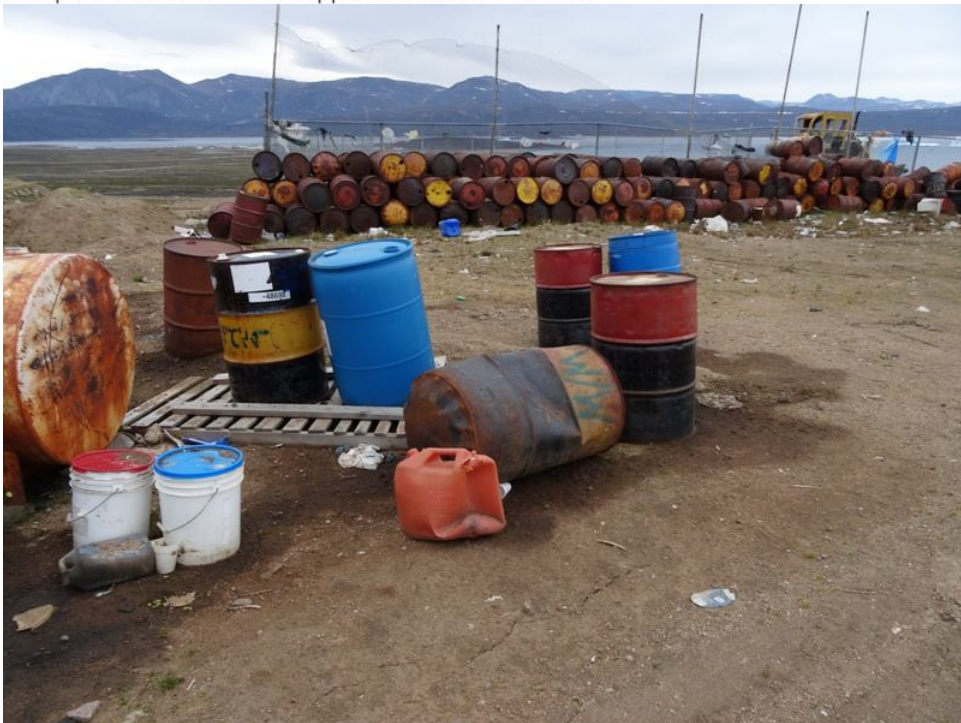
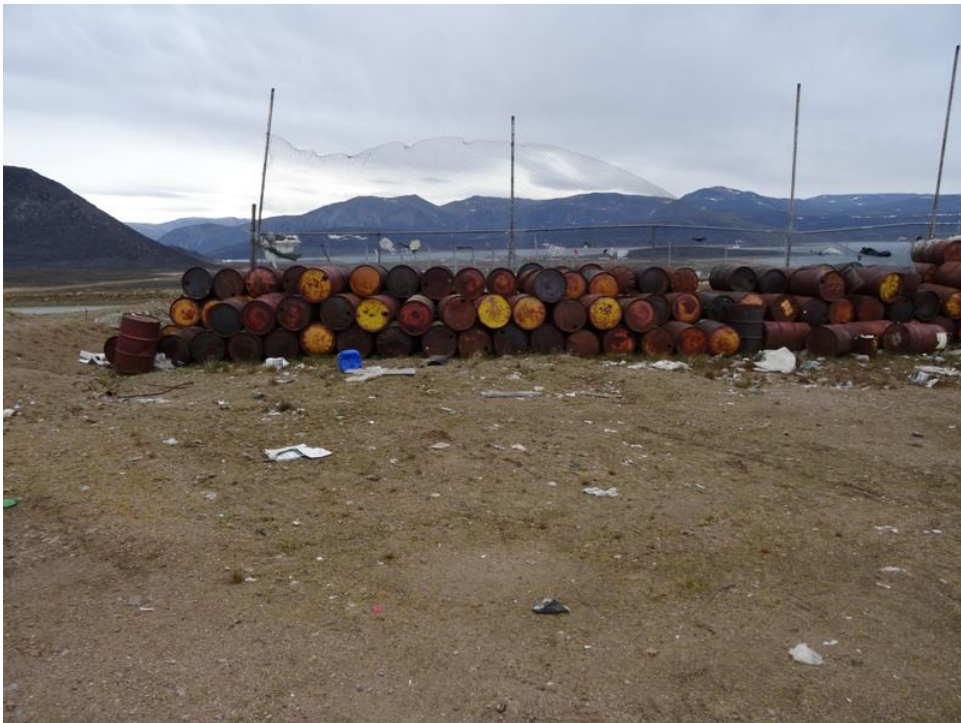
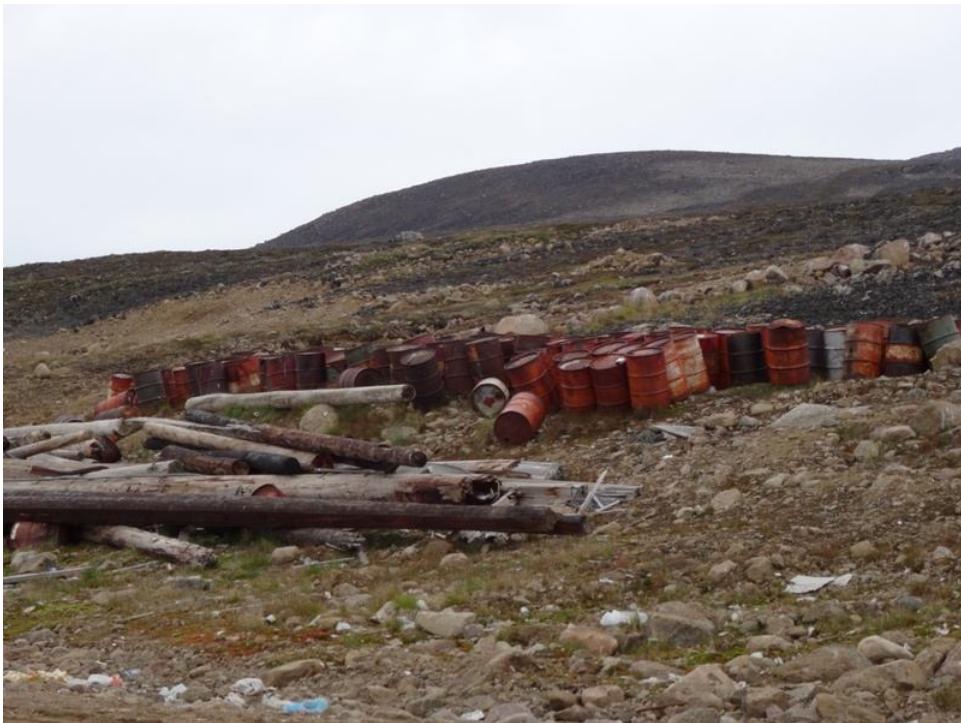
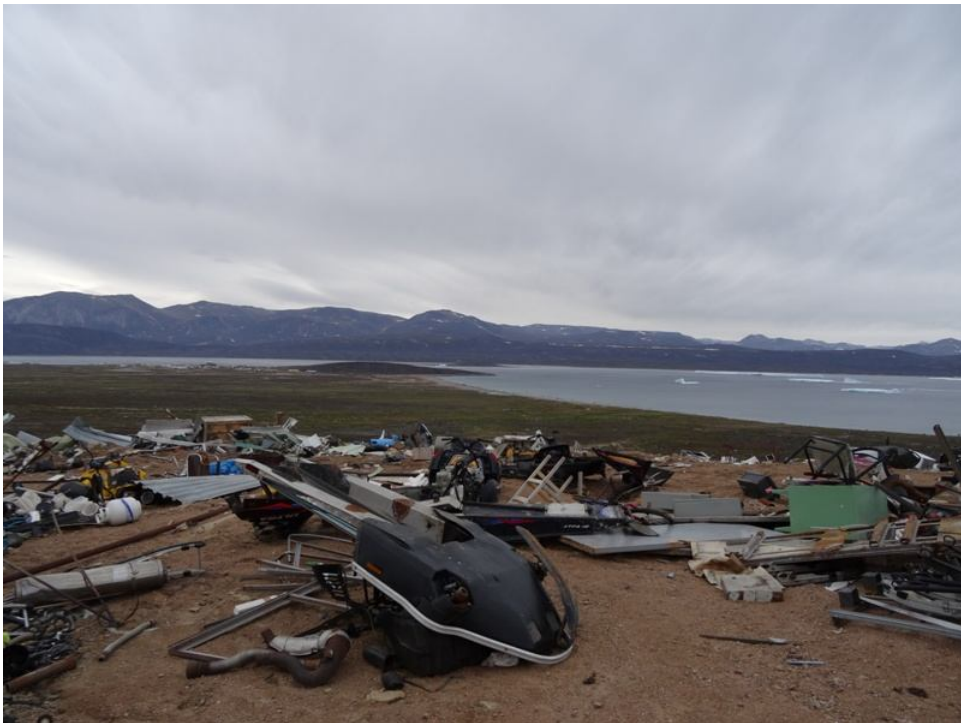
- Barrels of hazardous wastes identified in every inspection conducted since 2006 have not been moved and in fact more barrels have been transported into and around the site. These barrels of waste oil and other unknown products have been found to be leaking and have been the victim of vandalism at the site. The area has some liner placed within it however the ground is saturated with spilled product and must be remediated.

Figure 23 Contaminated soils and barels at Solid Waste Management Area

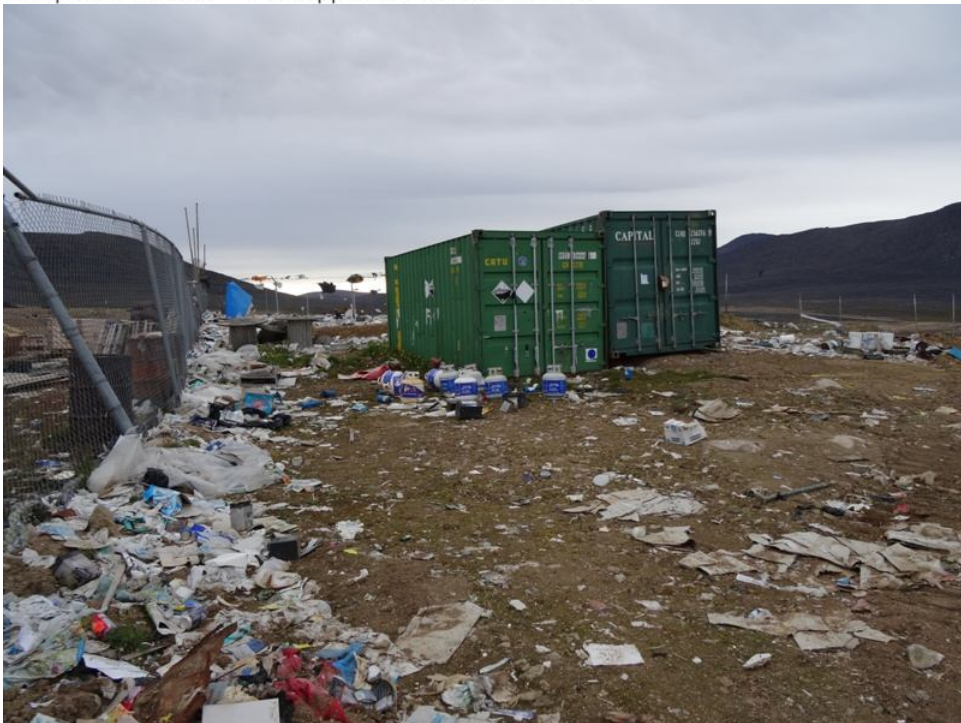
- There continues to be a lack of segregation within the facility to remove and isolate hazardous materials. A sea-can was noted as being present however the doors were locked and the contents of the unit could not be inspected. Batteries and other materials were noted within the Municipal burn and bury area adjacent to the location of the sea-can.

Figure 26 Sea Cans - Haz Mat Storage Area

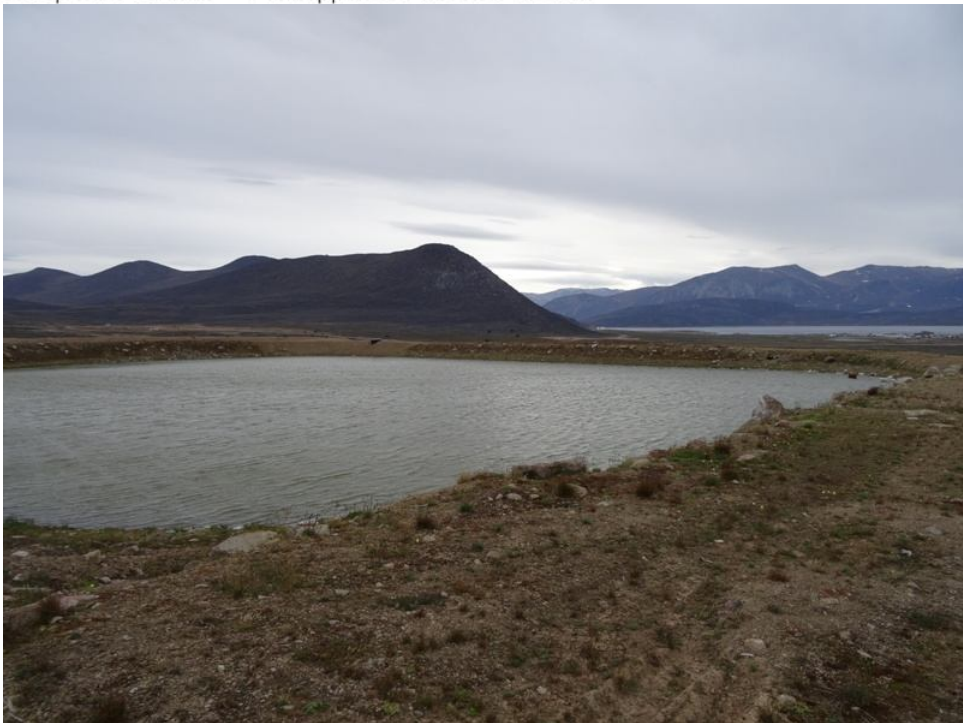
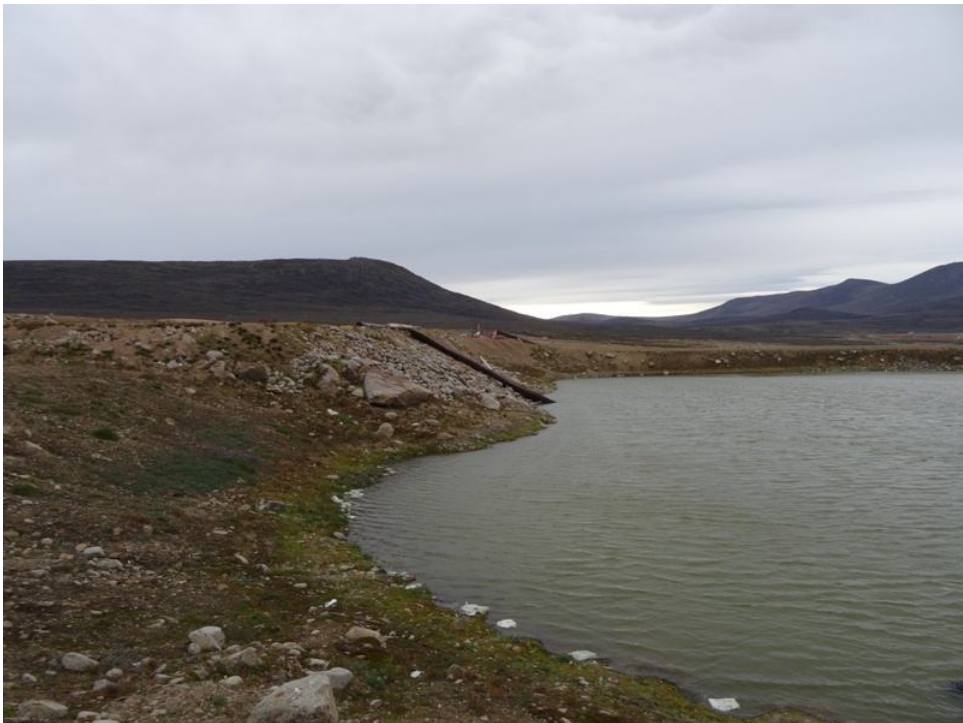
- Staff on site stated that the Old cell of the two cell system has been continued to be filled over the last three years but has not yet been decanted.
- The level of effluent in the new cell (2010) has not risen past the current level however on site municipal staff confirmed that the cell also continues to be filled regularly by the vacuum truck.

These statements have caused some concern for the Inspector. If effluent has continued to be deposited in both cells over the last three years since the last inspection of 2011.. Why have the cells not needed to be decanted?. Where is the effluent going? No answers could be provided by the licensee. However at the end of the Inspection when traveling around to the opposite side (down gradient) there appears to be soils that is saturated and that a flow from the toe of the berm wall has developed. The GN representative, Mr. Bhabesh Roy the Regional Engineer did go out directly to that spot to investigate but did not have an opinion to share upon his return other than to say that the GN would be investigating this in 2015. (see Photos attached)

Figure 29 Old Lagoon syatem

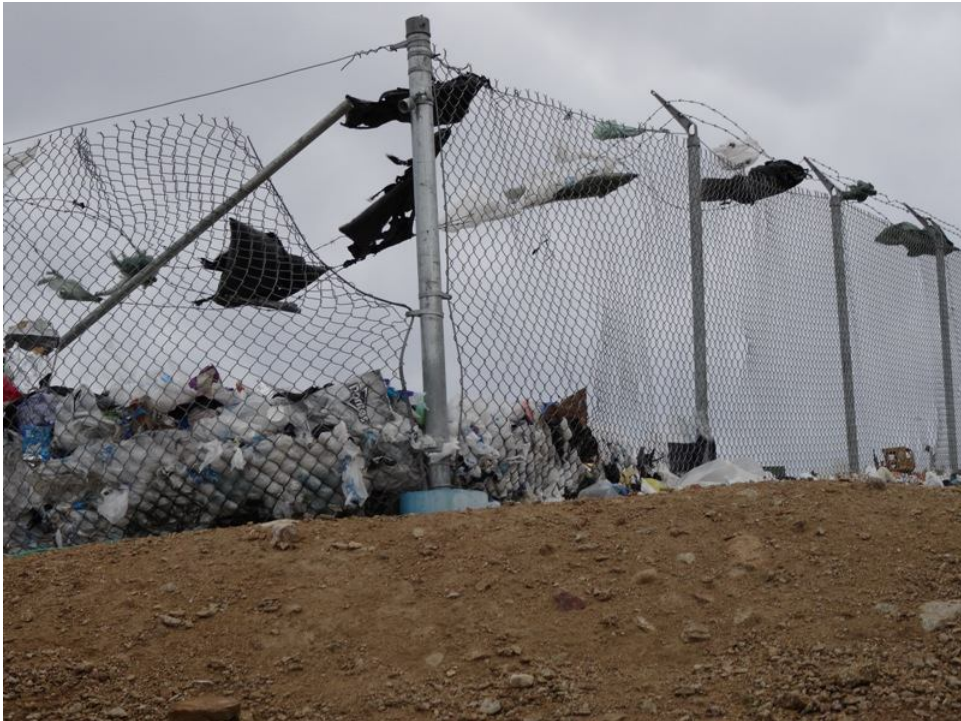
- Although fencing around the facility was noted the facility is built upon a substantial slope. This allows for wind to transit the area and eject materials from the facility and over the fence. The lack of cover materials was also identified as contributing to the on-going issues faced by the Licensee.

Figure 33 Municipal Waste Management Area Fencing

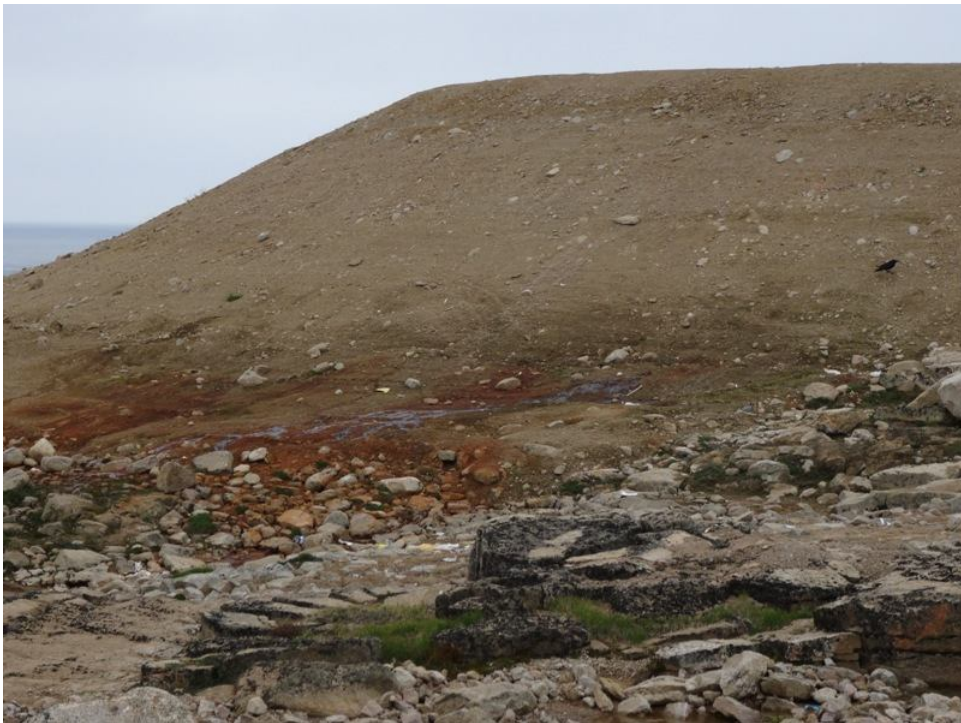
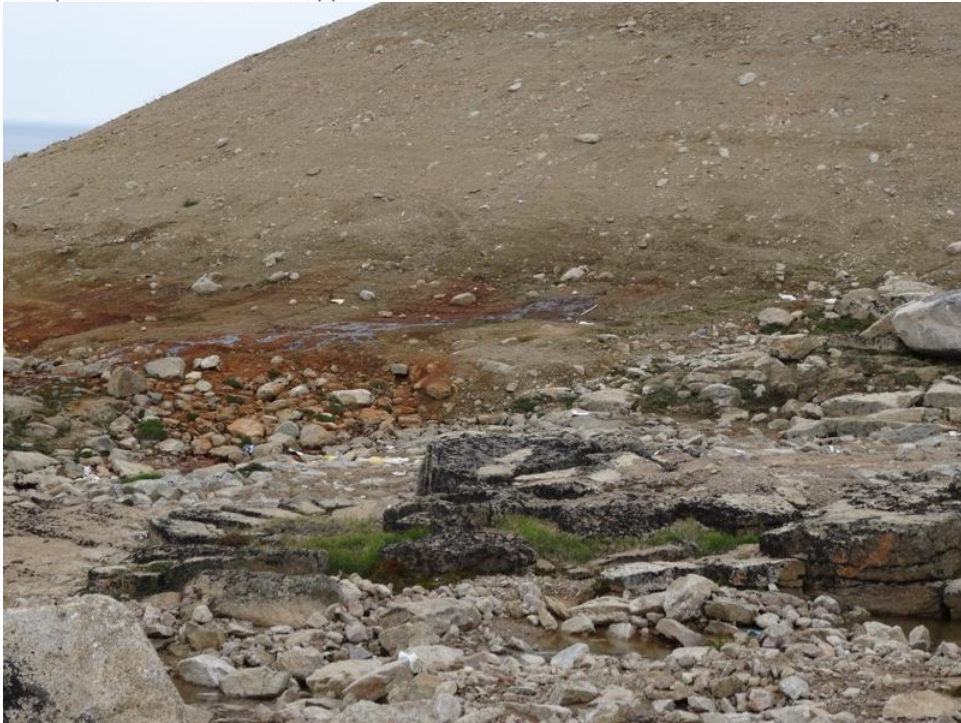
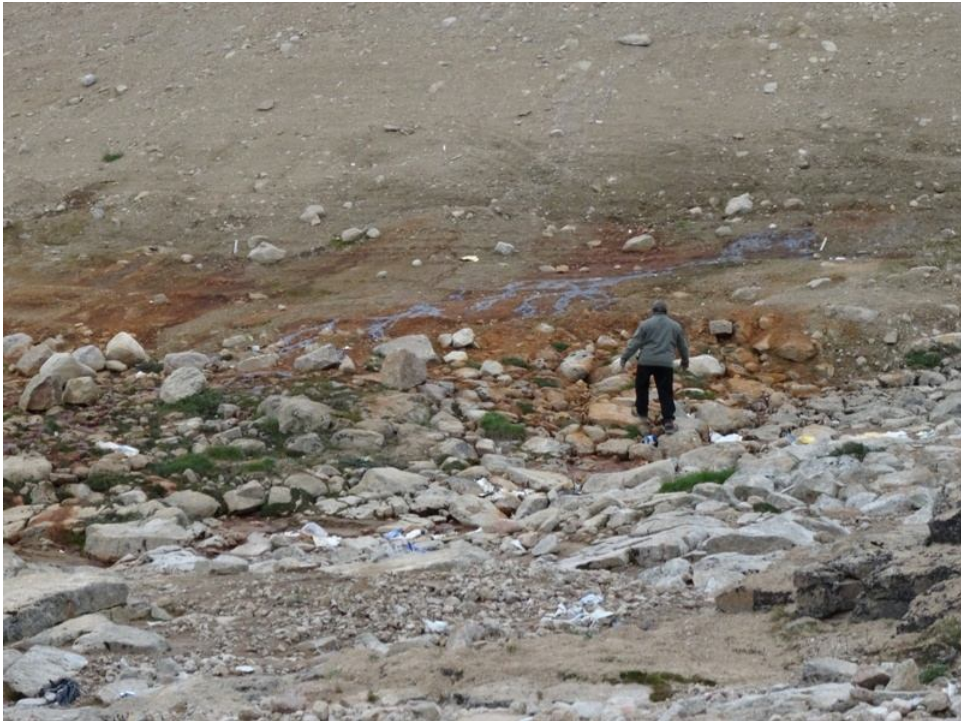
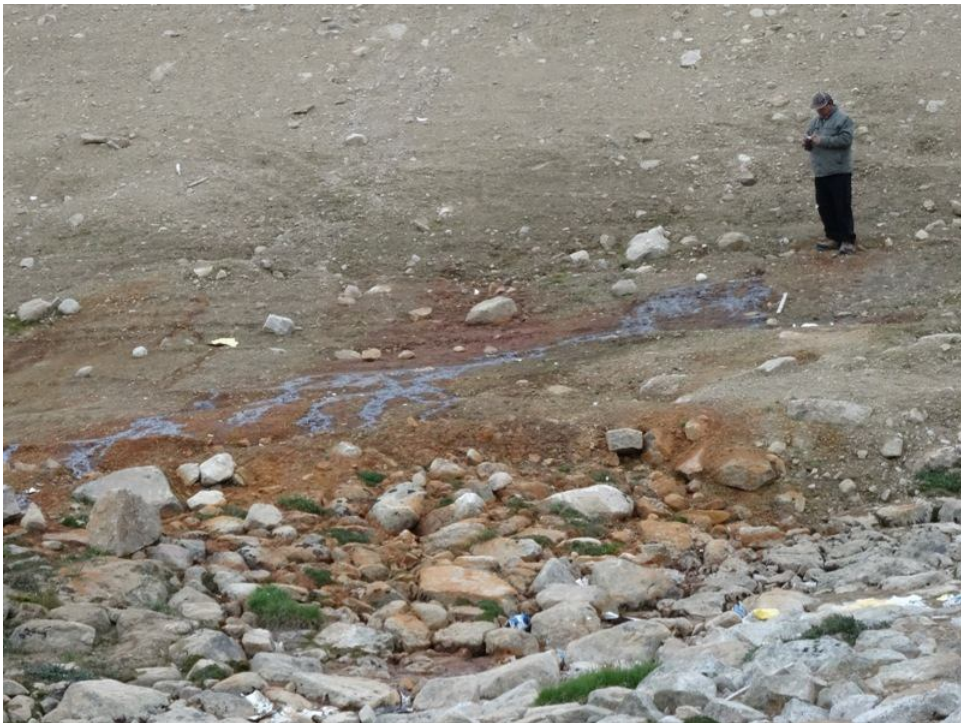
Figure 34 Flow from Toe of new lagoon cell
