WATER LICENCE INSPECTION FORM

Licensee	Licensee Representative
Hamlet of Qikiqtarjuaq	Bhabesh Roy
Licence No. / Expiry	Representative's Title
3BM-QIK1924 exp. September 19, 2024	Regional Engineer
Land / Other Authorizations	Land / Other Authorizations
Date of Inspection	Inspector
October 12 ,2021	Joseph Monteith
Activities Inspected	
<div><div><input type="checkbox"/> Camp</div><div><input type="checkbox"/> Drilling</div><div><input type="checkbox"/> Mining</div><div><input type="checkbox"/> Construction</div><div><input type="checkbox"/> Reclamation</div><div><input type="checkbox"/> Fuel Storage</div></div> <div><div><input type="checkbox"/> Roads/Hauling</div><div><input checked="" type="checkbox"/> Other: Potable Water Source, Waste Water Treatment Facility, Solid Waste Facility</div><div><input type="checkbox"/> Other:</div></div>

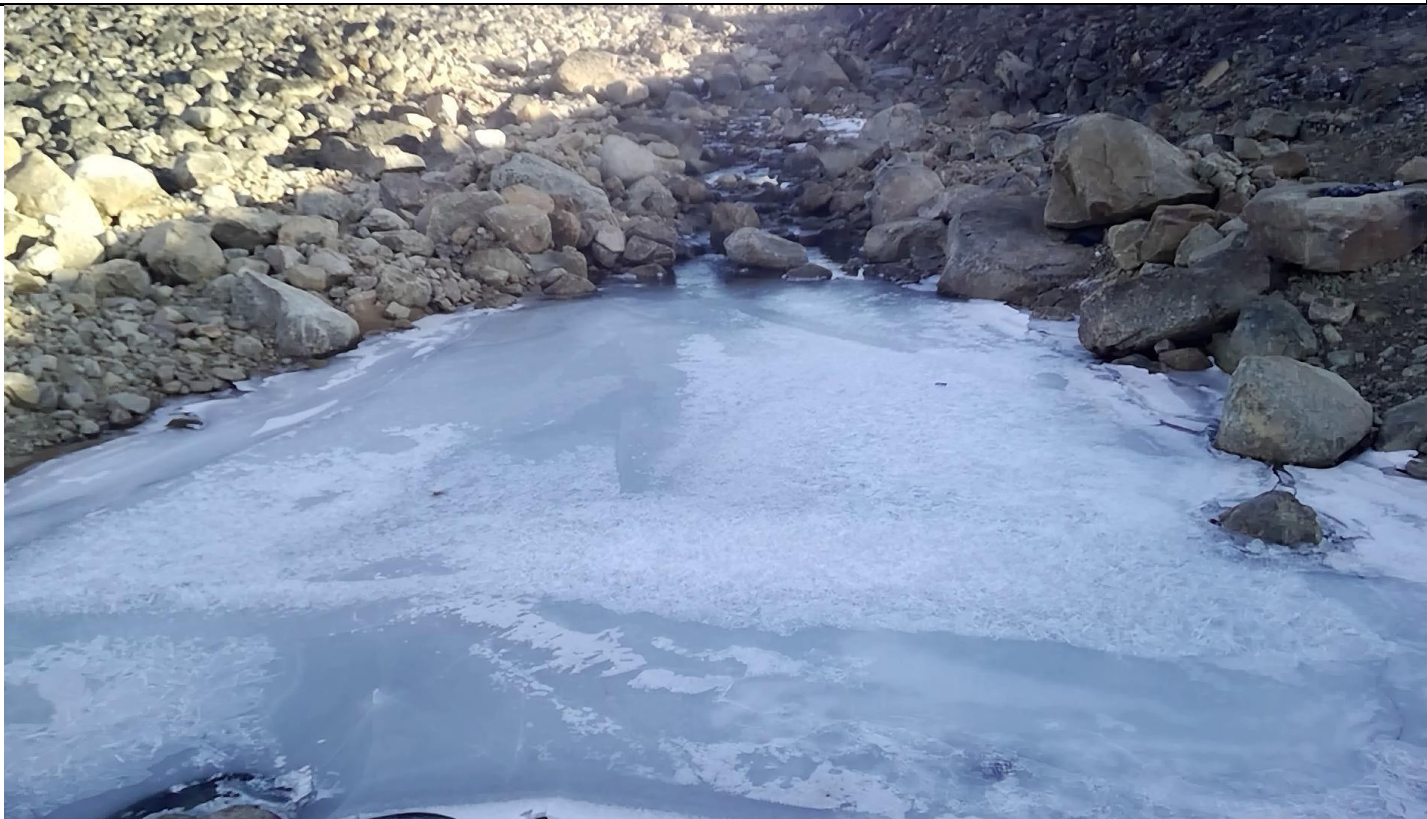
Date	Camera	Inspector	
October 12, 2021	Nikon Coolpix	Joseph Monteith	
Photo Log #1		Location	
Photo 1		Qikiqtarjuaq

1. Water is being withdrawn from Tulugak River (Photo 1). The water is transferred by gravity to the intake location, which settles approximately 4-6 inches above the intake pipe. The activity of filling up the Water reservoir requires filling the pipe (Photo #2) which recharges the reservoir as described above (See Photo #3) using underground pipe made out of HDPE approximately 8 inches in diameter transfers the water to the water reservoir, then into the treatment facility (See Photo #4). After filling up the reservoir the water is then transferred to the truck fill station and treated with liquid Chlorine, and filtered before being pumped into trucks for delivery (see Photo #5).

Description: Tulugak River: Water Withdrawal location. Ice froze the top portion of the ditch.

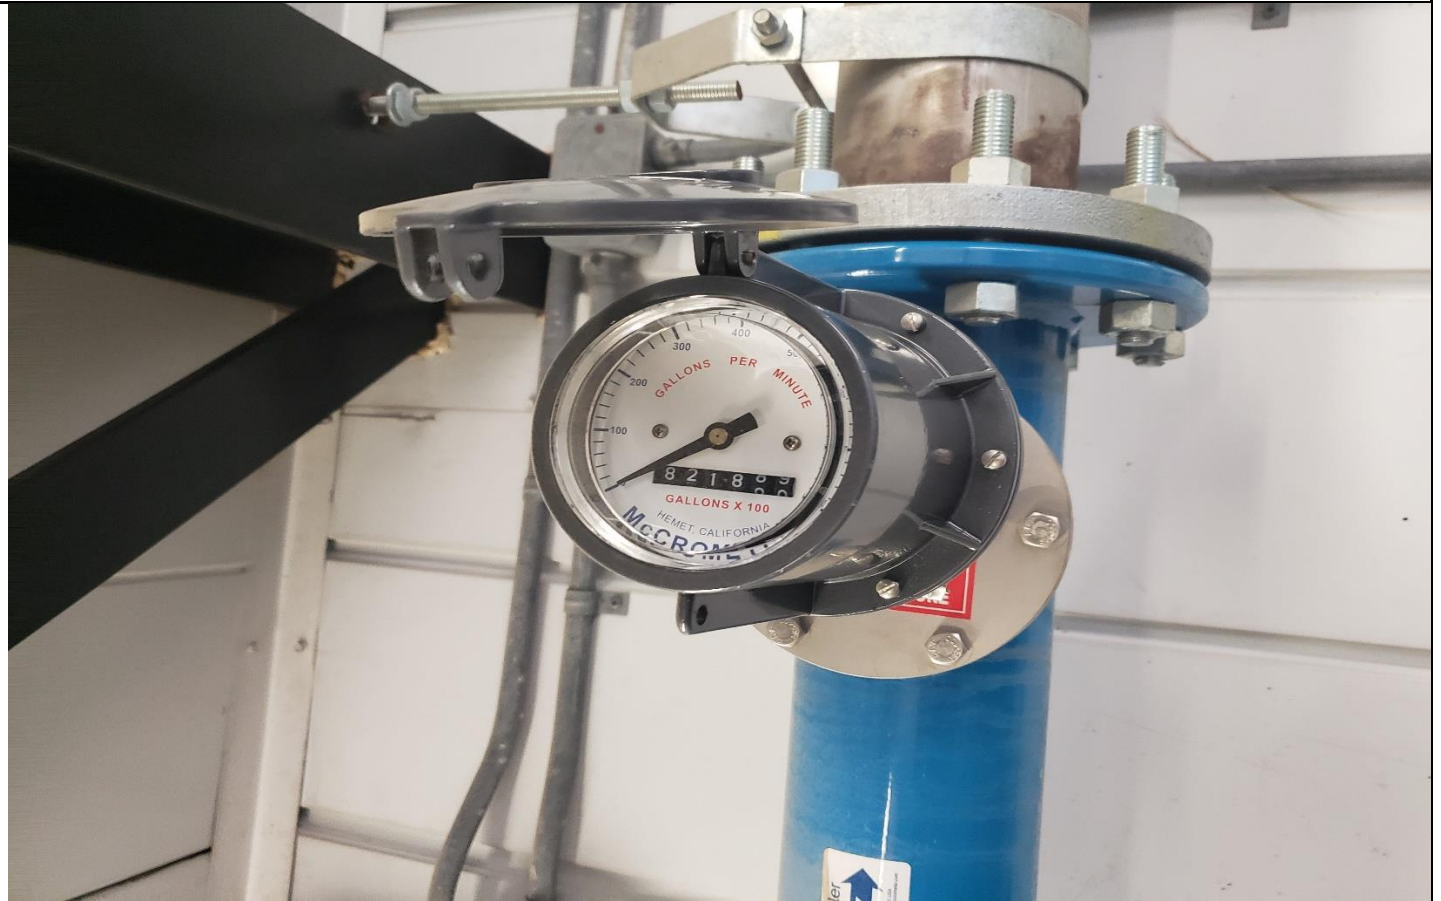
2. An operating water flow meter was observed on site, and read Gallons (Photo 6).
3. A log sheet for truck fill procedures undated showed a weekly total of 821800 Gallons was withdrawn at the time of the inspection (see Photo 7).

Description: Water Meter reads 821800 Gallons x 100

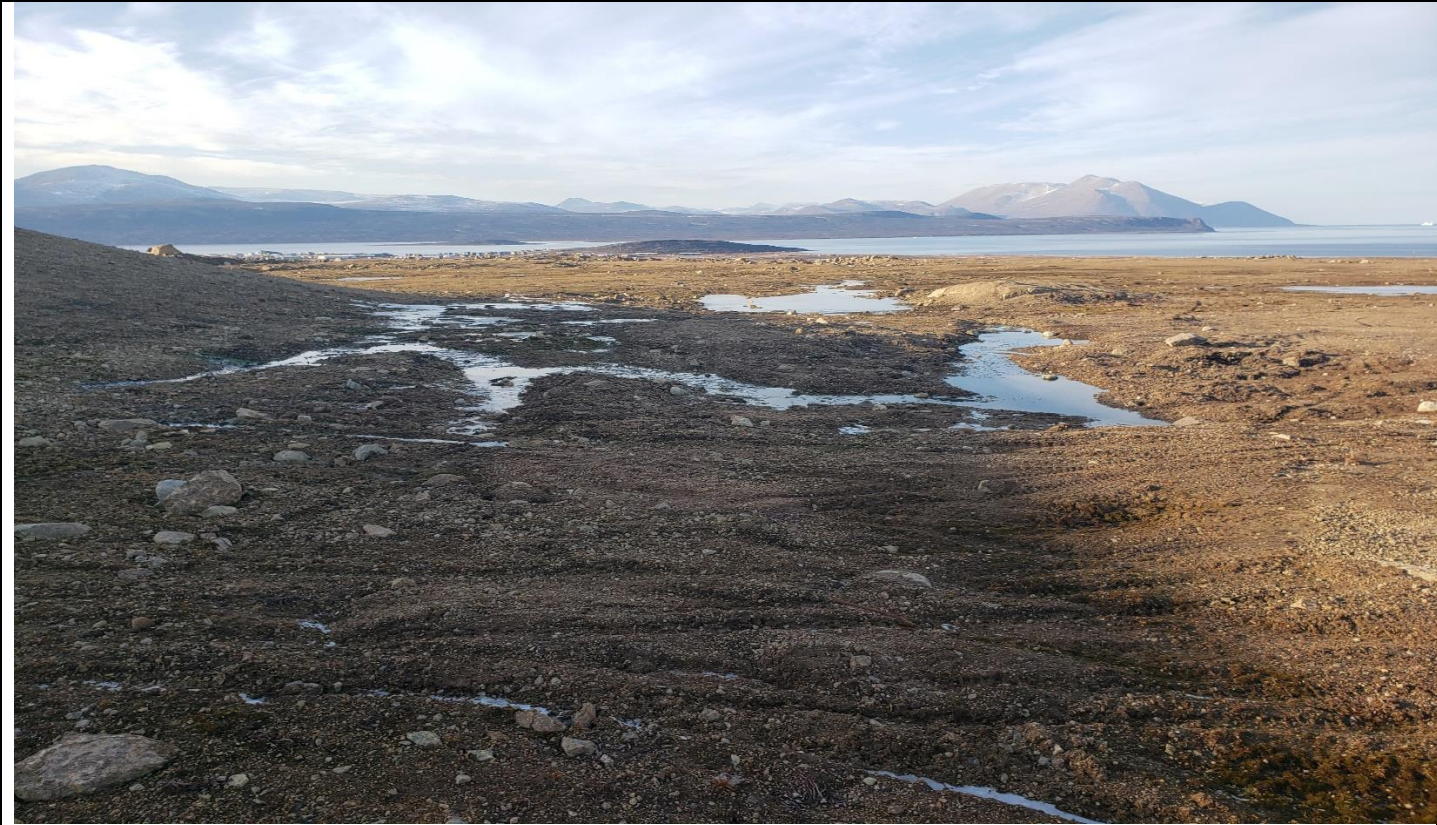
4. The water reservoir didn't appear to be working as intended as there is a suspected leak in the liner of the reservoir. The outer walls appeared to be slumping and leaking water from the reservoir on the North wall of the reservoir (Photo 8). Samuel Nuqingaq, Municipal Forman for Hamlet of Qikiqtarjuaq said that once the reservoir hits 22 metres full(measured diagonally from the top of the water table to the bottom of the lagoon on the opposite side of the water table measurement), the leak of the water reservoir begins. At the time of the inspection the recharge pipe was closed, and the water level below the recharge pipe (See photo 3).

Description: signs of slumping on outer wall of Water Reservoir. Once the reservoir reaches 22 metre(measured diagonally) the reservoir leaks
