WATER LICENCE INSPECTION FORM

Licensee	Licensee Representative
Hamlet of Qikiqtarjuaq	Gord Marinic
Licence No. / Expiry	Representative's Title
3BM-QIK1924	Regional Engineer
Land / Other Authorizations	Land / Other Authorizations
Date of Inspection	Inspector
June 22 ,2022	Joseph Monteith
Activities Inspected

On June 22, 2022, A water licence inspection was conducted by Water Resource Officer (WRO) Joseph Monteith at the Hamlet of Qikiqtarjuaq, Qikiqtani Region, Nunavut.

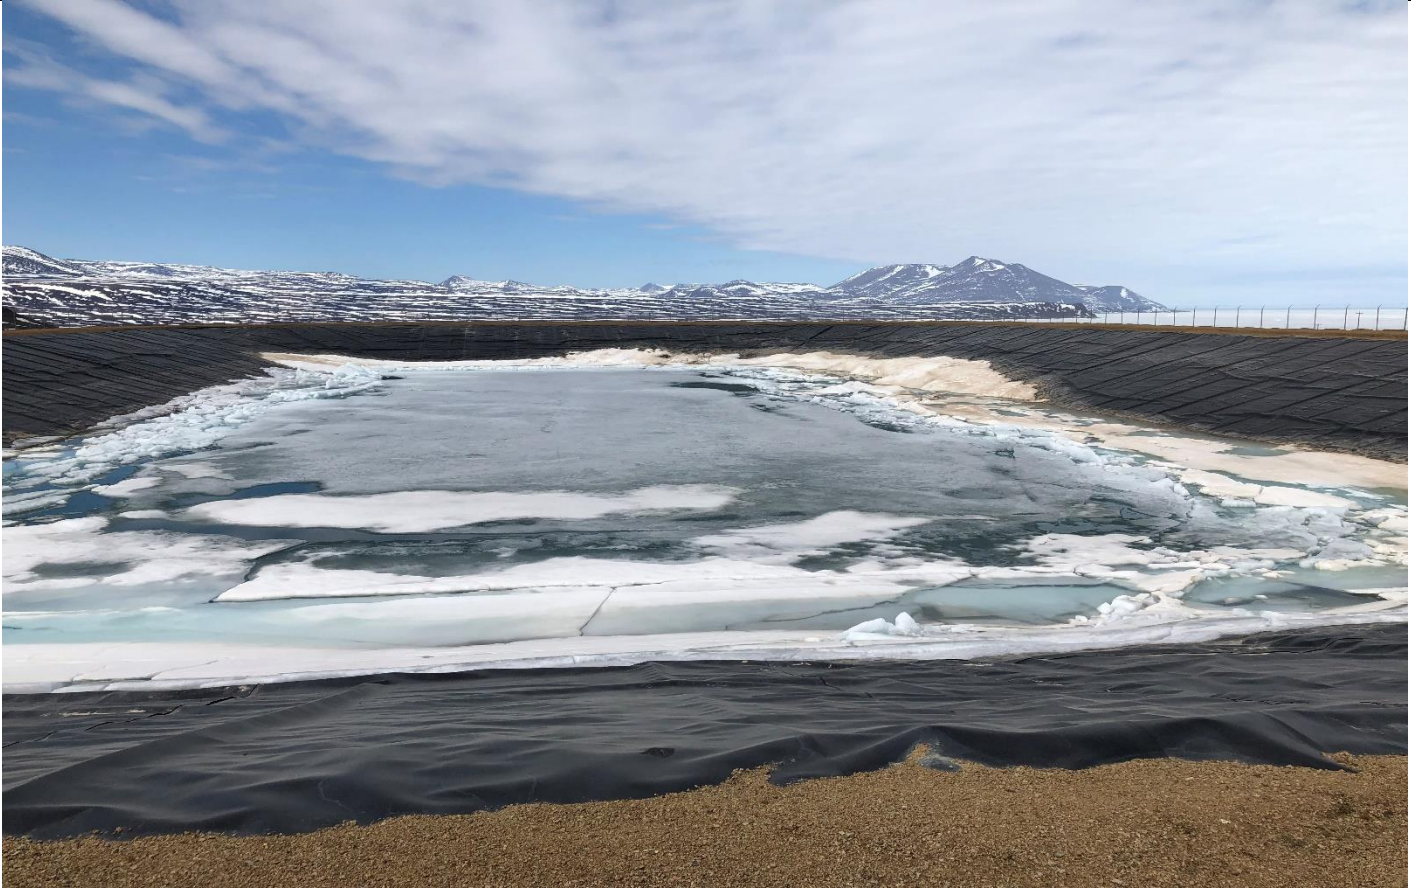
Photo 3

location, which settles approximately 4-6 inches above the intake pipe. The activity of filling up the Water reservoir requires filling the pipe (photo 2) which recharges the reservoir as described above (photo 3) using underground pipe made out of HDPE approximately 8 inches in diameter transfers the water to the water reservoir, then into the treatment facility (photo 4). After filling up the reservoir the water is then transferred to the truck fill station and treated with liquid Chlorine, and filtered before being pumped into trucks for delivery (photo #5). At the time of the inspection the recharge pipe was closed, and the water level below the recharge pipe (photo 3).

Description: Water Reservoir – intake pipe from water withdrawal location at Tulugak River. Uncontrolled withdrawal of water from the water source

- Purchase the proper cap for the Water Treatment Facility Water Reservoir Recharge Pipe, to stop the leak of water into the reservoir.
 - Consolidate all hazardous waste in the burn and cap, and bulk metals facilities and segregate

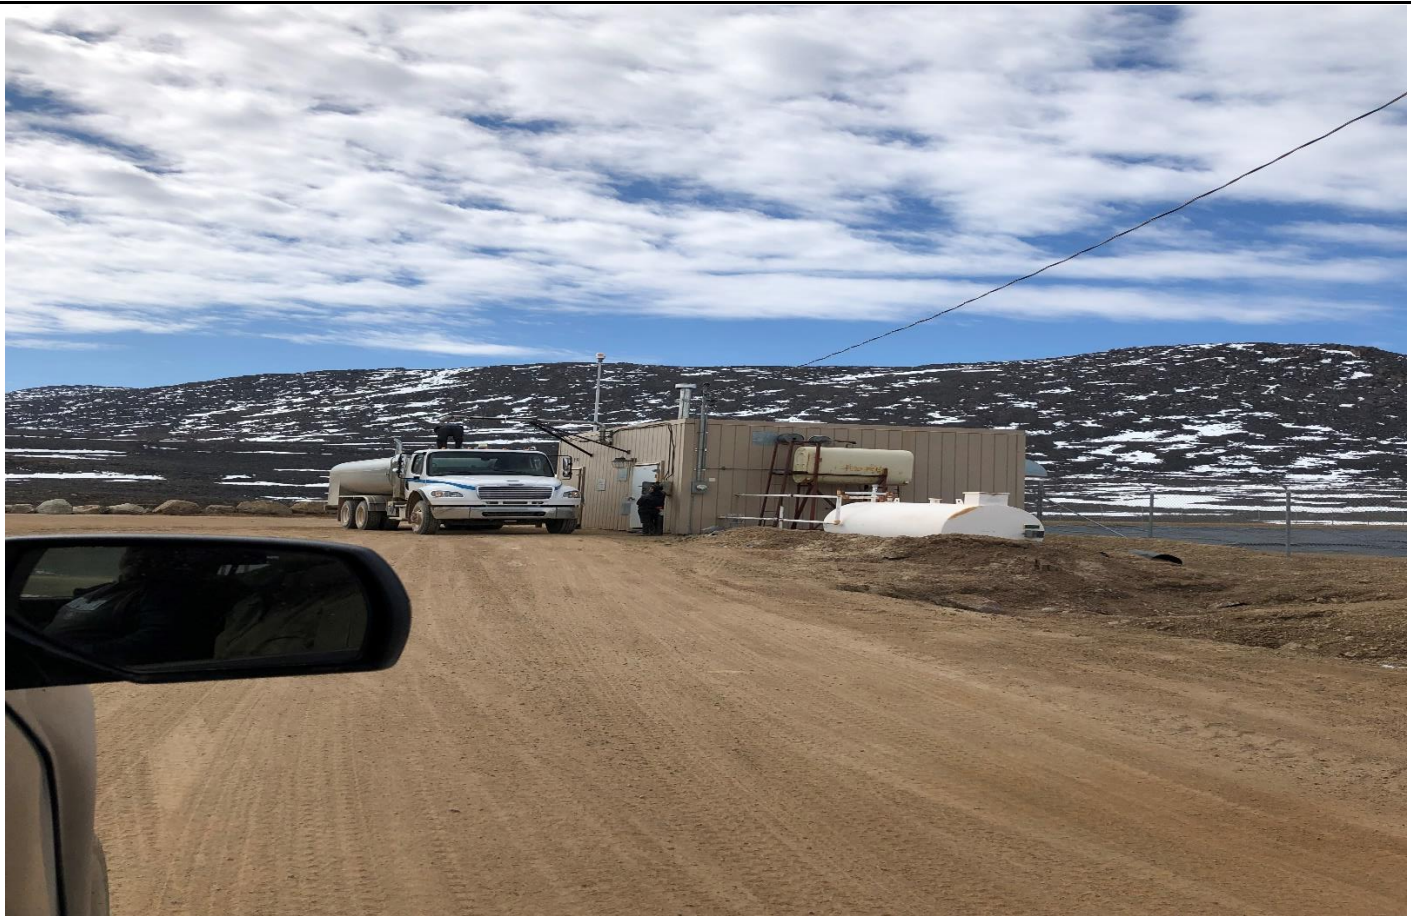
Photo Log #
Photo 4

Description: Water Treatment Facility/Truck Pumping House. Samuel Nuqingaq

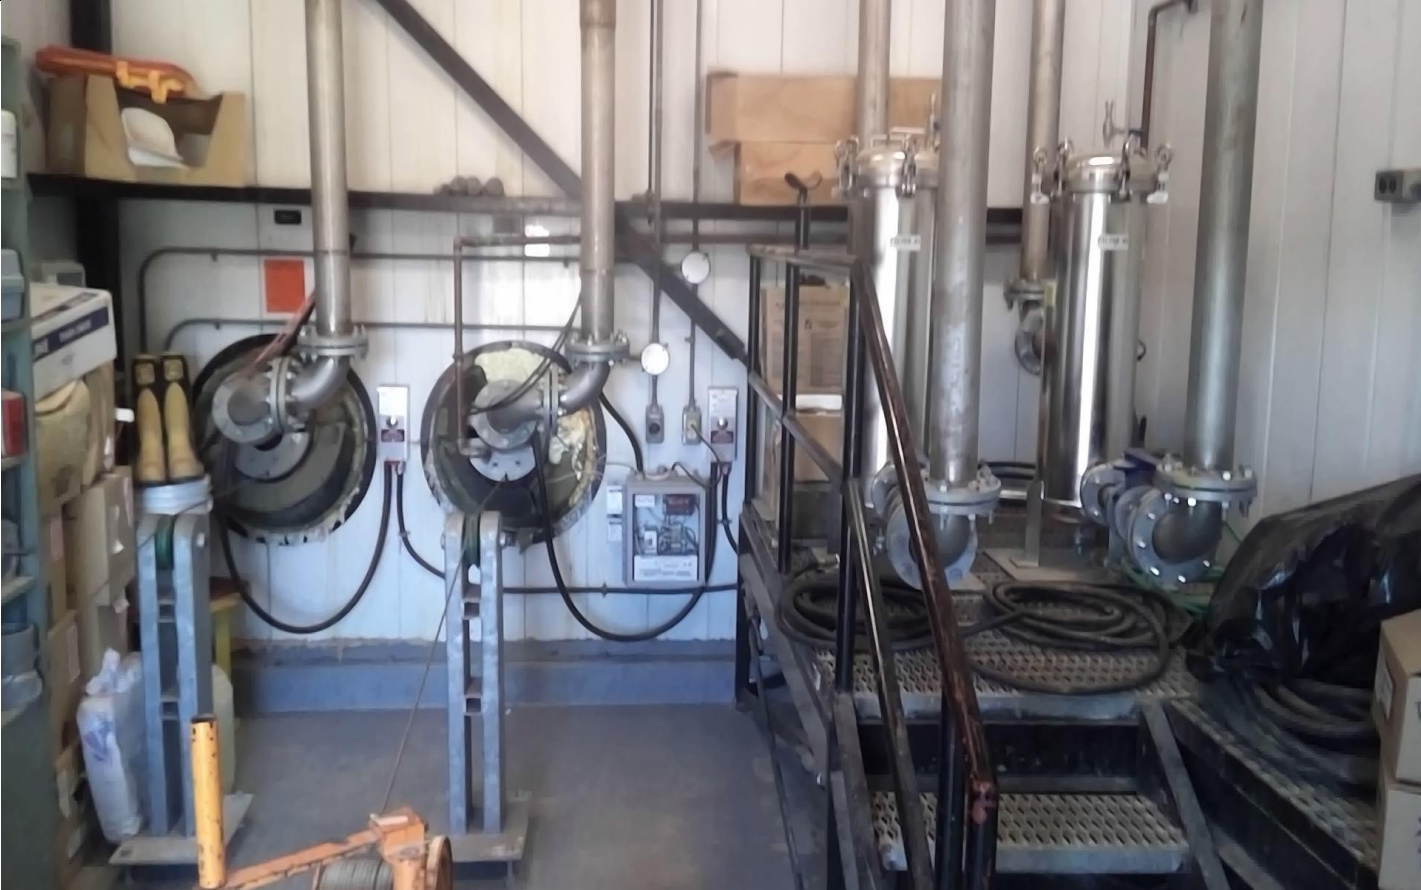
Photo 5

Description: Inside Water Treatment Plant. Mobile Water Pump with mesh screen behind auger drill.

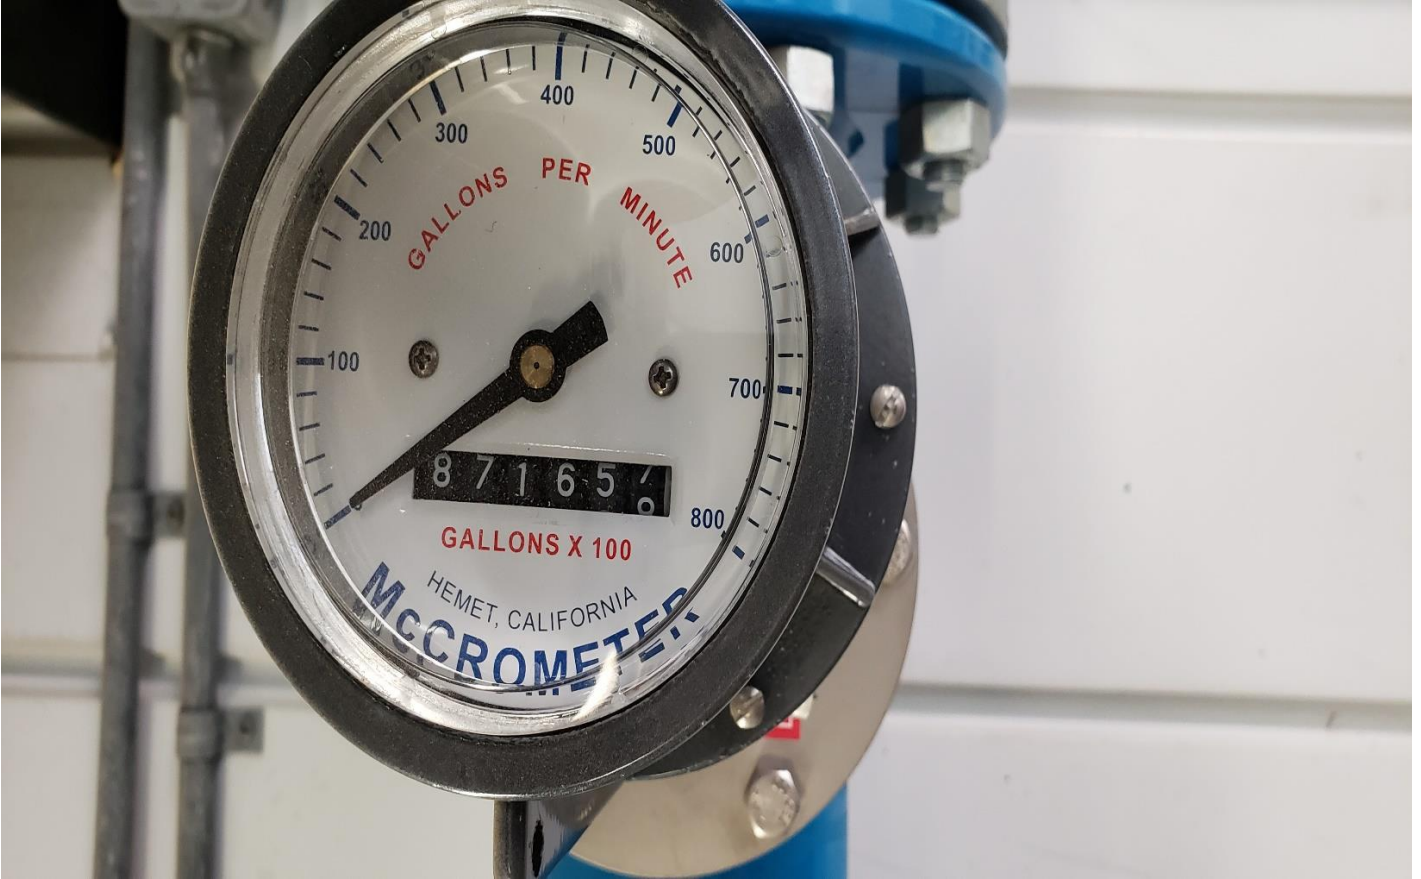
Photo 6

- 2. An operating water flow meter was observed on site, and read Gallons (photo 6).
- 3. A log sheet for truck fill procedures undated showed a weekly total of 34954497 Litres was withdrawn at the time of the inspection (photo 7).

Description: McCrometer Water Meter reads 871658 Gallons x 100

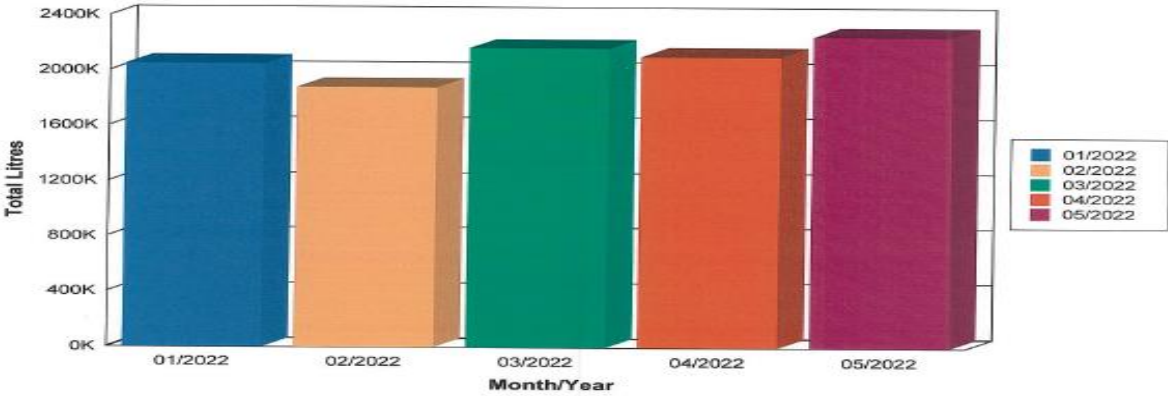
- 5. On June 27, 2022 Samuel Nuqingaq, Qikiqtarjuaq foreman, Hamlet of Qikiqtarjuaq emailed WRO Monteith a copy of the Hamlet of Qikiqtarjuaq's Water Usage Records. Water Usage Records between January 2022, and May 2022 shows a total of 10,455,952.40 Litres withdrawn.

Description: Water Usage Records between January 2022, and May 2022 shows a total of 10,455,952.40 Litres withdrawn.

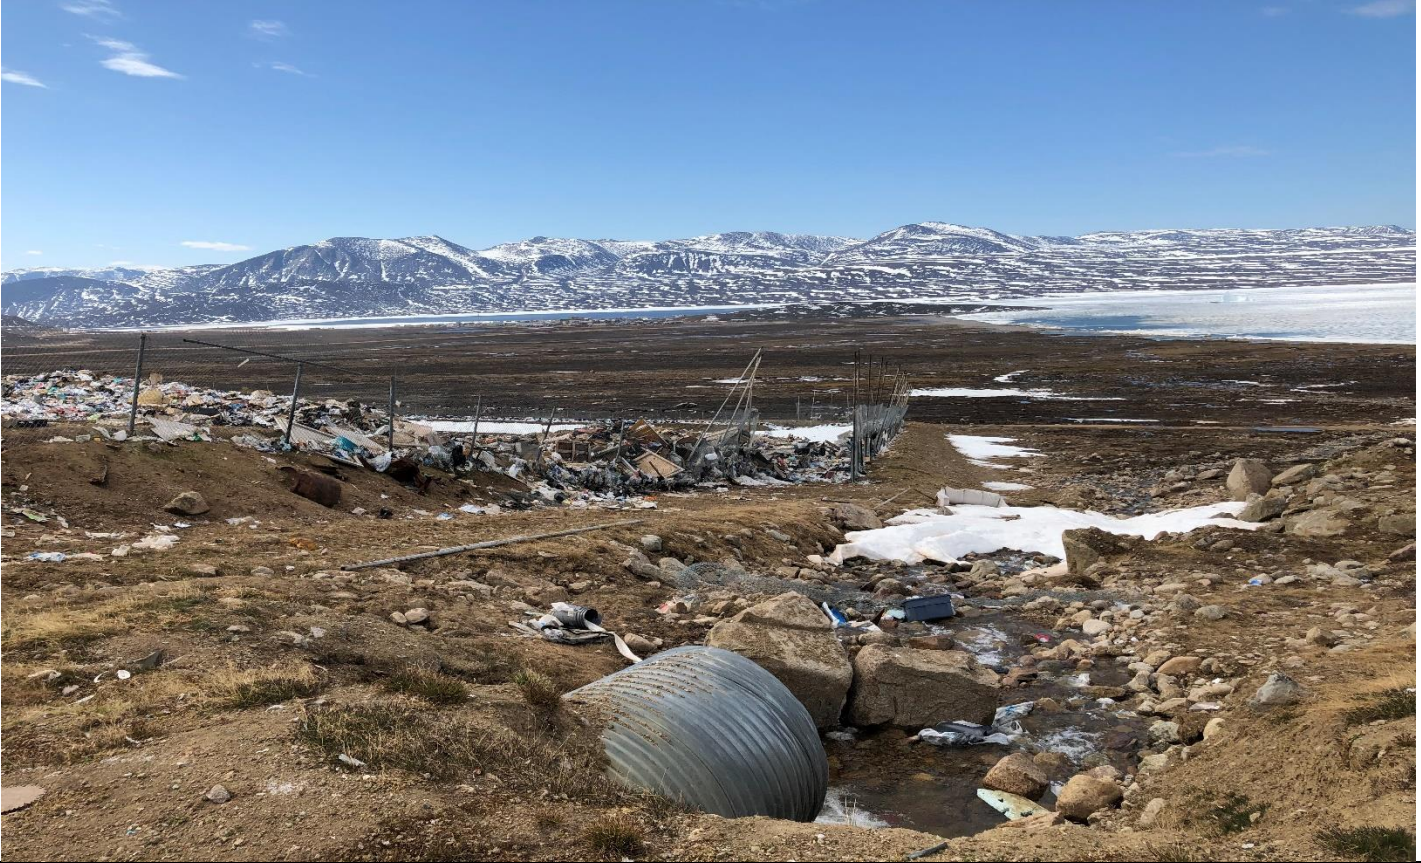
Photo 11

- 13. The licensee manages their solid waste by segregating the hazardous waste, burning and capping, and stocking bulk metals and woods separately. The licensee manages water by building dykes to limit the amount of water flowing in and out of the facility.
- 14. The Solid Waste Facility has good signage indicating where the metals dump, and land farm.
- 15. The hazardous Waste is within the fenced part of the burn and cap section of the Solid Waste Facility. Although there is sea can for the public to deposit waste in, it is full of batteries, paints, waste oil containers. Some signs of hazardous waste was observed in the burn and cap. Another sea can to deposit more hazardous waste was requested by Bhabesh Roy, P,Eng., Regional Engineer in 2021.
- 16. The fencing around the burn and cap facility requires maintenance on the East wall and repair on the North wall

Description: Fence requires repair on the North East side of burn and cap facility

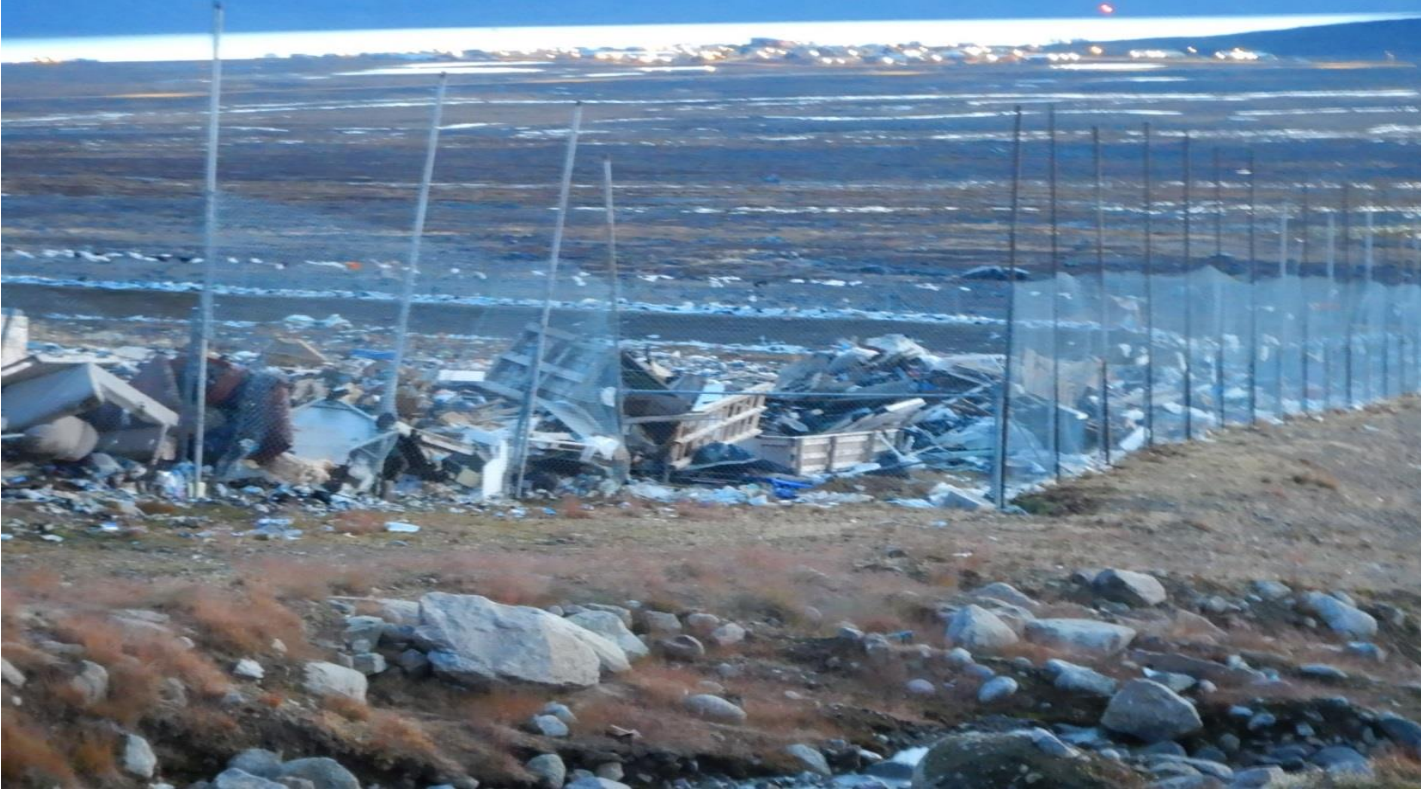
Photo 12

Description: Damaged fencing on North Side of Wall of burn and cap facility

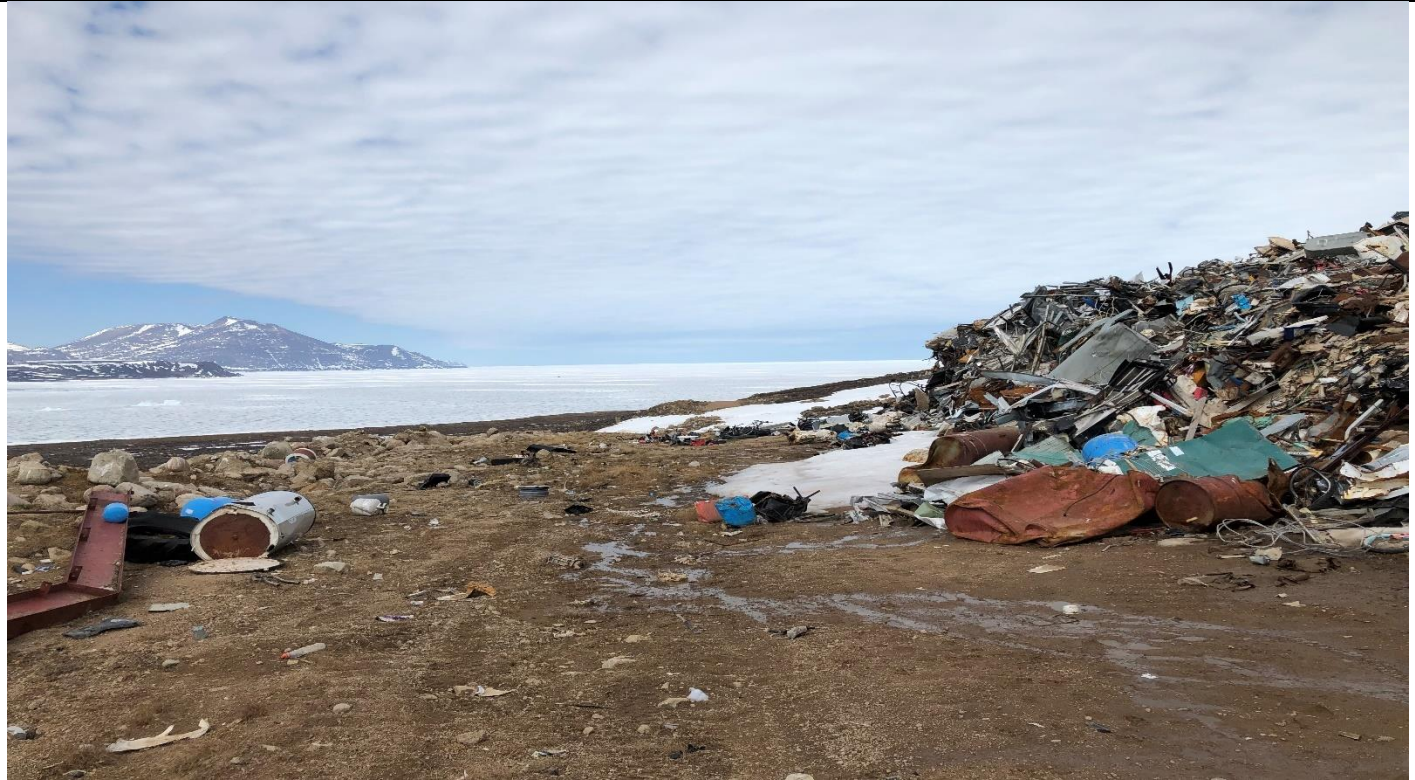
Photo Log #1	Location
Photo 14	Qikiqtarjuaq

- 17. Further to the Solid Waste Facility is a mix of historic metals waste home heating fuel tanks, white waste such as washers, dryers, fridges, freezers, and hazardous waste as oil drums, and propane tanks in bermed and no berm sections on the south side. Some of the bermed sections have lining, but are improperly installed or unmaintained (photo 16).

Description: Below the lined, and unlined berms and mixed metals. Water exiting the bulk metals. Observed 2019, this area seems to be the natural drainage route of water.

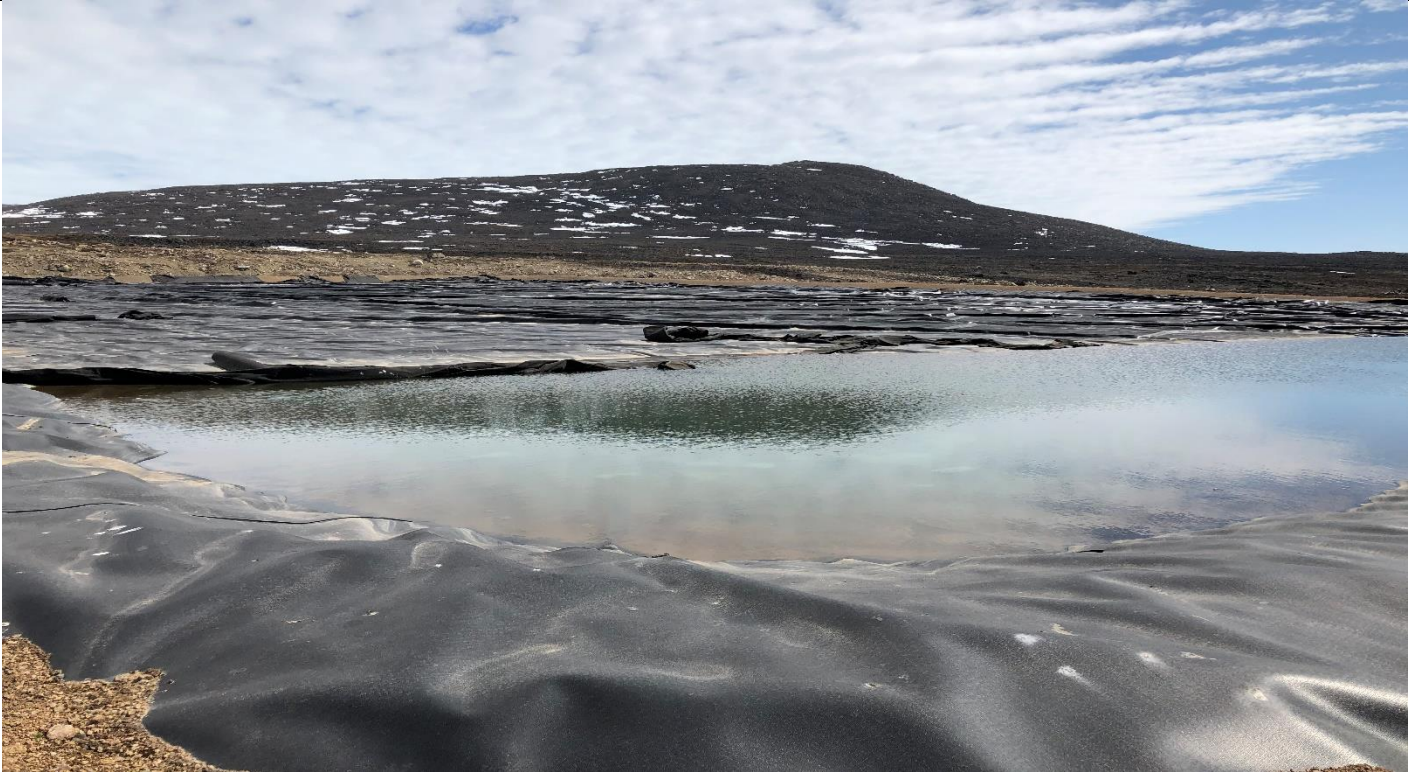
Photo 14

- 18. Hazardous Waste was observed throughout the Solid Waste Facility. Numerous signs of historic spills (photos 15).
- 19. A soil treatment facility lays uncommission. It was observed that the incomplete soil remediation project contained water (photo 13), and must be discharged appropriately as per the water licence discharge requirements. The plan to complete the soil treatment facility was authorized to be completed. At the time of the inspection, it was noted that the consulting engineer of the facility had visited the site, but did not say it was completed.

Description: Water in the soil remediation berm. No signs of activity in 2021, but the accumulation of water in the berm indicates the berm isn't damaged.

- Provide an update for the completion of the Soil Remediation Structure.
 - Investigate the cause of the leak, and slumping of the Water Treatment Facility Reservoir walls.

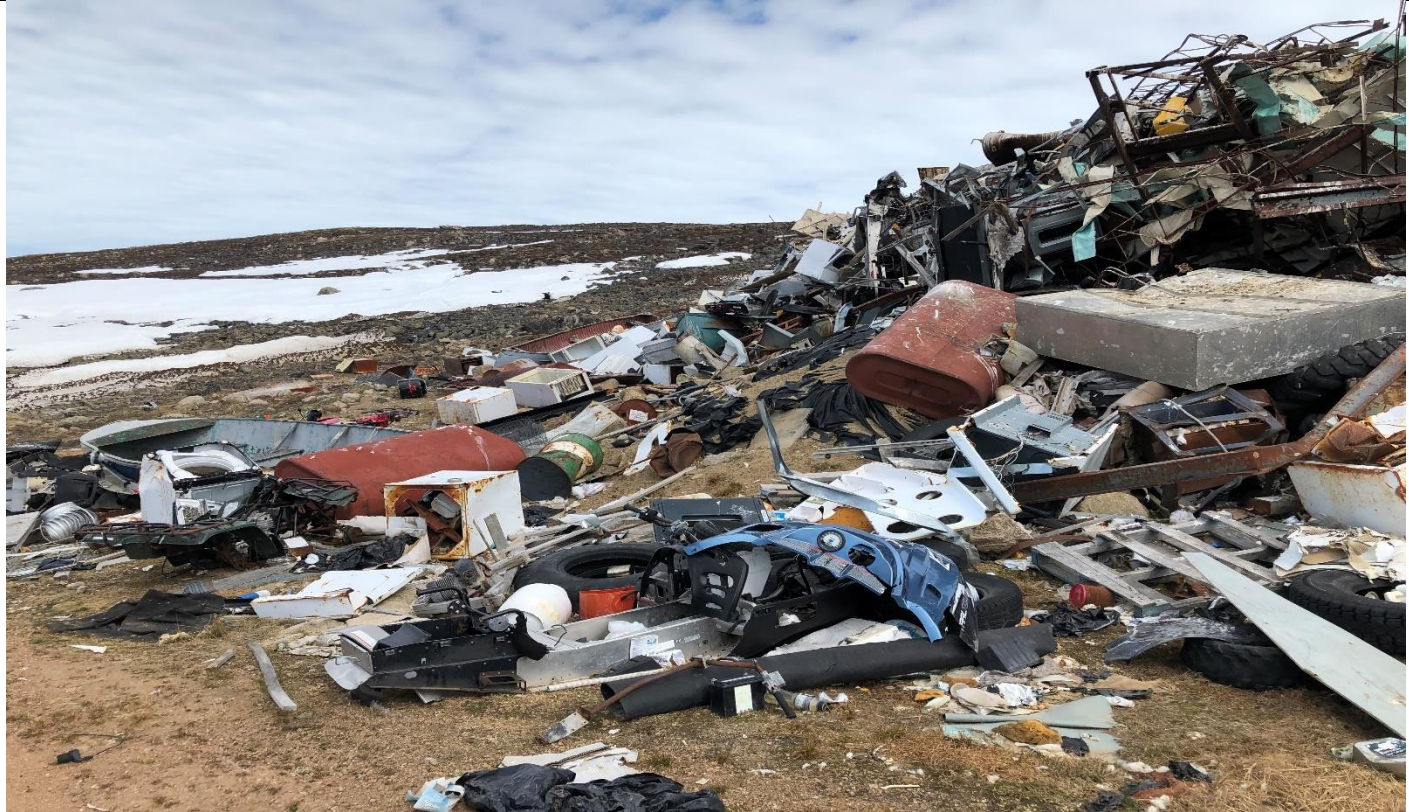
Photo Log #1
Photo 15

Description: Hazardous waste in the bulk metals section of the solid waste facility. Batteries, paint cans, and propane tanks.

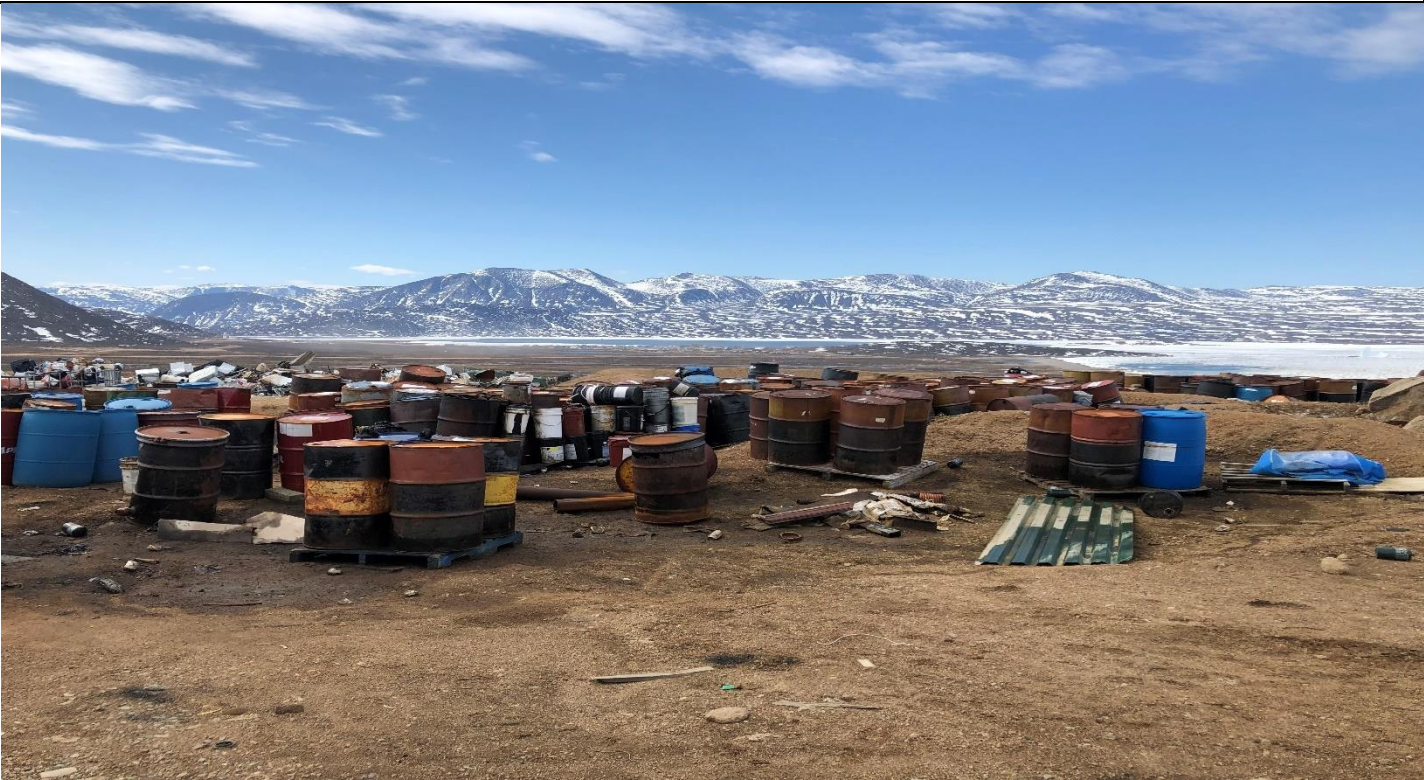
Photo 15

Description: Hazardous Waste Facility. Multiple signs of spills. Signs of historic spills.

- Submit a spill report for the historical spills observed in the Hazardous Waste Facility.
