## ANNUAL REPORT FOR THE HAMLET OF QIKIQTARJUAQ, 2021

The following information is compiled pursuant to the requirements of Part B, Item 1 of Water Licence No. **3BM-QIK1924** issued to the **Hamlet of Qikiqtarjuaq**.

WATER LICENCE INSPECTION FORM

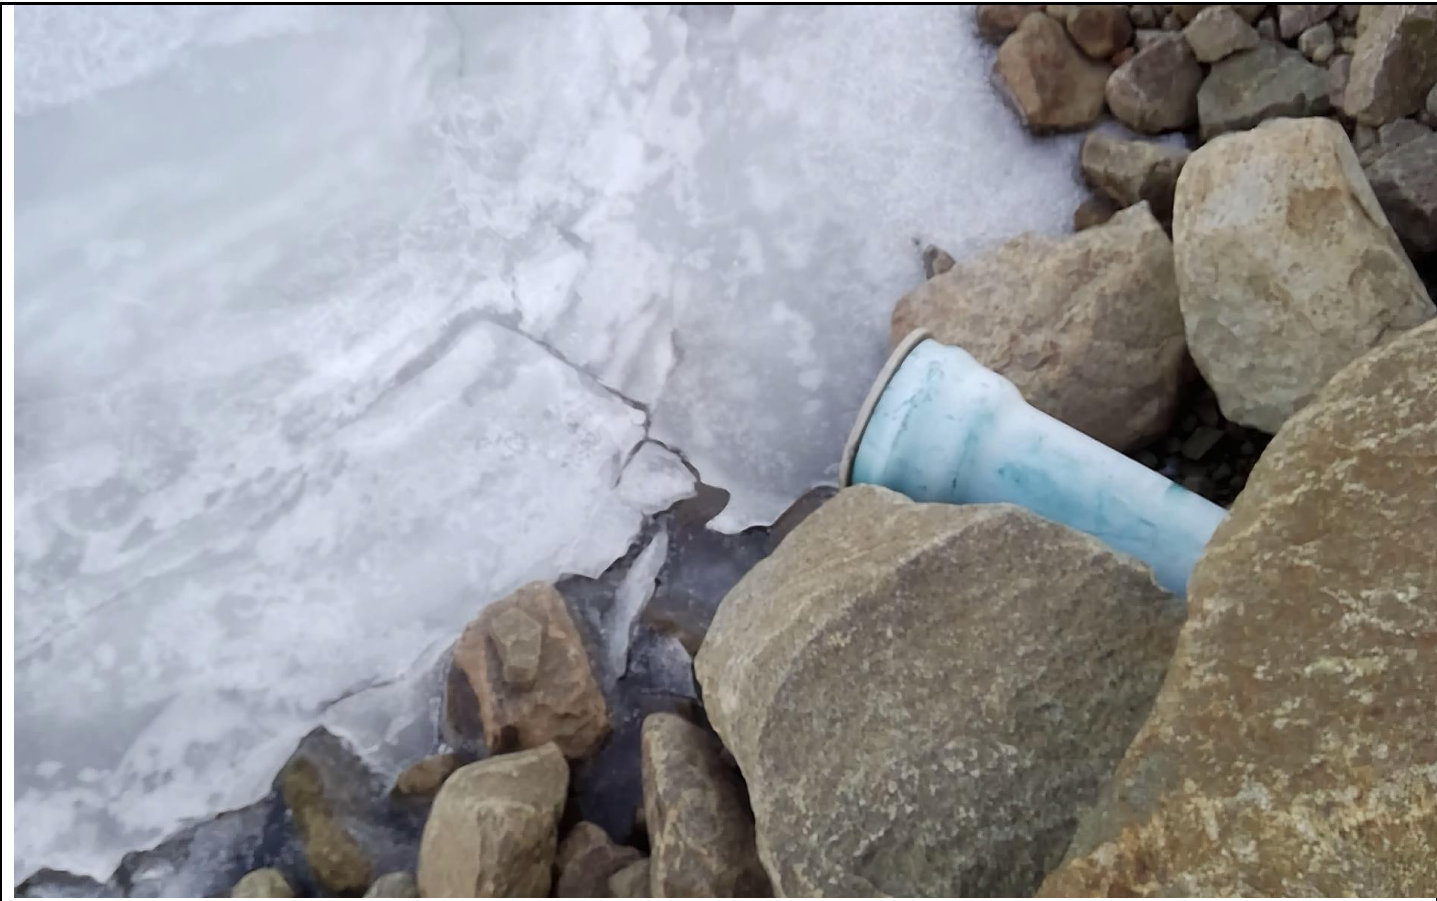
Photo Log #1	Location
Photo 2	Qikiqtarjuaq

Description: water intake pipe. More than 50% below the water table.

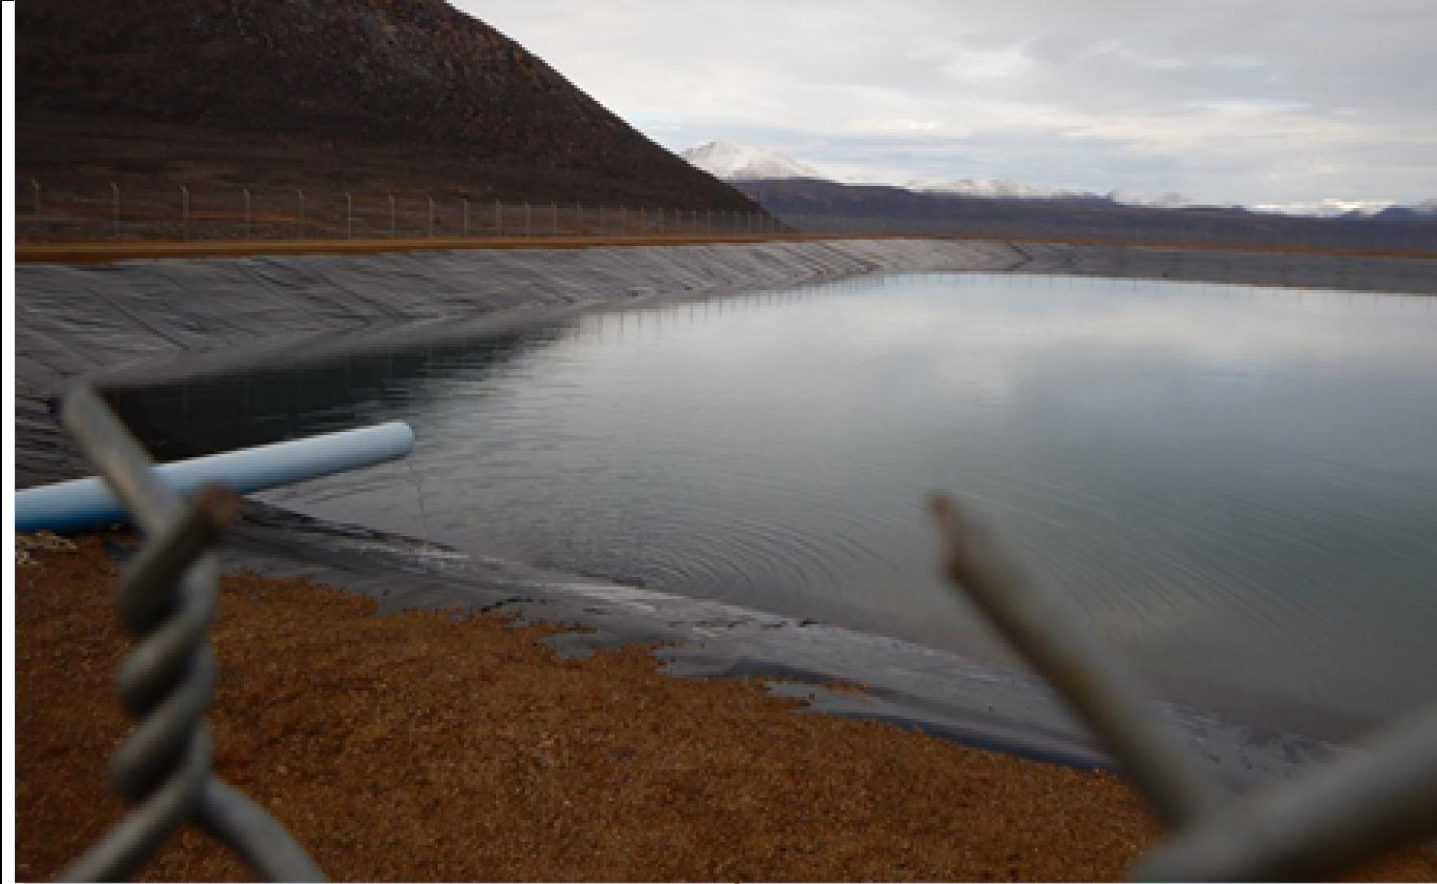
Photo Log #1	Location
Photo 3	Qikiqtarjuaq

- 4. The water reservoir didn't appear to be working as intended as there is a suspected leak in the liner of the reservoir. The outer walls appeared to be slumping and leaking water from the reservoir on the North wall of the reservoir (Photo 8). Samuel Nuqingaq, Municipal Forman for Hamlet of Qikiqtarjuaq said that once the reservoir hits 22 metres full(measured diagonally from the top of the water table to the bottom of the lagoon on the opposite side of the water table measurement), the leak of the water reservoir begins. At the time of the inspection the recharge pipe was closed, and the water level below the recharge pipe (See photo 3).

Description: Water Reservoir – intake pipe from water withdrawal location at Tulugak River. Uncontrolled withdrawal of water from the water source

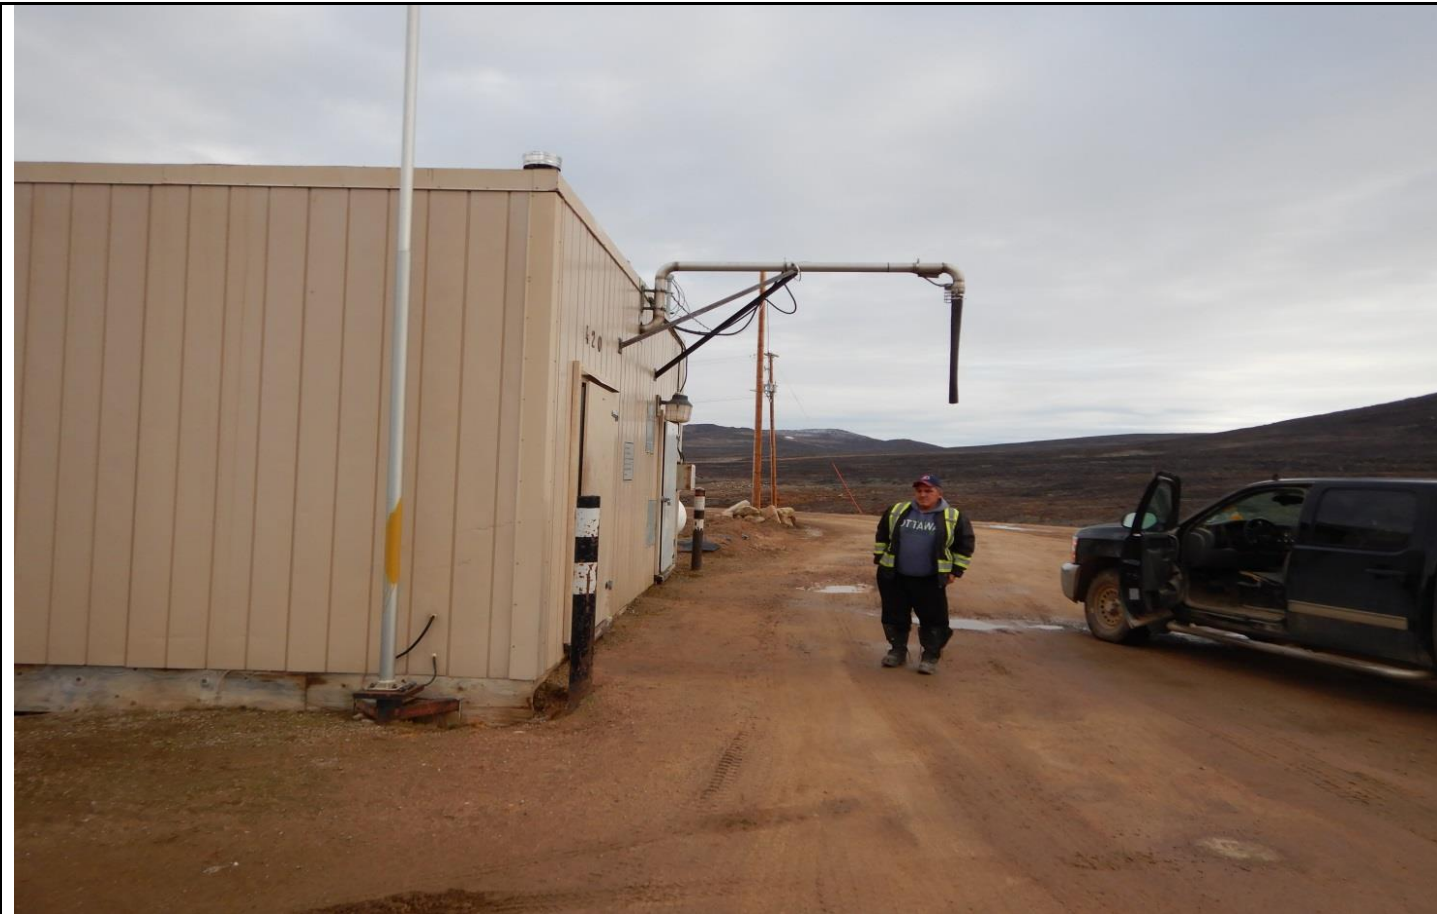
Photo Log #	Location
Photo 4	Qikiqtarjuaq

Description: Water Treatment Facility/Truck Pumping House. Samuel Nuqingaq

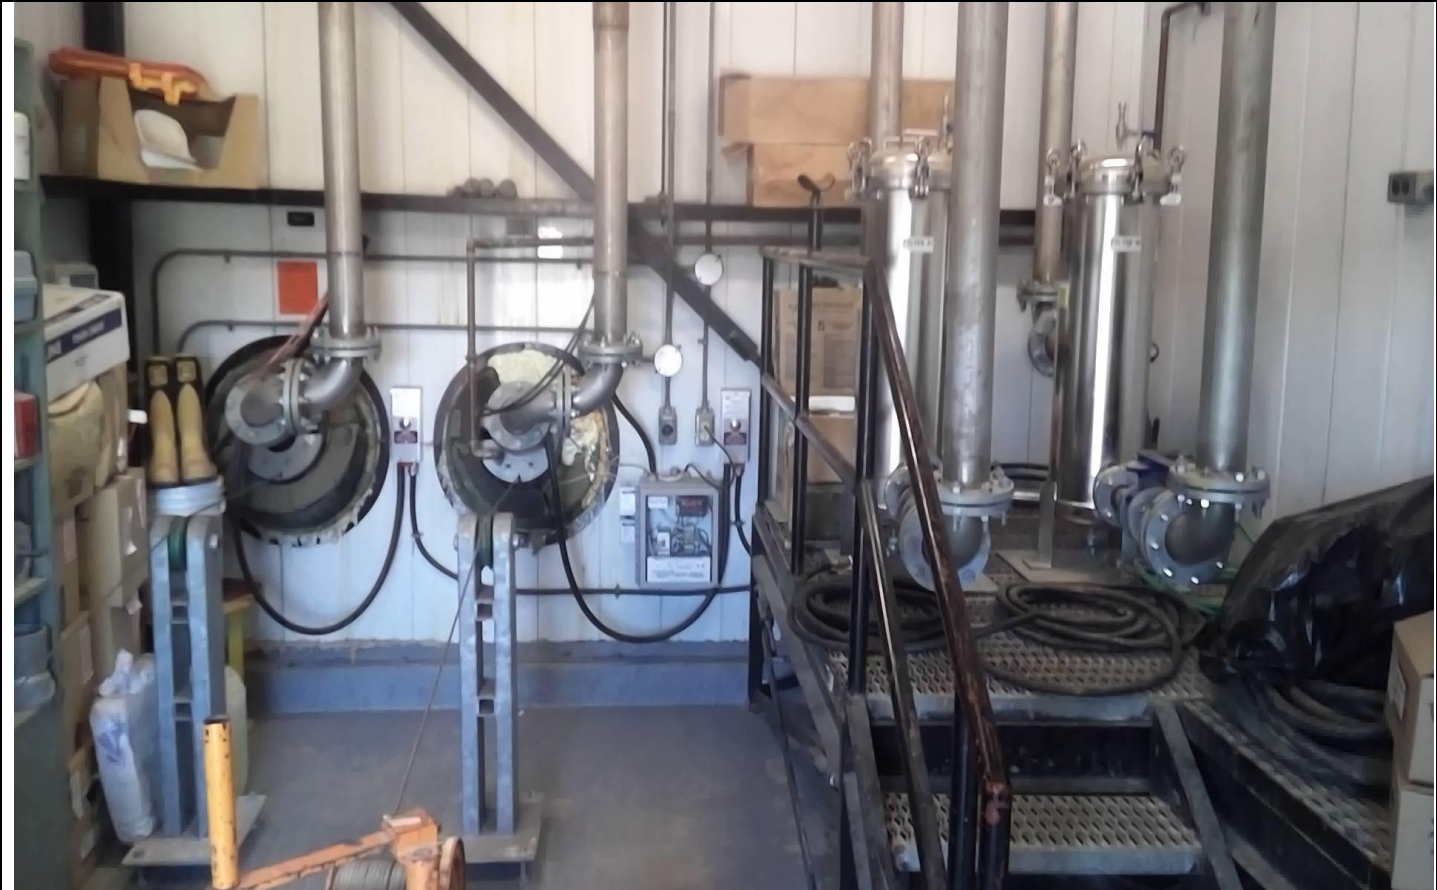
Photo Log #	Location
Photo 5	Qikiqtarjuaq

Description: Inside Water Treatment Plant. Mobile Water Pump with mesh screen behind auger drill.

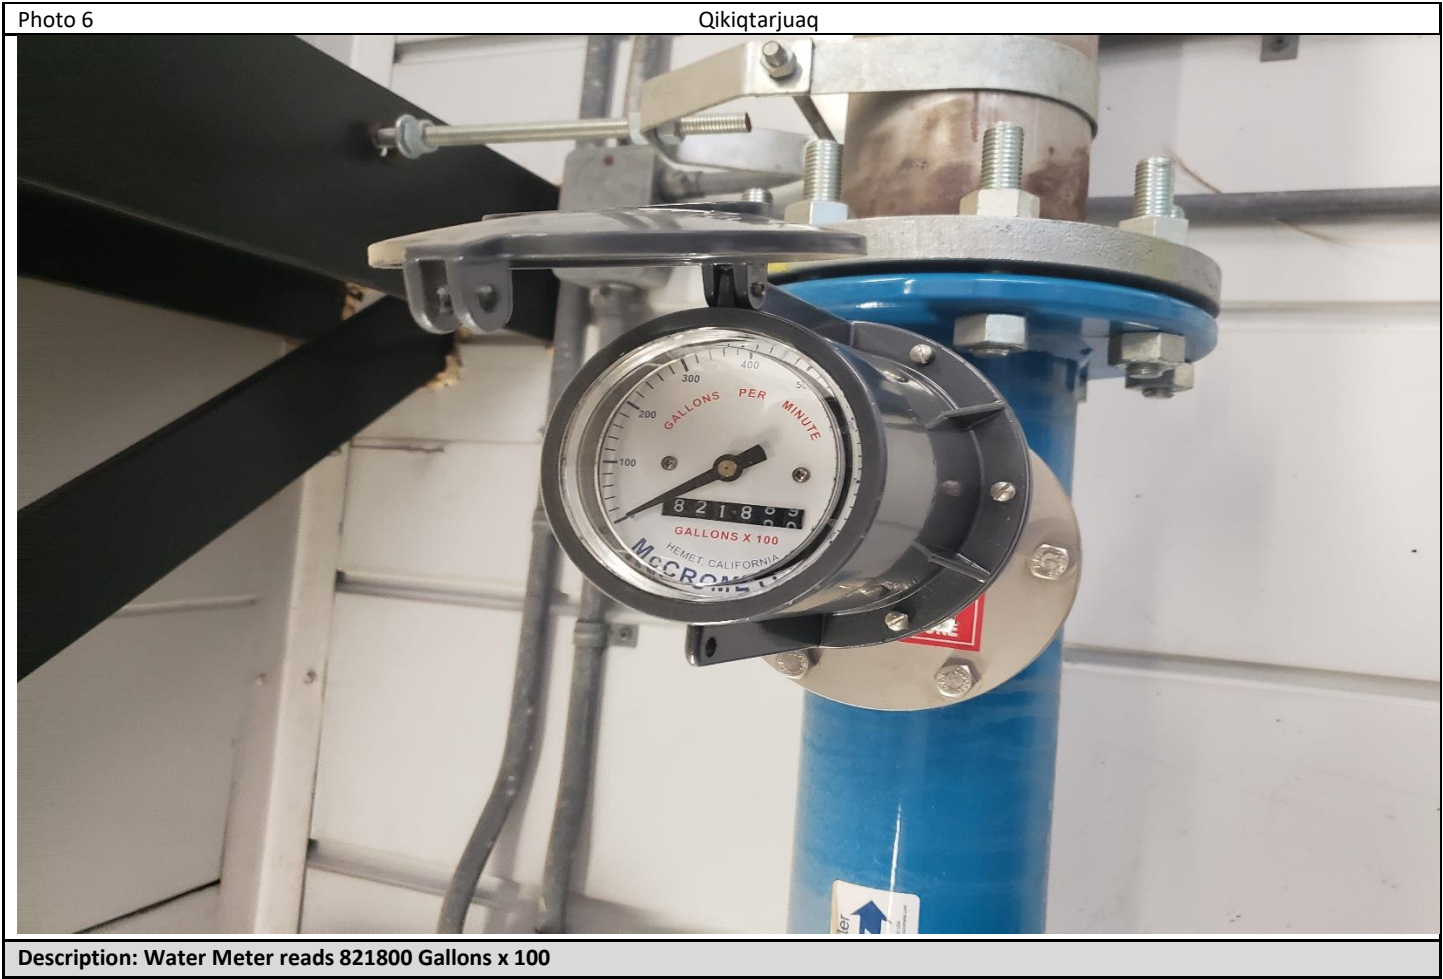
- 2. An operating water flow meter was observed on site, and read Gallons (Photo 6).
- 3. A log sheet for truck fill procedures undated showed a weekly total of 821800 Gallons was withdrawn at the time of the inspection (see Photo 7).

Description: Water Meter reads 821800 Gallons x 100

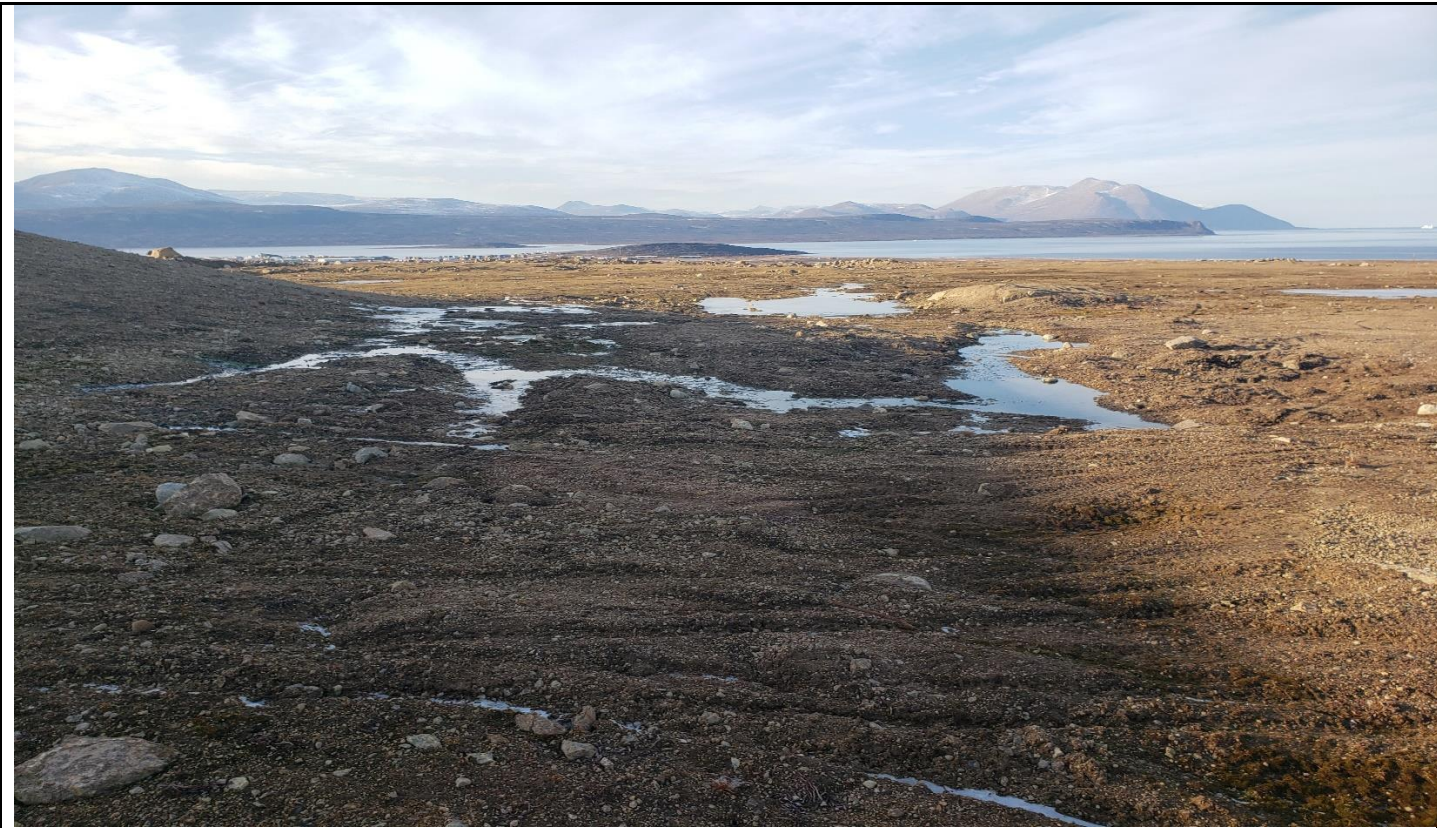
Photo Log #1Location  
Photo 8Qikiqtarjuaq

Description: signs of slumping on outer wall of Water Reservoir. Once the reservoir reaches 22 metre(measured diagonally) the reservoir leaks

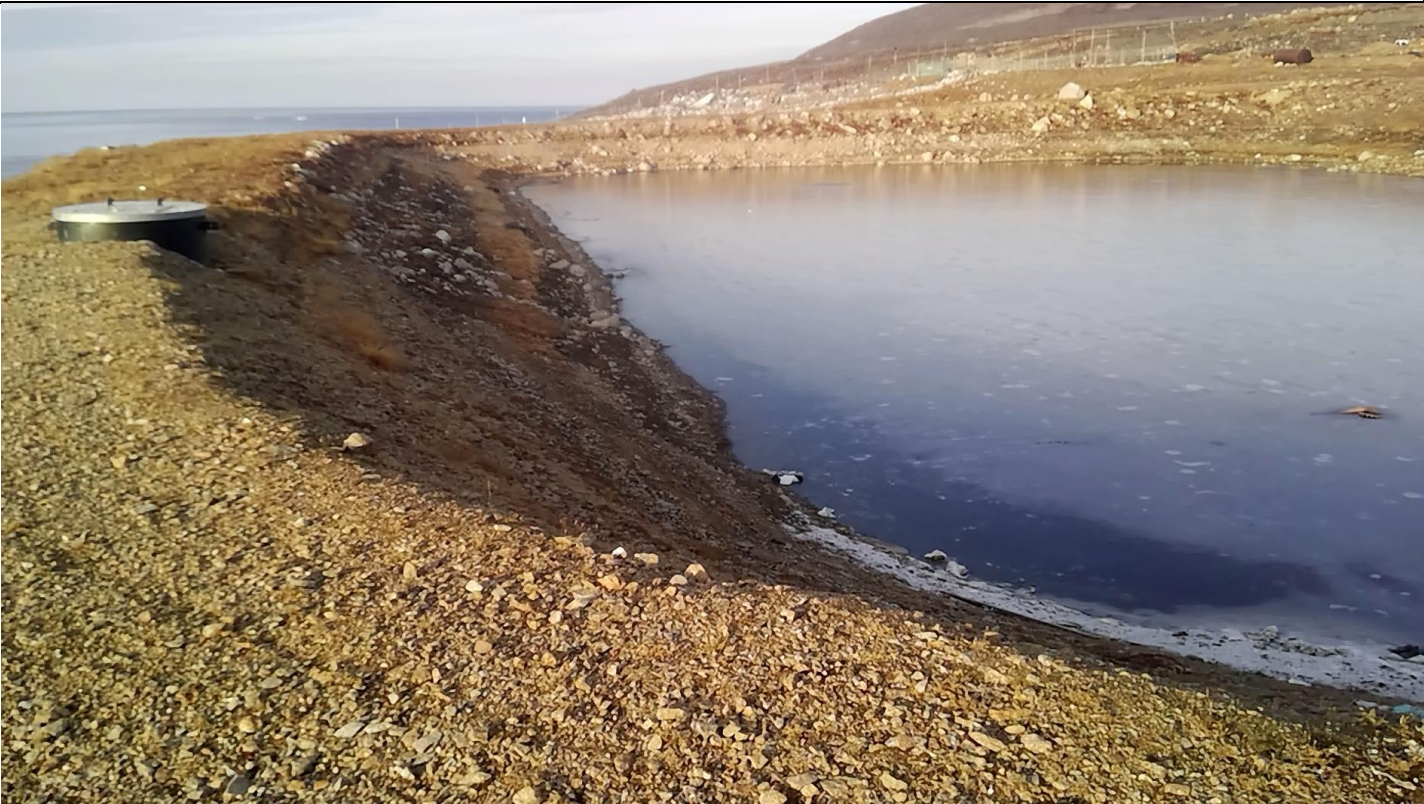
Photo 12

Description: Signs of windblown garbage in Waste Water Treatment Facility – Decanting Pipe appears above the lagoon waste water table. Freeboard appears to be above the 1 metre freeboard. Some free blown garbage observed in the lagoon.

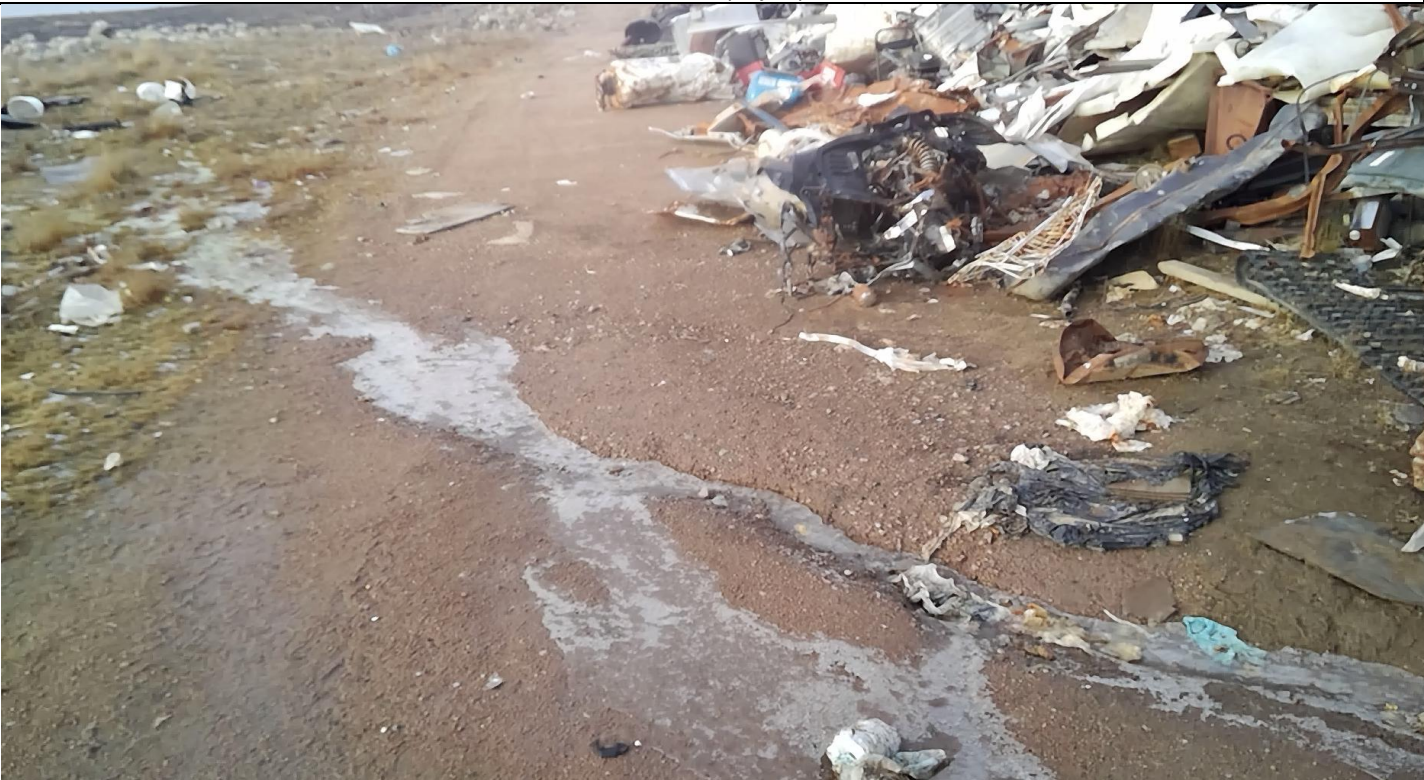
Photo 13

Description: Below the lined, and unlined berms and mixed metals. Water exiting the bulk metals. Observed 2019, this area seems to be the natural drainage route of water.

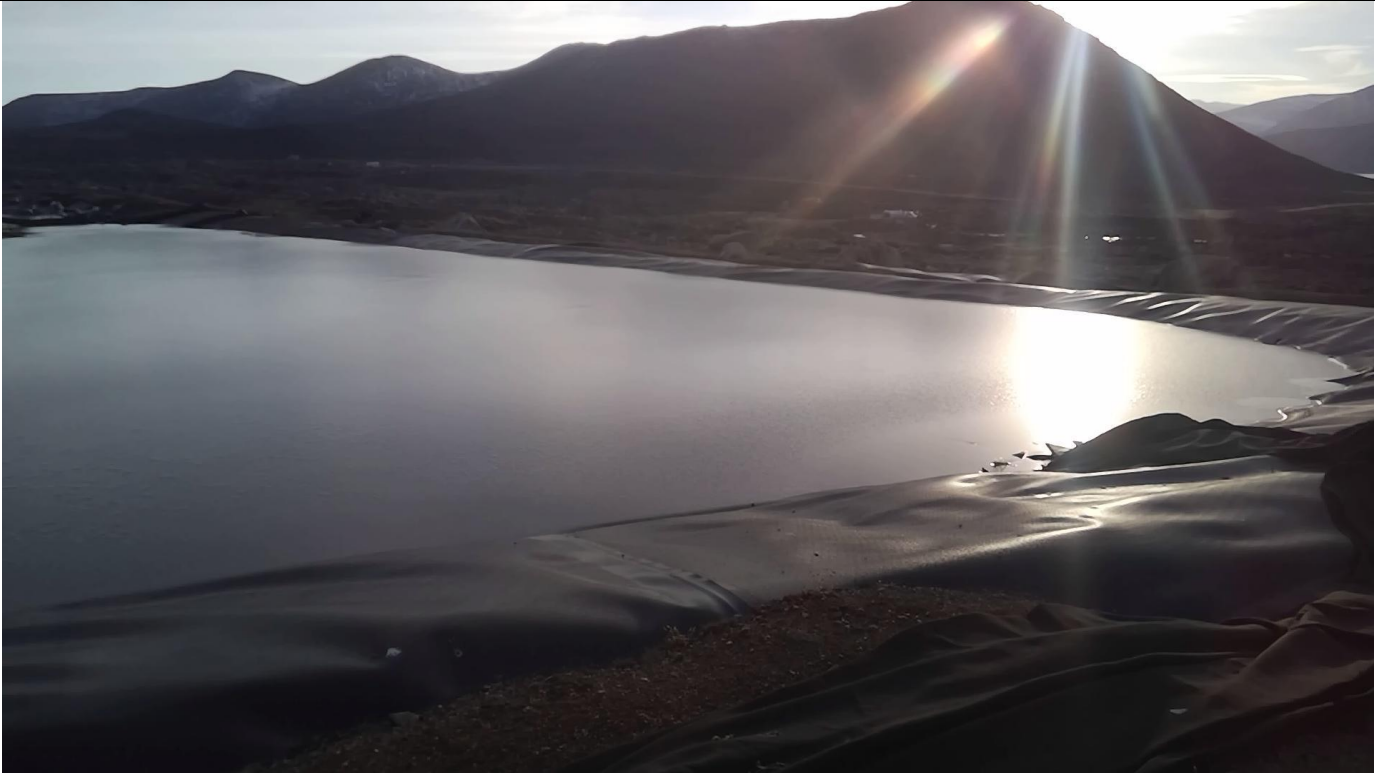
Photo Log #1	Location
Photo 14	Qikiqtarjuaq

Description: Water in the soil remediation berm. No signs of activity in 2021, but the accumulation of water in the berm indicates the berm isn't damaged.

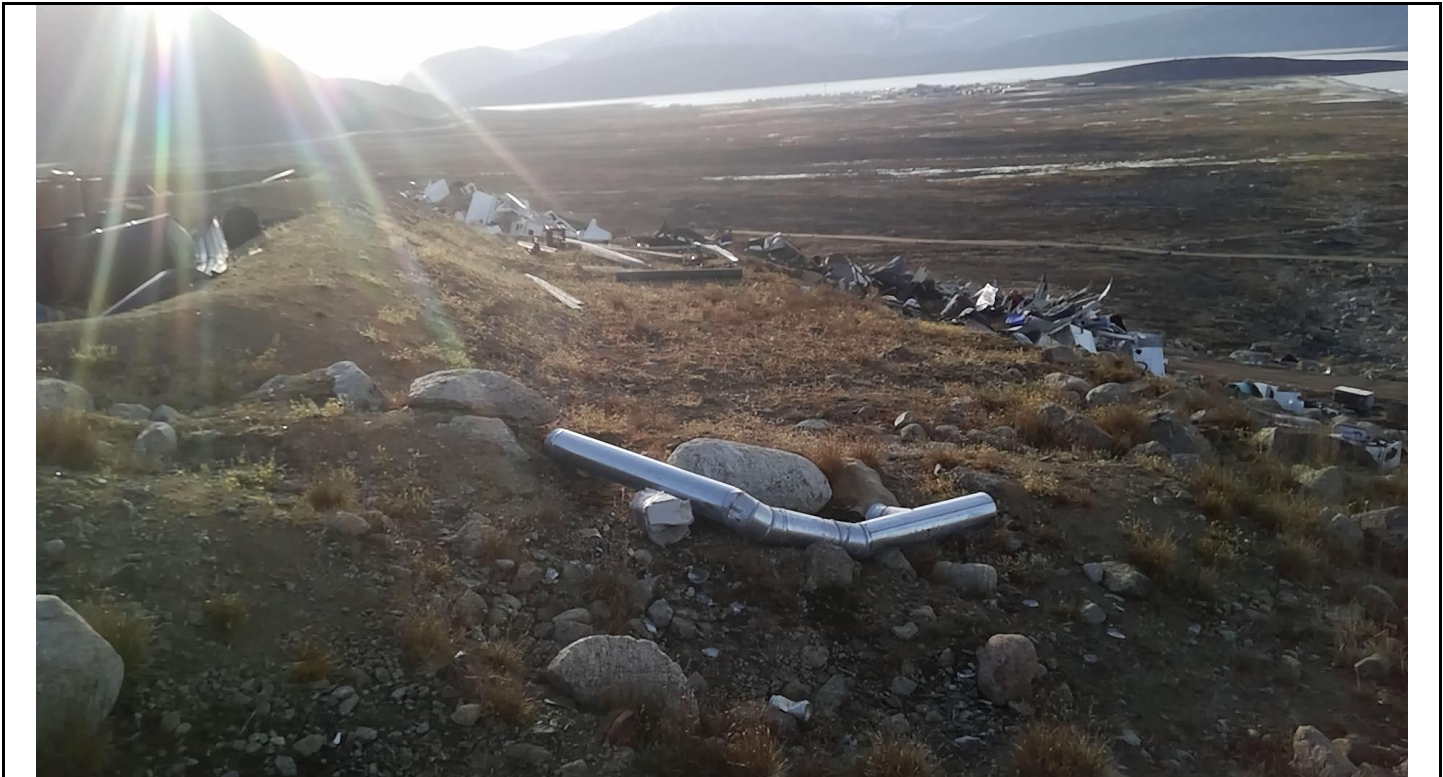
Photo Log #1	Location
Photo 15	Qikiqtarjuaq

Description: Back section of the Hazardous Waste Facility. Multiple berms for storage of hazardous waste.
