WATER LICENCE INSPECTION FORM

Licensee	Licensee Representative
Hamlet of Rankin Inlet	Ashley Yamana
Licence No. / Expiry	Representative's Title
3BM-RAN1520/ Dec 20/20	Acting Senior Administrative Officer
Land / Other Authorizations	Land / Other Authorizations
Municipal	--
Date of Inspection	Inspector
August 26 <sup>th</sup> 2020	Atuat Shouldice
Activities Inspected	
<div><input type="checkbox"/> Camp<input type="checkbox"/> Drilling<input type="checkbox"/> Mining<input type="checkbox"/> Construction<input type="checkbox"/> Reclamation<input type="checkbox"/> Fuel Storage</div> <div><input type="checkbox"/> Roads/Hauling<input checked="" type="checkbox"/> Other: Waste Disposal Facility<input type="checkbox"/> Other:</div>

Licence 3BM-RAN1520 is issued to the Hamlet for the use of water and deposit of waste associated with the Landfill. The Licence expired on December 20<sup>th</sup> 2020. A renewal application was submitted in September 2020.

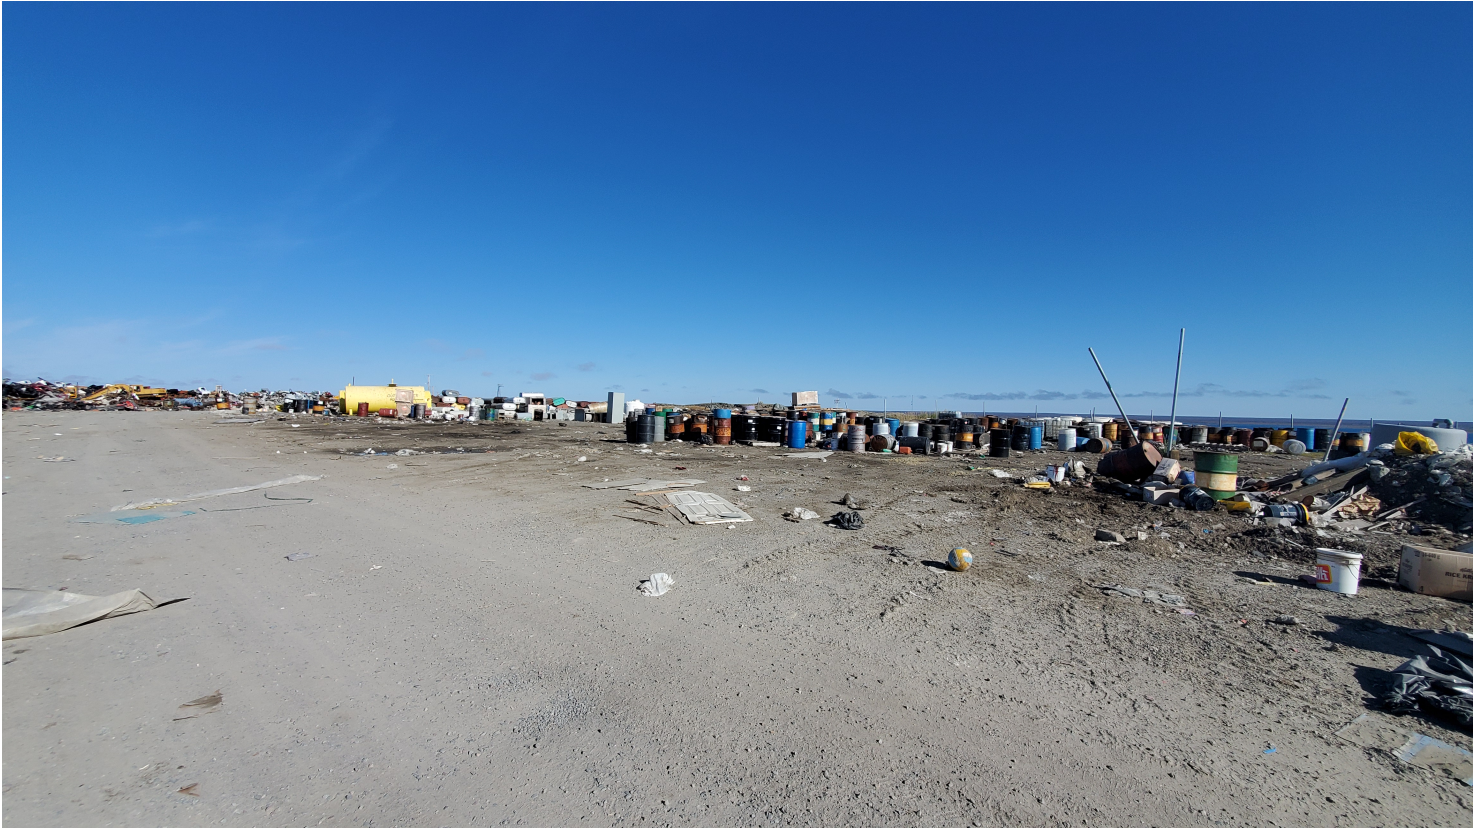
PHOTO LOG			
Date:	Authorization Number:	Camera/Model:	Inspector
August 26th, 2020	3BM-RAN1520	Samsung S10	RMO Shouldice
Photo No.	Lat/Long (DD.MM.SS.SS, NAD83)		
Photo 1	N64° 48' 40.9", W98° 51' 4.73"		
Description:			
Hazardous waste storage area looking south to main entrance.
