Indian and Northern
Affairs Canada

October 28, 2003

Re: Water licence inspection for September 17, 2003

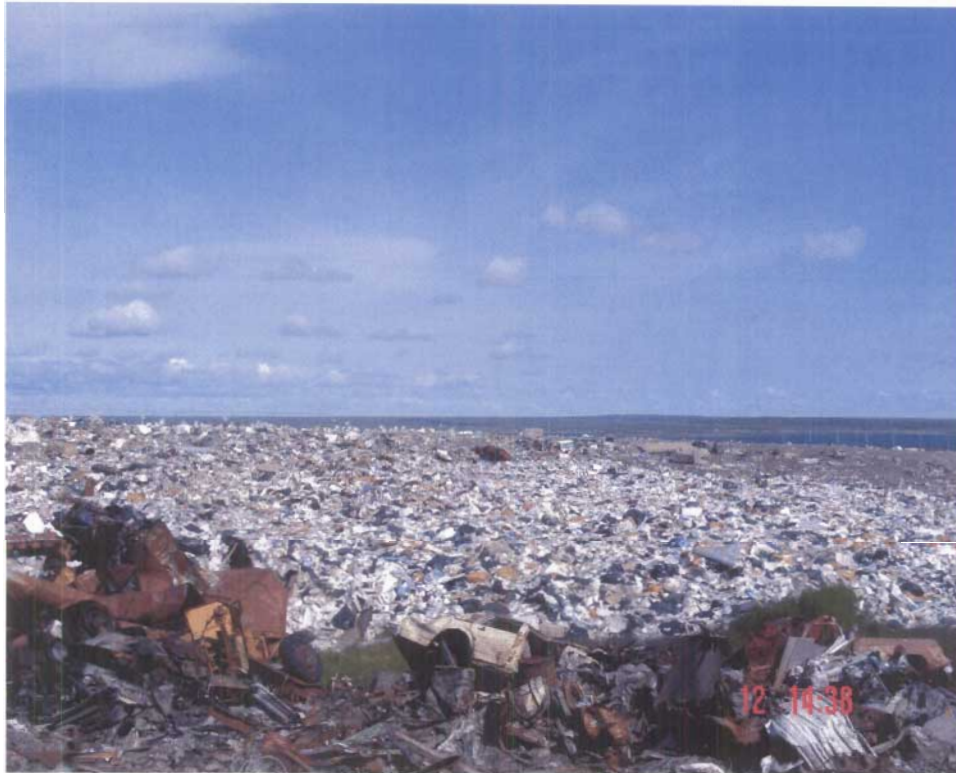
Waste metal is not segregated and is easily observed throughout the landfill. Also, no attempt has been made to segregate and contain hazardous materials. A properly marked area of the landfill should be set aside to hold hazardous materials. This area should include containment structures for hazardous materials such as lead acid batteries, waste paint and solvents.

Figure 1. Unsegregated waste in the Rankin Inlet landfill.

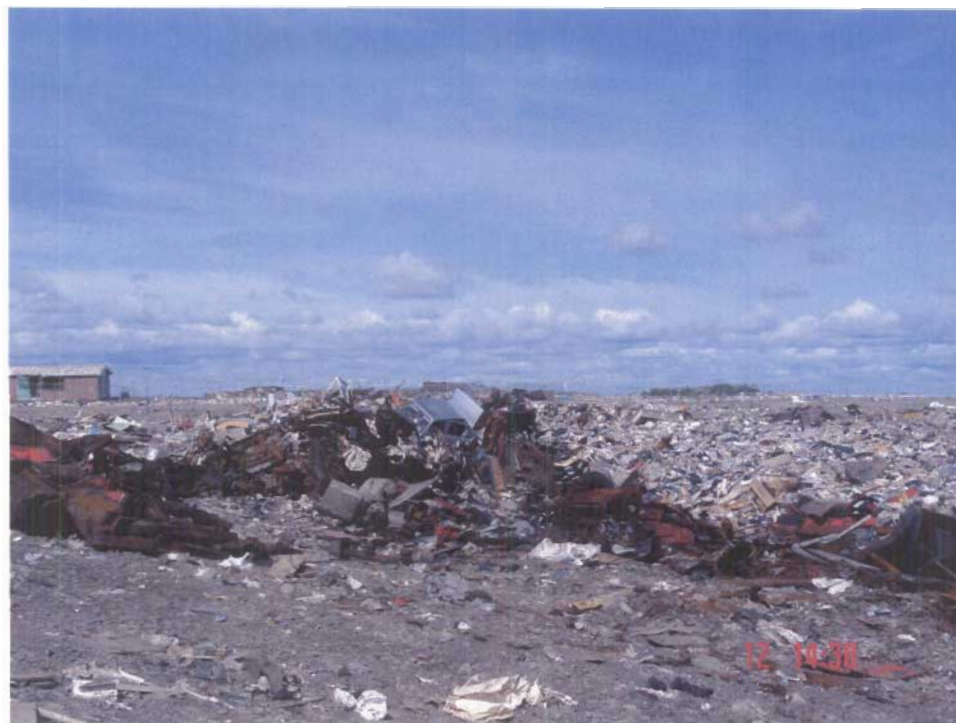
Figure 2. Unsegregated waste in the Rankin Inlet landfill.

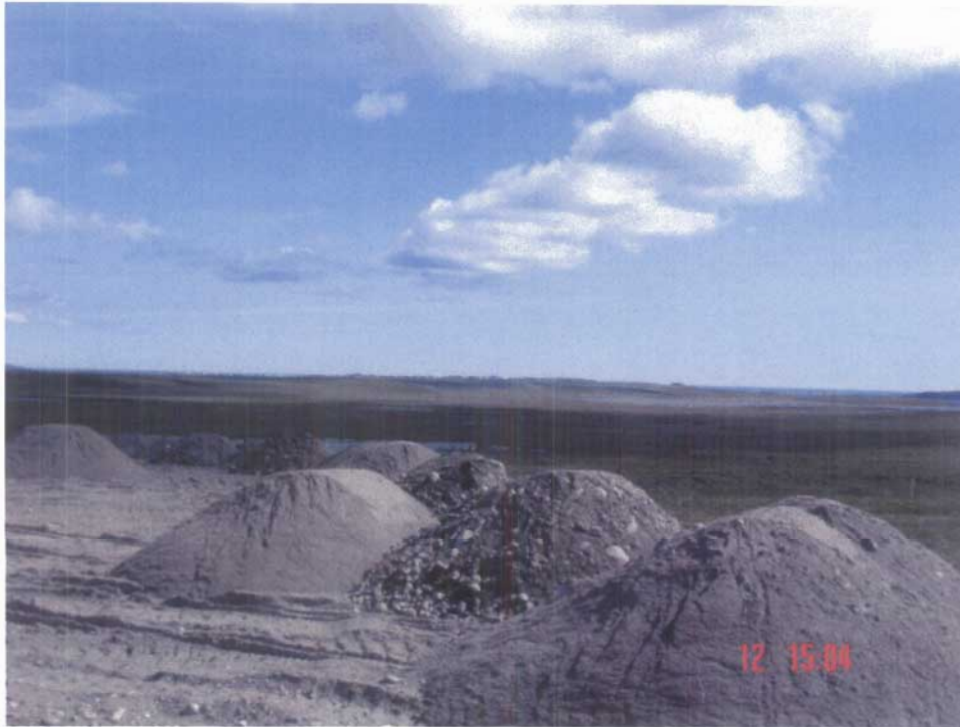
Construction of a new landfill is scheduled to begin in September 2003 with completion sometime in late 2004 or early 2005 (figure 3). According to Ron Roach, the SAO, an A&R plan has not yet been started for the old landfill. The water licence states that the A&R plan was to be submitted with the preliminary design drawings for the new landfill facility.

Figure 3. Granular material deposited at the site of the new landfill for the Hamlet of Rankin Inlet.
