WATER LICENCE INSPECTION FORM

Licensee	Licensee Representative
Hamlet of Rankin Inlet	Justin Merrit (A/SAO), Joe Kaludjak (Hamlet Foreman), Megan Lusty (CGS)
Licence No. / Expiry (DD/MM/YYYY)	Representative's Title
3BM-RAN1214 (31/05/14)	-----
Date of Inspection (DD/MM/YYYY)	Inspector
19/08/14	WRO C. Wilson

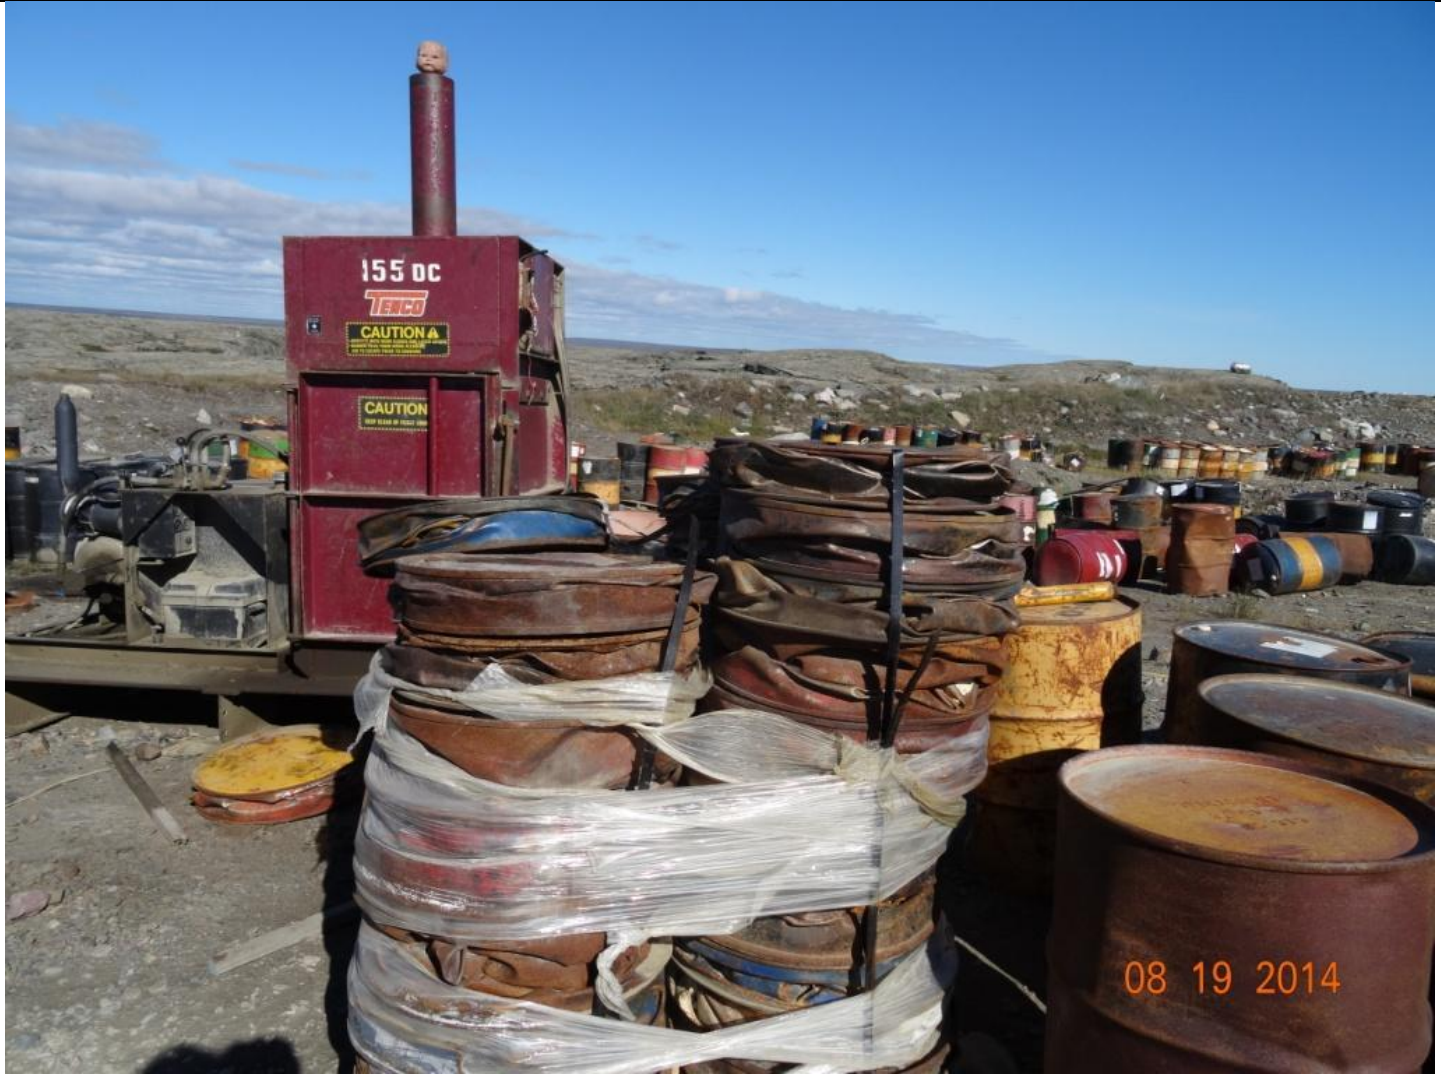
Location name:	Lat/Long (DD.MM.SS.SS, NAD83)
Photo 3	62 48' 03.4" N, 92 04' 22.0" W

- 8) Though progress has been made on sorting new hazardous waste the historical waste found inside the landfill remains an issue. 300 plus drums of unknown materials are found lining the entrance road of the dump. It was noted that drums are being crushed and palletized.
- 9) Contaminated soil has been historically deposited into the landfill, the Hamlet is aware that this activity is unacceptable. The party responsible for the contaminated soil is inevitable responsible for the soil treatment. The Hamlet is encouraged to report dumping to the Environment Protection Officers- GN. Recently CGS has started accepting contaminated soils into their landfarm (water licence 1BR-RAN0914) which is across the street from the Hamlet's Landfarm.

Description:
Rankin Inlet Landfill. Drum storage area.
