WATER LICENCE INSPECTION FORM

| Hamlet of Rankin Inlet | Darren Flynn |
| 3BM-RAN2025/ Dec 20,2025 | Senior Administrative Officer |
| 6/24/2021 | Atuat SHOULDICE |

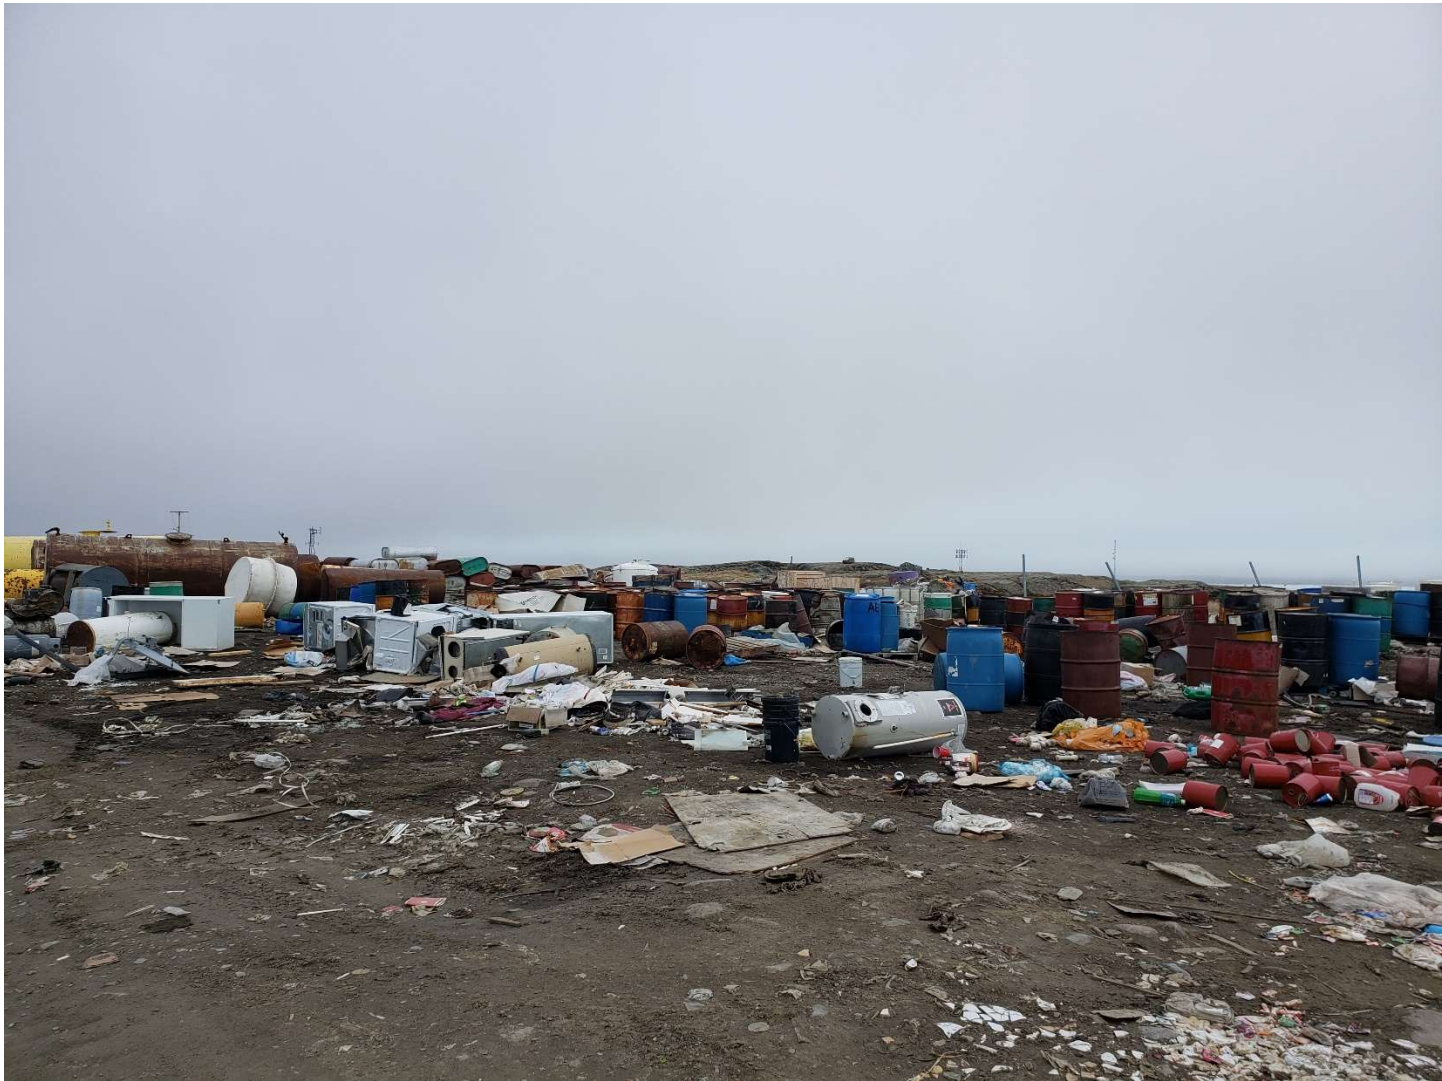
| Photo No. | Lat/Long (DD.MM.SS.SS, NAD83) |
|---|---|
| Photo 1 | Marked on provided map. |

Description: Waste oil drums, waste garbage, since inspection has been cleaned up.

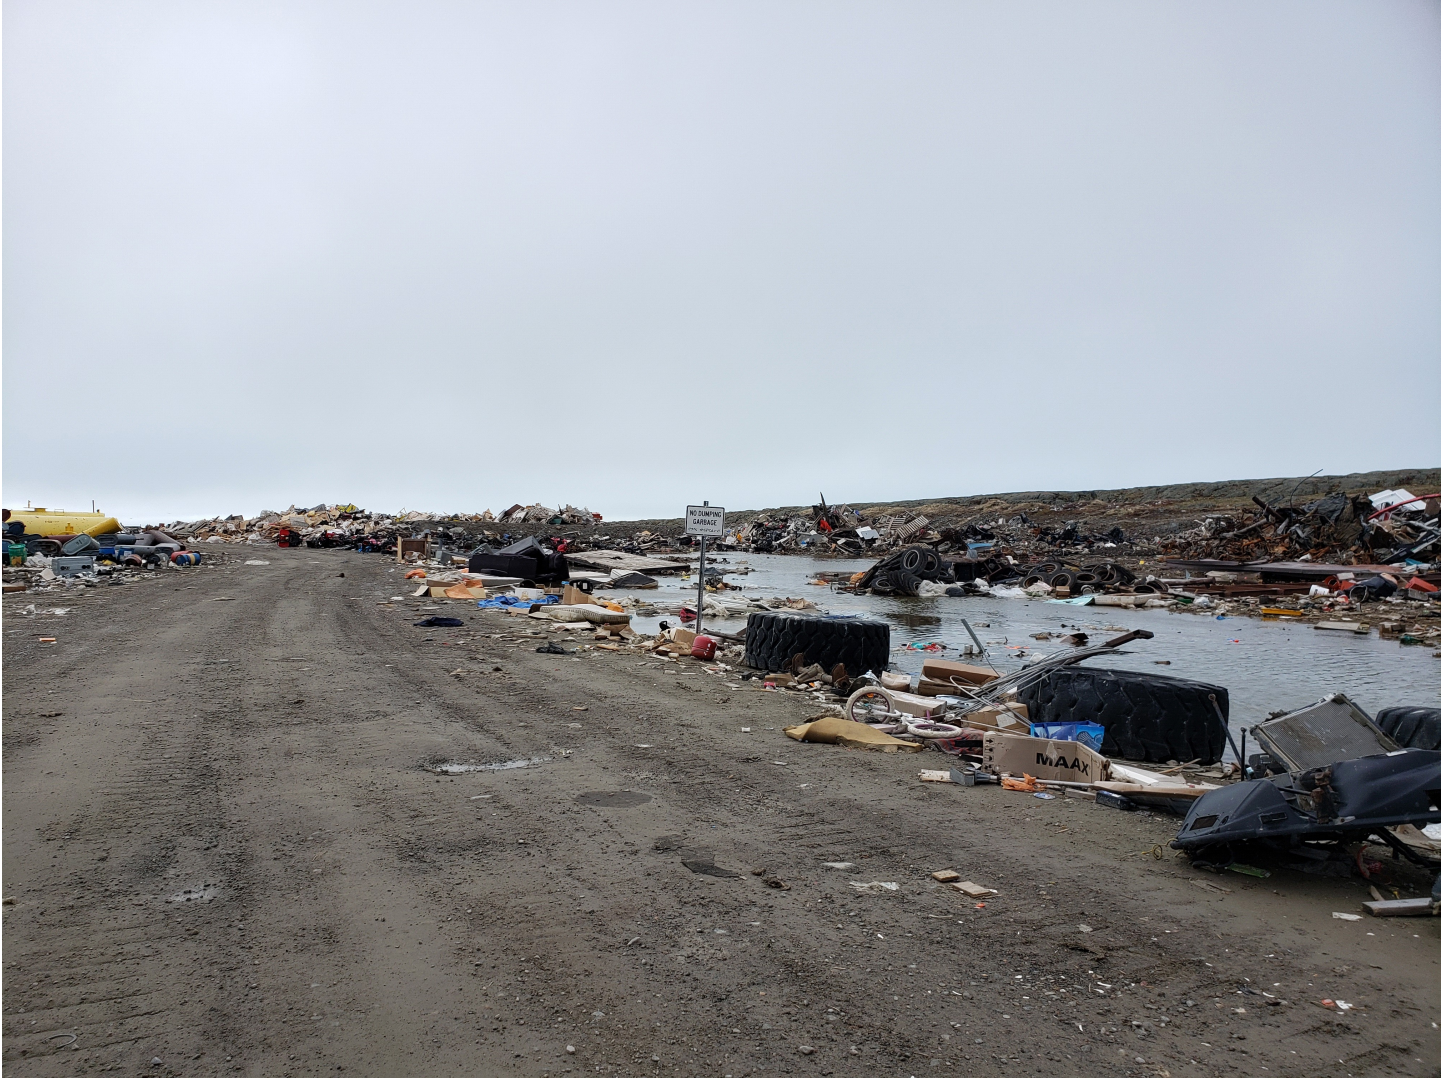
| PHOTO LOG | | | |
|--|---|---|---|
| Photo 2 | | Marked on provided map. | |

| PHOTO LOG | | | |
|--|---|---|---|
| Description: balk storage area, since inspection the land fill attendant have been working on segregation. | | | |

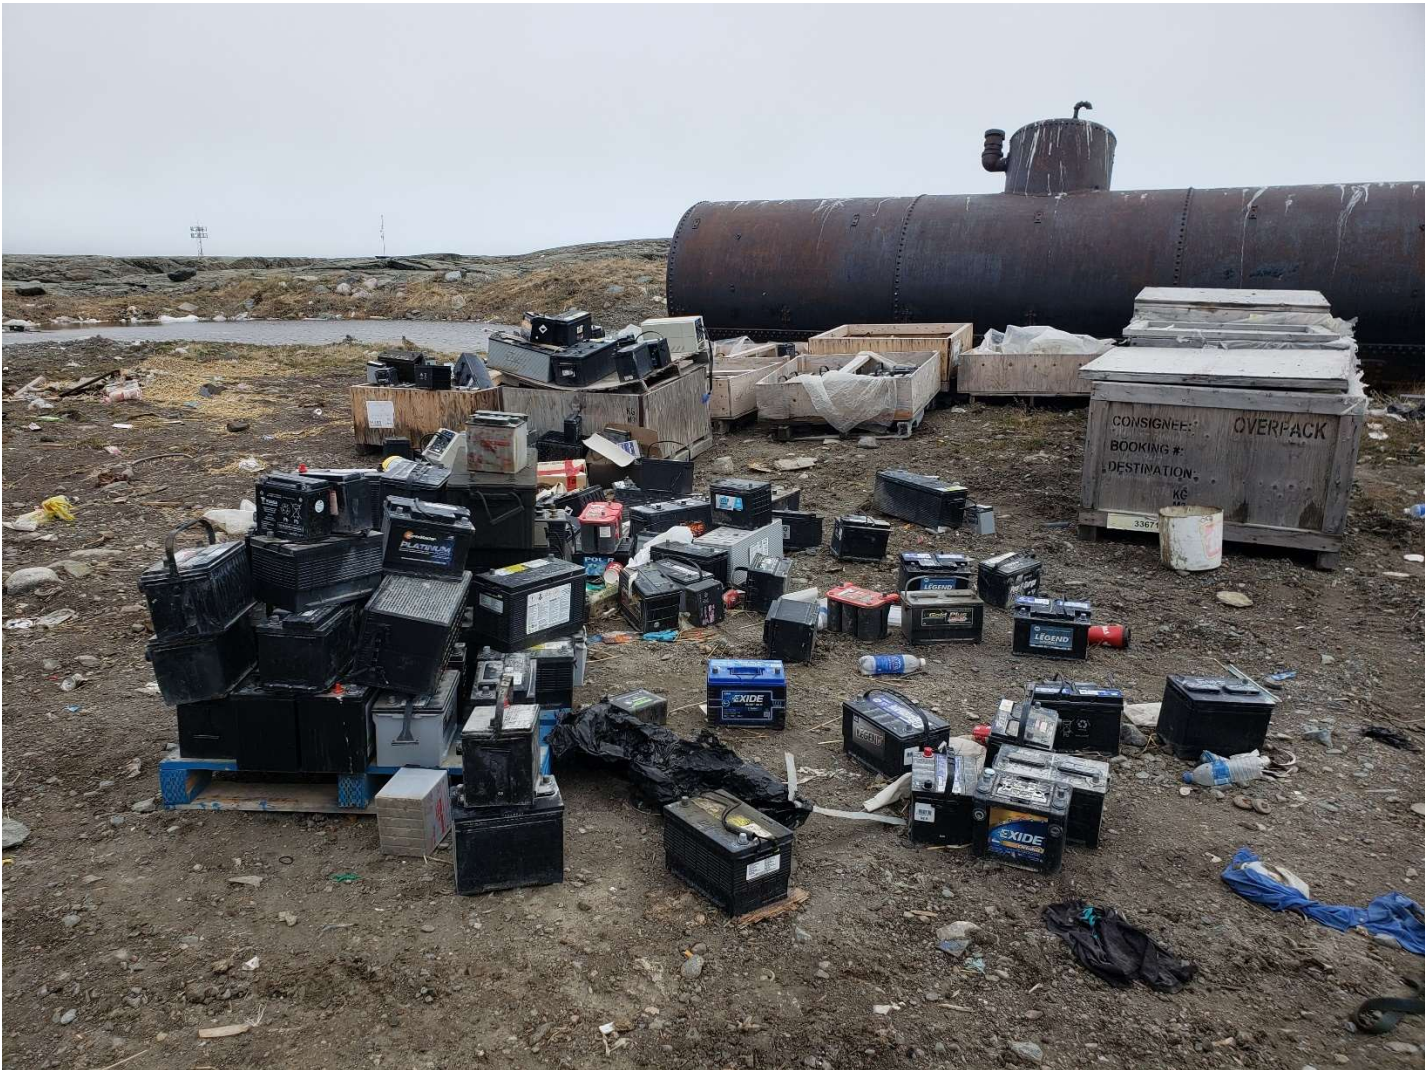
| PHOTO LOG | | | |
|---|---|---|---|
| Photo 3 | | | |

| PHOTO LOG | | | |
|---|---|---|---|
| Description: winter collection of discarded batteries to be stored. | | | |
