**WATER LICENCE INSPECTION FORM**☒ Original
☐ Follow-Up Report

Licensee	Licensee Representative
3BM-RAN2025	Darren Flynn
Licence No. / Expiry	Representative's Title
December 20, 2025	Senior Administrative Officer
Land Authorization No. / Expiry	Land Authorization Expiry
NA	NA
Date of Inspection	Inspector
August 18, 2022	WRO K AMSEL
Activities Inspected	
<input type="checkbox"/> Camp <input type="checkbox"/> Drilling <input type="checkbox"/> Mining <input type="checkbox"/> Construction <input type="checkbox"/> Reclamation <input type="checkbox"/> Fuel Storage <input type="checkbox"/> Roads/Hauling <input checked="" type="checkbox"/> Other: Solid Waste Disposal Facility <input type="checkbox"/> Other:

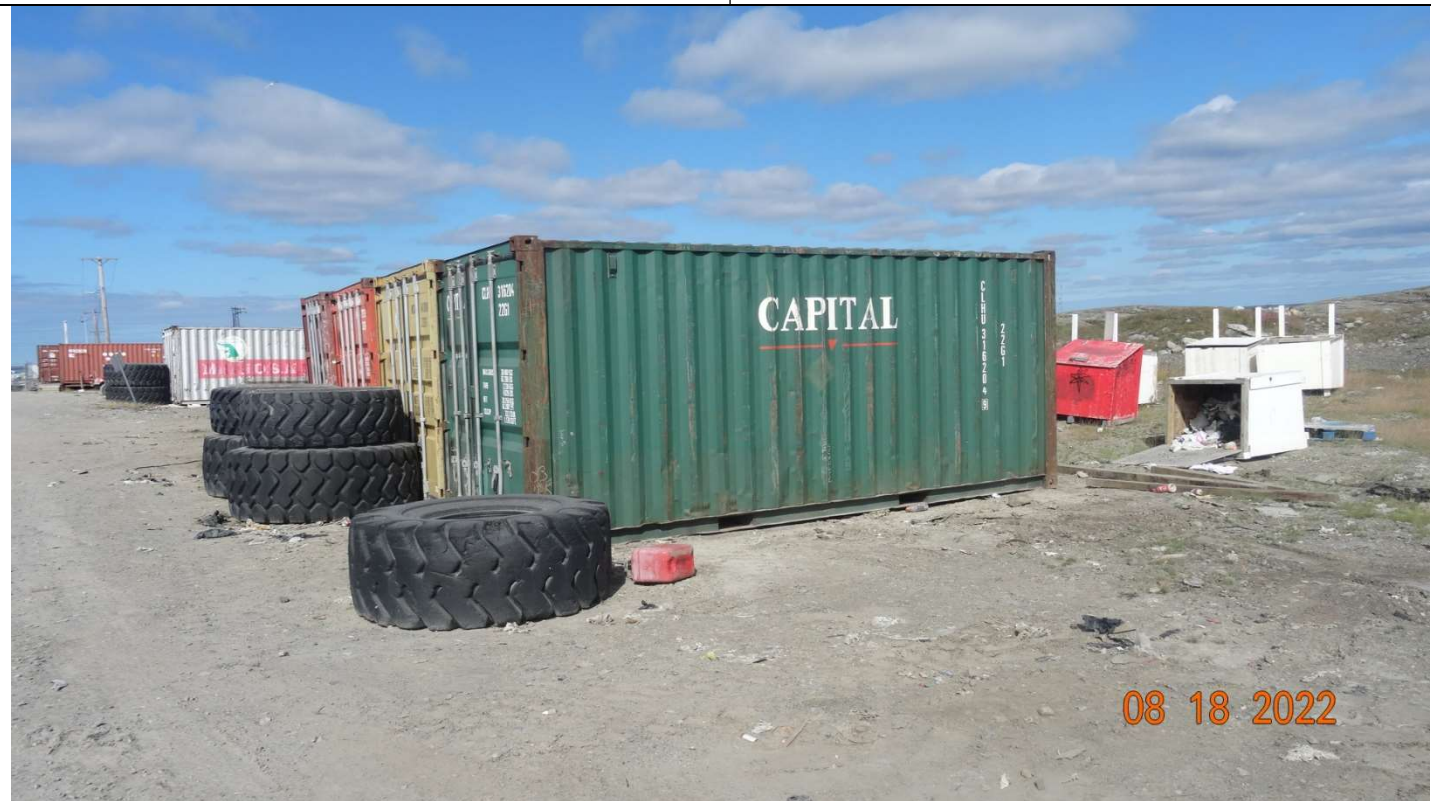
Photo 1	
---------	--

1. Solid and steel waste
 - a. 4 sea cans are present for the storage of propane cylinders, other compressed gas cylinders and batteries. The Inspector finds this is in compliance with Part D Item 4 of the Licence. (Photo 1).

Description:
Sea cans used for storage of batteries, compressed gas cylinders and propane cylinders.

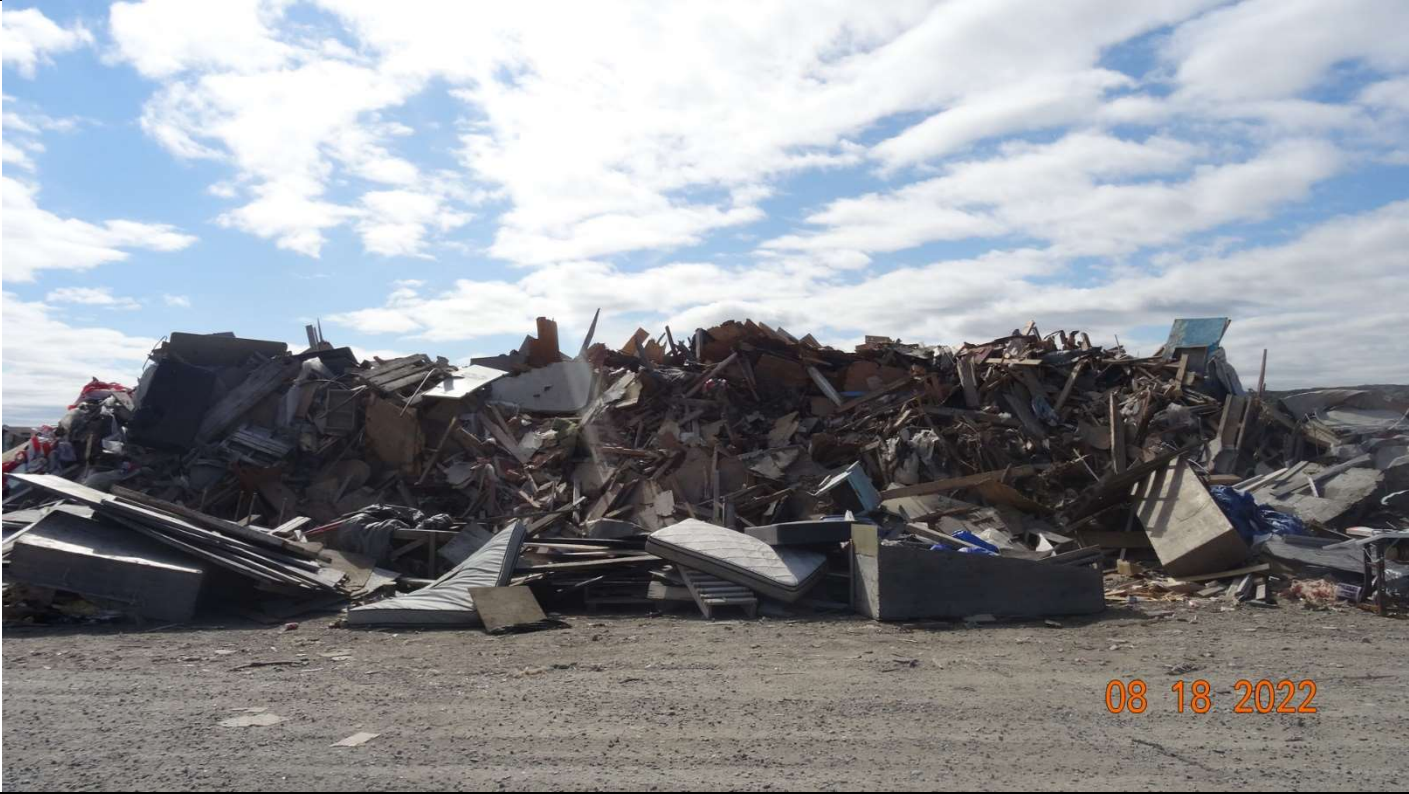
Date:	Authorization Number:	Camera/Model:	Inspector
August 18, 2022	3BM-RAN2025	Sony DSC-HX50V	WRO K Amsel
Photo No.	Lat/Long (DD.MM.SS.SS, NAD83)		
Photo 5

3. Wood area and burn area
 - a. A large pile of wood is present on the South side of the Facility. Representatives allow the pile to remain for a period of time to allow community members to recover any usable wood for construction projects or for wood stoves and bonfires. (Photo 5)

Description:			
Wood Pile.

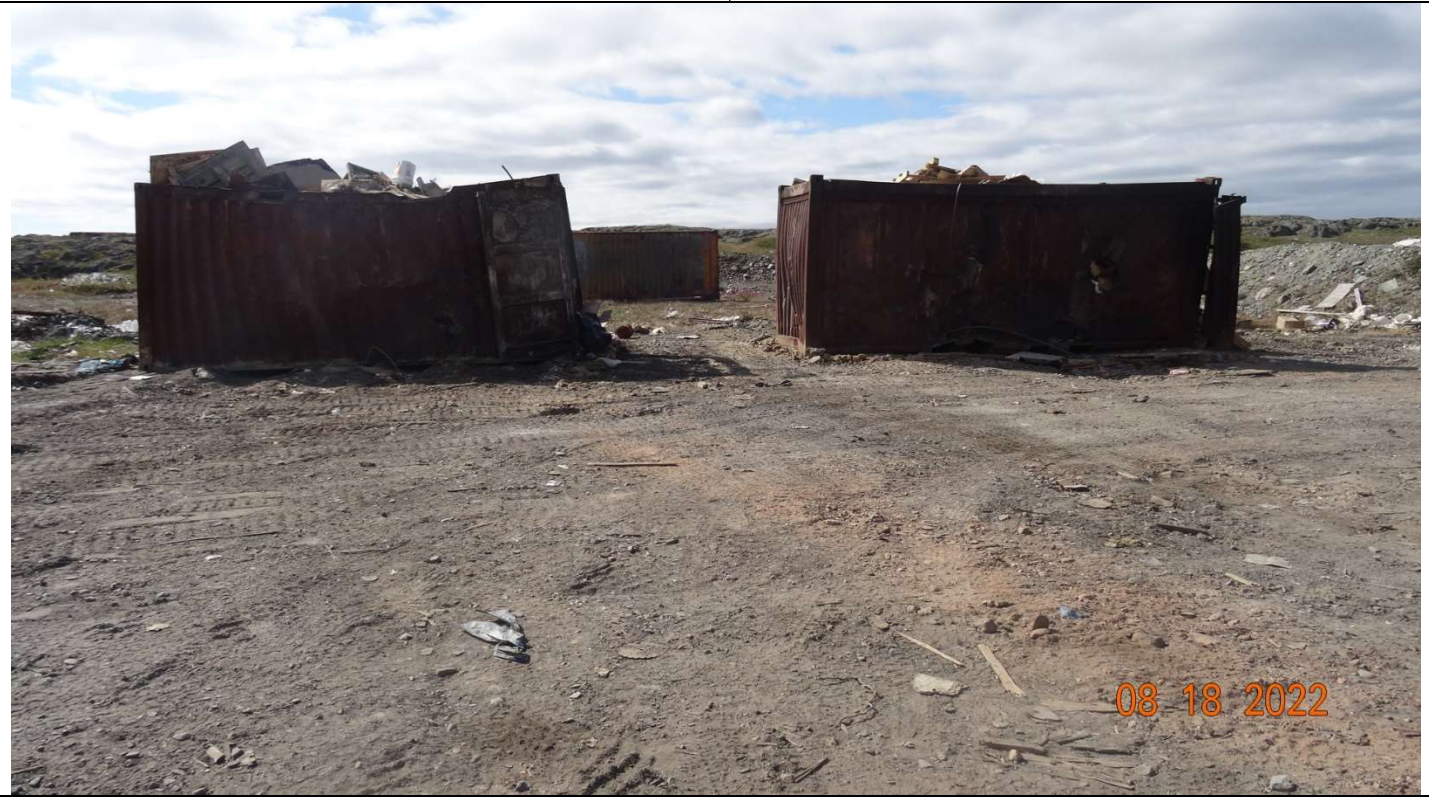
Date: August 18, 2022	Authorization Number: 3BM-RAN2025	Camera/Model: Sony DSC-HX50V	Inspector WRO K Amsel
Photo No. Photo 6		Lat/Long (DD.MM.SS.SS, NAD83)

- b. After salvageable wood is removed the remainder is burned in sea cans which are placed in an isolated area to prevent other items or parts of the Facility from catching fire. (Photo 6)

- c. During the inspection the sea cans had been packed with wood and were ready to be burned. The sea can was mostly packed with wood, however a plastic pallet and two 5 gal buckets were observed in the sea can as well. These items are easily segregated prior to burning and is not compliant with Part D Item 3 of the Licence.

Description: Wood burning bins.

- not open burn plastics, wood treated with preservatives, electric wire, Styrofoam, asbestos or painted wood
- Prepare signage and notify Inspector a suitable time and date, to install the signage at the new location for RAN-2
