**Re: Resolute Bay Application - background information**

# Volume 1 - Utilidor Upgrade

**Volume 1 - Utilidor Upgrade**  
Resolute Bay, NT

Public Works & Services,  
Government of the Northwest Territories

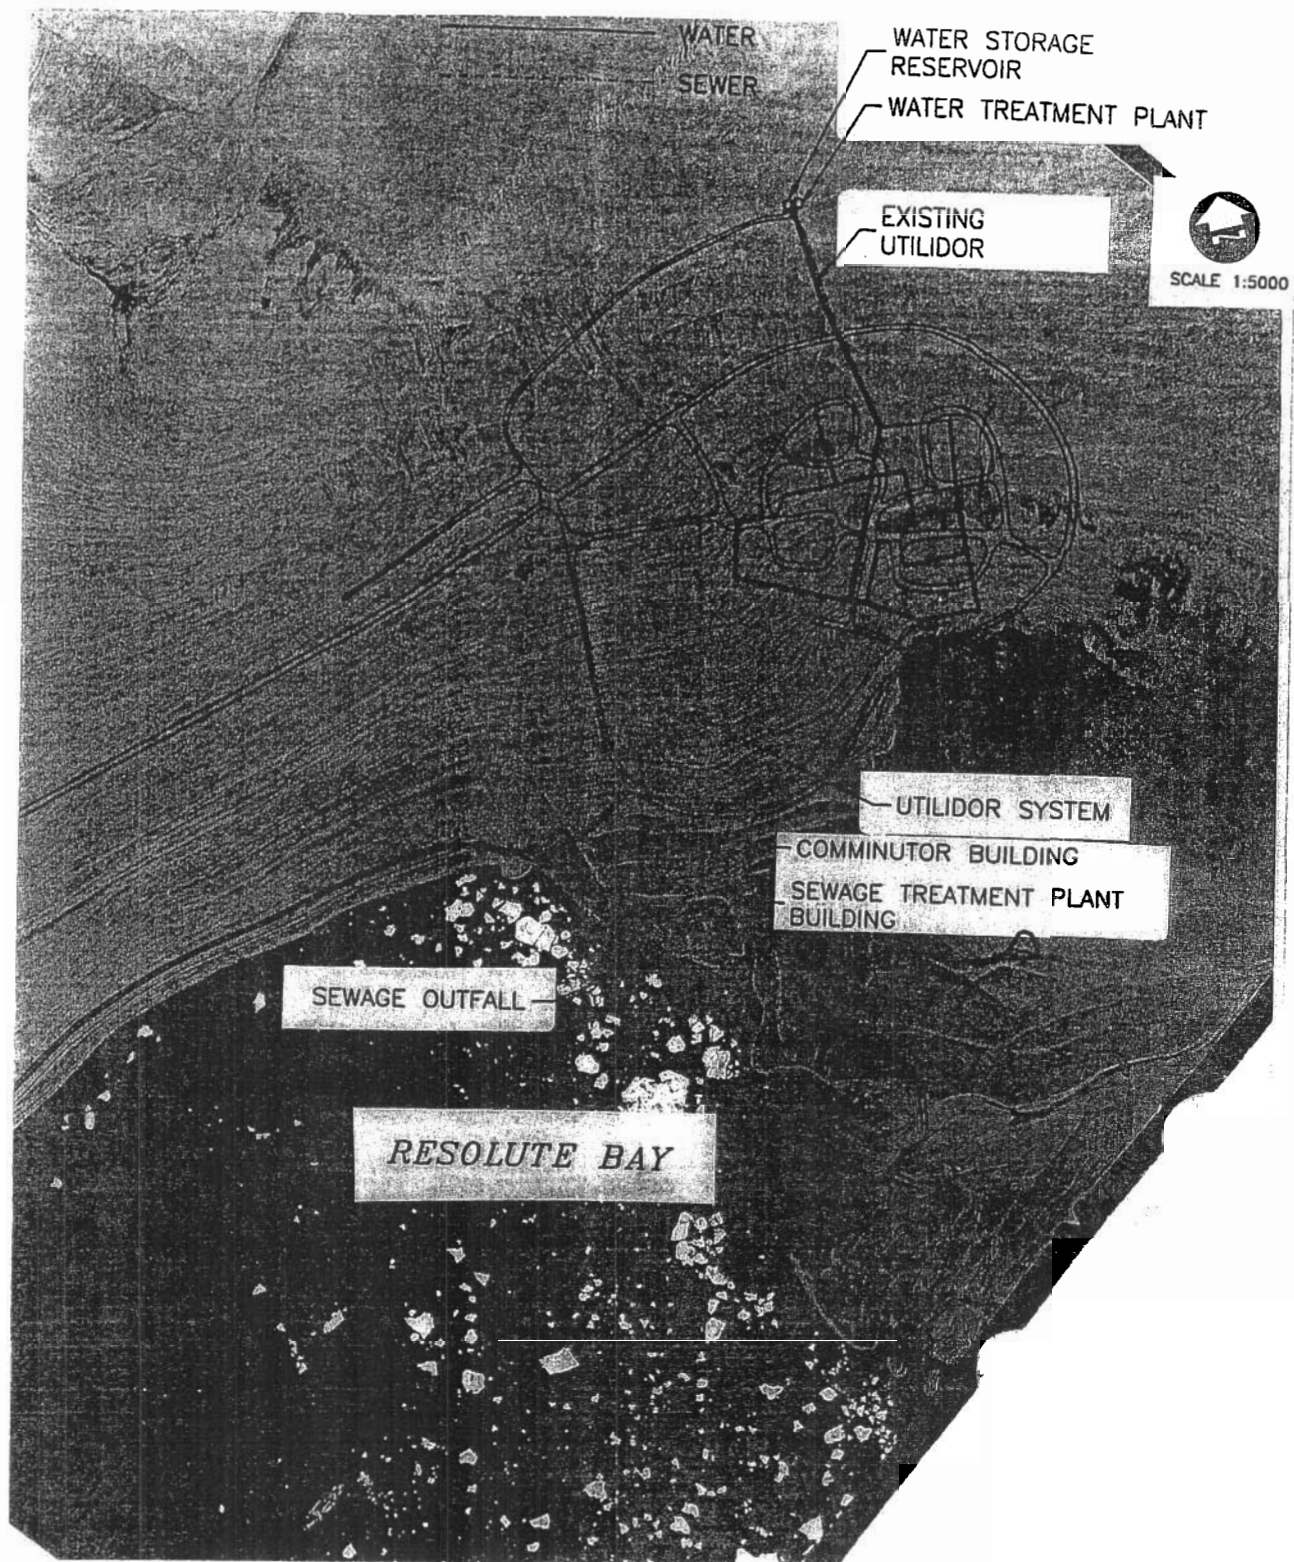
The DPW&S Maintainer provided a description of the repairs that have been made to the utilidor system over the years. In total 12 repair clamps have been installed on the main system. Ten of the repair clamps have been installed on the water mains and two on the sewer mains. The Maintainer, Mr. Neil MacDonald, has been in Resolute Bay since 1986. The exact years of the repairs are not recorded; however, he provided an indication of which repairs occurred prior to his arrival in the community. Further, he indicated that there were no repairs completed on the mains in the first five years of his service in the community. The following is a list of the locations of the repair clamps as noted by the DPW&S Maintainer. The approximate location of the breaks is shown in **Figure 3.2.1**.

From	To	Distance	Comments
AV21	AV30	6 m from AV21	Watermain, repair clamp, prior to 1986, split in pipe
		18 m from AV21	Watermain, repair clamp, prior to 1986, split in pipe
		6 m from AV21	Sewermain, repair clamp, since 1991, collapsed pipe
		18 m from AV21	Sewermain, repair clamp, since 1991, collapsed pipe
AV30	AV29	12 m from AV30	Watermain, 600 mm long repair clamp over a 500 mm long split in pipe, since 1991
AV3	AV2	Mid point	Watermain, prior to 1986
AV4	AV5	At AV 4	Watermain pipe flange broke in AV. Replaced with new 2.5 meter section of pipe and repair clamp installed 2.5 m from AV, since 1991
AV10	AV11	At AV10	Watermain pipe flange broke in AV. Replaced with new 2.5 meter section of pipe and repair clamp installed 2.5 m from AV, since 1991
AV9	AV10	9 m from AV 9	Watermain, approx. 400 mm split, since 1991
		18 m from AV 9	Watermain, approx. 400 mm split, since 1991
AV5	AV6		Watermain, small crack 50 mm to 75 mm long, since 1991

AV27	AV28	At 90 bend	Watermain, small split, since 1991
AV20	AV22		Frozen due to no flow condition and is reported to be a result of the pit orifice system.

The utilidor was constructed over phases known as Stage 1A and Stage 1B. The limits of each year's construction is shown on Figure 3.2.1. Stage 1A was completed in 1977, and Stage 1B was completed in 1978. All the repair clamps have been placed on piping installed under the Stage 1A phase of the work. Sewermain settlement would appear to be more predominant in the Stage 1B area, but it does appear in both stages.

Though the cause of the pipe failures can not be determined with certainty, it is most likely that the failures were due to ground water flow, and the stresses placed on the pipes due to the freeze action of the ground water which creates ground movements.

In Resolute Bay there are 2 links that meet the above values for replacement. These are from AV21 to 30 m past AV30 and AV8 to AV10. These repairs would cover 8 of the 12 recorded breaks. These sections should take priority over other pipe replacement sections.
