DRAFT Resolute, Nunavut Dump Site Investigation
Hamlet of Resolute, Nunavut

Project No. 003-GNCGS

The Government of Nunavut
Department of Community and Government Services

September 5, 2008

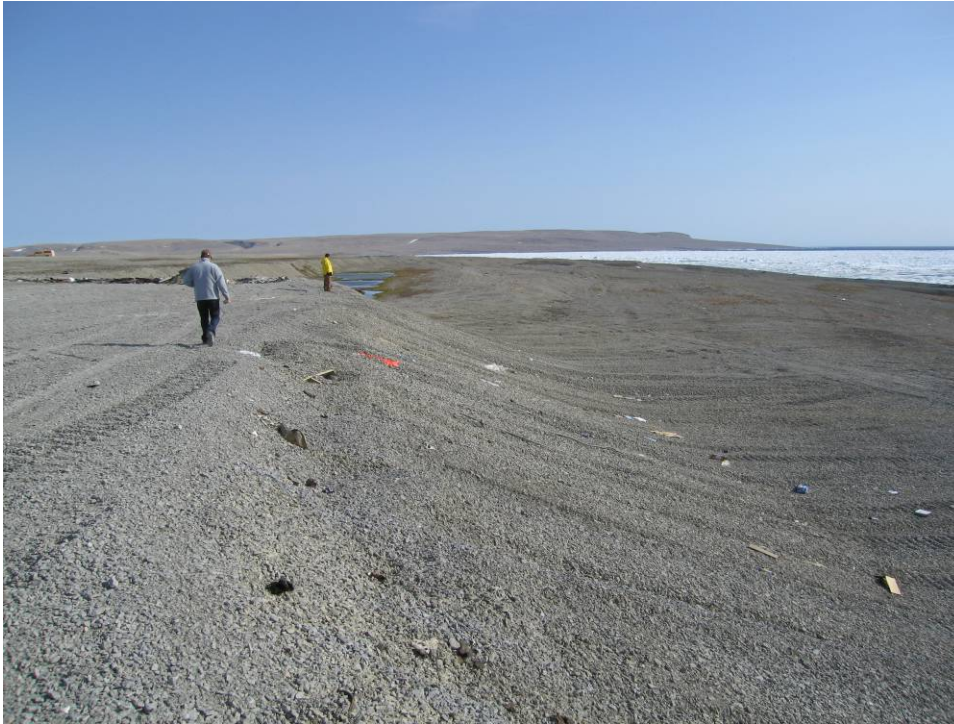
Figure 3: Photograph of recently covered and graded existing municipal dump site from perspective along top of the waste pile. Note recently burned waste piles in the foreground.

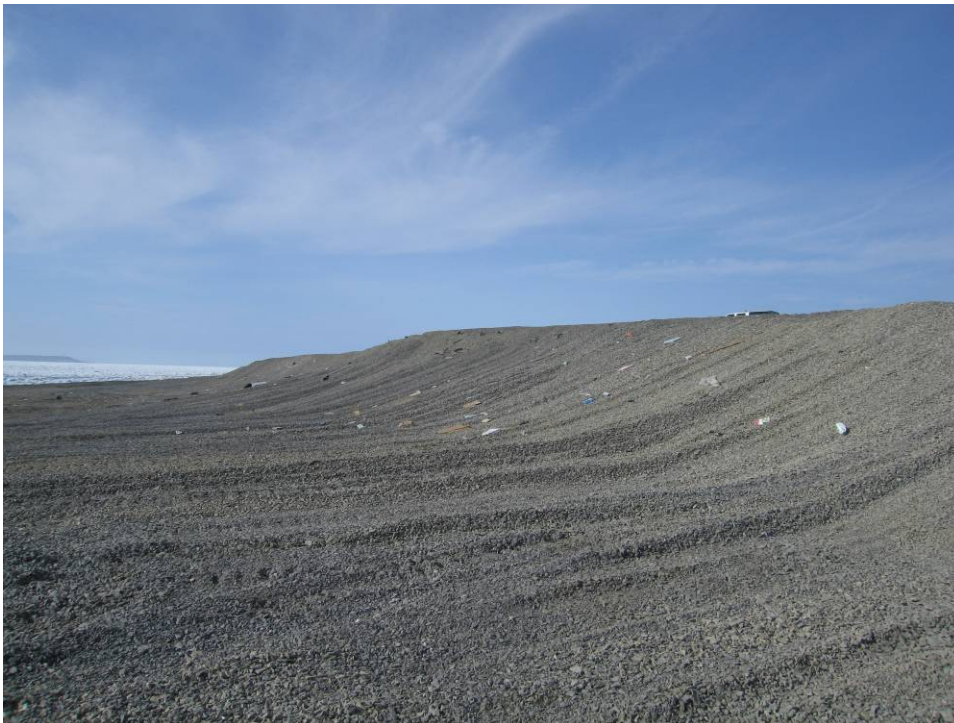
Figure 4: Photograph of recently covered and graded existing municipal dump site from perspective at base of waste pile slope.

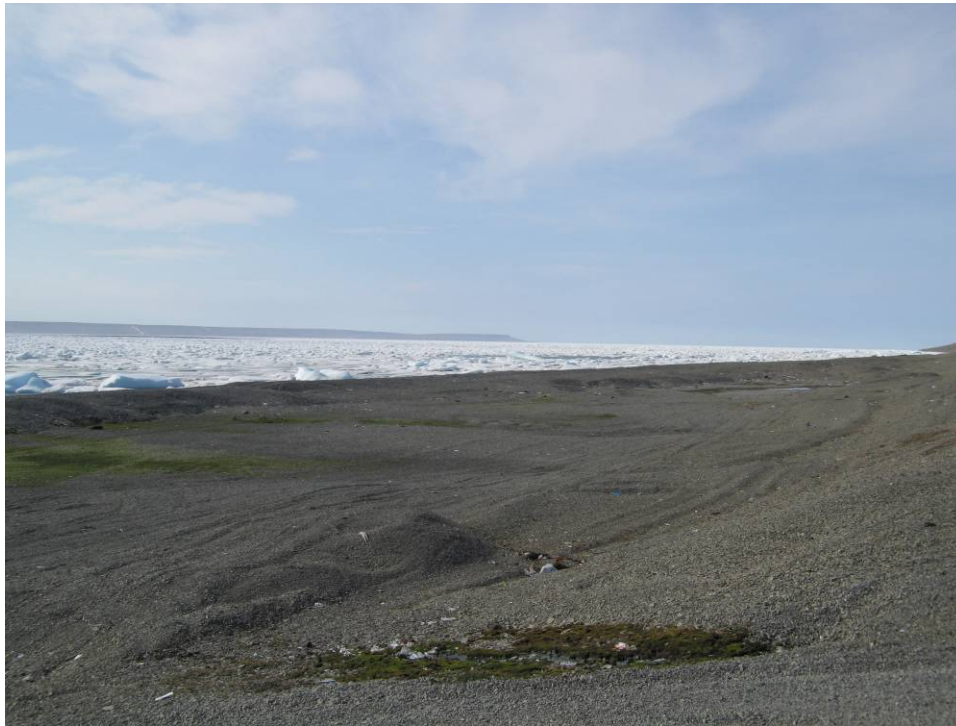
Figure 5: Photograph of ground surface between existing municipal dump site and ocean from perspective at base of municipal dump site.

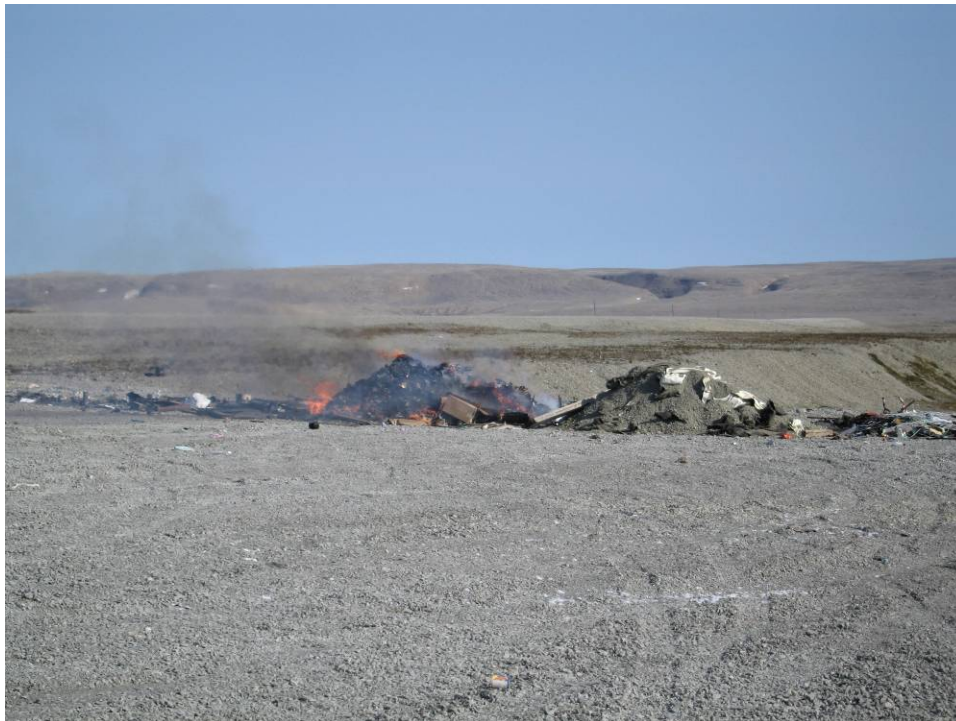
Figure 6: Photograph of recently burned waste pile.

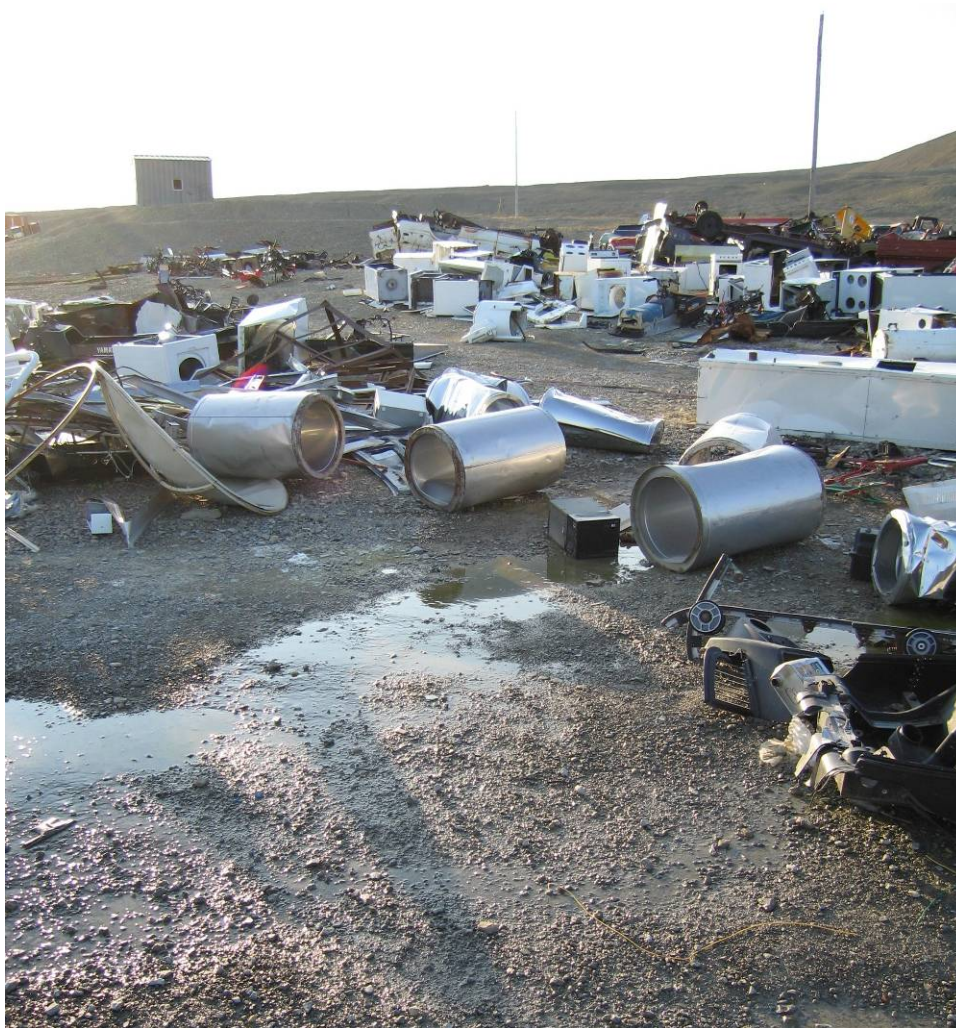
Figure 9: Photograph of groundwater seep exiting the miscellaneous bulky metals site.

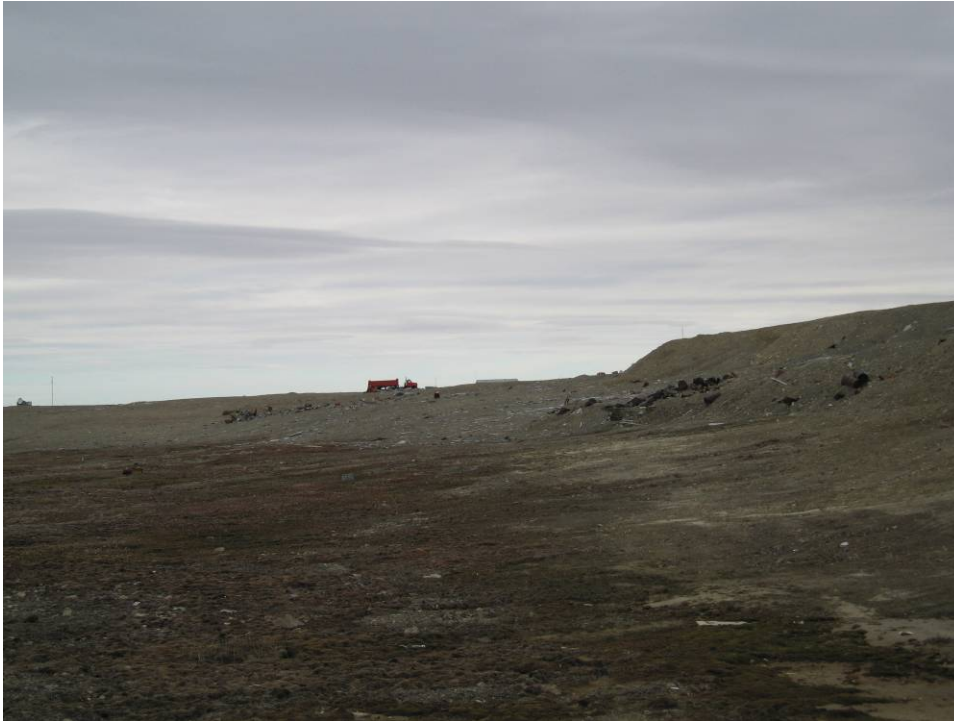
West of airport road within the vicinity of the industrial buildings, miscellaneous bulky metals waste was observed to be end dumped over a ridge. The ridge is about 150 m west of airport road and has a drop in topography of about 10 to 20 m. Items appeared to be mainly barrels with miscellaneous metals. It is unknown if there is buried waste along this ridge. Figure 10 and 11 provide photographs of the bulky metals along the ridge. From the surveyed maps provided by the GN, this land is within the airport property.

Figure 10: Photograph of bulky metals end dumped over ridge adjacent to airport.

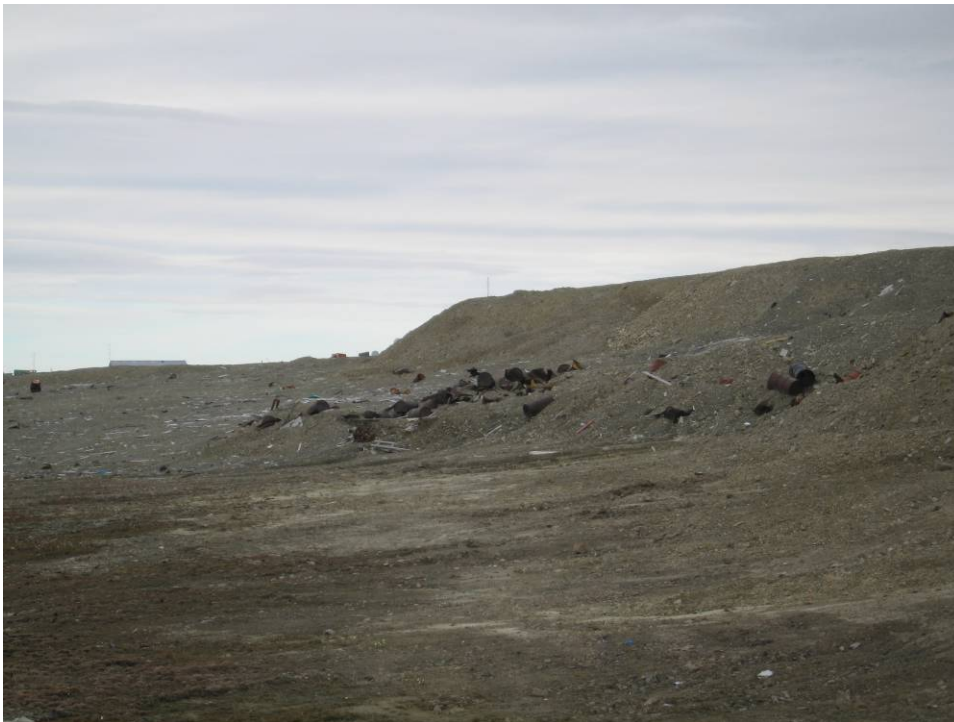
Figure 11: Photograph of bulky metals end dumped over ridge adjacent to airport.

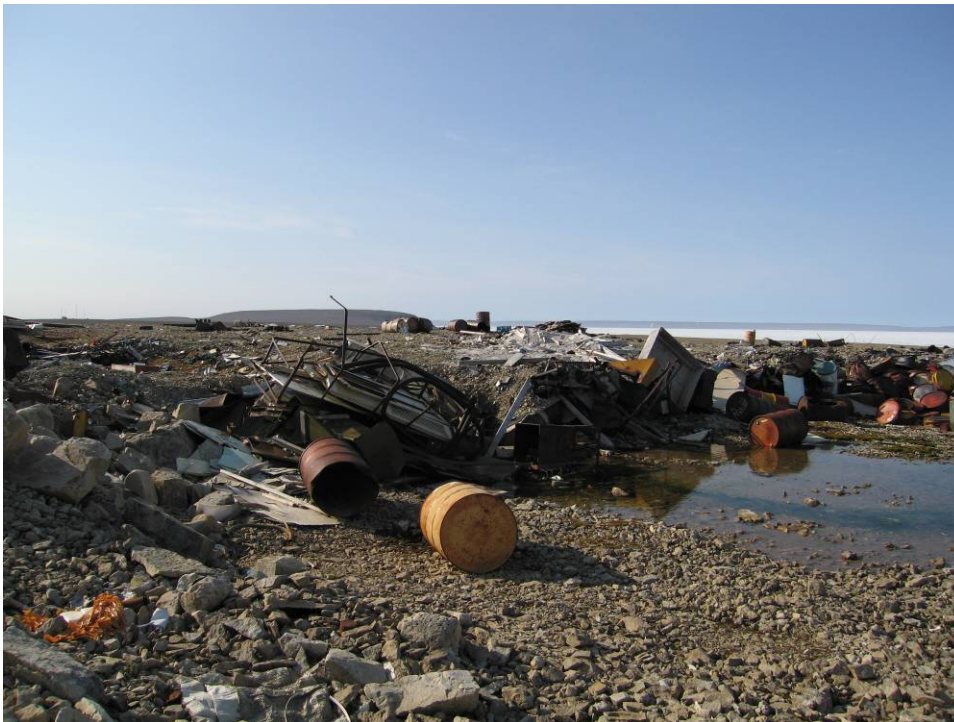
Figure 17: North side of existing BMDS and pooled water.

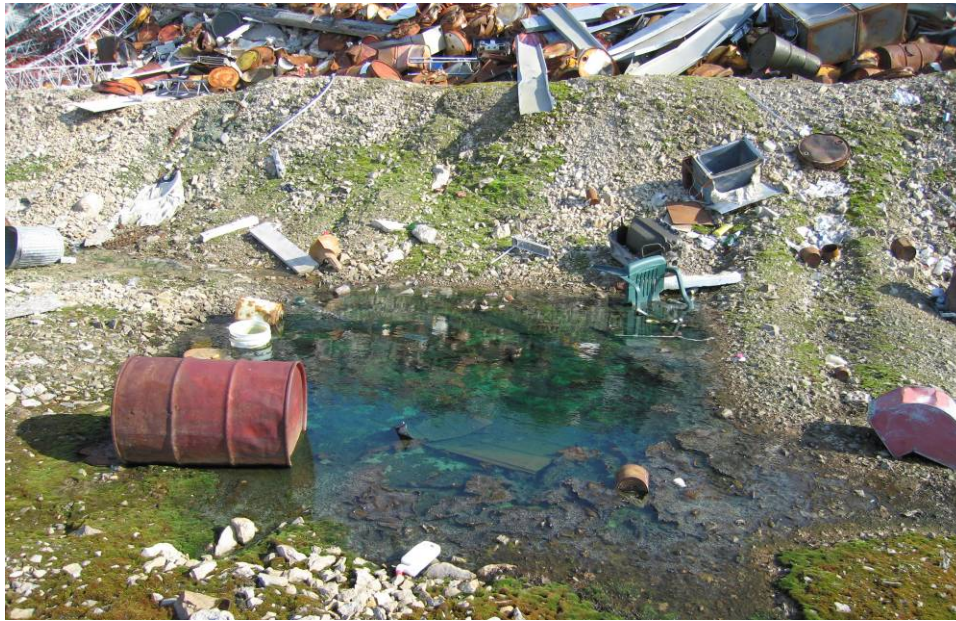
Figure 22: Blue colour pond adjacent to existing BMDS perimeter berm.

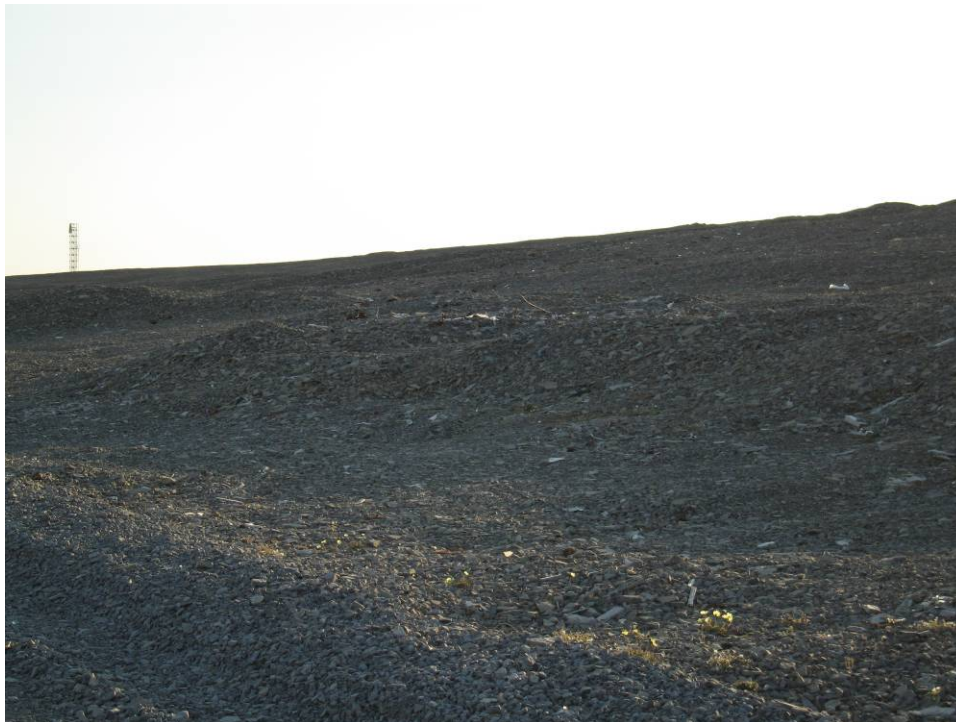
- ii. Along the north shore of Resolute Bay, waste and bulky metal waste was day-lighting through the as-placed gravel cover. From discussion with community members, this shore is a location of buried military waste. Figures 24 and 25 provide photographs of Resolute Bay and the buried waste along its shore.

Figure 25: Photograph of waste materials day-lighting from gravel-cover along shore of Resolute Bay, looking east.

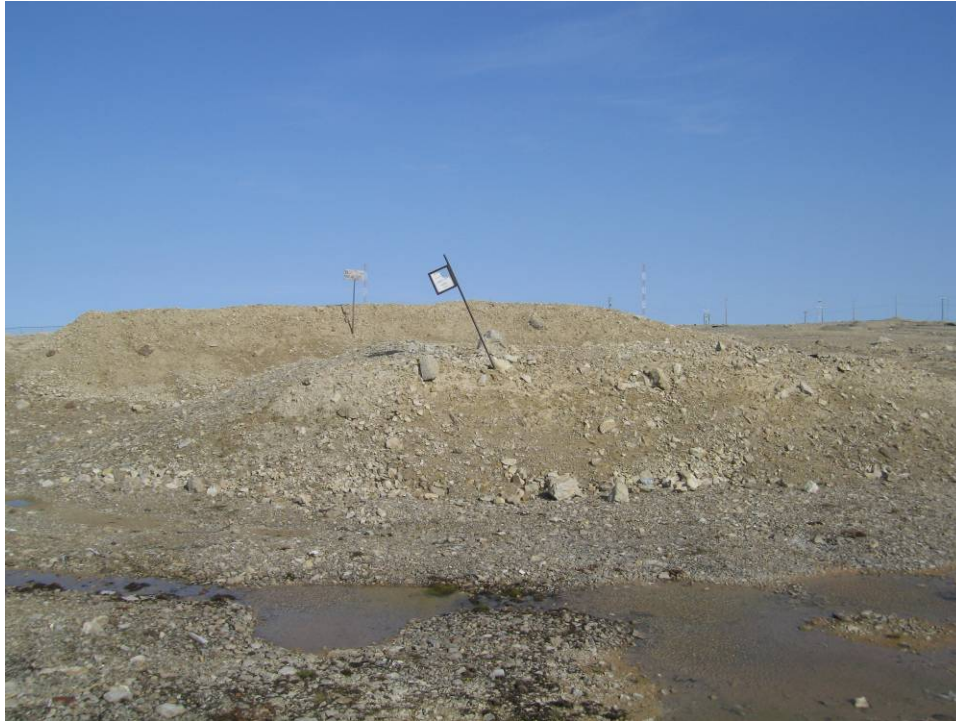
- v. Adjacent to the south-east corner of the proposed MDS there is a sign that marks a burn waste pile with dimensions of about 4 m x 10 m x 3 m. From visual inspection, the burn waste is covered with pit run gravel. No attempts were completed to assess cover thickness. No controls or safeguards were provided around the piles to limit site drainage or restrict public access for safety. Figure 26 depicts the burn waste pile and asbestos pile.

- vi. Adjacent to the burn waste pile near the south-east corner of the proposed MDS, there is a sign that marks an asbestos pile. The asbestos pile is about 3 m x 10 m x 2 m in size. From visual inspection, the asbestos is covered with pit run gravel. No attempts were completed to assess cover thickness. No controls or safeguards were provided around the piles to limit site drainage or restrict public access for safety. Figure 26 depicts the burn waste pile and asbestos pile.

Figure 26: Photograph of burn waste (background) and asbestos piles (foreground).

- vii. Separate of hazardous materials from bulky waste and municipal waste.
- viii. Appropriately dispose of hazardous materials, such as asbestos and burn ash.

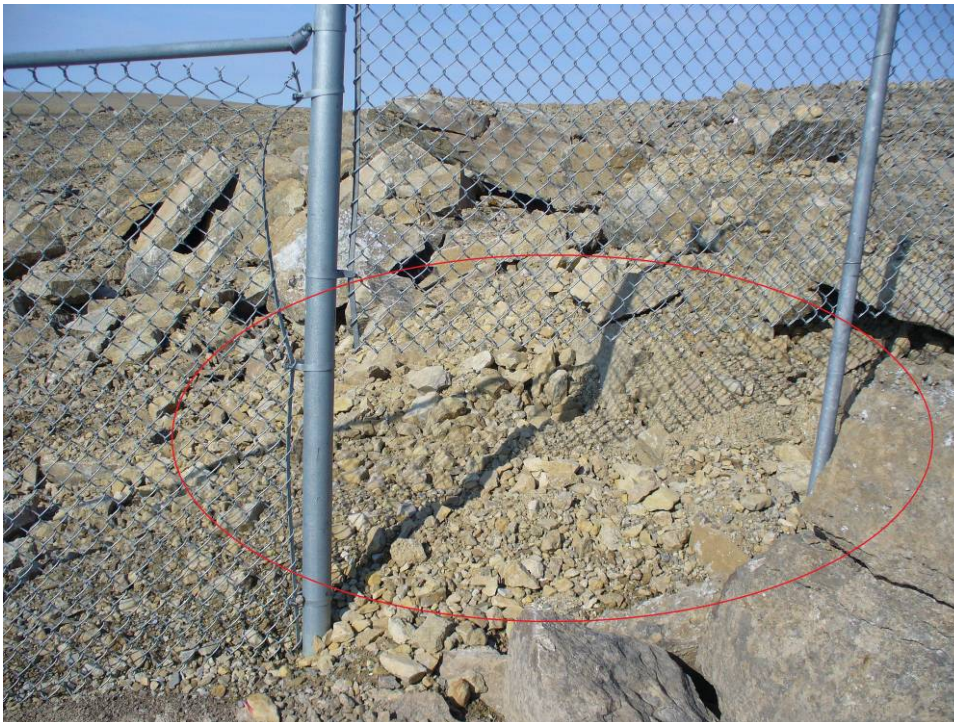
- ii. The maximum 50 mm spacing between grade and bottom of chain link indicated on the drawing could not be achieved everywhere due to the terrain, resulting in significant localized gapping at the underside of fence (refer to Figure 34).

Figure 34: Gapping at base of fence based on terrain.

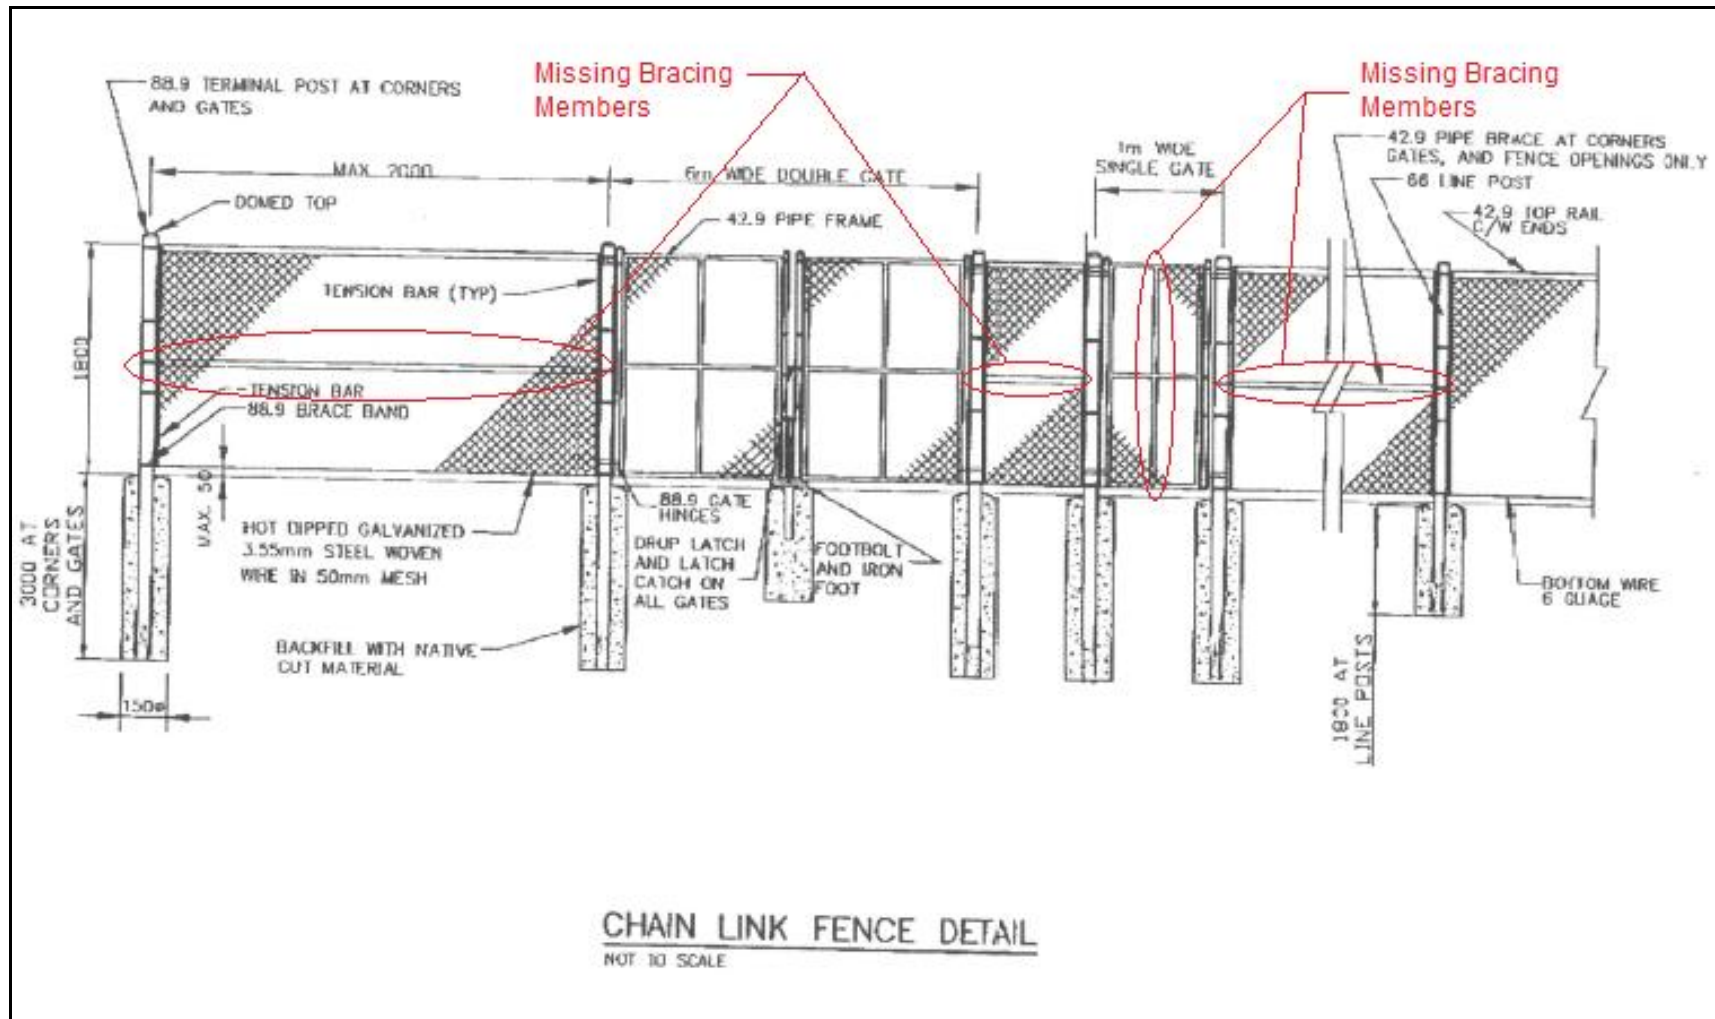
- iii. A vertical bracing member in the pedestrian door was not in place (refer to Figure 35).
- iv. Horizontal bracing members adjacent to gate and door shown on the drawing were not in place (refer to Figure 35).

Figure 35: Drawing showing missing bracing members at gates.

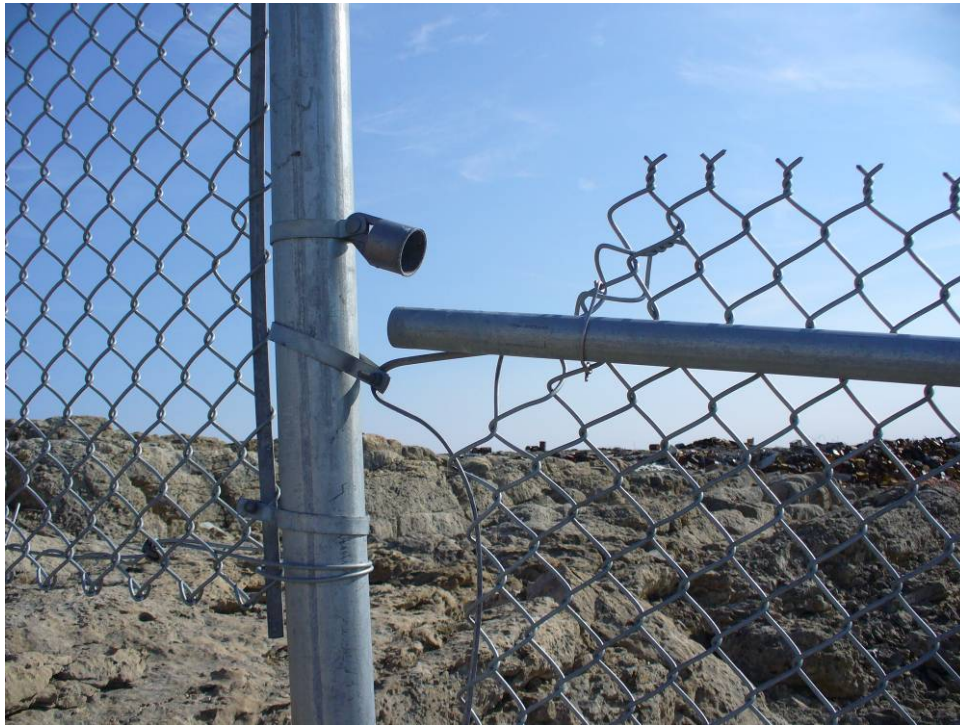
- v. Tension bars were found to be deformed (refer to Figure 36).
- vi. Disconnected top rail to 88.9 mm posts noted (refer to Figure 36).
- vii. Some domed tops for main 88.9 mm dia. post members were missing allowing water into the centre of the posts.

Figure 36: Top rail connection, disconnected.

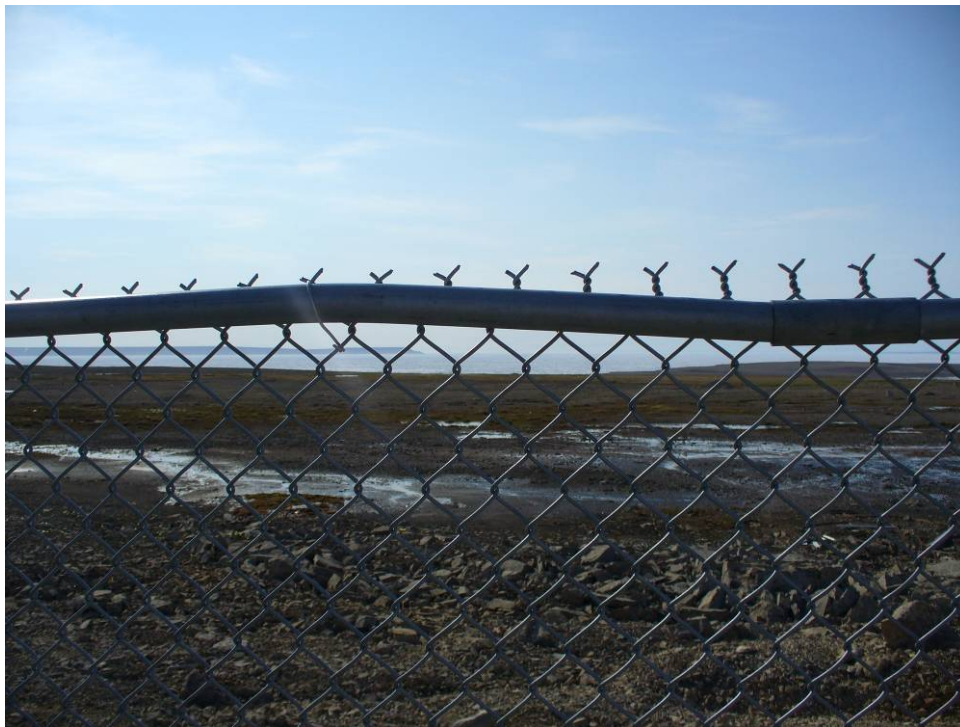
- viii. Bent top rail noted (localized; refer to Figure 37).
- ix. Disconnected top rail noted (localized; refer to Figure 38).
- x. Single top rail to intermediate post connection found to be disconnected (localized; refer to Figure 39).

Figure 37: Localized bent top rail.

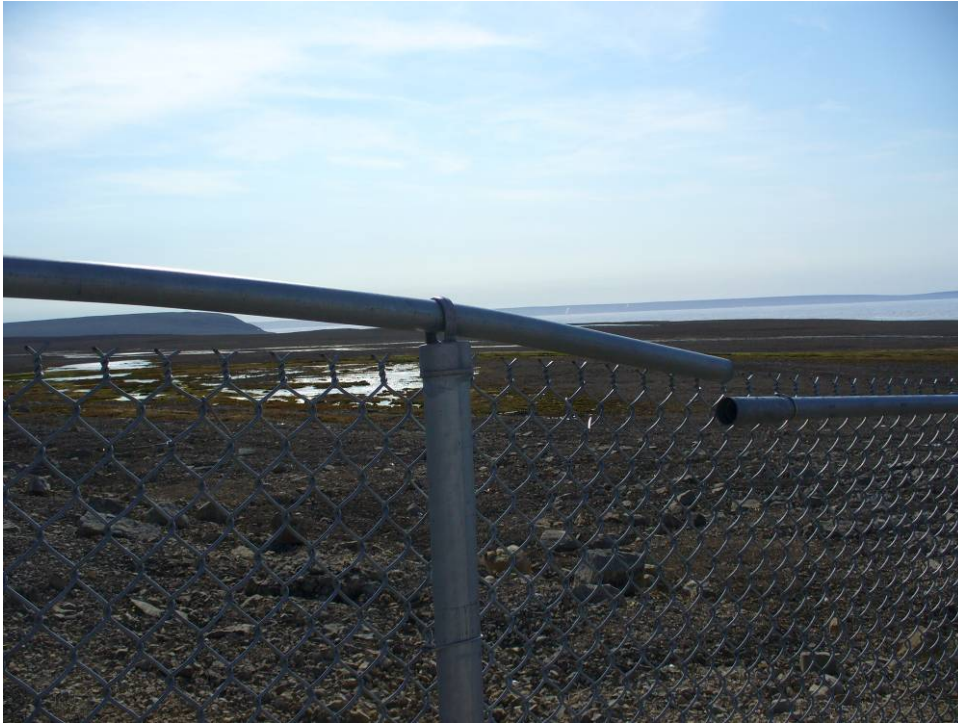
Figure 38: Localized disconnection of top rail at top rail sleeve.

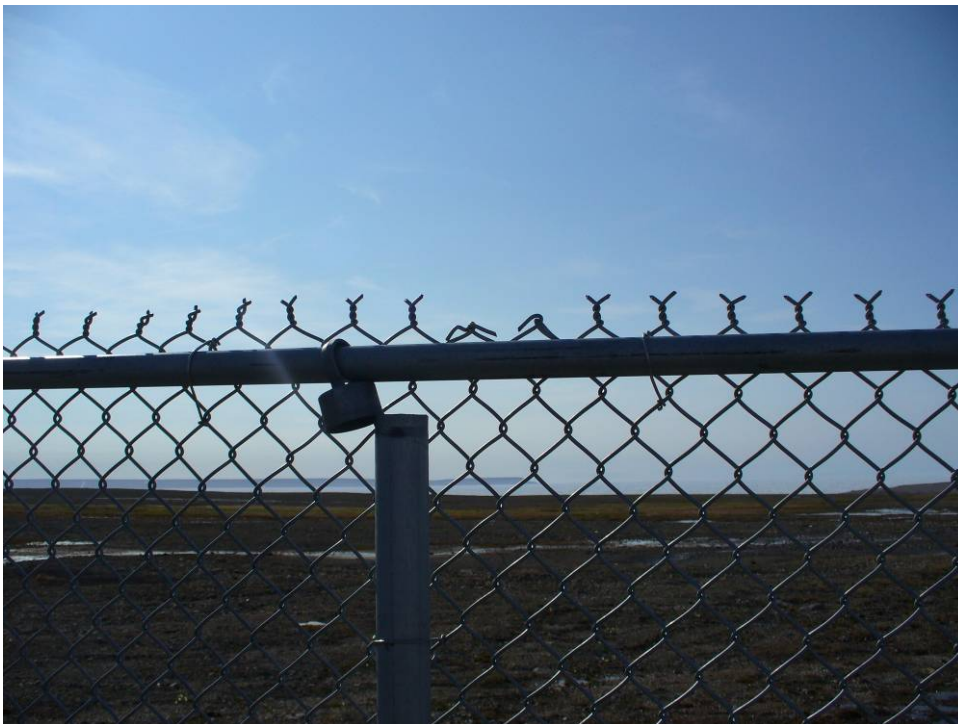
Figure 39: Disconnect top rail to line post at top of post.

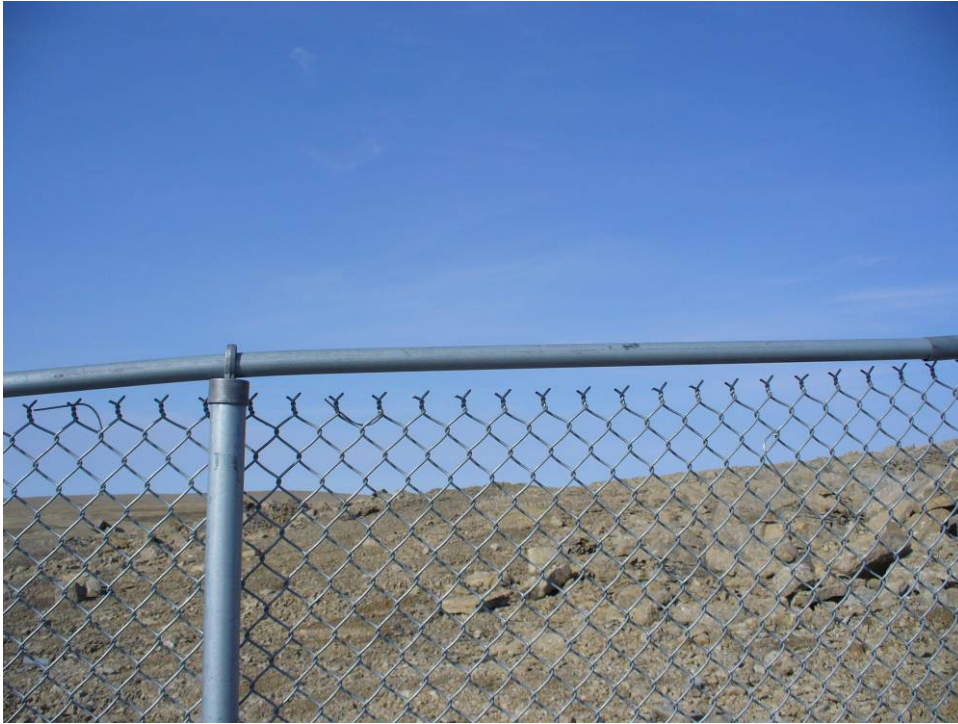
- xi. Chain link short from top rail noted at north side (localized; refer to Figure 40).
- xii. Single location where horizontal brace should be added at north-east corner along road (localized; refer to Figure 41).

Figure 40: Chain link short from top rail.

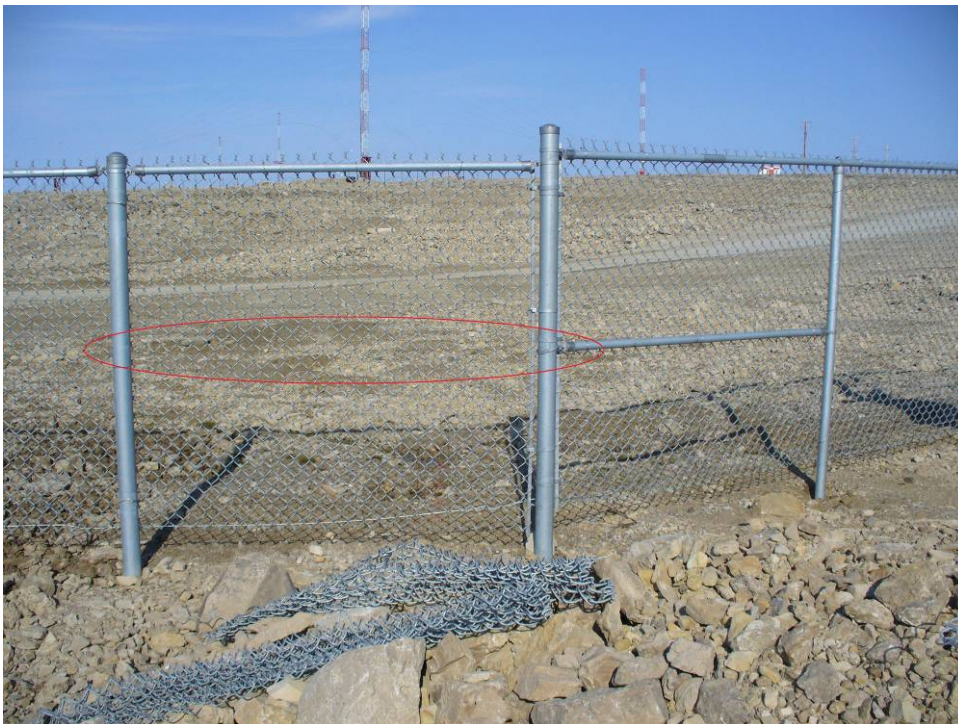
Figure 41: Potential location for addition of new bracing member.

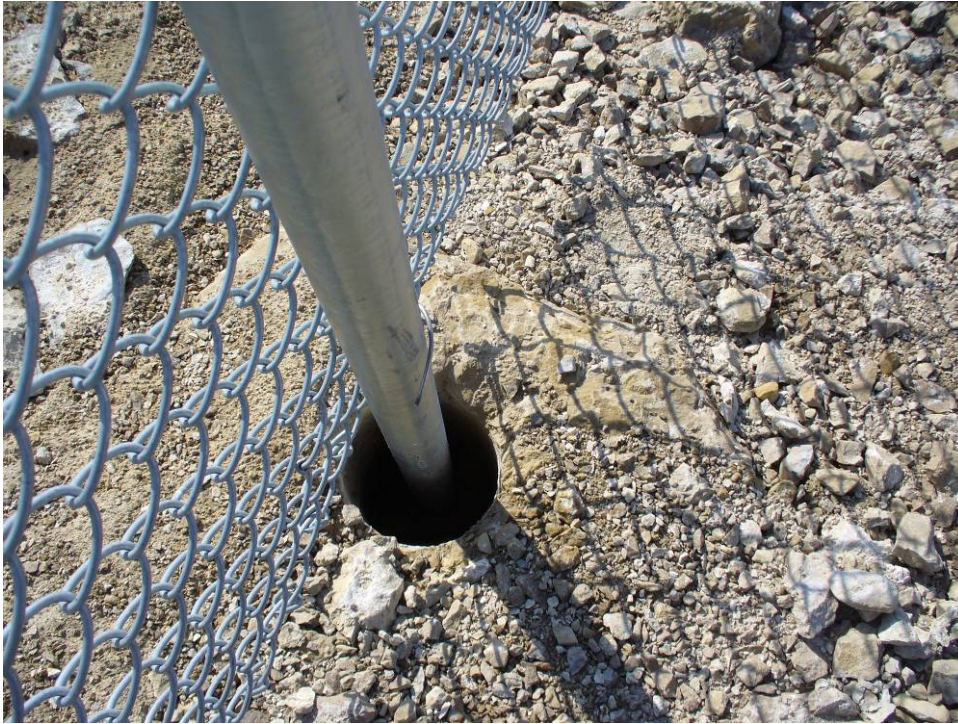
- xiii. Some of the drilled holes for the existing posts were not completely backfilled (refer to Figure 42).

Figure 42: Drilled and embedded post lacking backfill to top of hole.
