**Resolute, Nunavut Dump Site Investigation Hamlet  
of Resolute, Nunavut**

**Project No. 003-GNCGS**

**The Government of Nunavut  
Department of Community and Government Services**

September 5, 2008

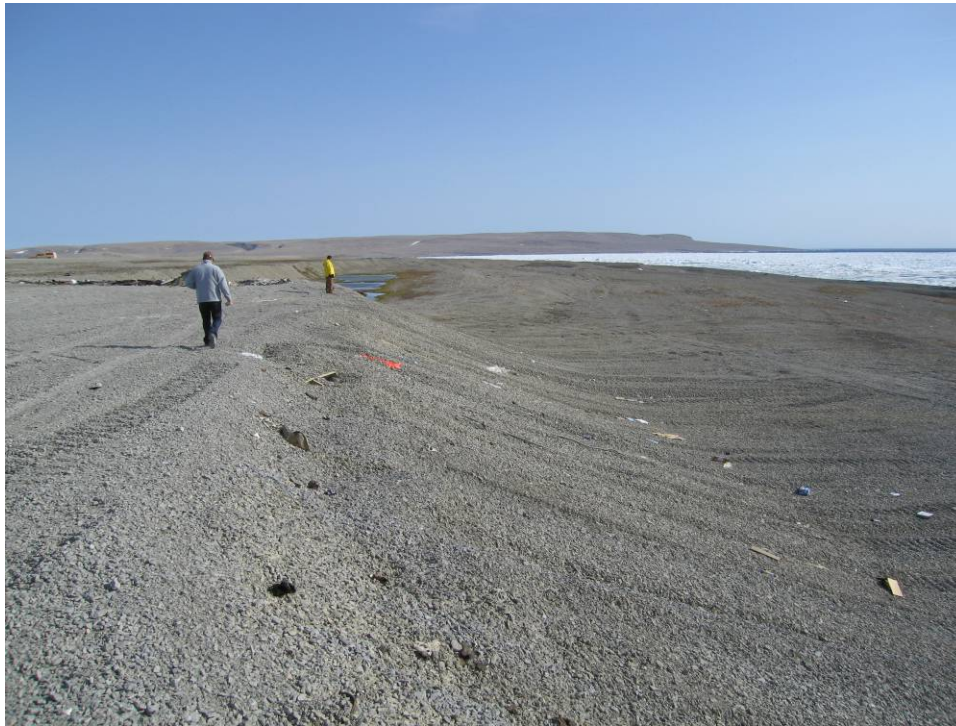
Figure 3: Photograph of recently covered and graded existing municipal dump site from perspective along top of the waste pile. Note recently burned waste piles in the foreground.

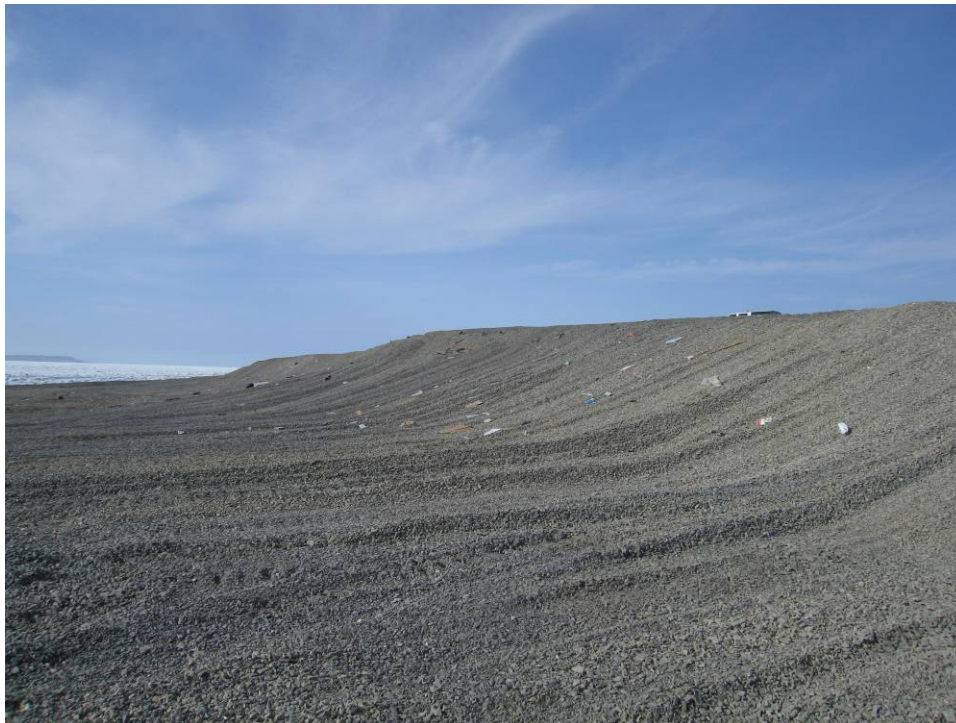
Figure 4: Photograph of recently covered and graded existing municipal dump site from perspective at base of waste pile slope.

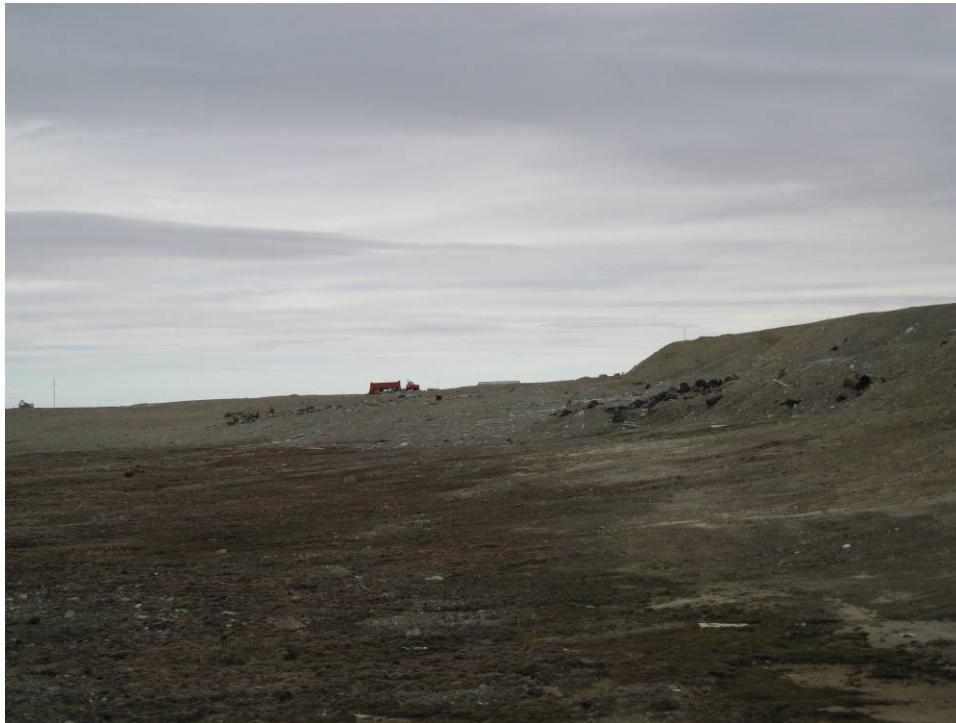
West of airport road within the vicinity of the industrial buildings, miscellaneous bulky metals waste was observed to be end dumped over a ridge. The ridge is about 150 m west of airport road and has a drop in topography of about 10 to 20 m. Items appeared to be mainly barrels with miscellaneous metals. It is unknown if there is buried waste along this ridge. Figure 10 and 11 provide photographs of the bulky metals along the ridge. From the surveyed maps provided by the GN, this land is within the airport property.

Figure 10: Photograph of bulky metals end dumped over ridge adjacent to airport.

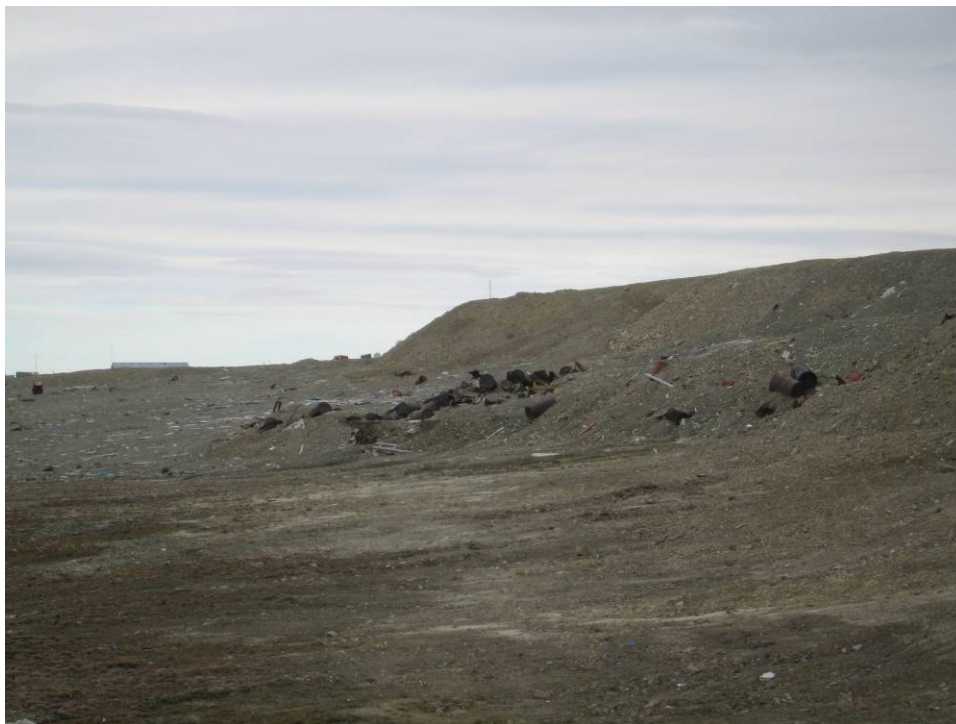
Figure 11: Photograph of bulky metals end dumped over ridge adjacent to airport.

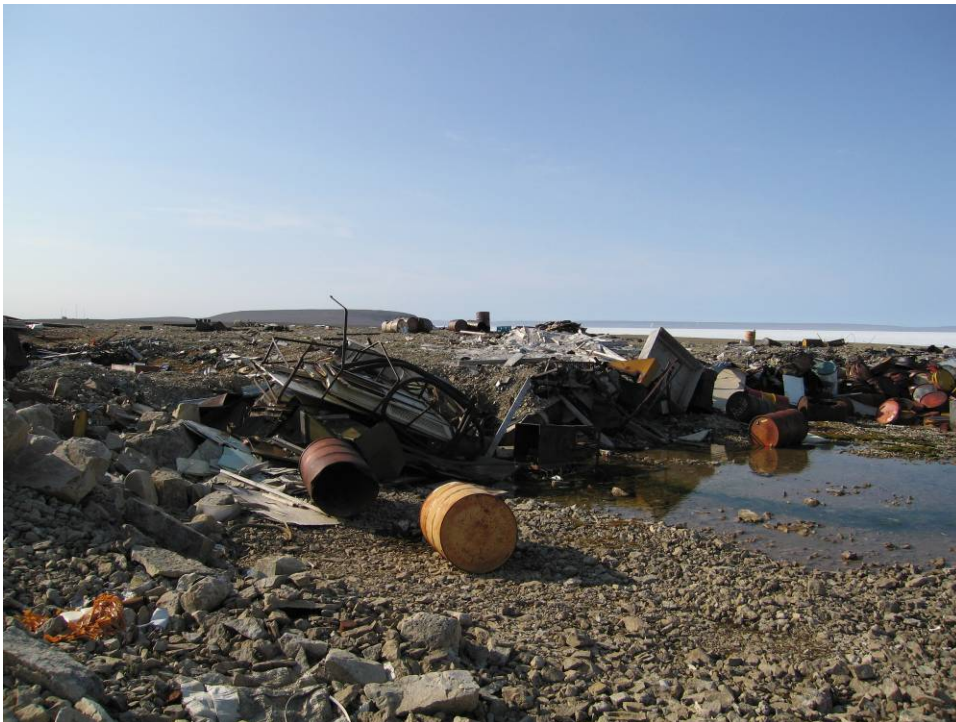
Figure 17: North side of existing BMDS and pooled water.

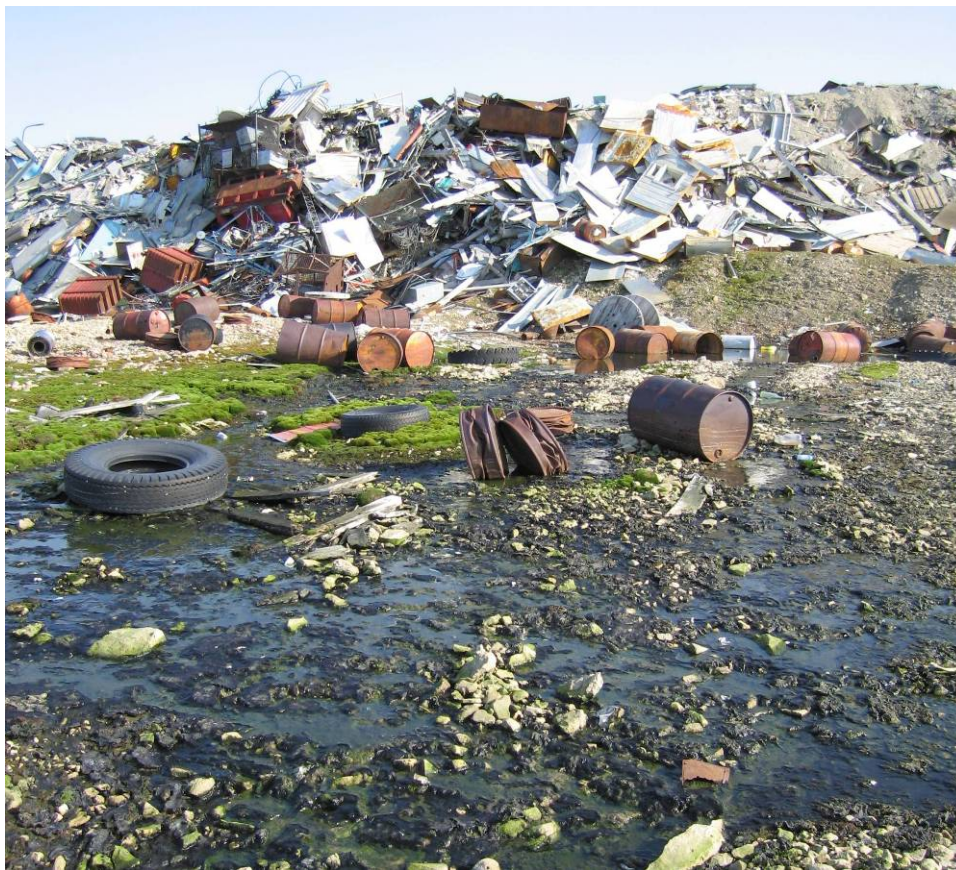
Figure 23: Drainage area on south-west side of existing BMDS.

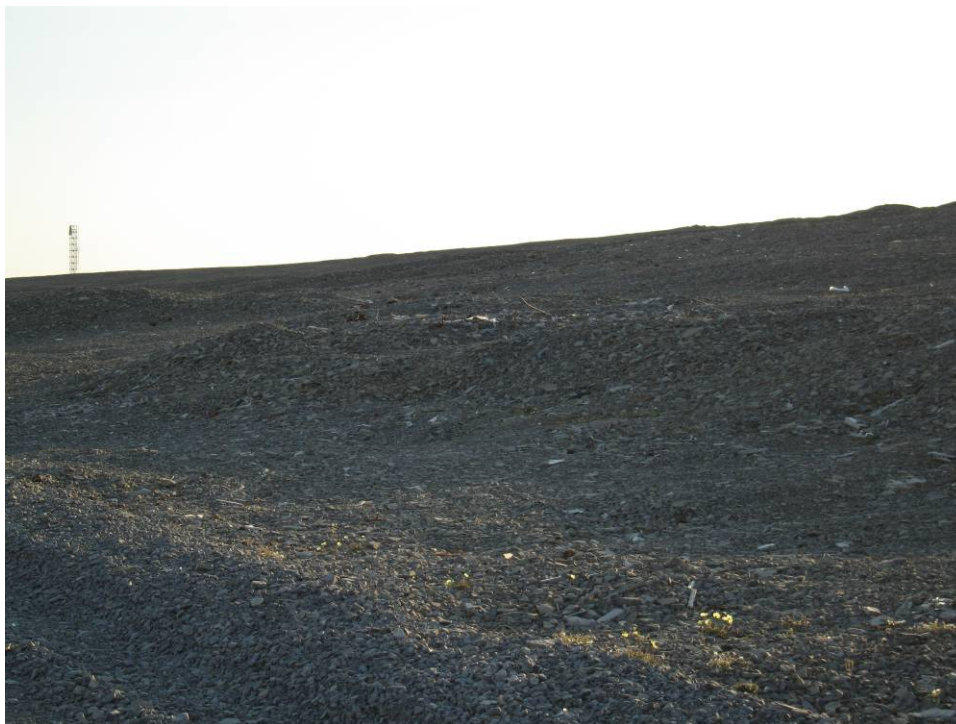
- ii. Along the north shore of Resolute Bay, waste and bulky metal waste was day-lighting through the as-placed gravel cover. From discussion with community members, this shore is a location of buried military waste. Figures 24 and 25 provide photographs of Resolute Bay and the buried waste along its shore.

Figure 25: Photograph of waste materials day-lighting from gravel-cover along shore of Resolute Bay, looking east.

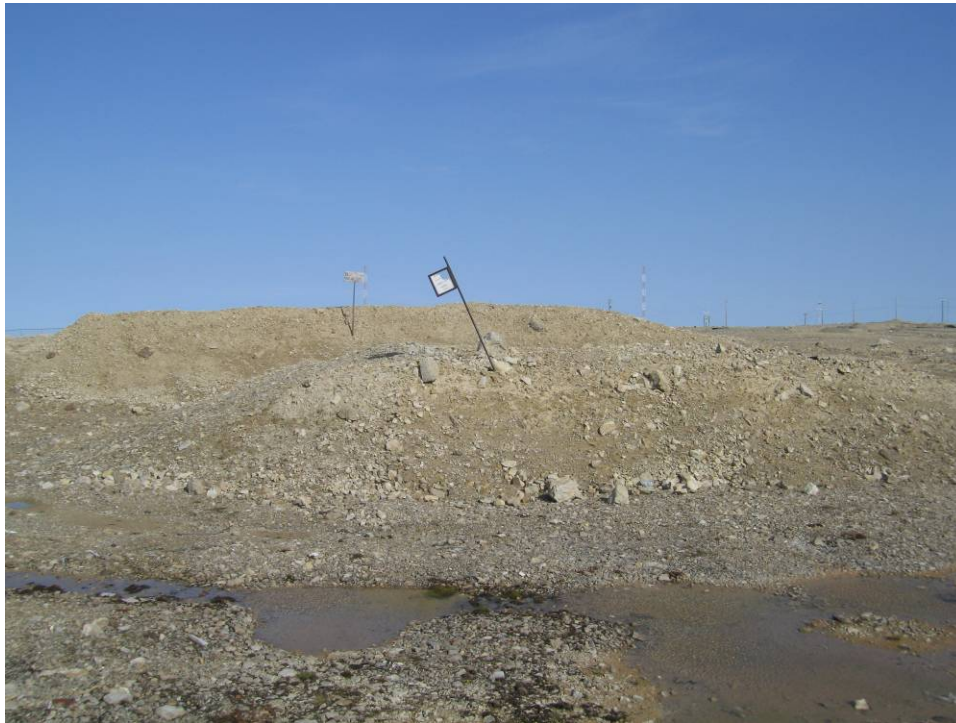
- v. Adjacent to the south-east corner of the proposed MDS there is a sign that marks a burn waste pile with dimensions of about 4 m x 10 m x 3 m. From visual inspection, the burn waste is covered with pit run gravel. No attempts were completed to assess cover thickness. No controls or safeguards were provided around the piles to limit site drainage or restrict public access for safety. Figure 26 depicts the burn waste pile and asbestos pile.

- vi. Adjacent to the burn waste pile near the south-east corner of the proposed MDS, there is a sign that marks an asbestos pile. The asbestos pile is about 3 m x 10 m x 2 m in size. From visual inspection, the asbestos is covered with pit run gravel. No attempts were completed to assess cover thickness. No controls or safeguards were provided around the piles to limit site drainage or restrict public access for safety. Figure 26 depicts the burn waste pile and asbestos pile.

Figure 26: Photograph of burn waste (background) and asbestos piles (foreground).

- vii. Separate of hazardous materials from bulky waste and municipal waste.
- viii. Appropriately dispose of hazardous materials, such as asbestos and burn ash.

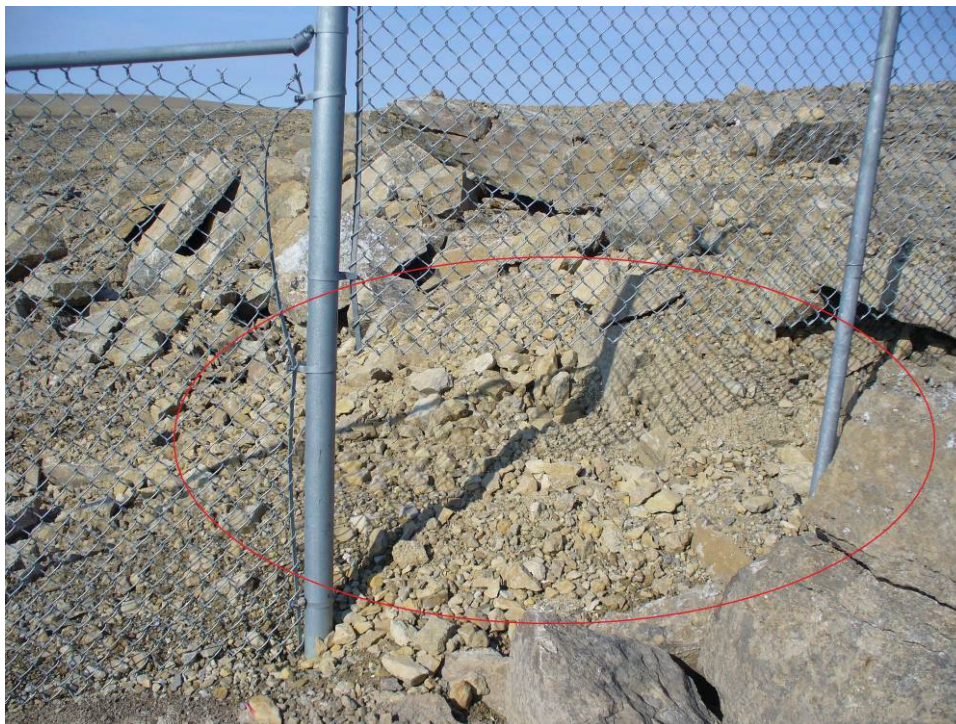
- ii. The maximum 50 mm spacing between grade and bottom of chain link indicated on the drawing could not be achieved everywhere due to the terrain, resulting in significant localized gapping at the underside of fence (refer to Figure 34).

Figure 34: Gapping at base of fence based on terrain.

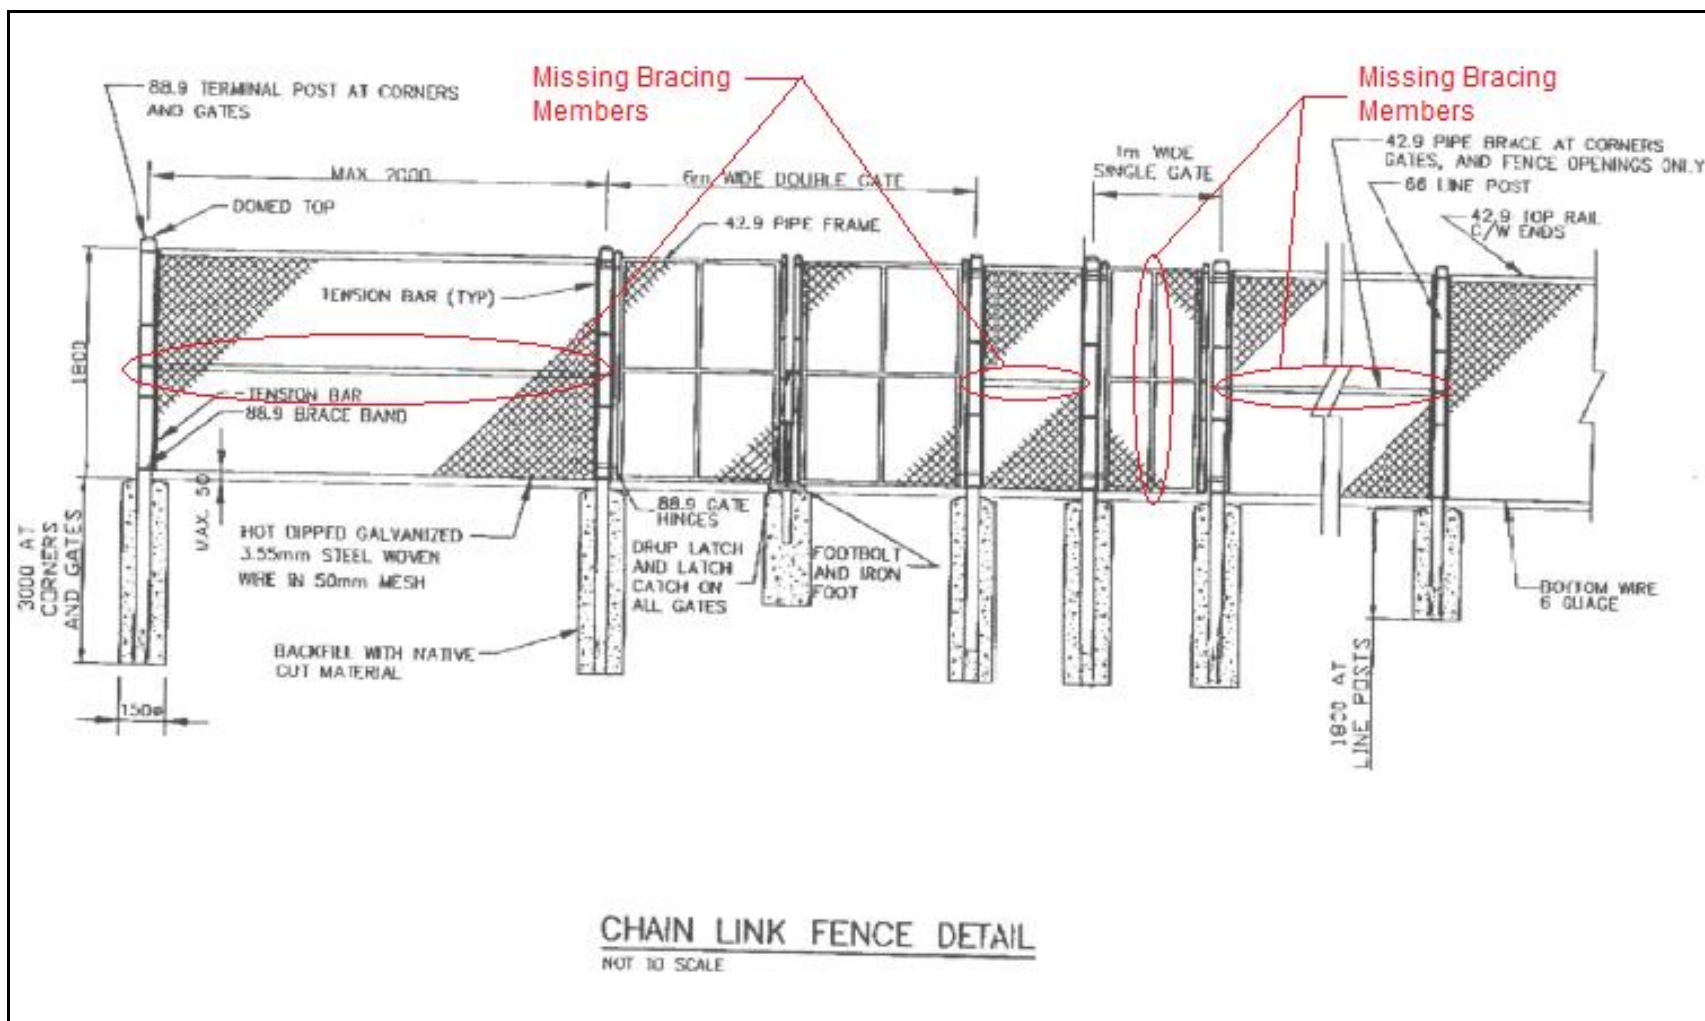
- iii. A vertical bracing member in the pedestrian door was not in place (refer to Figure 35).
- iv. Horizontal bracing members adjacent to gate and door shown on the drawing were not in place (refer to Figure 35).

Figure 35: Drawing showing missing bracing members at gates.

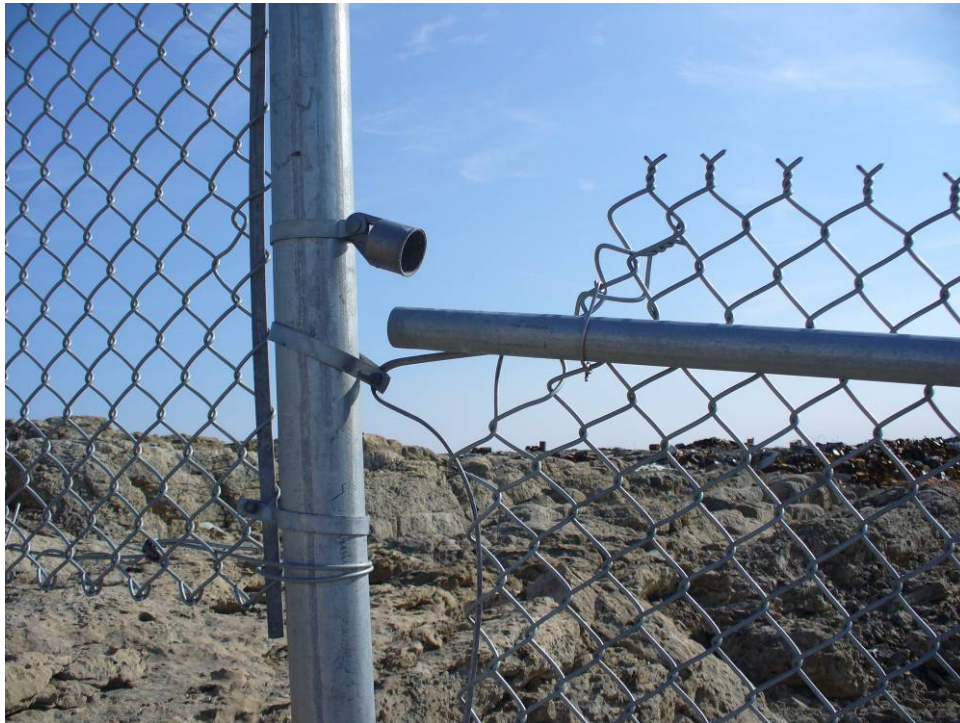
- v. Tension bars were found to be deformed (refer to Figure 36).
- vi. Disconnected top rail to 88.9 mm posts noted (refer to Figure 36).
- vii. Some domed tops for main 88.9 mm dia. post members were missing allowing water into the centre of the posts.

Figure 36: Top rail connection, disconnected.

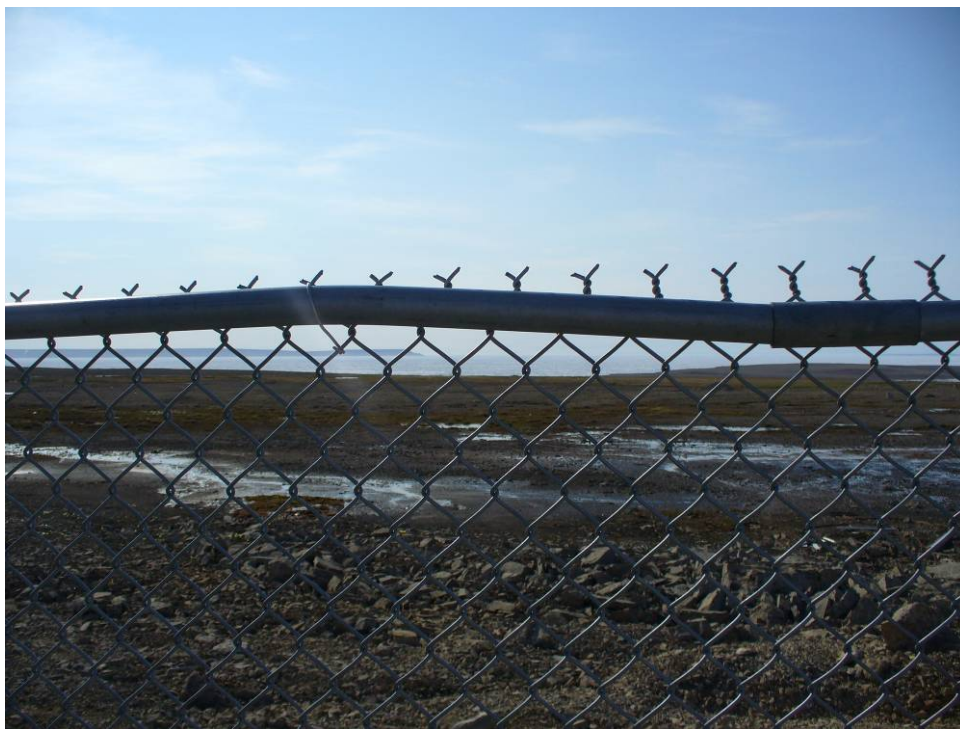
- viii. Bent top rail noted (localized; refer to Figure 37).
- ix. Disconnected top rail noted (localized; refer to Figure 38).
- x. Single top rail to intermediate post connection found to be disconnected (localized; refer to Figure 39).

Figure 37: Localized bent top rail.

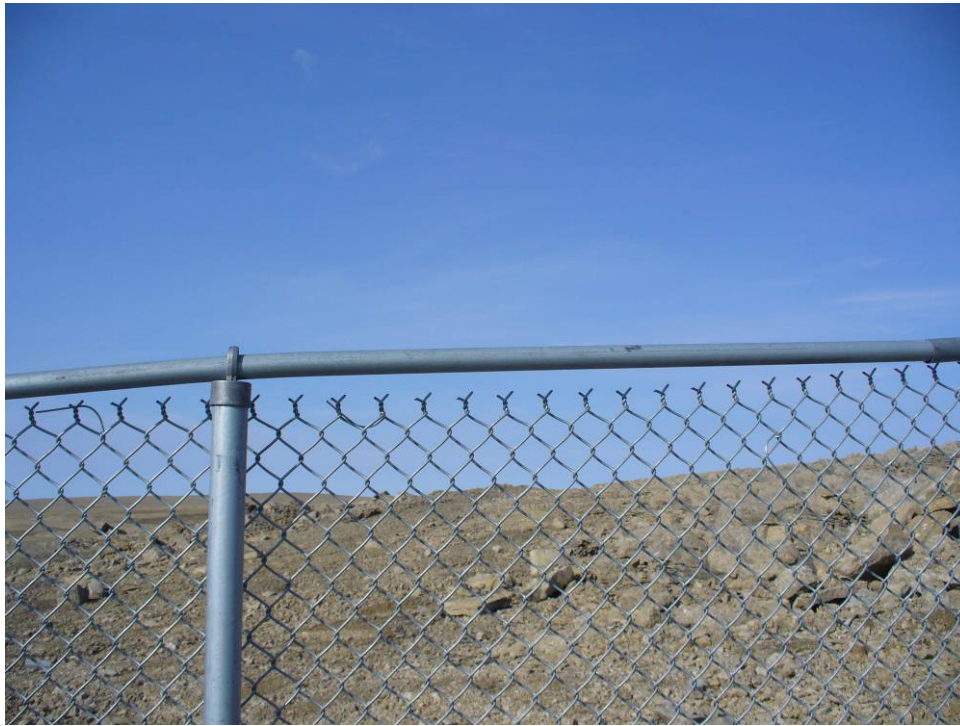
- xi. Chain link short from top rail noted at north side (localized; refer to Figure 40).
- xii. Single location where horizontal brace should be added at north-east corner along road (localized; refer to Figure 41).

Figure 40: Chain link short from top rail.

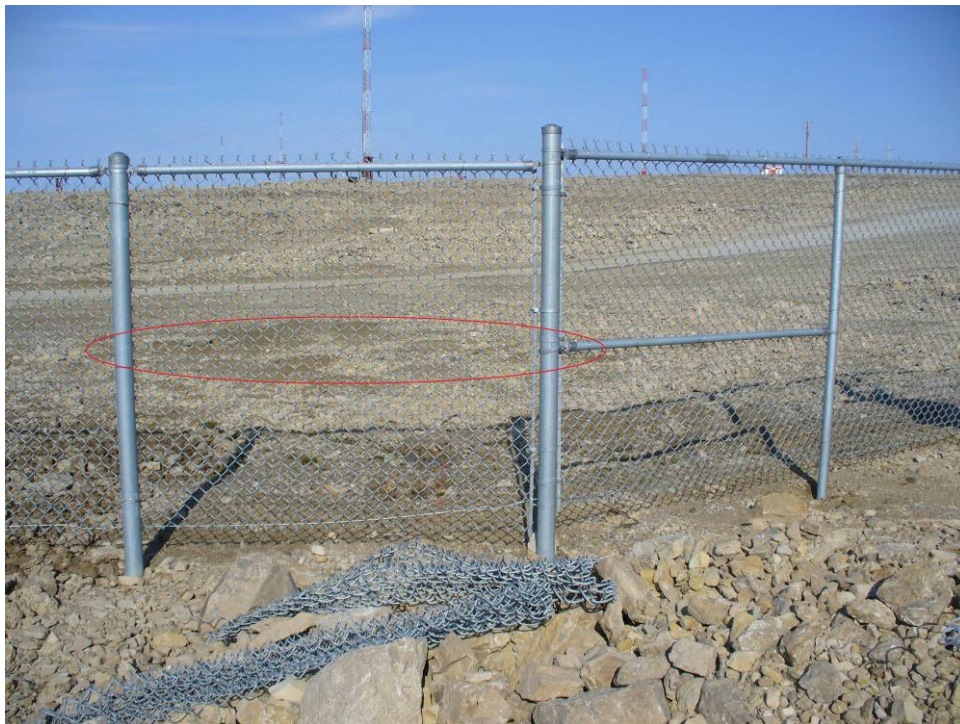
Figure 41: Potential location for addition of new bracing member.
