WATER LICENCE INSPECTION FORM

Licensee		Licensee	Representat	ive				
Hamlet of Res	solute Bay	Bhab	Bhabesh Roy					
Licence No. / Expiry		Represe	ntative's Title)				
3BM-RES1520	0	Regio	onal Eng	gineer				
Land / Other Authoriza	Land / Other Authorizations Land / Other Authorizations							
Date of Inspection		Inspecto						
June 23,2017		Jonat	than Me	esher				
Activities Inspected Camp Roads/Hauling	☐ Drilling ☐ Other: Water D		Mining ☐ Construction ☐ Reclamation ☐ Fuel Storage ☐ Other: Municipal					
Conditions:	A - Acceptable	C - Concern U - Unacce	eptable	NA – Not Applicable	NI – Not Inspe	cted		
Water Use	Condition Com	ment Site Conditions	Condition	Comment Haz/Mat Manage	ement Condition (Comment		
Intake/Screen	NA	Water Management Structures		Storage	С			
Flow Measure. Dev		Culverts / Bridges	NA	Spills	NI			
Source:	NA	Drainage	NA	Spill Plan	A			
Water Use:	NA	Erosion / Sediment	NA					
Recirculation (y /n	n) NA	Mitigation Measures	NA	Administrative

Photo Log			
Date	Authorization	Camera	Inspector
June 23, 2017	N4L3-1571 (3BM-RES1520)	Sony Cyber shot	J. Mesher

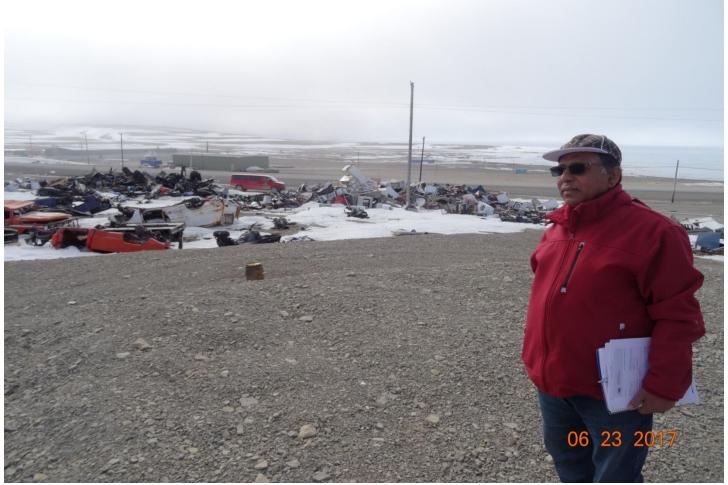
<u>Inspection</u>								
 No sign of the Haza 	e sign of leachate of water entering ordous waste is se	leaving the facility. See figure the facility. See figure 2 for up gregated in a berm like structu is the Arctic Ocean, this site d	gradient f Ire. See Fi	from the facility. gure 1 for hazardous mat	erial.	ters.		
 Solid Waste Disposal Facility This facility in managed by the burn and cover procedure. The facility does not appear to be lined or contained There was no sign of water flowing into or from the facility. See figure 4 for up gradient and figure 5 for down

Figure 1: Down gradient of metal dump.

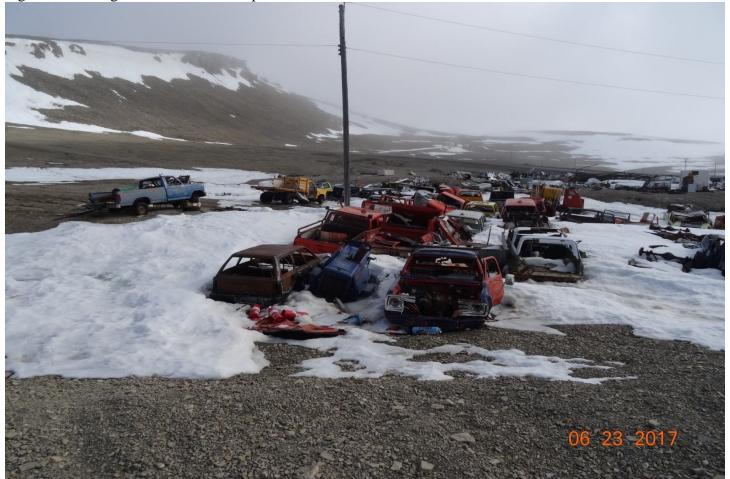
Figure 2: Up gradient from the metal dump.

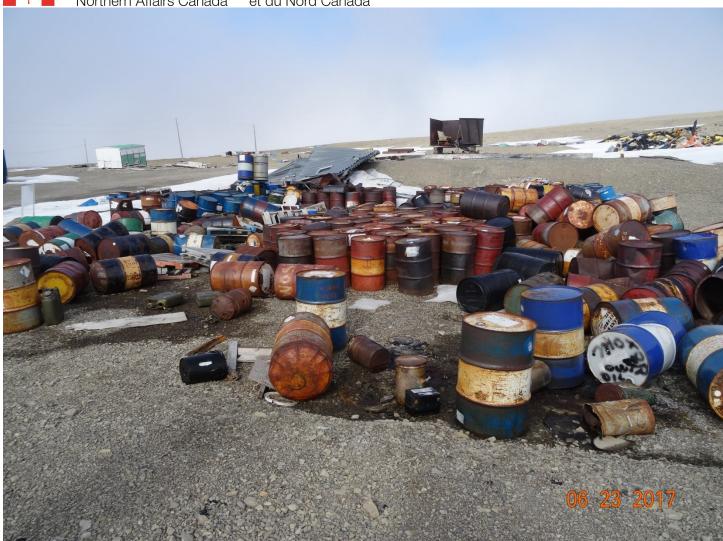
Figure 3: Hazardous Material.

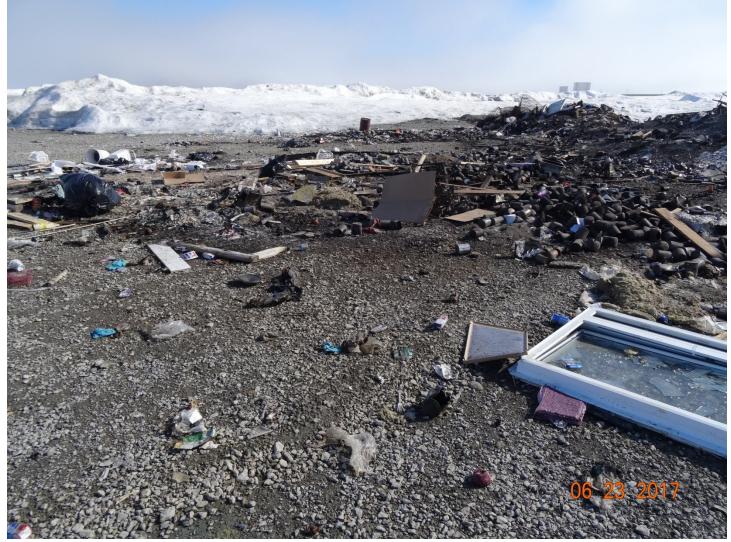
- gradient of the dumping site.
- 7. During the inspection it was noted that the Licensee is dumping snow up gradient from the municipal refuse, this may cause the melt water to be mixed with ash and produce Leachate. Any unlicenced discharge of waste is considered a spill and is required to be reported to the NU-Spill line.
- 8. The nearest body of water is the Arctic Ocean and this site does not appear to the inspector to effect inland waters.

Figure 4: Up gradient of municipal refuse.
