**Resolute, Nunavut Dump Site Investigation Hamlet  
of Resolute, Nunavut**

**Project No. 003-GNCGS**

**The Government of Nunavut  
Department of Community and Government Services**

September 5, 2008

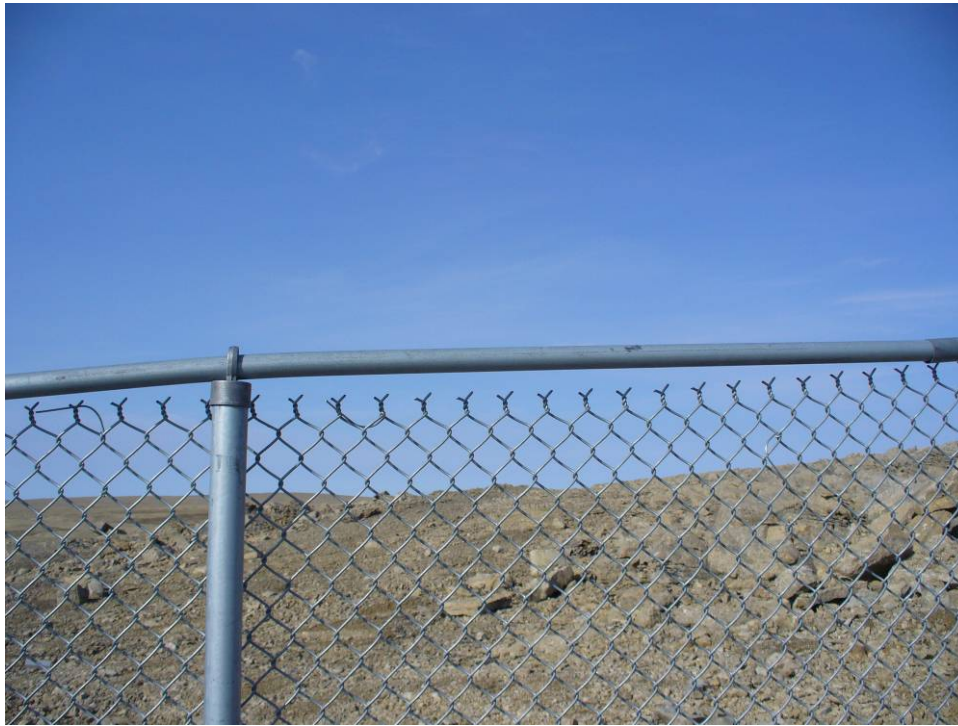
- xi. Chain link short from top rail noted at north side (localized; refer to Figure 40).
- xii. Single location where horizontal brace should be added at north-east corner along road (localized; refer to Figure 41).

Figure 40: Chain link short from top rail.

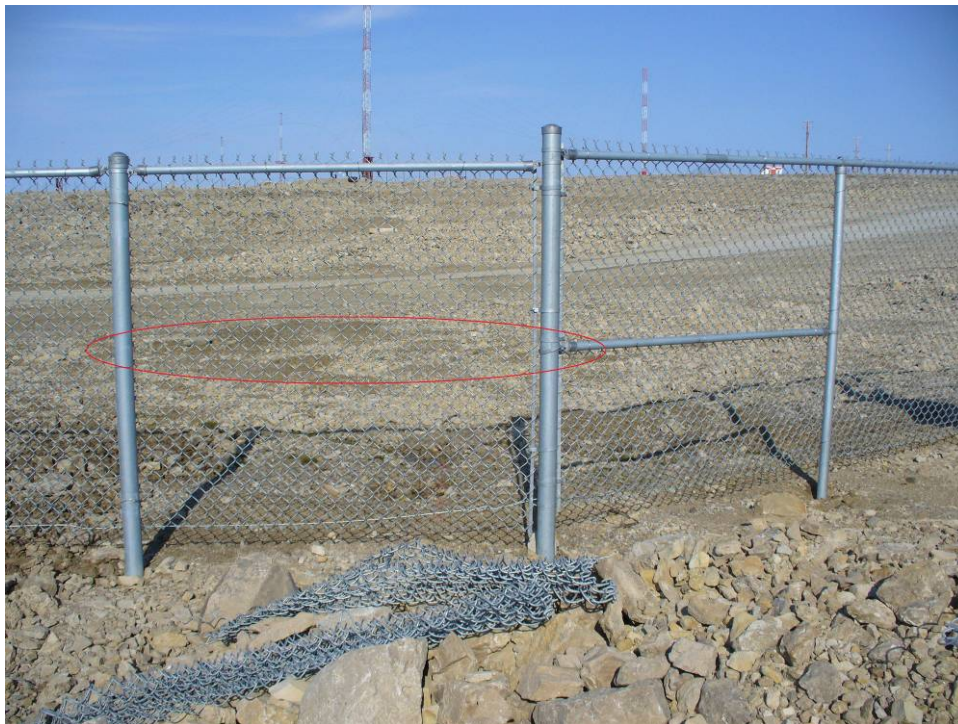
Figure 41: Potential location for addition of new bracing member.

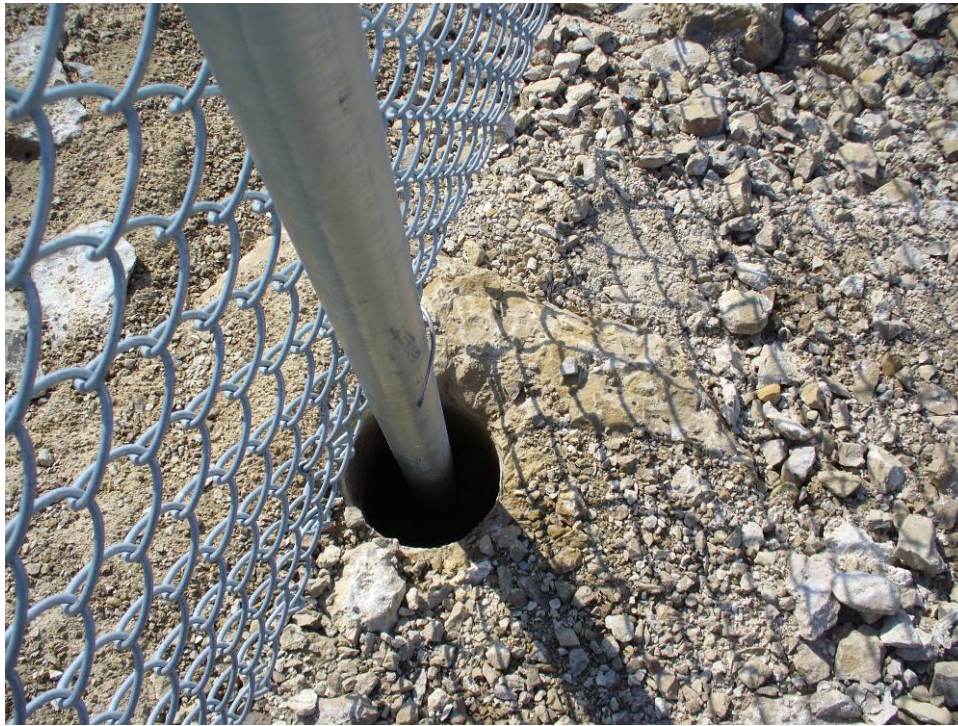
- xiii. Some of the drilled holes for the existing posts were not completely backfilled (refer to Figure 42).

Figure 42: Drilled and embedded post lacking backfill to top of hole.
