**Sanikiluaq Truck Fill Station
Evaluation of Existing Condition**

Type of Document
Final

Project Name
Assessment of the Sanikiluaq Water Intake

Project Number
OTT-00209718-A0

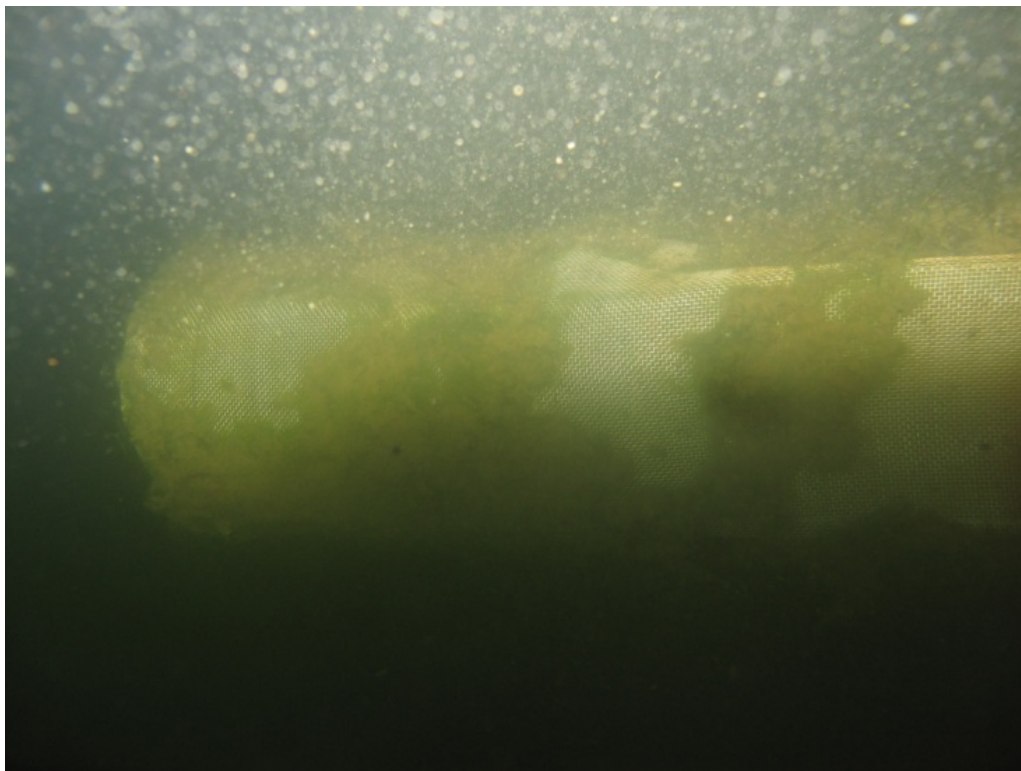
- The back-up ring at the connection between the elbow and the intake screen displayed some deterioration due to corrosion. This ring, together with the bolts, was considered suitable to remain in service.
- The screen was found to be in good condition. The screen was coated with vegetation. A photograph of this accumulation is presented in Appendix A of this report.

- It was noted that the intake screen displayed some inwards distortion, which may be indicative of larger than normal pressure difference across the screen.
- The screen was not removed for an internal inspection, as it was felt this would damage the back-up ring making replacement impossible.
- During the inspection the external surface of the screen was cleaned of accumulated vegetation.

Photo 1: Intake Screen Prior to Cleaning

No further short term actions, which require attention prior to next construction season, were identified. An inspection of the intake, by a dive team, on a five year cycle is recommended. This inspection should include cleaning of the screen of accumulated vegetation. The back-up ring that retains the intake screen should be replaced during the next underwater inspection.

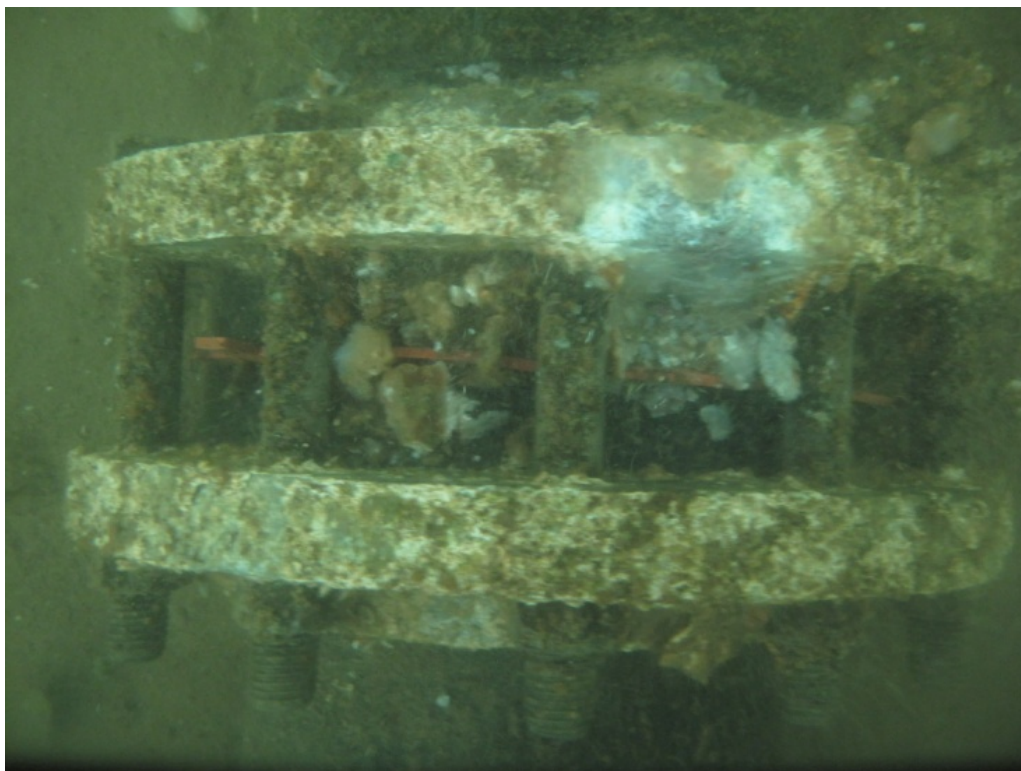
There was no opportunity for water and silt entry into the intake pipeline at the lateral.

Photo 3: Typical Flanged Joint at Lateral

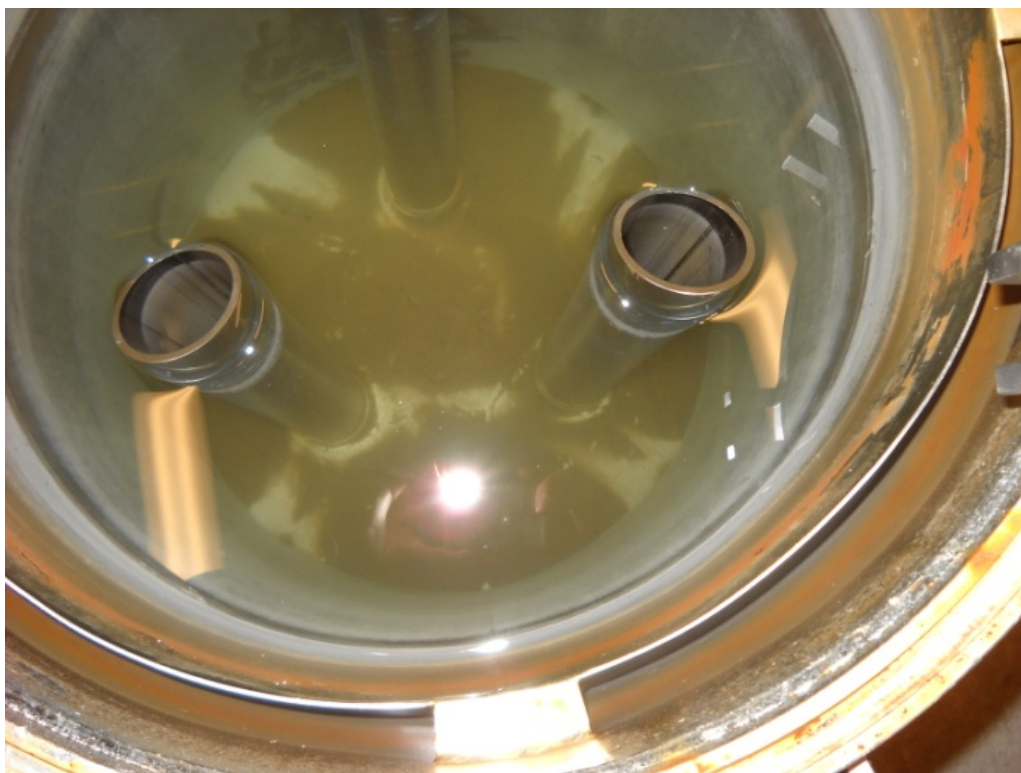
All of the filters were opened for an internal inspection. The construction of the filter housings provides for only partial draining of the housings to the level of the discharge tubes within the filter cartridges. No filter cartridges were found in any of the filter housings. The interior of the filter housings was found to be generally clean with a small accumulation of a material that appeared to be greenish-brown organic silt. The housing that normally contained the coarse filters (20 μm) also displayed a limited accumulation of a material that resembled fish scales. Photos illustrating the internal conditions within the filters are presented in Appendix A of this report.

It was noted that the bottom chamber had been piped to the drainage trench, and that the cartridge chamber had not been provided with such a drain.

Photo 4: Filter Housing 20 Micron

It is recommended that the filters be returned to service. This requires that the filter housings be emptied, cleaned, disinfected, flushed of disinfectant solution and that filter cartridges be installed. The disinfection process should be conducted in accordance with AWWA Standard C653-03 Disinfection of Water Treatment Plants. It is also appropriate to replace the gaskets between the housings and the covers at this time. Annual replacement of these gaskets is a typical maintenance requirement for this type of filter.

It is recommended that valved drain piping be provided from the cartridge chamber to the drainage trench. This will facilitate ongoing internal cleaning and maintenance.

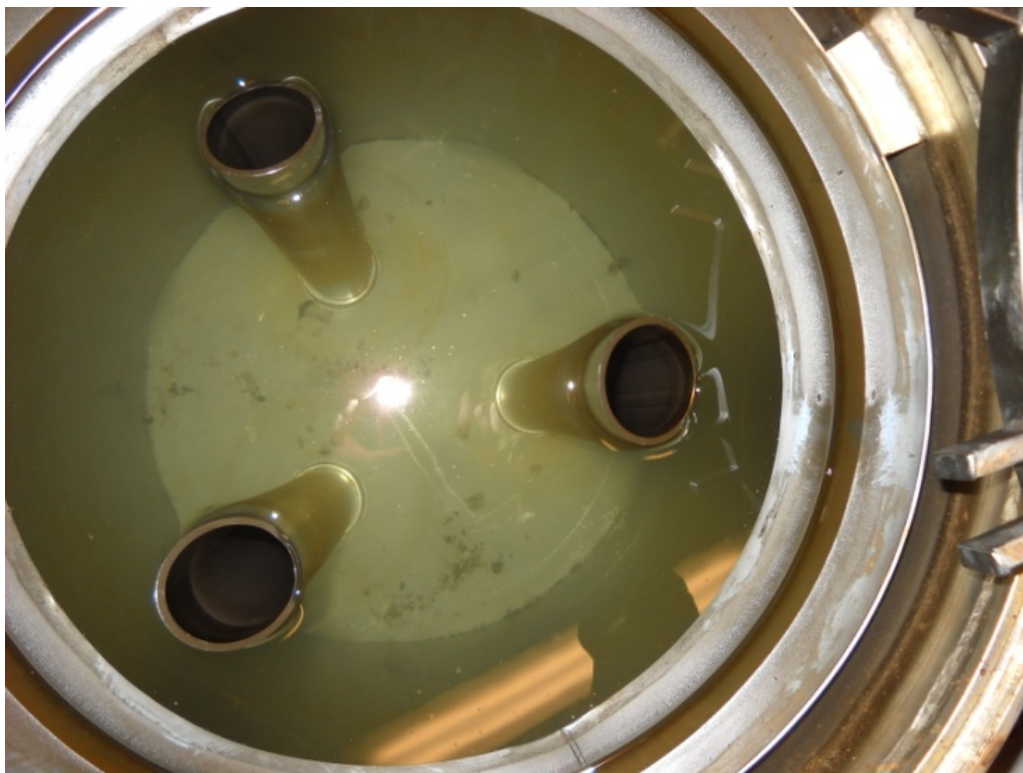
Photo 5: Filter Housing 5 Micron

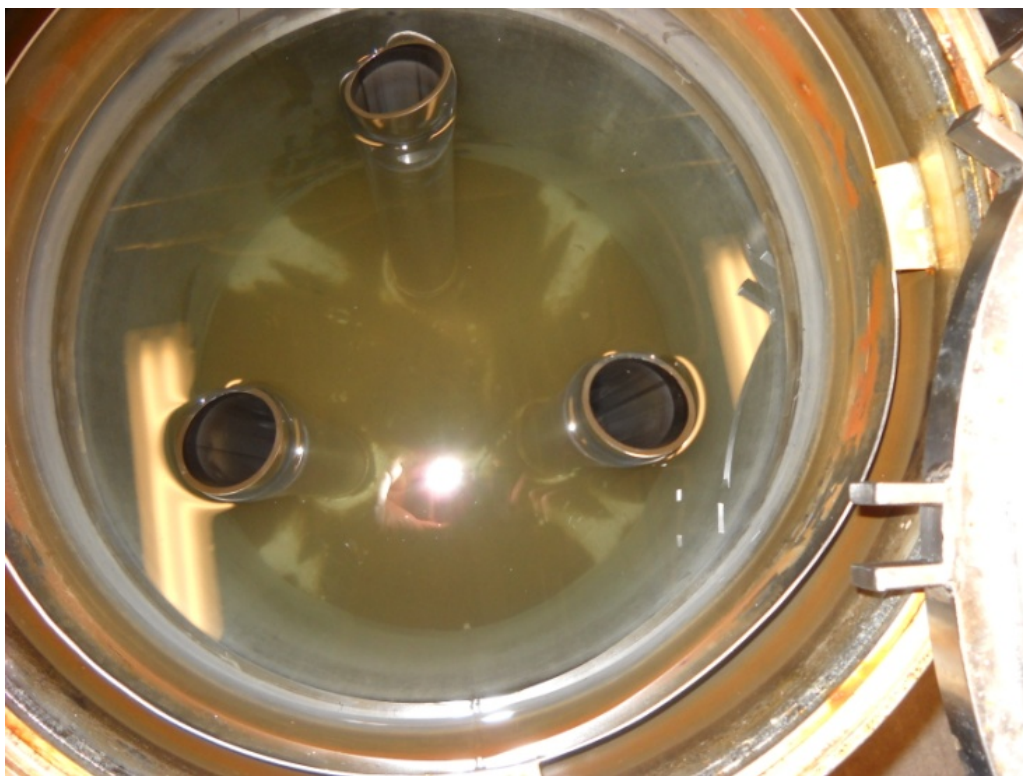
Photo 6: Filter Housing 5 Micron

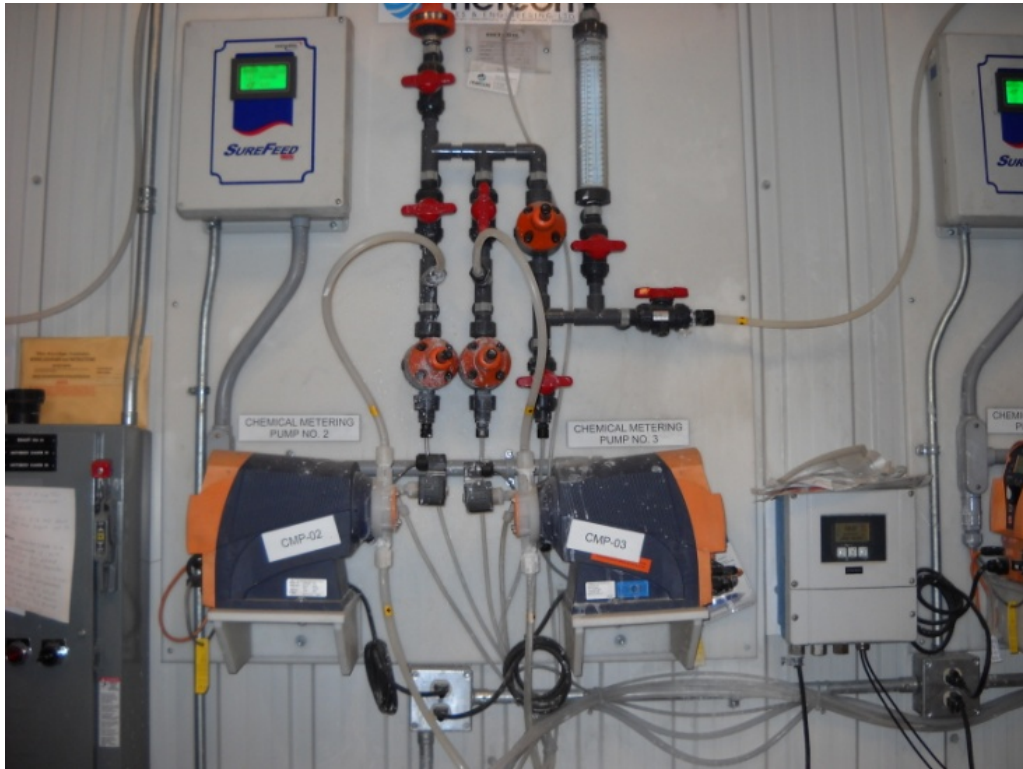
It was noted that operational personnel have become familiar with the metering pumps and are capable of the ongoing maintenance and repair required to keep the pumps in service. It also appears that chlorine concentration of the treated water is measured daily and the operating staff has become familiar with adjustment of the metering pumps to achieve a desirable treated water chlorine concentration.

Photo 7: Metering Pumps

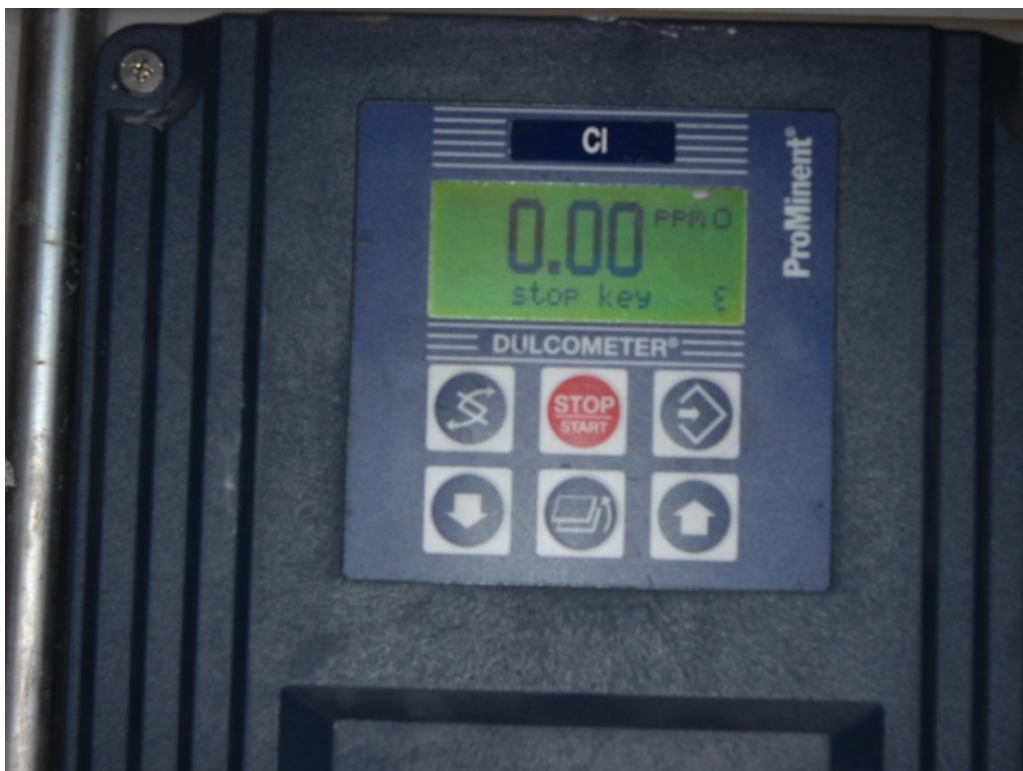
All of the chlorine controllers were found to be powered and appear to be functional. The displays of these controllers provided the following indications.

Photo 8: Chlorine Controller

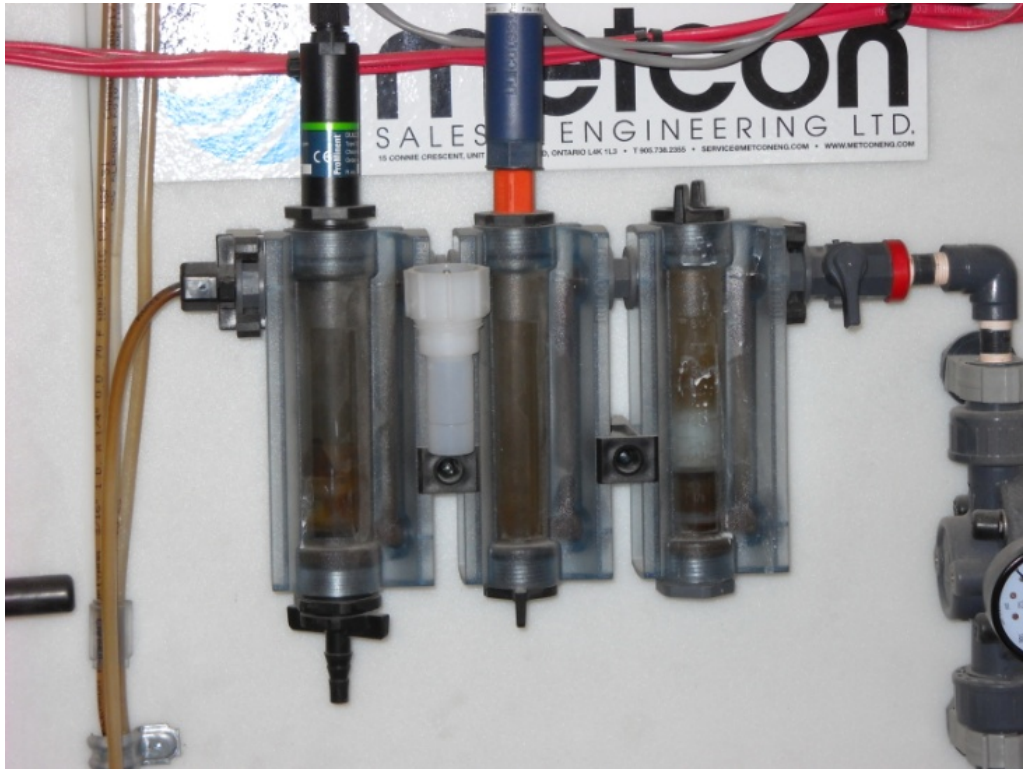
Photo 9: Inline Chlorine Measurement

The chlorine sensors should be returned to serviceable condition. This would require cleaning of the in-line sensor housing, replacement of chlorine measurement membranes and electrolyte and replacement of the pH probes. It is the manufacturer's recommendation that the chlorine probes be serviced every 8 to 10 months, or if they provide unreliable indications. It is also recommended that the pH probe be replaced on an annual basis.

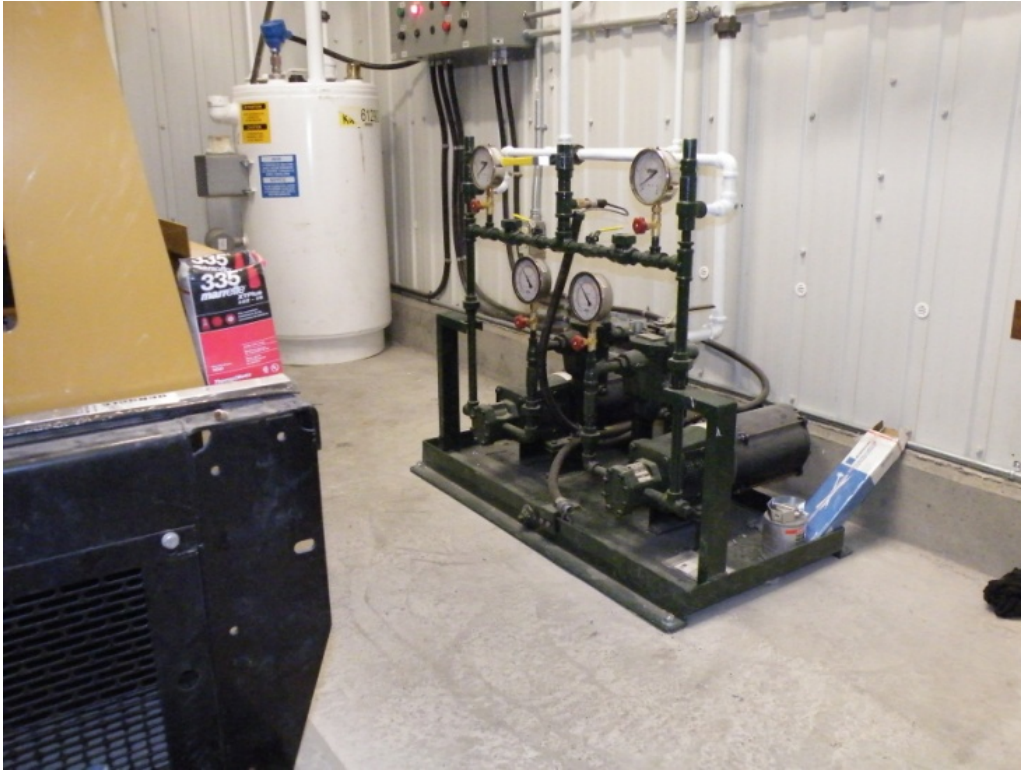
Subsequent to the site visit, a review of the photographs taken during a visit to the site in December 2010 was undertaken. It is noted that the level transmitter was changed following the 2010 visit. We also note that the current transmitter makes use of a different sensing technology from the original installation. No information has been obtained regarding the reason for the change of this transmitter. It is also noted that the new transmitter is located in closer proximity to the fuel inflow point than the original transmitter. No operating instructions for the current transmitter were located at the site. Due to a lack of operating instructions the impact of adjustment to various parameters of the level transmitter could not be investigated. There is also the potential for interference between the ultrasonic beam and the tank wall.

Photo 11: Transfer Pumps and Day Tank (December 2010)

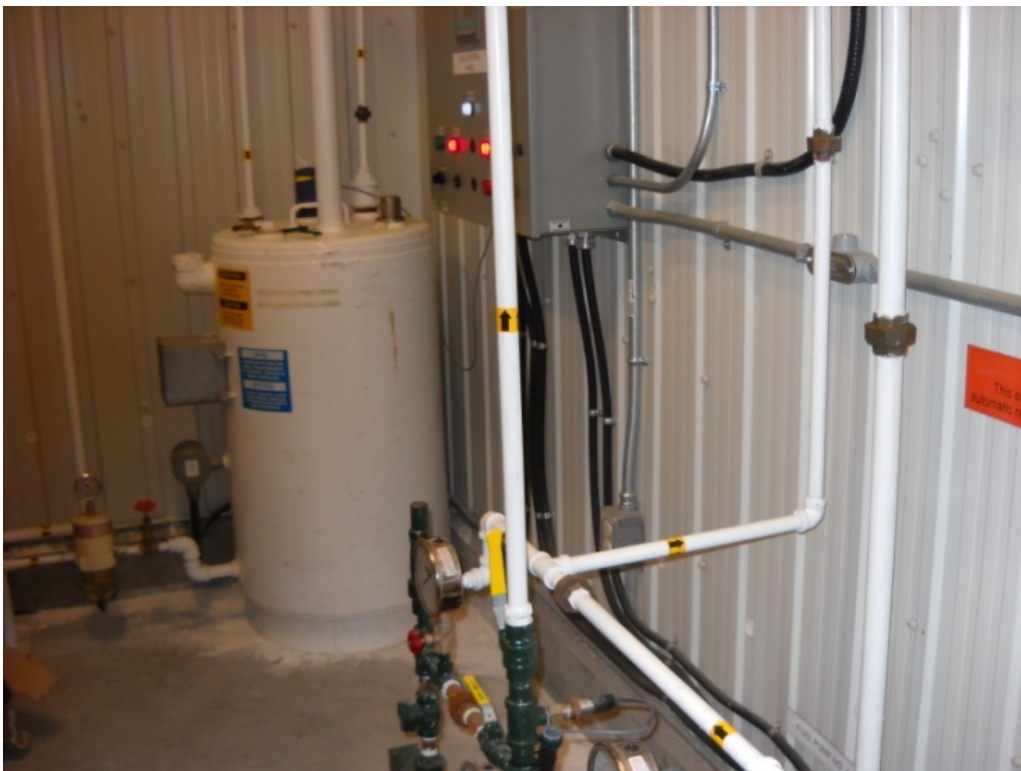
Based on observations of the panel indications of tank levels, it was concluded that the indication of day tank level was instable during operation of the transfer pumps. It was also noted that the inflow point from the transfer pumps was in close proximity to the ultrasonic transmitter. This may be the result of several conditions including interference from the spray of fuel into the tank and misinterpretation of the fuel level due to waves due to the fuel splashing into the tank.

Photo 12: Day Tank (November 2012)

It is recommended that the reliable automated operation of the fuel transfer pumps be re-established. It appears that reliable measurement of the level in the day tank is key to the reliability of this system.

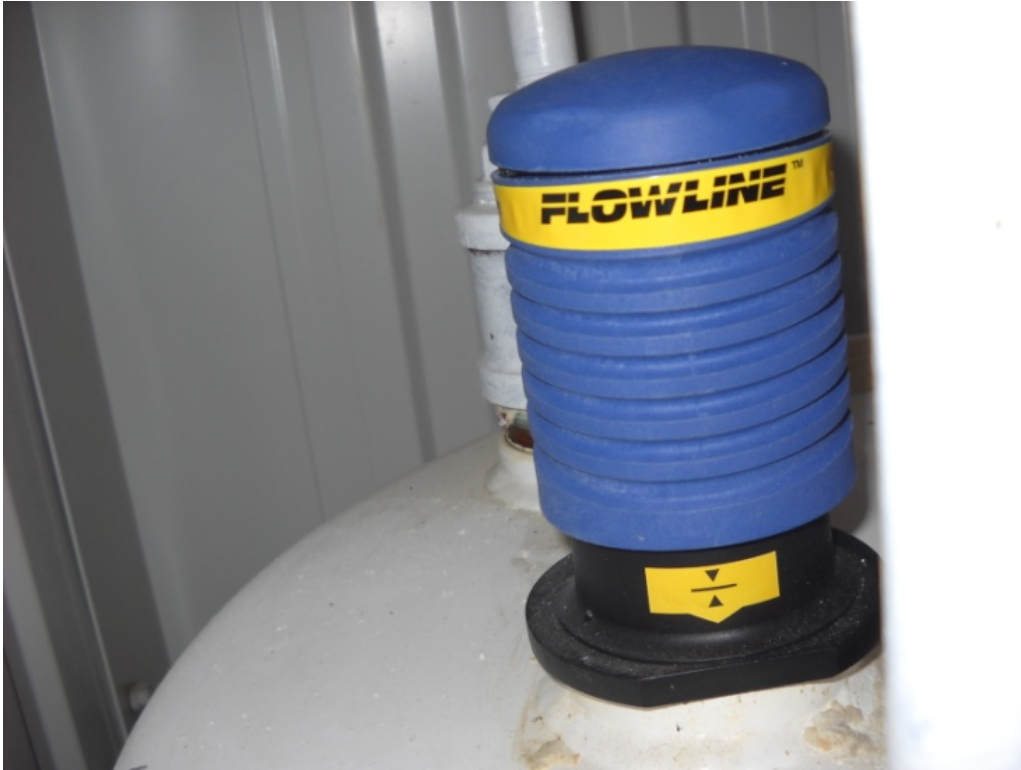
Photo 13: Day Tank Level Sensor

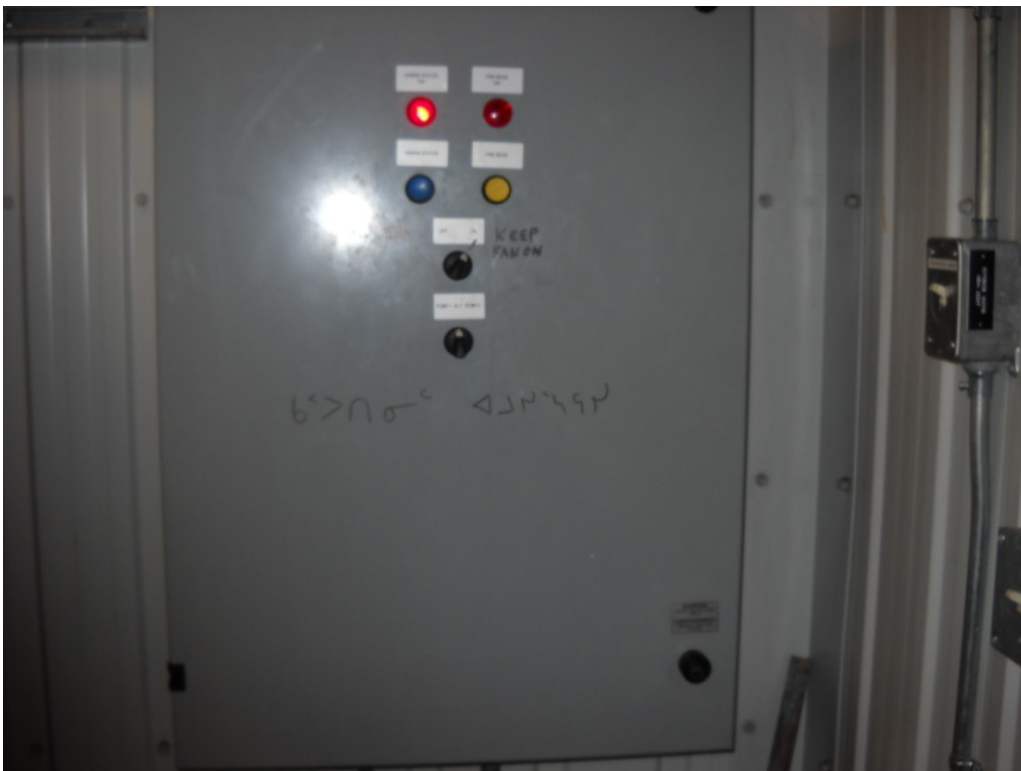
It was initially noted that the control system was not in use and that the pumps were under manual control. Pump operation was achieved using the pump selector on the control panel, followed by switching on the control panel. This was followed by manually starting a chlorine metering pump. It appeared that pump WP 01 was the preferred selection. Both pumps (WP 01 and WP 02) appear to provide approximately 500 litres per minute. Pump WP 01 appeared to provide a slightly higher rate of flow. Both pumps are performing in a fashion that is consistent with the manufacturer's predictions. Based upon an interpolation of the pump performance curve, the variation in flow, as noted between February and November 2012, would arise from a modest increase in total dynamic head of approximately 3.6 metres (5 psi).

Photo 14: Facility Control Panel

- The automated control system for the building should be retained in service. This will permit automated operation of the ventilation and chlorination systems.
